# Without site investigation ground is a hazard

Site Investigation Steering Group

## Publications in the **Site investigation in construction series:**

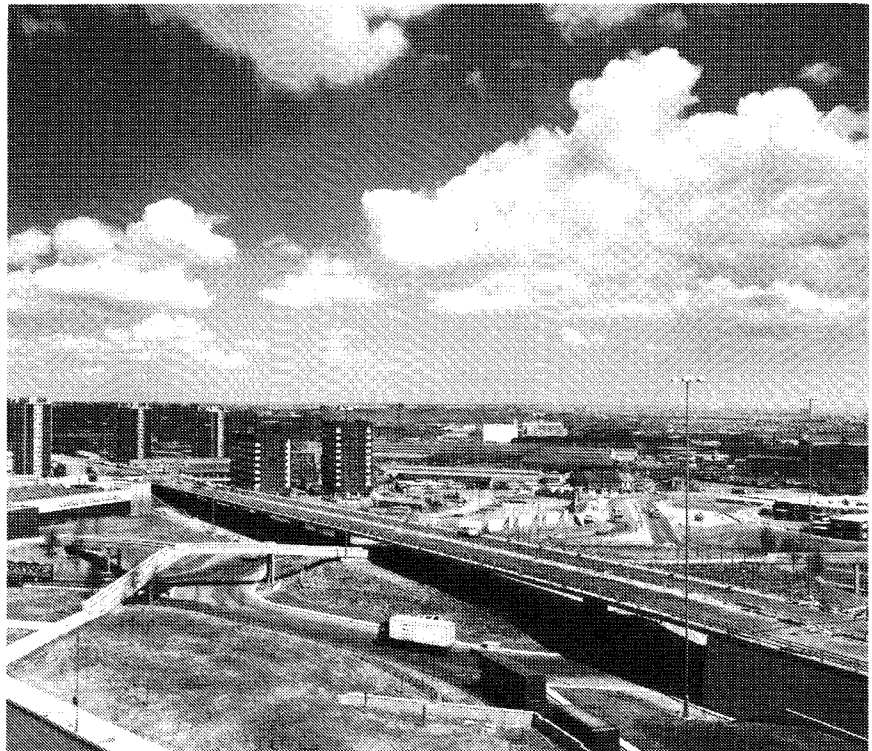
**Description** The photograph shows a four-carriageway viaduct in an urban area, and the underlying ground conditions have been illustrated. All the coal seams had probably been mined in the late 18th and early 19th centuries by pillar and room working. No records were available but it was known from earlier investigations that the workings had not completely collapsed, i.e. cavities remained, as they were overlain by a 'bridging' stratum of massive sandstone some 10 m thick.

*Four-carriageway viaduct*

In considering the viaduct foundations the above approach was rejected because high concentrated loads occurred at each pier and any local weakness in the sandstone might have created excessive settlement. Furthermore, for economy and elegance a continuous supported prestressed concrete viaduct had been chosen which could only tolerate small settlements at the piers.

**Solution** The cavities of the main coal seams were filled with a cheap fly ash-cement grout beneath and immediately beyond the foundation of each viaduct pier and abutment to ensure that collapse of the workings some distance away could not cause settlement or rotation of the foundations.

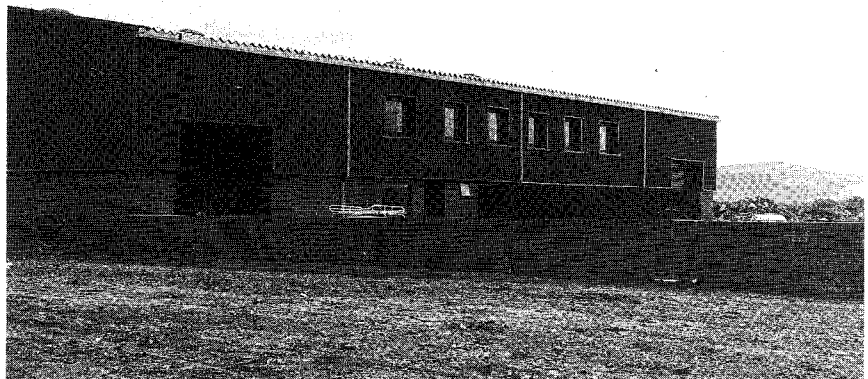
The steel frame of the structure was built on 10 m deep piles whereas the external cladding and internal walls were founded on strip footings in 1 m deep by 1 m wide trenches overlying tip material. The tip material was believed to have been placed 18 years earlier and was therefore capable of accepting low bearing pressures without excessive settlement.

*Completed factory building*

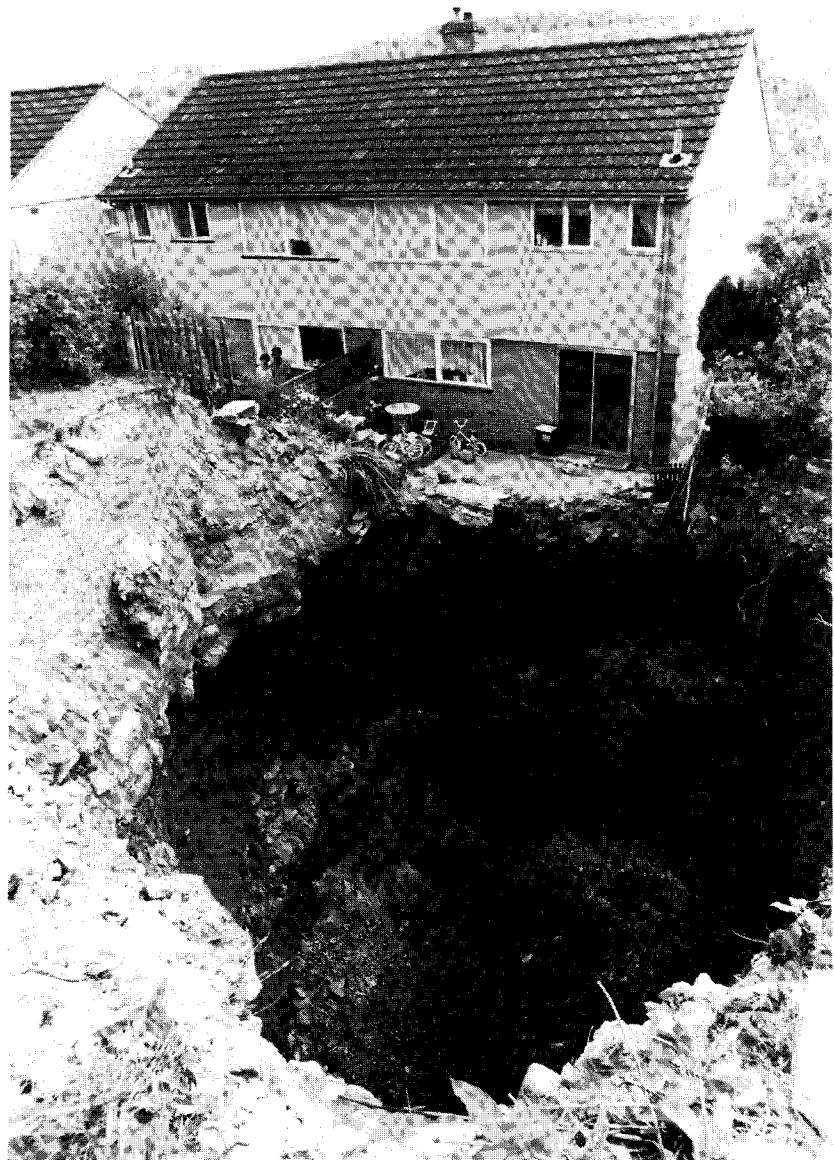
**Problem** Collapse of an old mine shaft leading to a surface 'crown' hole brought into question the surface stability across the whole housing estate.

*Gunnislake garden hole*

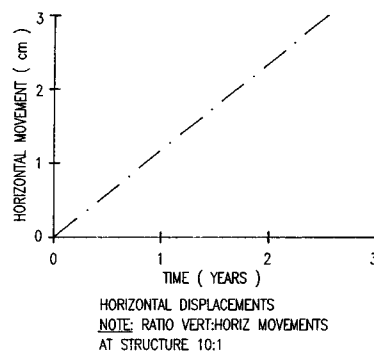
**Description** The existence of peats and very soft clays overlying glacial deposits was known from an earlier site investigation. Nevertheless, significant depths of fill were placed on the soft deposits and buildings were constructed on piled foundations close to the crest of the fill.

### *Ground movements in very soft organic deposits*

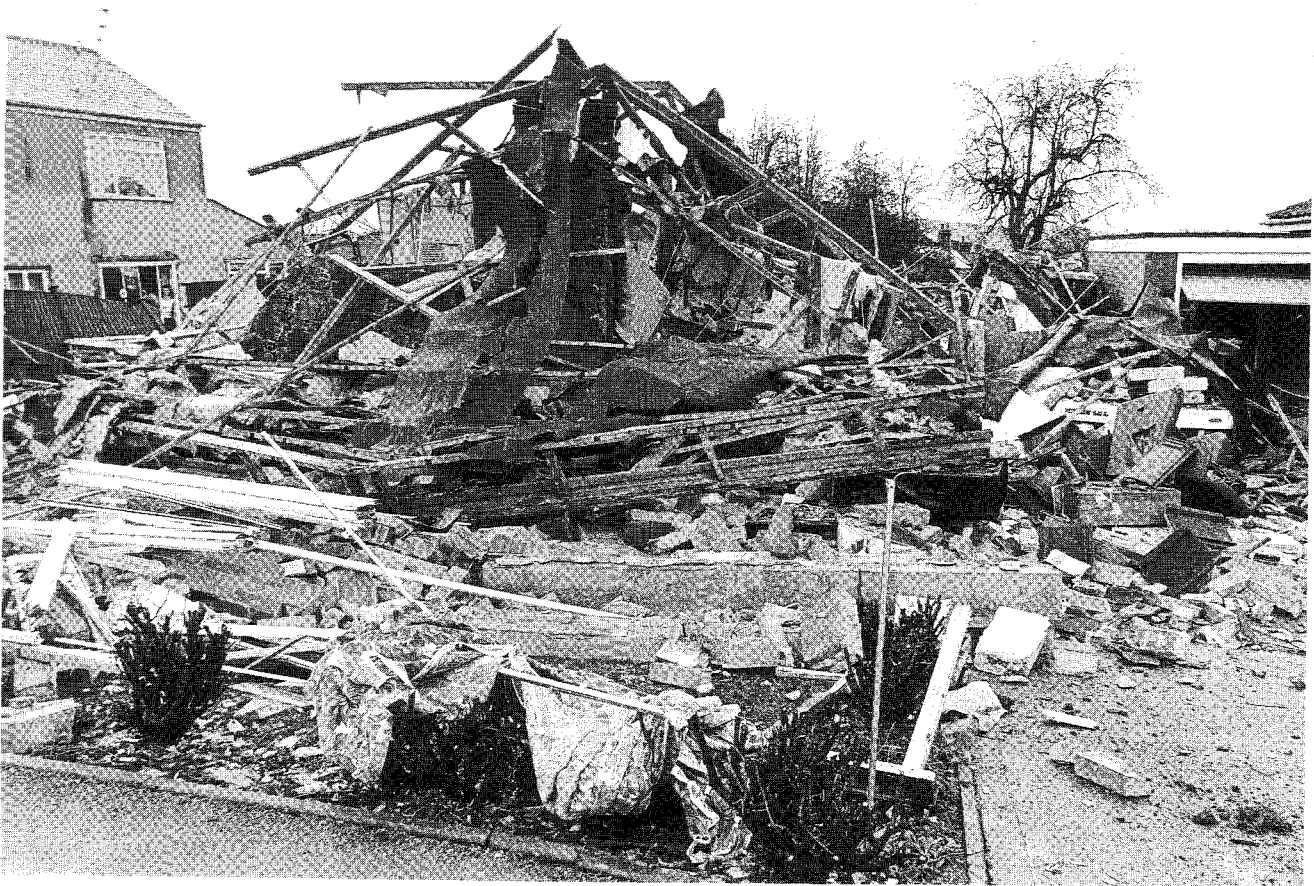
## Landfill gas explosion

**Description** The photograph shows a house that was completely destroyed by a methane gas explosion, badly injuring the three occupants. Subsequently at a Public Inquiry, the sequence of events leading up to the incident was established and evidence produced to ascertain the origin of the methane. During the proceedings it became apparent that signs of ground heating had been detected approximately 100 metres beyond the boundary of a nearby infill some years before the explosion but that the phenomenon had been misinterpreted as a shallow burning coal seam.

**Observation** Had the geology of the area and the geochemistry of methane been known to the investigators at that time, it is possible that the landfill would have been identified as the source of the methane and the area protected from the dangers of uncontrolled gas migration.

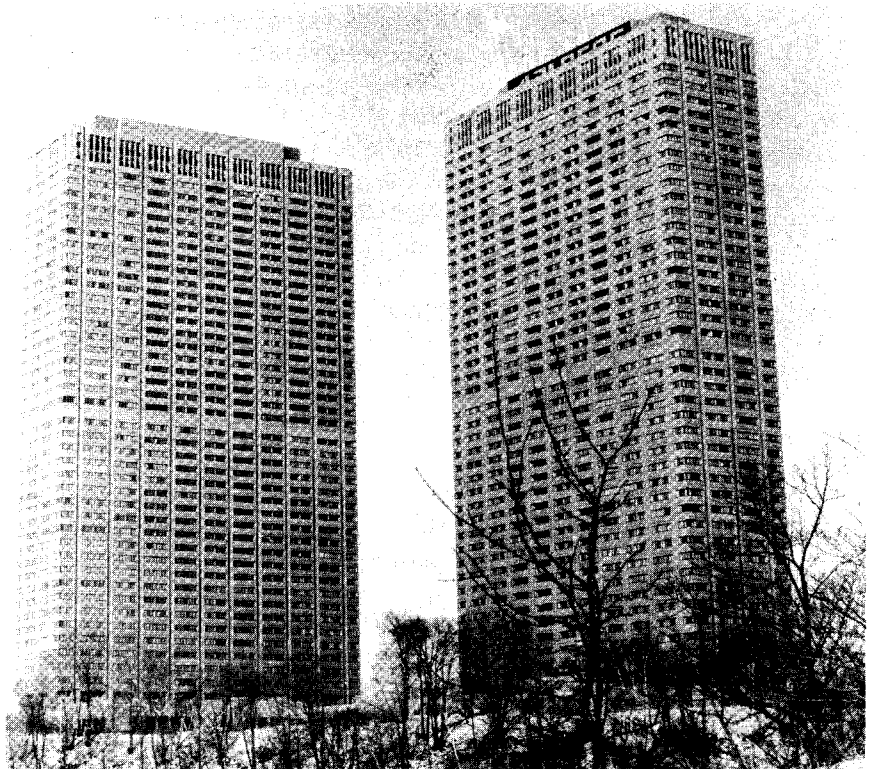
*Two apartment buildings built on different ground*

**Description** Two similar apartment buildings were constructed in close proximity. One building was founded onto bedrock through concrete caissons, and the second was placed on a simple concrete raft bearing on glacial soil overlying the rock.

**Observation** The foundations were constructed routinely and the difference in designs was dictated by differences in the subsurface geology revealed by an accurate site investigation with appropriate interpretation of the ground data.
