Appraisal and repair of timber structures

Peter Ross

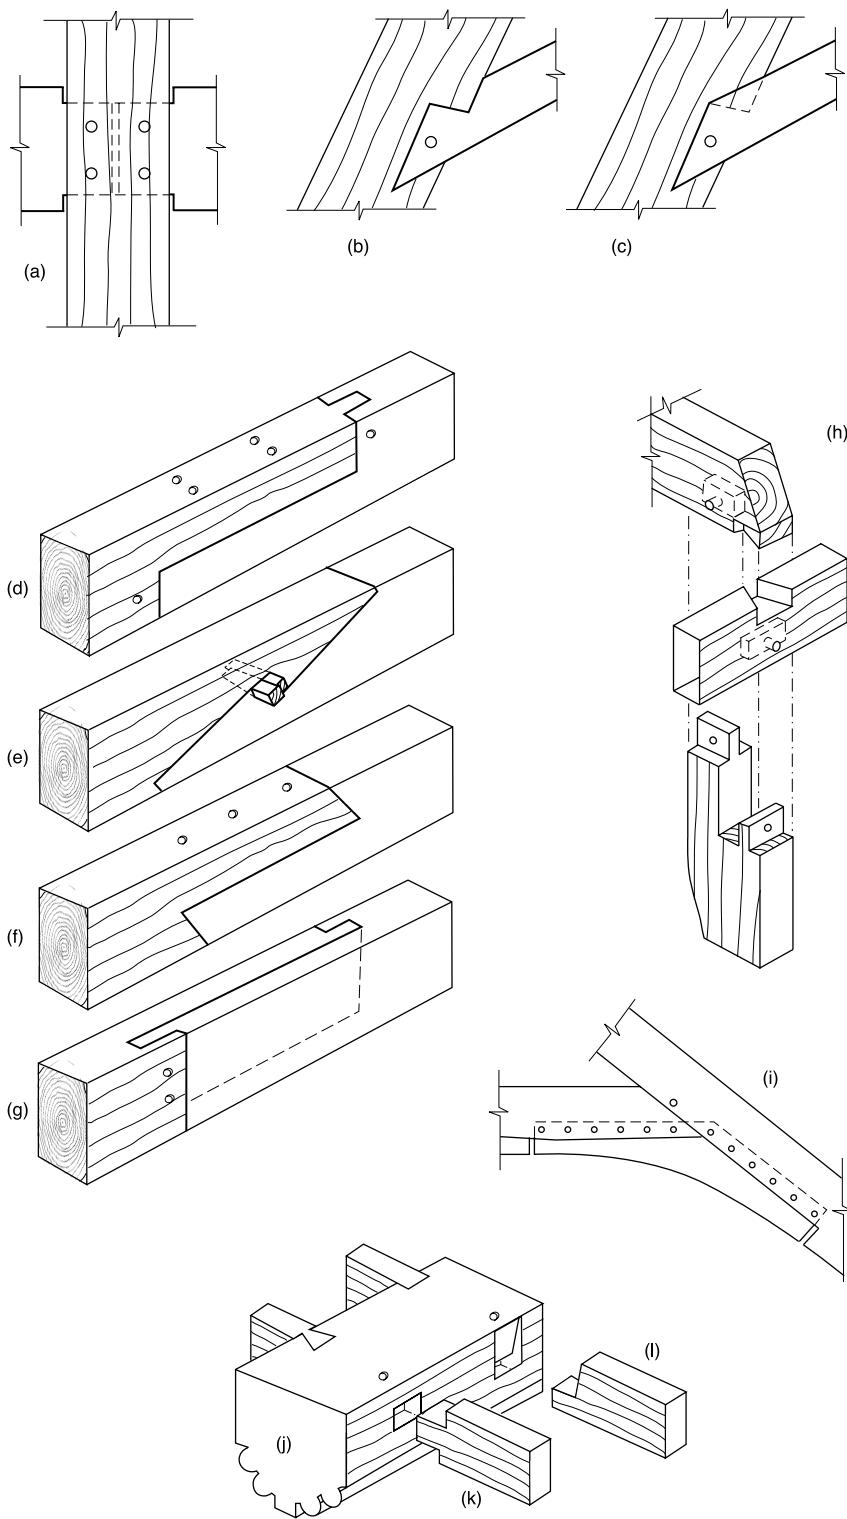
Fig. 2.4 Medieval joints

- *Mortice and tenon*: primarily transmits compression through bearing on the shoulder, and shear by the interlock of the tenon and mortice. It is pegged primarily for location during assembly and general integrity. Since the end distances beyond the peg are necessarily limited, the joint is not relied upon to transmit significant tensile forces (Fig. 2.4(a)).
- *Notched lap*: used more on early structures, and has small tensile strength. It was most often employed on diagonal wind braces (b–c).
- *Scarf joint*: used to extend long members within their profile. Since it can never be as strong as the unjointed section, the joint is placed at a less critical position in the member length. There are an amazing number of variations on the basic form, using blades which are either tapered

or simply halved, and set either vertically or horizontally, together with different methods of locking the two halves together with dowels or more elaborate mechanical interlock (Fig. 2.4(d–g)).

In all framed structures, the joints (Fig. 2.4) are generally the most critical elements. Only the basic joints have been illustrated.

This example has been dealt with in some detail, because it is important to understand the way in which such joints work. It is one of a range of traditional scarf joints which can be used for a repair. Some others are shown in Fig. 2.4.

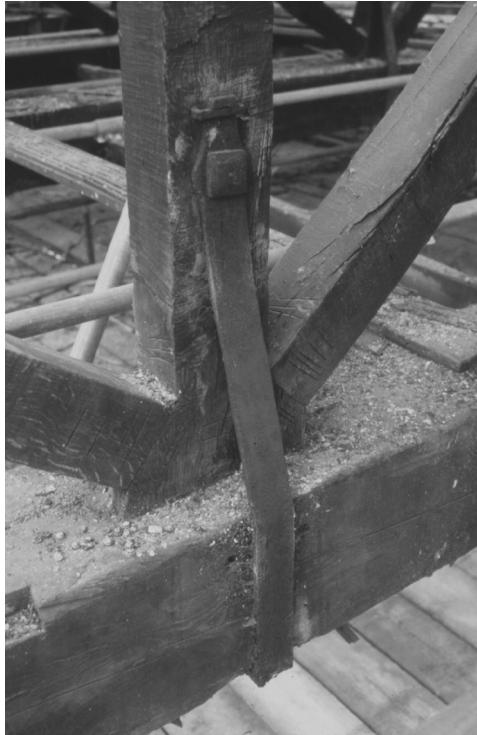
Fig. 2.5(b) Square Chapel, Halifax. Roof truss tie beam strap

the ceiling below. Iron straps were introduced to reinforce the central tension joint between the post and tie beam (Fig. 2.5(b)). Floor construction was radically changed in order to present a flat ceiling for plaster; the principal beams carried a 'double' floor, i.e., floor joists above and ceiling joists below, sometimes with a pugging layer to contribute to sound reduction.

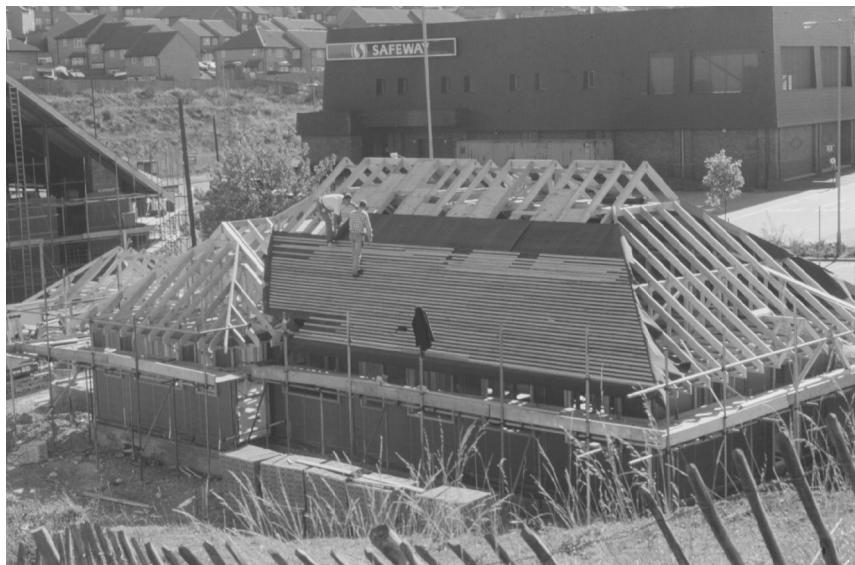
Fig. 2.12 Trussed rafters.
Church, Walderslade, Kent

The roofs were made with trussed rafters, again a construction form with its origins in America (d). Embedded in the timber by hydraulic presses, pressed metal plate fasteners enabled pitched trusses of domestic span to be made cheaply and easily (Fig. 2.12).

In America they were stabilised by an over-sheathing of ply, but when the principle was taken up in the UK, it was decided (except in Scotland) that the ply was expensive and unnecessary, and stability was achieved by a combination of the tiling battens and triangulating members. Their success was immediate, and it is estimated that from the 1960s on, they were used for 95% of new-build low-rise housing, and that upwards of 50 million have been installed. With the domestic market conquered, the fabricators then extended the use of truss rafters into the field of larger-span institutional and commercial buildings.

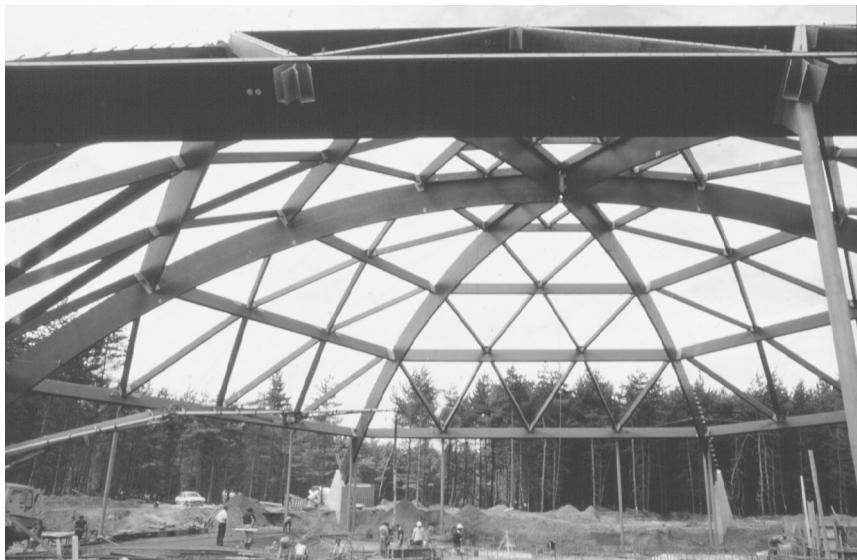
Fig. 2.13 Dome, 70 m span, of glued laminated timber, at Center Parcs, Sherwood Forest

Organic glues performed well in dry conditions, but they were moisture-susceptible. The formaldehyde glues, developed in the 1930s, were more resistant, but phenol-formaldehyde, the first to be produced, needed heat while curing. While this was possible in plywood manufacture, it was difficult to heat large structural components. The urea-formaldehyde glues, which cured at normal interior temperatures, were developed commercially during the second World War, and used on the later models of the Mosquito aeroplane. From the 1950s onward, glued laminated beams with moisture resistant adhesives came into general use for structural work, and allowed the fabrication of timber elements which were limited in size only by considerations of transport (Fig. 2.13).

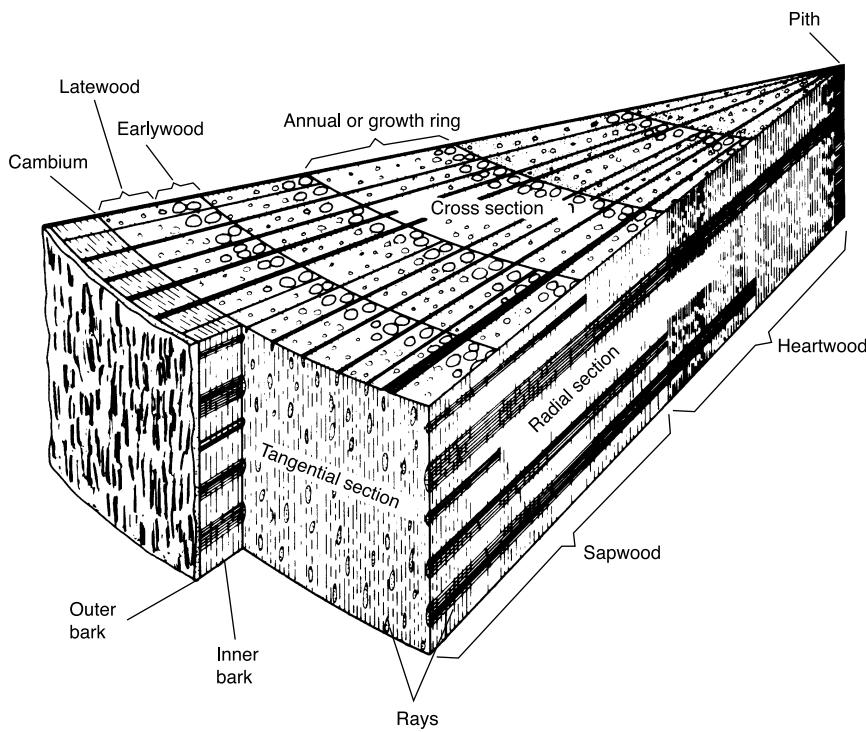
All trees are perennial plants capable of secondary thickening, that is, they are capable of adding yearly growth to the previous year's wood. The main part of the tree is the trunk, which supports the branches and leaves (or needles) forming the crown. The bark (Fig. 3.1) protects the cambium layer, where growth takes place. The trunk itself is made of cells, which are generally elongated in shape. Water from the soil, containing nutrients, moves upwards through the sapwood cells to the leaves. There the process of photosynthesis takes place—water combines with carbon dioxide from the atmosphere, (catalysed by chlorophyll using energy from sunlight) and produces a basic sugar. The sap carries this sugar back down through the inner bark to build new cells in the cambial layer.

Fig. 3.1 Diagram of a segment cut from a five-year-old stem of a hardwood

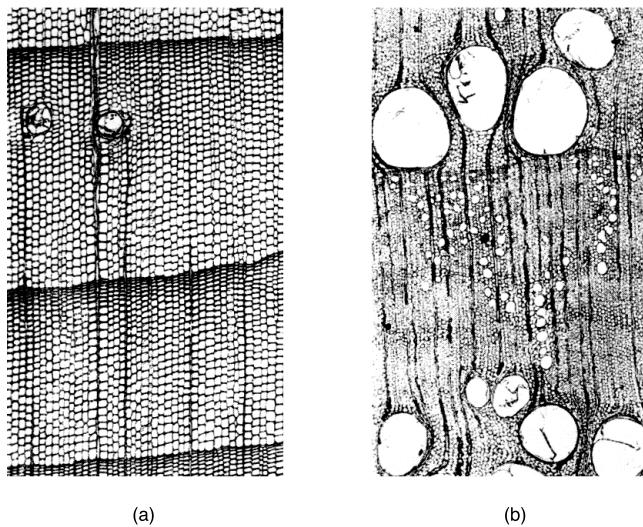
Fig. 3.2 Cross-sections to
approximately the same scale
of (a) a softwood (*Pinus*
sylvestris) with growth rings
around 1 mm apart and
(b) a hardwood (European
Oak) showing vessels in
growth rings around 2 mm apart

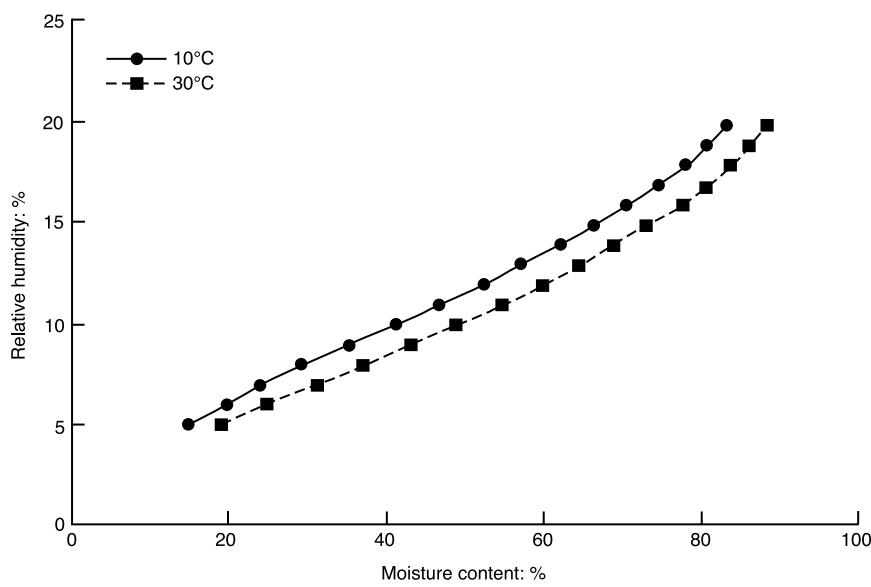
As the moisture content continues to fall, the cell walls now begin to lose moisture, which results in shrinkage across the width of the cell structure at a rate, from FSP to zero MC, which is roughly linear. At the same time, the properties of the timber change; both the strength and the stiffness (the modulus of elasticity or E value) increase as the MC reduces. Eventually (for a given relative humidity (RH) of the surrounding air) the MC will stabilise at a value known as the equilibrium moisture content (EMC). The relationship between air RH and timber EMC is shown in Fig. 3.3. It can be seen that the difference between the graph for 30°C and 10°C is only

Fig. 3.3 Relationship between RH and EMC

10%. Thus the MC of timber depends almost entirely upon the RH of the surrounding air, and very little upon the ambient temperature alone.

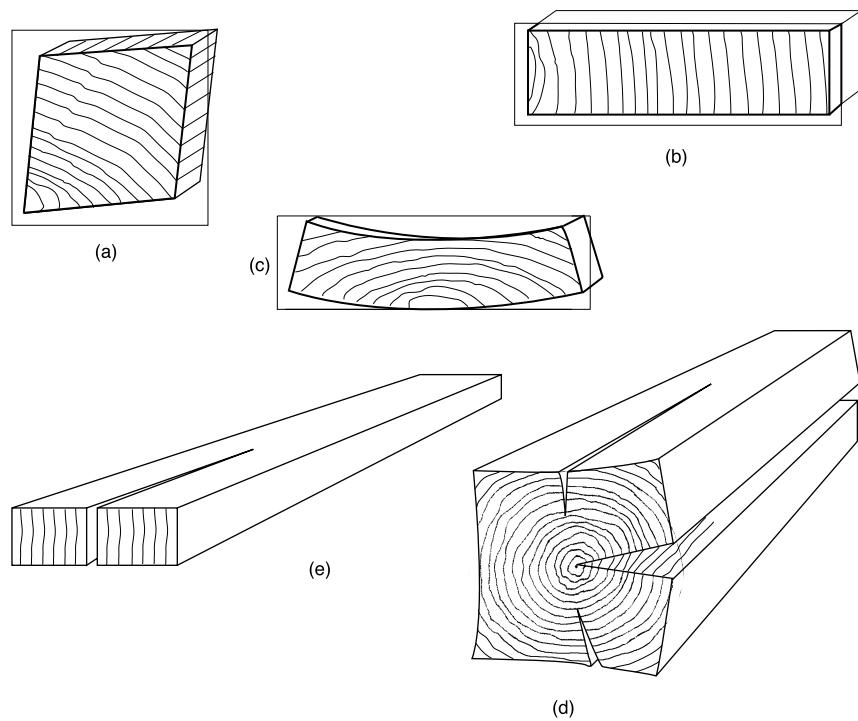
Looking at the effect of this shrinkage on the timber profile, let us consider first some short pieces of oak cut from a large log (Fig. 3.4). The distortion of the square piece (a) into a diamond demonstrates the different rate of radial and tangential shrinkage. Floor boards which are quarter- or rift-sawn (b) will stay flatter than boards which are plain-sawn (c). As an aid to predicting the distortion, imagine that as a piece dries the growth rings tend to straighten out.

Fig. 3.4 Drying distortion of
timber sections

These pieces were deliberately cut as short sections, and as a consequence dried out rapidly, because timber is some 20 times more permeable along the grain than across the grain.

In general, the only case when drying fissures will occur through the full depth of the piece (when they are known as splits) is at each end. Due to the more rapid loss of moisture from the end grain, the whole cross-section will try to shrink against the restraint provided by the body of the piece (e).

By reference to Fig. 3.4, it can be seen that pieces from different parts of the log will move in different ways when drying out. For smaller pieces (say, less than 150 mm) it is possible to exclude boxed heart, with a reduction in the amount of splitting which will take place. For larger pieces, it is usual to allow the inclusion of boxed heart.

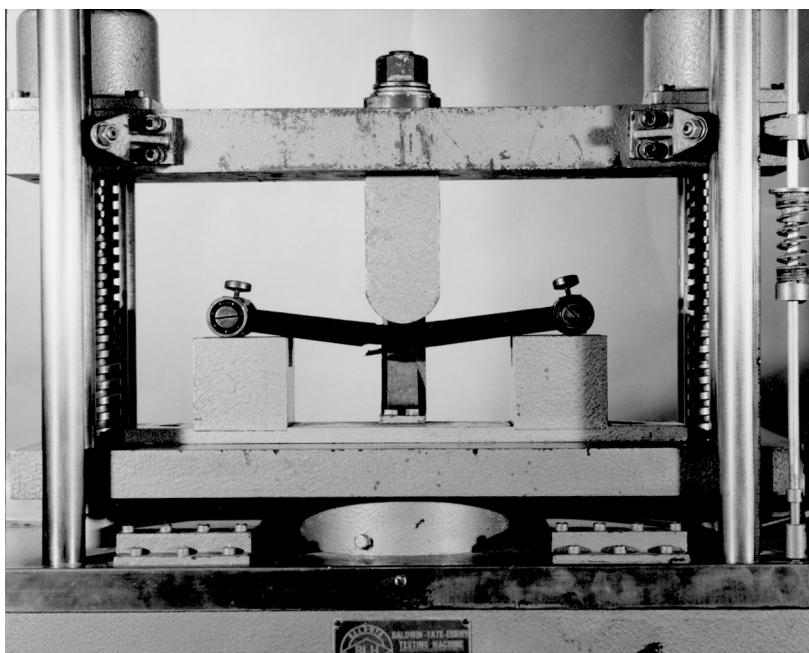
Fig. 3.5 Static bending test using $300 \times 20 \times 20$ mm specimen (Princes Risborough Laboratory, © Crown Copyright)

Methods of testing small clear specimens of timber. Clear specimens are straight-grained pieces, with no strength-reducing defects such as knots or fissures. The bending test, for example, is carried out by loading $300 \times 20 \times 20$ mm samples to failure over a period of a few minutes (Fig. 3.5). Typical results for the modulus of rupture (assuming simple bending theory) of redwood at 12% MC are shown in Fig. 3.6(a); the relatively large deviation reflecting the variability in the strength properties of timber. If, however, the strength results were to be related to sample density, the scatter would be considerably reduced.

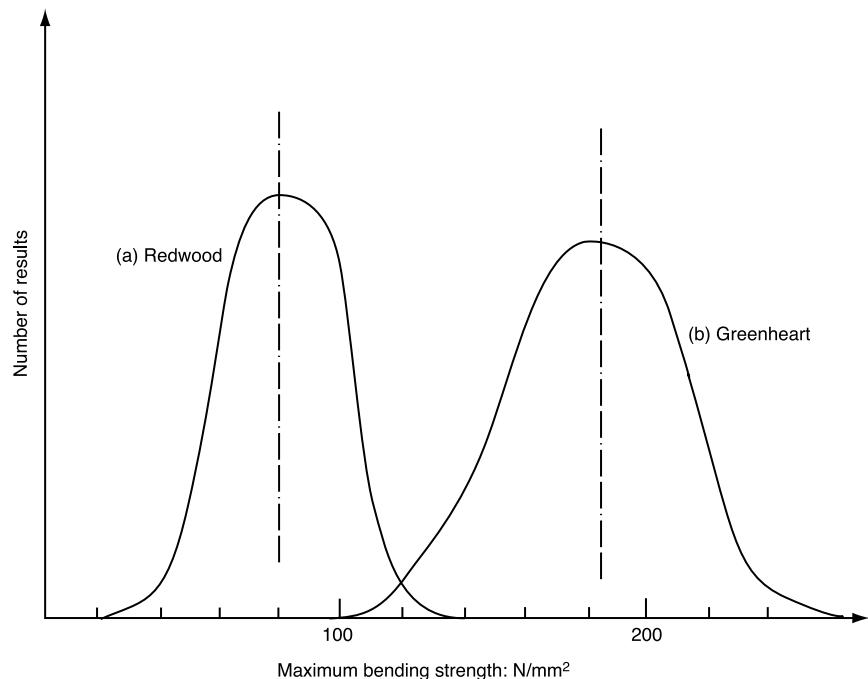
Redwood is a medium strength softwood, with an average density at test of around 460 kg/m^3 . The same tests on greenheart, which has a density of approximately 880 kg/m^3 , show a proportionate increase in strength (b). In general, the correlation between density and bending strength is independent of species. This relationship is also true of compression parallel to the grain, which averages a value of about half the bending strength. Figure 3.7 shows the relationship between maximum compression strength and density (actually plotted as nominal specific gravity) for all species, for the green condition (>30% MC) and air-dried (12% MC). The difference between the two lines shows that the strength of timber is also dependent upon moisture content. The relationship between these two factors for redwood (corrected for density) is shown in Fig. 3.8. The increase in strength below FSP to 0% MC is almost linear. Remember, however, that this is for small clear samples. The effect is less pronounced for structural sizes with defects in them. Knots, for instance, remain the same size as the timber dries, and fissures may get a little deeper.

Fig. 3.6 Results of small clear bending tests on (a) Redwood and (b) Greenheart

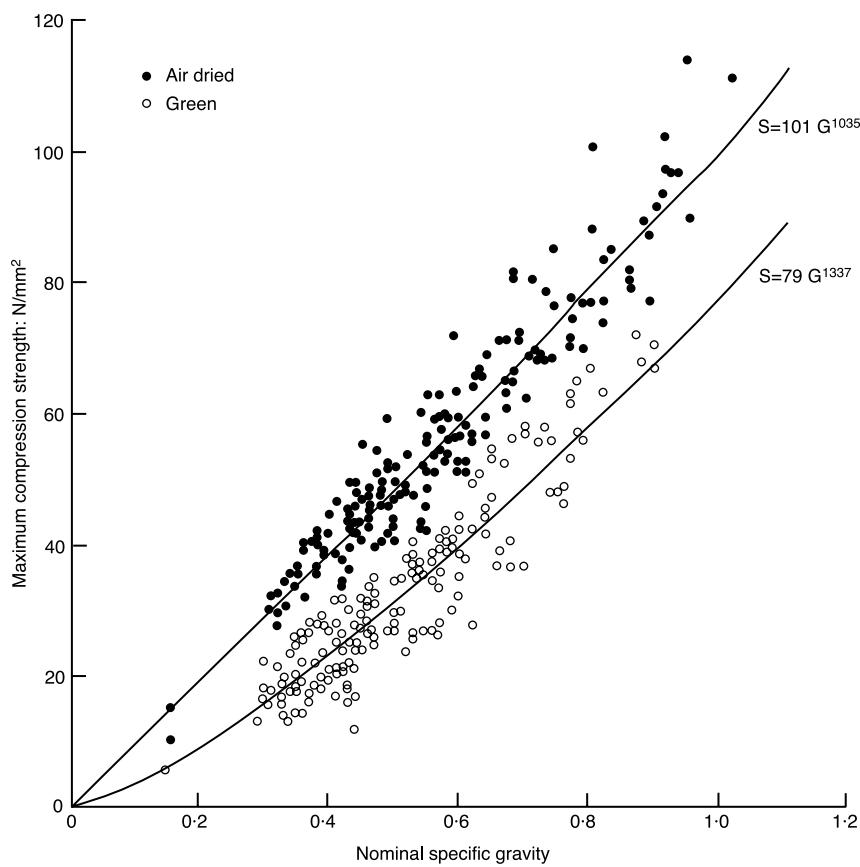
Fig. 3.7 The relation of maximum compression strength to nominal specific gravity for all species tested, green and air dried (Princes Risborough Laboratory, © Crown Copyright)

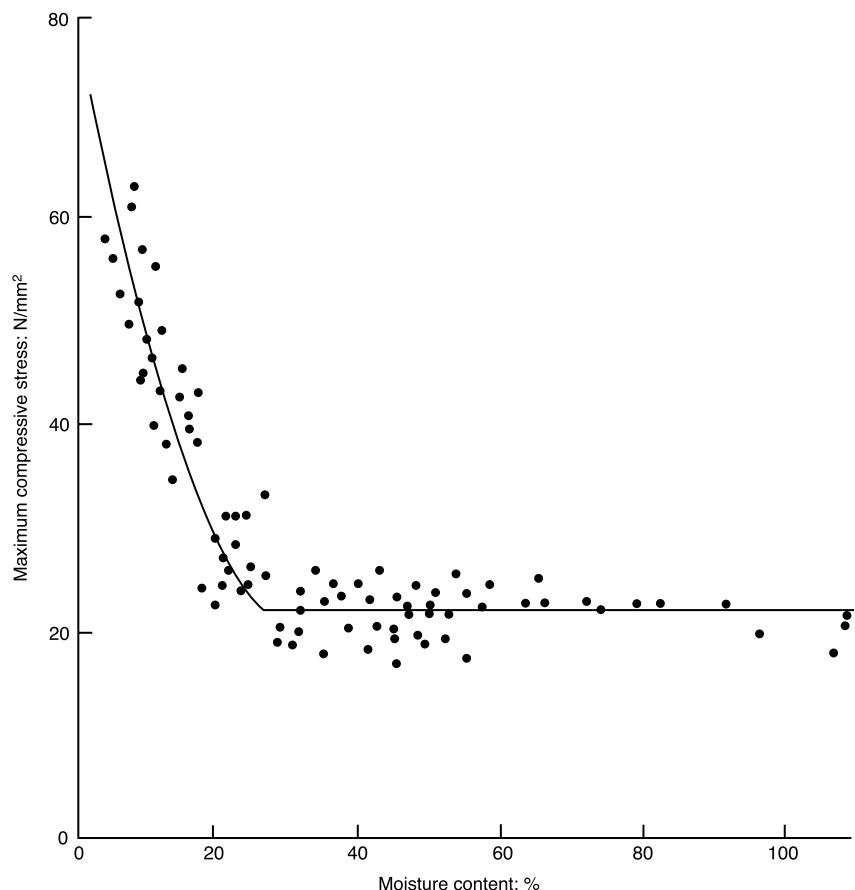
Fig. 3.8 The relation of maximum compressive strength to moisture content. Timber species—Douglas fir

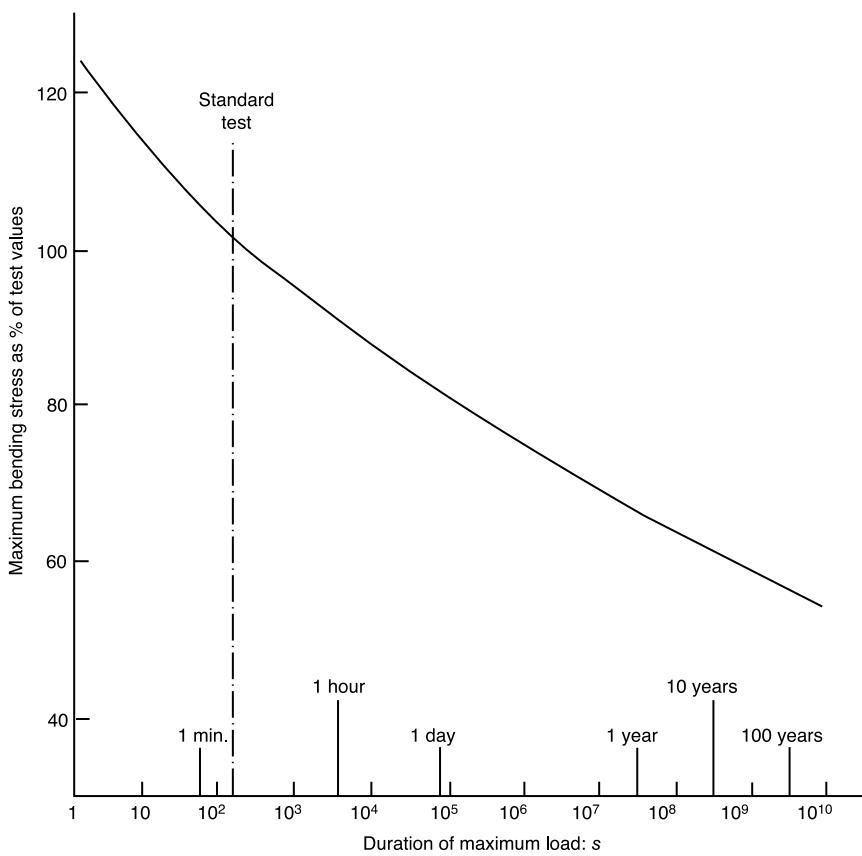
Also note that timber is stronger in the short term than in the long term. The load which could be carried indefinitely by a piece of timber will only be about half the load which would cause short-term failure (Fig. 3.9).

Fig. 3.9 The relation between maximum bending stress and duration of load (the Madison Curve)

Fig. A2.2 The relation between maximum bending stress and duration of load (Fig. 3.9) with the values of K_3 , the duration-of-load factor from BS5268, superimposed upon it

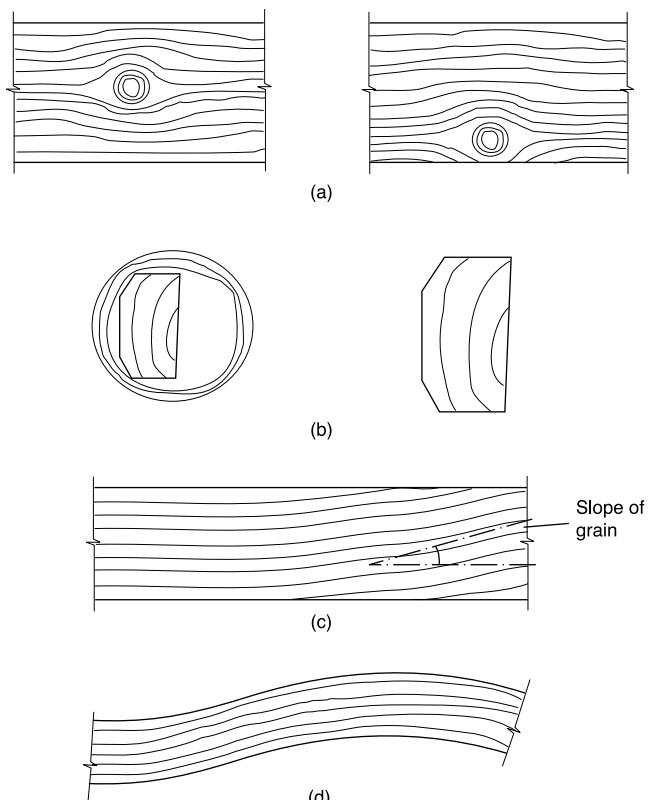
- *Knots* The effect of a knot is locally to produce a marked disturbance in the line of the grain. Going back to the model of the drinking straws, it is obvious that this weakens the piece as a whole, more particularly in tension, since lateral compressive and tensile forces are needed to divert axial forces along the grain lines (Fig. 3.10(a)). If the knot is near the centre of the piece there is more chance of mobilising these forces than if the knot is nearer the edges, or margins. In addition, the grain line of an edge knot is generally 'cut' by the edge of the piece, which further reduces the strength.
- *Wane* A term for missing timber, generally at an arris (the edge of the member), stemming from an over-ambitious attempt to cut a rectangle from a circle (Fig. 3.10(b)). Wane is seen more on older timbers, and often relates to the removal of sapwood.

Fig. 3.10 Defects in timber

- *Slope of grain* Since the test specimens were small, it was possible to align their faces with the grain. When sawing a structural piece from a trunk which may be slightly curved or bowed, the grain will lie at an angle to the face for some part of its length (Fig. 3.10(c)). Cutting across the fibres again reduces the strength of the piece. It should be noted, however, that much medieval timber was split, rather than sawn. Examples can be seen of decorative braces where the line of the grain has determined the line of the piece, giving a slope of grain which is effectively zero, and optimising its strength (Fig. 3.10(d)). Hanging knees for timber ships were cut from the trunk and a principal branch in order to turn the angle while giving the piece strength, and the technique of cleaving, or following the grain, is still employed today for some fencing work. The technique should also improve durability as the surface contains less cut cells and, hence, is less likely to absorb water.

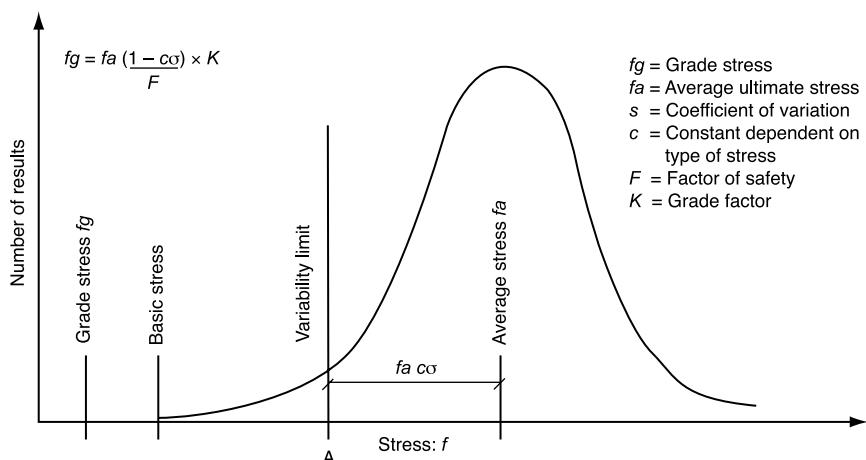
Fig. 3.11 Derivation of grade stress from small clear test results

A glance at the permissible stresses in the table from CP 112 shows that they are very much lower than the results of tests quoted previously. It is helpful to understand how the one is derived from the other. Figure 3.11 shows a typical distribution of test results on small clear specimens of redwood in bending. Line A shows the value below which 1% of the results would be expected to fall. A global factor of 2.44 is applied to this value to cover for the effects of size, moisture content and duration of loading, in addition to an overall factor of safety. This gives a basic stress which would be applicable to a piece of full-size clear timber. The grade stresses for CP 112 represent numerically a percentage of that basic stress. The grade stresses in the current code were not related to tests on small clears, but derived directly from tests on structural size timbers, with the aim of providing the same order of safety with a greater degree of reliability.

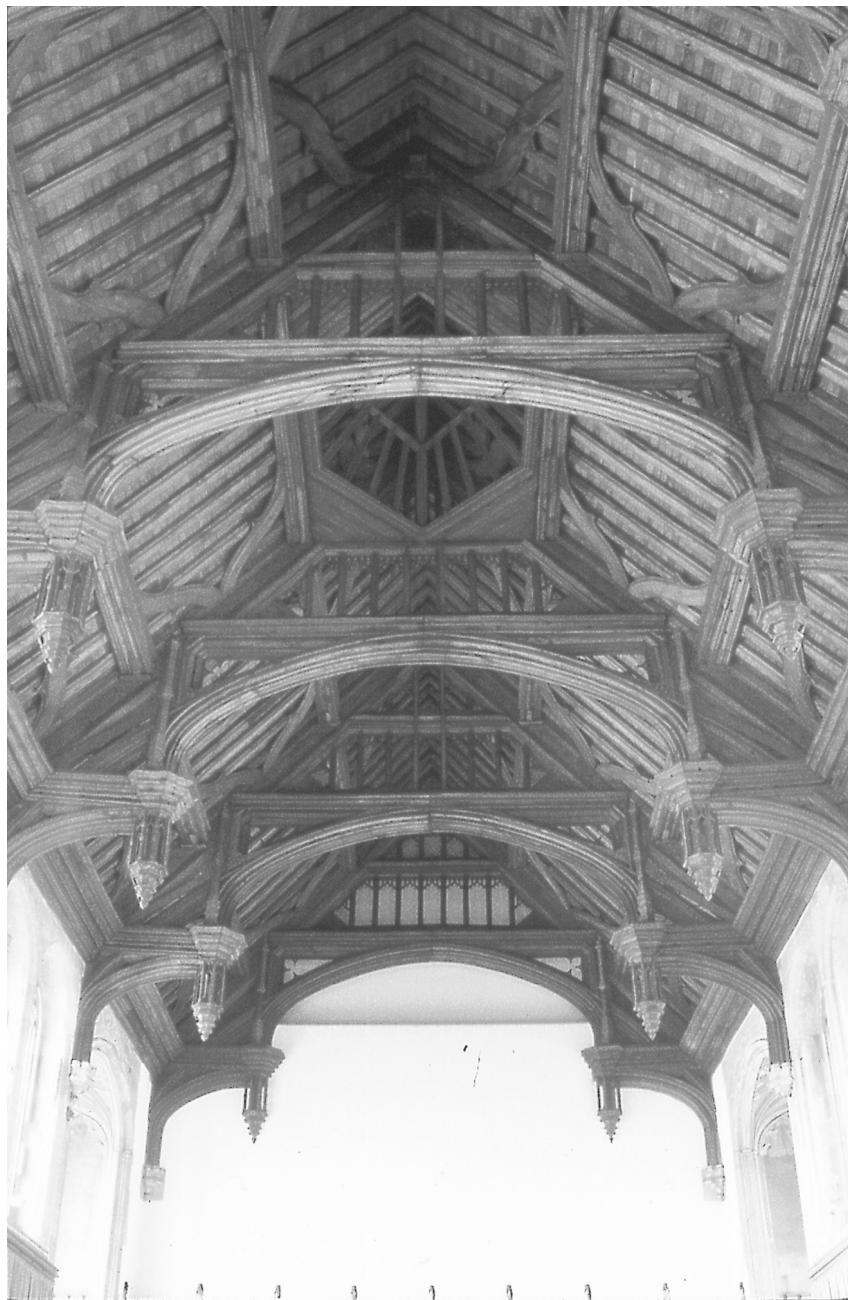
Eltham Palace, London. The hammer-beam roof of the Great Hall, begun by Edward IV in 1475.

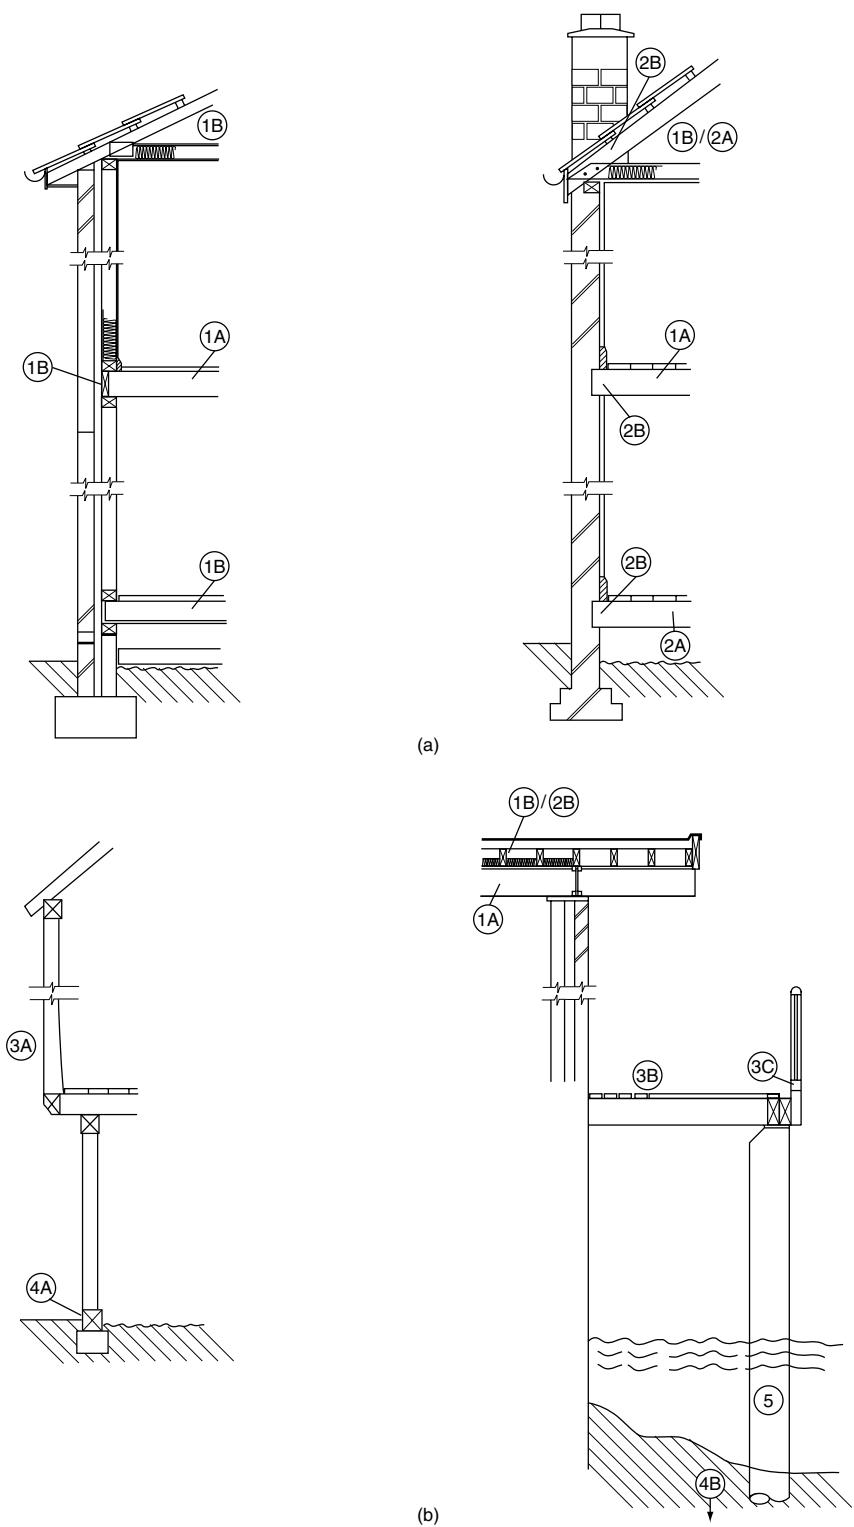
Figure 4.1 illustrates these different classes. The areas of higher risk are generally concealed from view, and it is for this reason that most structural appraisals will require some local opening-up.

Fig. 4.1 Examples of the
location of the various hazard
classes

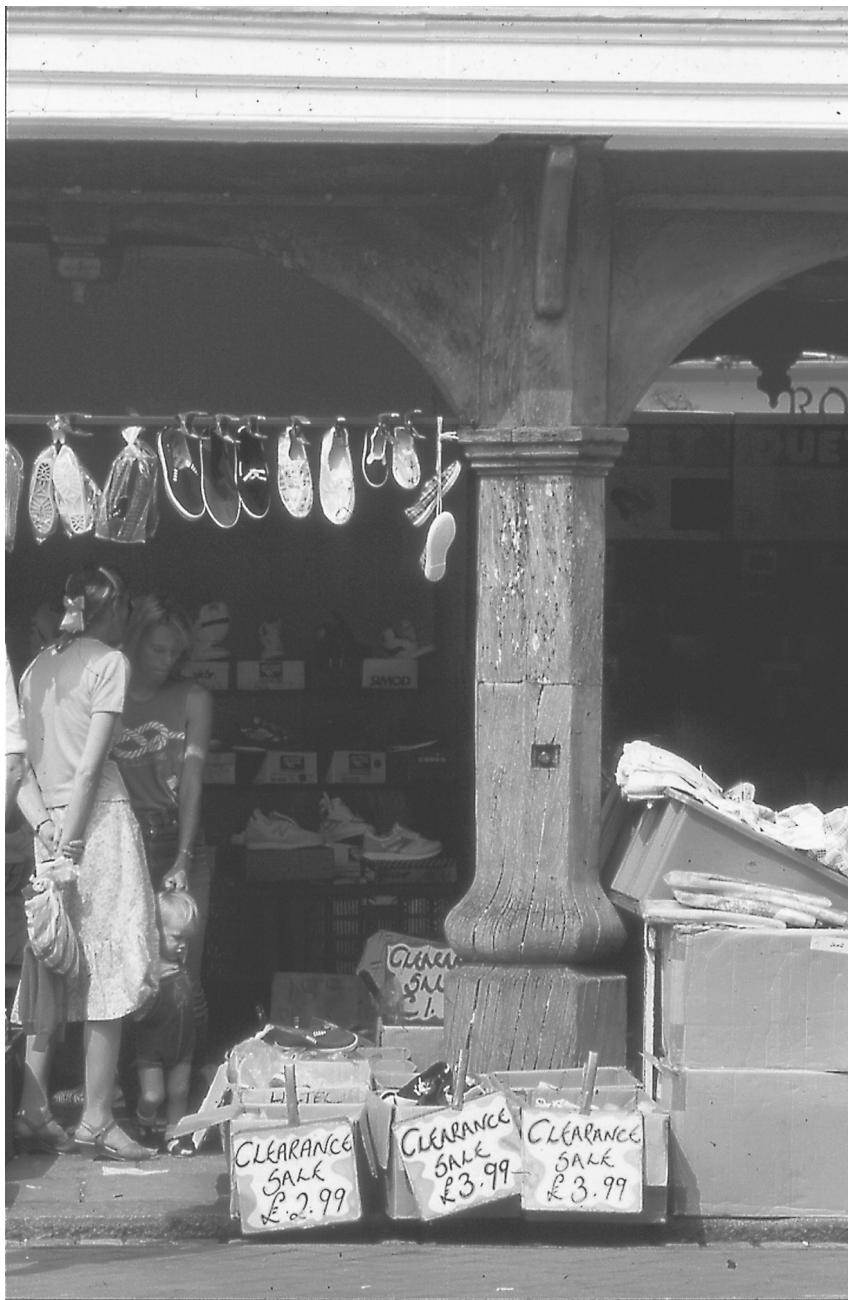
The Guildhall, Faversham. The arcades of the Guildhall date from 1574. A simple half-lap nineteenth century repair can be seen to the base of the post.

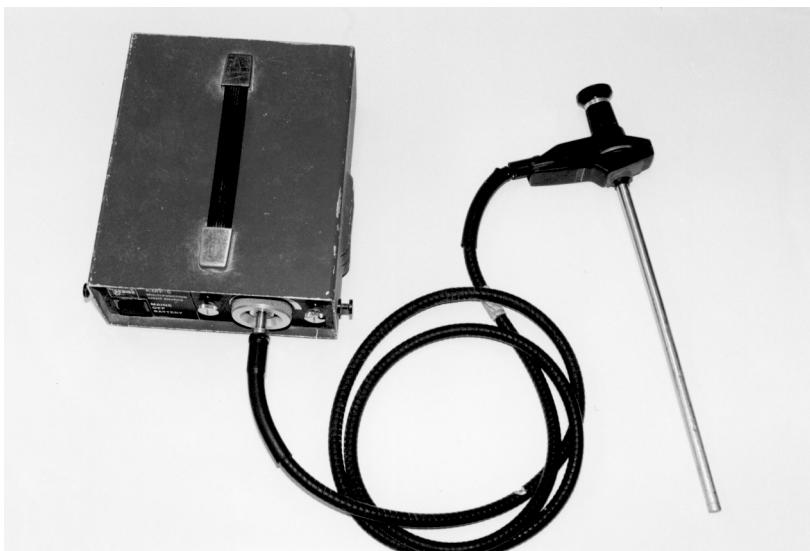
The need to examine members which are normally concealed has already been mentioned. The Borescope was originally developed to examine cavities in brickwork and consists, in effect, of a small periscope, which can be inserted through a 10 mm hole. At the tip is a powerful light source, fed through optical fibres, which illuminates the cavity to about a 1.5 m radius (Fig. 10.1). The instrument can also be used to examine similar cavities in timber framed work, such as suspended floors, flat roofs or stud walls, either by direct viewing, or (with an adaptor) to take record photographs. Holes should be resealed if they have penetrated a vapour membrane.

Fig. 10.1 The Borescope

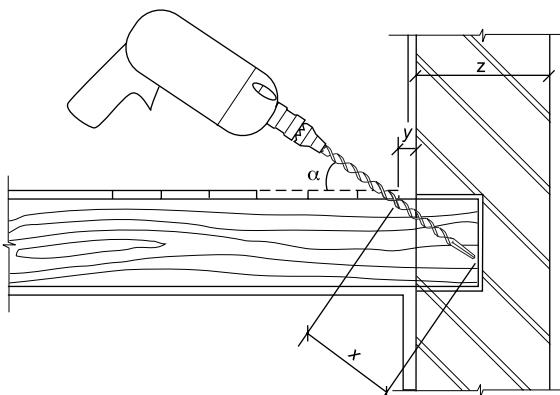
Fig. 10.2 Auger drilling

beams built into a solid external wall (Fig. 10.2), or the end of a roof truss in the eaves. In such cases a long auger bit may be used, mounted in a power drill and run at slow speed. The shavings can be cleared regularly, and their position in the timber defined by plotting to scale the angle of the drill and the depth of penetration. If the pitch is judged correctly, the end of the beam can be located. This is useful, because it can be used to establish the brick cover to the beam end; something to be taken into account in judging the risk of future rot.

The condition and smell of the shavings will also give an indication of the beam end condition, and they can be collected and oven dried for moisture content as noted above, although the weight collected would have to be borne in mind when considering the accuracy of the result.

It may be that the survey reveals areas which are sound but where, nevertheless, there is a risk of rot in the future. Inevitably, we return to the previous example of the joists built into an external wall where a sample survey, perhaps using the technique shown in figure 10.2, had indicated that the joist end condition was generally good, but that there was a potential for moisture ingress. If general remedial work such as that described above was not feasible, considered to be too expensive, or conflicted unacceptably with conservation principles, the client should be made aware of, and agree to, the decision to accept the current condition. Some arrangements for monitoring the condition in the future should then be built into a maintenance strategy.

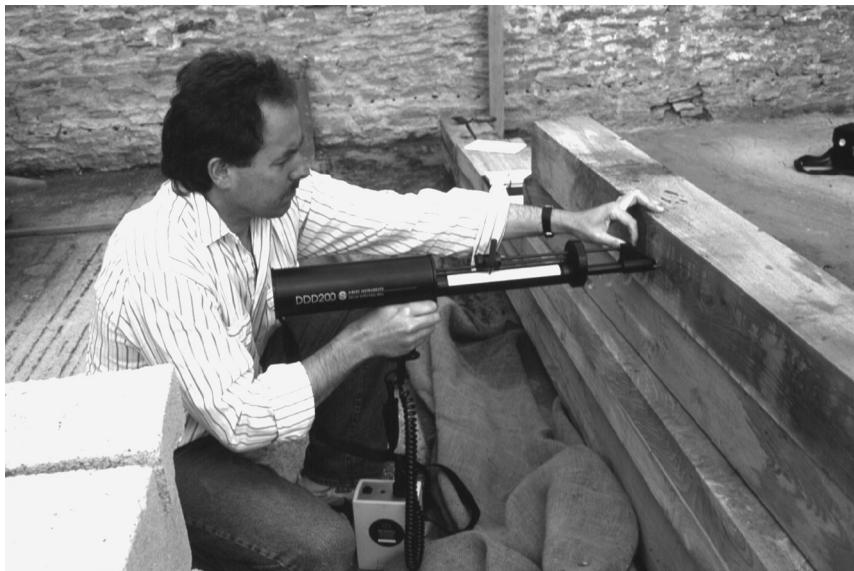
The Sibert drill is essentially a more sophisticated version of the technique described above (Fig. 10.3). The drill bit is only 3 mm in diameter, but is nevertheless able to penetrate up to 200 mm into timber. The rate of penetration of the bit under a constant load is recorded as a trace on paper mounted on a drum (Fig. 10.4). Less dense timber is detected by faster penetration of the drill. In the figures the drill is being used to establish the residual profile of sound timber in some roof trusses over a barn, which in the past have suffered severe insect attack. The trace can be calibrated by drilling into obviously sound timber at some other point on the member.

Fig. 10.3 The Sibert drill

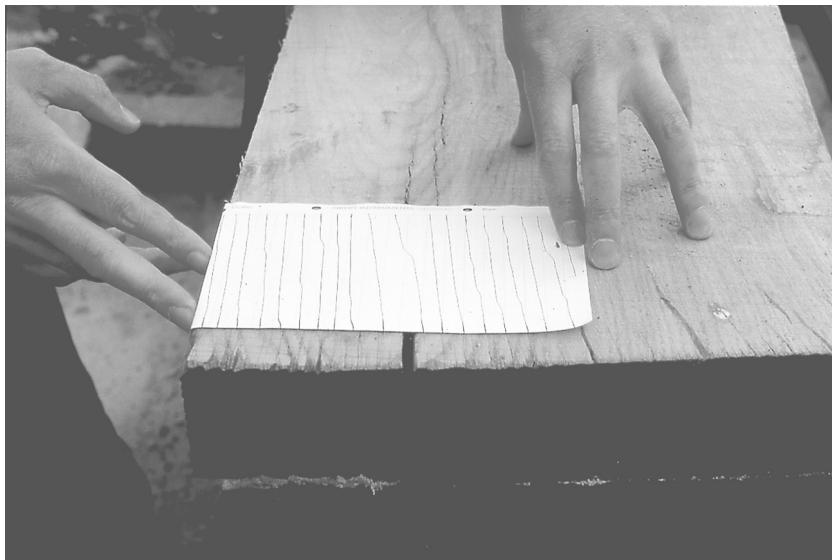
Fig. 10.4 Trace showing the rate of penetration of the bit under constant load, and showing the jump in alignment as the head passes through the split

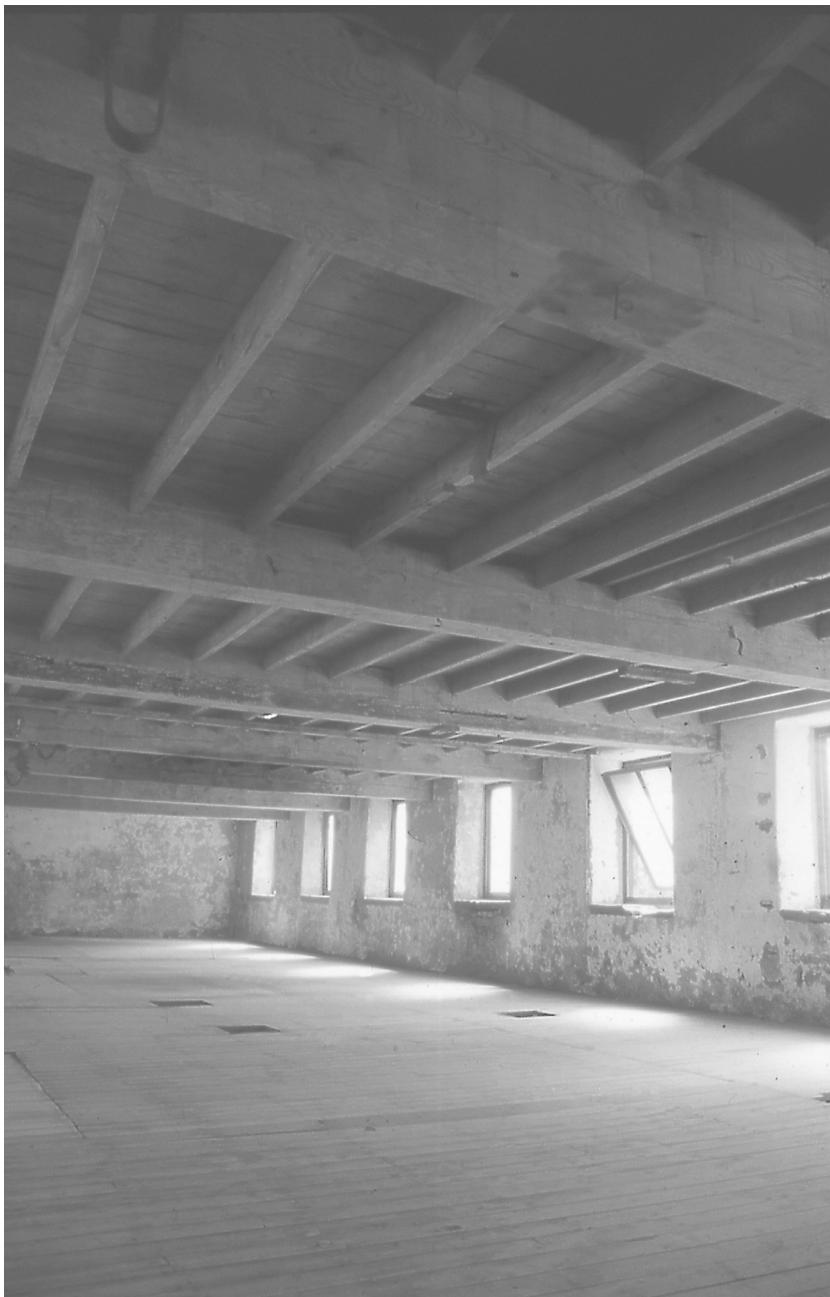
Arkwright's Mill building at Cromford Mill, Derbyshire. Dating from around 1780, this is possibly the world's first factory, with stone walls supporting timber floors of large redwood principals.

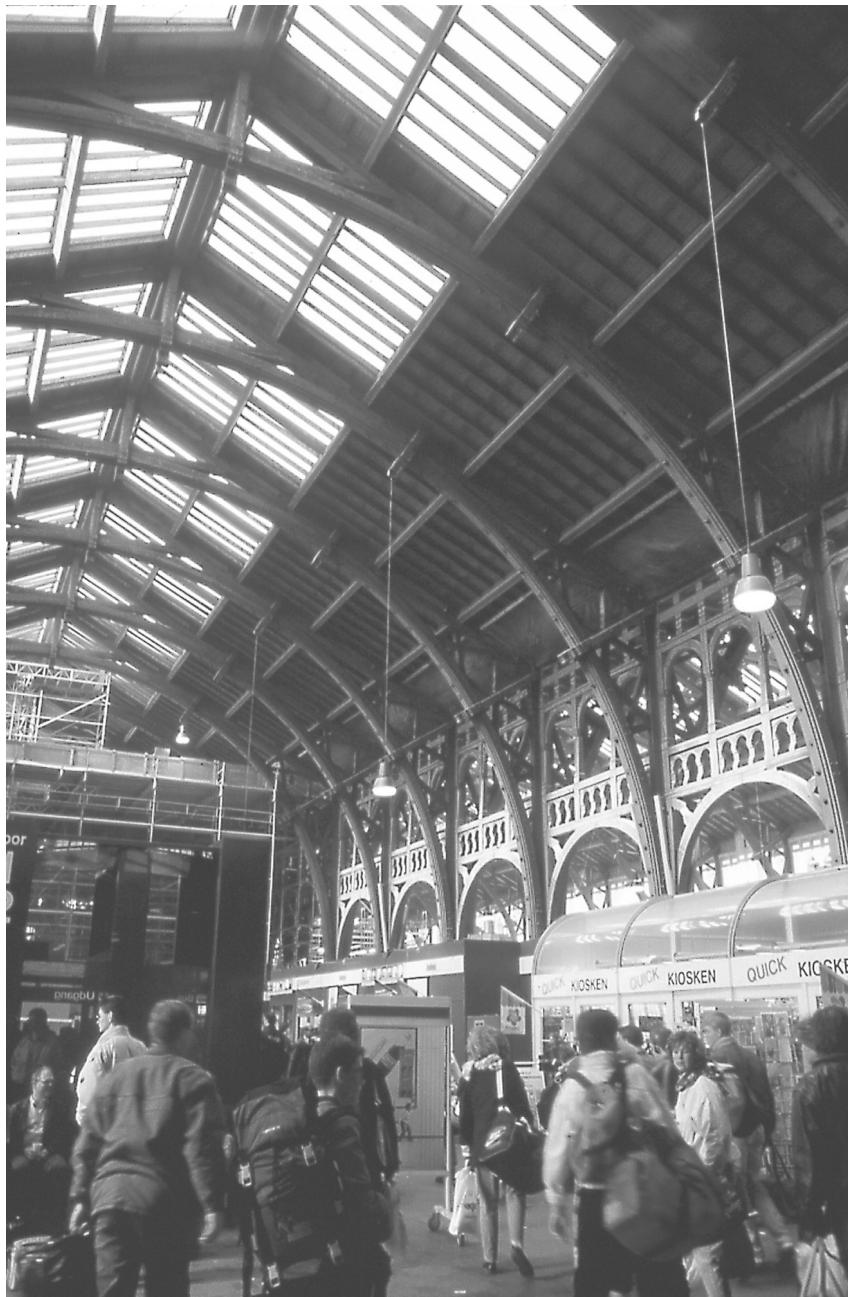
Concourse roof, Main Railway Station, Copenhagen, Denmark. Europe's best bolted laminated roof; one hundred foot span arches dating from 1901.

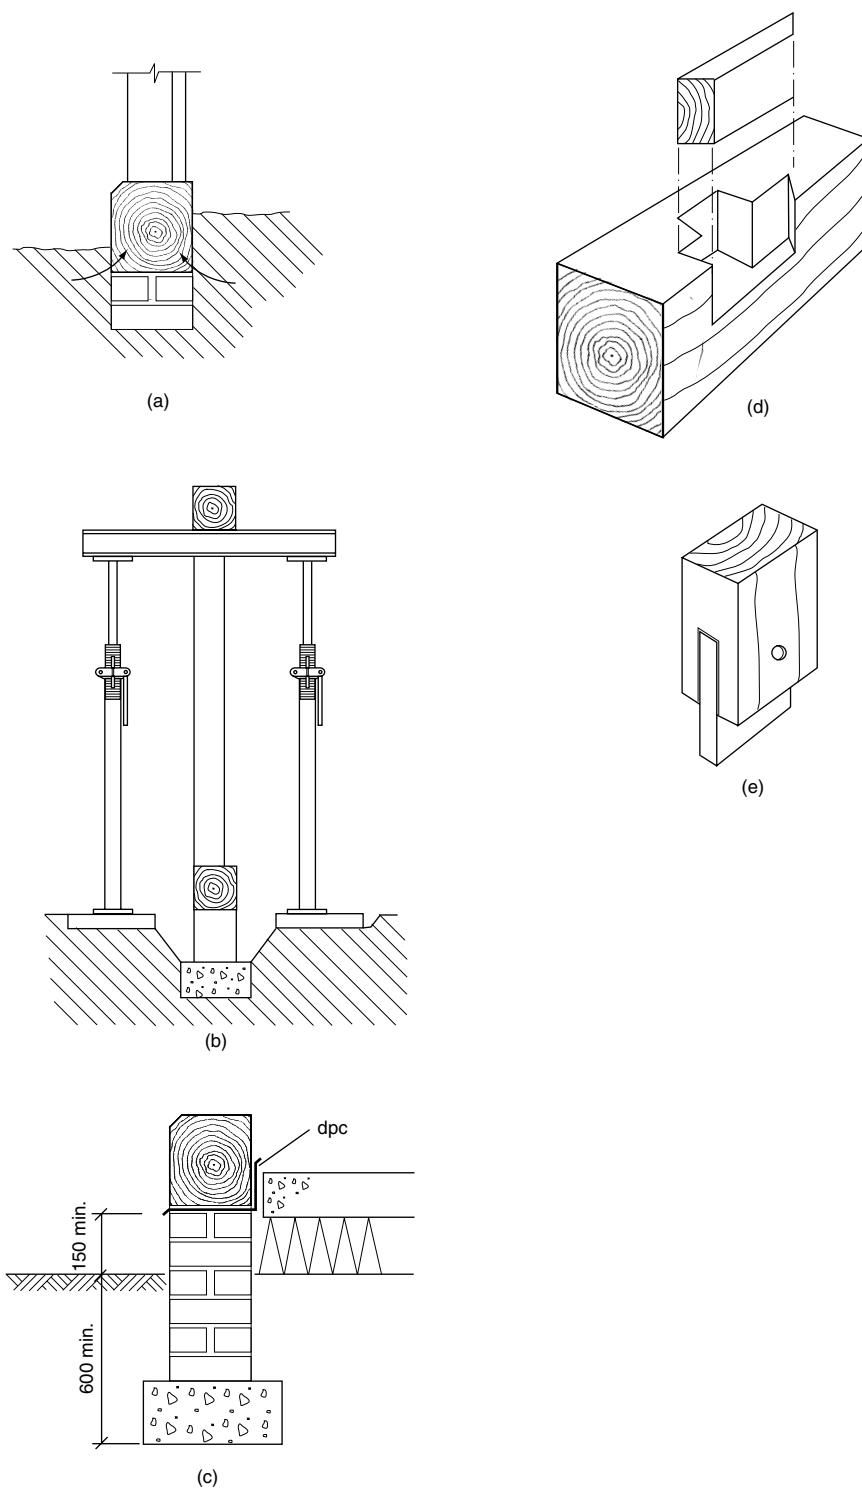
The need to replace complete members occurs most often in cill plates which have been in direct contact with the ground (Fig. 12.1(a)). Indeed, it would be true to say that most medieval frames have either already had replacements fitted, or have been lifted up and put on some form of plinth, in order to reduce the moisture content level of the plate. Since the foundations to timber frames are generally shallow, and sometimes even non-existent, differential settlement is quite common, resulting in a cill plate which is neither level nor straight. If the distortion is not too severe, and the building is a simple framed structure such as a barn, then it may be possible to improve the line by propping and jacking (b). For a domestic structure, with internal plastering, it is normally wiser to accept the *status quo*. This may mean sawing the cill plate to a curve, the precise shape of which can be established by cutting a template.

Fig. 12.1(a) Cill plate in direct contact with the ground;
 (b) Propping and jacking of the first floor beam over sill plate;
 (c) Deepening of the foundations; (d) Studs closed by wedged filler pieces; (e) Studs modified and fitted with slip tenons

The replacement of all, or part, of the cill plate will need local temporary underpinning of the superstructure. If the foundations are very shallow, and there is evidence of seasonal, or progressive movement, it may be a good idea to take the opportunity to deepen them (c). This would also allow the cill plate to be offered up onto the stud tenons. In all cases the cill plate should be laid on a dpc and, if necessary, consideration given to locally modifying the immediate ground level, so that the plate is raised 150 mm or so above it. The aim of this work is to put the new cill plate into hazard class 3A and to render the frame stable. Conservation arguments about interfering with a relatively minor part of the original fabric should not be allowed to compromise the aim of durability.
