Appraisal and repair of timber structures

Peter Ross

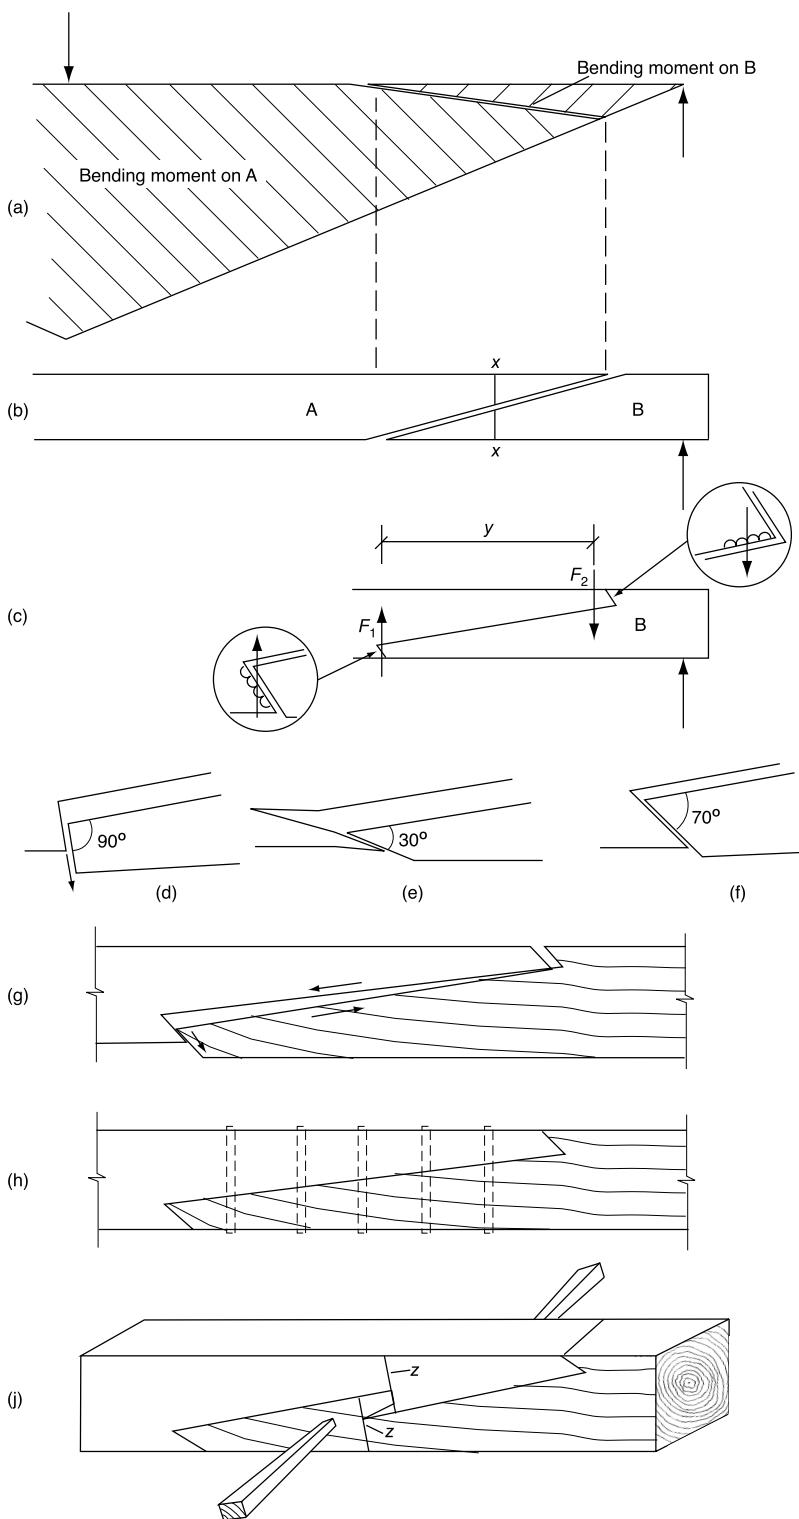
The repaired beam as a whole has to sustain the applied bending moment, (Fig. 12.2(a)), and so the function of the joint is to transfer the bending moment locally from the original member (A) to the new member (B). This is most efficiently done by tapering the sections (b), although it can be seen from section $x-x$ that the capacity at the centre section (M_{jnt}) can only be half the capacity of the unjointed section (M_{orig}). In addition, (b) is

Fig. 12.2 Transfer of the bending moment

not yet a joint, because there is no mechanical connection between the two parts. This could be done by undersquinting the abutments, as in (c). The two bearing points allow restraining forces to be developed (F_1 , F_2), separated by the distance y . The couple $F \times y$ is the resistance moment of the joint, and for this to reach the potential capacity limit of M_{jnt} , y will be in the region of $3d$ to $4d$, where d is the beam depth.

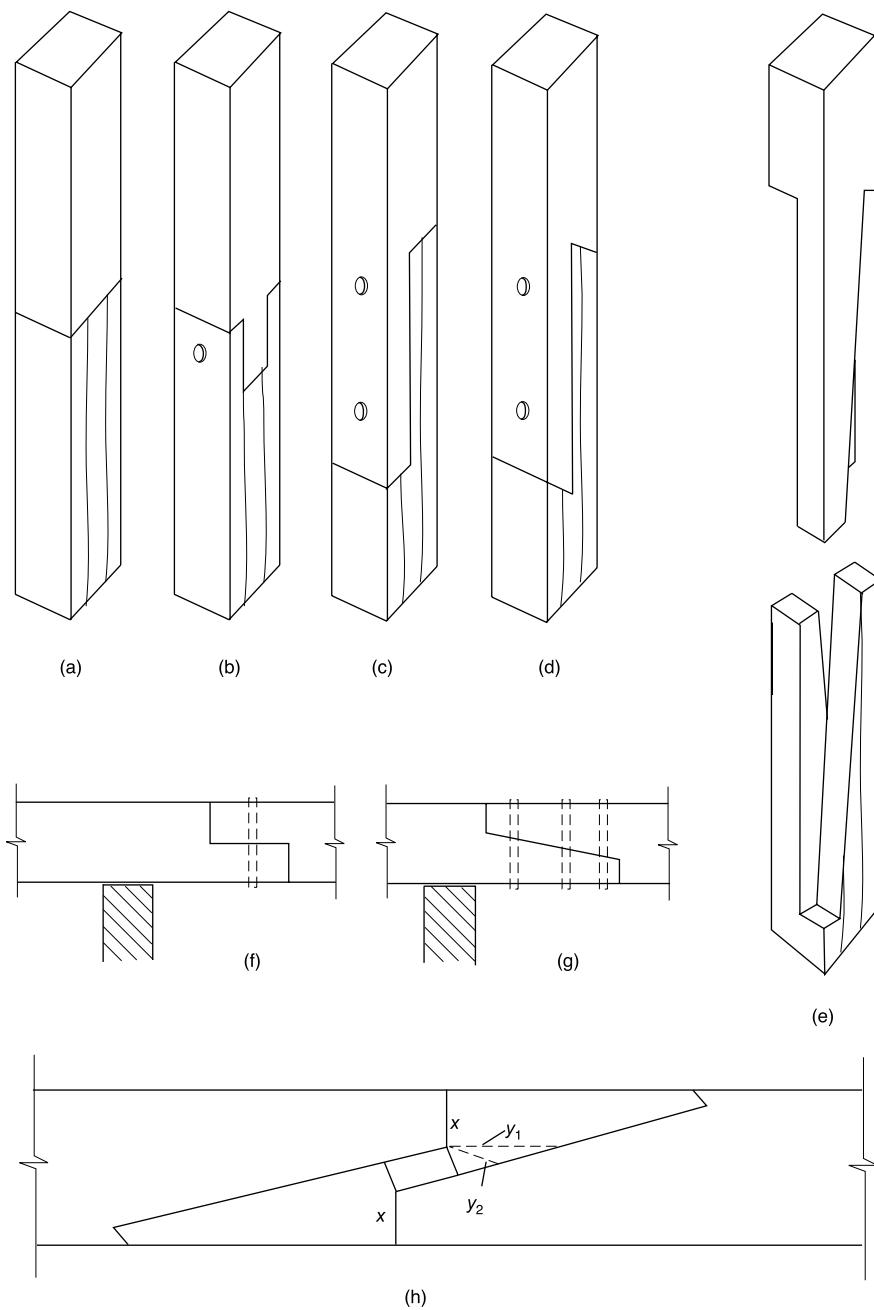
At its simplest, a compression joint may be formed by directly butting two faces (Fig. 12.3(a)). However, in practice, most compression members are prone to buckling, and so some resistance must generally be provided to secondary bending about major and minor axes. For light duties, an open mortice and tenon may be adequate (b); for more significant lateral loads a step in the bearing surface (the scarf principle again) is more appropriate (c), although cutting inaccuracies will probably mean that one surface predominates for bearing. A slight squint on the bearing surfaces assists buckling resistance (d). If you are very confident of the standard of workmanship, the scissors scarf (e) gives a fine virtuoso effect, providing very high resistance to lateral bending, but with some loss of direct compression capacity (due to the potential splitting effect of the scissor ends).

Fig. 12.3 (a-e) Compression joints; (f-g) shear joints and (h) tension joint

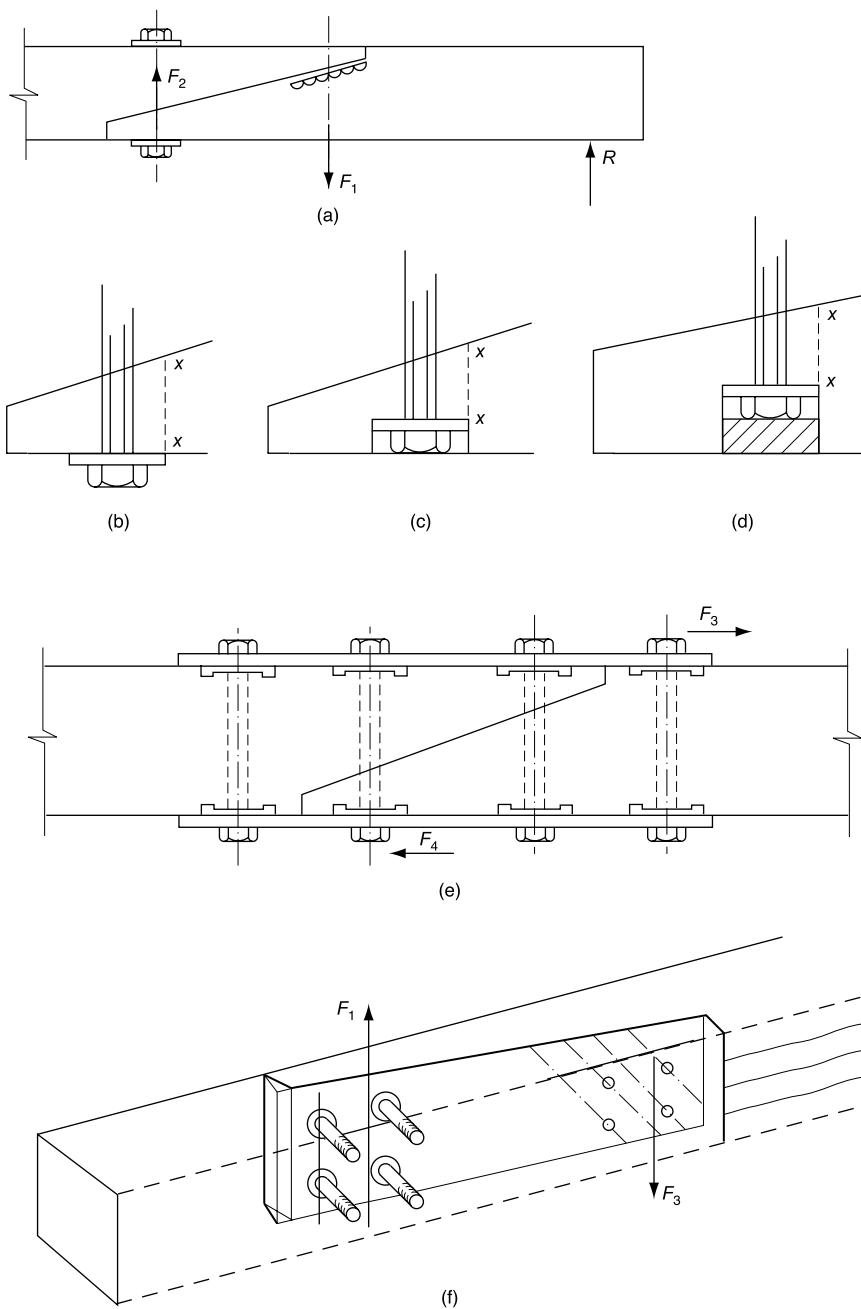
The use of metal fasteners enables joints of higher strength and stiffness to be made. This is due partly to the increased shear strength of a steel bolt over a timber dowel, but is also due to the tensile forces that can be developed in the bolt by using washers, and the large shear capacity of the range of metal connectors (Fig. 12.4(a)–(f)).

The joint can be further strengthened by the addition of top and bottom straps (e), since this introduces an additional restraining couple F_3-F_4 . In order that the couple can be considered as acting together with F_1-F_2 , it is important that there is very little bolt slip; shear connectors are recommended.

Metal fasteners also enable a strong joint to be made using a simple edge-splayed scarf (f). In this case all the load is transmitted by the fasteners (which, as timber pegs, would give a relatively weak joint). The restraining couple is simply that developed by the bolt groups, which can be fitted with split rings

Fig. 12.4 Scarfs with metal fasteners in bending

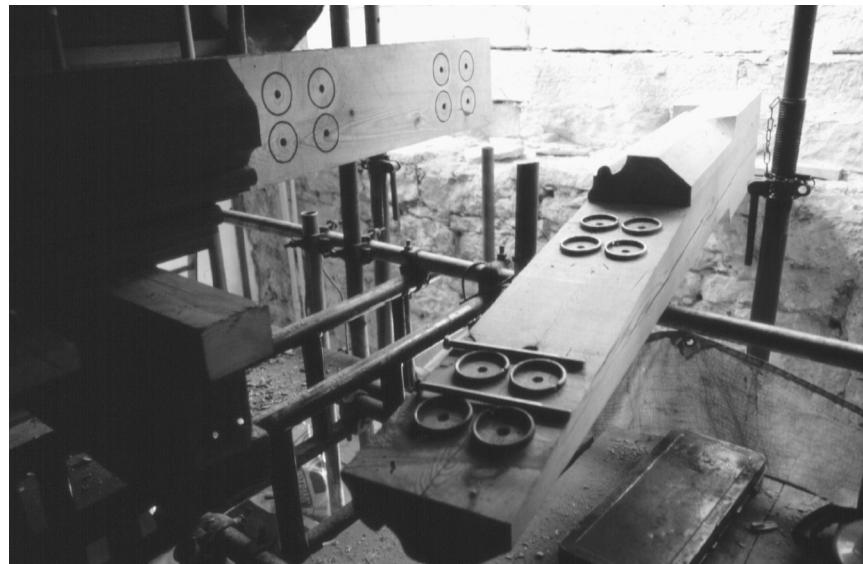
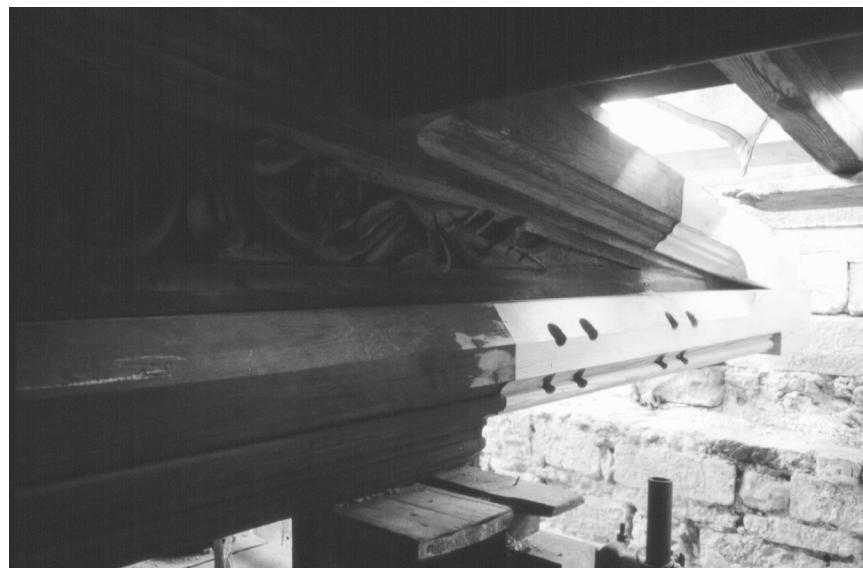
Fig. 12.5 *A vertical splayed scarf with bolts and split rings used in Cranbrook Church, Kent. (a) The joint before assembly, showing the bolts and split rings. (b) The assembled joint. (The boltholes are still to be plugged, and the bottom moulding added)*

row of fasteners, the distance between them will be fixed by the original (seasoned) piece. Thus, for a green oak repair, two rows of split rings may bring the risk of a central split developing due to drying shrinkage. An example of the joint is shown in Fig. 12.5, where the beam has moulded sides, and a conventional face-splayed scarf would have been impractical. In this case, the new section was cut from reclaimed (i.e., seasoned) timber.

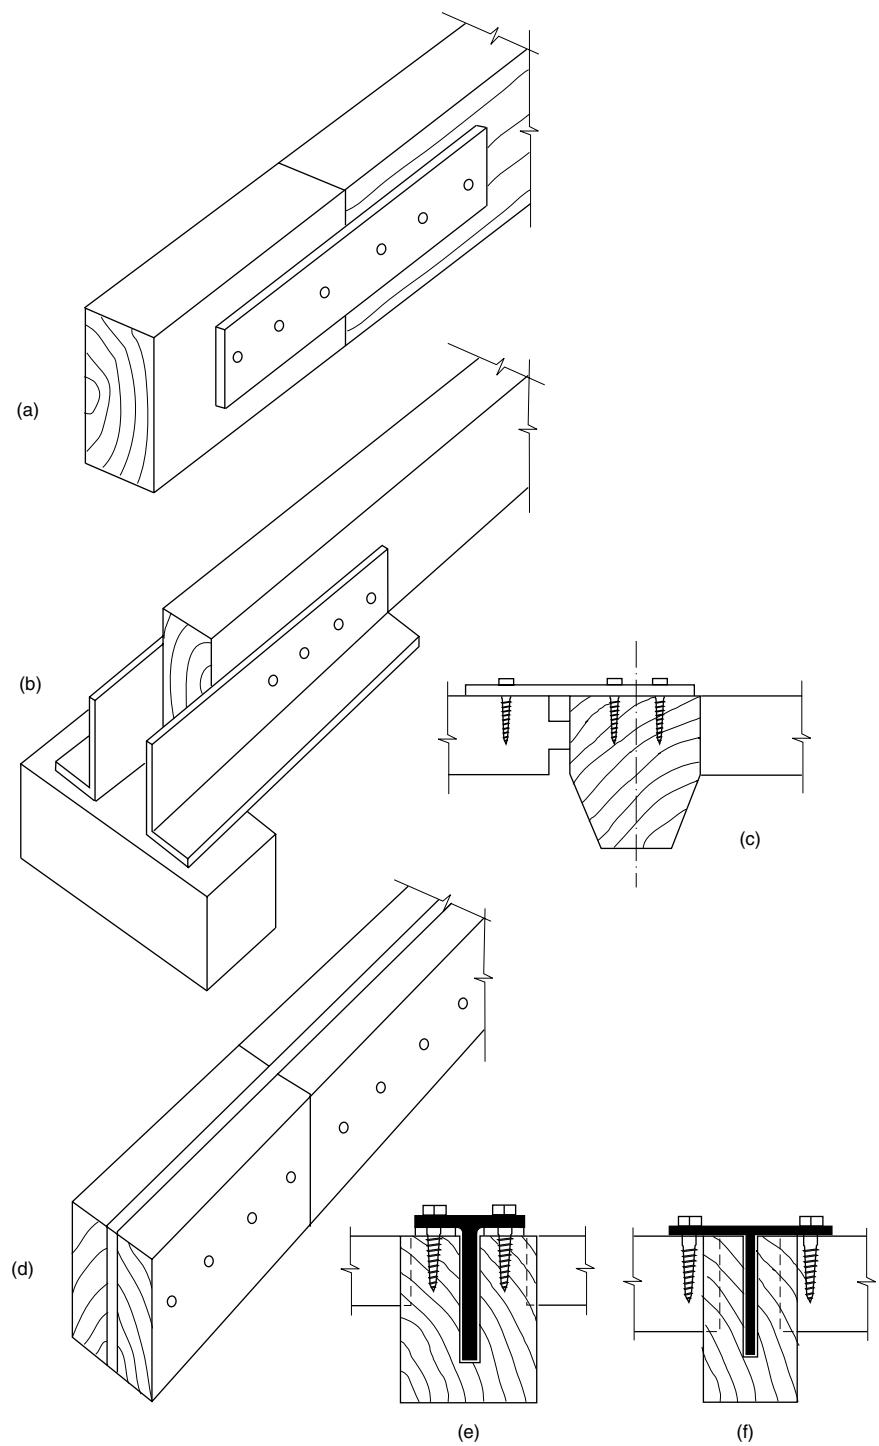
Plates applied to each side of the member, generally metal (although solid timber or plywood can be used), and placed across a simple butt joint (Fig. 12.6(a)). The plates take all the load and can be designed using nails, screws, bolts, or bolts with connectors. If greater strength is required, sections such as angles or channels can be used. This is a useful detail if the splices are to be extended into a wall to provide end bearing where rotten joist ends have been cut off (b). This detail is appropriate where it is not possible, or practical, to cure the dampness in the wall. The steel should, as a minimum, be galvanised. It may be necessary to replace a 'dummy' member, in order to provide fixing for the floorboards or the ceiling. Of all the repairs shown in this chapter, this one is probably used more than any other.

A flitch plate lies inside the timber (d) and is usually employed to add strength or stiffness to a heavily loaded member. If a blind slot can be cut from above, the flitch will be completely concealed. Fixing by side bolts is difficult, because

Fig. 12.6 Joints made with
metal reinforcements (a) splice
plates (b) splice angles (c) top
plate (d) flitch plate (e) and
(f) flitch tee piece

In attempting to keep remedial work to the minimum, consider the use of the 100-year rule, and the possibility of load tests, where they are feasible. For medieval structures, the use of the repair types shown in section 12.1 allows the retention of the original connections, for there is no doubt that part of our appreciation of such structure lies in following the logic of way in which the frame is assembled. However, on occasion, a simple metal strap may allow much original material to be kept (Fig. 12.6(c)).

The critical member of many older floors is usually the principal beam, and the capacity of the floor as a whole can be increased if the principal beam can be strengthened. This can be sometimes be achieved with splice plates or channels (b), if the common joists allow sufficient depth. A fitch plate, perhaps in the form of a tee, is another way of increasing strength (c) but may be considered to be too intrusive. In these cases, it is sometimes possible to increase strength by building a second steel beam at right angles to the principal. Figure 13.4 shows such a beam, used in the Bell Inn at Gloucester.

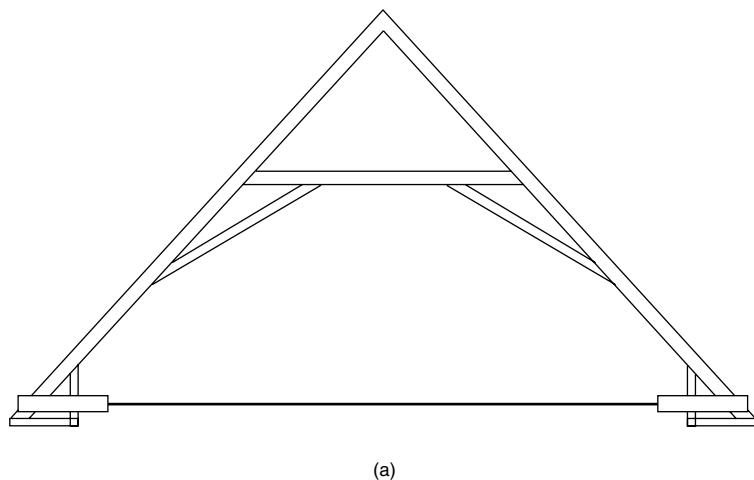
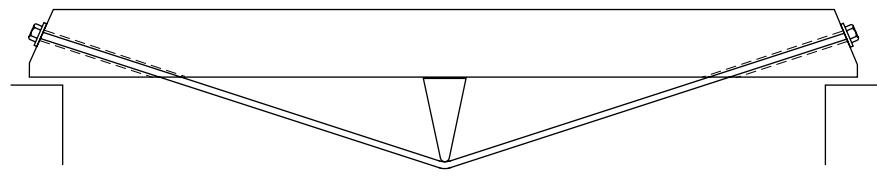
It is also possible to reinforce timber frames by adding steel members. Examples are shown in Fig. 12.7, where a bottom tie is added to an A frame roof truss (a), and strut and members are added to a beam to convert it into a bowstring truss (b). The principle of tying the feet of a roof truss is also described in section 18.4, and if the supports are unable to provide the lateral restraint necessary, then this may be the only feasible way to ensure stability. The steel members are visible, but are small in cross-section as they are simple tension members. Intermediate supports may be necessary to avoid sag in the ties. The steelwork should be detailed so that its function is clear, and it can be read as a later addition to the original structure—the idea of clarity that is referred to in 13.2, where I suggest that repairs should represent the time at which they were done.

Fig. 12.7 Examples showing
the reinforcement of timber
elements by adding steel members

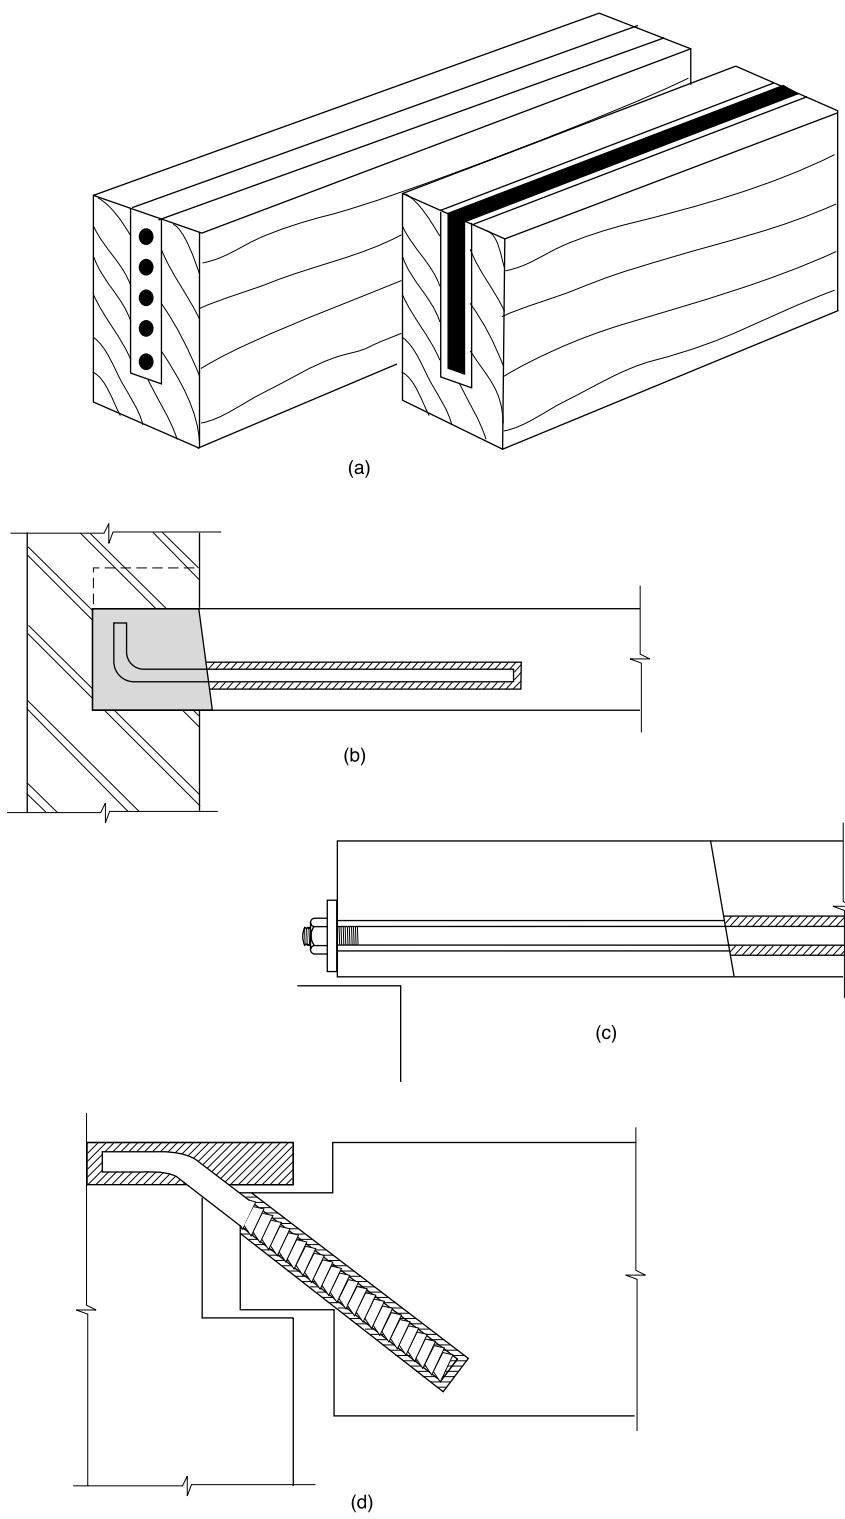
If a beam has some rot in the centre, which makes it inadequate, or it is required to increase the bending capacity, then an epoxy may be used to bond steel into a slot cut along the centre of the beam from above (Fig. 12.8). The steel can either be in the form of reinforcing bars (a), or a vertical blade (b). Individual rods are easier to handle, and will adapt to the line of the beam, but a higher section modulus can be achieved with a blade.

Epoxy-bonded steel can also be used for general strap or tie purposes, e.g., at joints, if movement has occurred which reduces the joint strength (e).

Fig. 12.8 Repairing rot in the centre of a beam by using steel and epoxy resin

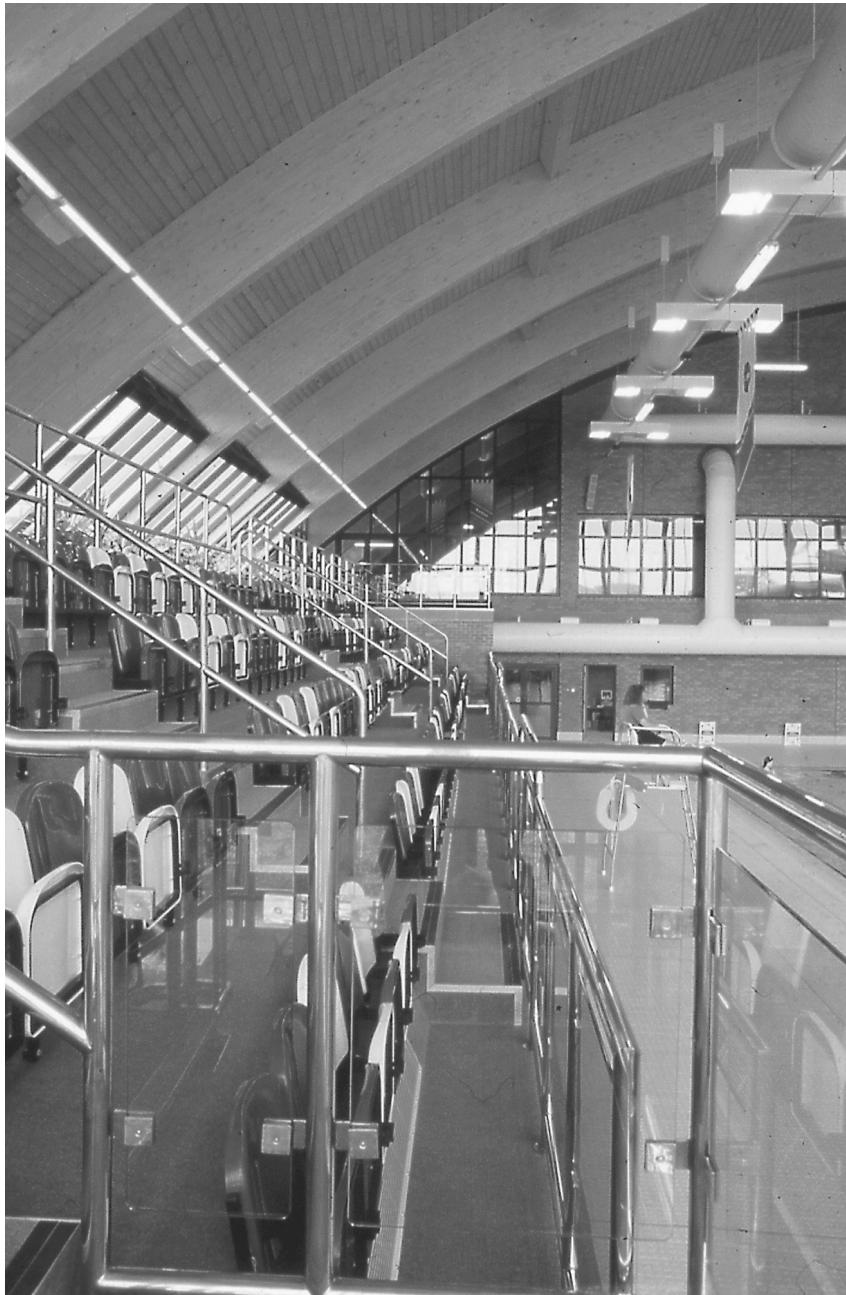
*Littledown Sports Centre,
Bournemouth. A forty metre
span roof of three-pin glued
laminated arches, with a boarded
roof of solid timber, built in
1984.*

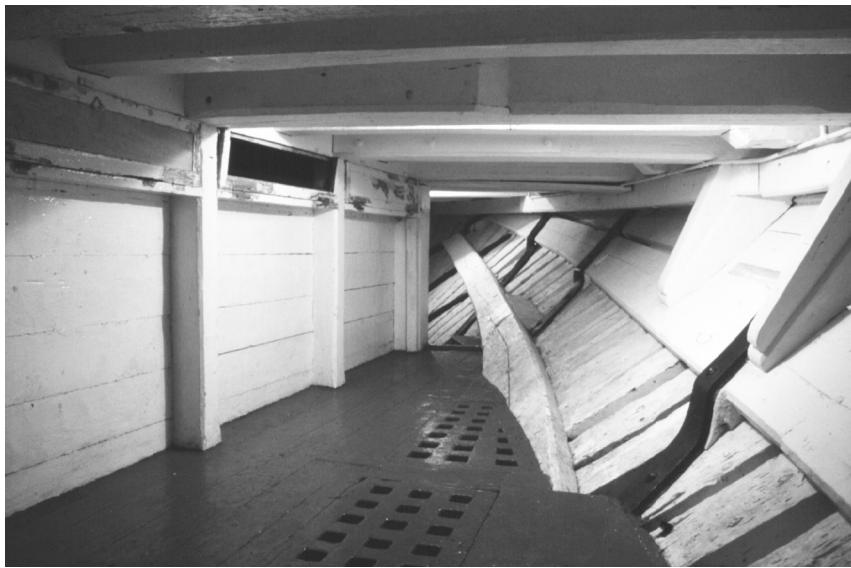
Fig. 13.1 The Frigate 'Unicorn' at Dundee. A conservator's dream—all original timber from 1824

The starting point of an audit is to determine which part of the structure is, or might be, original. The frigate *Unicorn* is admittedly an unusual example of a timber structure, but a glance at the framing, bound in by the iron straps, indicates that it must all be original, since replacement of individual members is virtually impossible (Fig. 13.1). A closer inspection shows that this is indeed so, despite the fact that the ship has been in the water since 1824. The reason for the high significance allocated to original structure is that we can then be sure of the form in relation to history—later replications always bring something of their own age with them.

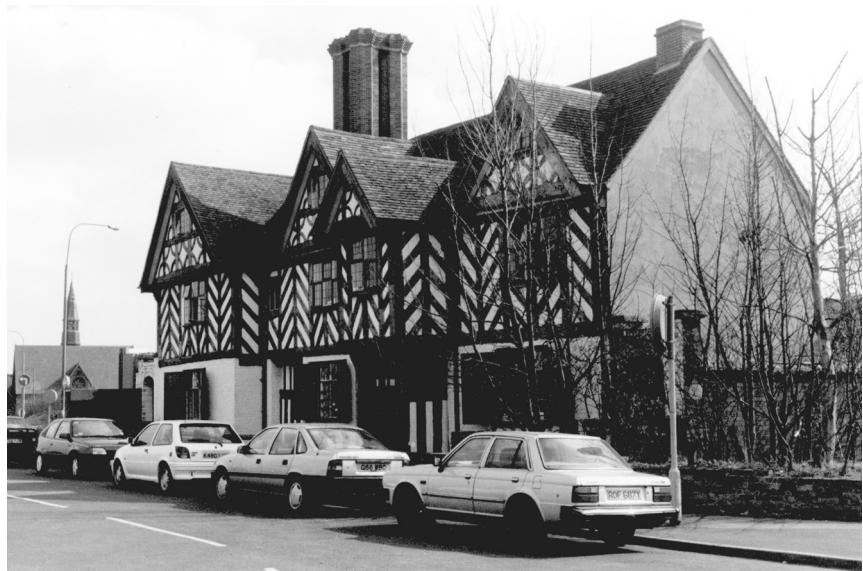
Fig. 13.2 Stratford House, Birmingham. The front part of the house is seventeenth century, with exposed timber frames. The rear is eighteenth century, with brick walls and a concealed timber first floor and roof. Neither part is more significant than the other—the real significance of the house is the clear delineation of the two periods of construction

Buildings which are equivalent of the *Unicorn* are in the minority—most have been extended with time, as has happened to many of our parish churches. Occasionally, the extension may be equal to the original building, as at Stratford House, Birmingham (Fig. 13.2).

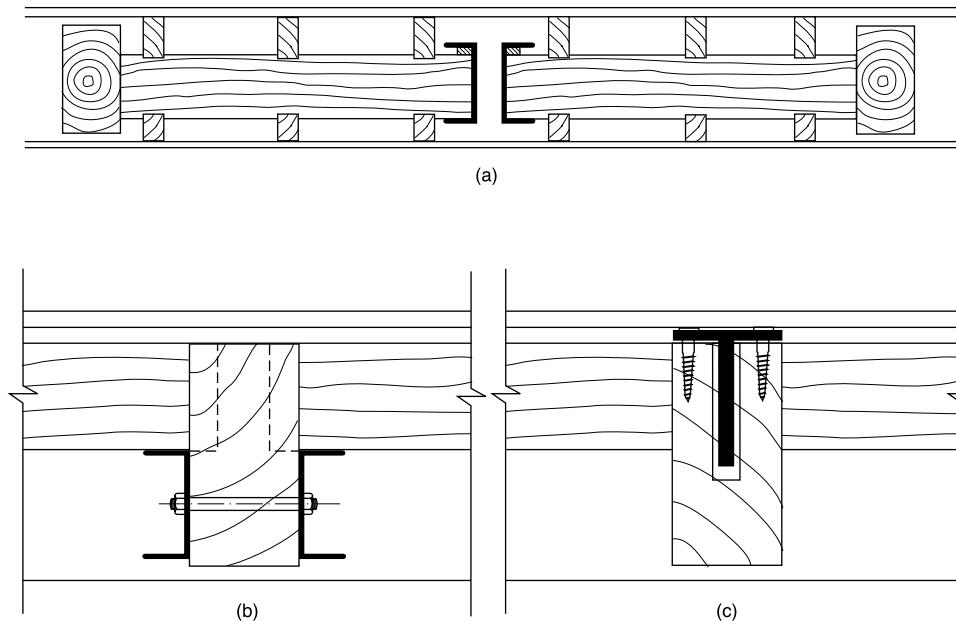
Fig. 13.3
A traditional repair
to a barn

If load tests are not feasible, then some of the repair techniques shown in Fig. 13.3(a)–(c) can also be used to increase floor capacity, although they involve a considerable intervention in the floor structure which is generally irreversible. They can, however, be used where the floor structure is judged to have a relatively low significance within the building as a whole.

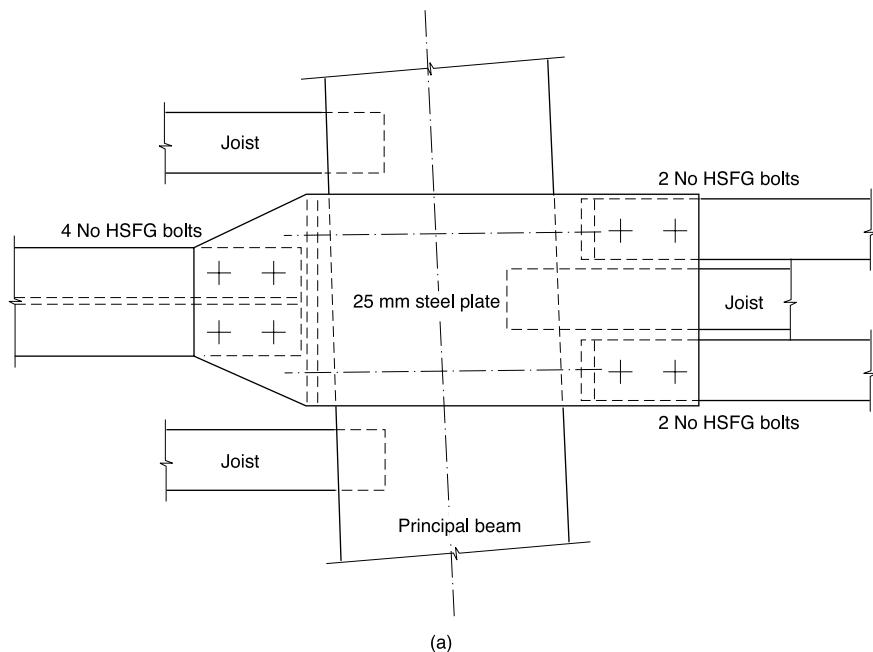
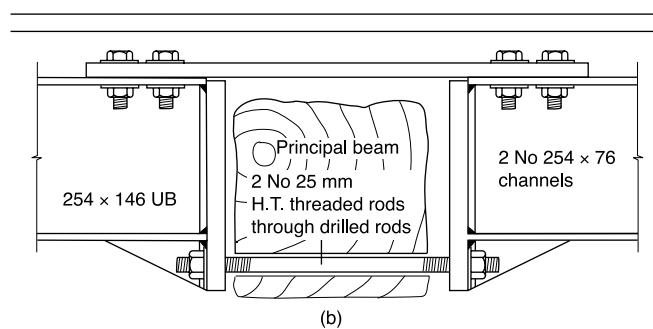
Fig. 13.4(a) and (b) The Bell Inn, Gloucester. The floor was strengthened by providing a second 'principal' beam in steel at right angles to the original

The options for strengthening the beams are shown in Fig. 13.4. The location and spacing of the joists mean that any steel added from the top would have to be in the form of a flitch plate let into a central groove cut into the member. This could either be fixed with an epoxy resin, or bolted into position, and would need cutting to a curved profile based on a survey, to allow for the creep deflection. Where the floors had been firred up to level over all the span, a fabricated T-member could be used. The beams could more easily be spliced from below with, e.g., channels, but this would involve cutting into the ceilings and, more importantly, the covings. A broad estimate of the cost of strengthening most of the beams by one or other of these methods was around £50 000. Against this, a budget price for grading the beams and load testing 20 of them (25% of the total) was in the order of £13 000. The test proportion was provisional, but based upon the proportion of beams which had critical applied stresses.

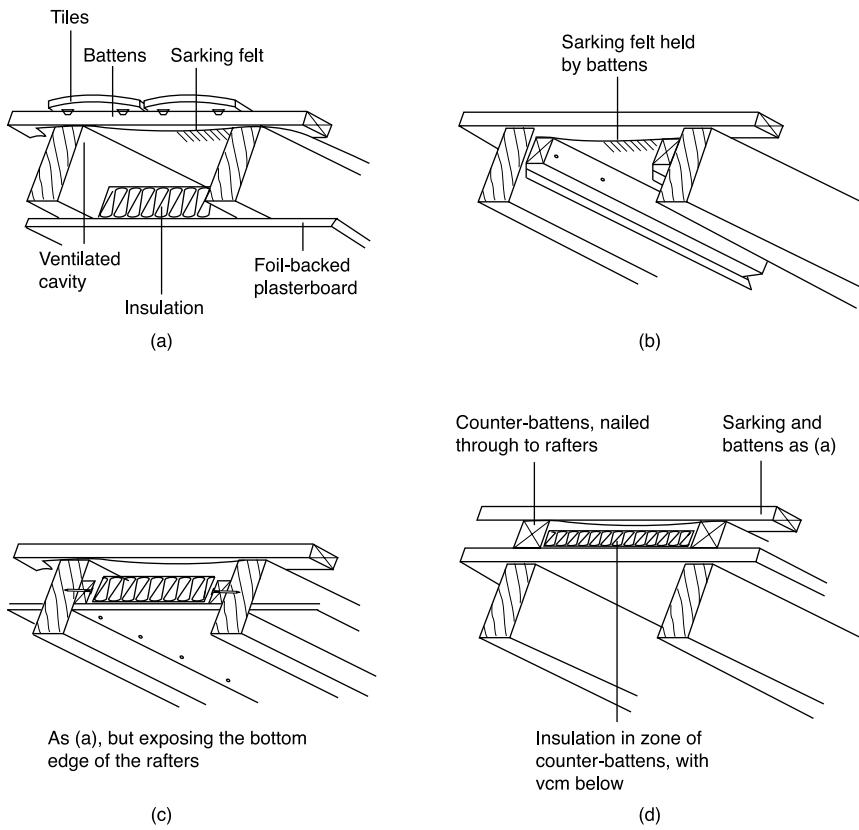
Fig. 13.5 Adding insulation to a pitched roof

rafters (Fig. 13.5(a)). If there is no sarking felt, it would be prudent to introduce it as shown, although this is an imperfect form, and the tops of the rafters are still at risk (b). This is still a cold roof, and relies on a good vapour control membrane, and trickle ventilation through the laps in the sarking. The arrangement is often used for the conversion of lofts into habitable spaces. Detail (a) can be recessed as in (c) to allow the rafters to be seen in part if they have sufficient depth to accommodate the insulation.

Where the rafters and boarding are significant, e.g., in an open roof, the best arrangement is to work from outside, as shown in (d). The removal and replacement of the tiles (or slates) is of course a major consideration, and in many cases would mean that the work would only be economic at a time when the roof covering itself was the subject of general repair.

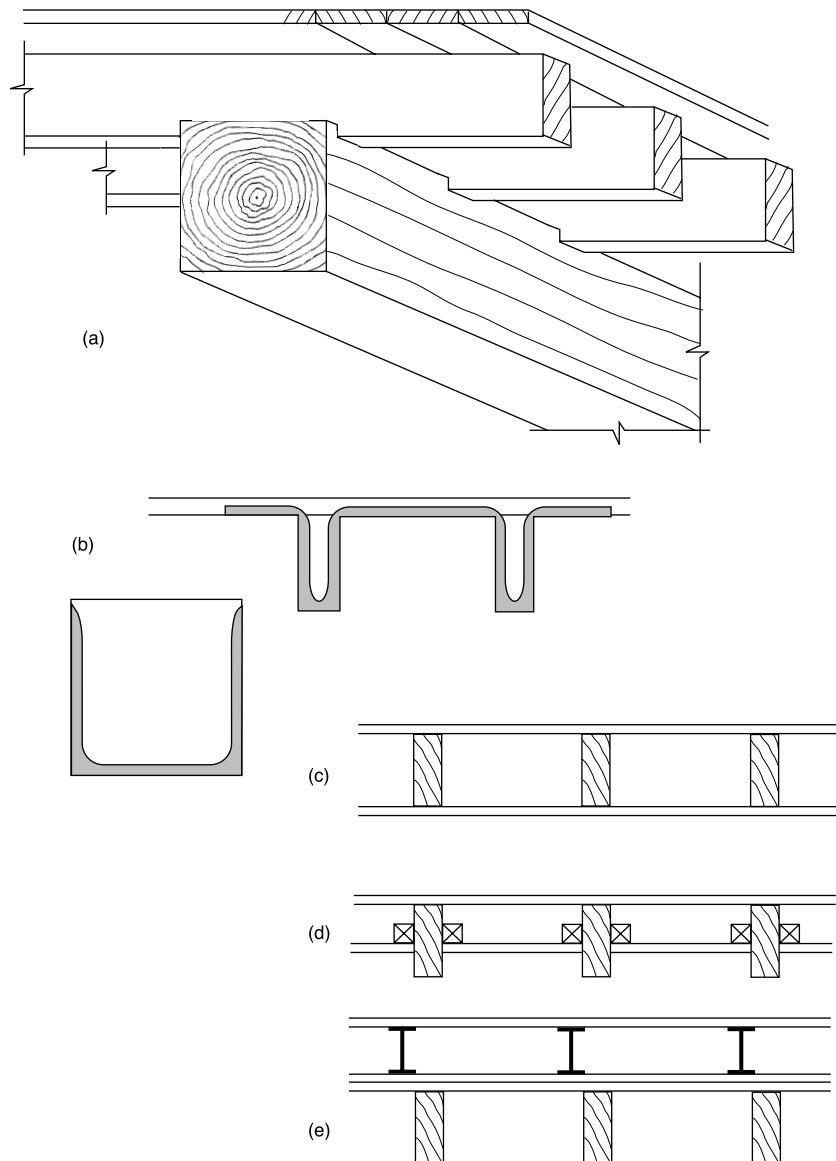
Fig. 13.6 (a) A typical warehouse open floor.
(b) The effect of the same charring thickness on the different elements.
(c) to (e) Options for additional fire resistance

example let us take a mid-nineteenth century warehouse with large principal beams, common joists and boarding (Fig. 13.6(a)). Given a charring rate of 40 mm per hour, the principal beam will obviously have a period of resistance in excess of two hours (b). In contrast, the joists could achieve about an hour, with less than half an hour for the planks.

The options run broadly in parallel with those suggested for insulation. The joists could be underlain with a fire board to achieve any required period of resistance (c). If concealing the joists is not acceptable, the board can be fixed between them (d). This reveals the joist rhythm, but the proportions are

altered. If the whole of the underside of the floor was considered to be significant, then an independent floor could be constructed, spanning between the principal beams with fire protected steel joists (headroom permitting), creating at the same time a service floor (e).

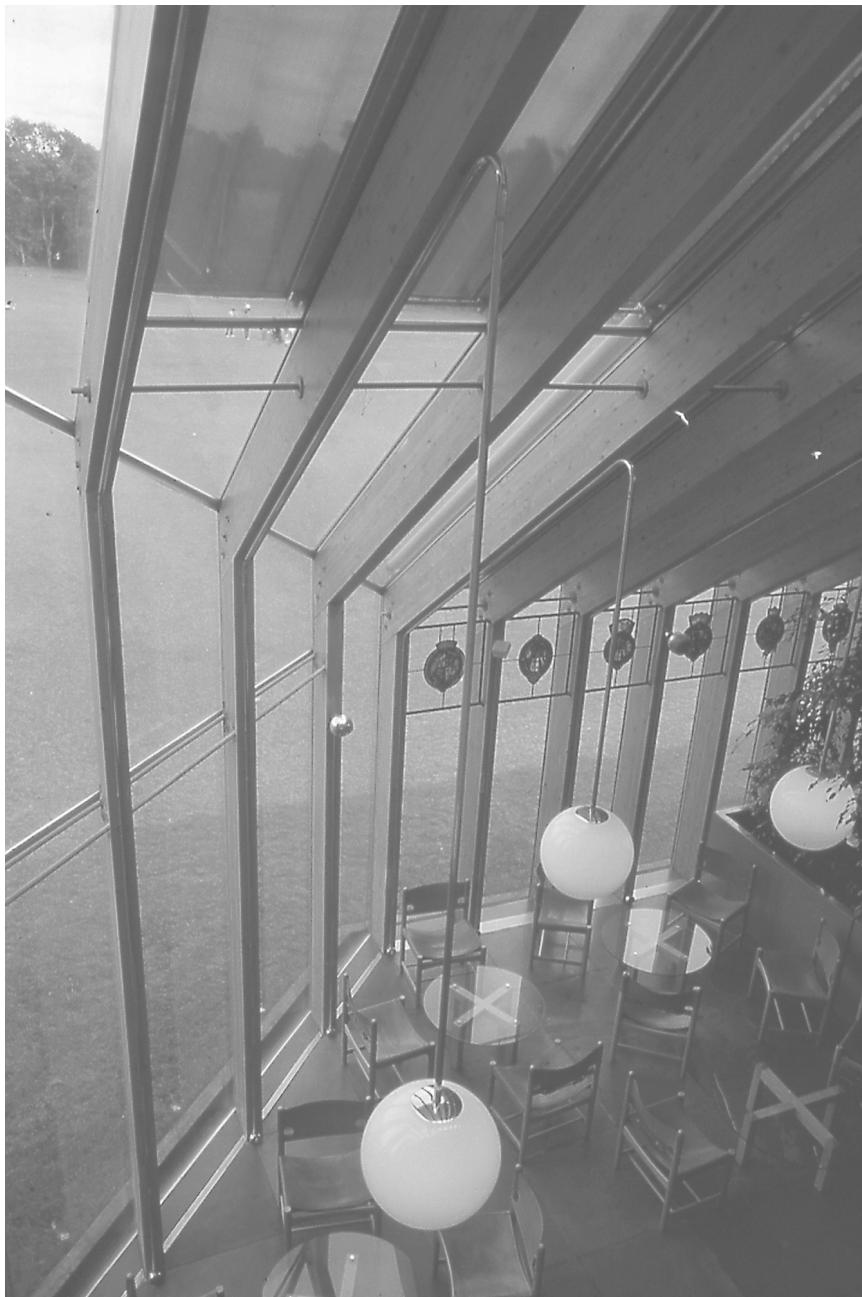
*Burrell Museum, Glasgow.
Softwood glulam frames, glazed
externally and neatly turning the
corner of the restaurant.*

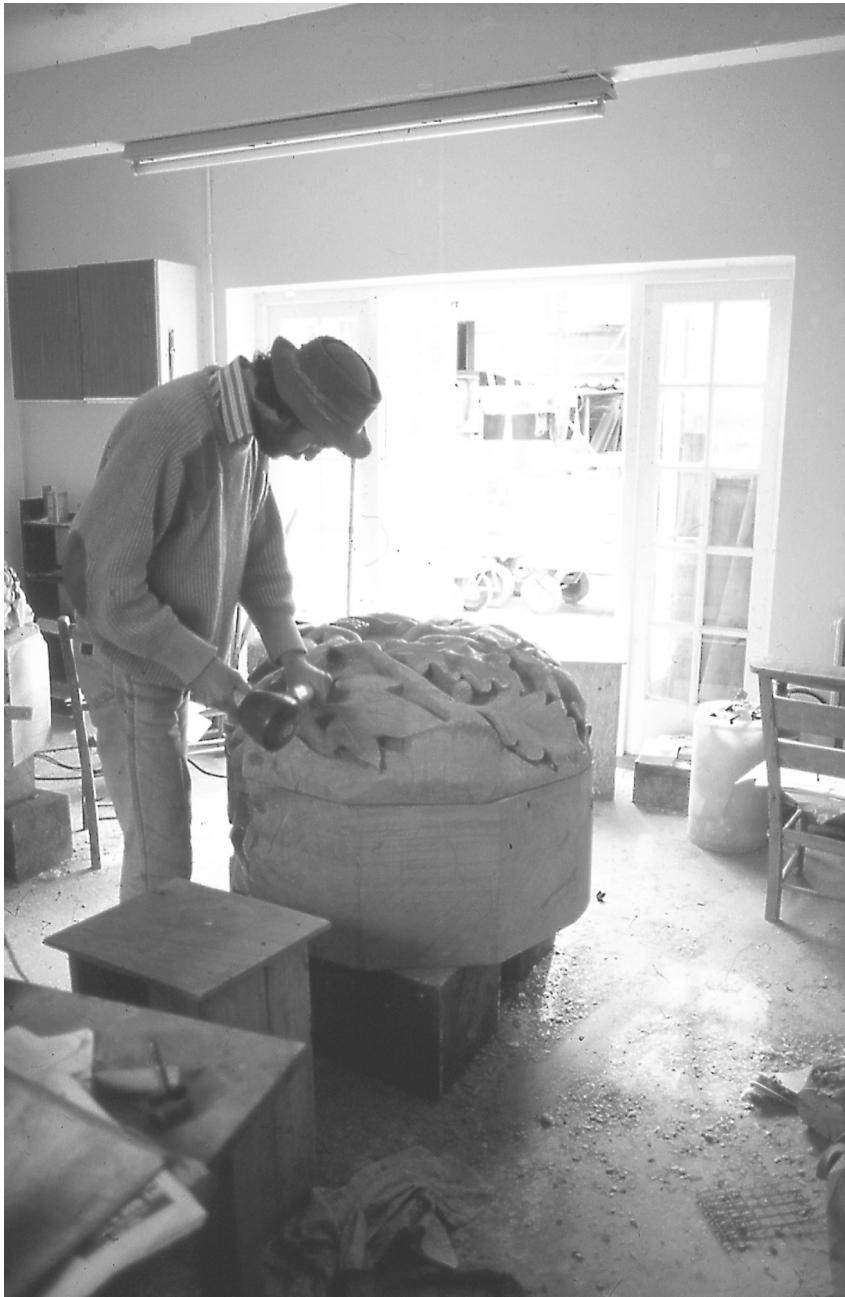
*York Minster, South Transept
Roof boss. Carving one of the
vault bosses from a block of
glued laminated oak.*

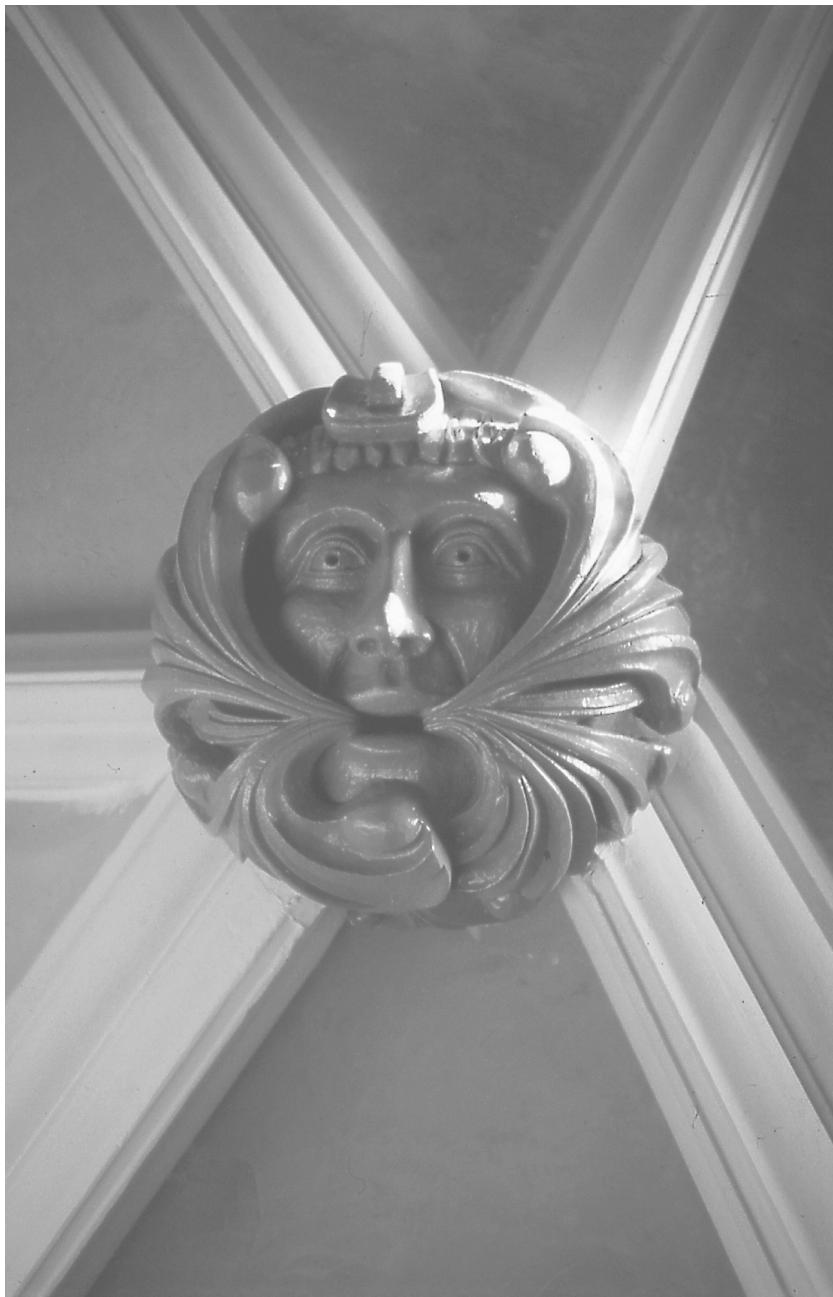
*York Minster, South Transept,
new roof boss. A representation
of the 'green man', carved from a
block of laminated oak.*

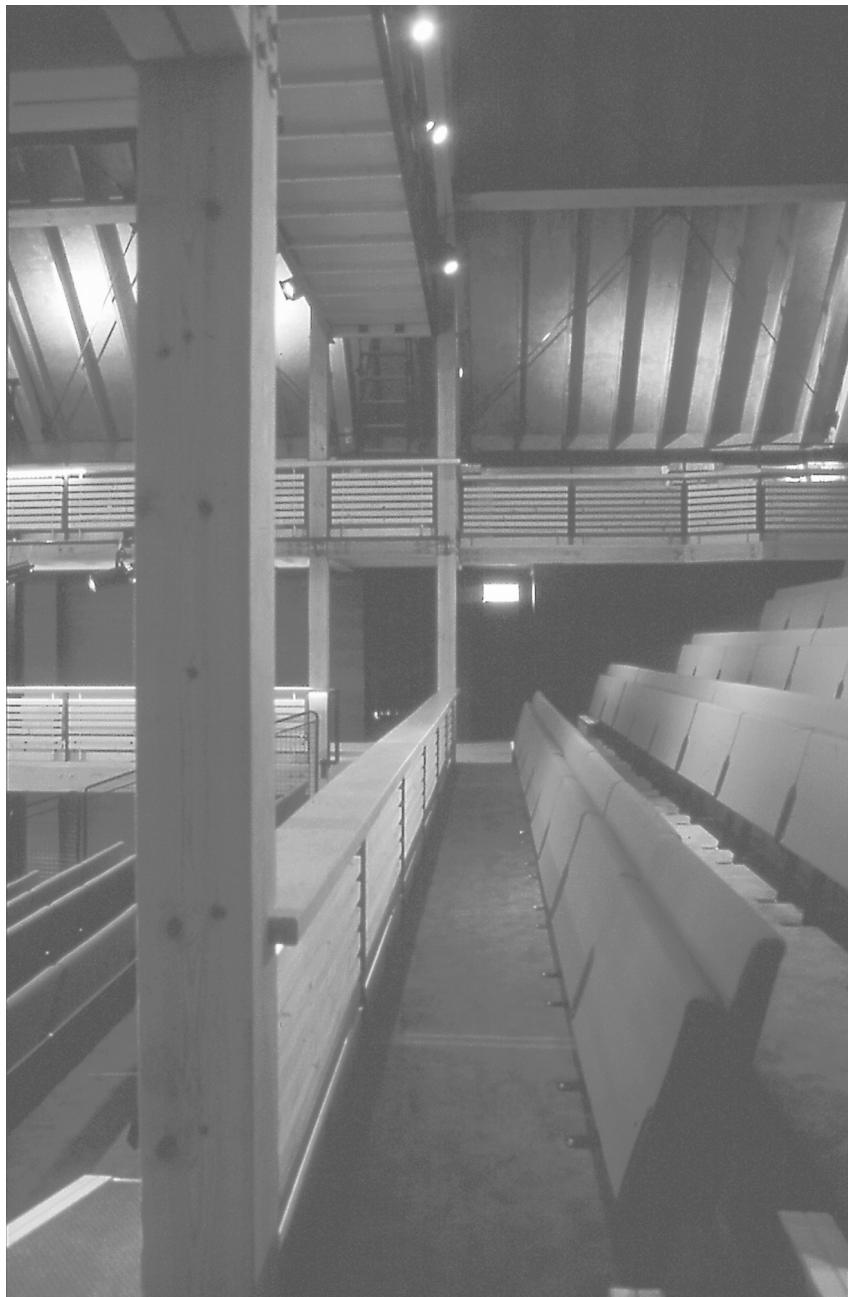
*Frensham Heights School,
Farnham, Surrey. The
Performing Arts Centre
auditorium, framed in redwood
glulams.*

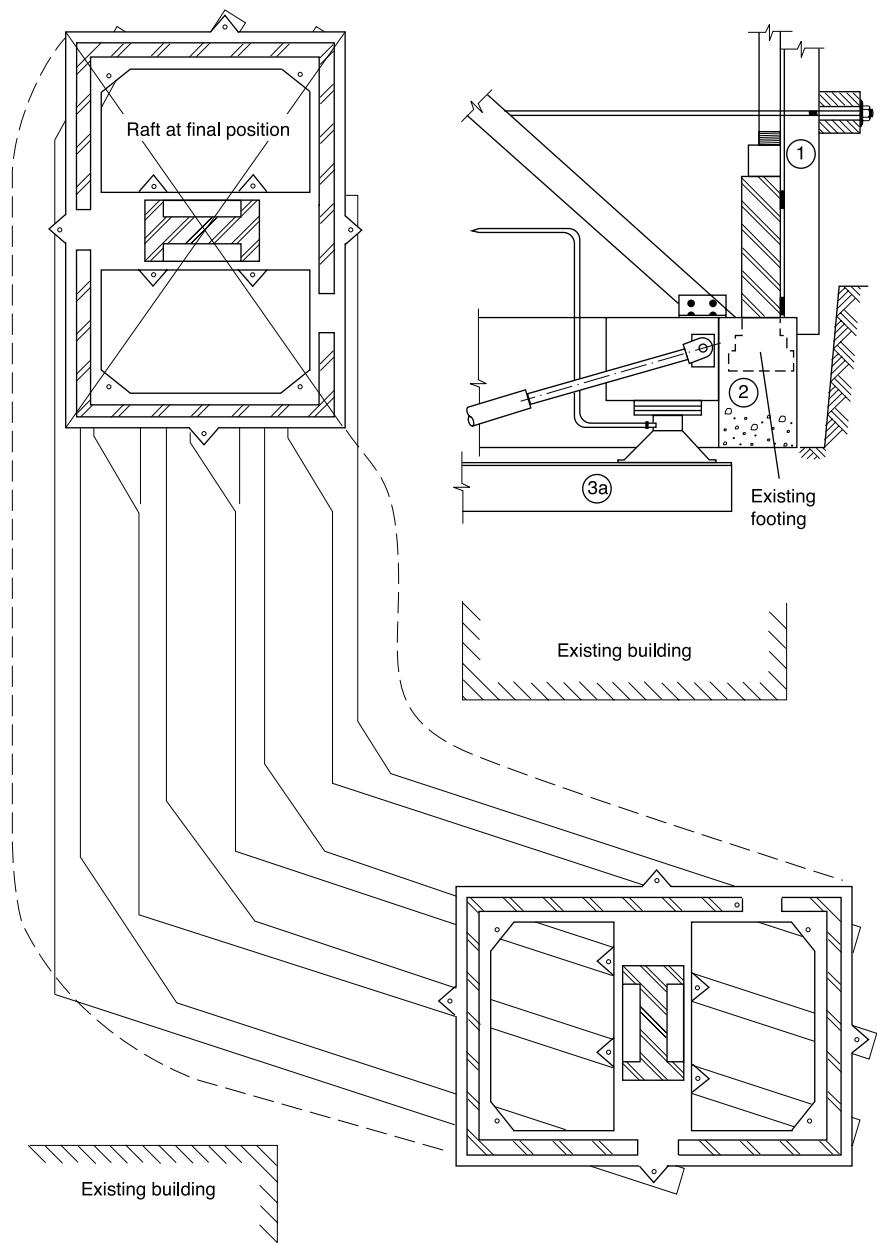
- 3(a) A running track is constructed below the bearing frame, leading to the new location, with prepared top surface.

Fig. 17.1 General sequence of work in the 'lift and slide' method

4(a) The building, on its bearing frame, is slid along the track to the new location. The move may be made by the use of simple rollers, e.g., scaffold tubes, or proprietary sliding bearings, which need a metal plate surface to the track, and operate on the hovercraft principle, with grease instead of air. It is possible to change the orientation of the building, and to 'steer' around other buildings.

If the condition of the frame does not appear to be conducive to dismantling, or if in situ elements and finishes, such as brickwork and plaster, are of major significance in the overall structure, then only a lift and slide move may be feasible. Although the costs associated with such a method are obviously considerable, they will depend upon the size of the structure, and the distance moved. The details of any scheme will depend on the particular circumstances, but the following is an outline of the general sequence of work (Fig. 17.1).
