Appraisal and repair of timber structures

Peter Ross

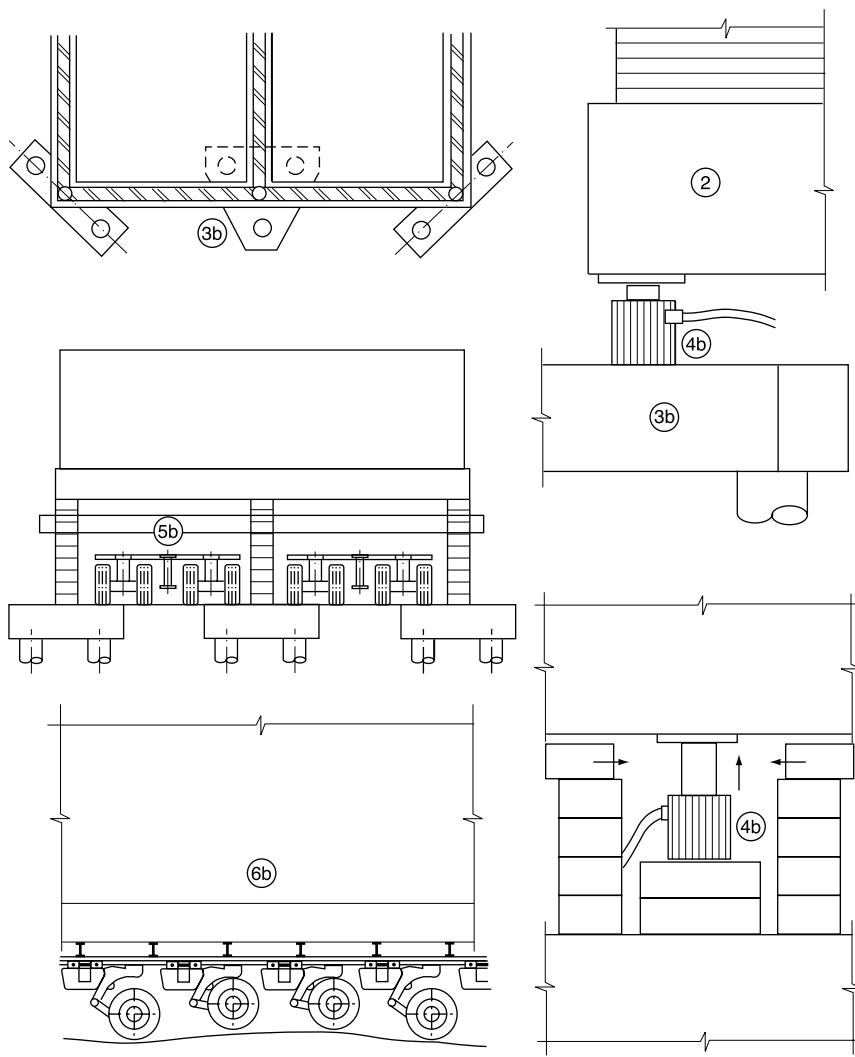
Fig. 17.2 Construction sequence for longer distances or a change of level

- 3(b) Foundations using pads, or mini-piles, are installed below the frame to provide jacking points.
- 4(b) Using jacks and blocks, the frame is jacked up to the new, or travelling level.
- 5(b) The transport rigs are introduced below the frame. These rigs are usually built up from wheeled modules, and the assembly is steerable and self-levelling, and can be raised to lift the frame off the blocks.
- 6(b) The rig is towed to a new location, over a prepared track. A slight incline in the track may be feasible. When the building is in its new position, the lifting procedure is reversed to lower the frame onto new foundations.

OR, for longer distances, or change of level (Fig. 17.2)

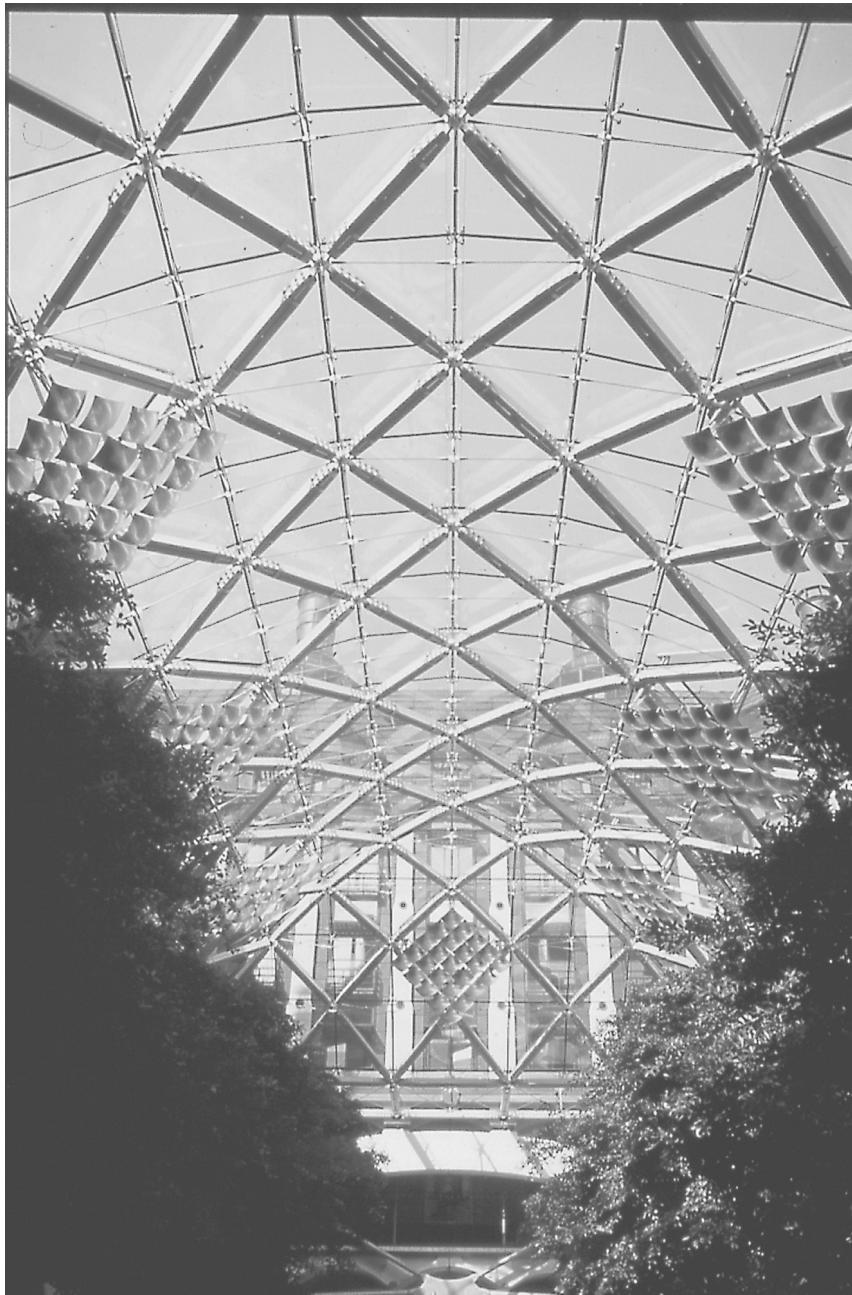
The courtyard roof of Portcullis House, London. A diagonal lattice vault in American white oak, with stainless steel nodes.

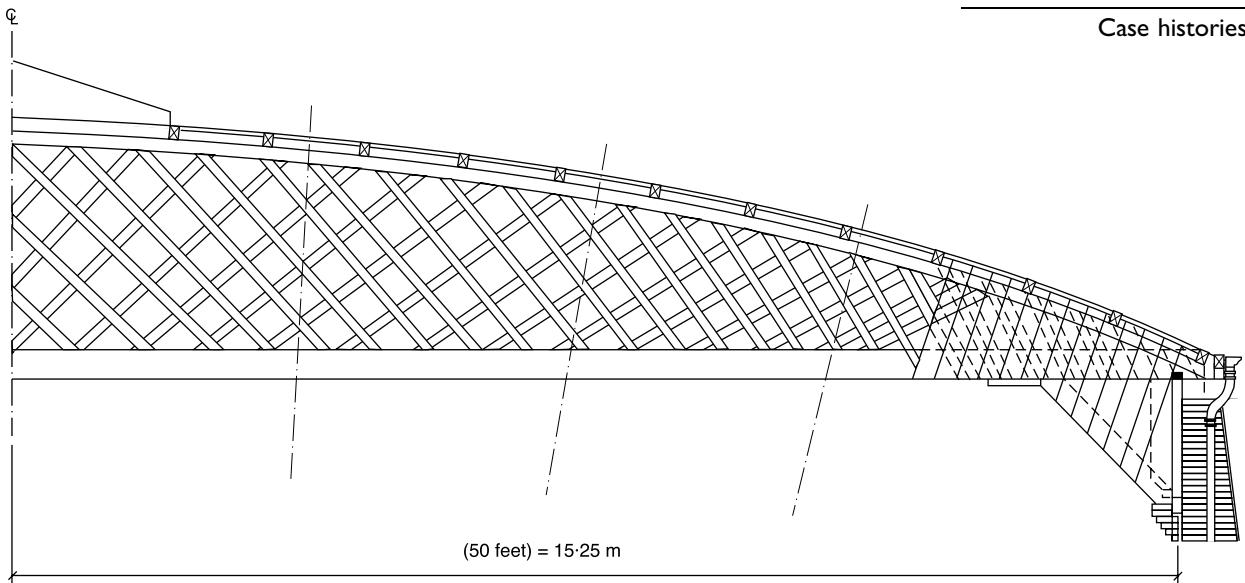
Fig. 18.1.1 Duxford Hangar: half elevation of roof truss

Each truss is fabricated in two halves (Fig. 18.1.1), which are then joined together by nailing through the diagonals. Each bottom tie is made up of four pieces nailed together, with staggered laps, and the top boom of two square pieces, slender enough to be pulled to the required curvature. The diagonals are in the sophisticated form of an orthogonal lattice, canted over towards each end of the truss, and engineers can spend hours debating the merits of this arrangement. The trusses are spaced at approximately 3 m centres, and joined by purlins and cross-bracing. It is likely that the original roof decks were made up of diagonal boards covered with bituminous felt, replaced at some time with corrugated iron. In 1990 the Museum began a programme of roof covering replacement, using a proprietary insulated profiled aluminium system.

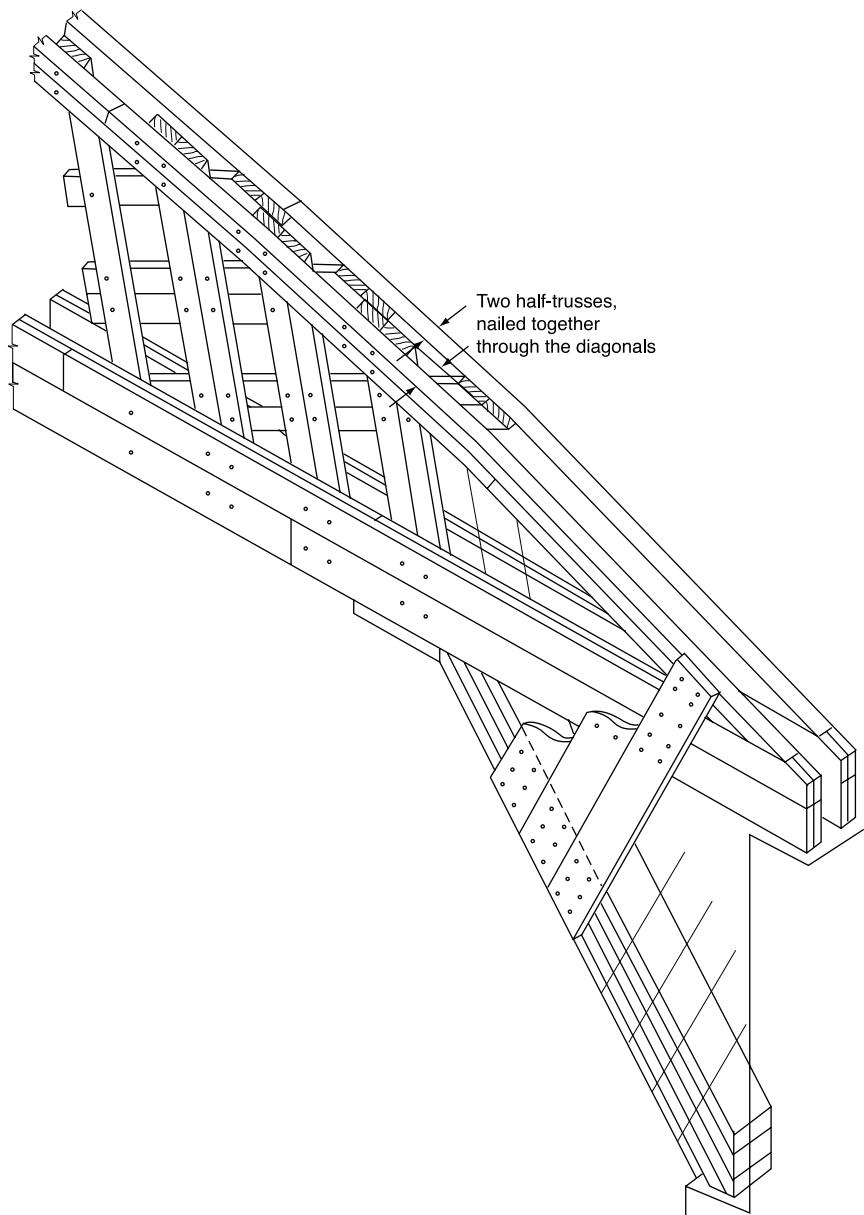
Fig. 18.1.2 Truss construction

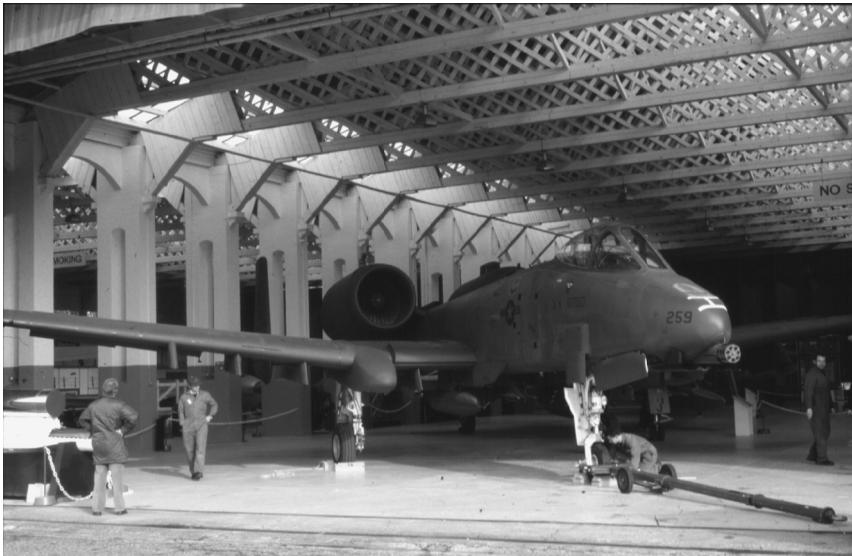
Fig. 18.1.3 Interior

All of the surviving three hangars at Duxford are of a similar form (the fourth was burnt during the making of the film *The Battle of Britain*). Each hangar (Fig. 18.1.3) has two halls, with trusses spanning onto brick walls. The ends of each building are closed by pairs of sliding–folding doors, which in themselves are significant pieces of carpentry. Each door is made up of 18 leaves hinged onto sliding uprights. Each leaf is framed, often

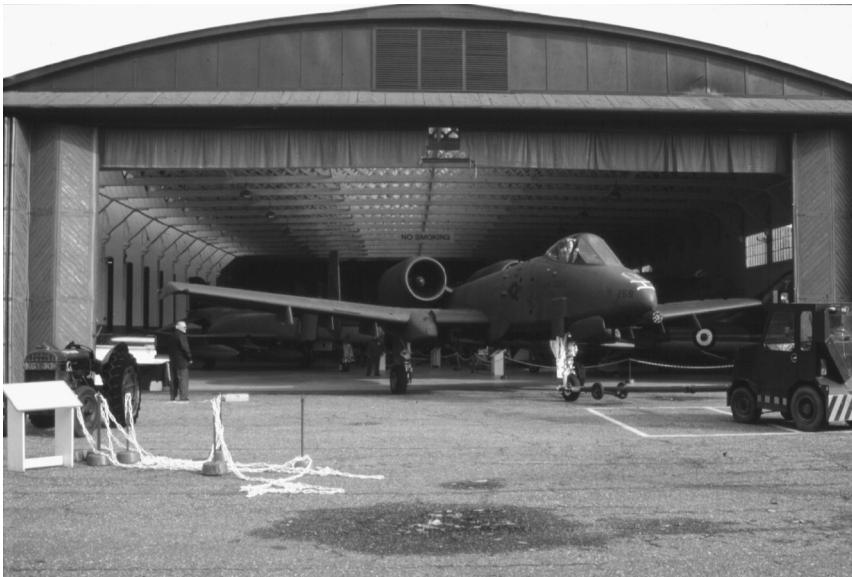
Fig. 18.1.4 Exterior view of doors in the fully open position

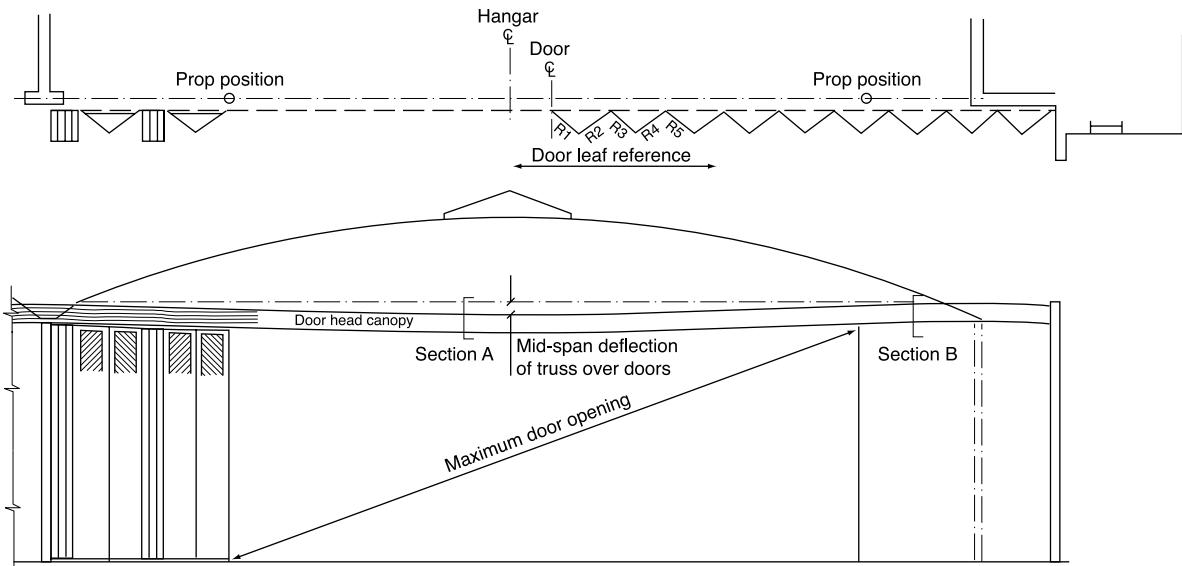
Fig. 18.1.5(a) Door details

a steel truss adjacent which took over its duties. However, the study of the doors immediately showed that they did not open to the full span of the building. Props could be placed at the limit of the opening, which would reduce the truss span by a third (Fig. 18.1.5). Since deflection is proportional to the fourth power of the span, the influence of creep would be reduced by one hundred fold, and would, in effect, be eliminated.

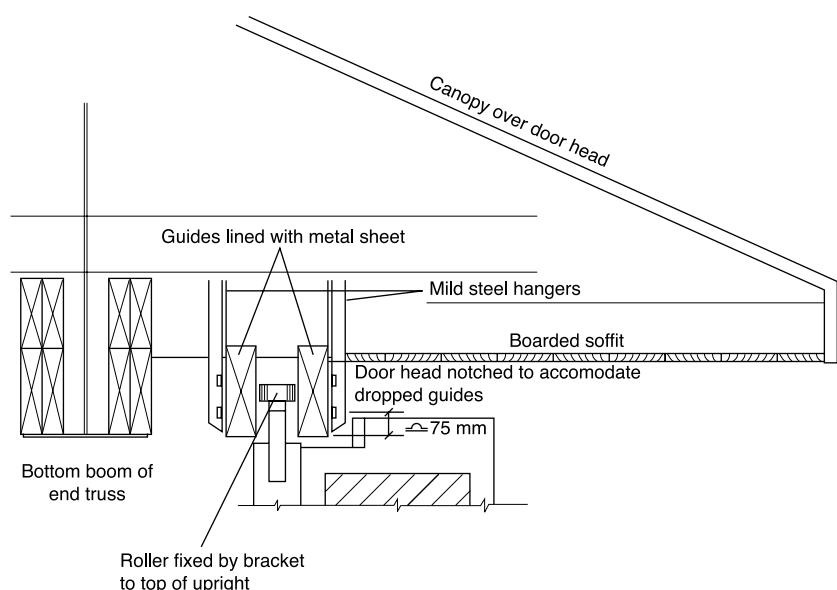
Fig. 18.1.5(b) Centre section A

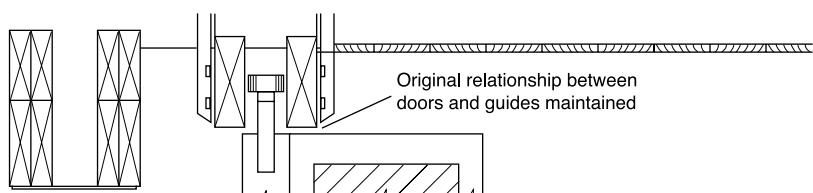
Fig. 18.1.5(c) Support section B

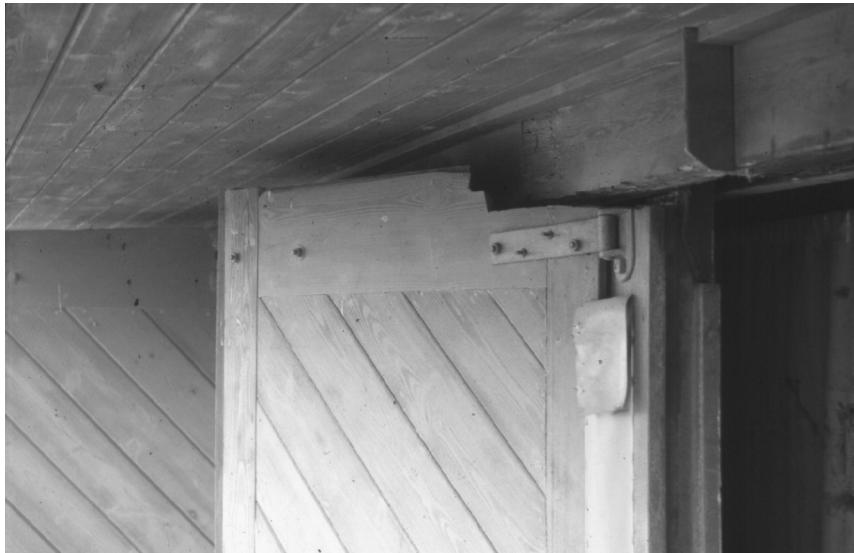
Fig. 18.1.6 Door head notched by 80 mm to accommodate the deflecting guide rails

The trusses are relatively shallow, with a span/centre depth ratio of 9:1. Although their strength is still adequate (a sample number were load-tested a few years before). A survey of several guide rails (Fig. 18.1.6) (that would originally have been set to level) showed a mid-span deflection of around 70 mm to 80 mm, which would represent the creep component of deflection.

Although it is not large in relation to the truss itself (span/400), it was much larger than the clearance over the doors, and it was for this reason that they had been notched. Some guides were binding despite the notches, so it was clear that creep deflection was on-going.

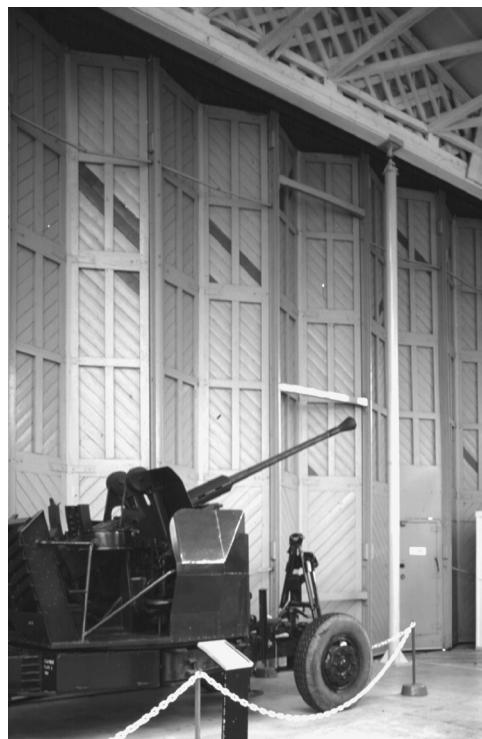
Fig. 18.1.7(a) View of prop

that creep deflection results in a permanent set of timber members. It was decided therefore to design the two props with screw jack heads (adapted from concrete falsework props) in order to test the potential for lifting the trusses (Fig. 18.1.7). This could not be done 'blind', however, because the jacks might simply lift the truss off its bearings. Thus a Fressinnet flat-jack with a pressure gauge was placed on each jack to indicate the load in the prop, and an estimate was made of the truss dead weight.

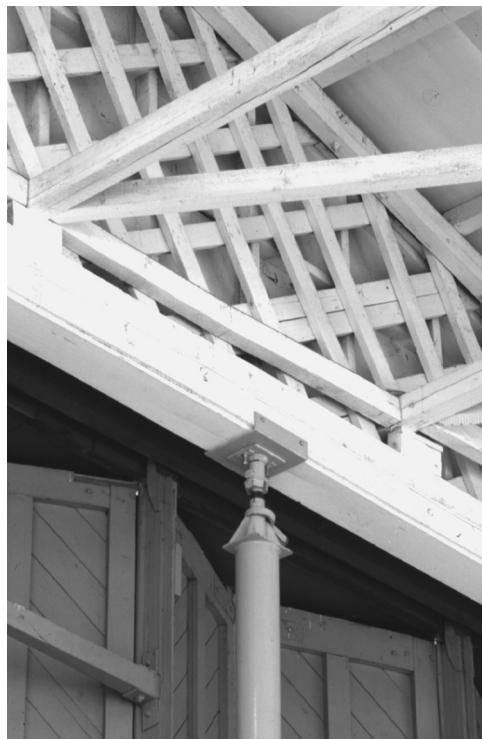
Fig. 18.1.7(b) Detail of jack
head

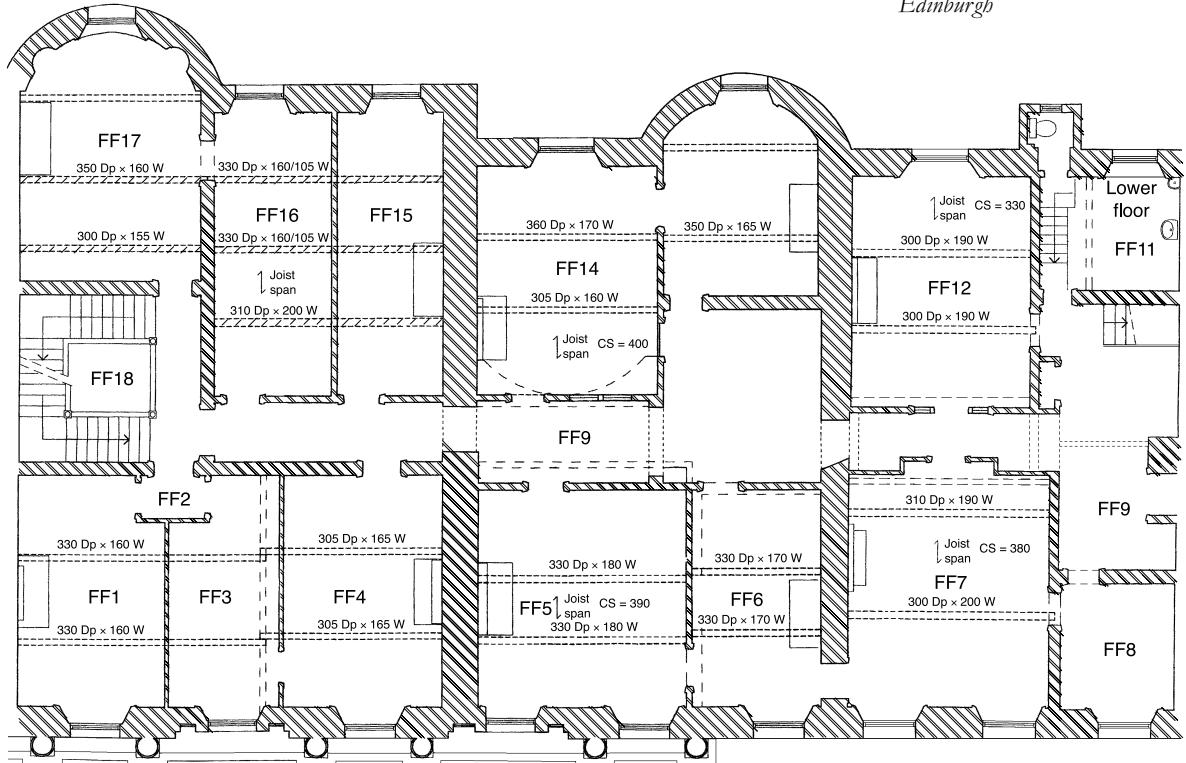
Fig. 18.2.1 First floor plan of 26–28 Charlotte Square, Edinburgh

Tongued and grooved boarding (not original)

The first stage was to lift some boards (which fortunately lie parallel to the principal beams) and survey the construction (Figs 18.2.1 and 18.2.2). The houses are typical of the area, with solid masonry walls, and timber floors of large principal beams with common joists notched into them. A 'deafening'

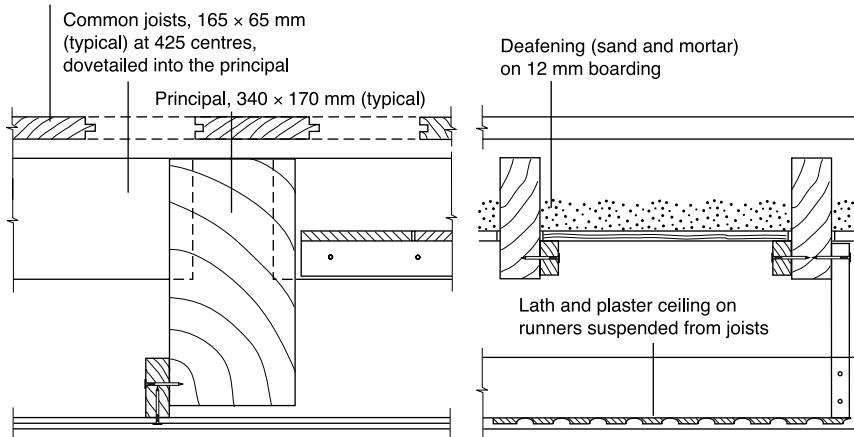
Fig. 18.2.2 Details of the floor construction

layer of boards and mortar is fitted between the joists, and the plaster ceiling below has elaborate covings. At some time in the past, the original boards (which would have been plain butt-edged) had been lifted, and replaced with tongued and grooved boarding laid on tapered firrings to correct an average mid-span creep deflection of around 50 mm. In addition to the joist notches, the top flanges of the principal beams have been randomly grooved for electrical conduits, locally up to 40 mm deep.

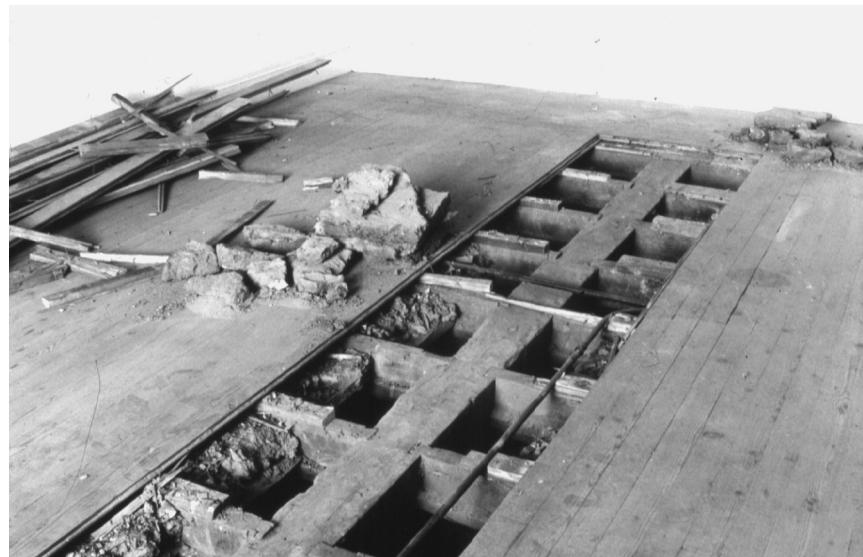
Fig. 18.2.3 Floorboards removed locally, exposing a principal beam with the common joists dovetailed into it

A cultural audit of the floor construction showed the floorboards were recent, and of low significance on the basis of replaceability. The floor structure below was largely original, with a high standard of workmanship. Dovetail ends to the common joists were well fitted, and the timber was generally in sound condition, the only damage being the notches and holes cut later for services. The ceilings below were in many cases original lath and plaster, and much of the elaborate decorative coving has survived. Overall, the ceilings and, more particularly, the covings had the highest significance, with the floor structure also significant. From a conservation viewpoint the ideal solution would be one which left the ceilings and floor framing unaltered, and if necessary disturbed only the boarding and deafening.

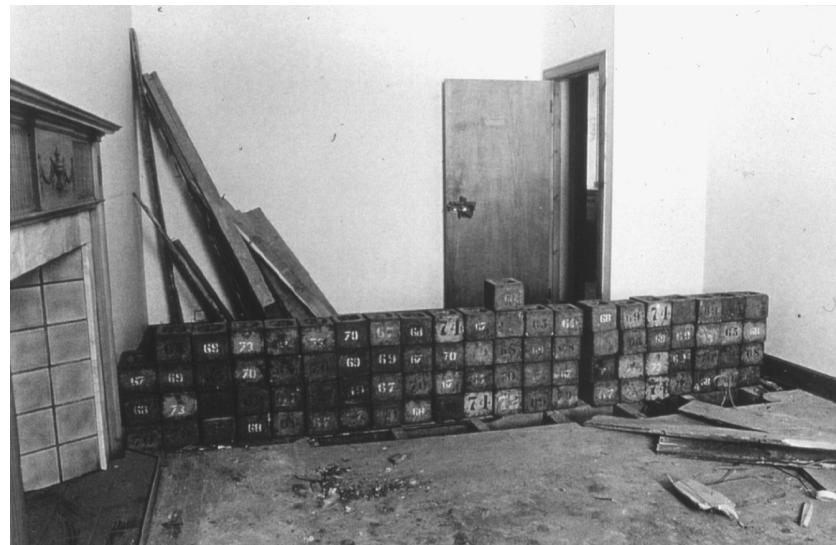
Fig. 18.2.4 Load testing

The load tests were carried out in accordance with the procedure in appendix 2, using cast iron weights (Fig. 18.2.4), and measuring deflection on dial gauges installed at low level below weights suspended on piano wires (Fig. 18.2.6). Deflections were also measured on beams adjacent to the beam under test, to assess the degree of load sharing.

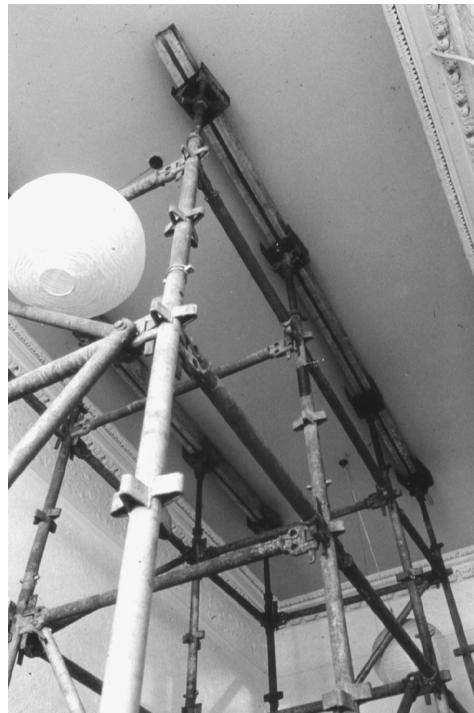
Fig. 18.2.5 Safety framework in place during test. The screw heads are adjusted to give a minimal clearance

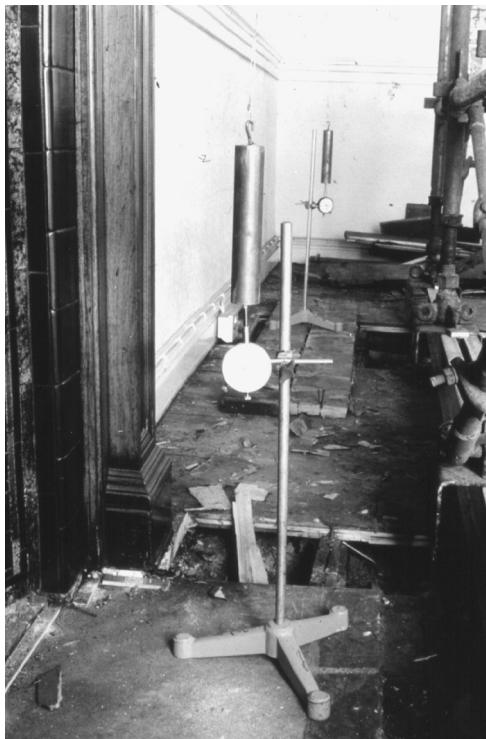
Fig. 18.2.6 Dial gauges measuring the deflection of a weight attached by a piano wire to the floor above

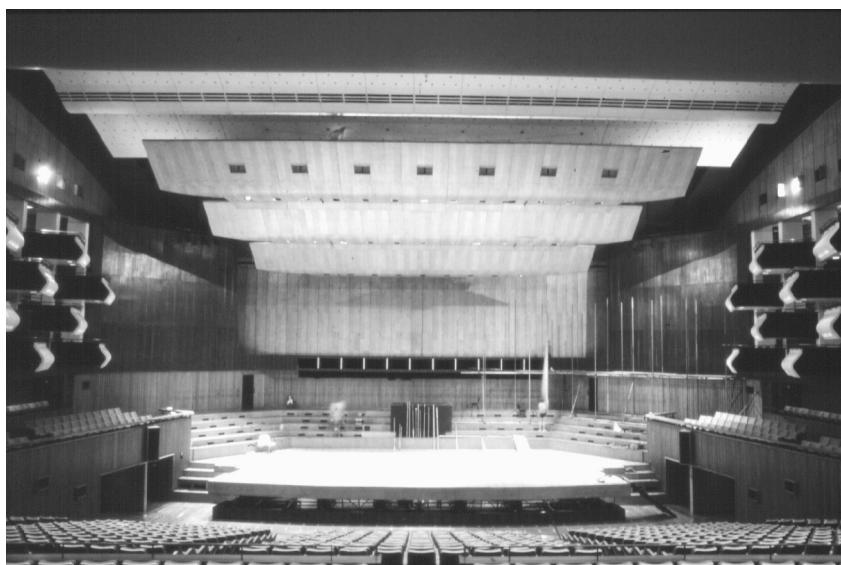
The canopy acts as an acoustic reflector, and consists of a lower profiled surface of blockboard faced with beech plywood, supported by six plyweb

Fig. 18.3.1 The acoustic canopy over the stage

The main auditorium was originally designed for concert performances only, with an acoustic canopy suspended above the platform (Fig. 18.3.1). After some years the London Festival Ballet came into being, and gave regular performances in the Hall, using a scenery frame at the rear of the stage. This latter arrangement was rather restrictive, since it was directly under the lowest point of the canopy.

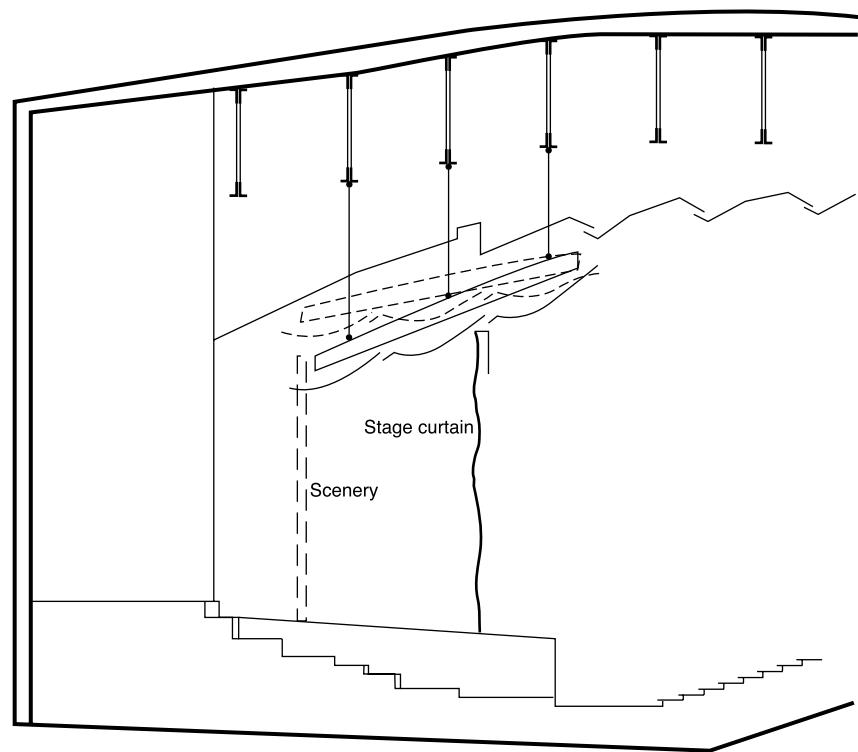
Fig. 18.3.2 Section of the Royal Festival Hall, showing the position of a stage curtain, and the potential for lifting the acoustic canopy

beams, each in turn suspended by three steel drop-rods from the roof trusses above the auditorium ceiling (Fig. 18.3.2). If each beam was structurally dependent upon the three points of support, it would be difficult to avoid a temporary overstress when they were lifted. A possible method would be to introduce a spreader beam to pick up the front two hangers, but this would be relatively expensive to install. If it could be shown that the beams were able to span between the outer rods only, the canopy could simply be raised by lifting the rear rods.

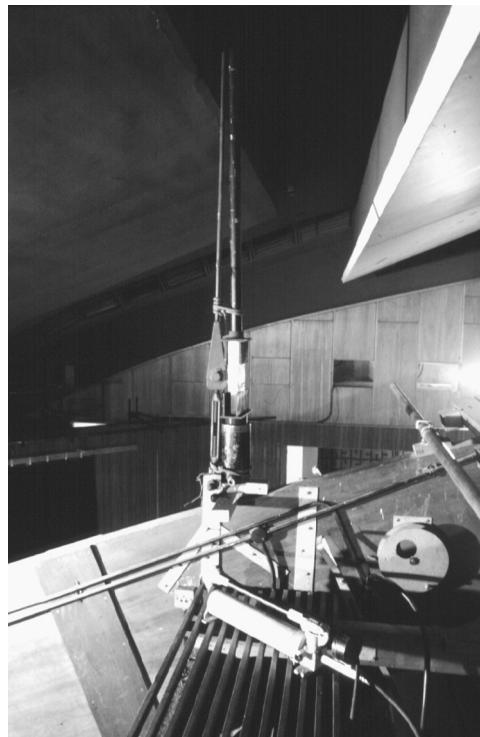
The tests were carried out during a rare period of Hall closure for maintenance. The test load factor was determined in accordance with the procedure described in Appendix 2. A duration-of-load factor of 1.5 was used, together with a dead load factor of 1.2, giving an overall load factor of 1.8. The point load necessary to increase the central bending moment by this factor is approximately 1 tonne. This load was applied to each beam in 0.25 tonne increments, and held for one hour. The operation was carried out safely,

*Fig. 18.3.4 Load test
arrangement. A scaffold tube
from the roof truss above sits on
a load cell, which in turn sits on
a hydraulic jack, which can be
activated by the pump in the
foreground*

because the middle hangar remained in place, with the turnbuckle simply adjusted to the position of slackness. Deflection was very simply measured from the relative movement of the rod ends in the turnbuckle, using vernier callipers—just occasionally one has this sort of luck. All the beams took the load satisfactorily, with deflections of only 3–6 mm. Residual deflection (around 1 mm) probably relates to a slight embedment of the supporting bolts.

At first sight the load test also looks expensive. The canopy is not designed to have weights distributed across it, and there would be the possibility of accidental damage. In addition, a safety scaffold from the platform below would be a substantial undertaking. However, a hydraulic jack could be used to apply a central point load to each beam, acting against a strut from the roof truss above (Fig. 18.3.4).

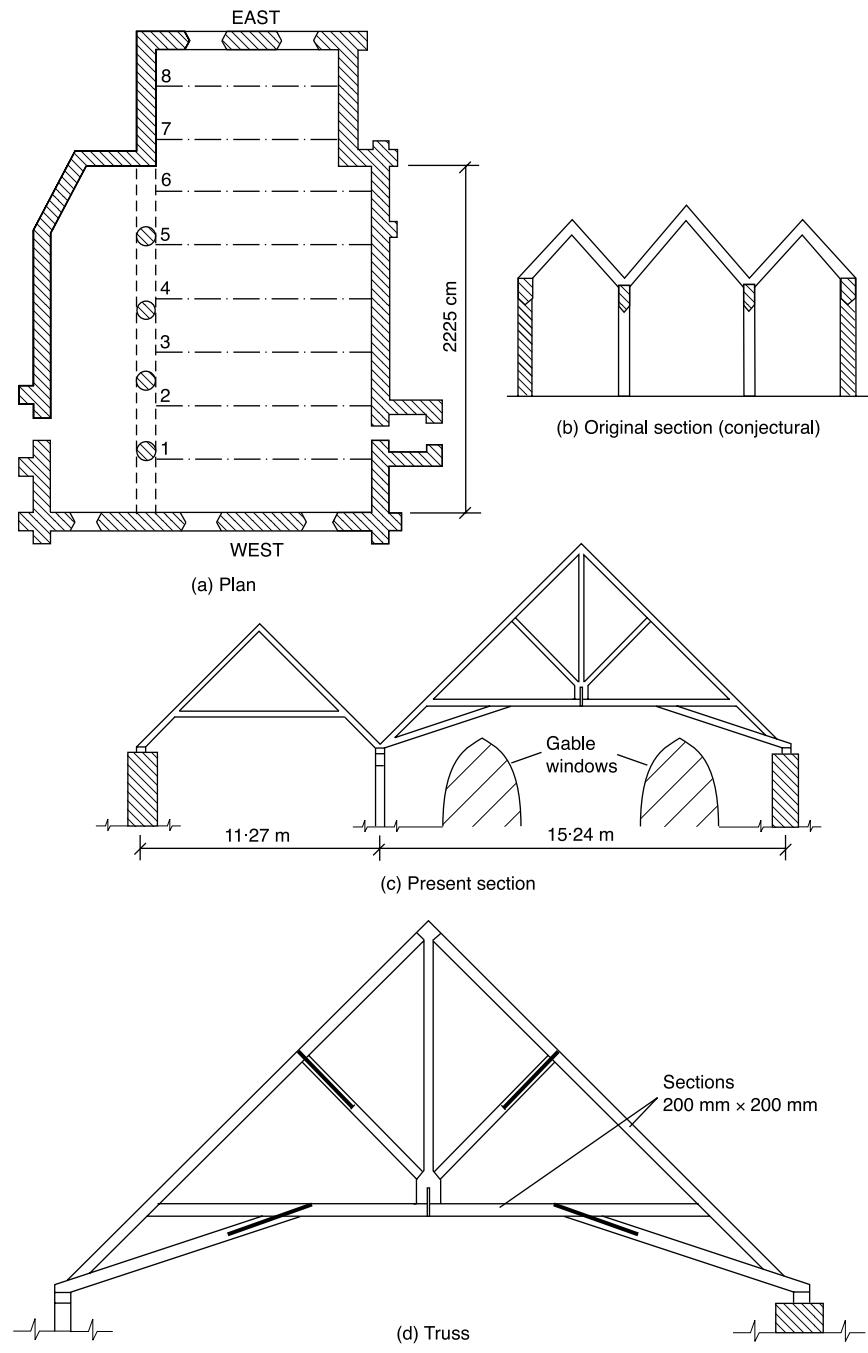
Fig. 18.4.1 Plan and sections of the church of St Mary the Virgin at Sandwich

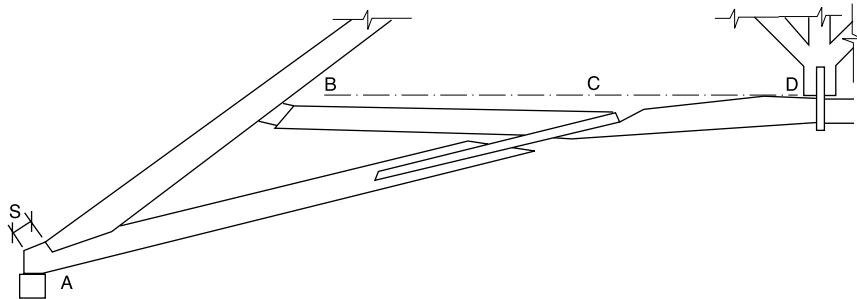
the bottom ties (Fig. 18.4.2), which varied from 50–200 mm. This member had already been replaced in one truss, another was fractured, and a third braced with steel straps (Fig. 18.4.3). This has lead to a pronounced spread of the rafter feet at A, and bending of the tie at C in Fig. 18.4.2.

Fig. 18.4.2 Bending deflection of the bottom tie

An elastic analysis was made of the critical condition which, as is usual for roofs, is dead load (self-weight and tiles) and snow load, and the member stresses compared with the permissible stresses in BS 5268. The results showed high, but not unacceptable, stresses in the timber, and an outward deflection of only 20 mm using a 'dry' modulus of elasticity (E_{dry}) of 10 000 N/mm² (Fig. 18.4.4, condition 1). The assumption of dry timber was obviously not correct, and it is more likely that the truss had been fabricated 'green', as large members such as these take many years to dry out. The effect of creep can reduce the apparent E value by a factor of three or even more. The deflection of member BD would thus increase considerably if it were erected and loaded at an unseasoned moisture content of around 60%, which then dropped to a cold roof equilibrium moisture content of 16–18%. It was also evident that the two-bolt connection of the strap at C was overloaded and the trusses showed varying degrees of slip at B of up to 100 mm.

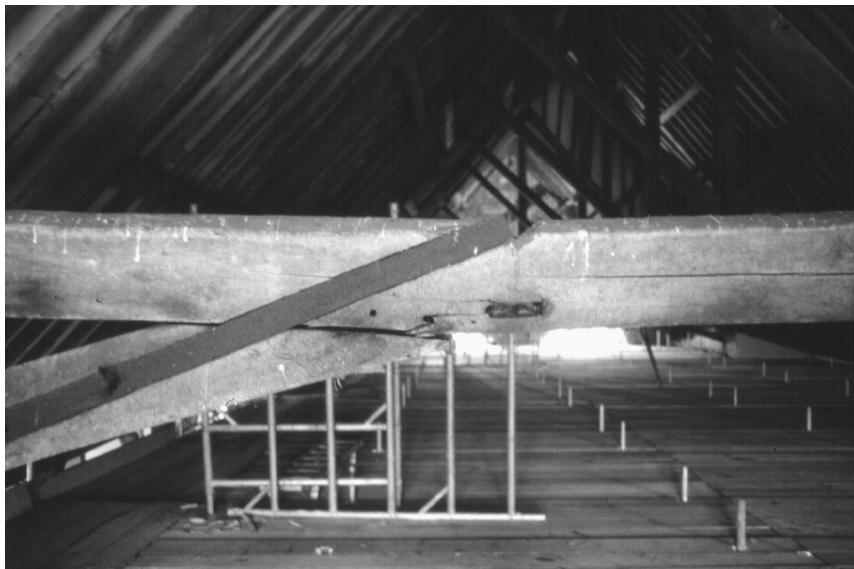
Fig. 18.4.3 Bending and part fracture of the bottom tie

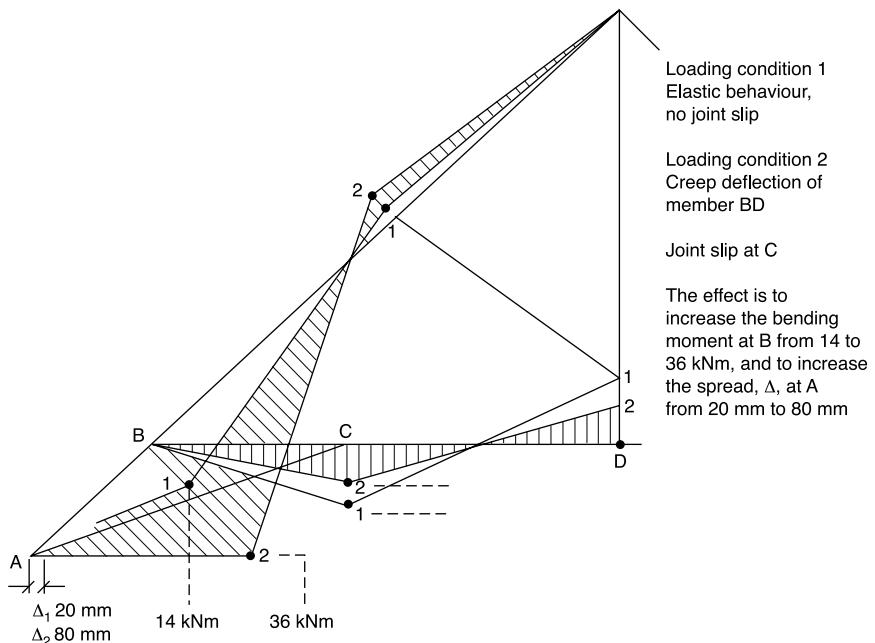
Loading on plan	Snow Tiles Frame	0.7 kN/m 0.6 kN/m	0.5 kN/m ²
$1.3 \text{ kN/m} + 0.5 \text{ kN/m} = 1.8 \text{ kN/m}^2$

Typical bending moments (Purlin eccentricity neglected)

Fig. 18.4.4 Load conditions 1 and 2

tenon, and needing the later addition of steel straps and bolts. A second analysis, using an equivalent E value of 3000 N/mm^2 , and introducing joint slip at C, gave results which were close to the observed distortions, and showed almost a three-fold rise in the bending moment at B (Fig. 18.4.4, condition 2).

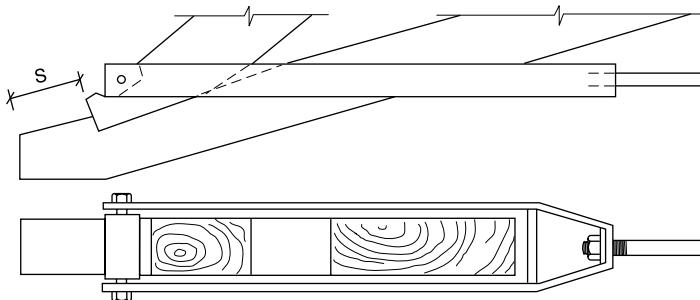
Fig. 18.4.5 The introduction of a steel tie

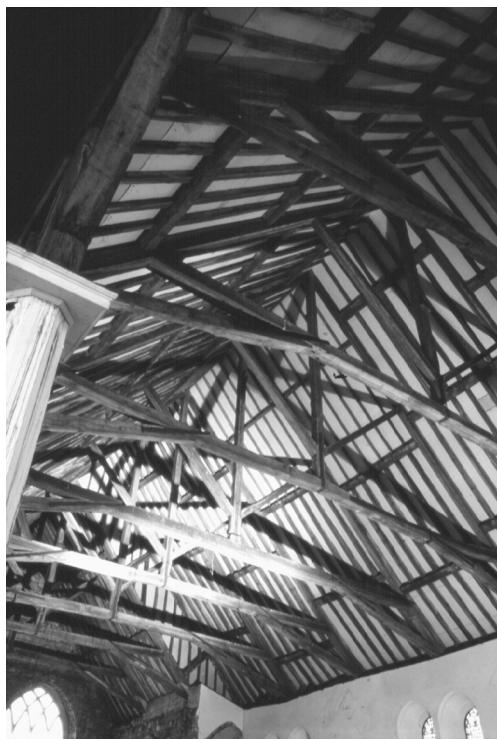
*Fig. 18.4.6 Roof illuminated by
a portable floodlight for initial
inspection*

The initial survey had been carried out from a moveable tower scaffold, using a portable floodlight, and recording details with photographs (Fig. 18.4.6). It is important at this time to obtain enough information to establish the general condition, so that the scope of the remedial works is reasonably well defined. A further detailed survey could only be done when full access had been provided by the contractor.

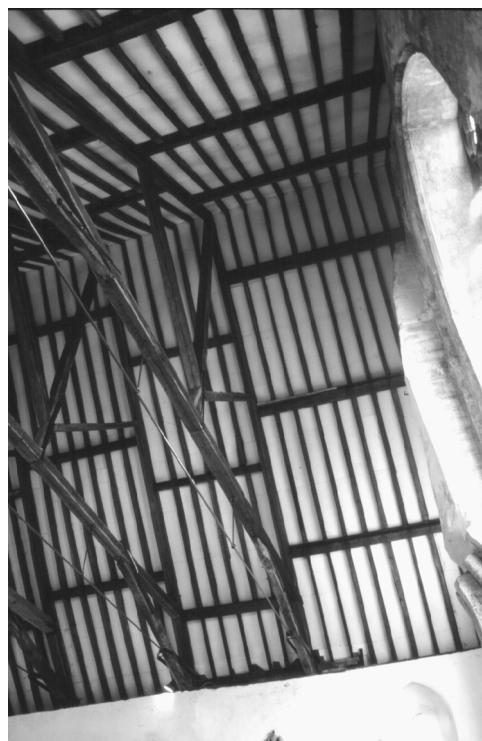
*Fig. 18.4.7 Work complete,
with the tie rods just discernible*

The repairs complete (Fig. 18.4.7), all the timbers were given two coats of a gel preservative insecticide.

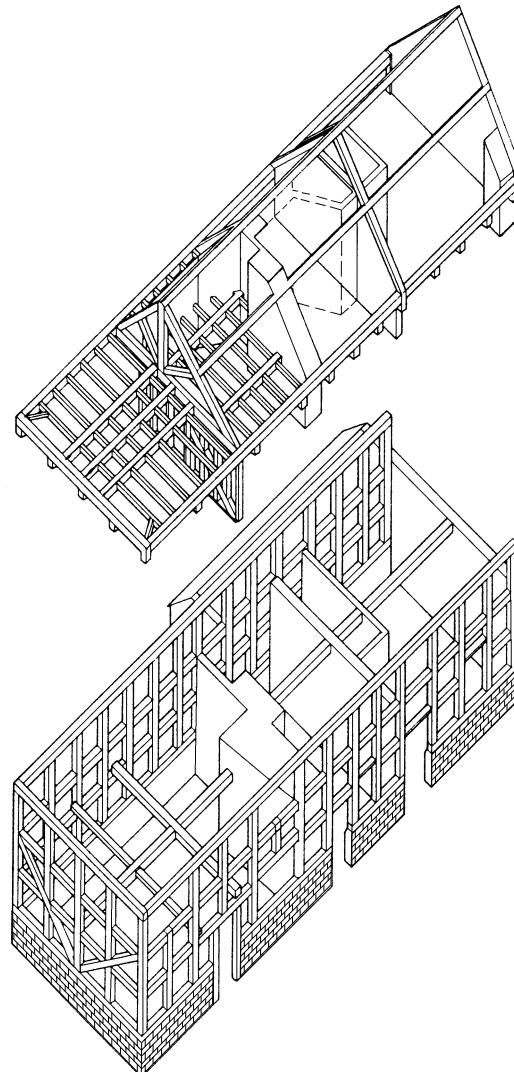
Fig. 18.5.2 Axonometric of the
frame

The frame itself is of oak, probably seventeenth century, and a typically northern pattern with double-pegged mortise and tenon joints. It is now infilled with brick, obviously a later replacement for wattle and daub, and dating probably from the eighteenth century. There was, in fact, evidence of the original infill, since some of the frame members showed a shallow groove into which the hazel twigs would have been set to form the wattle, before daubing with a render—some of the members, that is, but not all—and it was clear that with tenoned joints throughout, individual members could not be replaced without dismantling the whole assembly. It seemed that the frame, like so many others, had already been dismantled and re-erected, and our proposal was nothing new. The bricks date variously from the eighteenth and nineteenth centuries, but the external joinery, much repaired, as well as most of the internal finishes, are clearly twentieth-century work (Fig. 18.5.3).

As the property has a Grade II listing, the Department agreed to a feasibility study for moving it. Originally two houses, the building is a composite structure—part timber frame, part brick (Fig. 18.5.2). A lift-and-slide move did not look feasible, due in part to the length of the building but, more significantly, to the general slope of the land. This left dismantling and re-erection as, in conservation terms, a last option.

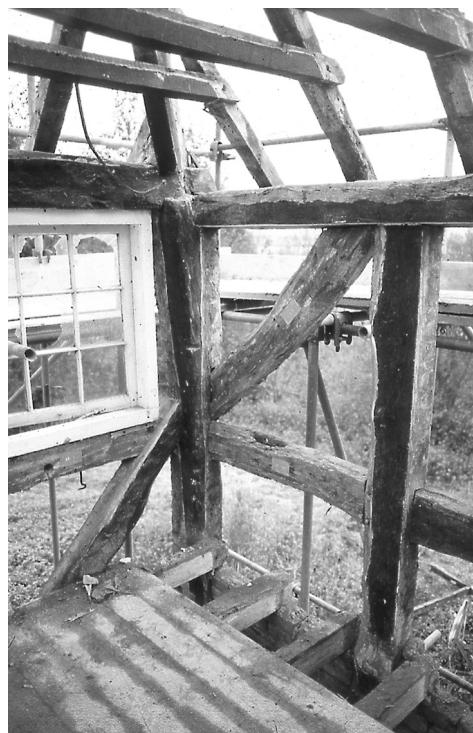
Fig. 18.5.5 Frame members
with identification tags

With a contractor appointed, the dismantling began in November 1988 (Fig. 18.5.4). The individual frame members were identified with a code stamped onto metal tags, since so many of them were almost identical. Apart from the sill, which was to be renewed totally, the frame members were in good condition for their age (Fig. 18.5.5). Only one member was replaced, and

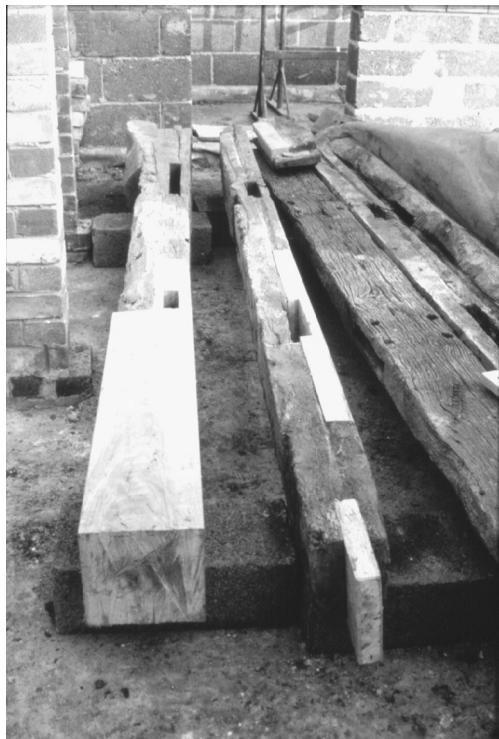
Fig. 18.5.6 The few members which needed repair

three others received new ends. These were joined by simple half-laps, fixed with stainless steel bolts. Bituminous paint had been applied to the external timber, creating the black-and-white image of the frame which was first popularised by the Victorians. This was removed by careful sand-blasting, using very fine material.

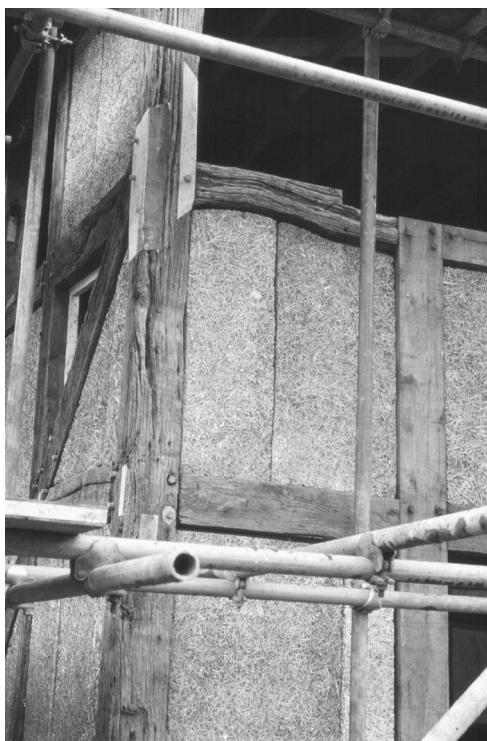
Fig. 18.5.8 A corner post with small patch repairs, and the frame infilled with woodwool panels

The timber frame is a very robust box, and there were no problems in justifying the members for strength. Small patch repairs were made, mainly to improve the weather resistance of the surface and eliminate any pockets where water could lie (Fig. 18.5.8).

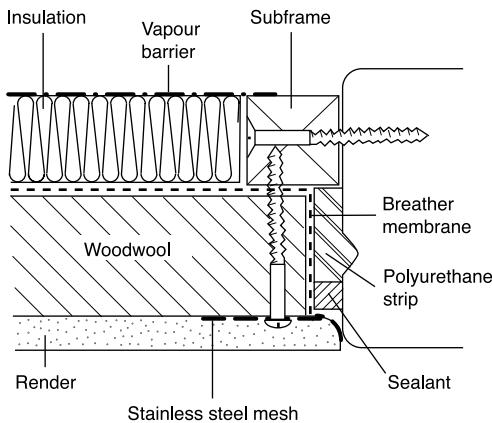
Fig. 18.5.9 New external wall construction

lining, it would be difficult to stop the brick holding water against the frame—a point which had become evident during the initial survey. Eventually it was decided to revert to the ‘original’ solution of a render infill. The base for the render is a panel of woodwool fixed to a sub-frame (Fig. 18.5.9). The panel is enveloped by a breather membrane, and the perimeter gap is filled by a bitumen-impregnated polyurethane strip. The aim of this detail is to minimise the depth to which water can penetrate along the side of the frame.

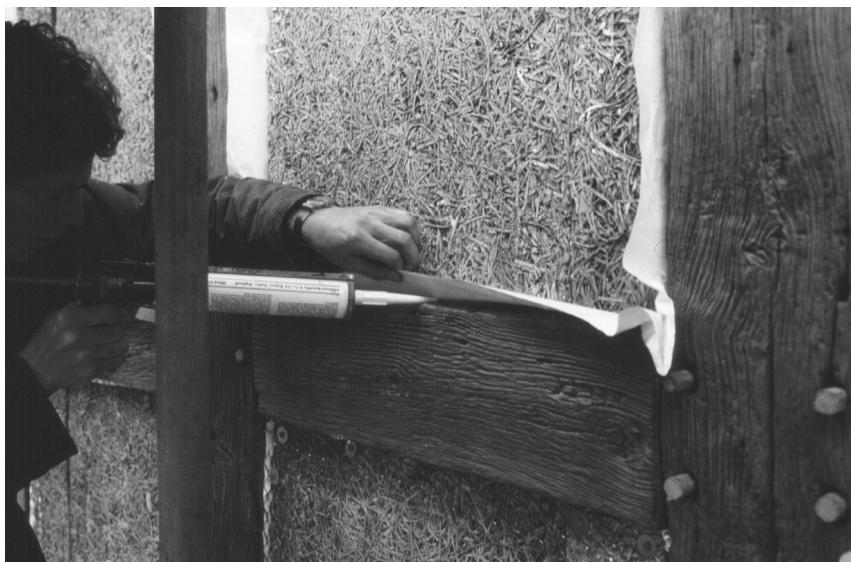
The render itself is a 1:1:6 mix, finished off with a weaker coat of 1:2:9. Stainless steel mesh supports the render at the perimeter of the panel (Fig. 18.5.10). The original intention had been to coat the panels with a lime wash, but the final appearance of the render was pleasing enough for them

Fig. 18.5.10 Panel sealant

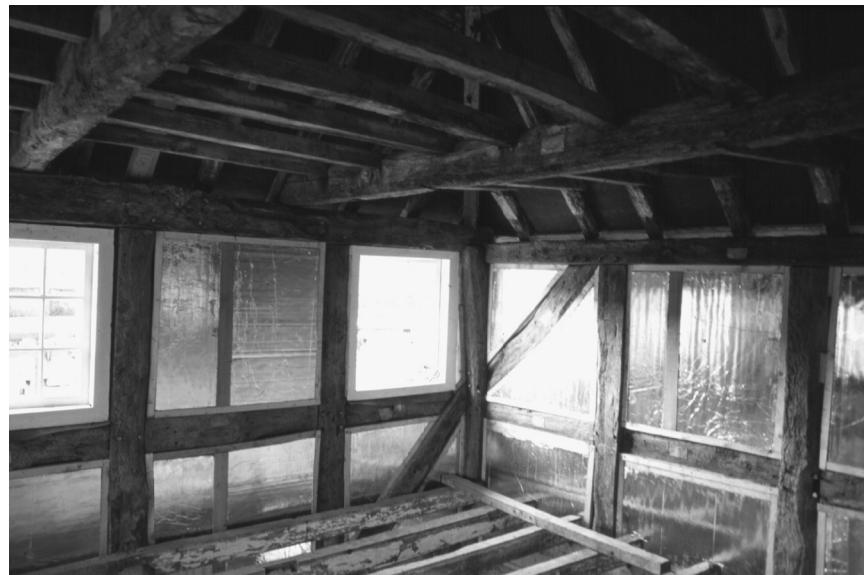
*Fig. 18.5.11 Internal view
of the frame, infilled with
foil-backed plasterboard*
