Appraisal and repair of timber structures

Peter Ross

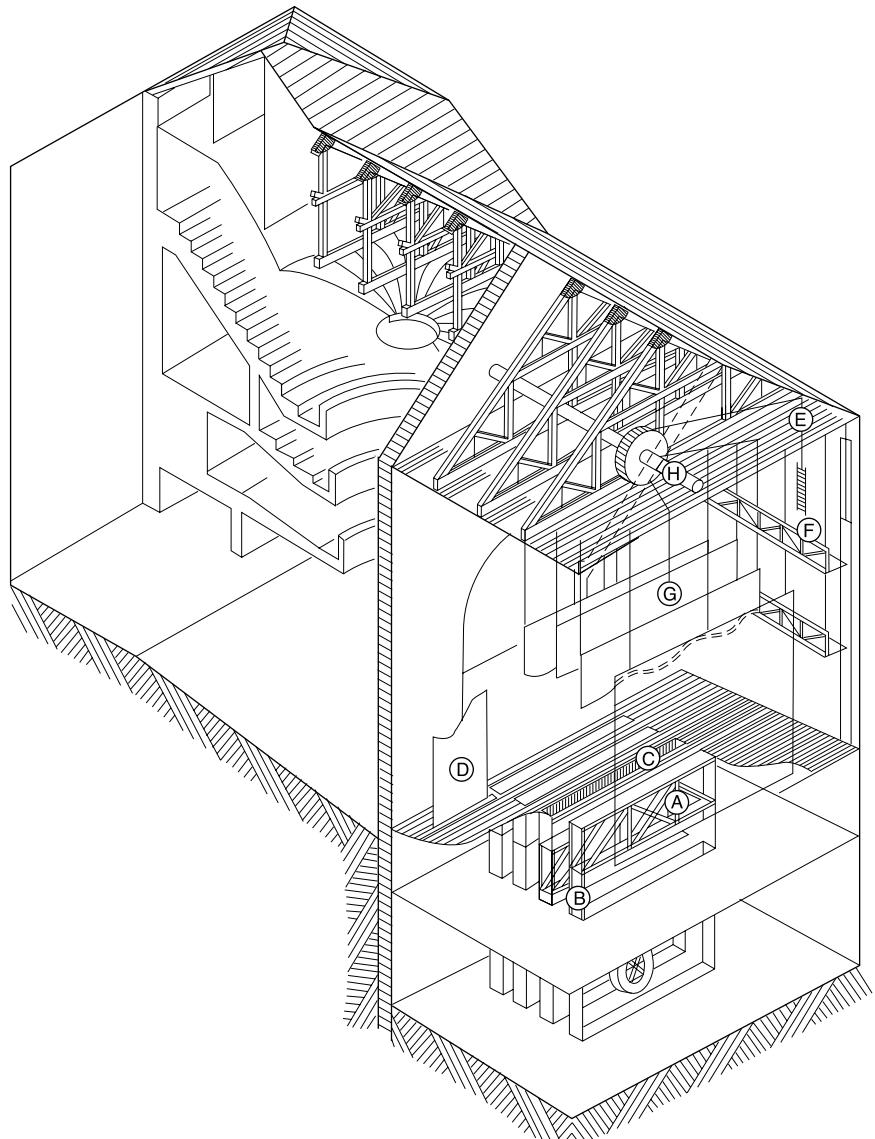
Fig. 18.6.1 Plan of Tyne
Theatre

(Fig. 18.6.1), since the stage is set over a ten metre deep pit. Bridges (A), running between guides (B) and fitted with counter-balances, could be lowered from stage level through cuts (C). Large sets (D) could be slid sideways into the wings, between floor runners and head guides.

Scenes, painted on canvas sheets, could be 'flown' out of sight into the void above the stage, thus known as the fly tower. This was done by means of ropes, passing over pulleys fixed to the grid (E), a series of slats supported by the truss ties, and then tied off to cleats on the bridge rail (F). Borders (G) could be raised a relatively short distance by ropes wound around a central shaft (H), also supported on the trusses. If another border was wound the opposite way, it could be lowered at the same time and 'the sky' replaced by 'the forest'. All these effects (given a sufficiency of 'hands') could be made to happen simultaneously as, for instance, in the transformation scene of a pantomime.

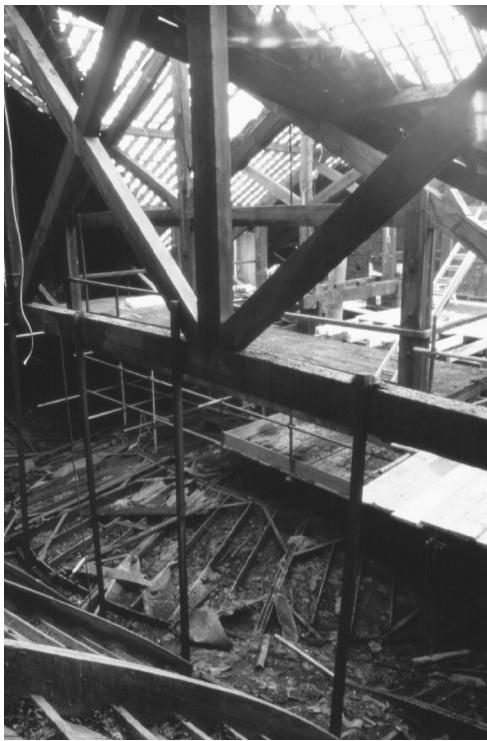
Fig. 18.6.2 Charred trusses over the auditorium, with the theatre ceiling suspended below

The first task was to survey the damage (Fig. 18.6.2). Normally, a fire-damaged roof would be propped before any survey work began, but the ceiling below was the original, and virtually undamaged, and so there was a reluctance to create large openings in it. A cautious inspection showed that the truss member sections were generally not reduced by more than 25%, and the absence of the slates meant that no roof dead or superimposed snow load could be built up. There was thus an adequate margin of safety to carry out a general inspection. One node had suffered extensive charring due to the effect of a broken ventilation duct, which had acted like a blowtorch. This was strengthened with shaped splice plates and tie rods (Fig. 18.6.3). An analysis of the trusses, allowing for the general charring reductions, showed that there was still an adequate residual strength, and the replacement of the purlins, rafters and slates would then be relatively straightforward. An outline scheme for the repair of the roof was prepared, and the loss assessors approved the work in a series of contract packages.

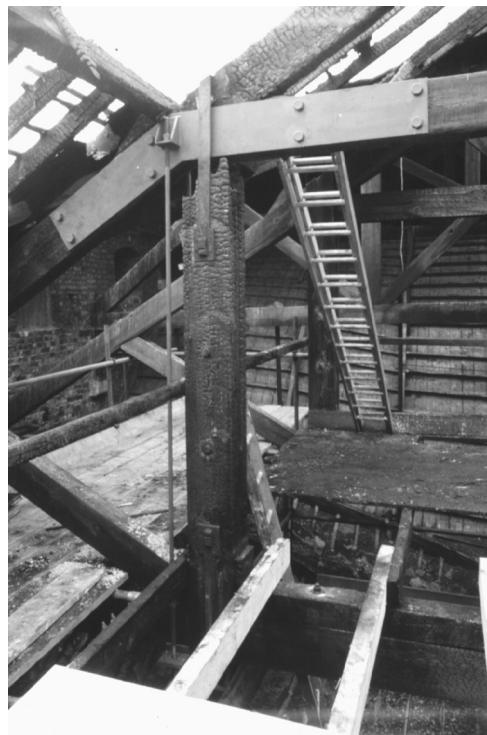
*Fig. 18.6.5 Truss strengthening
with shaped splice plates and tie
rods*

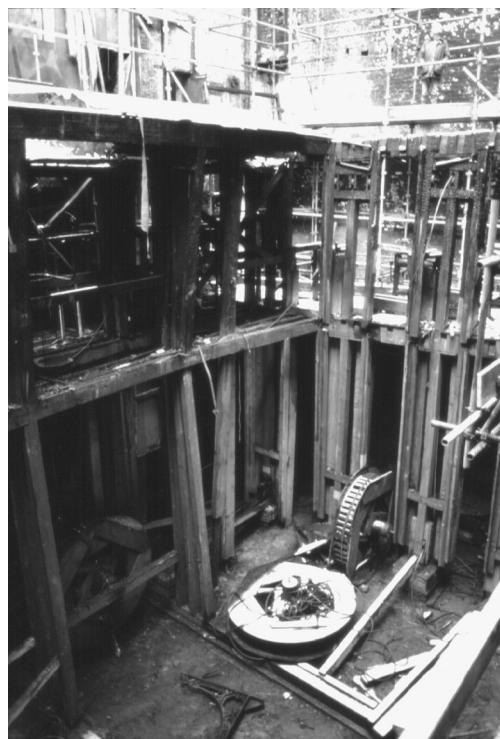
Fig. 18.6.6 Fire damage below the stage, which is the top level in the figure

Some of the machinery at the Tyne had been damaged in the fire (Fig. 18.6.6), but much below stage was recoverable. Since the staff had an intimate knowledge of the construction and most of the elements were straightforward items of carpentry, it was feasible to replace the damaged parts with replicas, thus allowing the machinery to be understood and appreciated once more (Fig. 18.6.7).

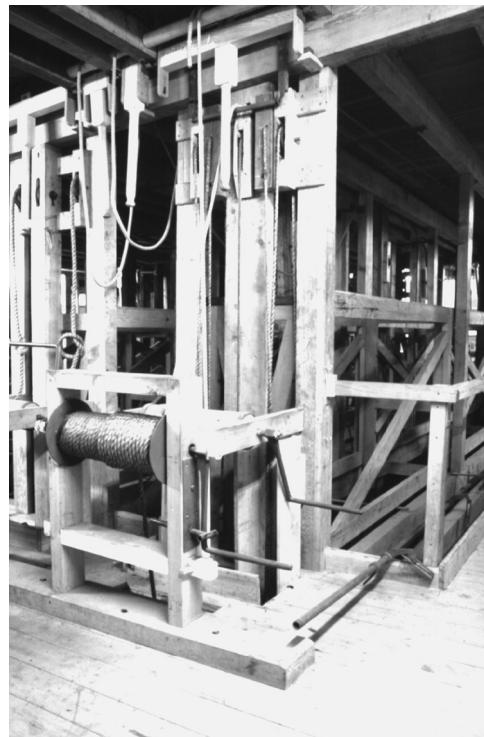
*Fig. 18.6.7 Below-stage
machinery after repair*

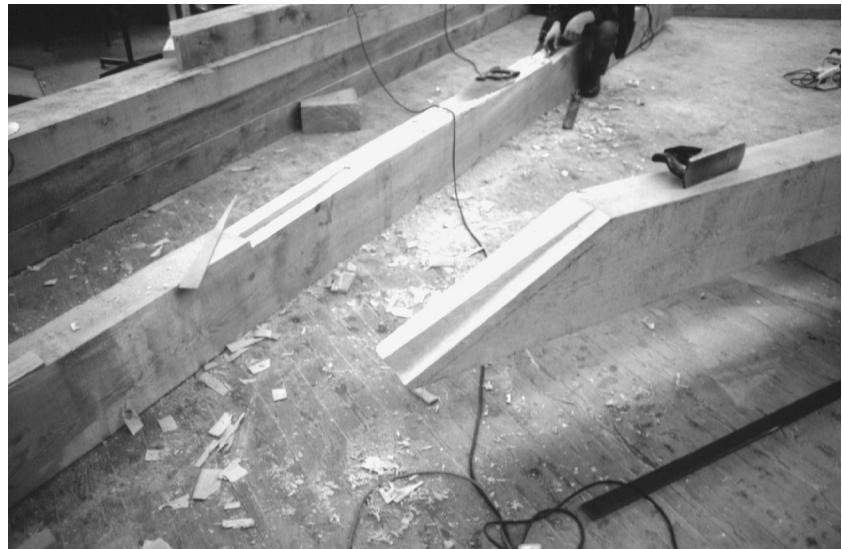
*Fig. 18.6.8 Truss assembly.
The joint between a principal
rafter (to the left) and the
mid-height collar (to the right)*

The contractor's workshop was large enough to allow the trusses to be laid out and assembled on the floor (Fig. 18.6.8). Transporting an assembled truss

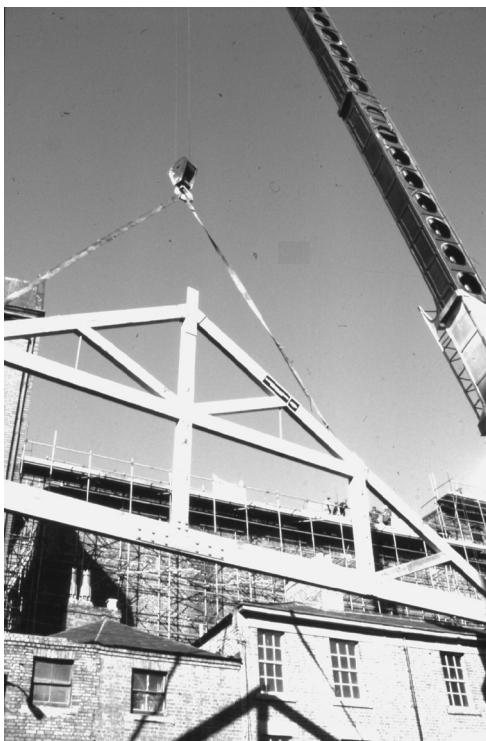
Fig. 18.6.9 Erection of truss

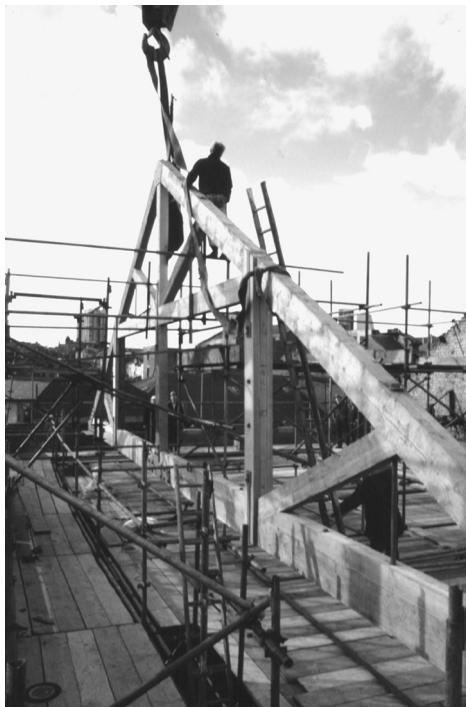
Fig. 18.6.10 Scaffolding and 'toast-rack' supporting the truss as the slings are slackened off

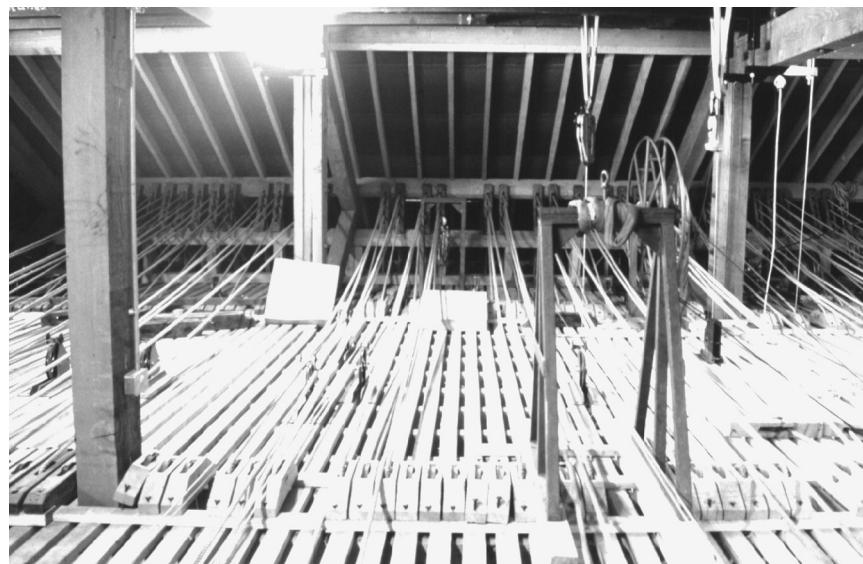
Fig. 18.6.11 Roof complete with sarking felt above and the fly tower grid rebuilt on the bottom members of the trusses

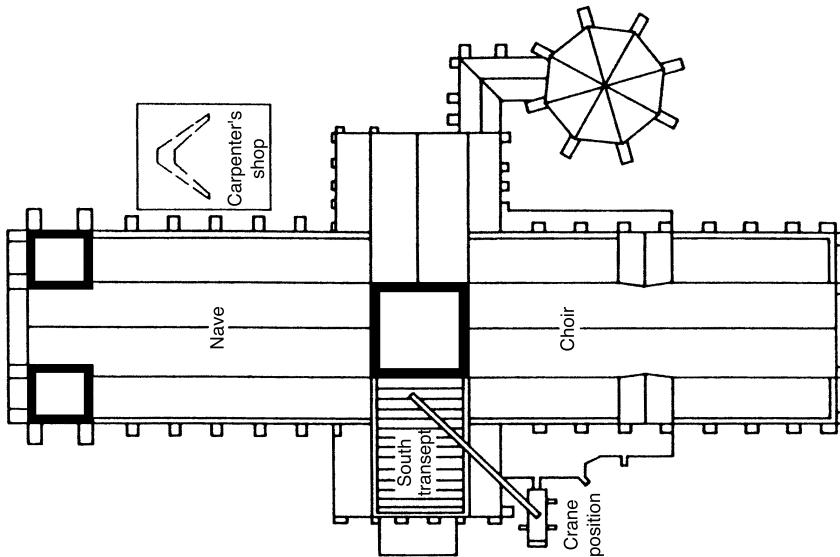
Fig. 18.7.1 Plan of York Minster

York Minster is the largest of the English medieval cathedrals and dates originally from Norman times, although no part of that fabric exists above ground today. The long rebuilding programme began in the mid-thirteenth century with the two transepts (Fig. 18.7.1), which would originally have

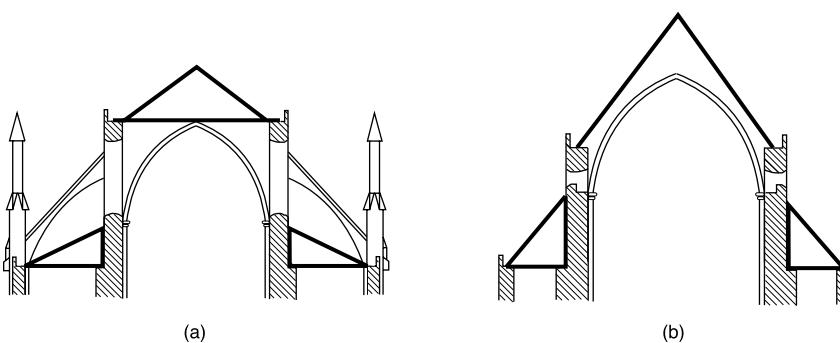
Fig. 18.7.2 (a) Nave cross-section, showing the triangular trusses, clerestory windows and vault in the 'correct' relationship. (b) South transept cross-section, showing the original thirteenth century steep roof and small clerestory windows. The fifteenth century vault could only be built by an incursion into the roof space

had open timber roofs, supported by the arcade walls with their small clerestory windows (Fig. 18.7.2(a)). The nave and the choir were demolished and rebuilt in the fourteenth and fifteenth centuries respectively. The nave cross-section (b) shows the development of the gothic style, with the larger clerestory windows and ribbed vaulting.

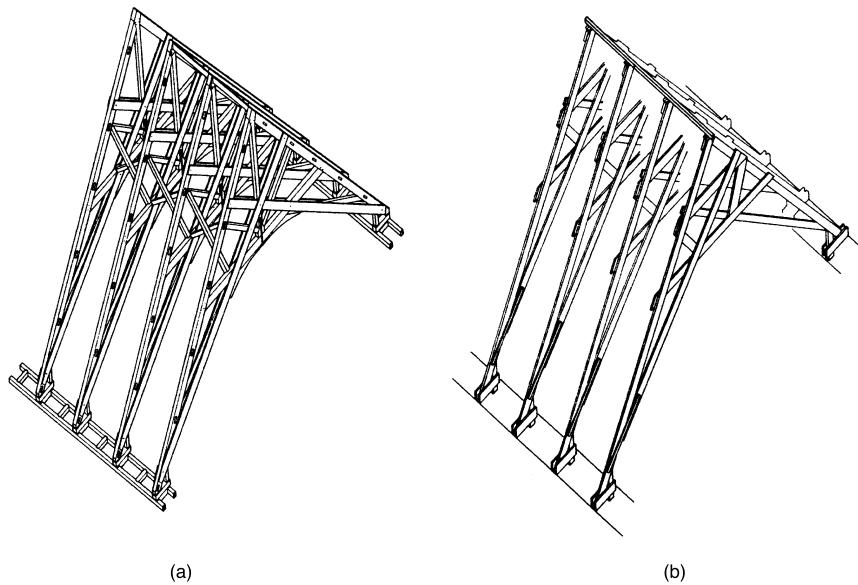
Fig. 18.7.3 A comparison of the two roof structures: (a) the eighteenth century trusses overlain with scissor bracing in the nineteenth century (b) the post-fire scheme, shown in more detail in Fig. 18.7.7

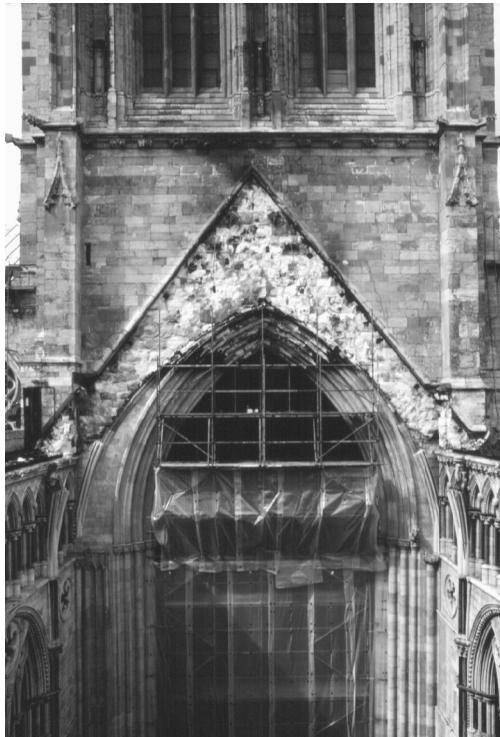
Fig. 18.7.4 The central tower, after the fire, showing the outlines of the roof and the vault

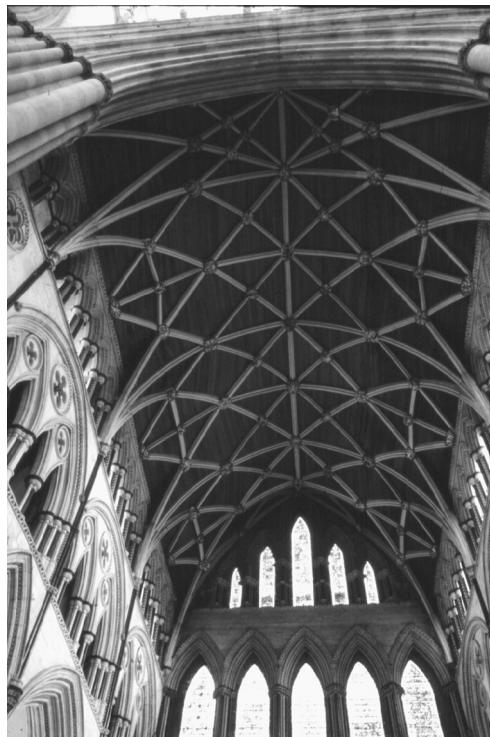
Fig. 18.7.5 The undamaged
North Transept vault

In the event, sanity prevailed. The symmetry of the cathedral more or less demanded that the vault, with its pattern of ribs, be replaced in something like its original form, as could still be seen in the North transept (Fig. 18.7.5), and the new vault would, of course, need a roof structure to support both it and a replacement covering of lead.

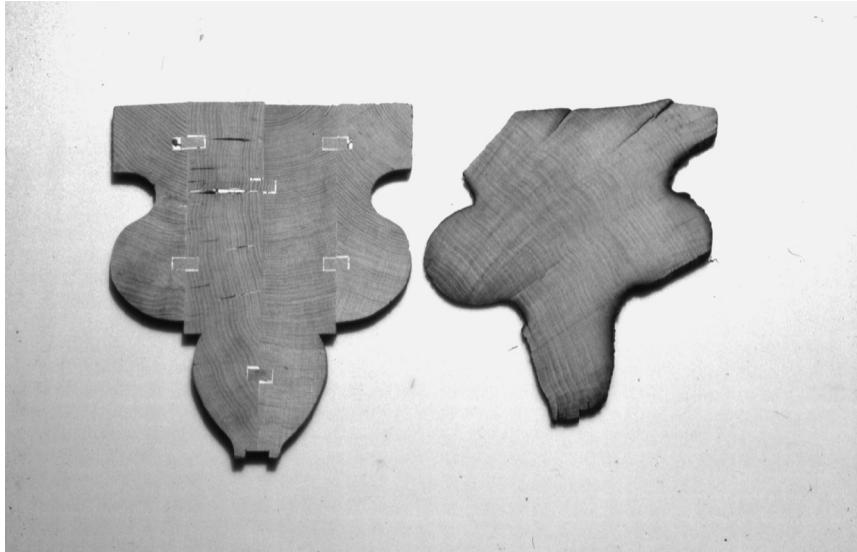
Fig. 18.7.6 Vault rib sections. To the right, the charred original timber. To the left, the new section of four laminates glued and jointed

The original vault ribs were single curved pieces of oak, approximately 300 × 300 mm in cross-section, and up to 6 m long. To find equivalent pieces for all the various conditions of curvature would have been almost impossible, and so they were fabricated as vertical glulams, using four laminates for the major ribs, fitting in neatly with the original profile (Fig. 18.7.6). The individual planks were kiln-dried and then glued with a urea-formaldehyde adhesive. In addition, occasional through-bolts were used, with recessed and plugged heads. Thus, the new ribs to all intents and purposes replicated the originals, although the bosses, traditionally regarded as an opportunity for contemporary craft, were newly designed by the carvers themselves.

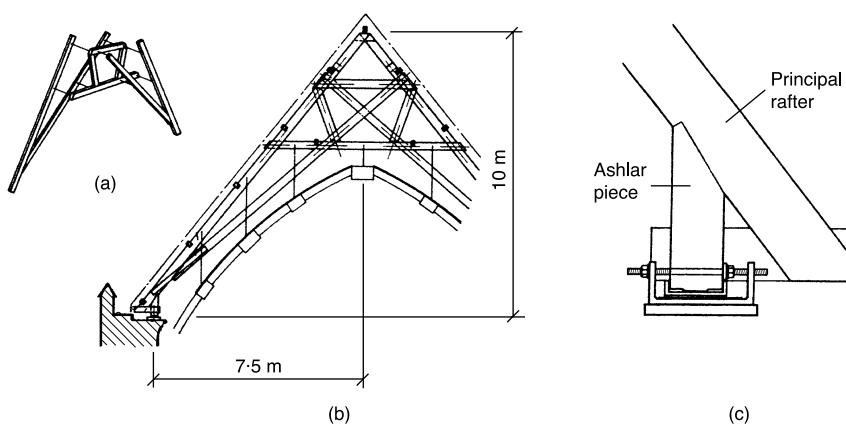
Fig. 18.7.7 The roof trusses (a) concept: two 'scissors' on each side of the collars (b) overall dimensions (c) sliding foot detail

The truss outline is determined by the profiles of the roof and vault (Fig. 18.7.7(a) and (b)). A truss of this form, with no eaves tie, produces an out-thrust at its feet. In addition, there was some evidence that the original

With the full load of the roof in place, it was now possible to relax the truss feet, using the threaded rods built into each bearing on the East side (Fig. 18.7.7(c)). In order to monitor the outward thrusts, three of the rods were fitted with small flatjacks connected to pressure gauges, which acted as load cells. The centre trusses (6 and 7) were relaxed to give a residual 10% thrust, obtained with an outward movement of 30 mm. The relaxation of the other trusses was tapered down to zero at trusses 1 and 13, as the purlins were fixed to the masonry at each end of the transept.

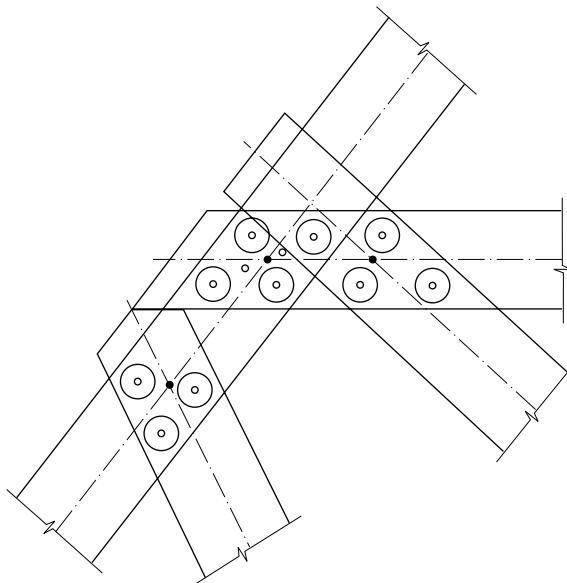
Fig. 18.7.8 Top frame joint, showing the layout of the bolts and connectors, and the offsets in the centreline intersections

Since most of the members are only in face contact with each other, the obvious method of connecting them is to use bolts. However, most of the joints are near the ends of the members, and so there would be an unacceptably high risk of splits developing through the bolt holes. Therefore, connectors were used, as they are much more tolerant of splits in the timber, with the overlap of two timbers allowing the use of four 102 mm

connectors (Fig. 18.7.8). The split ring connector is the more efficient, but if on drying twisting of the timber should occur which could not be restrained by the bolts, then the purchase of the ring in the timber would be reduced. For this reason double shear plate connectors were used on each bolt. All metal components are made from Grade 316 stainless steel, including the shear connector castings and bolts, which are in fact rods threaded at each end.

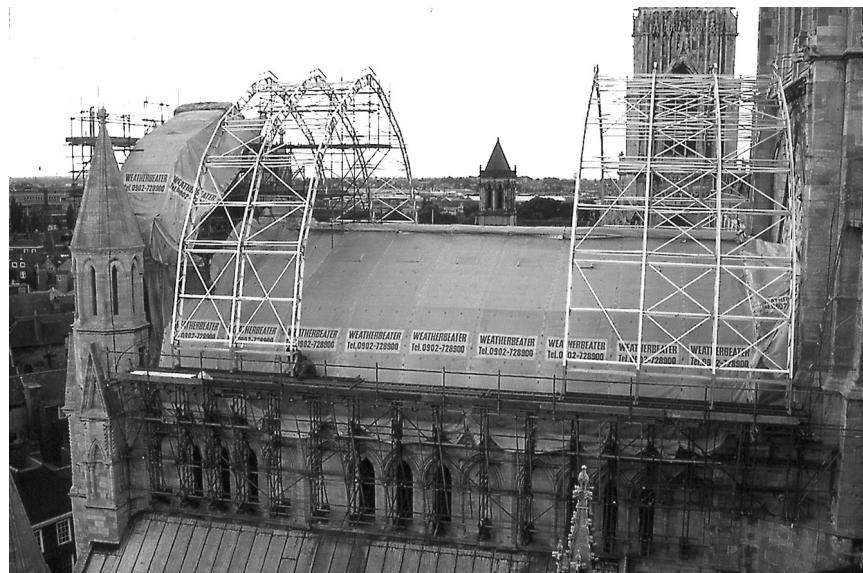
Fig. 18.7.9 The first temporary roof cover, with the second in process of assembly over it

A cover for the transept was obviously required, to protect the remaining masonry structure from the weather, and to allow repair work to proceed without interruption. The first temporary cover (Fig. 18.7.9) consisted of aluminium framed arches covered with PVC sheeting. Successive frames were built at the gable end, and 'launched' out over the transept on alloy rails set in each gutter line on the head of the wall, as the void below was not yet scaffolded out. The transept was covered within three weeks of the fire.

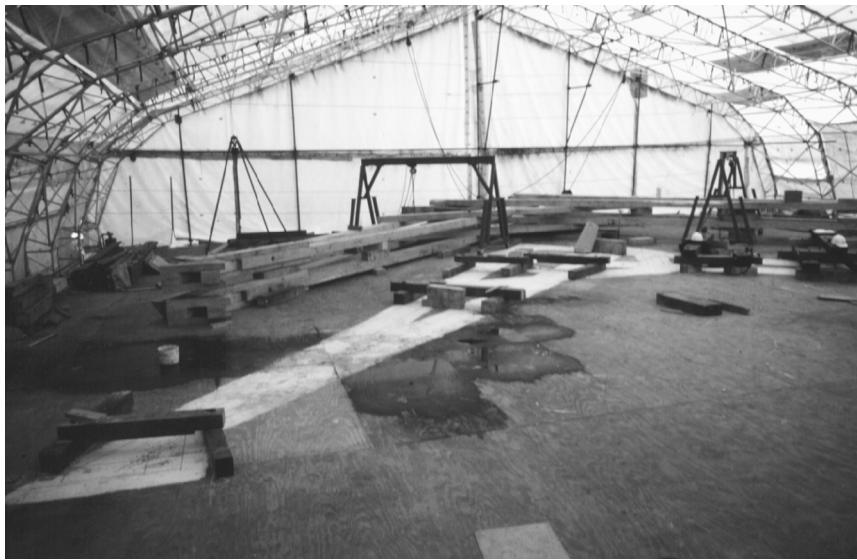
Fig. 18.7.10 The first temporary cover, re-used as the workshop. Two trusses have been fabricated and moved clear of the fabrication outline drawn on the floor

The trusses were fabricated in the temporary workshop erected on the North side of the nave (Fig. 18.7.10). The profile of the truss was drawn on the floor, and the large timbers were manhandled over it using simple shear legs—assembly techniques which almost certainly had medieval antecedents.

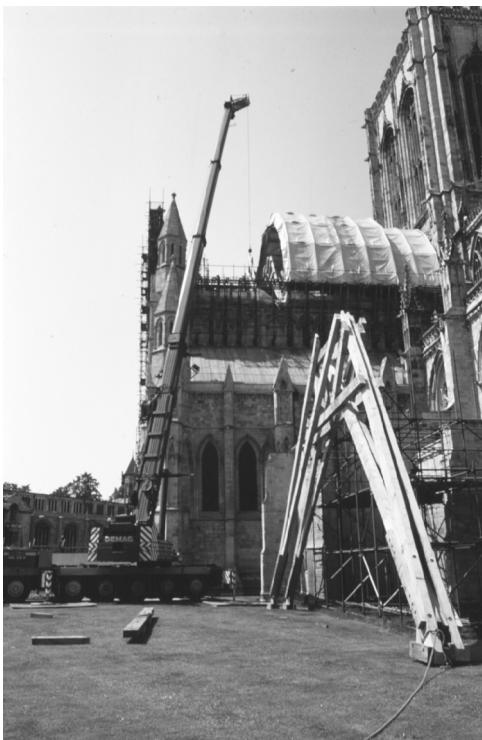
Fig. 18.7.11 Craning the trusses into position

The high moisture content of the timber meant that if, after fabrication, the truss was taken apart for any length of time, reassembly might prove difficult. The problem was solved by avoiding it; the trusses, once made, were left assembled until a group of four were complete. With a Sunday road closure, the trusses were taken around the West end of the Minster by mobile crane and stacked against a side chapel, ready for lifting into position the following day by a larger mobile crane (Fig. 18.7.11).

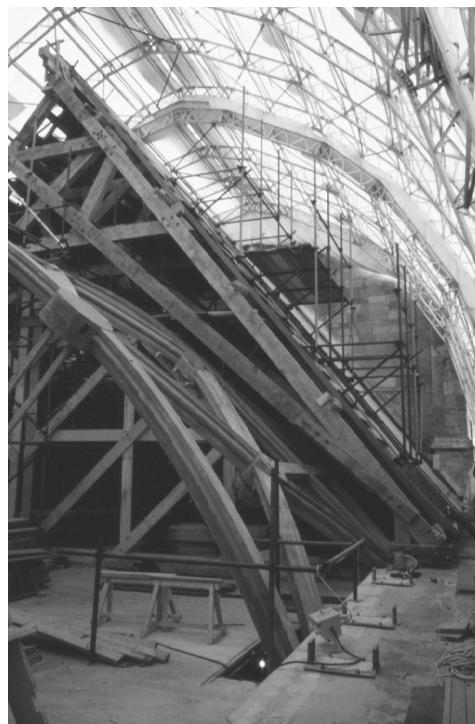
Fig. 18.7.12 The first four trusses erected over the ribs of the vault, with minimal clearance

The first four trusses were lifted in December 1985, followed by the second group of four in February 1986 (Fig. 18.7.12). The work of fabrication

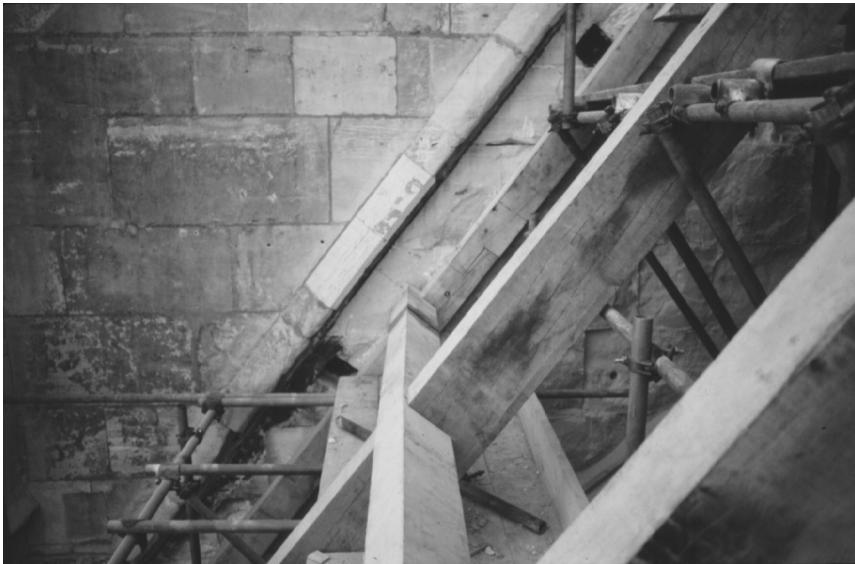
Fig. 18.7.13 The dripstone on the central tower generates the basic roof line. Small variations along the length can be sweetened by varying the depth of the truss notches to receive the purlins

As soon as the first trusses were in position, the work of fitting the purlins and rafters began. The profile of the roof is not constant for the length of the transept, as the span reduces by 200 mm, and ridge line rises by 250 mm, from the central tower to the South gable. Rather than attempt to make 13 trusses with different dimensions, a mean size was used for each group. The resulting steps in profile were 'sweetened' by adjusting the depth to which the purlins were notched over the trusses (Fig. 18.7.13).

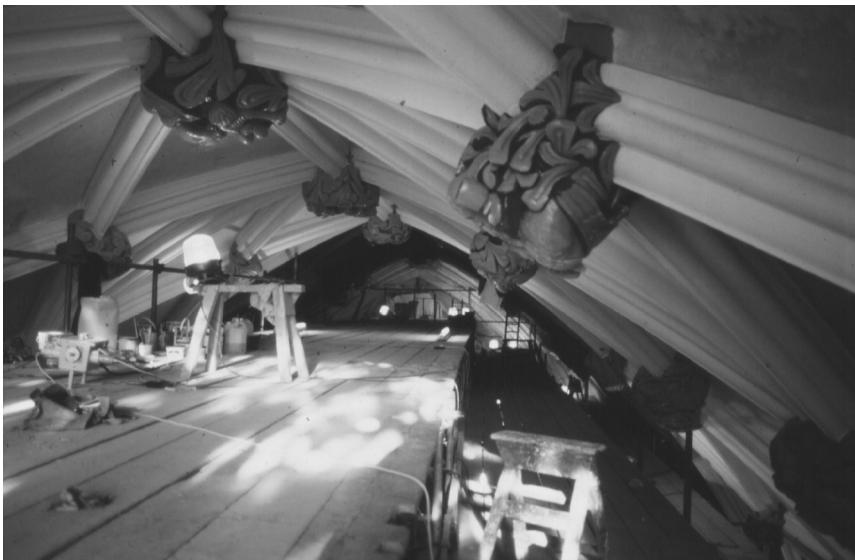
Fig. 18.7.14 Finishing work to the crown of the vault

The roof was now complete, but much work remained to be done on the vault (Fig. 18.7.14). The curved ribs, of glued laminated oak, were painstakingly fitted together, and each web was infilled with plaster on a base of expanded metal lath. When all was dry, the decoration and gliding could begin. The roof trusses had been drying out all this while, and the resulting shrinkage across the grain had produced the inevitable longitudinal splits. These are all well within acceptable limits, however, and the trusses have remained true to line. Checks in the summer of 1988, with the timber some three years cut, showed that the heart timber was down to a moisture

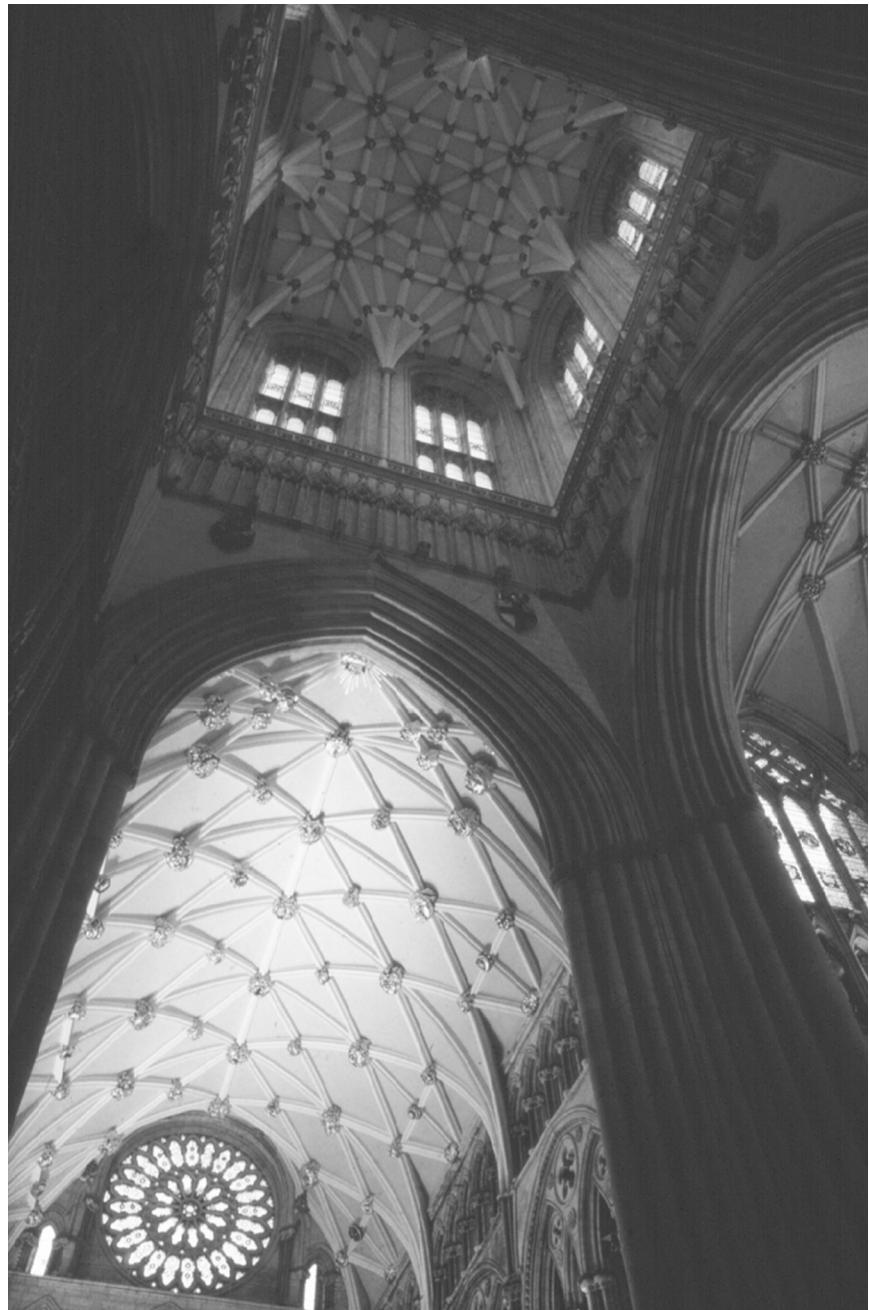
*Fig. 18.7.15 The central tower,
with the new Transept roof, and
(to the right) the nave roof*

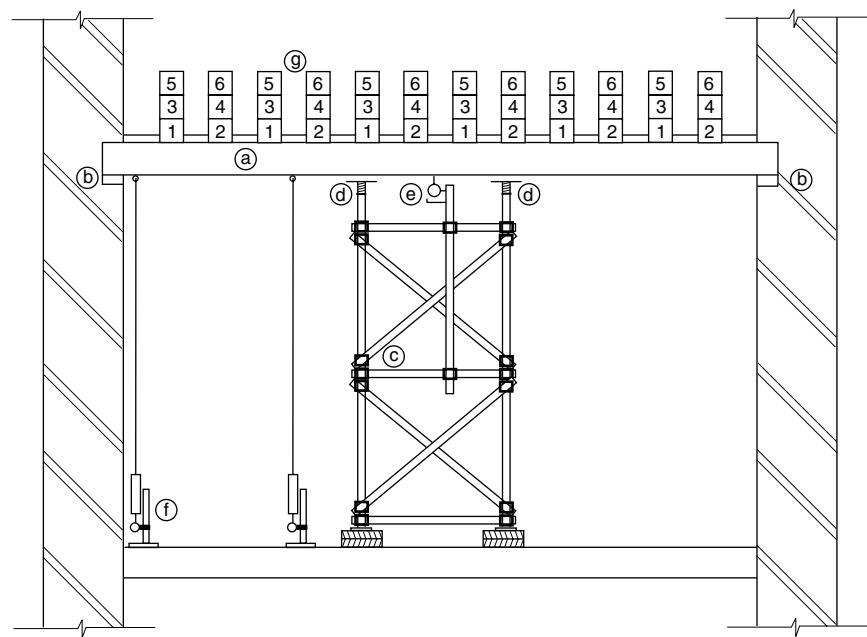
- (a) Element to be tested
- (b) Check adequacy of element bearings
- (c) Safety scaffold, designed to take at least twice the applied load
(e.g., by lateral spread if the floor below is of identical construction)
- (d) Screw heads to scaffold, set to minimal clearance and further adjusted if necessary during test
- (e) Dial gauge firmly mounted on the scaffold, or
- (f) firmly fixed to the floor, reading the deflection of a weight suspended on a piano wire
- (g) Test weights, applied in, e.g., six steps in the order noted

The load test is most often used for floors. A typical test arrangement is shown in Fig. A2.1. The most reliable and practical form of test load is a set of scale weights; generally 56 lb, or 25.5 kilos. Bags of sand may be acceptable, if they have been properly checked for weight. Barrels filled

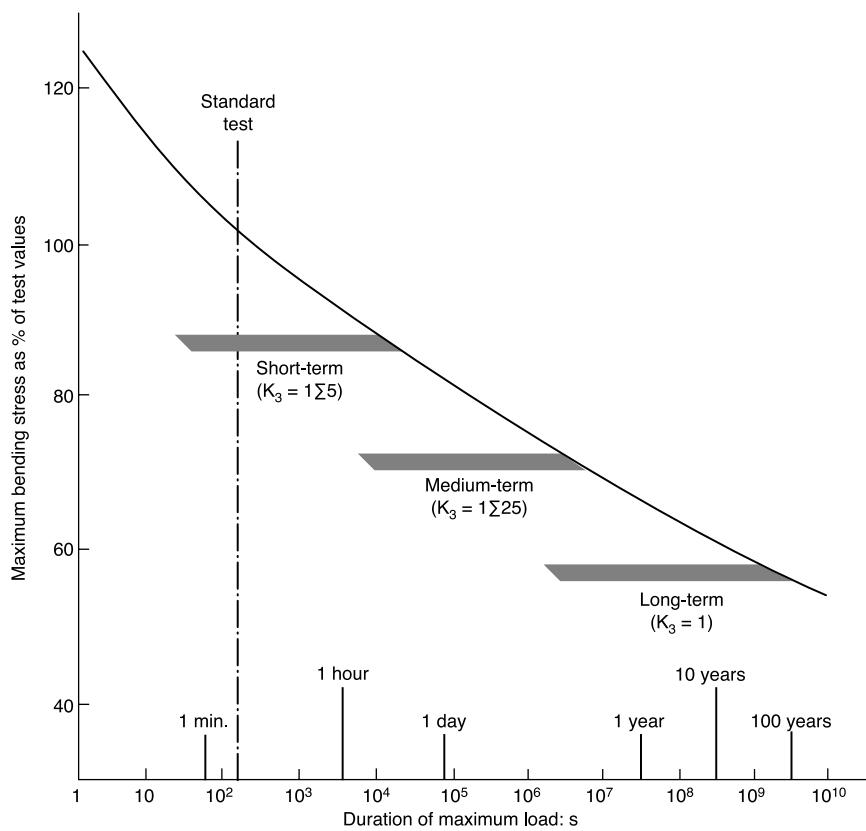
Fig. A2.2 The relation between maximum bending stress and duration of load (Fig. 3.9) with the values of K_3 , the duration-of-load factor from BS5268, superimposed upon it

Most load tests are, of necessity, brief, and so it is necessary to increase the test load by some factor to compensate for the shorter load duration. To take the example of the Royal Festival Hall canopy (18.3), the test load was held only for an hour i.e., a short-term load duration, but represented predominantly the canopy self-weight, or permanent load. But using the graph it can be seen that the test load has to be increased by a factor $K_{3\text{test}}/K_{3\text{design}}$, i.e., 1.5. At Charlotte Square (18.2) the test load was held for 24 hours (a medium-term load) representing predominantly superimposed load (classified by BS 5268 as long-term load). Thus the design load was increased by a factor of 1.25 to give the test load.

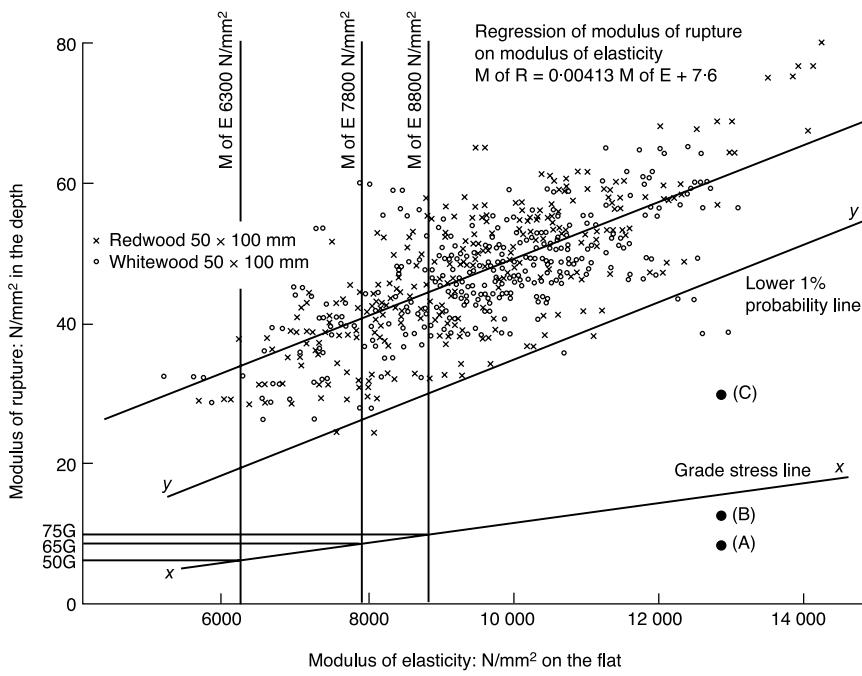
Fig. A2.3. The relationship between modulus of rupture and modulus of elasticity for redwood and whitewood (Crown copyright)

For simple beams of softwood an additional check may be made, using the broad relationship which exists for timber between stiffness and strength. Figure A2.3 shows the relation between the modulus of rupture and the modulus of elasticity, based on tests of sample planks of redwood and whitewood. Line $x-x$ represents the grade stress, and line $y-y$ the lower 1% probability failure line of the test population. The margin between the two is the factor of safety.

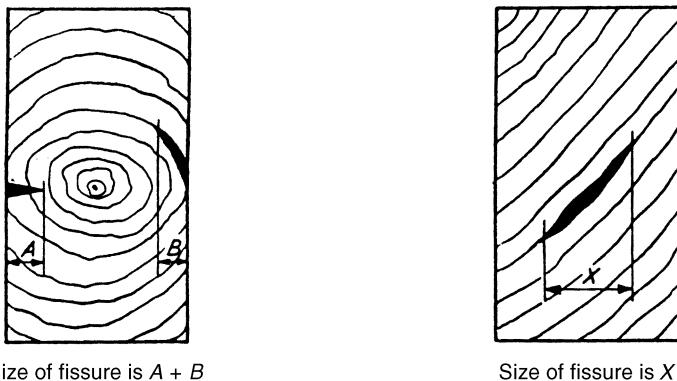
A.8.1 Measurement. The size of fissures at the end of the member should be taken as the distance between lines enclosing the fissures and parallel to a pair of opposite surfaces (see Fig. 12). The sum of all fissures measured at either end of the member should be taken for the purpose of assessing the magnitude of the defect.

Fig. 12. Fissures

The size of fissures occurring on the surface of the member should be measured by means of a feeler gauge, not exceeding 0.15 mm thick, and the maximum depth of fissures occurring at any cross section should be taken for assessing the magnitude of the defect.

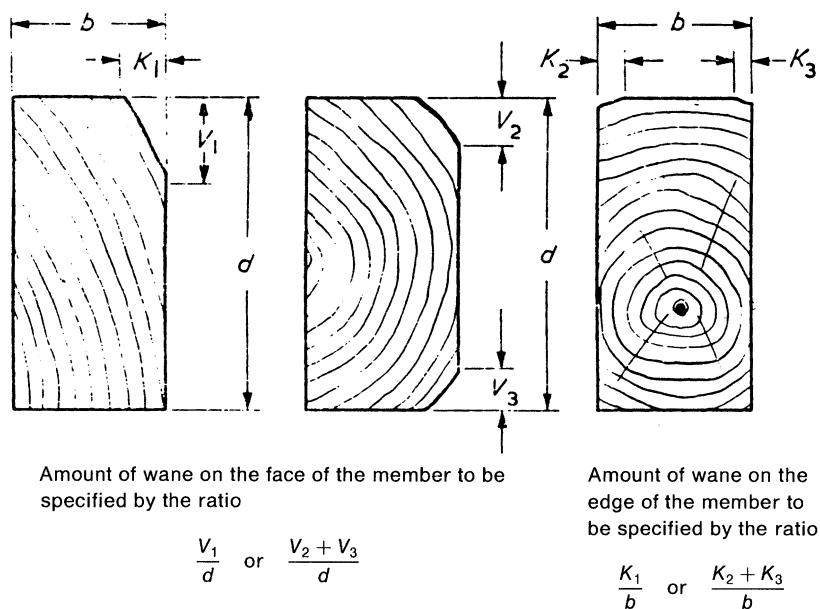
A.11.1 Measurement. The amount of wane on any surface should be the sum of the wane at the two arrises, and should be expressed as a fraction of the width of the surface on which it occurs (see Fig. 13).

Fig. 13. Extent of wane

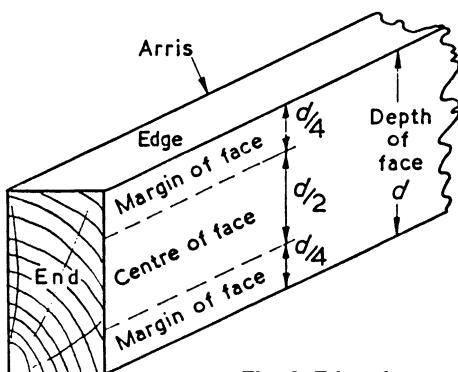
Fig. 6. Edge, face and arris

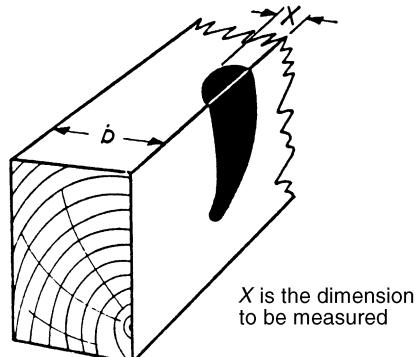
A.16.1.1 Splay knots. A splay knot should be measured only on the edge of the piece and its size taken as the width between the arris on which it occurs and a line touching the knot parallel with the arris (see Fig. 7).

Fig. 7. Splay knot

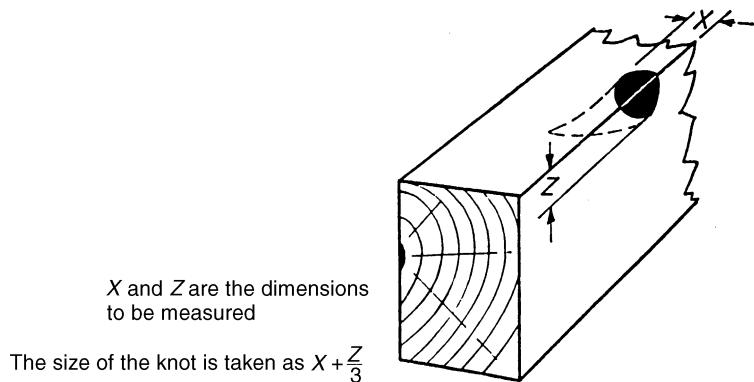
Where it emerges on the side further from the pith, the size should be taken as the width of the knot on the edge between the arris on which it occurs and a line touching the knot parallel with the arris, plus one third of its depth on the face (see Fig. 8).

Fig. 8. Arris knot

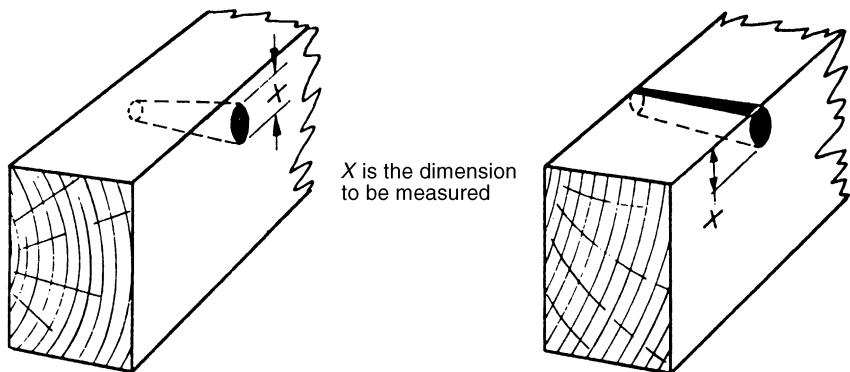
Fig. 10. Margin knots

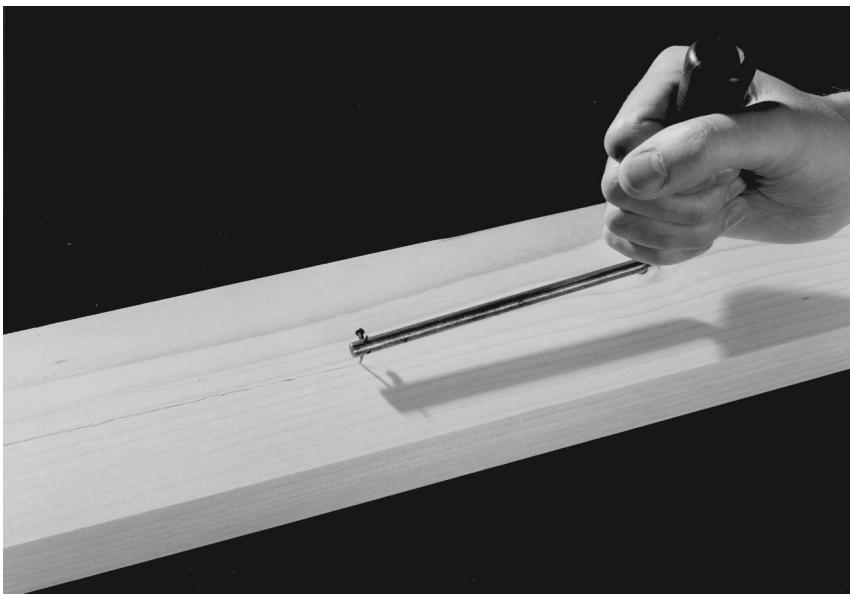
- *Slope of grain* Do not confuse slope of the grain with figure. Fissures indicate the true slope of grain but, in their absence, the slope can be determined with a scribe (Fig. A3.2) which consists of a cranked rod with a swivel handle and a needle at the tip. When drawn across the timber, the needle will follow the grain line. When spiral grain occurs, the slope of grain should be determined by measuring the worst slopes of grain on the faces and edges, and taking the square root of the sum of the squares and slopes.

Fig. A3.2 Use of a scribe to
determine the slope of grain

Slope of grain can be more accurately determined by means of a scribe, as shown in Fig. 14, comprising a cranked rod with a swivel handle and a needle, similar to a gramophone needle, at the tip, set to a slight trailing angle. The

needle is pressed into the wood and the scribe is drawn along with a steady action in the apparent direction of the grain, which is indicated more precisely as the needle forms a groove. If the pressure on the needle is insufficient it may be dragged across the grain; on the other hand, a steady action is impossible if the pressure is excessive and the needle penetrates too far into the wood. In Douglas fir the summerwood is relatively dense and the needle meeting it tends to be diverted, resulting in a step in the groove, the avoidance of which requires a particularly slow and steady action as each springwood stripe is met.
