# Domestic Building Surveys

Andrew R. Williams

**Andrew R. Williams**  
Building Services (Technical)  
Chartered Quantity Surveyors  
Corporate Building Surveyors  
UK

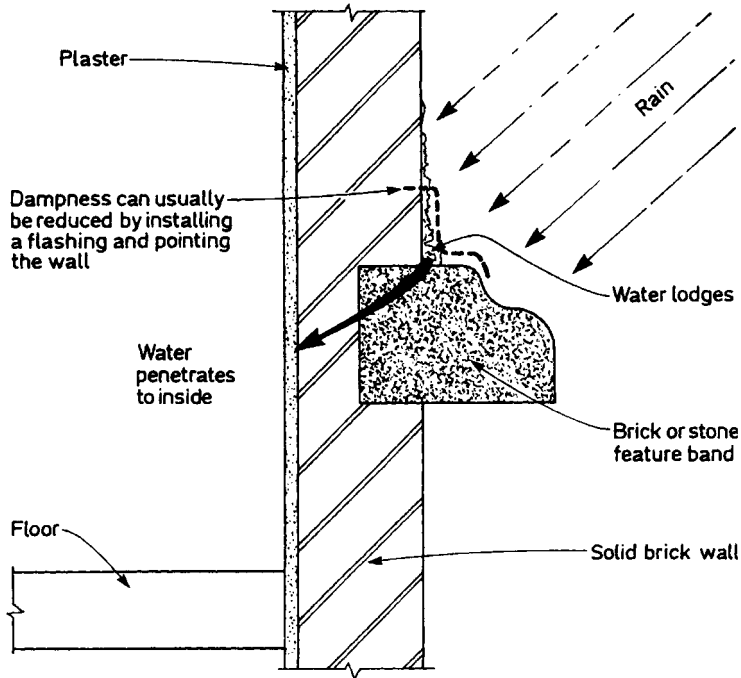
*Fig. 2.1* Damp entering via band in wall.

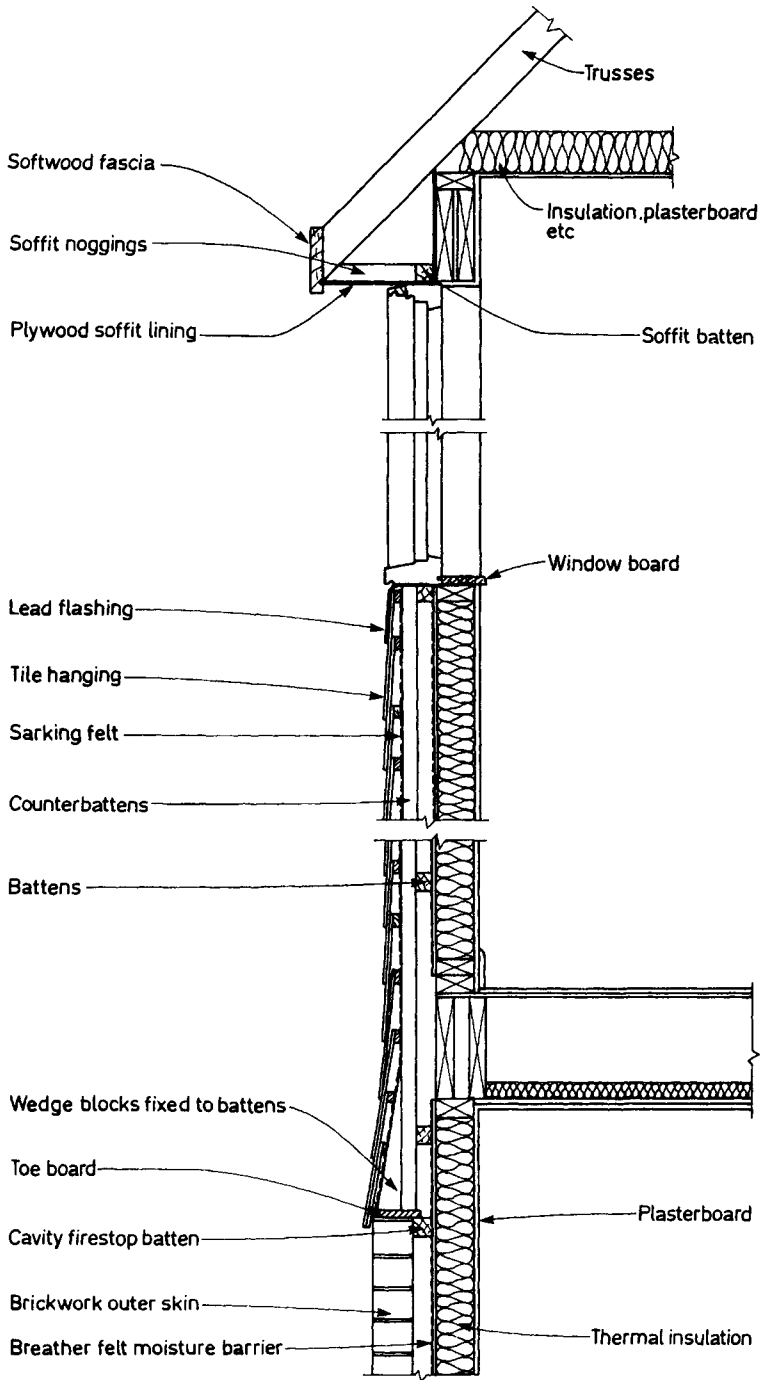
Fig. 3.1 Typical timber frame section.

His house was a relatively modern town house. The house was fairly conventional but the front and back walls of the house were built in what has become known as 'timber frame construction'. (Without going into the technicalities, [Fig. 3.1](#) shows the basic type of construction.)

- (a) Solid wall rendered externally.
- (b) Timber frame (beyond the scope of this book which deals with conventional construction, see Fig. 3.1).

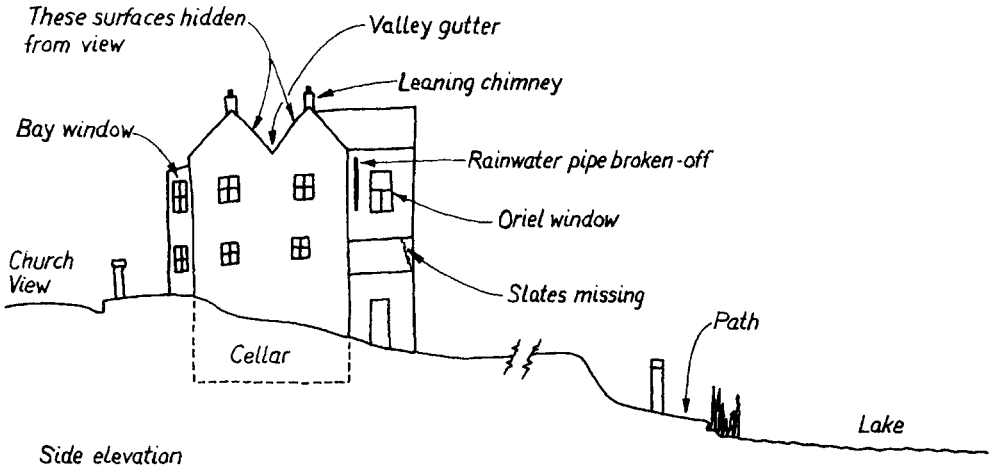
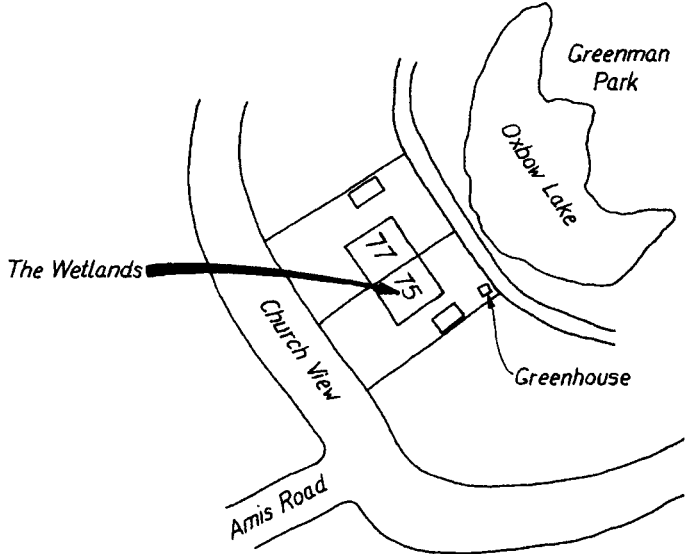
Side elevation

Cellar plan

Fig. 4.1 Sketch of 'The Wetlands'.

*(See [Fig. 4.1](#) for sketch of property and surroundings... This sketch was made prior to carrying out the survey. When dealing with large properties a sketch of the building can save a great deal of writing.)*

Then, whilst the electrician and plumber went to find the meters and stop cocks, I made an outline sketch of the building (Fig. 4.1).

My next real concern was the valley (see [Fig. 4.1](#) for location). While secret gutters and valleys are acceptable building construction, they have an inbuilt weakness. If the lead perishes then the surrounding timbers will start to be dampened by rainwater. Once damp, fungi can take hold. Despite the dust, I tried to crawl as close as possible to the base of the valley and secret gutter and was rewarded by finding a dry rot outbreak in one location. Perhaps I had better amplify at this point. Dry rot is, in my opinion, one of the worst defects that houses in the UK can suffer from unless checked in the early stages. The fungus is to houses what cancer is to humans. Given the right conditions, dry rot can spread extremely rapidly and will drive its tendrils behind plaster and through brickwork. It needs a specialist to kill it. Dry rot has several forms during its lifetime but the most obvious is the

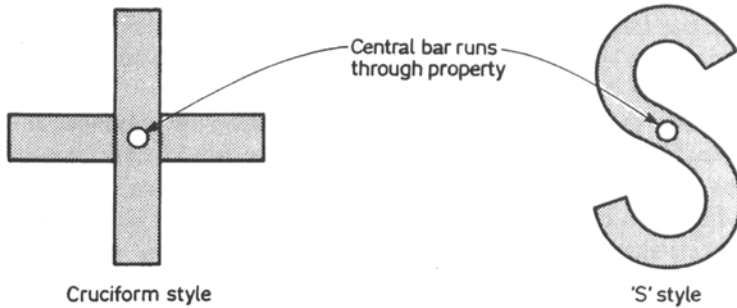
Fig. 4.2 Typical ties.

Vernon didn’t think that this would be necessary, but we agreed that I could take my engineer with me. His duties would be restricted to the matter of possible settlement and the inspection of a tie in one of the external walls and I would check the house out for other defects. (Typical ties are illustrated in Fig. 4.2.) It was a common

practice at one time to stabilize bulges in walls by running a large diameter metal rod through a building and then placing a tie plate externally. The tie then prevented further movement.

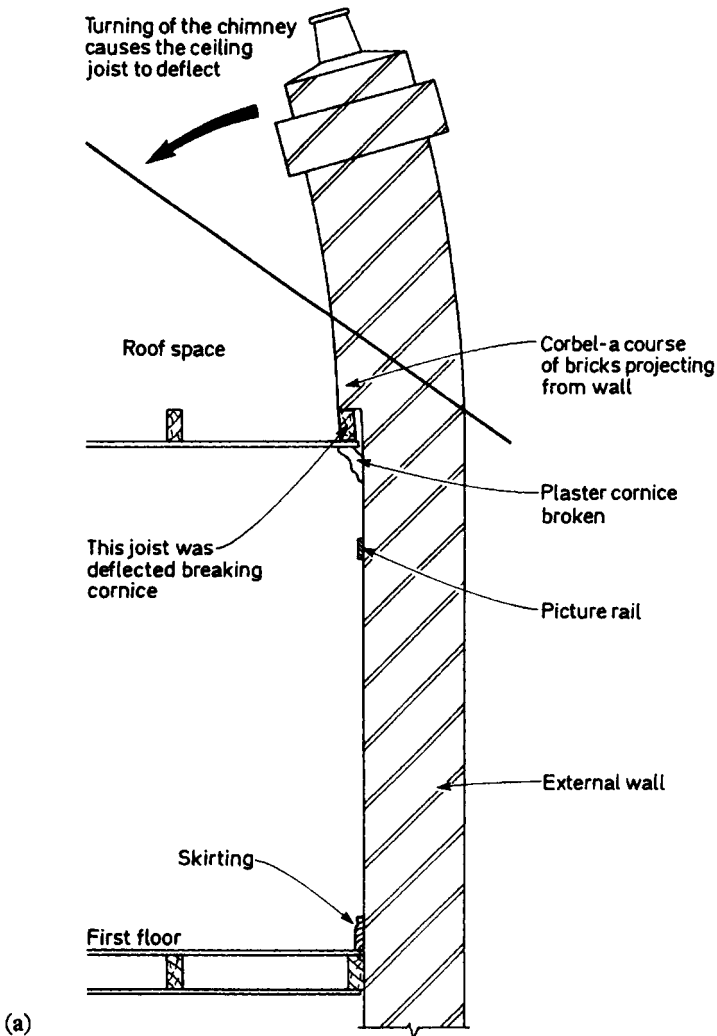
Fig. 4.3(a) and (b) Leaning chimney.

- (a) One chimney was leaning inwards towards the house (*this item was discussed previously with my engineer*) and, if left, I had no doubt that the new owner would find it crashing through into his bedroom at some future date.
- (b) There were slates missing off a verge. (A verge is the edge of a slated or tiled roof that overhangs the gable.)
- (c) Ridge tiles were missing in two locations.
- (d) Moss was growing on walls where rainwater pipes were broken off.
- (e) There was a crack in a cove in an upstairs bedroom.

quite some time in the loft space later on in the survey to satisfy myself regarding the cause (Fig. 4.3(a)).

Once I had finished my general inspection of the timbers, I then went to find the chimney that had a lean. It was then that I discovered the reason for the damaged coving in one of the bedrooms. The chimney breast inside the loft was wider than the external wall of the house and the wall had been corbelled out ([Fig. 4.3](#)). The lean had forced the corbel into a ceiling joist which had bent and broken the coving below.

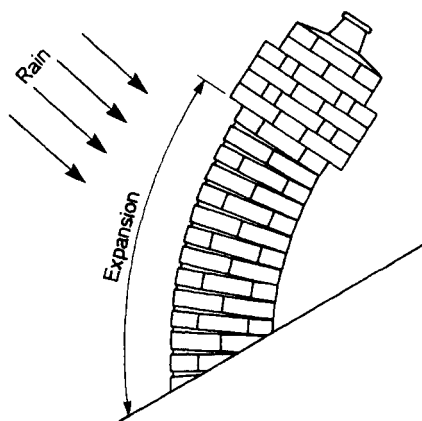
(b) Leans on chimneys caused by being saturated on one side for a long time - sulphates from flue gasses attack mortar causing bending away from the normal wind/rain direction

*Fig. 4.3 Continued*

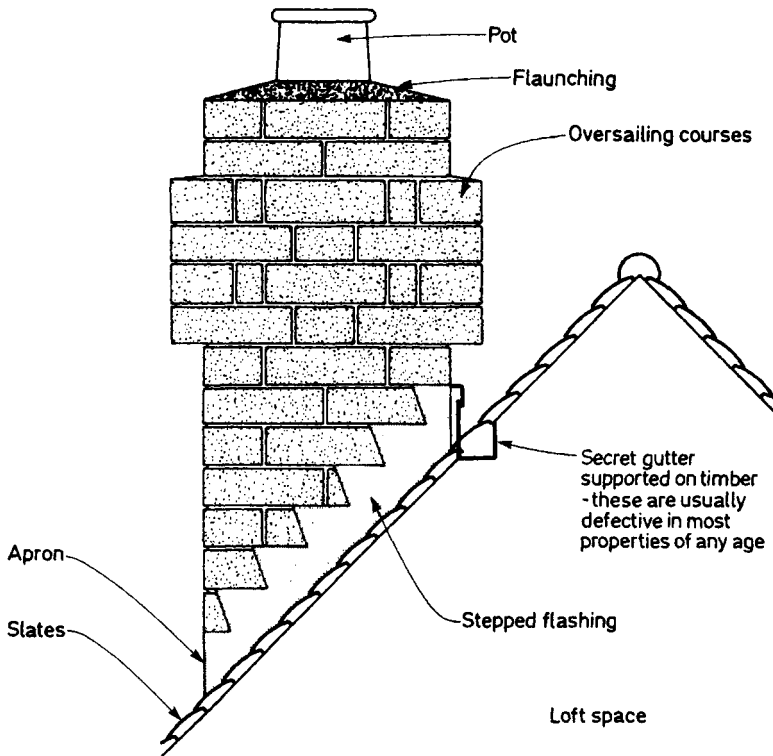
Fig. 4.4 Chimney details.

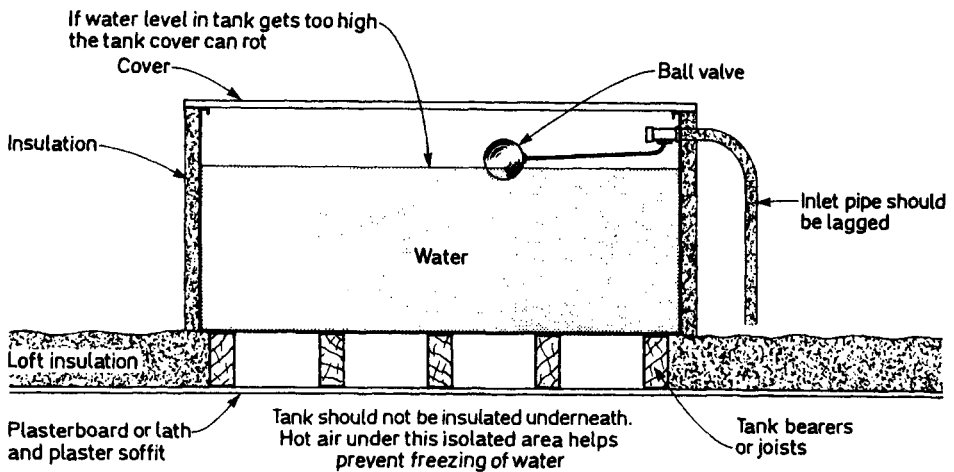
*Fig. 4.5* Typical water tank.

Apparently the ball valve in the tank (Fig. 4.5) had been defective for years and the previous owners had not bothered to have it repaired. They had merely wired it up in an attempt to stop the tank overflowing. The water level had inevitably risen during periods of the

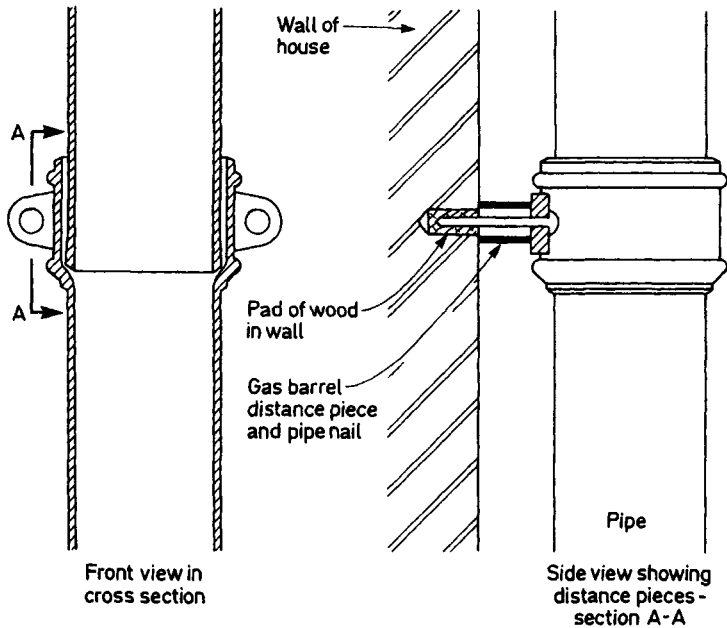
Fig. 4.6 Cast iron pipe with ears.

The downpipes were the old cast iron type and set away from the wall with 'gas barrel distance pieces' (Fig. 4.6).

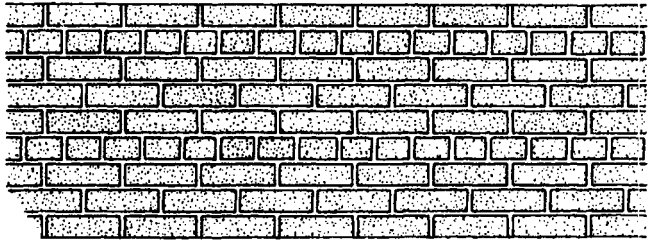
The external appearance shows mainly stretchers with a row of headers every three, five or seven courses

Fig. 4.7 English garden wall bond.

Solid walls can usually be noted because most cavity walls are built in stretcher bond (Fig. 11.9); solid walls are normally built in English, Flemish or English garden wall bonds (see Figs 4.7, 11.10 and 11.11).

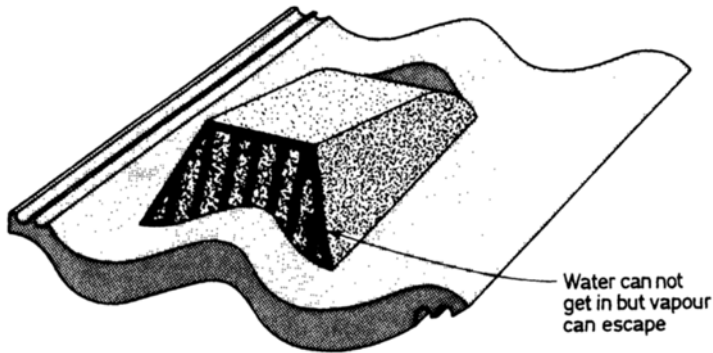
*Fig. 4.8* Typical roof ventilation tile (various types available to suit slate or tile profiles).

locations and found the moisture levels very high. My suspicion at that point in time was that the hessian and bitumen were preventing air flow in the loft and consequently trapping moisture. (As you will note from my report ([Appendix A](#)), I came to the conclusion that ventilating slates needed installing, [Fig. 4.8](#).) Condensation in loft spaces is becoming a common problem, because as insulation thicknesses increase, without more ventilation being provided, the risk of condensation also increases.

I made a note on my recorder that the client should contact a firm of dry rot and woodworm specialists in order to obtain a full survey of the extent of the various attacks and also noted that, in my opinion, additional ventilation should be provided in the roof. (See [Fig. 4.8](#) for typical ventilation tile.) My reasons for this recommendation were that lack of adequate ventilation is one of the causes of dry rot and bad ventilation can also, as previously mentioned, allow moisture vapour to build up in lofts.

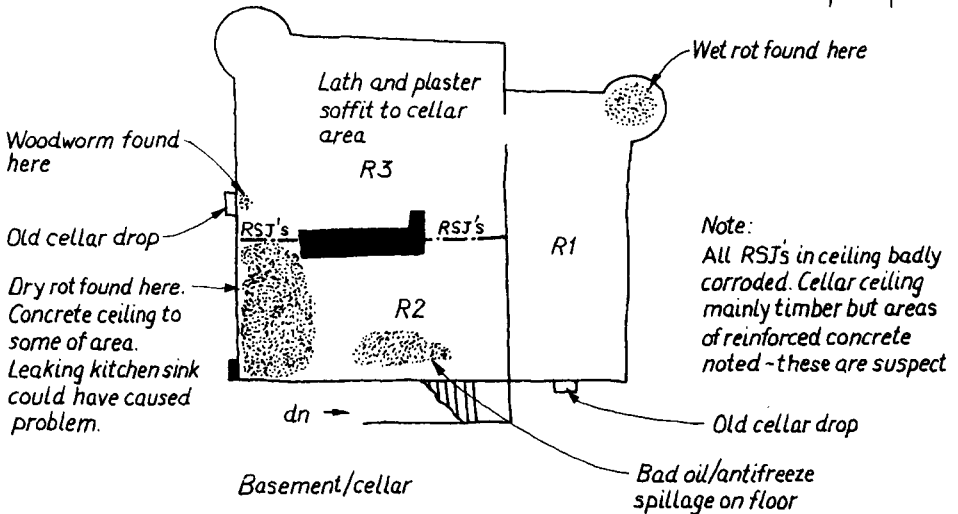
(a) Sketches not to scale ~ Ref only

Fig. 5.1(a) and (b) Sketch of 72 Ninetails Avenue.

*(See Fig. 5.1 for sketch of Ninetails Avenue. As previously indicated, Appendix B is based upon a genuine survey but names of clients, the location plan, addresses and the like have been amended and fictitious ones used to ensure anonymity of all parties. Sketches similar to those depicted in the figures were incorporated into the original report so that major defects could be located at a glance.)*

The terms large and small are very subjective but I am sure that perhaps 80 per cent of the home hunting population of this country would give their eyeteeth to own a house like 72 Ninetails Avenue. Admittedly, the house has only three bedrooms but each one is almost double the size that you get in the usual modern house. In addition, the property possesses two large living rooms and each had feature windows (Fig. 5.1).

The Ninetails Avenue report is also interesting, as I have said before, if viewed as a purely technical exercise. [Figure 5.1](#) gives a fair indication of some of the major defects, the areas affected and the basic structure of the property. (These sketches were made in addition to the notes taken on a pocket tape recorder.)

As indicated above, I included a sketch similar to [Fig. 5.1](#) in the report because I wanted to ensure that all parties could appreciate where and how extensive the problems were and to ensure that they could relate the written descriptions to exact locations.

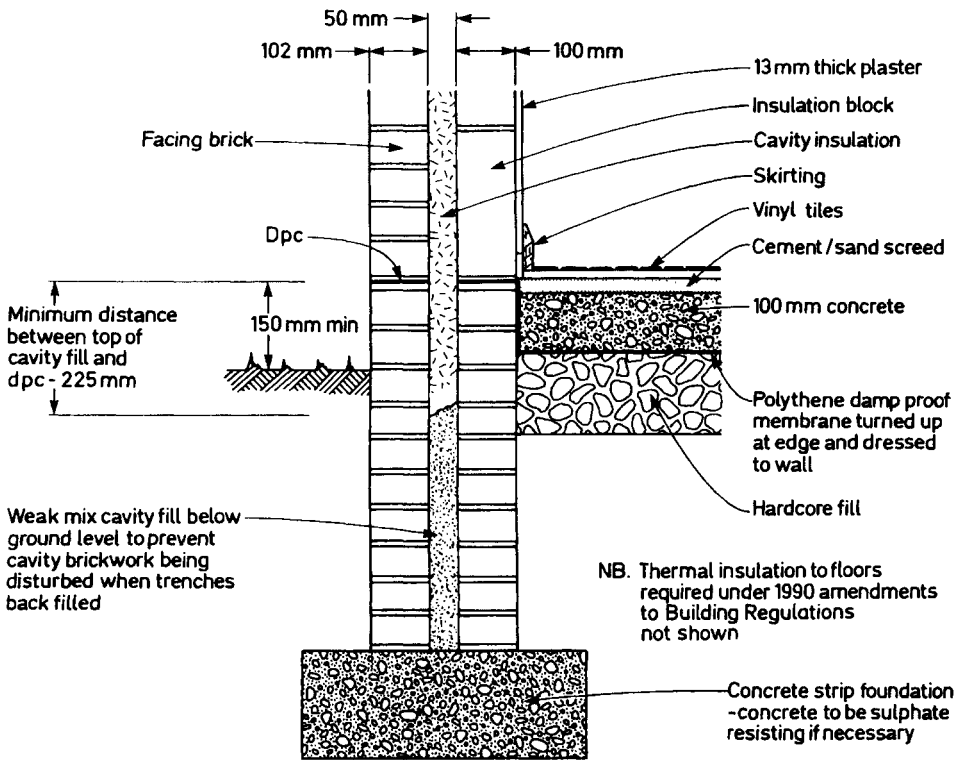
Fig. 11.1 Typical domestic foundation/concrete floor (modern).

Most houses built under modern regulations will be of cavity construction. Cavity walls (Figs 11.1–11.3 and 11.7) below ground level usually comprise two half brick skins with a weak concrete cavity fill between. Note that the cavity fill should be kept down 225mm from the wall damp proof course. Above ground level, the two skins are usually a skin of facing brick, a skin of thermal block and a cavity between. Fears of an impending energy crisis have forced the government to pass regulations which are continuously upgrading thermal insulation in dwellings. The insulation factor is described as the 'U' value. If you want to know more about this topic, I would suggest that you refer to *The Building Regulations* or Pilkington Insulation's *Green Book Design Manual* (see Chapter 18, p. 167, for other useful texts).

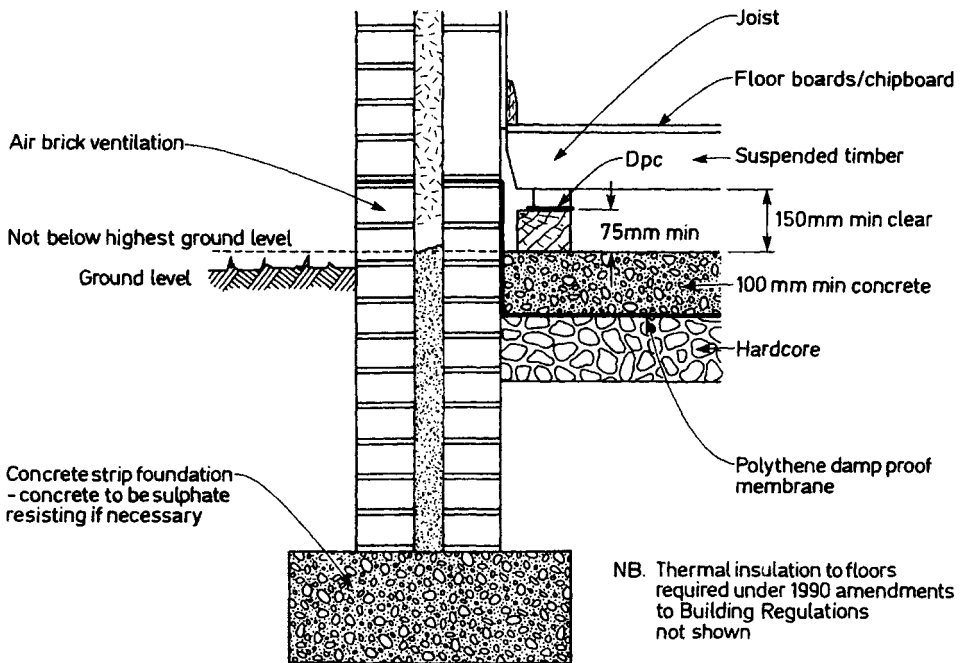
*Fig. 11.2* Typical foundation/suspended timber floor.

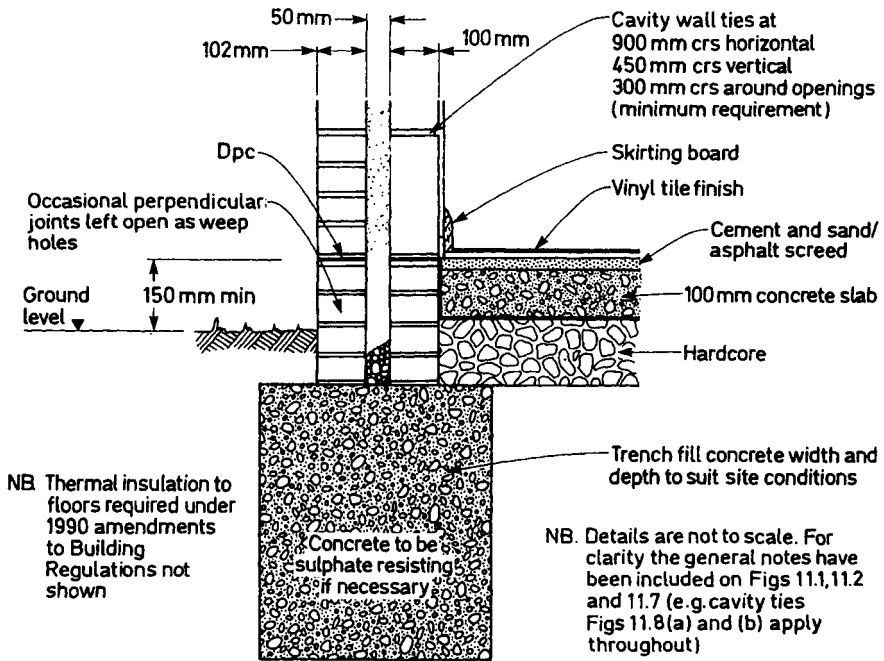
Fig. 11.3 Trench fill foundation.

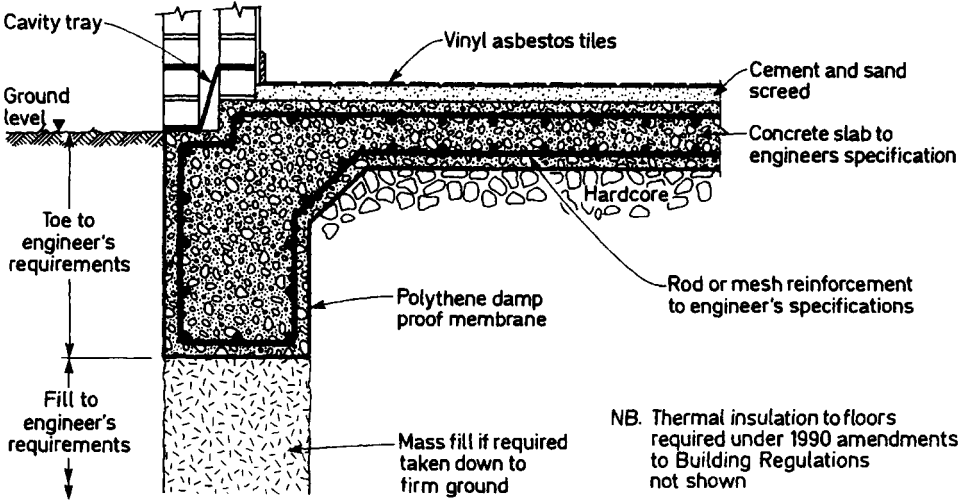
Fig. 11.4 Typical raft/tied footing (modern).

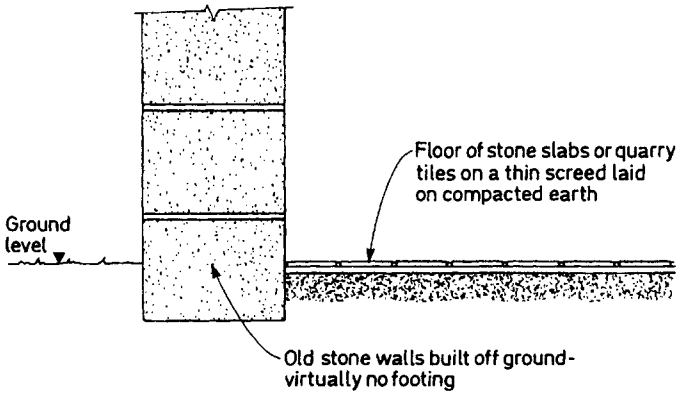
Fig. 11.5 Typical foundation in old cottage.

In older properties built before modern Building Regulations came into effect the footing could well be built in very shallow trenches or off spread footings (see Figs 11.5 and 11.6). These types of construction are obviously less stable than modern strip footings. (*Shallow footings built on clay soil can suffer from frost heave.*)

Walls of older houses (Figs 11.5 and 11.6) are generally of solid construction. Solid walls are not as watertight or thermally resistant as cavity walls and this is why cavity construction is now the most common form of external wall used in domestic construction.

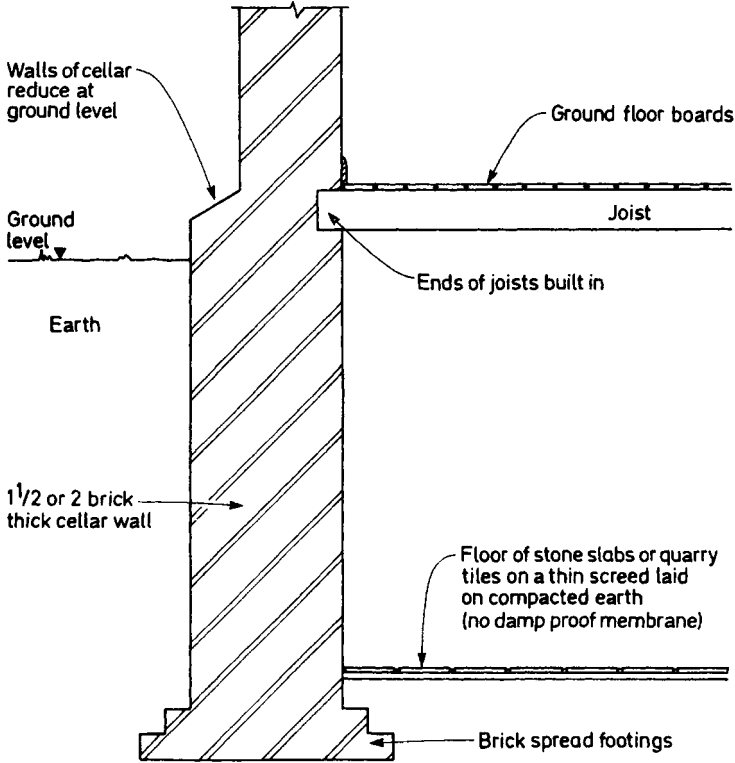
Fig. 11.6 Typical old cellar detail.

and should be replaced (Figs 11.5 and 11.6). The main dangers of this type of floor is that lino or vinyl sheeting if it is laid over the tiles can force moisture to build up under the covering. This process is known as sweating. The excess moisture can encourage dry rot and wet rot outbreaks.

Old quarry tile floors are always likely to let in dampness (see [Fig. 11.6](#)) as they do not usually have a damp proof membrane incorporated in the construction.

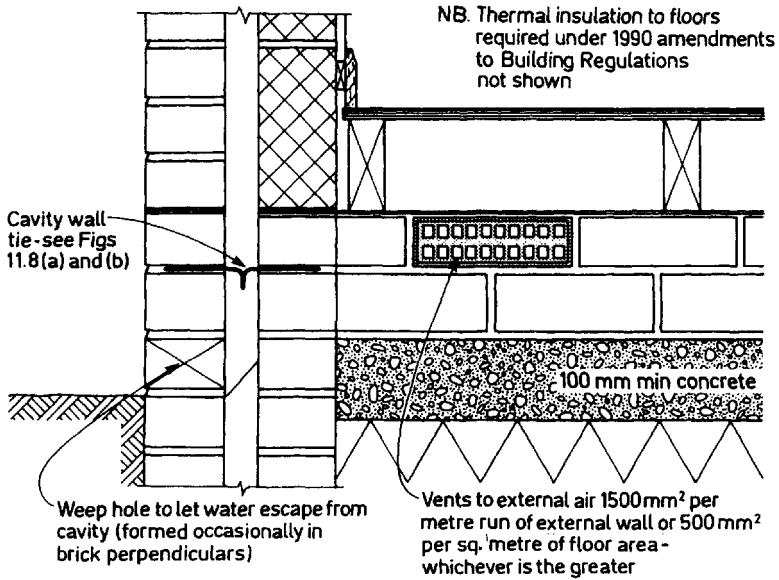
Fig. 11.7 Suspended floor showing ventilation (modern).

A timber floor still requires a hardcore bed and a 100mm concrete slab (Figs 11.2 and 11.7), which is why it is more expensive to construct in normal conditions. (If a large amount of fill is required because of site levels, then it could be cheaper to put in a timber floor.) Some people prefer timber floors as they are not as hard on the legs if one is standing up a great deal.

Where there is a suspended timber floor in the ground floor, there should be 1500mm<sup>2</sup> per metre run of external wall or 500mm<sup>2</sup>/m<sup>2</sup> of floor area whichever is greater (see [Fig. 11.7](#)).

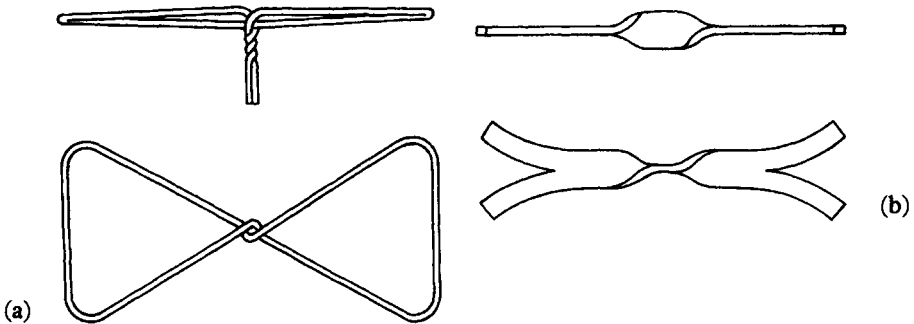
Fig. 11.8 (a) Butterfly wall tie. (b) Vertical twist tie.

The two 'skins' are held together with wall ties. There are two types of tie in common use, the butterfly and the vertical twist type (see [Fig. 11.8](#) (a) and (b)). These ties were at one time made of galvanized steel. The zinc layer on the cheaper ties was very thin and over a period of years the zinc tends to degrade leaving the steel to rust. The loss of the zinc and subsequent rusting can be accelerated if the wall ties were built into walls that had been built in 'aggressive' mortar. Once the metal in the ties starts to turn into rust, an expansion process starts. The total vertical expansion in a two storey building can be as much as 50mm. This sort of damage does not normally occur when light 'butterfly' ties have been used. The visible effects are horizontal cracking in the mortar joints on the outer leaf of brickwork coinciding with the level of the ties which are usually four courses apart. The cracks are usually several millimetres wide and mainly on the horizontal joints (see [Fig. 12.6](#)).

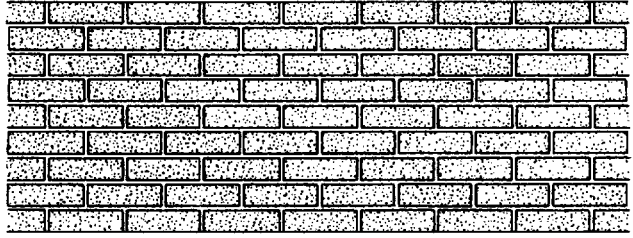
The external appearance shown as all stretchers

Fig. 11.9 Stretcher bond.

value of  $0.45 \text{ W/m}^2\text{k}$  (unless 'trade-offs' can be agreed— $0.60 \text{ W/m}^2\text{k}$  between a dwelling and a partially ventilated space such as a garage). The usual external skin of a cavity wall is in the facing brick. Stretcher bond on the external skin (Fig. 11.9) usually indicates the existence of a cavity wall.

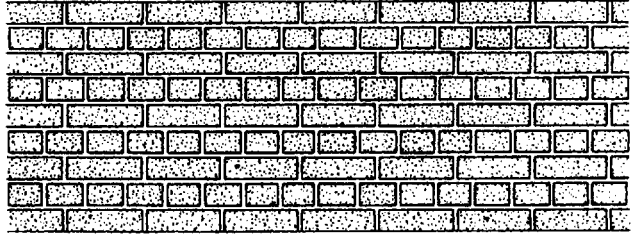
The external appearance shows alternate layers of headers and stretchers

Fig. 11.10 English bond.

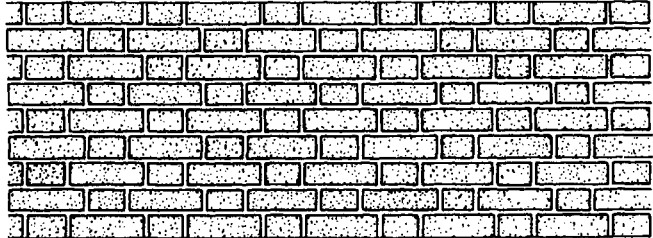
The external appearance shows alternate headers and stretchers in each course

Fig. 11.11 Flemish bond.

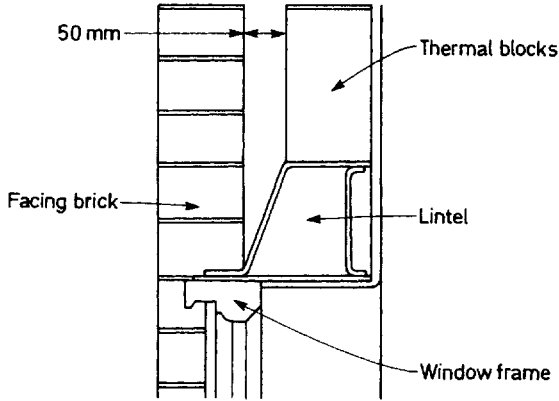
Fig. 11.12 Steel lintel detail.

The most usual type of lintels used on modern houses is metal 'Catnic' or similar type (see Fig. 11.12).

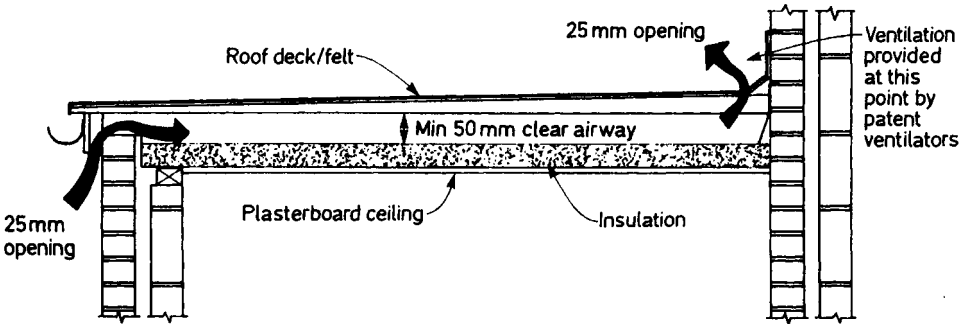
NOTE :- All openings are to be continuous or provided by patent product which gives the same area of ventilation. Details after Willan Building Products (Glidevale)

Fig. 11.13 Flat roof with abutments.

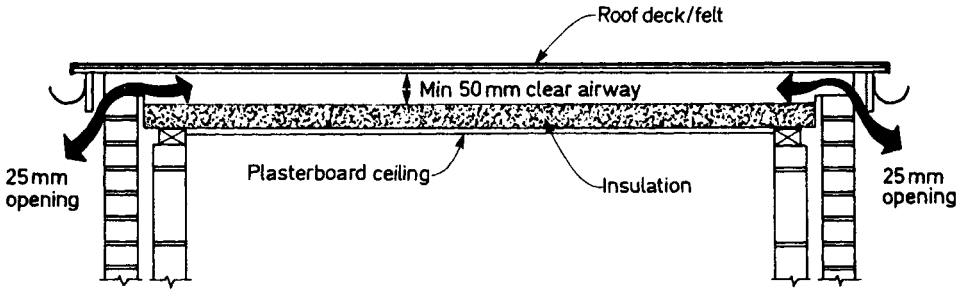
Fig. 11.14 Flat roof.

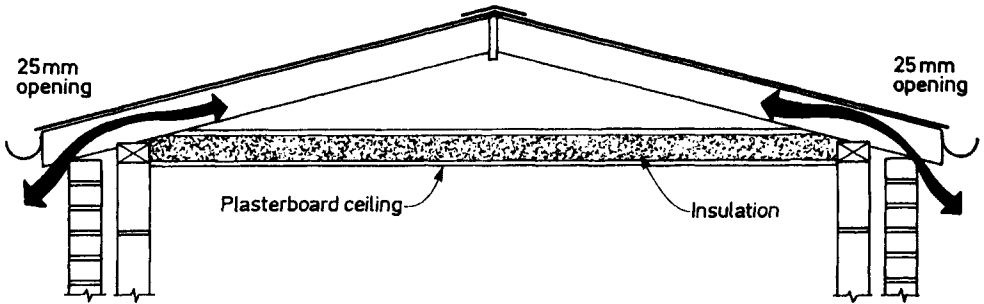
Fig. 11.15 Duopitch roof below 15 degrees.

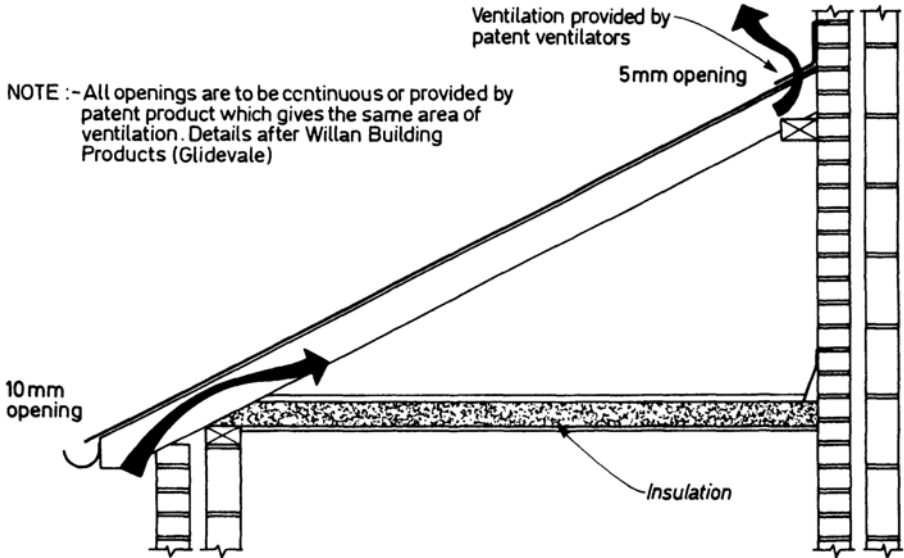
Fig. 11.16 Monopitch roof over 15 degrees.

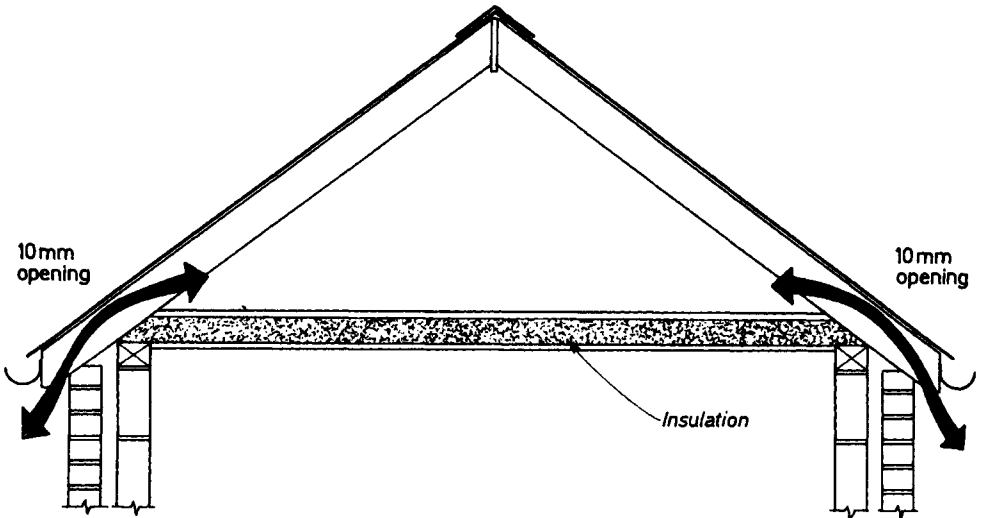
Fig. 11.17 Standard duopitch roof over 15 degrees.

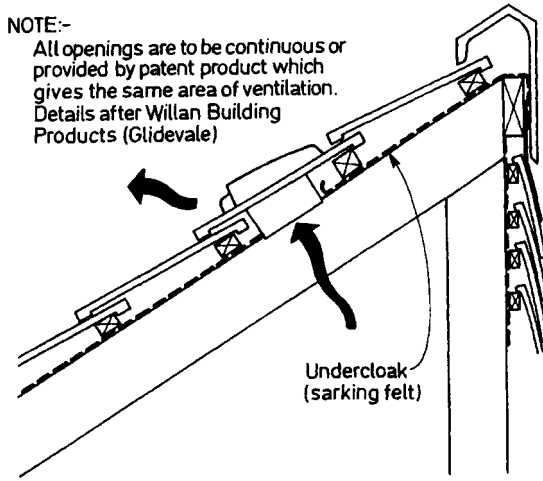
Fig. 11.18 Typical modern ventilation for monopitch situations.

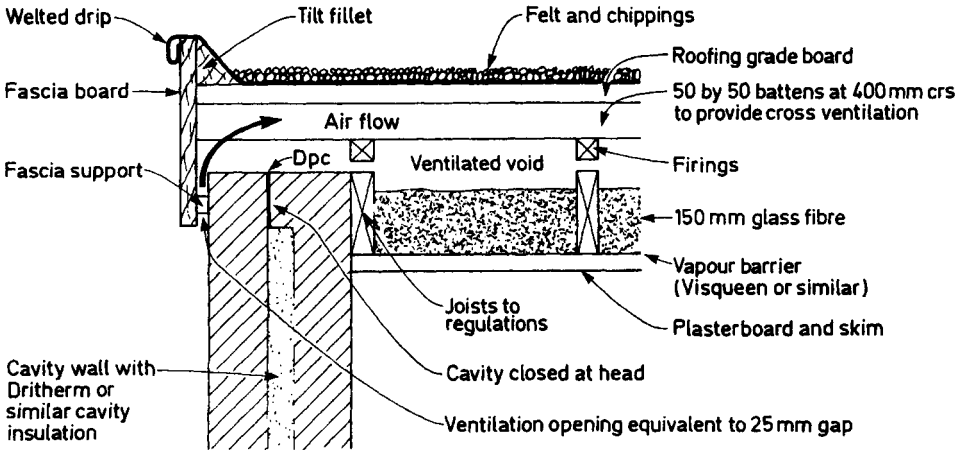
Fig. 11.19 Ventilating cold roof with tilt fillet fascia detail.

A typical flat roof details are shown in Figs 11.19 and 11.20. Note the ventilation details.

The roof details indicated are 'cold roof' type which is the cheapest type of flat roof. The roof is covered usually with three layers of bituminous felt (built up felt) which is covered by a 13mm layer of white limestone chippings laid shoulder to shoulder in bitumen. The purpose of the chippings is to reflect the heat of the sun. Without them the roof will perish. The other alternative is to use solar reflective paint but as this is not accepted by most Building Control departments as having any fire rating, solar reflective paint finish can't be used near to boundaries with other properties.

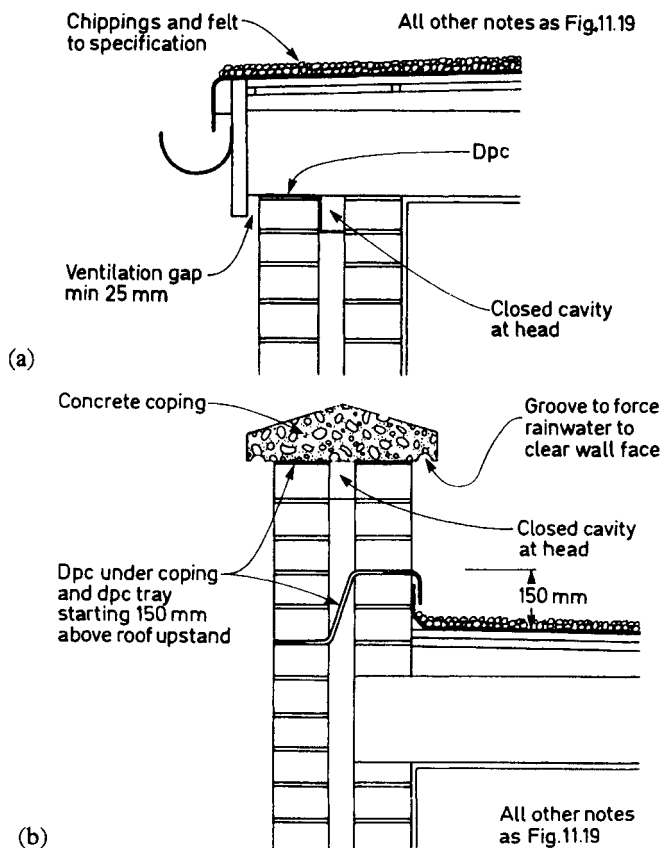
Fig. 11.20 (a) Ventilated cold roof details with gutter. (b) Ventilated cold roof details with parapet.

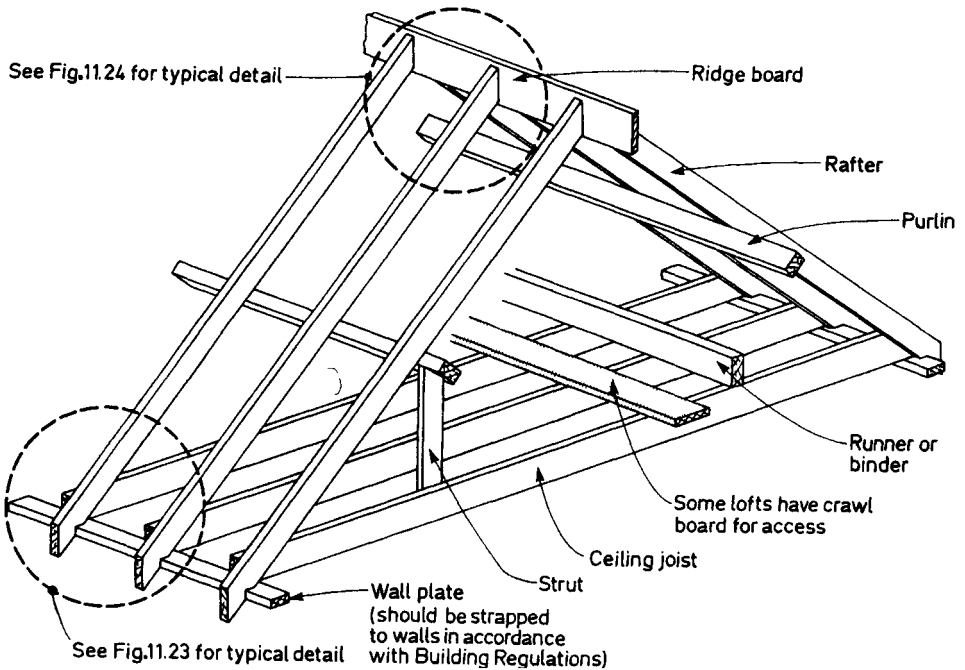
Fig. 11.21 Names of roof timbers in a traditional roof.

Refer to Figs 11.21–11.27. A pitched roof comprises a covering of concrete or clay tiles or slates. These must be laid to a suitable pitch (i.e. not less than the manufacturer's recommended slope or pitch).

(See Fig. 11.21)

The slates or tiles did not have underfelt below the covering. Instead a cement and sand or haired lime plaster was smeared underneath the slates to waterproof the construction. It is very common to find that this render has fallen away.

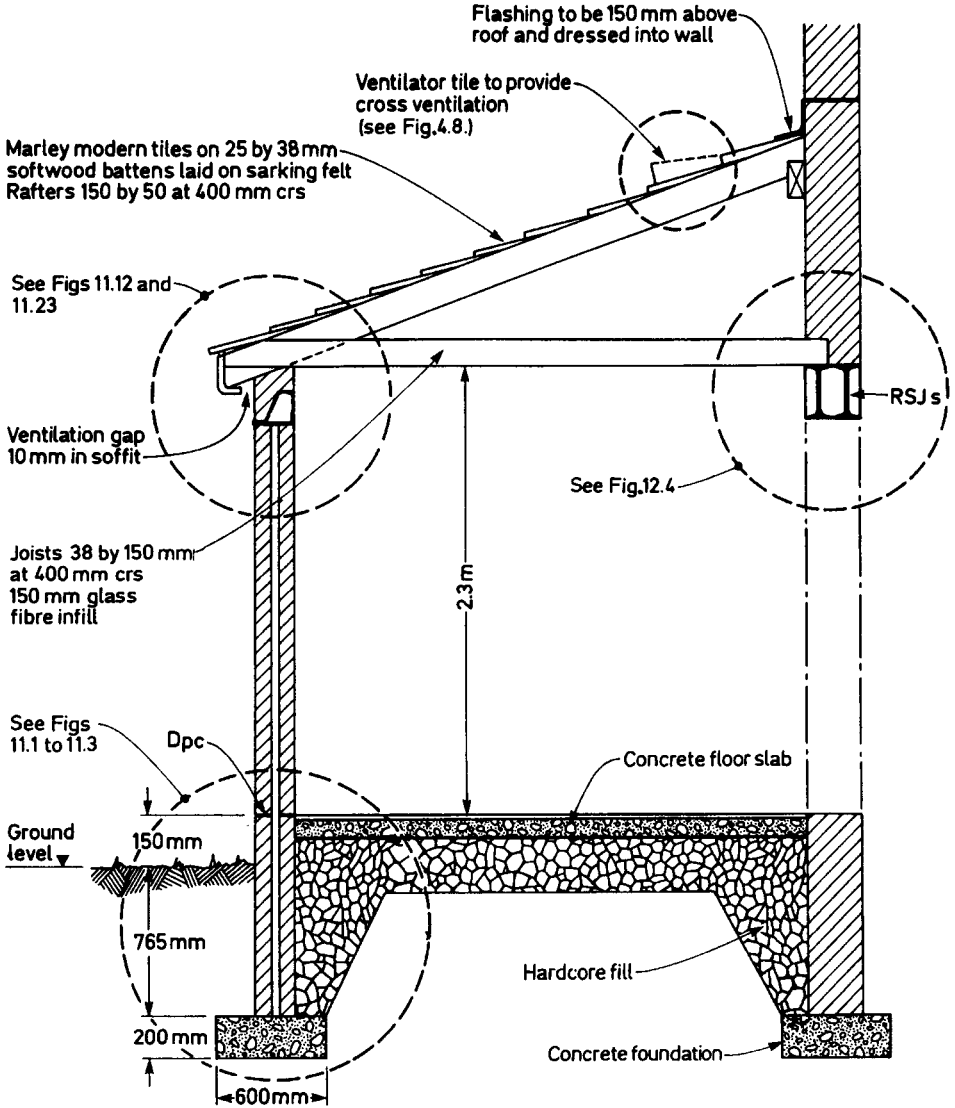
Fig. 11.22 Typical section through lean-to extension showing pitched roof over 15 degrees.

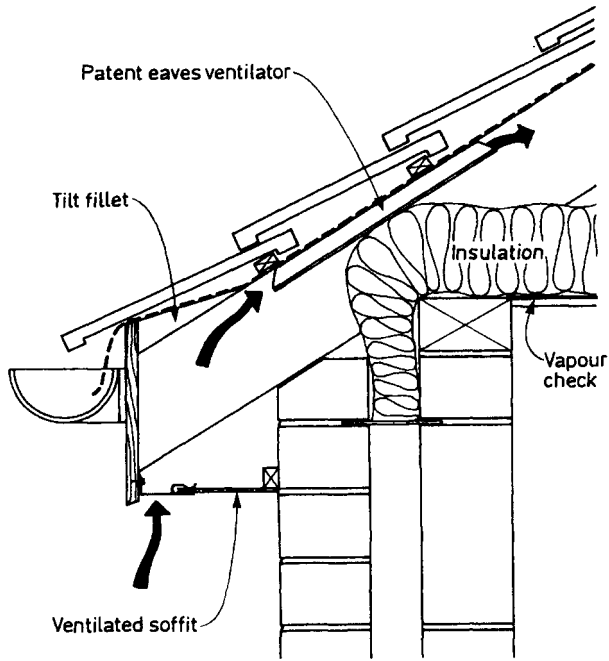
Fig. 11.23 Typical modern eaves detail.

manufacturer but the roofers caused a defect by putting an extra large tilt fillet beneath the eaves tiles (see [Fig. 11.23](#)). All the houses on the estate have suffered from leaking roofs and woodrot because of this fault.

Gutters will also leak if they are laid to incorrect falls. It is normal for the sarking felt to be turned into the back of the gutter (see Fig. 11.23). On one survey that I carried out recently, this had not been done and as the roof tiles did not project over the gutter, water was running behind the gutter and not into it. Evidence of the spillages was there to be seen. There was a great deal of moss on the path and water stains were apparent on the fascia board. Some houses have secret gutters behind parapet walls. As with any other secret gutter (see Fig. 11.25), leaks can occur without them becoming immediately apparent. In houses with parapets, check tops of walls and ceilings directly below the gutter with a moisture meter.

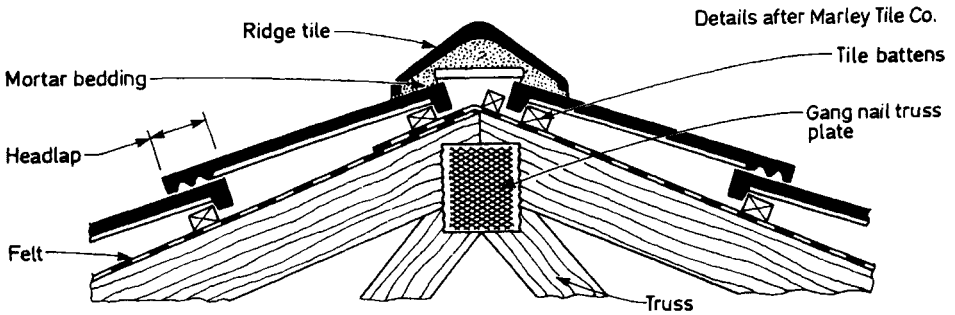
Fig. 11.24 Typical ridge.

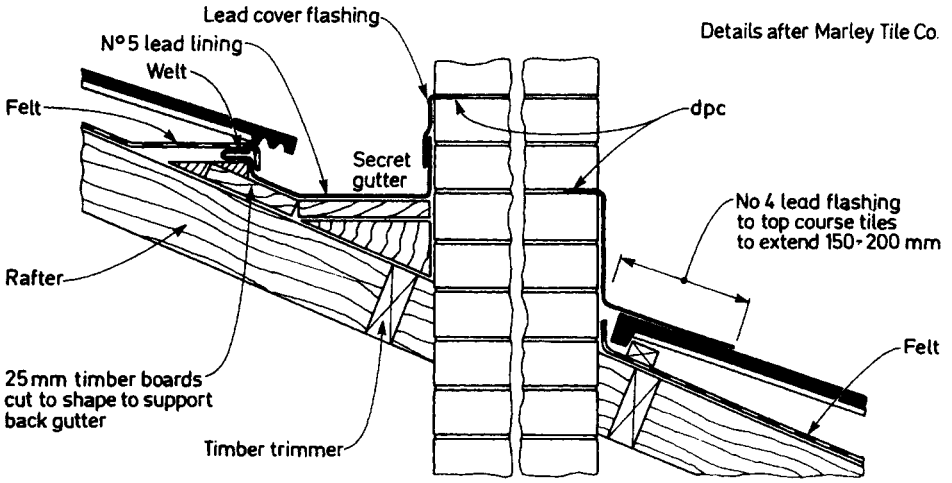
Fig. 11.25 Vertical abutment with secret gutter.

Once the general inspection was completed, I wormed my way towards the valley gutter and the secret gutter (Figs 11.25 and 11.26), fully anticipating to find damp. The house defeated me. The valley and secret gutter boards proved dry. (Within the 'green' zone on the moisture meter.)

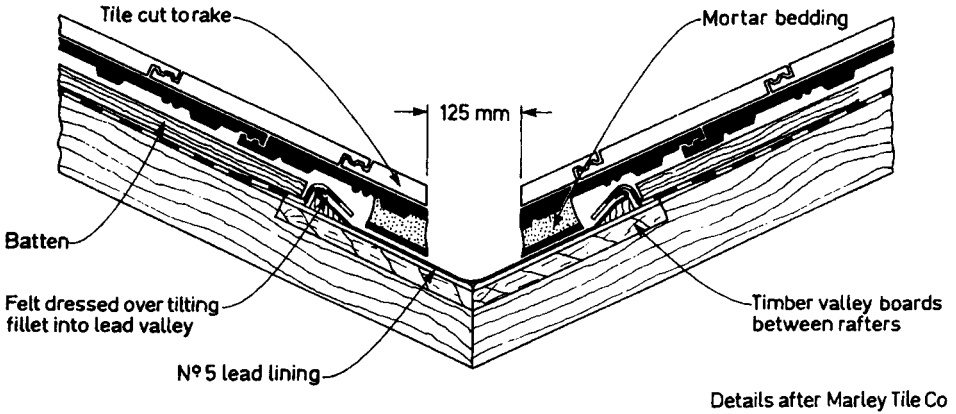
Fig. 11.26 Lead lined valley.

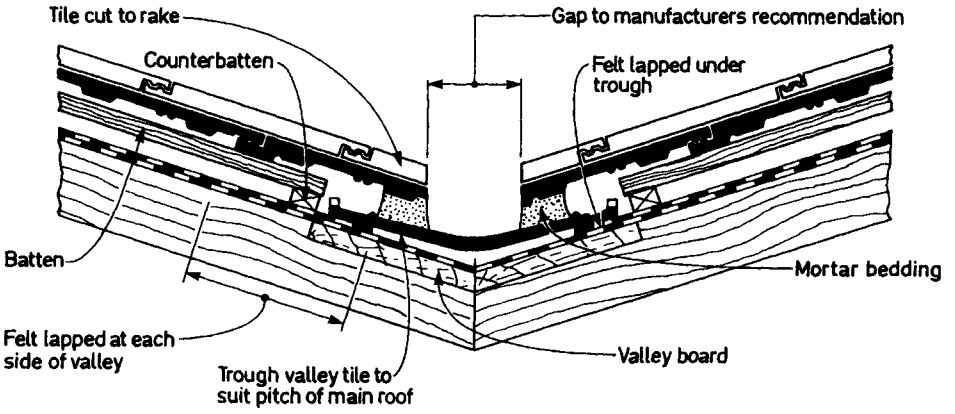
*Fig. 11.27* Valley with special tile.

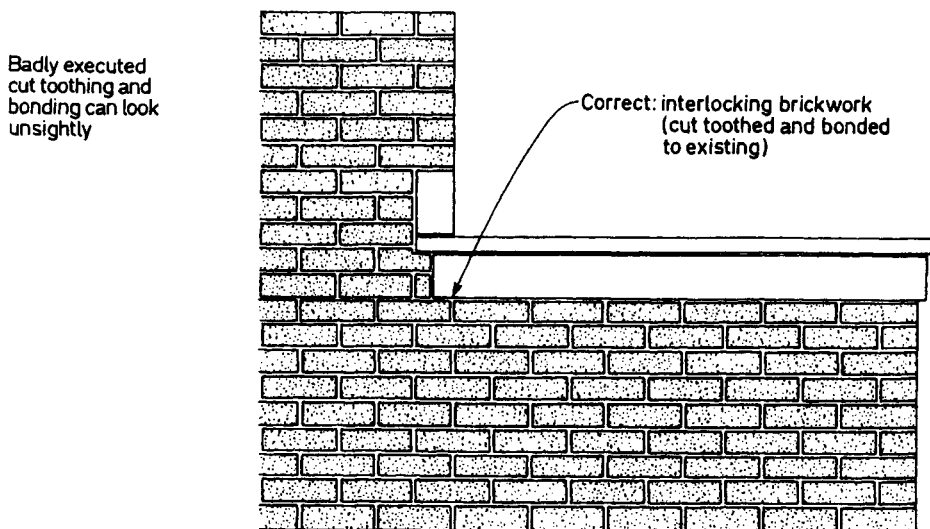
*Fig. 12.1* Correct vertical abutment.

The list of all possible design faults would undoubtedly be a very long one and I do not intend to try to attempt to cover every conceivable option. If you refer to [Figs 1, 2.1, 4.4, 12.2, 12.3](#) and [12.5](#) some design faults become apparent. Note in particular [Figs 12.1](#) and [12.2](#): extensions should be correctly bonded to the existing building and not merely butted up.

**Vertical abutments.** Where new walls abut old walls the brickwork should be cut, toothed and bonded to the existing. In other words, pockets cut in the old brickwork and the new bricks let in
