# Domestic Building Surveys

Andrew R. Williams

**Andrew R. Williams**  
Building Services (Technical)  
Chartered Quantity Surveyors  
Corporate Building Surveyors  
UK

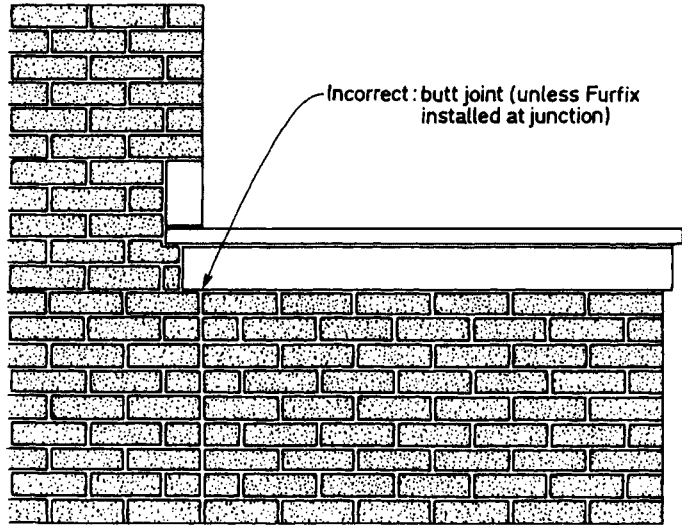
*Fig. 12.2* Incorrect vertical abutment.

The list of all possible design faults would undoubtedly be a very long one and I do not intend to try to attempt to cover every conceivable option. If you refer to [Figs 1, 2.1, 4.4, 12.2, 12.3](#) and [12.5](#) some design faults become apparent. Note in particular [Figs 12.1](#) and [12.2](#): extensions should be correctly bonded to the existing building and not merely butted up.

**Vertical abutments.** Where new walls abut old walls the brickwork should be cut, toothed and bonded to the existing. In other words, pockets cut in the old brickwork and the new bricks let in

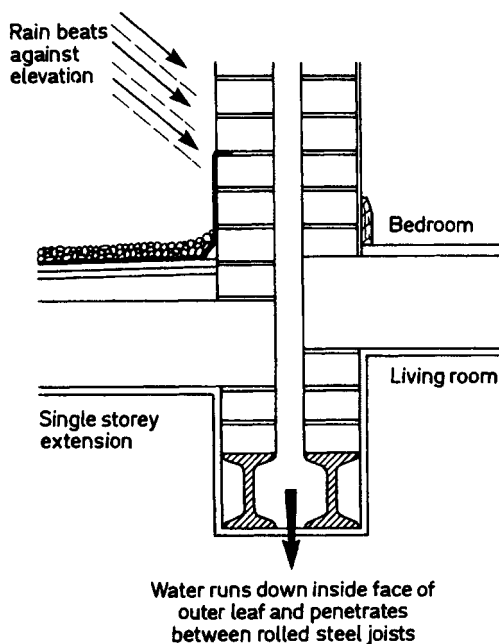
*Fig. 12.3* Incorrect detail for steel beams.

There are other causes of water penetration such as omission of cavity trays (see Fig. 12.3).

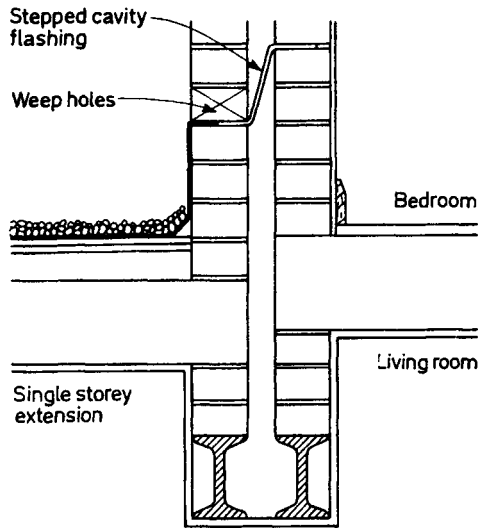
*Fig. 12.4* Correct detail for steel beams.

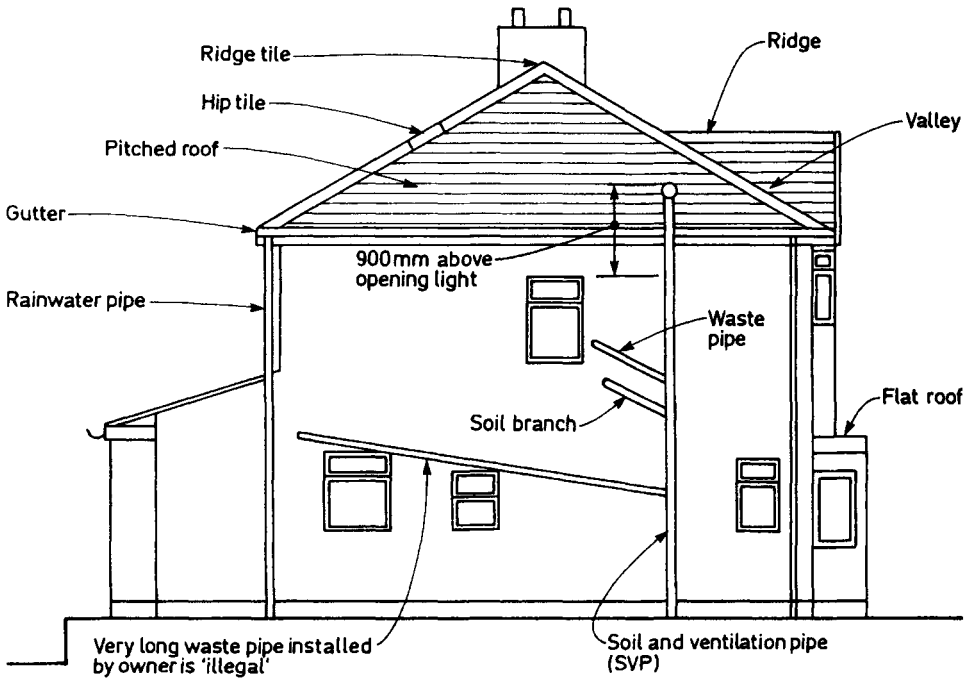
Fig. 12.5 External plumbing and roofing.

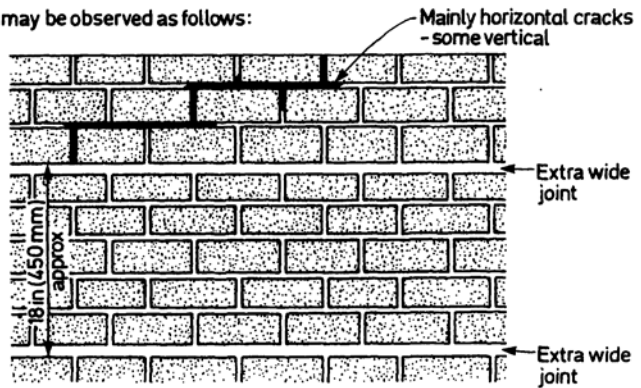
1. Gaps in the mortar joints visible with the naked eye horizontally and vertically
2. Wide mortar joints vertically 18 in (450 mm) apart
3. Movement of brickwork at door and window reveals
4. Bulging of brickwork and or rendering
5. Evidence of roof structure lifting

*Fig. 12.6* Cavity wall tie corrosion.

The two 'skins' are held together with wall ties. There are two types of tie in common use, the butterfly and the vertical twist type (see [Fig. 11.8](#) (a) and (b)). These ties were at one time made of galvanized steel. The zinc layer on the cheaper ties was very thin and over a period of years the zinc tends to degrade leaving the steel to rust. The loss of the zinc and subsequent rusting can be accelerated if the wall ties were built into walls that had been built in 'aggressive' mortar. Once the metal in the ties starts to turn into rust, an expansion process starts. The total vertical expansion in a two storey building can be as much as 50mm. This sort of damage does not normally occur when light 'butterfly' ties have been used. The visible effects are horizontal cracking in the mortar joints on the outer leaf of brickwork coinciding with the level of the ties which are usually four courses apart. The cracks are usually several millimetres wide and mainly on the horizontal joints (see [Fig. 12.6](#)).

Underpinning is a very expensive operation and not one to be undertaken lightly. However, it is usually cheaper than complete demolition. Cracking of walls can also be caused by cavity wall tie corrosion (see [Fig. 12.6](#) and [Chapter 12](#)).

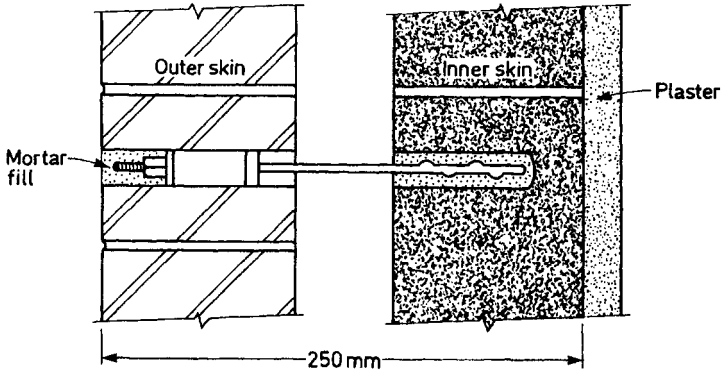
Fig. 12.7 Brick to low density blockwork inner leaf—replacement tie.

I think it is worth mentioning *Building Research Establishment Digest 329* at this point. It is obviously very expensive taking down the whole outer skin of a house to rectify cavity wall ties. This digest describes a way of installing wall ties in existing walls using the isolation technique. Using this method, the old tie is left in the wall but the end of the tie in the external skin is isolated by chiselling out a plug of mortar around the end of the old tie. Foam plugs are put in and the joint repointed. The foam plugs prevent any further expansion damage. New purpose made stainless steel ties are then inserted in new locations in the wall (see [Figs 12.7–12.9](#)). However, this technique is not recommended for walls with thin mortar joints as there will not be sufficient room for the technique to work. (A normal joint is 10mm.) Where the joints are too thin, then the only method of

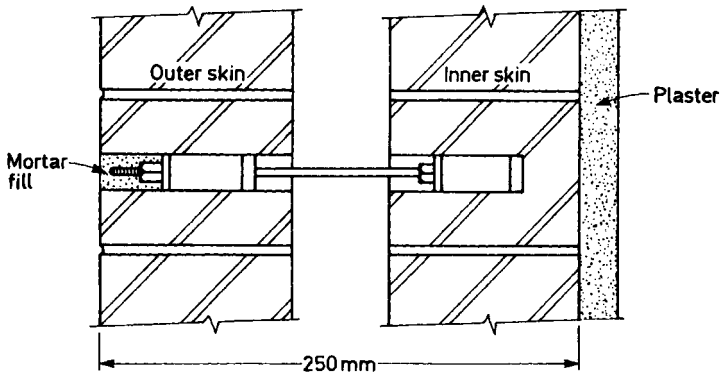
Fig. 12.8 Brick to brick inner leaf—replacement tie.

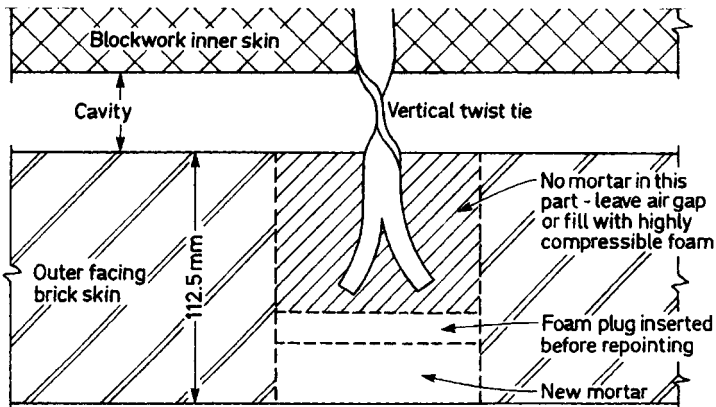
*Fig. 12.9* Plan view of typical cavity wall showing ends of existing wall tie isolated.

When inspecting a property that has supposedly been re-tied using this system look for small mortar 'dots' on the brickwork and that the old ties have been isolated. Make sure that beds are at least 10mm wide as per BRS 329 recommendations.

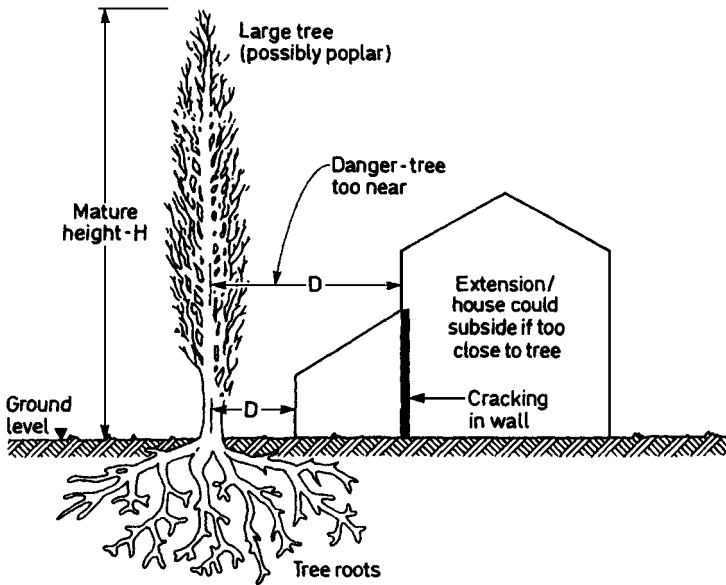
Fig. 12.10 Damage caused by trees.

Trees growing close to houses must always be treated with suspicion. The National House-Builders Council has recognized this problem and has published their recommendations in *NHBC Standards—Building Near Trees* (formerly Practice Note 3). When houses are built on areas of shrinkable clay and a tree is too close, it is likely in very dry weather that it will suck the moisture out of the clay beneath the foundations which then move downwards ([Fig. 12.10](#)). Obviously this

downward movement stresses the substructure and cracking is likely to be visible as the ground falls away. The cracking is predominantly diagonal and follows the horizontal and vertical mortar joints in the brickwork. The cracks are widest at the top and narrowest at the bottom. The cracks also tend to open and close during the course of the year depending upon rainfall. (This opening and closing is obviously not instantaneous, but measurements taken over a period of time can detect the movement.) Doors and window frame distortion is usually noticeable where subsidence has taken place.

Settlement and cracking can occur if a large tree is growing near to a house. Trees can extract large amounts of water out of the ground and this will cause clay soils in particular to shrink (see [Fig. 12.10](#)).

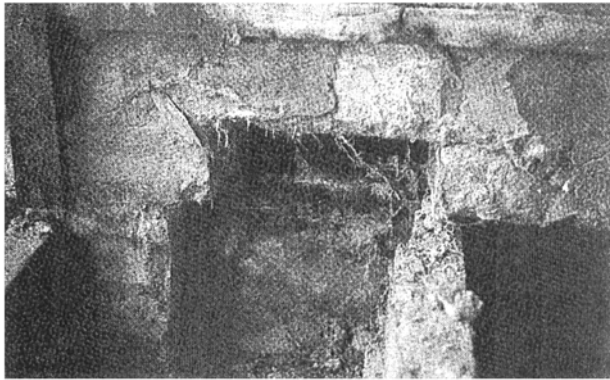
Plate A

Dry rot strands in masonry.

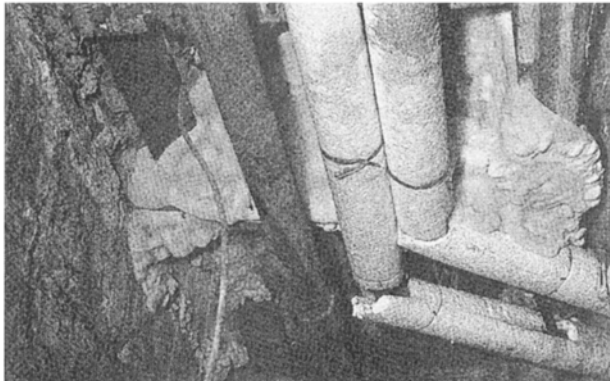
Plate B

Dry rot mycelium under a floor.

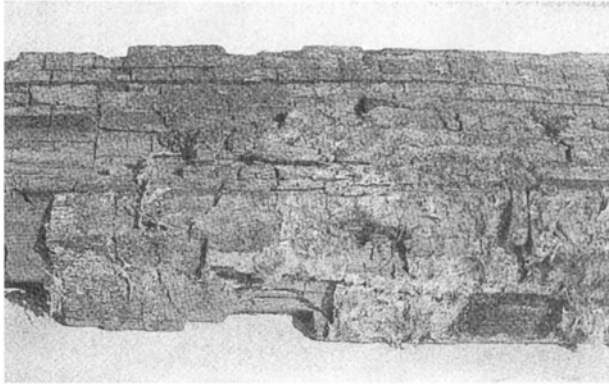
Plate C

Dry rot attack of wood.

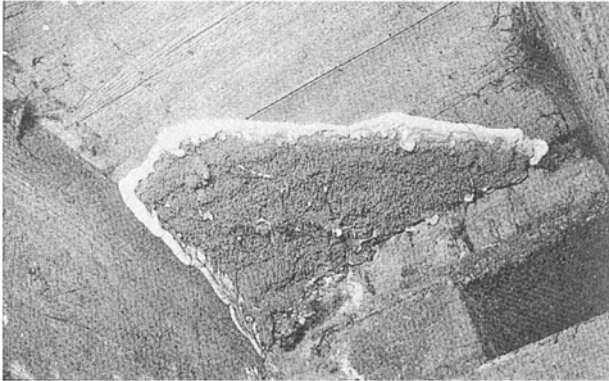
Plate D

Dry rot fruiting body.

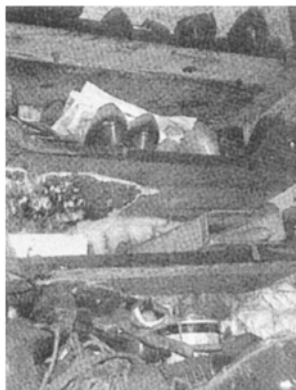
Plate E

Dry rot spore dust is often deposited near fruit bodies.

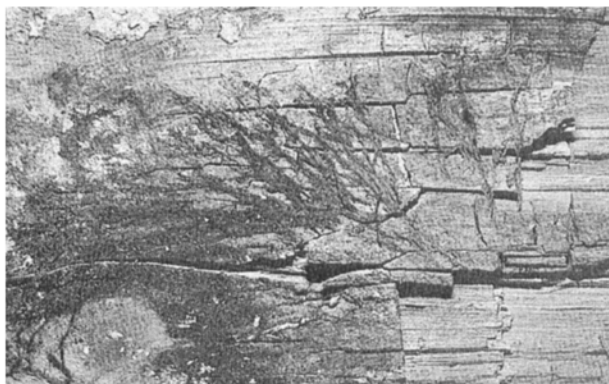
Plate F

*Coniophora puteana*. Cellular fungus.

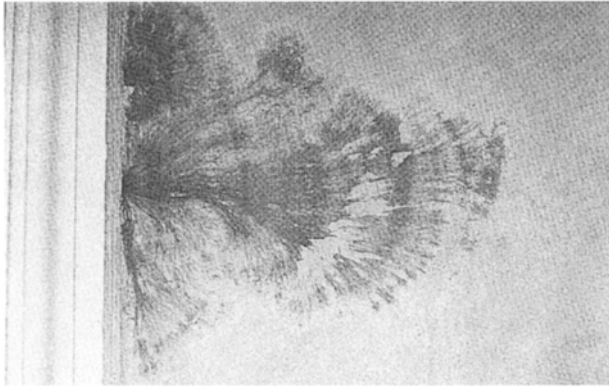
Plate G

Brown strands of *Coniophora*.

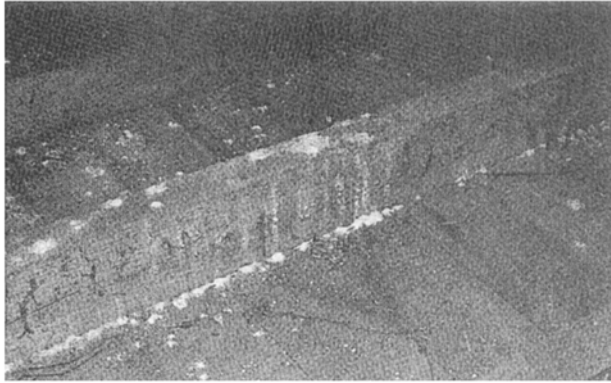
Plate H

Common furniture beetle damage in ceiling joists.

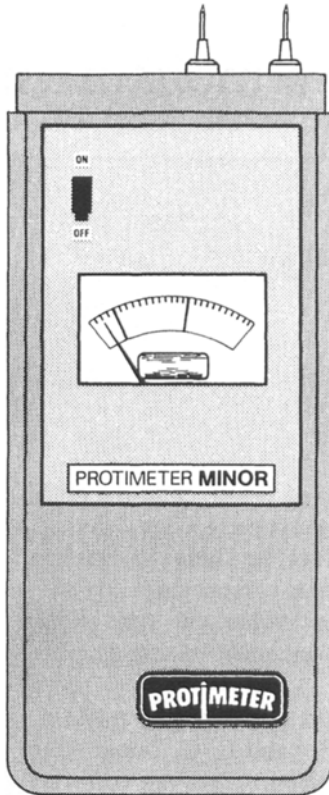
*Fig. 15.1* Moisture meter.

Moisture meters display readings either on a simple dial (as [Fig. 15.1](#)) or on a series of glowing lights (LEDs). The modern LED display has the advantage of being able to measure moisture levels from 6% up to 100%. Most meters are colour banded, green, yellow and red.

It is generally accepted that wood is 'safe' whilst its moisture level, as indicated by a moisture meter, is in the 'green zone'.

If a reading is obtained in the 'yellow zone', then there could be problems. Once readings are obtained in the 'red zone', then there is a very real danger of woodrot either being present or outbreaks occurring in the future, if the cause of the excessive dampness is not removed. (See 'Biological agencies', [Chapter 12](#).)
