# *Beyond Failure*

Forensic Case Studies  
for Civil Engineers

NORBERT J. DELATTE JR., PH.D., P.E.

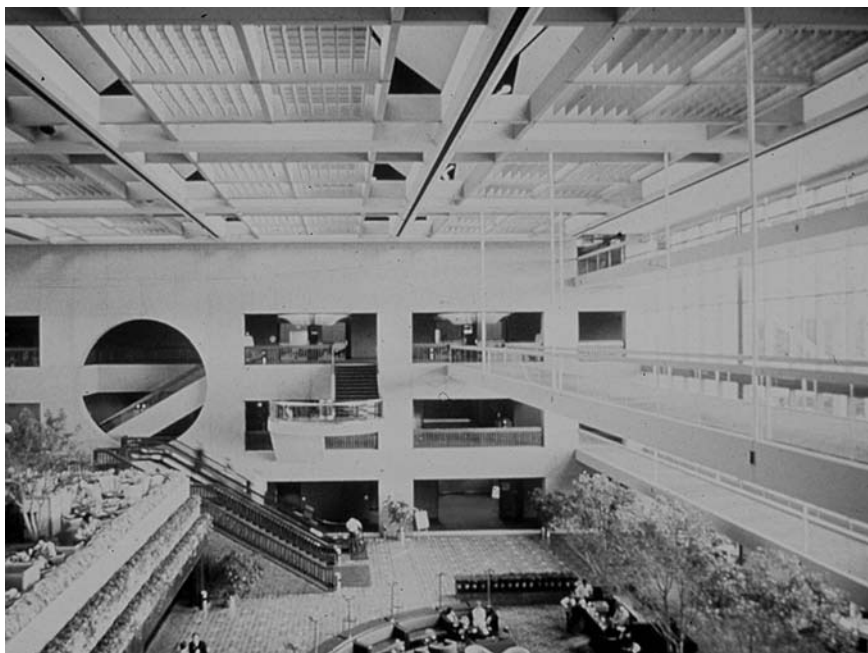
**Figure 2-2.** The Kansas City Hyatt Regency atrium walkways.  
 Courtesy National Bureau of Standards/National Institute of Standards and Technology.

ceiling (Feld and Carper 1997, p. 216). The walkways before the collapse are shown in Fig. 2-2.

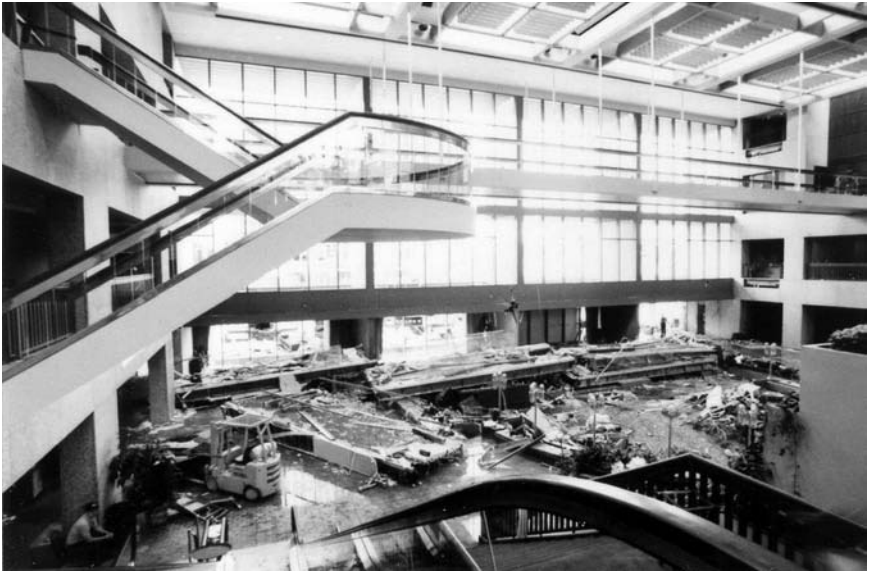
**Figure 2-3.** Scene of the Kansas City Hyatt Regency collapse.

radio station's dance competition (Feld and Carper 1997, pp. 214–215). At 7:05 P.M., a loud crack echoed throughout the building, and the second- and fourth-floor walkways crashed to the ground, killing 114 people and injuring more than 200 others. It was the worst structural failure in the history of the United States (Levy and Salvadori 1992, p. 224). The scene of the collapse is shown in Fig. 2-3.

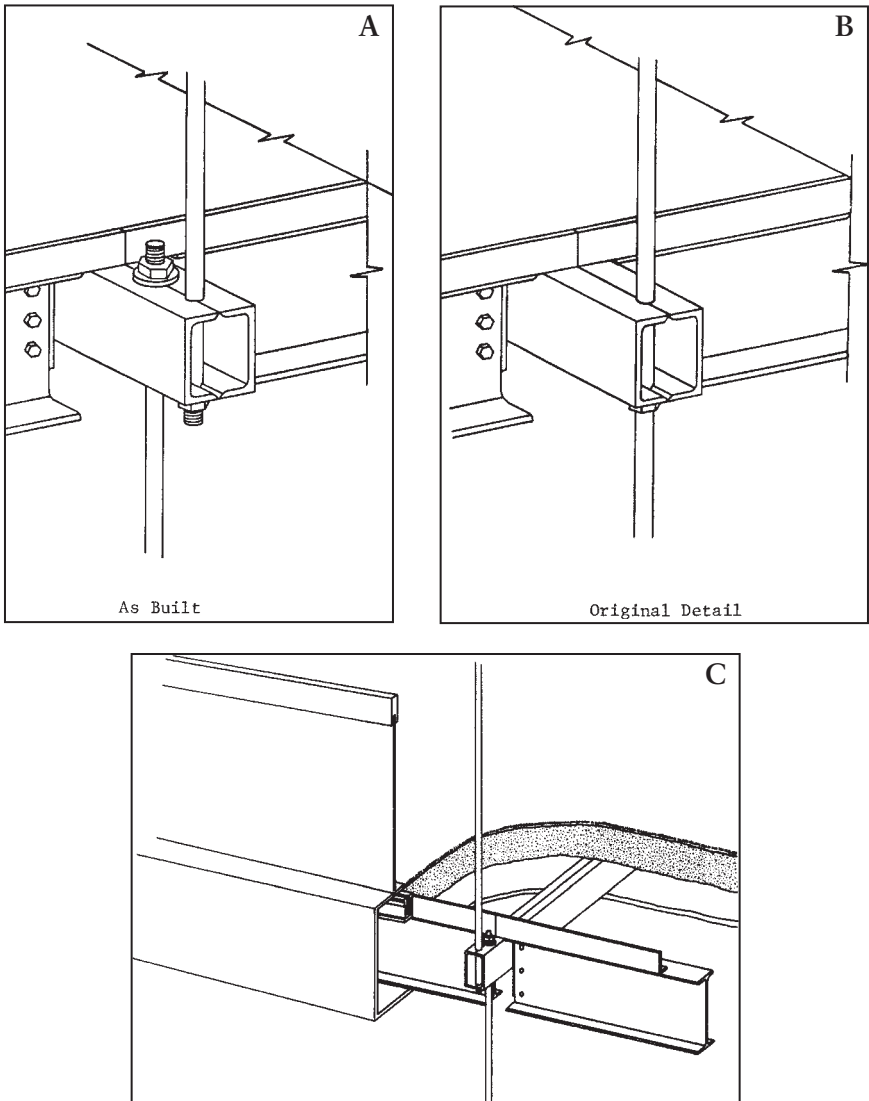
**Figure 2-4.** Original and as-built hanger details a, b, c.  
 Courtesy National Bureau of Standards/National Institute of Standards and Technology.

Originally, the second- and fourth-floor walkways were to be suspended from the same rod (Fig. 2-4a) and held in place by nuts. The preliminary design sketches contained a note specifying a strength of 413 MPa

This original design, however, was impractical because it called for a nut 20 ft (6.1 m) up the hanger rod and did not use sleeve nuts. The contractor modified this detail to use two hanger rods instead of one (Fig. 2-4b), and the engineer approved the design change without checking it. This design change doubled the stress exerted on the nut under the fourth-floor beam. Now this nut supported the weight of two walkways instead of just one (Roddis 1993, p. 1548). Figure 2-4c shows how the connection was integrated with the rest of the walkway. It was concealed and could not be easily inspected.

- January 1979: The fabricator called the structural engineer's project manager requesting a change from the continuous rod to two rods, offset, as shown in Figs. 2-4a and b. The project manager checked the moment and shear in the box beam and responded that the change was acceptable. He asked the fabricator to submit the request through channels for approval, but the fabricator never did this.

The free-body diagram is the basic equilibrium analysis tool to determine forces acting on a body. If the diagram is not drawn correctly, the forces cannot be calculated accurately, and the design may be unsafe. The importance of a correct free-body diagram may be shown through analysis of the Kansas City Hyatt Regency walkway collapse. Isolating the force of the box beam bearing against the nut shows that the force transfer changes between the configurations shown in Figs. 2-4a and 2-4b. The load on the connection was doubled, and it failed.

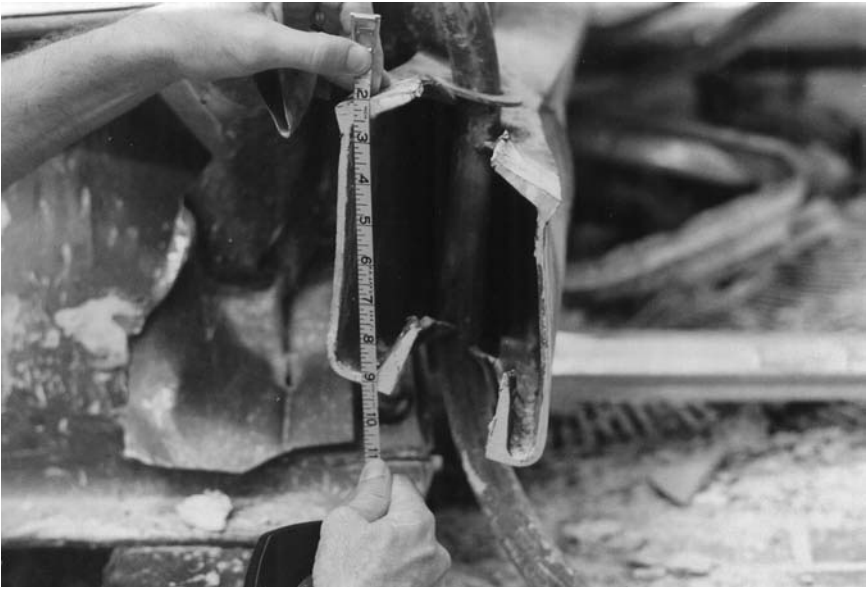
**Figure 2-5.** Failed fourth-floor beam.  
Courtesy Lee Lowery, Texas A&M University.

Moncarz and Taylor (2000) discussed the structural system in detail and analyzed the demand-to-capacity ratios of the components. Their firm, Failure Analysis Associates, had been retained by the project architect. Each walkway was made of lightweight concrete on metal decking, supported by longitudinal I-beam W  $16 \times 26$  stringers. The designation "W  $16 \times 26$ " means an I-shaped wide flange section, 16 in. (406 mm) deep and weighing 26 lb per linear foot (mass 38.7 kg per linear meter). The transverse beams were each made of two MC  $8 \times 8.5$  channels, welded toe to toe to form a box. A channel shape designated as MC  $8 \times 8.5$  is 8 in. (203 mm) deep and weighs 8.5 lb per linear foot (mass 12.7 kg per linear meter). Holes were drilled through the welds to hold the support rods. The bearing area for the hanger rod washer was flattened by grinding, further reducing capacity (Moncarz and Taylor 2000, p. 47). The failed fourth-floor beam is shown in Fig. 2-5, and the hanger rod is shown in Fig. 2-6.

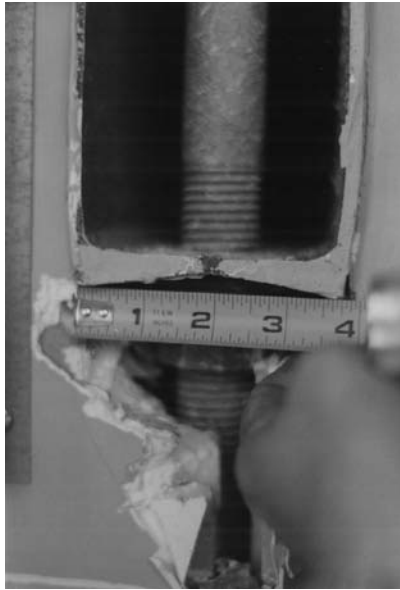
**Figure 2-7.** Third-floor beam showing deformation.  
Courtesy Lee Lowery, Texas A&M University.

Failure Analysis Associates carried out sophisticated computer modeling (finite element) analysis of the box beam connection. The connection was near failure with dead load only, and an additional live load of 7 people on the upper bridge and 56 on the lower bridge proved to be enough to trigger failure. Plastic deformation of the box beam was estimated at 3–6 mm (0.12–0.24 in.), which was hidden by the finish and fireproofing materials (Moncarz and Taylor 2000, p. 49). The third-floor beam, which did not fail, is shown in Fig. 2-7. This box beam showed substantial permanent deformation.

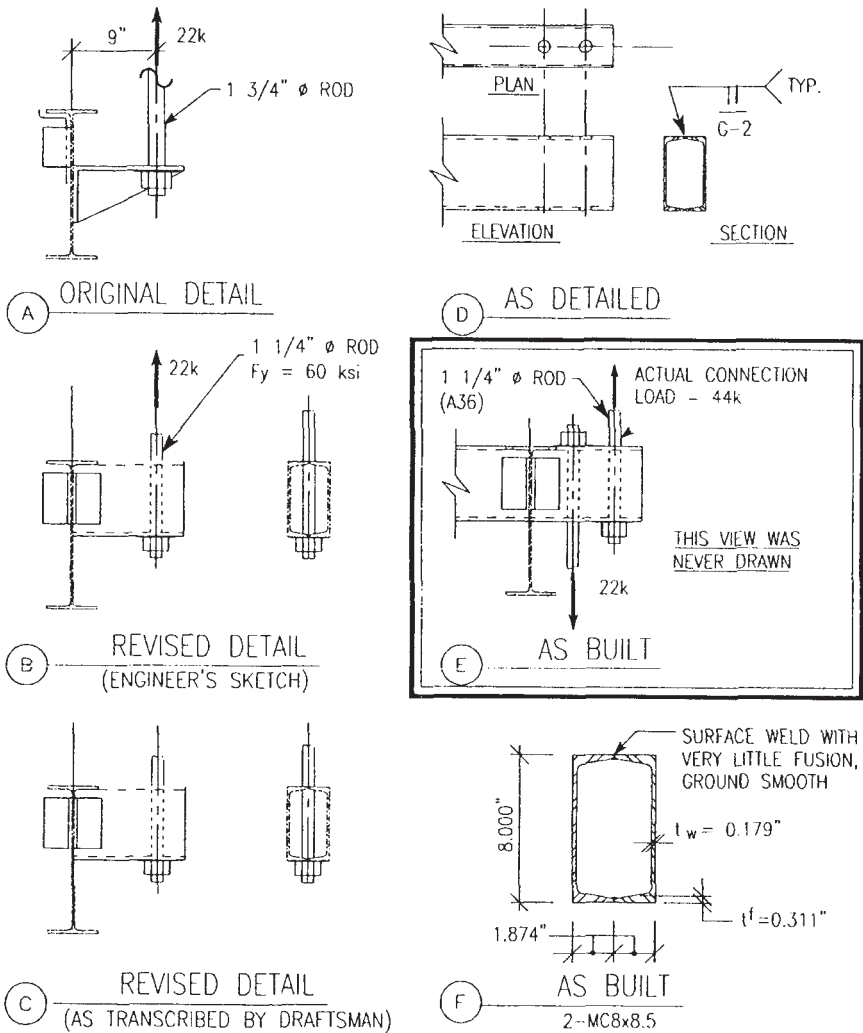
**Figure 2-8.** The evolution of the failed connection.  
*Source:* Luth (2000).

Luth (2000) details the steps in the design and construction process. He makes the important point that the critical connection was never designed and that the view represented by Fig. 2-4 was never drawn until after the failure. Luth's illustration of the various stages in the history of the connection is shown in Fig. 2-8.

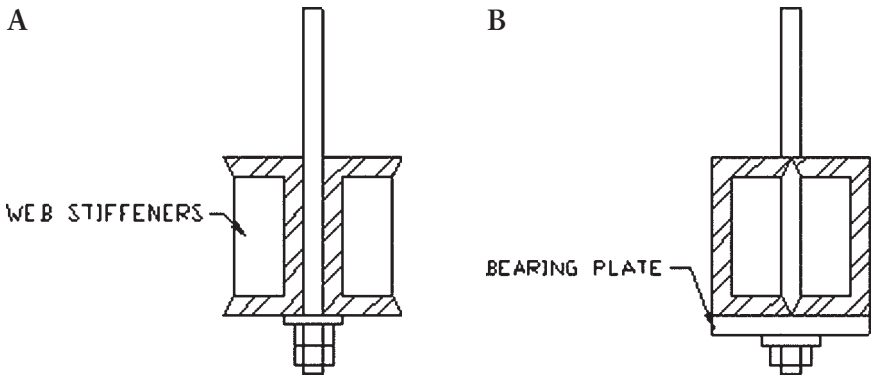
Figure 2-9a, b. Proposed alternative connection designs.

Many articles written referred to the connection as a "designed connection," and many alternate, satisfactory designs were presented. Two are shown in Fig. 2-9, based on Kaminetzky (1991, pp. 220–221).

The NBS report recommended that concentrated loads never be applied to flanges of steel sections. Load-distributing plates (shown in Fig. 2-9) should be used (Feld and Carper 1997, pp. 222–223).

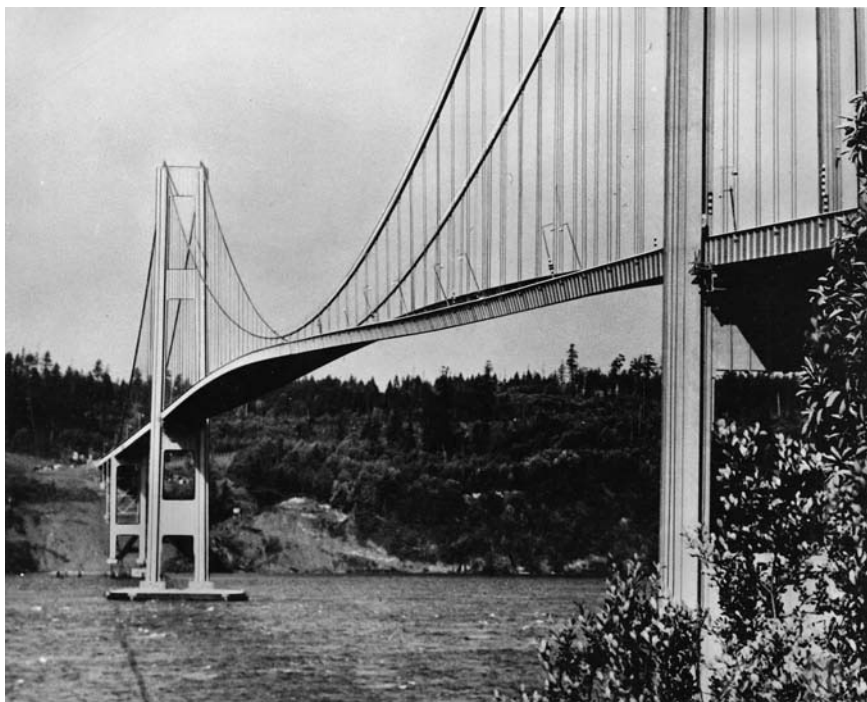
**Figure 2-10.** Tacoma Narrows Bridge torsional motion.  
Courtesy University of Washington Special Collections, photo UW21413.

The onlookers had not been concerned up to this point. Although the wind was the strongest so far since the bridge had been built, the motions were in line with what had been observed earlier. However, the sudden change in motion was alarming. Without any intermediate stage, violent torsional movement started. The movement changed from nine or ten smaller waves to the two dominant twisting waves. Farquharson was surprised because he had not observed this phenomenon in his wind tunnel tests (Scott 2001, p. 50). Figure 2-10 shows the torsional motions of the bridge.

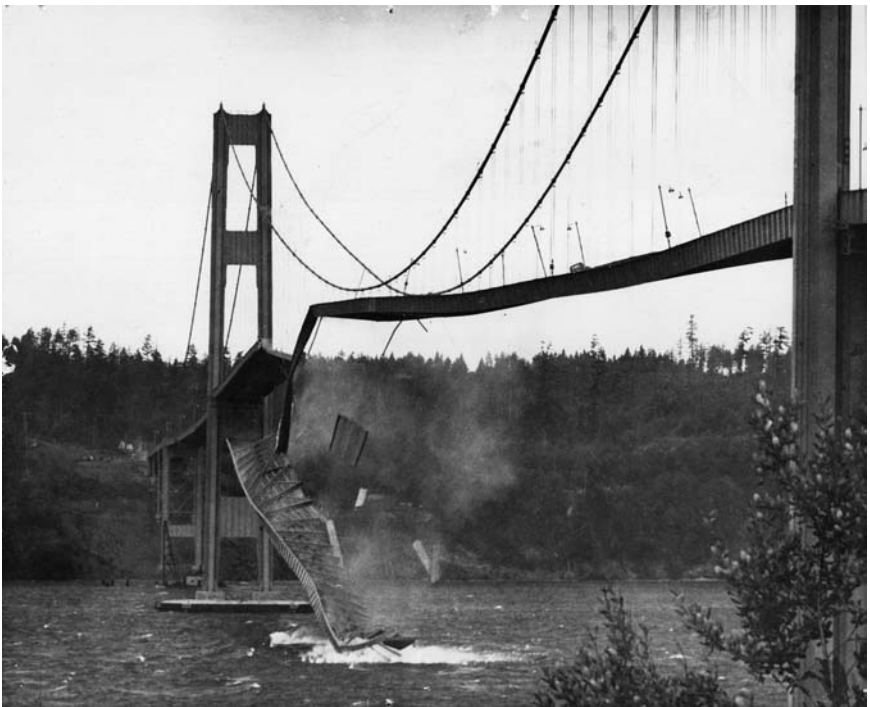
**Figure 2-11.** Tacoma Narrows Bridge collapse.

The concrete sidewalks and curbs were beginning to crumble, and lampposts were coming loose. A couple of minutes later, the stiffening girders in the middle of the bridge buckled, initiating the collapse. Then the suspender cables broke, and large sections of the main span dropped progressively, from the center outward, into the river below. Loud bangs were heard, similar to gunfire. The weight of the sagging side spans pulled the towers 3.7 m (12 ft) toward the shore, and the ruined bridge finally came to rest. The side spans, no longer balanced by the main span, dropped 18 m (60 ft) before coming back to a final sag of about 9 m (30 ft) (Feld and Carper 1997, Scott 2001, pp. 51–53). The bridge's only fatality was Coatsworth's cocker spaniel. Figure 2-11 shows the bridge collapsing.

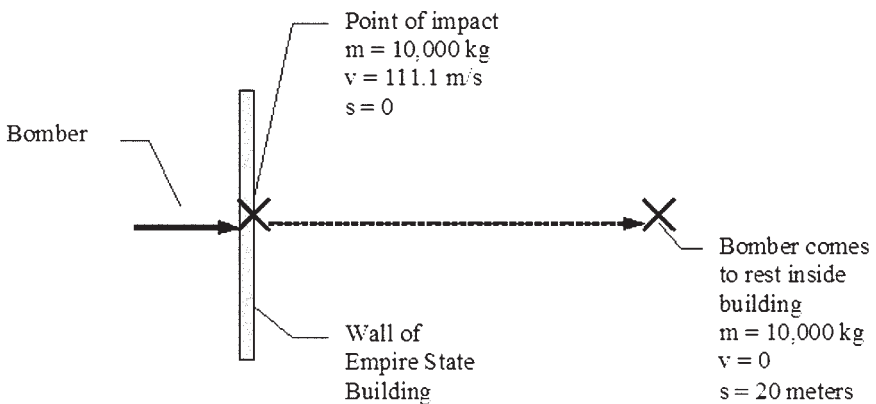
**Figure 2-12.** Bomber impact into Empire State Building.

the force-acceleration method), estimate the *distance* it took the bomber to come to rest (and use the work-energy method), or estimate the *time* it took the bomber to come to rest (and use the impulse-momentum method). The bomber did not pass through the building, so a distance of 10–20 m (33–66 ft) for the plane to come to rest could be used for calculations. If the bomber came to rest in 20 m (66 ft) with a constant deceleration, the force would be about 4,440 kN (1 million lb) exerted over about 0.25 s. The kinematics of impact are shown in Fig. 2-12.

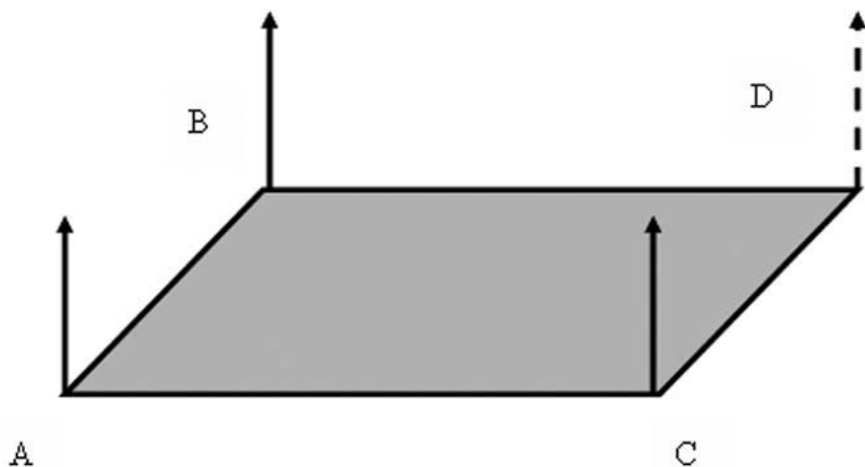
However, the remaining three cable supports do not constrain the free-body against movement under all loading conditions, as shown in Fig. 2-13. The removed cable is shown as dashed.

Without external load, the center of gravity of the bridge section lies on the straight line between cables B and C, and there is no tension in cable A. If a vehicle drives onto the bridge between point A and a straight line

Figure 2-13. Stability of a skewed simple span bridge.

between points B and C, then cable A supports the load. If, however, the vehicle drives past the line, then the bridge section topples over. Therefore, all four supports must be intact to keep the bridge safe, and the bridge is conditionally unstable if any one support is removed.

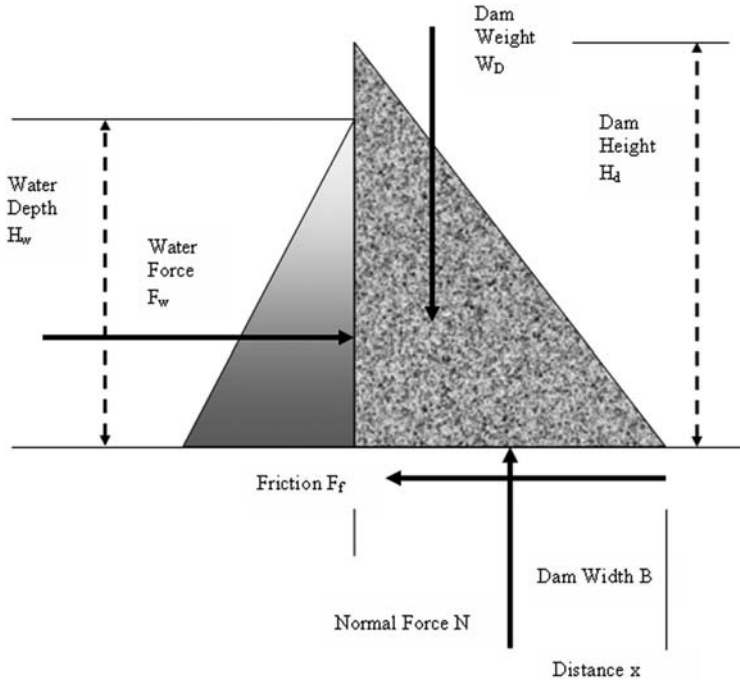
Figure 2-14. Free-body diagram of a concrete gravity dam (Austin, Pennsylvania).

A gravity dam may fail by either overturning or sliding. Because a gravity dam generally has a relatively constant cross section across the stream, it may be analyzed in two dimensions. Consider the free-body diagram of a simplified dam cross section as shown in Fig. 2-14.

where  $\gamma_c$  and  $\gamma_w$  are the unit weight of concrete and water, respectively. These weights are typically assumed to be 2,300 kg/m<sup>3</sup> (22.6 kN/m<sup>3</sup>; 145 lb/ft<sup>3</sup>) and 1,000 kg/m<sup>3</sup> (9.81 kN/m<sup>3</sup>; 62.4 lb/ft<sup>3</sup>). The resultant of the dam weight is  $\frac{2}{3} B$  from the downstream toe of the dam, and the water force resultant is  $\frac{1}{3} H_w$  from the base of the dam.

The other two forces acting on the free-body diagram shown in Fig. 2.14 are the normal force  $N$  and the friction force  $F_f$  acting on the base of the dam. The location of  $N$  is unknown and is designated by  $x$ . The

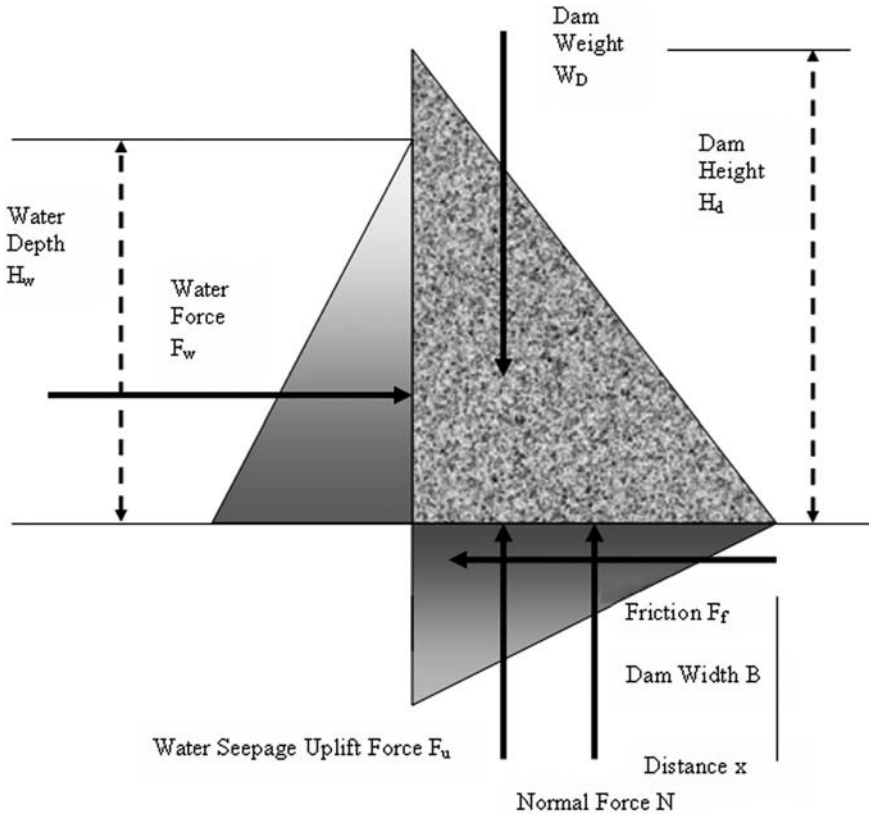
Figure 2-15. Revised free-body diagram of dam, considering seepage.

These calculations assume that there is no water seeping under the dam. If, however, there is seepage, then the water pressure provides an uplift force against the base of the dam. The Austin Dam had clear evidence of seepage. The revised free-body diagram of the dam, including seepage, is provided as Fig. 2-15.

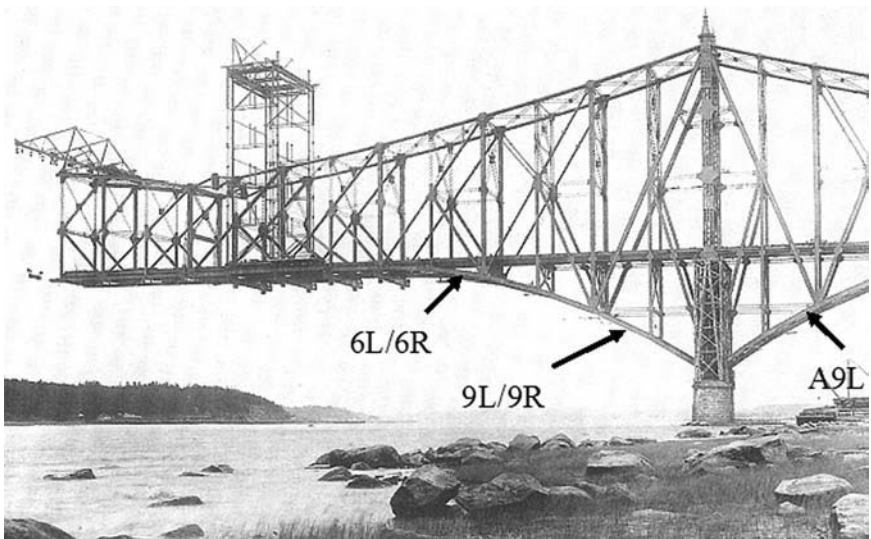
**Figure 3-1.** The Quebec Bridge just before the collapse.  
Courtesy Archives Canada.

The last photograph taken of the bridge before the collapse is shown in Fig. 3-1. The panels were numbered from 1, at the outer ends of the cantilever arms, through 10, at the piers. The anchor arm panels added

anchor and cantilever arms in the Quebec Bridge were slightly curved, as shown in Fig. 3-1, for aesthetic reasons. This design added difficulty to the fabrication of such unusually large members. The curvature also increased the secondary stresses on the members, reducing their buckling capacity. Secondary stresses are much more dangerous in compression than in tension members.

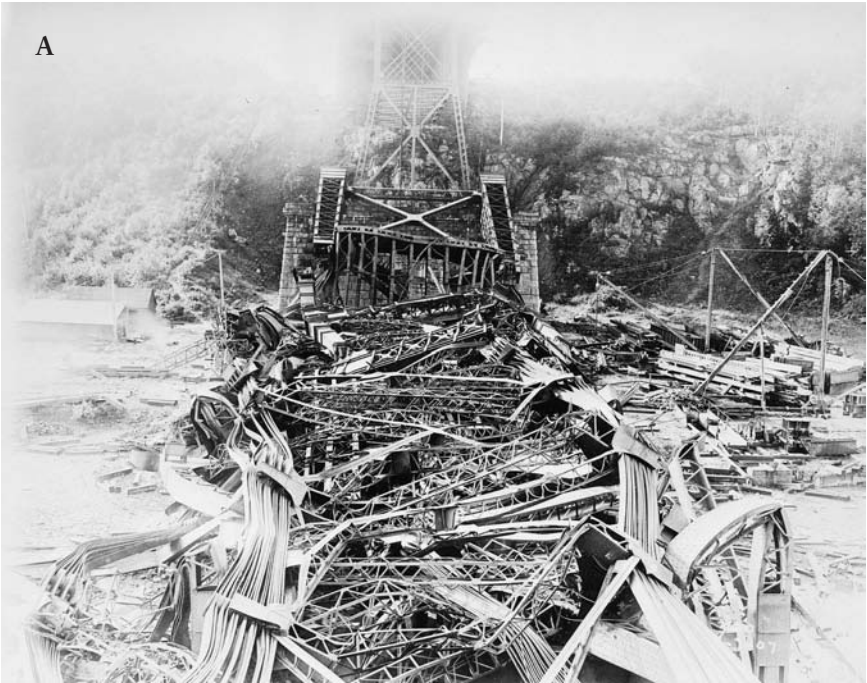
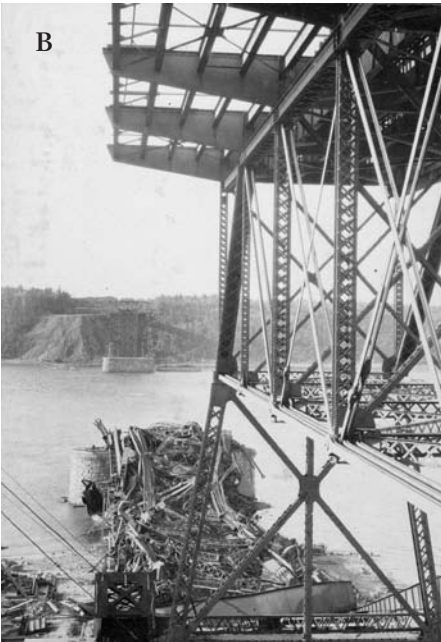
Figure 3-2a, b. The collapsed Quebec Bridge.  
Courtesy Archives Canada.

The A9L bottom compression chord, which was already bent, gave way under the increasing weight of the bridge. The load transferred to the opposite A9R chord, which also buckled. The piers were the only part of the structure that survived. The wreckage is shown in Fig. 3-2, looking from the south bank toward the pier. Of 38 Caughnawaga Mohawk ironworkers who had left their village to work on the bridge, 33 were killed and two were injured (Middleton 2001, p. 84).

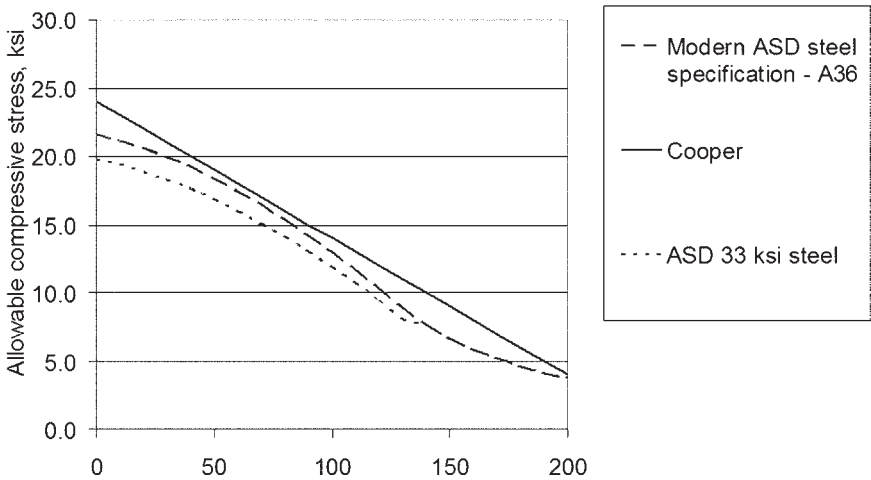
## Comparison of Allowable Stresses

Figure 3-3. Comparison of allowable compressive stresses.

Cooper's formula is compared to contemporary allowable stresses from the American Institute of Steel Construction (AISC 1998), as well as the 96.5 MPa (14 kip/in.<sup>2</sup>) compressive allowable stress adopted for the second bridge (Middleton 2001, p. 107) in Fig. 3-3. AISC curves are shown for both 230 MPa (33 kip/in.<sup>2</sup>) and 250 MPa (36 kip/in.<sup>2</sup>) steel. Cooper's allowable stresses are higher than those in use today by 3.3–8.7% over a range of slenderness ratios from 10 to 100. Given the lower and uncertain quality of the materials available to Cooper, along with the less developed state of

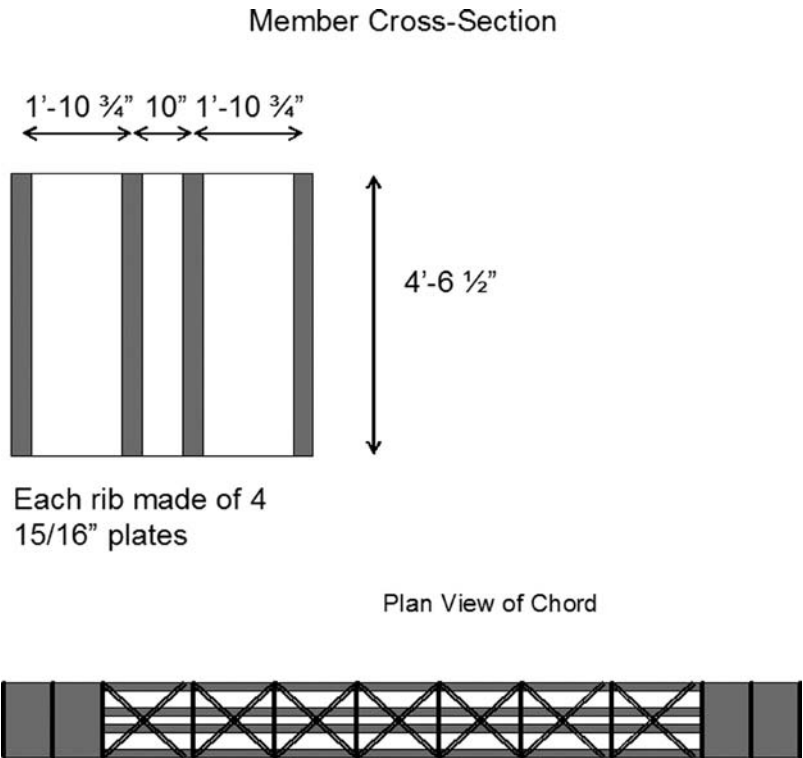
Figure 3-4. Built-up compression members.

The commission had suspected that the A9L compression chord failed because of improper latticing. Compression tests were performed on one-third scale models of the compression chords in November 1907 and January 1908 to verify this theory. The compression chord members for the Quebec Bridge consisted of four multilayered ribs (Fig. 3-4). They were stiffened by the use of diagonal latticing to make them act as one unit. During testing, the lattice system failed explosively because its rivets sheared, immediately followed by buckling of the chord. This result confirmed the commission's findings that the chords were inadequately designed. In Schneider's opinion,

These members consist of four separate ribs, not particularly well developed as compression members, and their connections to each other are not of sufficient strength to make them act as a unit. (Middleton 2001, p. 97)

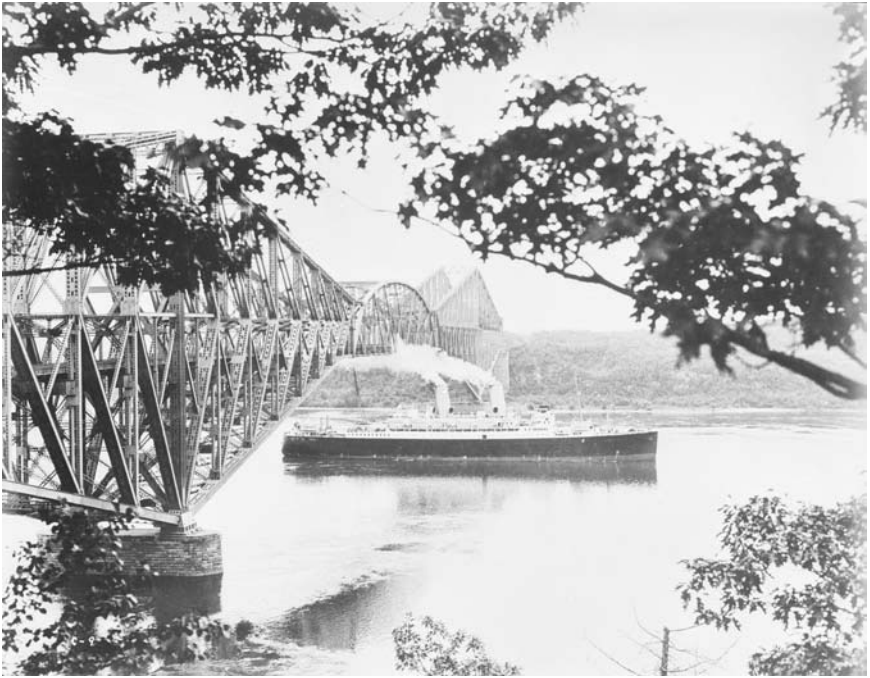
**Figure 3-5.** The second Quebec Bridge.  
Courtesy Archives Canada.

After the collapse, the government took over the design and construction of the new bridge. This takeover also provided the financial support for the project. The second bridge was substantially heavier than the first. Petroski (1995) compared dimensions of the two bridges, showing the dramatic increase in member sizes. The cross-sectional area of the critical compression member for the old bridge had been 543,000 mm<sup>2</sup> (842 in.<sup>2</sup>), whereas that of the new bridge was 1,250,000 mm<sup>2</sup> (1,941 in.<sup>2</sup>) (Petroski 1995, p. 113, Middleton 2001, p. 116). The second bridge is shown in Fig. 3-5.

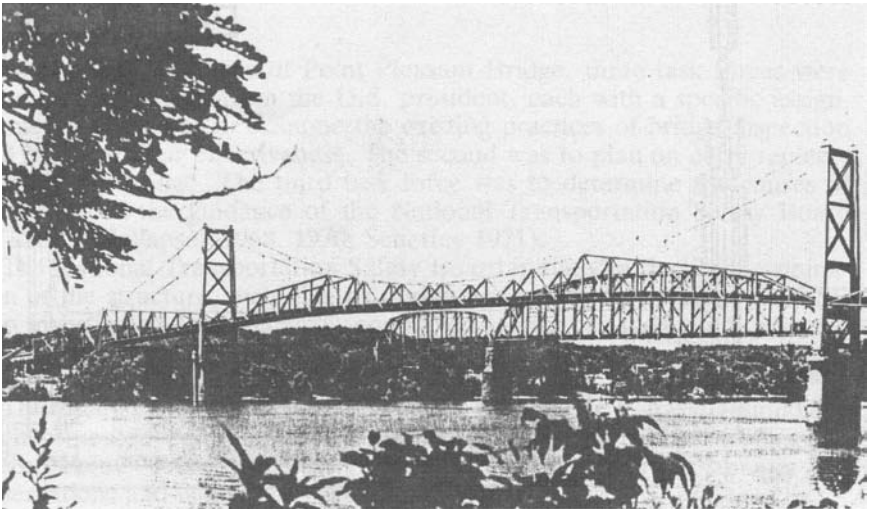
**Figure 3-6.** The Point Pleasant Bridge.  
*Source:* NTSB (1970).

The Point Pleasant Bridge, also known as the Silver Bridge, shown in Figs. 3-6 and 3-7, provided crossing for U.S. Route 35 over the Ohio River. It connected Columbus, Ohio, to Charleston, West Virginia. The bridge crossed between Point Pleasant, West Virginia, and Gallipolis, Ohio. The Point Pleasant Bridge not only allowed direct access between the state capitals of Ohio and West Virginia but also provided clearance for the cargo ships that passed through the Ohio River. Figure 3-8 shows the bridge cross section.

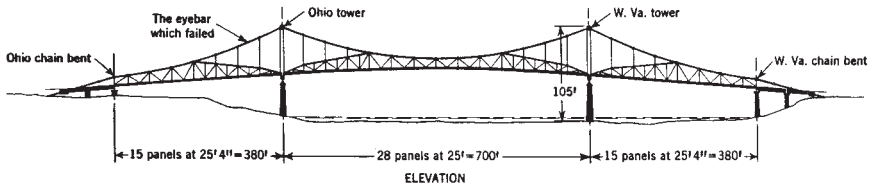
Figure 3-7. The Point Pleasant Bridge.

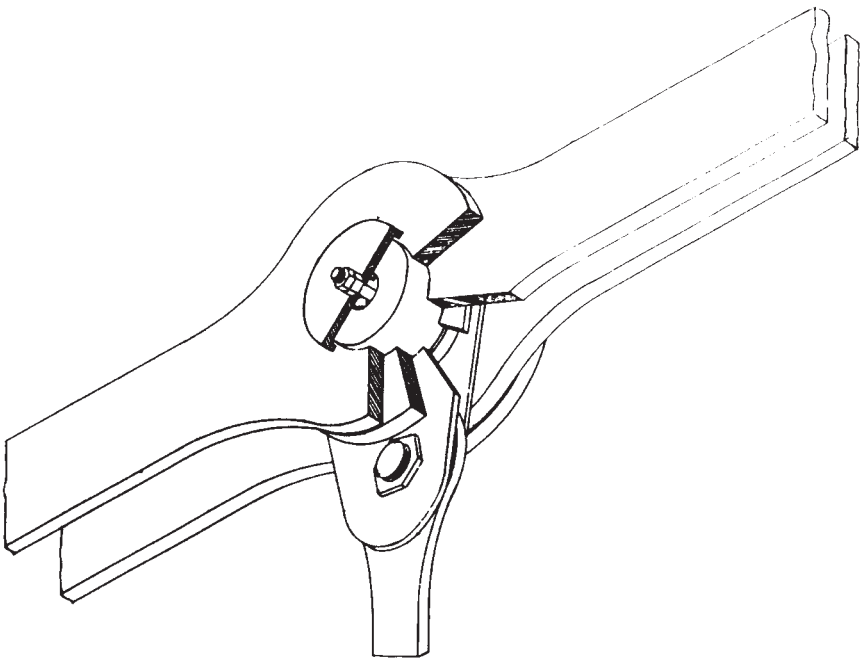
**Figure 3-9.** Point Pleasant Bridge eyebar connection.  
*Source:* NTSB (1970).

The bridge was completed in 1928. The General Contracting Company of Pittsburgh, constructed the piers. The American Bridge Company of Pittsburgh built the bridge. It was a unique design because it used high-tension eyebar chains, a unique anchorage system, and rocker towers. The eyebars were two force bar members with rounded eyes at each end. Because bed-rock was at a great depth, piles were octagons of reinforced concrete. The anchorage consisted of reinforced concrete troughs that were filled with soil and concrete. This substructure supported the bridge towers, which were joined by dowel rods. This connection allowed for a flexible connection that was designed to shift under different loads on the tower, and as the length of the chains changed because of temperature influences. This type of design was only used in one other bridge in the United States: the St. Mary's Bridge in West Virginia, also spanning the Ohio River. Although not integral to the Florianopolis truss design concept, the Point Pleasant and St. Mary's bridges introduced the use of high-strength, heat-treated carbon steel eyebars to the United States. The eyebar connection is shown in Fig. 3-9.

The design was also evaluated. The bridge did not provide any redundancy in the structural members that connected the suspension chain to the eyebars. Each joint contained two eyebars that connected to the suspension chains. A failure of one eyebar was enough to cause the collapse of the bridge (Lichtenstein 1993). The critical eyebar connection is shown in Fig. 3-9. Photographs of the connection after removal from the river are provided in Figs. 3-10 and 3-11.

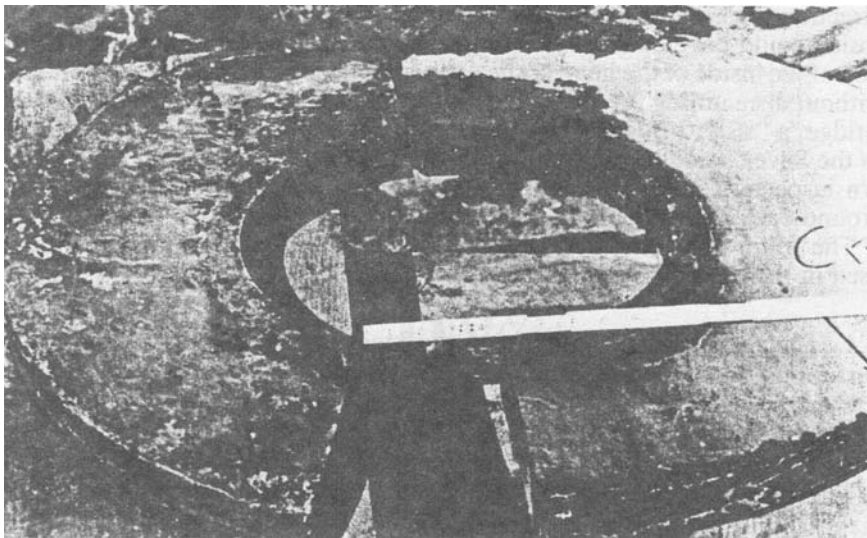
**Figure 3-10.** Fractured eyebar.  
*Source:* NSTB (1970).

As this analysis was underway, the reassembly of the bridge showed evidence of a cleavage fracture in eyebar 330, joint C13N, on the Ohio side of the truss. However, different opinions surfaced for the cause of this fracture. One opinion cited evidence for fatigue stress, whereas a different opinion explained the cause as a combination of stress corrosion and corrosion fatigue.

John Bennett of the U.S. Bureau of Standards noted the fracture pattern on the eyebar. One part of the fracture surface showed deeply encrusted rust, about 3 mm ( $\frac{1}{8}$  in.) long, which contrasted with the light rust from the Ohio River. This flaw was obviously old and might have even gone back to the forging of the eyebar four decades earlier. Cross sections of the eyebar revealed a number of small cracks, about the size of pinholes. One of these, it appeared, had grown into the  $3 \times 6$  mm ( $\frac{1}{8} \times \frac{1}{4}$  in.) flaw that had initiated the fracture (Wearne 2000, pp. 51–53).

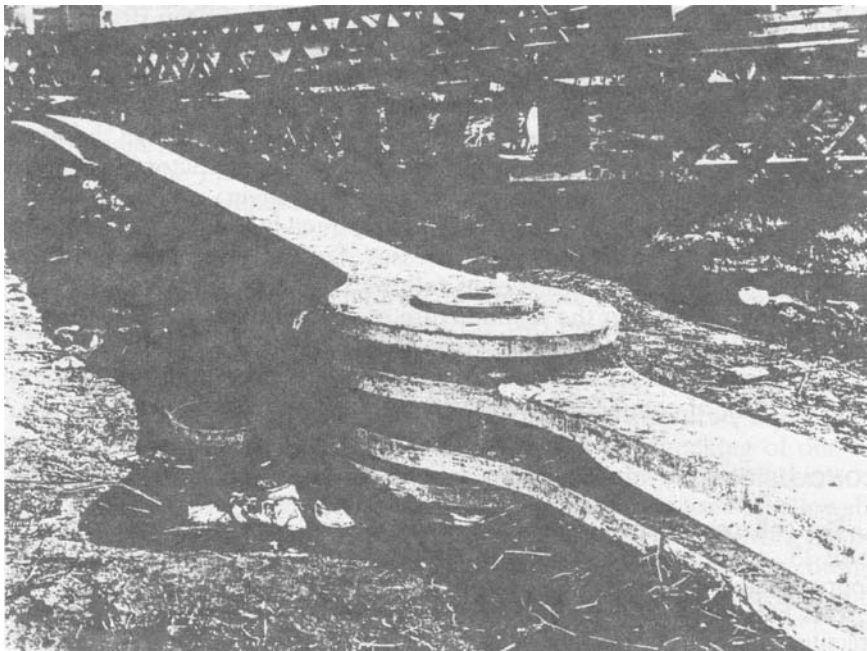
**Figure 3-11.** The failed joint reassembled.  
*Source:* NTBS (1970).

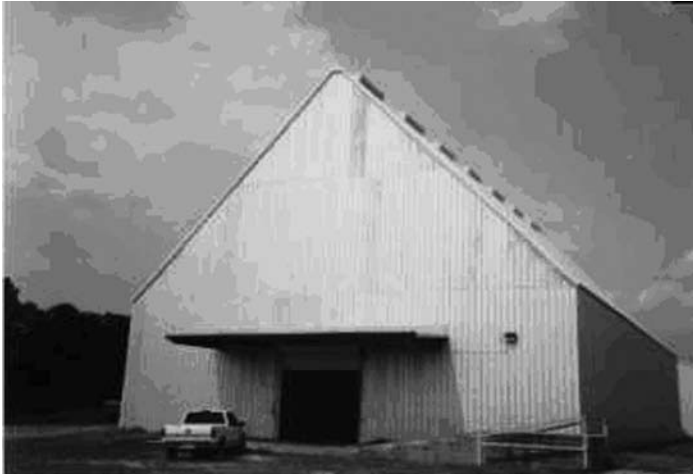
Figure 4-1. Metal building used to store cottonseed.

Each warehouse was  $24.4 \times 42.7$  m ( $80 \times 140$  ft) in plan. The warehouse side walls were a little more than 7.26 m (23 ft 10 in.) high, with the roof rising at a 45-degree angle to a peak 18.3 m (60 ft) high. One of the warehouses is shown in Fig. 4-1. The auger, intended to move the product from the loading end to the door, was at the peak of the roof.

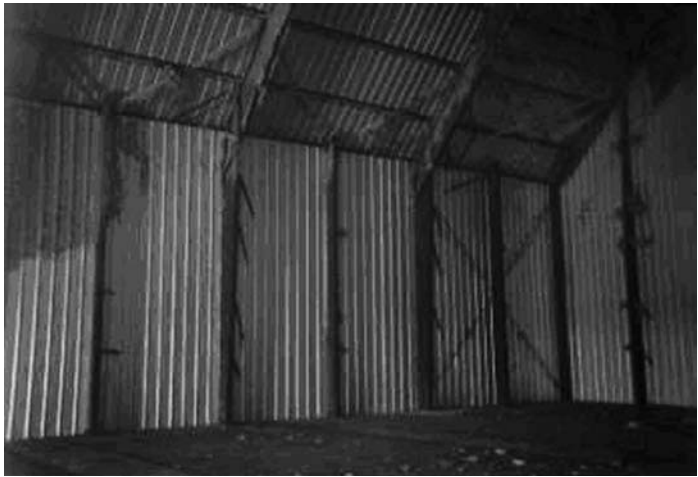
Figure 4-2. Interior framing.

The structural configuration of both warehouses was identical. The interior framing of one of the warehouses is shown in Fig. 4-2. Six gable frames were spaced at 6.1-m (20-ft) intervals. Between the gable frames were interior soldier columns. The tops of the interior soldier columns were

restrained by steel angle bracing leading back to the gable frames. Each of the pair of braces at the top of each column had two parts, with bolts attaching them to other parts of the structural secondary framing. The first and last bays had X-bracing for longitudinal stability of the structure. Each end wall had seven columns.

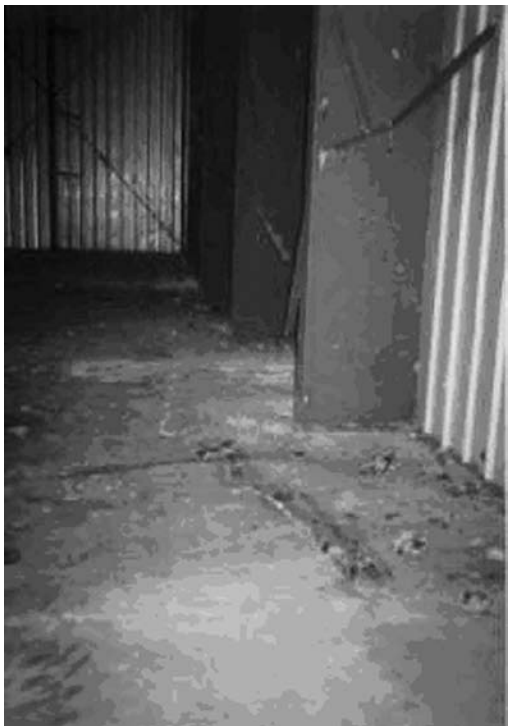
Figure 4-3. Damage to concrete foundation.

The fixed support at the base of each column in the warehouse implies two force resultants and one moment resultant (in two dimensions). In the design of the foundation, the force resultants were accounted for but not the moment. As a result, the column base plates twisted and cracked the concrete foundation, as shown in Fig. 4-3.

The buildings were heavily damaged. The metal skin had been stretched, and flange braces had been torn away along the walls. The concrete foundation had extensive cracking, with one crack 1 in. (25 mm) wide (Fig. 4-3). Details of the damage are provided in Delatte (2002).

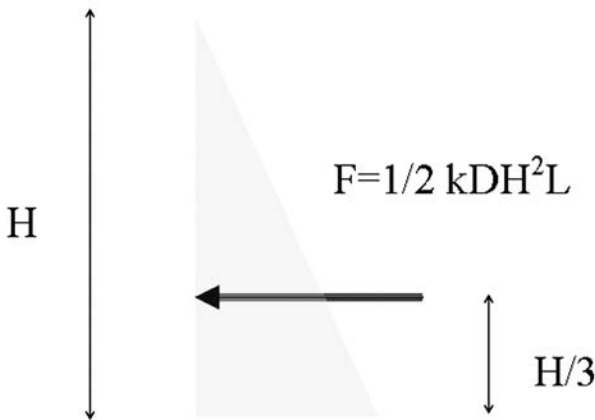
Figure 4-4. Resultant force due to cottonseed pressure.

where  $F$  = resultant force,  $L$  = length of wall between columns (3.05 m, or 10 ft), and other variables are as previously defined. The resultant force acts at  $\frac{1}{3} H$  from the bottom of the wall (Fig. 4-4).

Therefore, along the side walls, each column had an outward resultant force of 63.2 kN (14,200 lb) acting 2.42 m (8 ft) from the base of the wall. On the end walls, the outward resultant forces were as much as 303 kN (68,000 lb).

Because the building was loaded from one end, it was possible to have a full load of cottonseed on the far wall, with no load against the inside of the near wall (door end). This load provided a total force of 1,670 kN (375 kip) acting on the rear wall, at a location 4.66 m (15.3 ft) from the base of the wall. In fact, this condition was not only possible but also unavoidable in the course of operating the warehouses as intended.

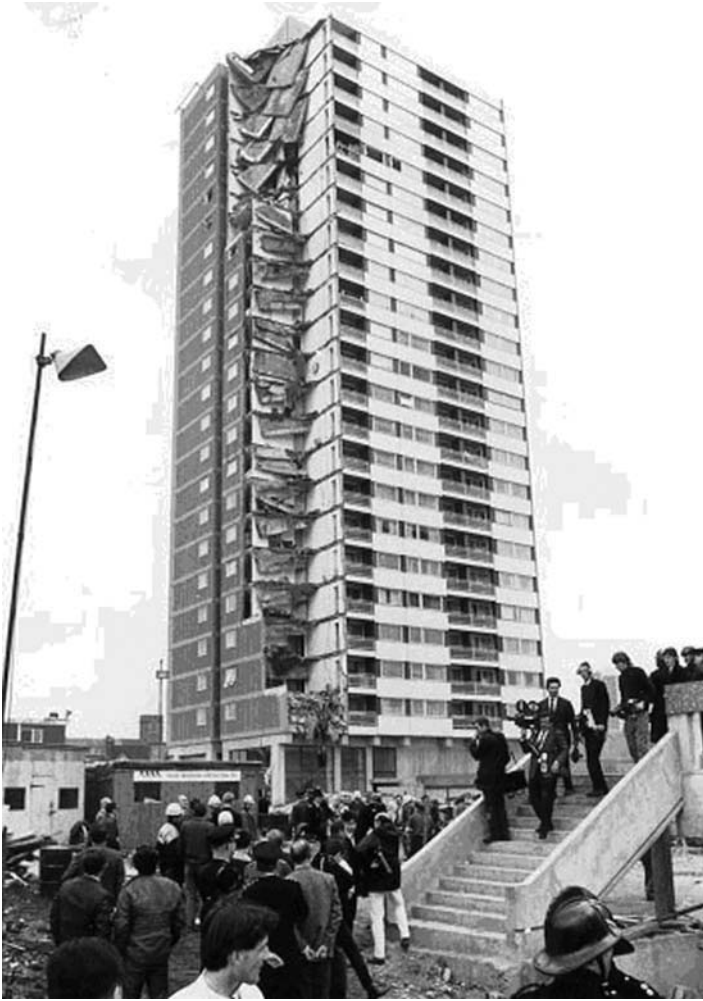
**Figure 4-5.** Ronan Point after collapse.  
*Source:* Pearson and Delatte (2005).

The pressure of the small gas explosion blew out the walls of her apartment and initiated a partial collapse of the structure that killed 4 people and injured 17. The partially collapsed structure is shown in Fig. 4-5, and the floor plan for apartment 90 is provided in Fig. 4-6.

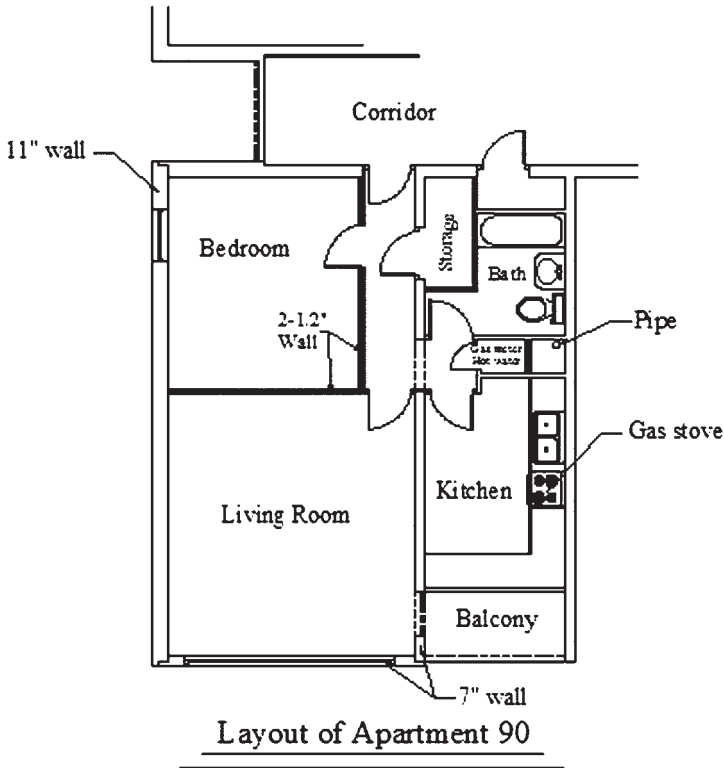
**Figure 4-6.** Floor plan of Ronan Point apartment.

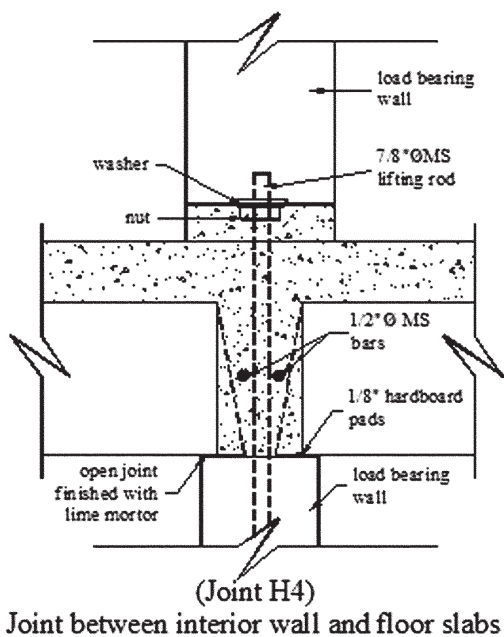
**Figure 4-7.** Ronan Point connection.

Ronan Point was the second of nine identical high-rise, precast, concrete flat plate structures that were erected in London after the war. In this type of structural system, each floor was supported by the load bearing walls directly beneath it. Gravity load transfer occurred only through these load-bearing walls. The wall and floor system panels were fitted together in slots. The joints were then bolted together and filled with dry pack mortar to secure the connections. The connections are shown in Fig. 4-7 and Fig. 4-8.

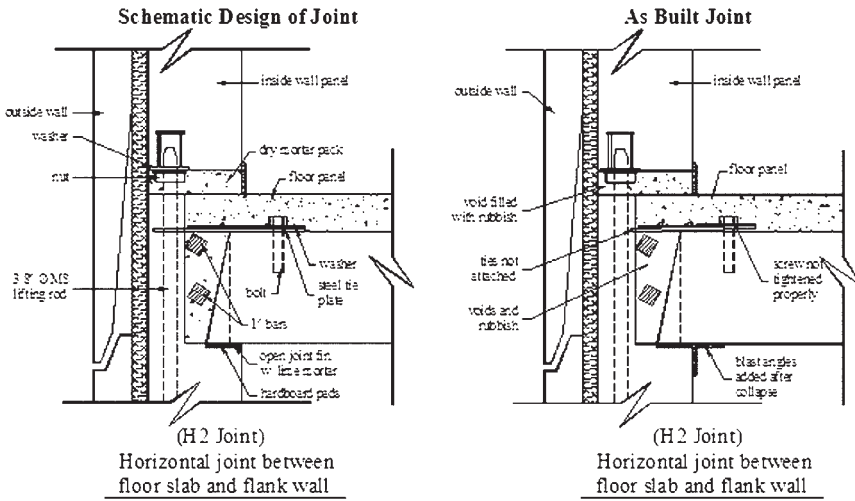
Figure 4-8. Ronan Point connection.

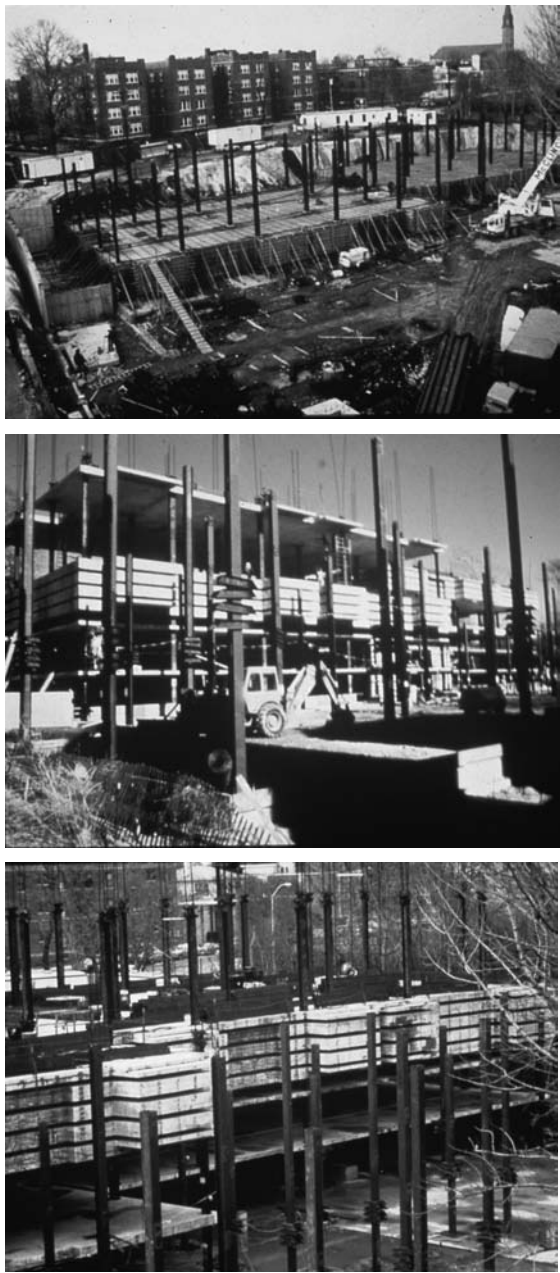
**Figure 4-9.** L'Ambiance Plaza Lift Slab Construction.  
Courtesy National Institute of Standards and Technology.

L'Ambiance Plaza was planned to be a 16-story building with 13 apartment levels topping 3 parking levels. It consisted of two offset rectangular towers,  $19.2 \times 34.1$  m ( $63 \times 112$  ft) each, connected by an elevator (Figs. 4-9 and 4-10). Post-tensioned concrete slabs 178 mm (7 in.) thick and steel columns made up its structural frame (Cuoco et al. 1992).

Using the lift-slab method, the floor slabs for all 16 levels were constructed on the ground, one on top of the other, with bond breakers between them (Fig. 4-9a). Then packages of two or three slabs were lifted into temporary position by a hydraulic lifting apparatus and held in place by steel wedges. The lifting apparatus consisted of a hydraulic jack on top of each column, with a pair of lifting rods extending down to lifting collars cast in the slab (Figs. 4-9b and 4-9c).

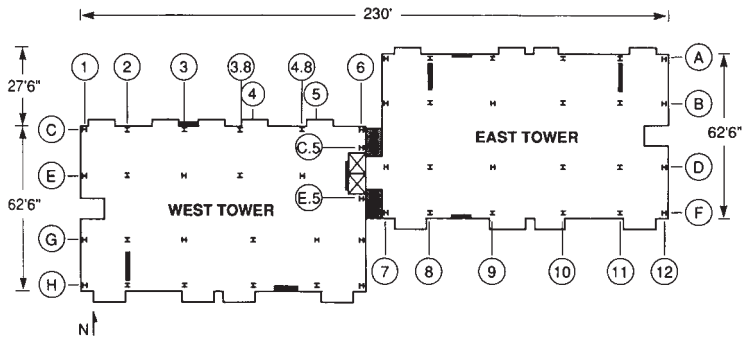
**Figure 4-10.** Floor plan of L'Ambiance Plaza.  
*Source:* Moncarz et al. (1992).
