# *Beyond Failure*

Forensic Case Studies  
for Civil Engineers

NORBERT J. DELATTE JR., PH.D., P.E.

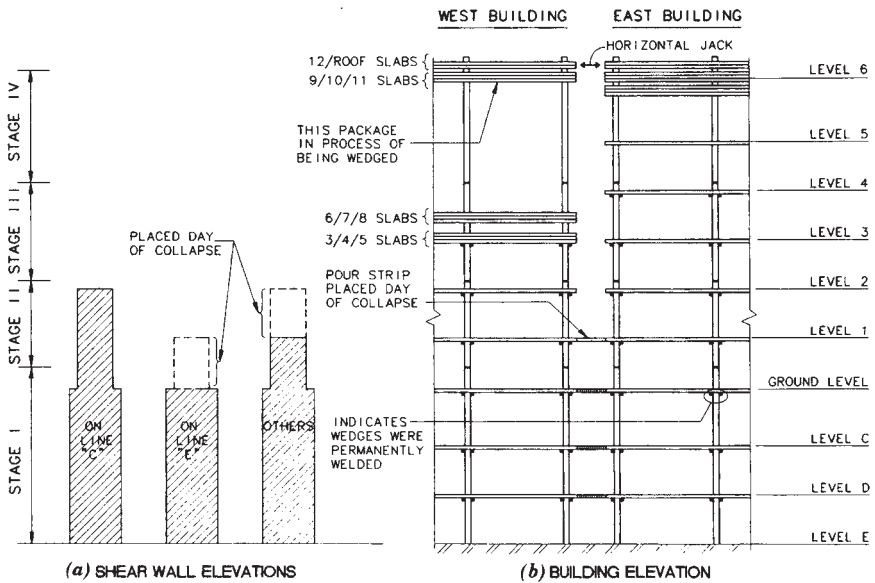
Figure 4-11. Elevation of L'Ambiance Plaza just before collapse.

At the time of the collapse, the building was a little more than halfway completed. In the west tower, the 9th, 10th, and 11th floor slab package was parked in stage IV directly under the 12th floor and roof package (Fig. 4-11). The shear walls were about five levels below the lifted slabs (Cuoco et al. 1992).

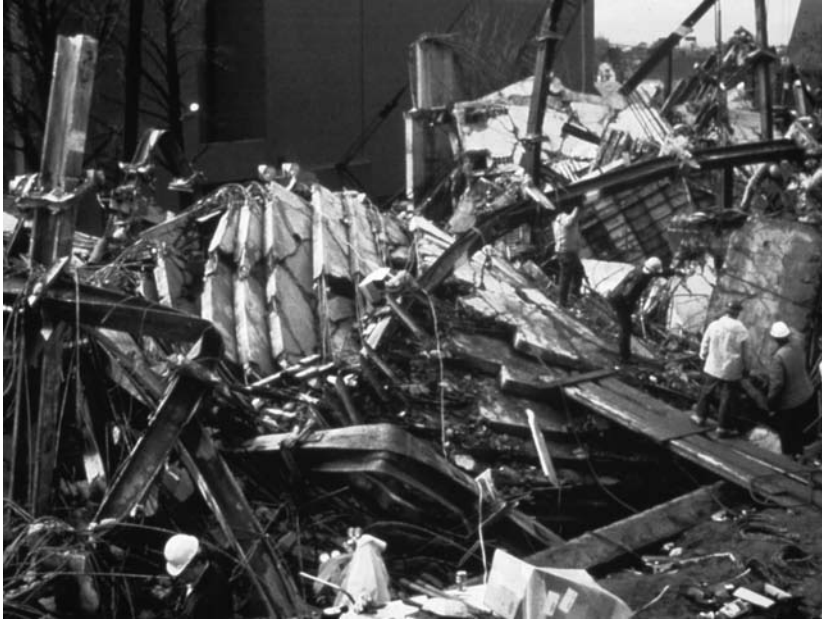
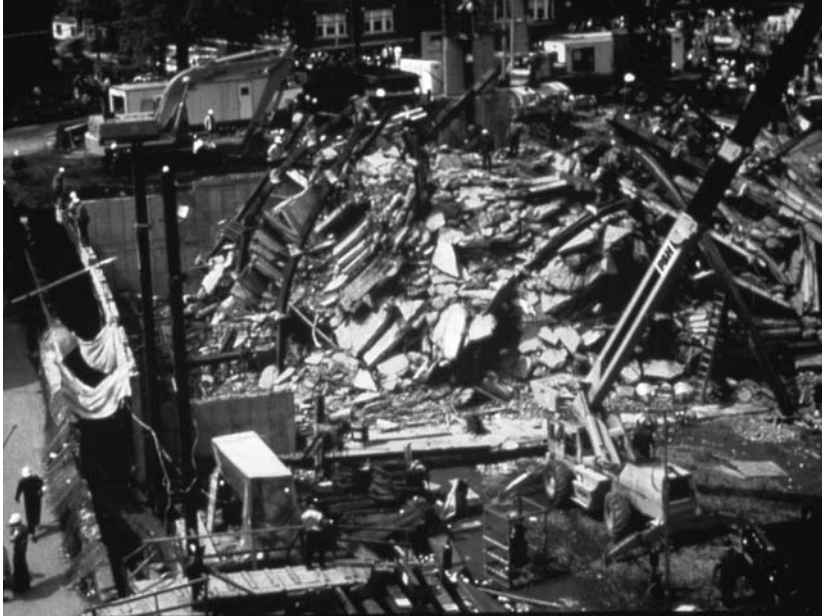
Figure 4-12a, b. The collapsed structure of L'Ambiance Plaza.  
Courtesy National Institute of Standards and Technology.

The workers were tack-welding wedges under the 9th-to-11th floor package to temporarily hold them in position, when a loud metallic sound followed by rumbling was heard. Kenneth Shepard, an ironworker who was installing wedges at the time, looked up to see the slab over him “cracking like ice breaking.” Suddenly, the slab fell onto the slab below it, which was unable to support this added weight and fell in turn. The entire structure collapsed, first the west tower and then the east tower, in 5 s, only 2.5 s longer than it would have taken an object to free fall from that height. Ten days of frantic rescue operations revealed that 28 construction workers had died in the collapse, making it the worst lift-slab construction accident ever. Kenneth Shepard was the only one on his crew to survive (Levy and Salvadori 1992). The collapsed structure is shown in Fig. 4-12.

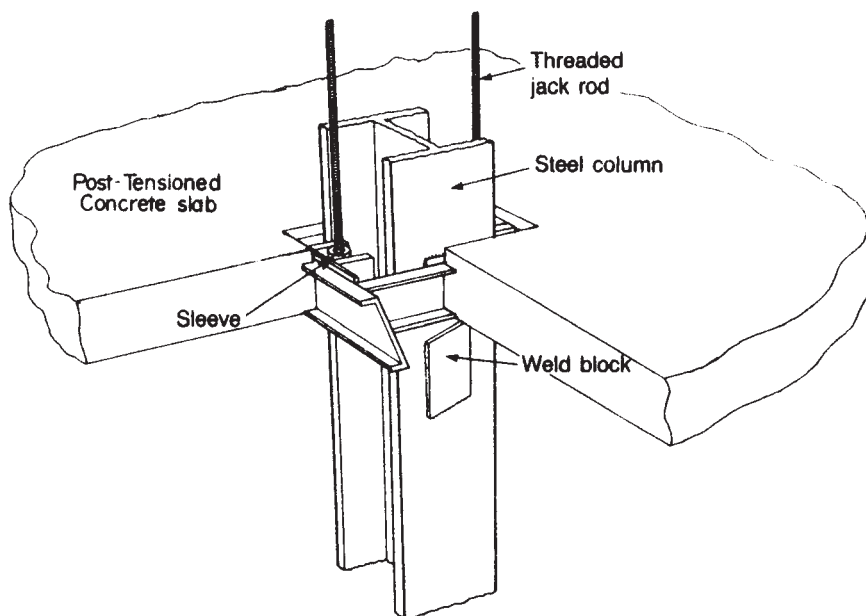
**Figure 4-13a.** Lifting assembly.

The NBS investigation concluded that the failure occurred at the building's most heavily loaded column, E4.8, or the adjacent column, E3.8, as a result of a lifting assembly failure (Fig. 4-13). The shear head reinforced the concrete slab at each column, transferred vertical loads from the slabs to the columns, and provided a place of attachment for the lifting assembly. It consisted of steel channels cast in the concrete slab, leaving a space for the lifting angle. The lifting angle had holes to pass the lifting rods through. These rods were raised by the hydraulic jacks on the columns above them (Levy and Salvadori 1992).

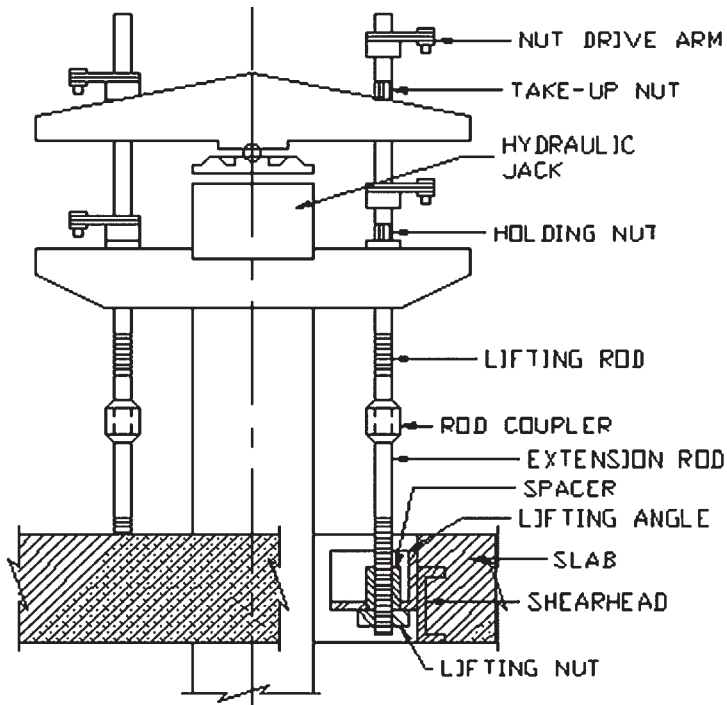
**Figure 4-13b.** Lifting assembly.  
*Source:* Martin and Delatte (2000).

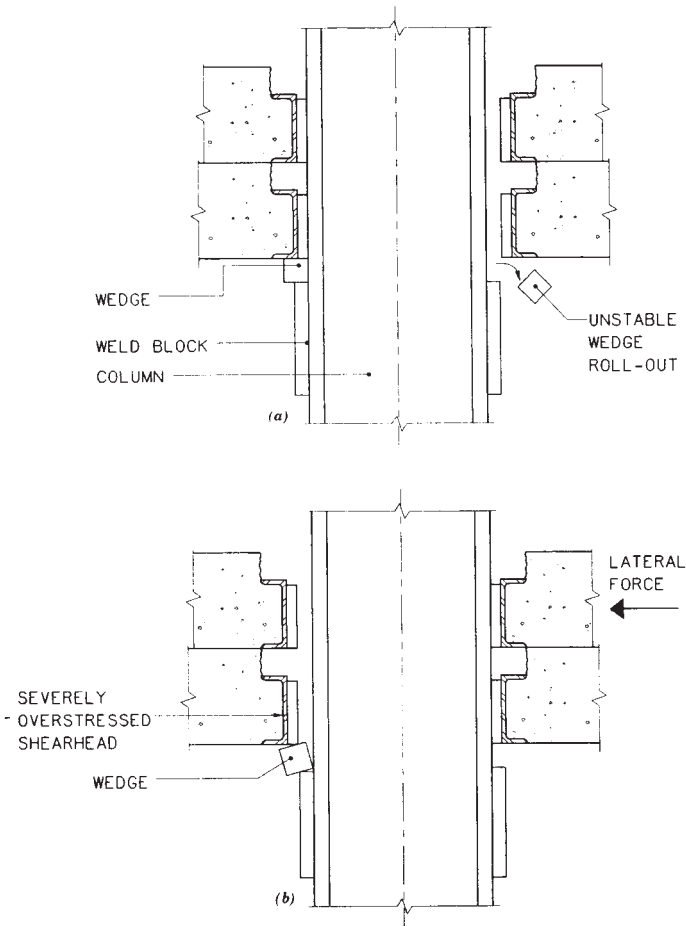
**Figure 4-14.** Wedges and wedge roll-out mechanism.

On the day of collapse, the lateral load from the hydraulic jack was exerted on the heavily loaded wedges, causing the west wedge to roll. Then the local adjustments to slab elevations caused the remaining wedge to roll out, initiating the collapse of the 12th floor–roof package and the west tower (Fig. 4-14). Forces transmitted through the pour strips or the horizontal jack, or the impact of the debris from the west tower, triggered the east tower's collapse (Cuoco et al. 1992). Zallen and Peraza (2004, pp. 28–29) refer to this as “theory 3—wedges falling out.”

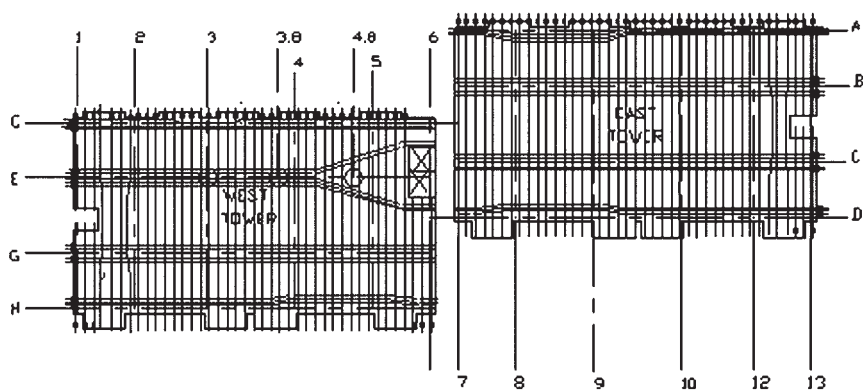
Figure 4-15. Post-tensioning tendon layout.

SSE analyzed the structural behavior of a typical west tower floor slab with respect to the unusual layout of the post-tensioning tendons (Fig. 4-15). The tendons in the east tower followed a typical two-way banded post-tensioning tendon layout. In this layout, the vertical tendons distributed the weight of the slab to the east-west column lines, which in turn distributed

the weight to the columns. The west tower, however, deviated from this pattern. At column 4.8E, the tendons split in two, both diverging from the column line. In the west tower, the vertical tendons still distributed the slab's weight to the column line. Along line E, however, there are no tendons to carry this weight. This setup violated the American Concrete Institute Building Code (ACI 1983). Kaminetsky points out that the code stipulates "a minimum of two tendons shall be provided in each direction through the critical shear section over columns" (1991, p. 84).

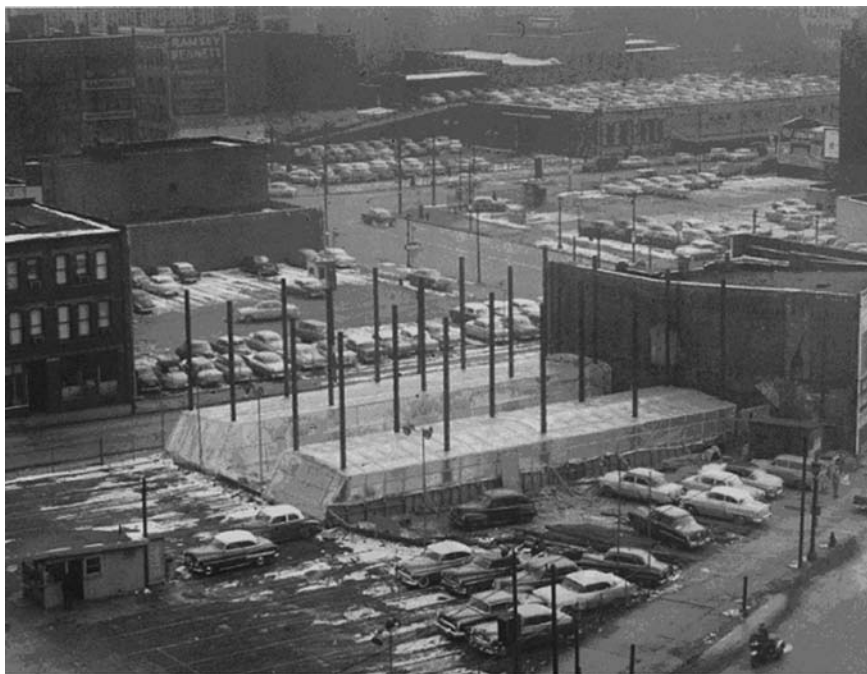
**Figure 4-16.** Cleveland parking garage under construction.  
Courtesy *Cleveland Press* Collection, Cleveland State University Library.

(180,000 lb). The slabs had been jacked into place on 18.5-m (61-ft) tall columns spaced 6.7 m (22 ft) on center. All of the slabs of the west tower were in place, secured by temporary steel wedges. The structure before the incident is shown in Fig. 4-16.

The sequence of events is illustrated in photos published in the *Cleveland Press* newspaper, shown here as Figs. 4-16 through 4-18. The newspaper is no longer published, but fortunately its archives were passed on to the Cleveland State University Library's special collections.

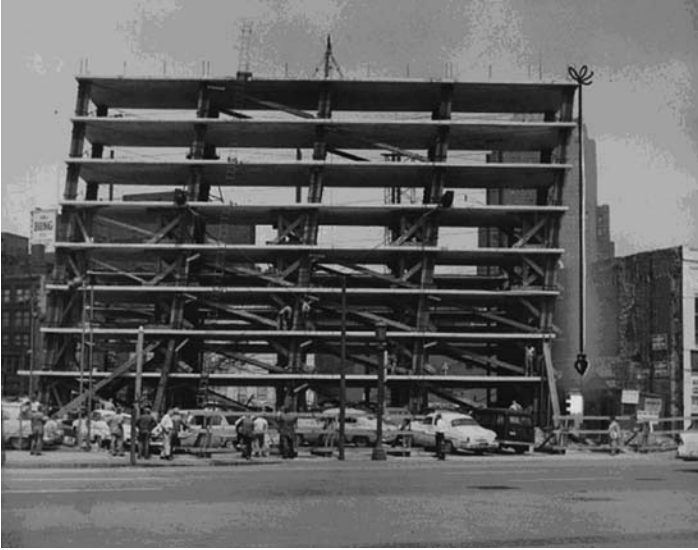
On the evening of April 6, winds gusted 56–80 km/h (35–50 mi/h). The structure shifted 2.1 m (7 ft) out of plumb in the long direction, with the fifth floor close to an adjacent building. The east tower, with only the second and third floors in place, was not affected by the wind. The sideways displacement of the Cleveland parking garage is shown in Fig. 4-17.

**Figure 4-17.** Sidesway displacement of Cleveland parking garage.  
Courtesy *Cleveland Press* Collection, Cleveland State University Library.

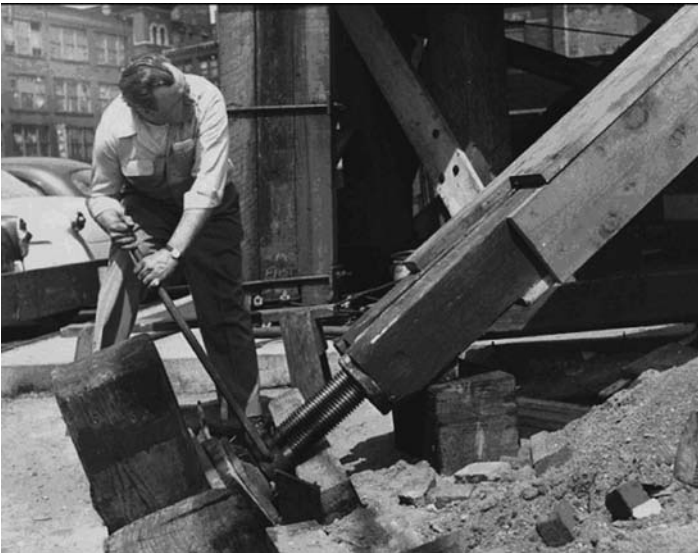
The building was secured with guys and temporary shoring on orders of the Cleveland building commissioner, who remarked, “if they had welded at each floor as they went along the building would have been braced and this would not have happened.” The west tower was eventually jacked back into place (Feld 1964, pp. 93–94). The work to restore the Cleveland parking garage to plumb is shown in Fig. 4-18.

**Figure 4-18.** Restoring the Cleveland parking garage to plumb.  
Courtesy *Cleveland Press* Collection, Cleveland State University Library.

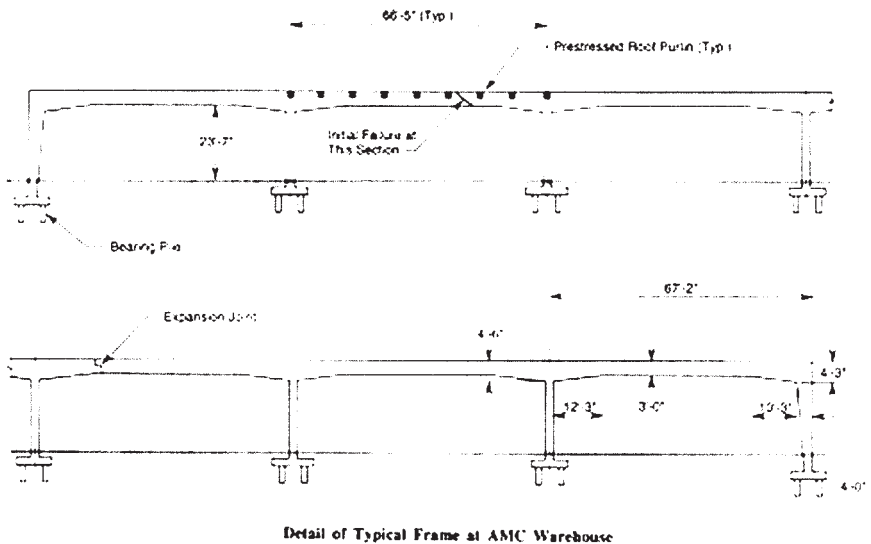
Severe cracking had been observed two weeks before the collapse, so the girder had been supported by temporary shoring. The cracks occurred about 0.45 m (1½ ft) past the end of the cutoff of the top negative reinforcement over the columns (Feld 1964, pp. 26–27). A typical AMC warehouse frame is shown in Fig. 5-1.

**Figure 5-1.** AMC Warehouse Frame (1 in. = 25.4 mm, 1 ft = 0.305 m).  
 Source: Shepherd and Frost (1995).

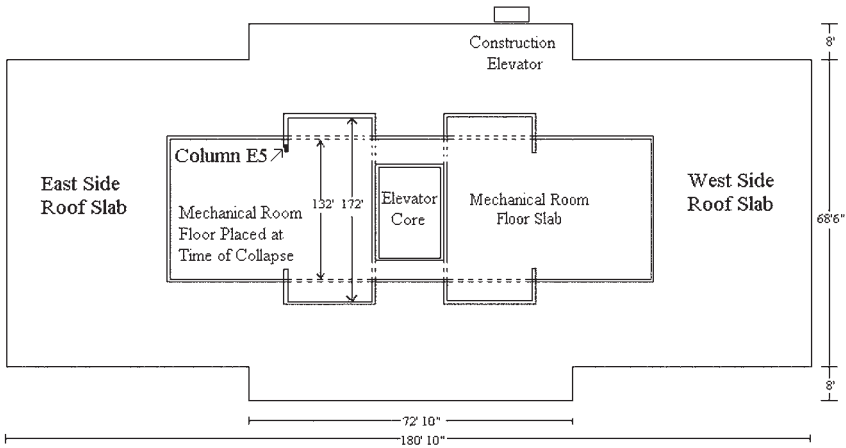
The building was cast-in-place reinforced concrete flat-slab construction with a central elevator shaft core. The floor plan is shown in Fig. 5-2. This style of construction is popular for multistory buildings because it reduces the slab thickness and the overall height of the building (Feld and Carper 1997). The flat slabs were 190 mm (7½ in.) thick, except for some bays near the elevator core and at stairwells, which were 230 mm (9 in.) thick. This design made possible a story height of 2.7 m (9 ft) for most of the floors.

**Figure 5-2.** Floor plan of 2000 Commonwealth Avenue.

The carpenter foreman was also in the area and immediately yelled a warning to the men working on the 16th floor and roof of a possible roof collapse. The slab had dropped 125–150 mm (5–6 in.) around the column, and there was a crack in the bottom of the slab extending from column E5 toward column D8. Column E5 is located directly below where the concrete was being placed for the mechanical room floor slab on the east side of the building, as shown in Fig. 5-2 (Granger et al. 1971).

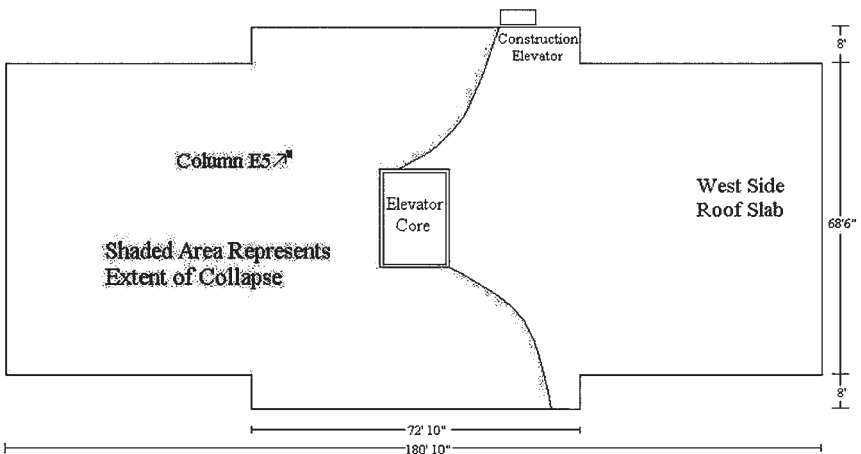
**Figure 5-3.** Extent of collapse.  
Source: King and Delatte (2004).

At first, the different floors were distinguishable, but later dust and debris made it difficult to tell them apart. When the dust finally settled, two-thirds of the building had collapsed. The east side and areas on either side of the elevator shaft were gone. Four workers were killed during the collapse, and 30 workers suffered injuries (Granger et al. 1971). The extent of damage is shown in Fig. 5-3. The elevator core probably prevented the collapse from propagating to the other half of the structure.

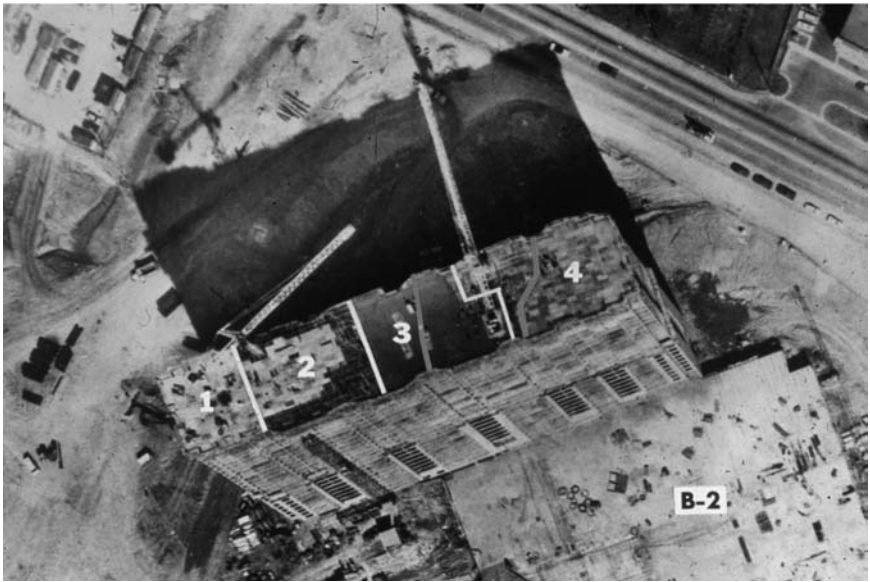
**Figure 5-5.** Skyline Plaza before the collapse.

The progressive collapse of 2000 Commonwealth Avenue was similar to the later structural failures of buildings at Skyline Plaza in Bailey's Crossroads, Virginia, and Harbour Cay Condominium in Cocoa Beach, Florida. On March 2, 1973, the Skyline Plaza apartment building collapsed while under construction. The collapse extended vertically through the building from the 24th floor, leaving an appearance of the structure as two separate high-rise buildings with a gap between them. The collapse tore a 18.3-m (60-ft) wide gap through the building all the way to the ground. At the time of the collapse, two practically identical reinforced concrete towers had been built (Kaminetzky 1991, p. 64). Figure 5-5 shows an aerial photograph of the structure shortly before the collapse. The collapsed structure is shown in Fig. 5-6.

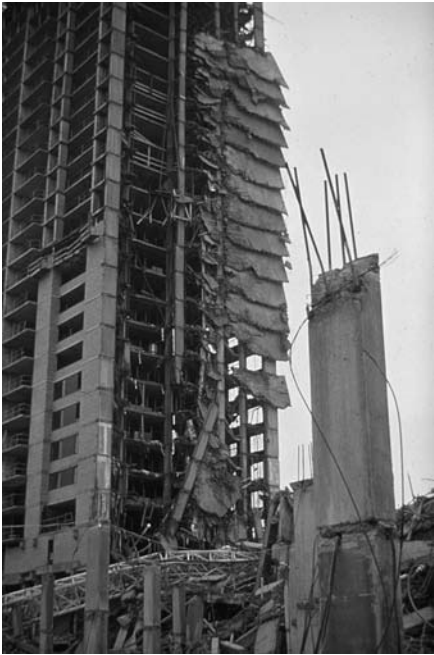
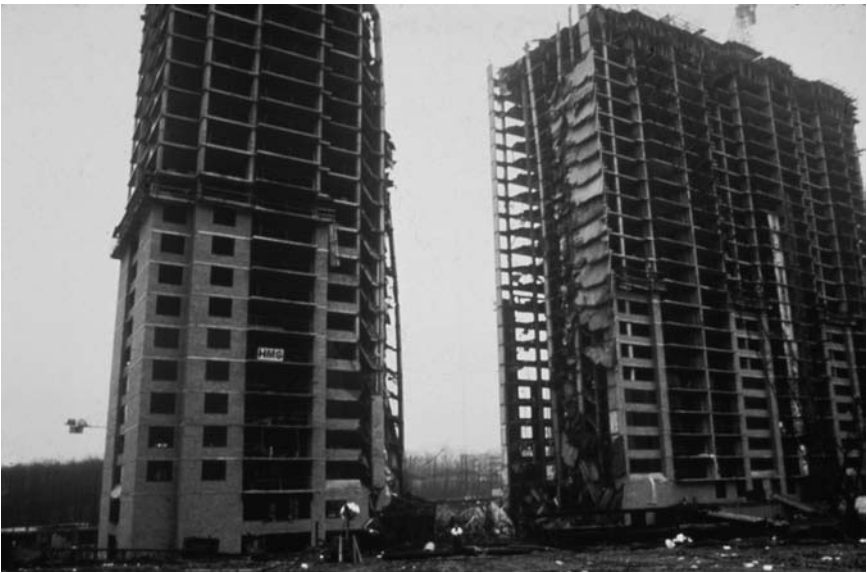
**Figure 5-6a, b.** Collapse of Skyline Plaza, Bailey's Crossroads.  
Courtesy National Bureau of Standards/National Institute of Standards and Technology.

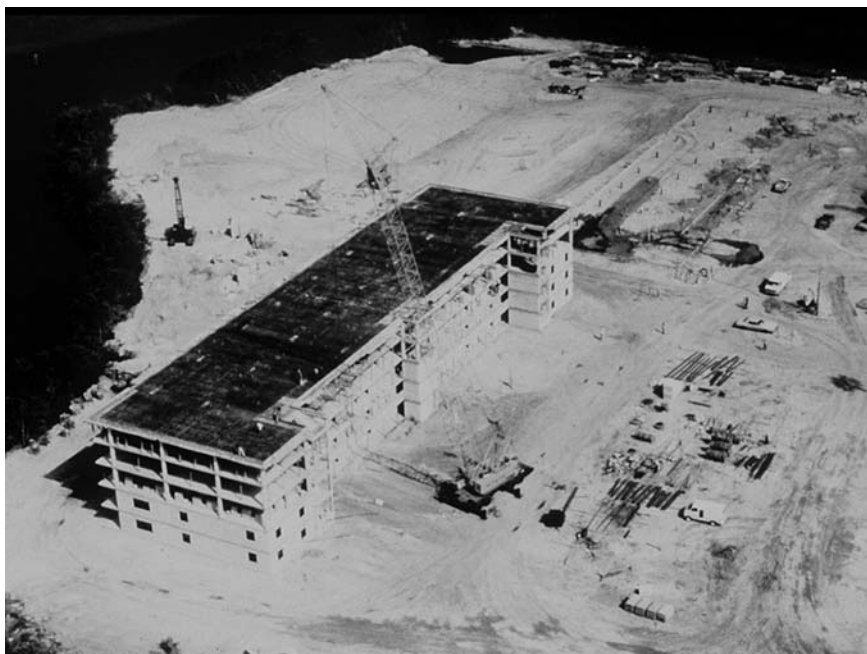
**Figure 5-7.** Harbour Cay Condominium before the collapse.

The collapse of the flat-plate Harbour Cay Condominium building in Cocoa Beach, Florida, on March 27, 1981, was caused by a punching shear failure that triggered a progressive collapse, much like those at 2000 Commonwealth Avenue in Boston and Skyline Plaza in Virginia. Eleven workers were killed and 23 were injured. Figure 5-7 shows the building before collapse, and Fig. 5-8 shows the structure afterward. As at Skyline Plaza, OSHA

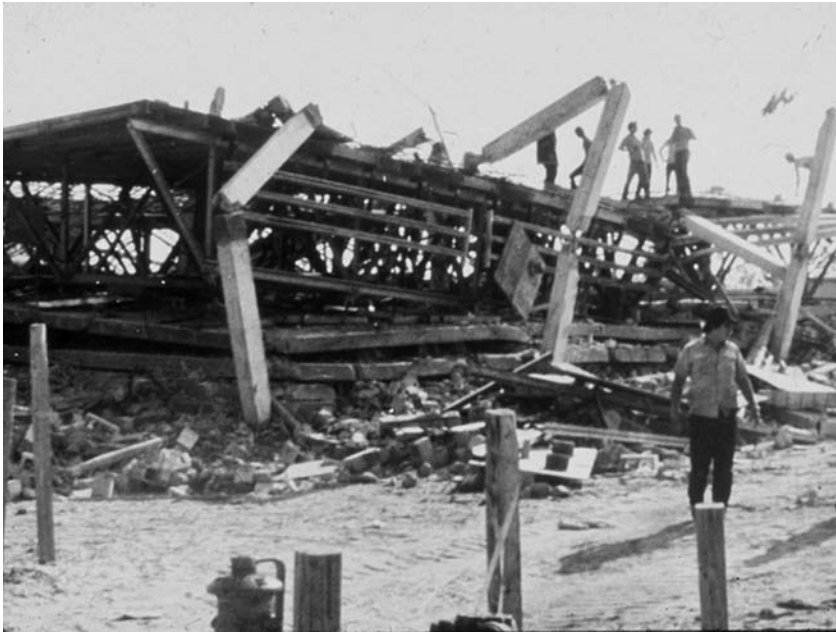
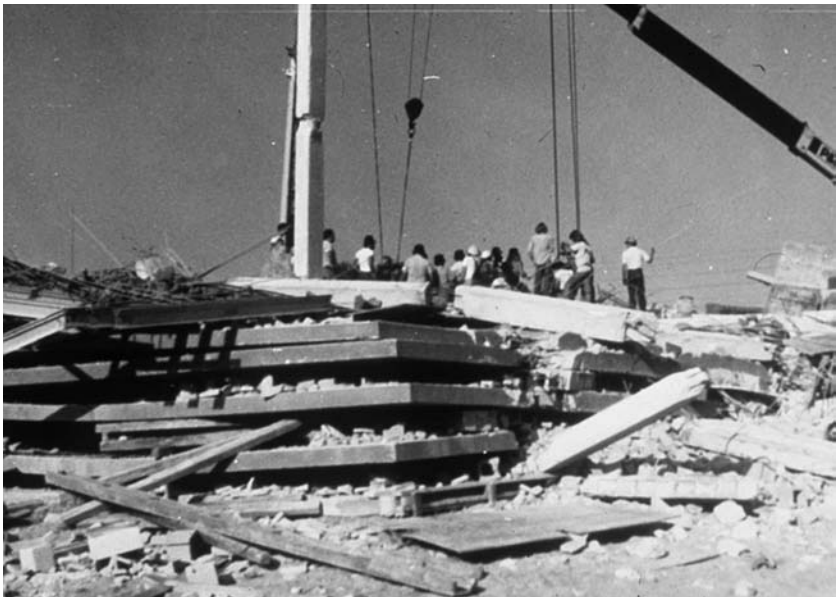
Figure 5-8a, b. Harbour Cay Condominium collapse.  
Courtesy National Bureau of Standards/National Institute of Standards and Technology.

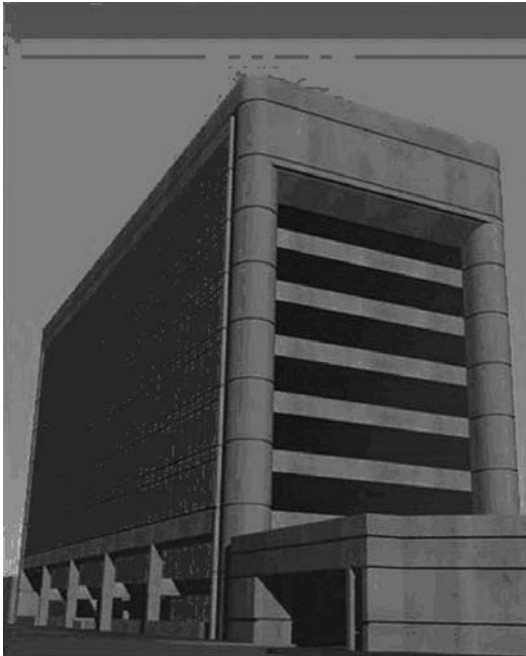
Some of the key structural features of the Murrah Building were reviewed by Hinman and Hammond (1997, pp. 3–5). The structure is shown in Fig. 5-9.

**Figure 5-9.** Oklahoma City Murrah Federal Building.  
*Source:* Ostersaas (2006).

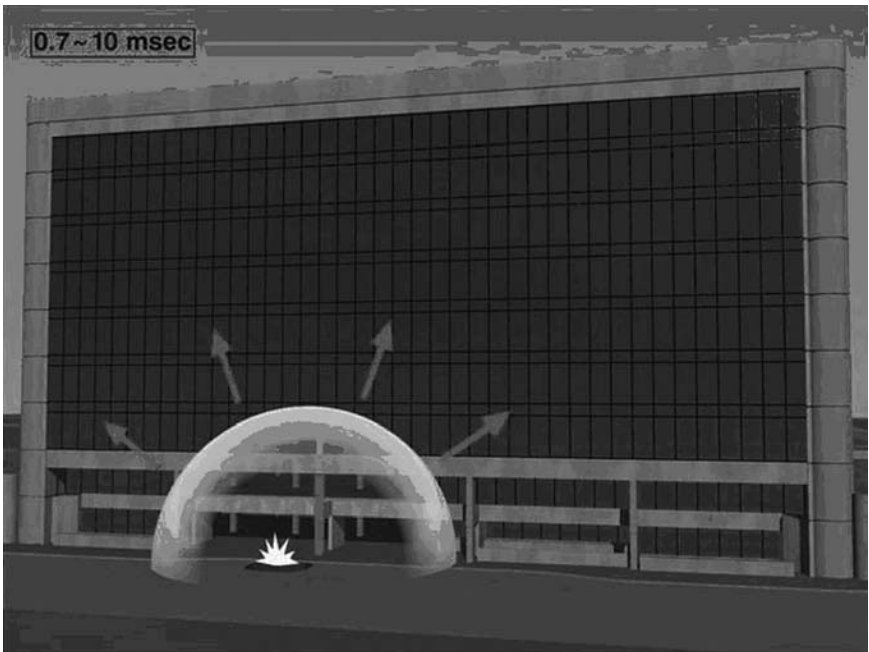
between the second and third floors, at the location of the transfer girders. This failure left the outer bay unsupported (Hinman and Hammond 1997, pp. 6–8). The G row of columns was along the north façade, and the F row was in the middle of the building between the north and south bays. The location of the explosion is shown in Fig. 5-10.

**Figure 5-10.** Location of bomb.

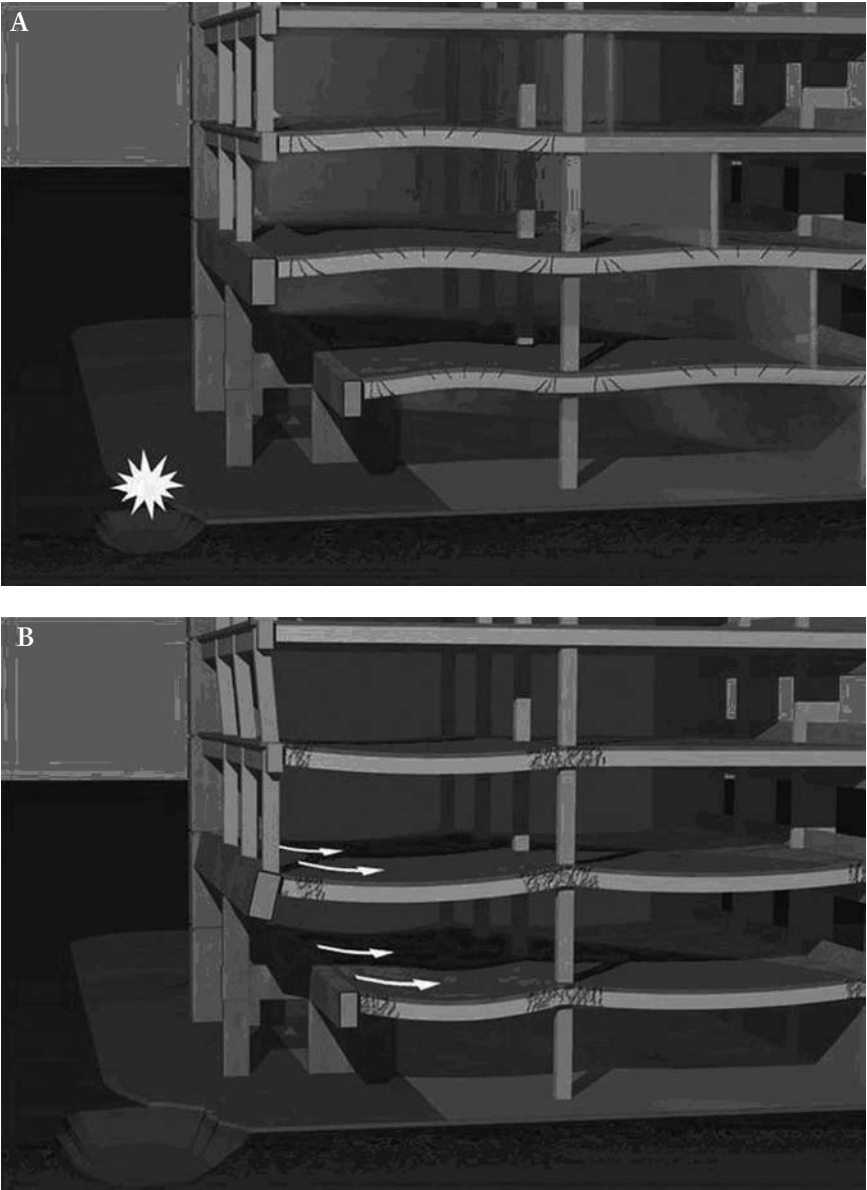
Because the floor slabs brace columns, their failure may lead to column buckling and overall disproportionate collapse. The floor slab failure and its effect on the structural frame are shown in Fig. 5-11.

Figure 5-11a, b. Failure of the floor slabs.  
*Source: Osteraas (2006).*

Floor slabs tend to be vulnerable to explosive effects due to their large surface area compared with other elements, such as columns. . . . Floor slabs are first subject to an upward and then a downward loading from the explosive forces. The upward loading causes cracking and weakening of the members in shear. This is followed by a downward pressure, causing collapse. As the slab deflects downward, it pulls the outer frame inward and causes this already weakened system to fail by buckling at the lower floors. Shear failure rather than flexural or bending failure occurs due to the extremely high intensity and short duration of the loading close-in to the explosion. In short, the slab is sheared off before it has a chance to bend. (Hinman and Hammond 1997, p. 8)

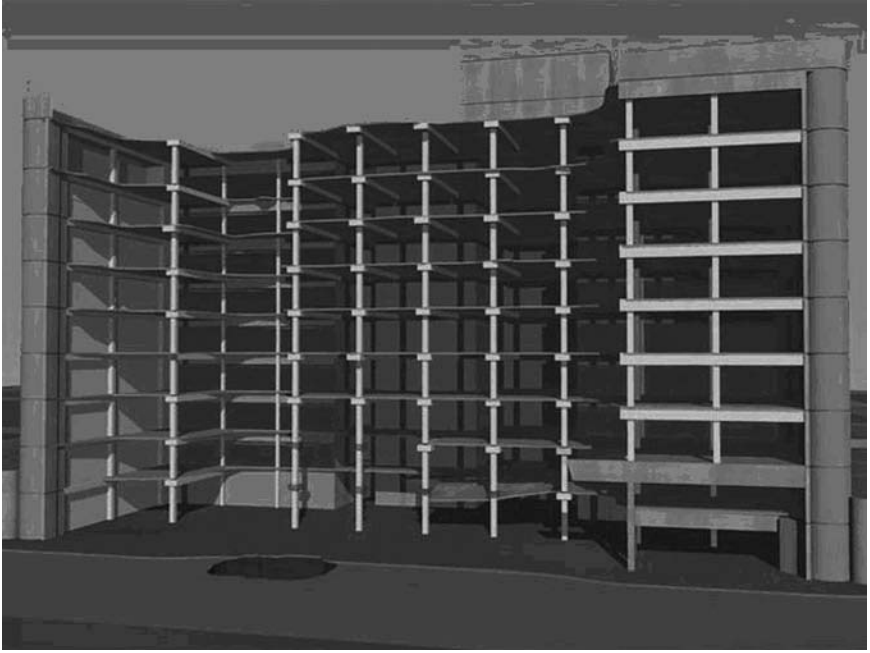
The structure after the attack is shown in Fig. 5-12.

**Figure 5-12.** Murrah Building following the attack and partial collapse.  
*Source:* Osteraas (2006).

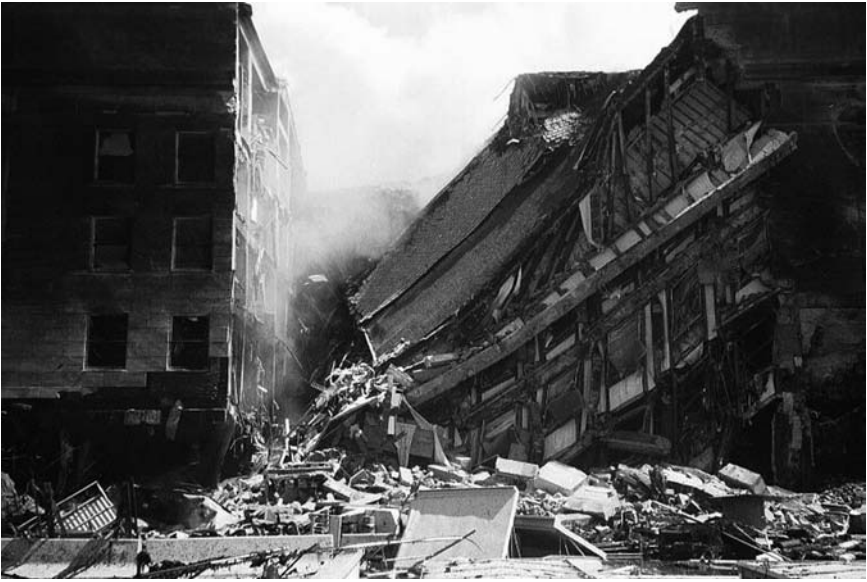
**Figure 5-13.** The Pentagon following the aircraft impact.

Part of the building in the renovated section to the south of the expansion joint subsequently collapsed about 20 min after the aircraft struck the building. Photos taken between the aircraft impact and the collapse show that this portion of the building was sagging by about 0.45–0.6 m (1½–2 ft). All five floors of the building collapsed. Some of the blast-resistant windows stayed in place even after the collapse. The collapse was confined to the outer E ring (Mlakar et al. 2003, pp. 17–26). Figure 5-13 shows the building after the collapse of the portion adjacent to the expansion joint.

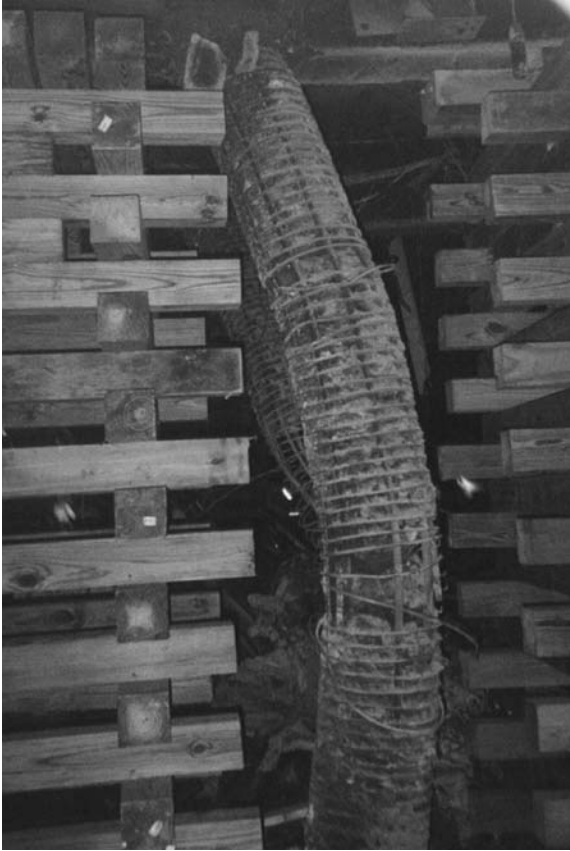
**Figure 5-14.** Damage to a spiral column.

The upgraded windows were generally in place in their reinforced frames. In contrast, the windows near the impact that had not been upgraded were mostly broken. Almost all the interior damage that had been inflicted was on the first story. The path of structural damage was 23–24 m (75–80 ft) wide and about 70 m (230 ft) long, tapering as it went further into the building. Severe damage from either the impact or the subsequent fire included heavy cracking and spalling. Several columns were bent at mid-height as much as three times the diameter of the spiral reinforcement, yet they remained attached at the ends (Mlakar et al. 2003, pp. 28–29). Figure 5-14 shows a damaged column.

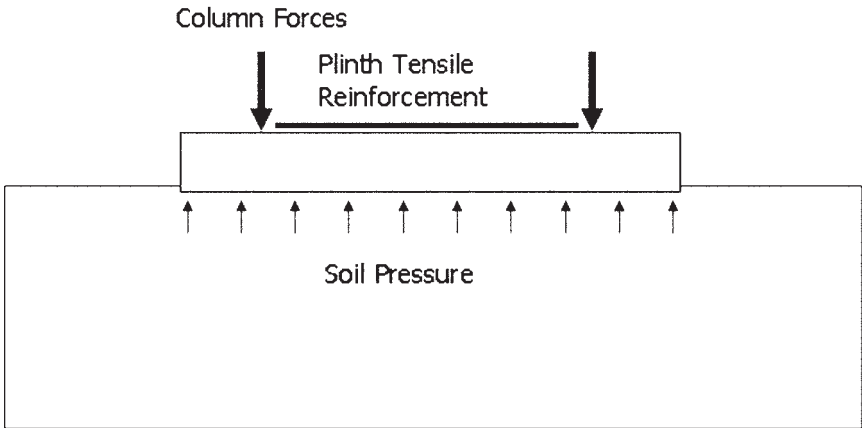
In 1957, plinth reinforcement was added to each of the four piers to correct the problem of vertical cracking. The plinth may be seen as an upside-down, uniformly loaded beam, with the soil-bearing pressure providing the uniform loading and the two columns acting as supports. It becomes obvious that the top of the plinth represents the tension face of the beam and requires reinforcement. The plinth reinforcement is shown in Fig. 5-15.

Figure 5-15. Schoharie Creek Bridge plinth reinforcement.

However, to be properly anchored, the tension reinforcement must be extended past the supports—in this case, into the columns—for the full development length required by the ACI Code. Obviously, this extension was not done, and it would have been difficult to extend the reinforcement through the columns without replacing the columns. Ironically, because the added plinth reinforcement was not adequately anchored, it may have contributed to the brittle and sudden nature of the subsequent collapse by supporting the plinth until most of it had been undermined.

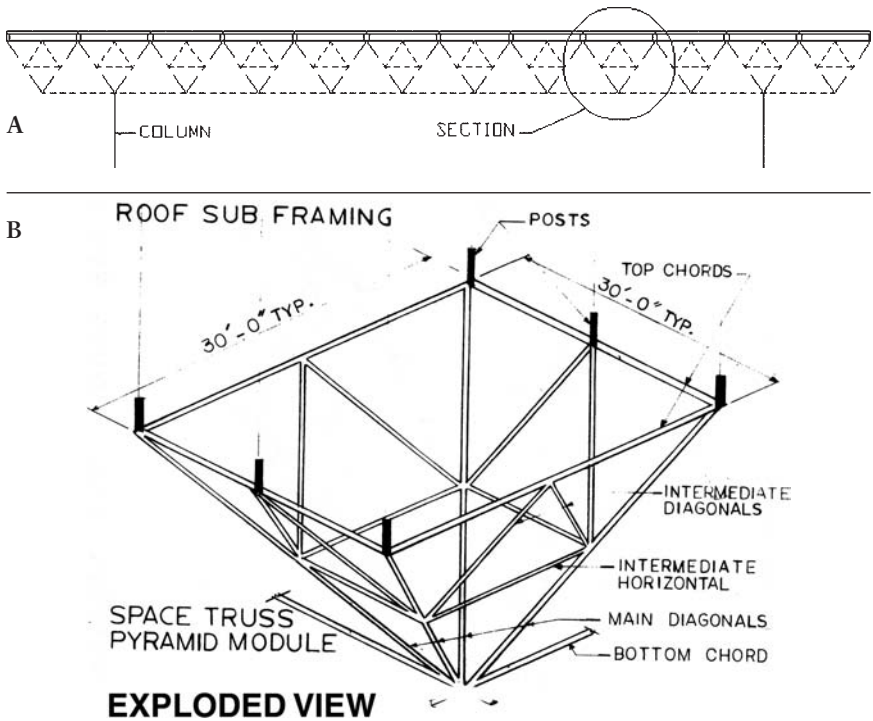
To save money, the engineers proposed an innovative design for the  $91.4 \times 110$  m ( $300 \times 360$  ft) space frame roof 25.3 m (83 ft) over the arena. The proposed roof consisted of two main layers arranged in  $9.14 \times 9.14$  m ( $30 \times 30$  ft) grids composed of horizontal steel bars 6.4 m (21 ft) apart. Diagonal members 9.14 m (30 ft) long connected the nodes of the upper and lower layers and, in turn, were braced by an intermediate layer of horizontal members. The 9.14-m (30-ft) members in the top layer were also braced at their midpoint by intermediate diagonal members (Fig. 6-1).

Figure 6-1a, b. Elevation and detail of Hartford Civic Center roof (1 ft = 0.305 m).  
 Courtesy Lev Zetlin Associates.

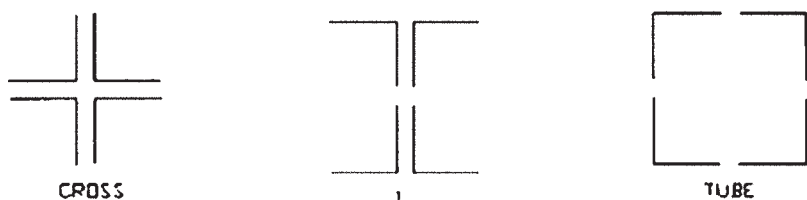
1. The cross-sectional configuration of the four steel angles making up each truss member did not provide good resistance to buckling. The cross-shaped built-up section has a much smaller radius of gyration than either an I-section or a tube section configuration of the same structural members (Fig. 6-2). As a result, the buckling load for the cross-shaped section is much lower than that of the other configurations.

Figure 6-2. Possible truss member configurations.

As a class example or homework problem, students may compare the moment of inertia for the cruciform, I, and tube configurations of four angles, as shown in Fig. 6-2. Angle legs ranged from 89 to 203 mm ( $3\frac{1}{2}$  to 8 in.) long and were 8–22 mm ( $\frac{5}{16}$ – $\frac{7}{8}$  in.) thick, depending on loads, and the angles were separated by spacers 19–22 mm ( $\frac{3}{4}$ – $\frac{7}{8}$  in.) thick (LZA 1978). For numerical examples,  $127 \times 127 \times 8$  mm ( $5 \times 5 \times \frac{5}{16}$  in.) angles may be used. The torsional stiffness of these configurations may also be calculated and compared.

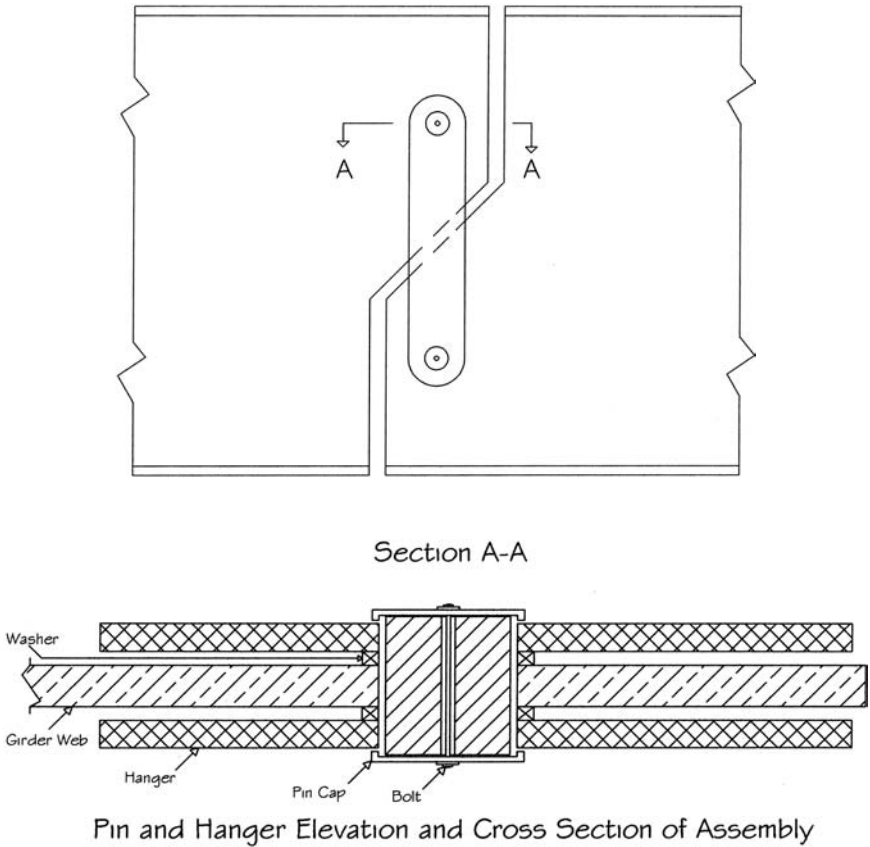
Figure 6-4. Pin and hanger assembly.

Figure 6-4 shows the pin and hanger assembly. Washers were used to separate hangers from the steel girders. Locking caps were used to keep the hanger from slipping off of the pin. According to the experts, the caps were thin and flimsy. "Calculations proved the caps' thickness was less than one half that required by the design regulations in force at the time of construction (1957)" (Levy and Salvadori 1992, p. 139). The thin pin caps could be easily bent.

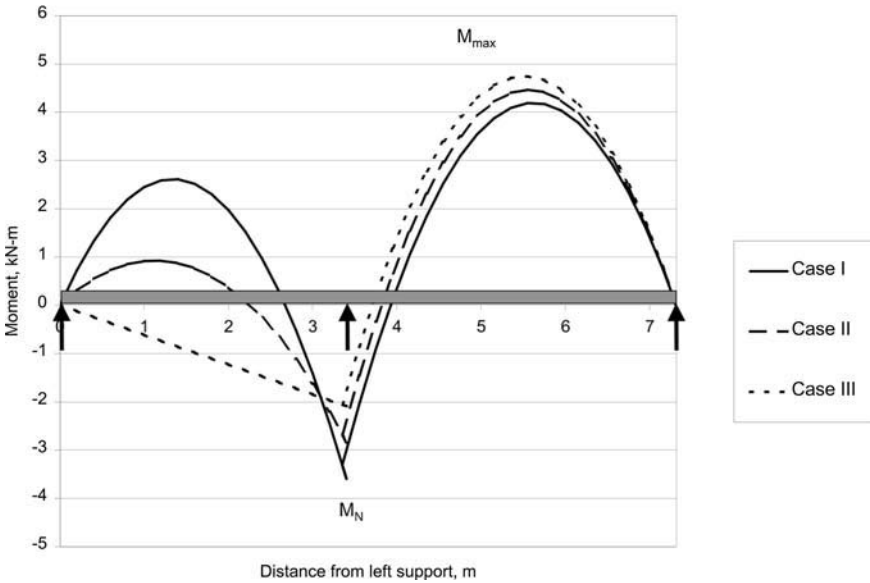
**Figure 6-5.** Bending moment diagrams.

Bending moments for these three load cases are shown in Table 6-2 and Fig. 6-5. The greatest absolute value of the moment is always the positive moment near the midspan of the longer beam, for the load cases considered.

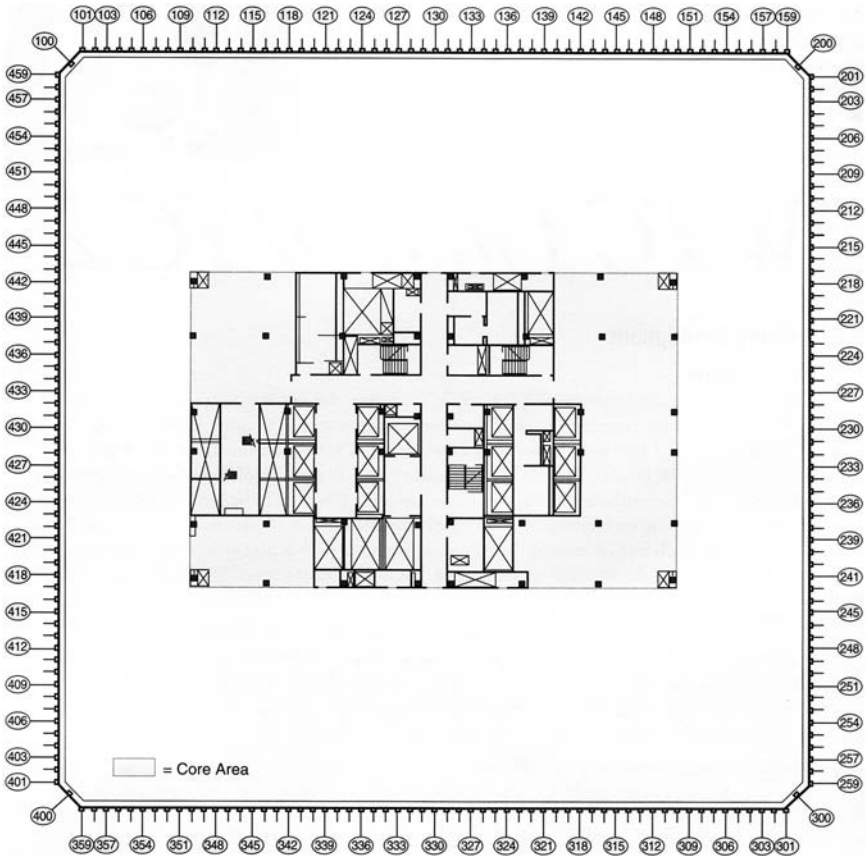
**Figure 6-6.** WTC typical floor plan.

The towers were of similar height, 417 m (1,368 ft) for WTC-1 and 415 m (1,362 ft) for WTC-2 at the roof. WTC-1 also supported a 110-m (360-ft) television and radio transmission tower. The buildings were square, a little more than  $63 \times 63$  m ( $207 \times 207$  ft) on a side, providing almost 0.4 hectare (1 acre) of floor space on each level. Each building also had a rectangular service core at the center,  $26.5 \times 42$  m ( $87 \times 137$  ft), housing three exit stairways, elevators, and escalators. The service core in WTC-1 was oriented east to west, and that in WTC-2 north to south (FEMA 2002, p. 2-1). Figure 6-6 shows a typical floor plan.

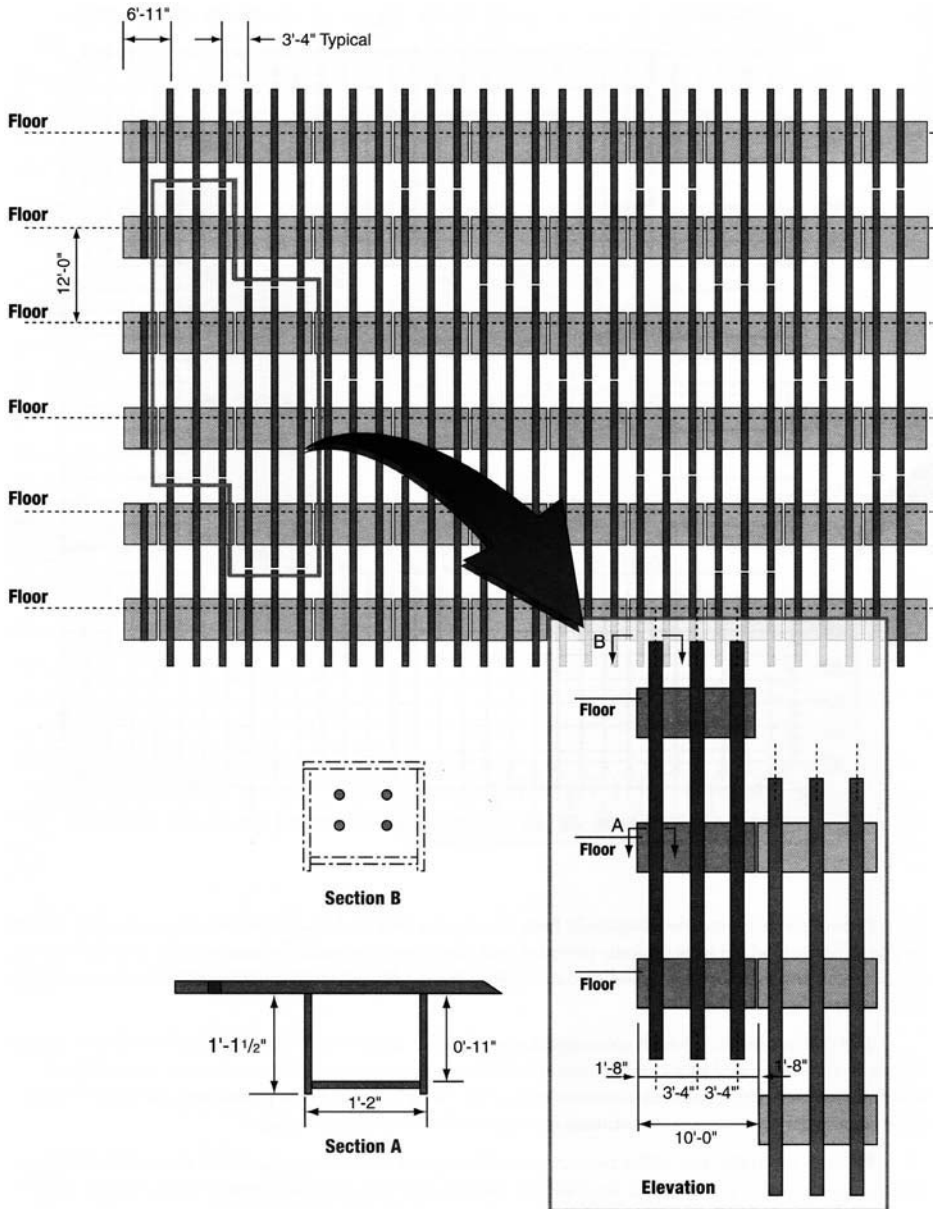
Figure 6-7. WTC bearing wall steel frame.  
Source: FEMA (2002).

The basic structural form for the building was a tube of closely spaced box columns, with about 59 per face of the building. At each floor, they were connected by 1.3-m (52-in.) deep spandrel plates. The outer steel frame was made of overlapping three-story-tall segments. Splices between segments were staggered, so that no more than one-third of the splices were on any one story. Plate thicknesses and grades of steel were varied to accommodate different loads. Under wind loading, the tube acted similarly to a box beam in flexure, with windward and leeward walls acting as compression and tension flanges connected by a Vierendeel truss web (FEMA 2002, pp. 2-2–2-3). Figure 6-7 shows the outer steel frame, and Fig. 6-8 shows the structural behavior under lateral loading.

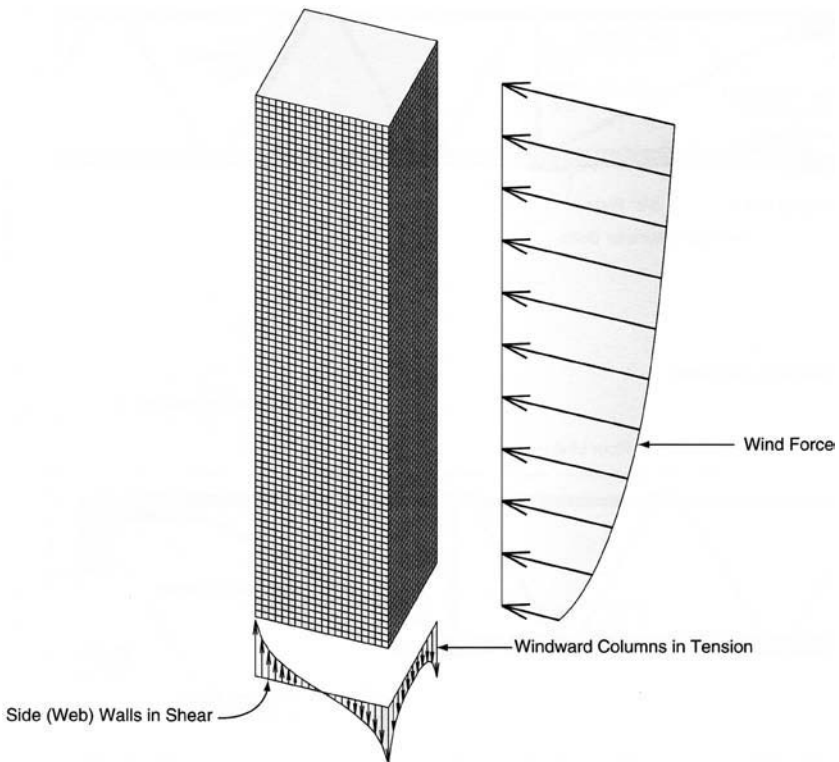
**Figure 6-8.** WTC structural behavior under lateral loading.  
*Source:* FEMA (2002).
