# *Beyond Failure*

Forensic Case Studies  
for Civil Engineers

NORBERT J. DELATTE JR., PH.D., P.E.

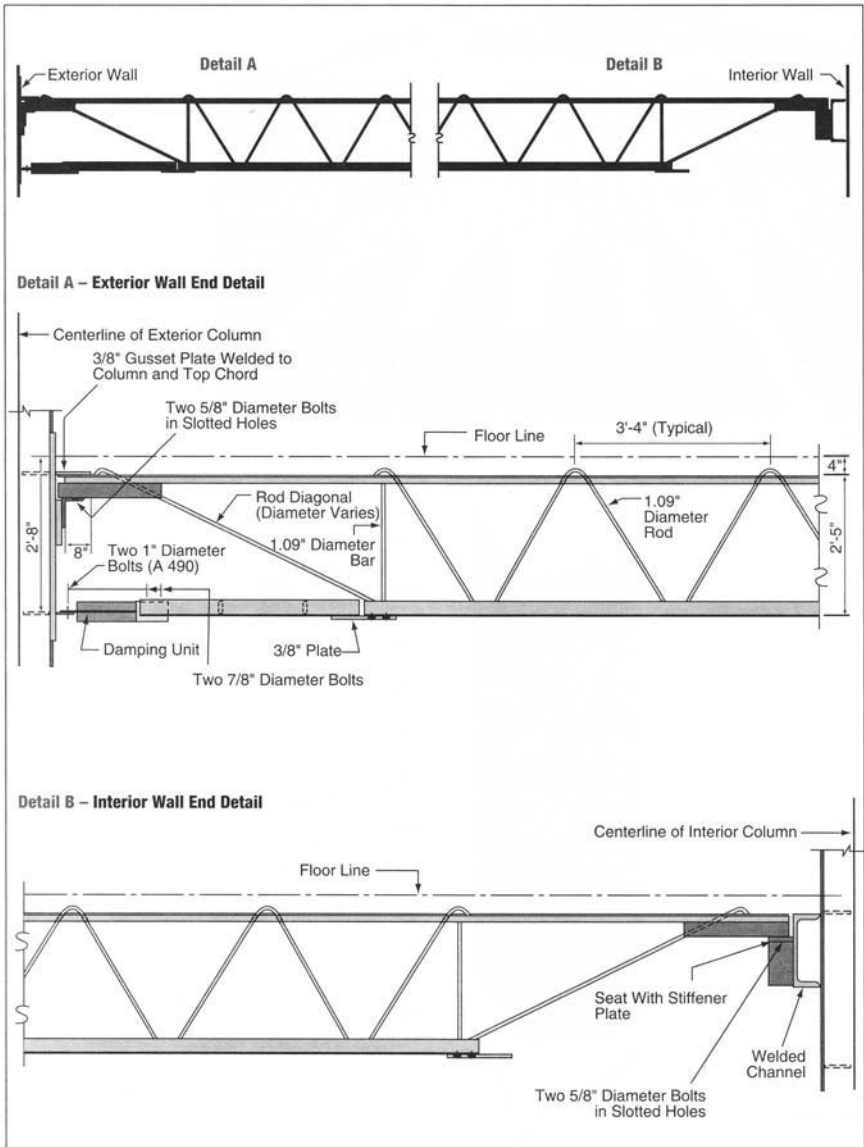
**Figure 6-9.** WTC trusses and end connection details.

The floor slab and framing system connected the outer tube to the inner core. The floor was 100-mm (4-in.) thick lightweight concrete on 38-mm (1½-in.) noncomposite steel deck. The floor rested on a series of composite floor trusses. The trusses were similar to open web joists but had more redundancy and better bracing. They were placed in pairs, approximately 2 m (6 ft 8 in.) apart. Transverse trusses ran between these main trusses. Truss spans were approximately 18 m (60 ft) to the sides and 10.7 m (35 ft) to the ends of the central cores. The truss top chords were supported at the outer wall in bearing by seats attached to alternate columns, and on seats at the central core (FEMA 2002, pp. 2-3-2-4). Figure 6-9 shows the trusses and end connection details.

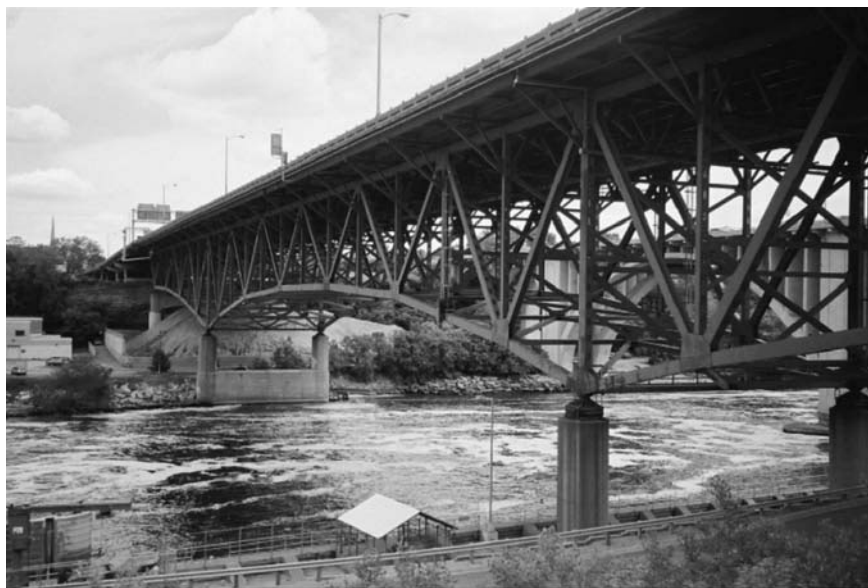
A view of the west side of the deck truss portion of the bridge, looking northeast.

**Figure 6-11.** Minneapolis I-35W Bridge before the collapse.

On August 1, 2007, an eight-lane, three-span section of the I-35W Bridge across the Mississippi River in downtown Minneapolis collapsed at approximately 6:00 P.M. It was crowded with rush hour traffic. The final death toll was 13. The bridge was the main north-south route through the city. Figure 6-11 shows the bridge before the collapse. Eyewitness reports suggested that a span at the south end collapsed first and that the failure propagated across the bridge to the other two spans in turn.

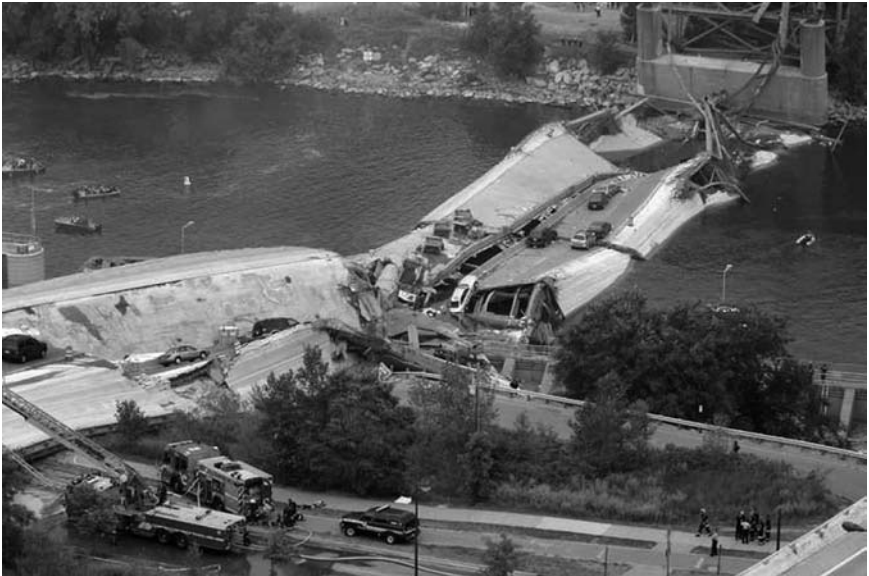
**Figure 6-12.** Wreckage of the collapsed Minneapolis I-35W Bridge.

Much of the wreckage remained above the water, but about 50 vehicles with their occupants went into the river. At the time, repairs were being made to the bridge deck, guardrails, and lights. Figure 6-12 shows the wreckage of the collapsed bridge.

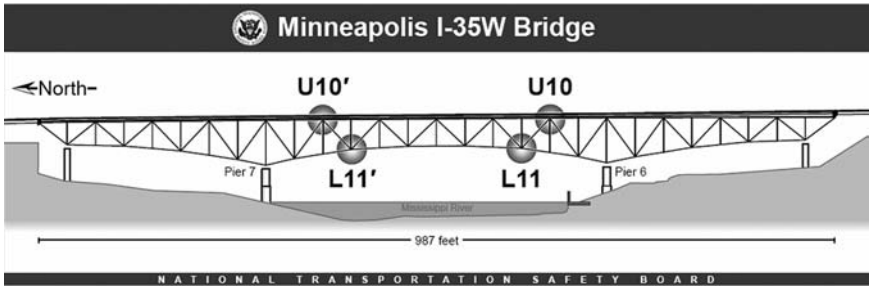
**Figure 6-13.** Minneapolis I-35W Bridge U10 and L11 gusset plates.

As of summer 2008, the cause of the I-35W Bridge collapse remains under investigation, and the final reports have yet to be written. However, considerable work has been done, and a critical design flaw that may well have been the cause of the collapse has been identified. The U10 and L11 gusset plates, shown in Fig. 6-13, were only about 13 mm ( $\frac{1}{2}$  in.) thick when they should have been 25 mm (1 in.) thick.

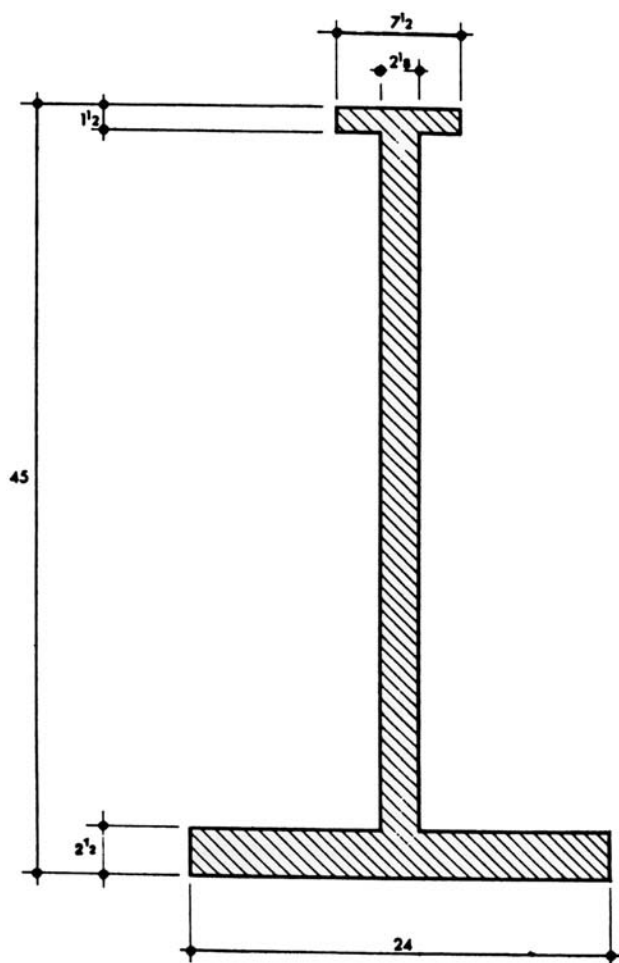
**Figure 6-14.** The Dee Bridge girders (1 in. = 25.4 mm).

Because cast iron is weaker in tension than in compression, the tension flanges of girders were larger than compression flanges by a ratio of 16:3, following the ratio of material strengths. The Dee Bridge had a relatively long simple span for the day of roughly 29 m (95 ft). The girder cross section is shown in Fig. 6-14. The bridge was also designed with a relatively low factor of safety of 1.5.

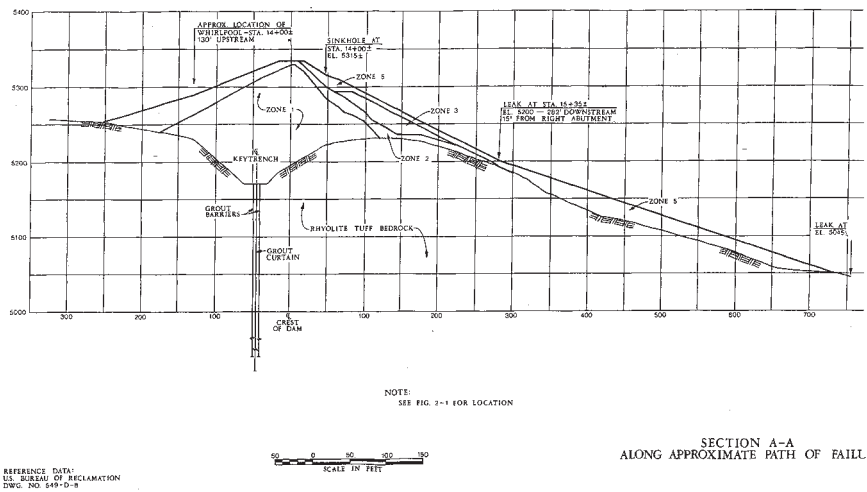
**Figure 7-2.** Initial failure indications.  
*Source:* Independent Panel (1976).

At 11:00 A.M., a whirlpool was observed in the reservoir directly upstream from the dam, and four bulldozers were sent to try to push riprap into the sinkhole near the dam crest (Independent Panel 1976). Two of the bulldozers were swallowed up by the rapidly expanding hole, and the operators were pulled to safety by ropes tied around their waists. Figure 7-2 shows a cross section of the dam with the approximate locations of the seepage, the sinkhole, and a whirlpool in the reservoir noted.

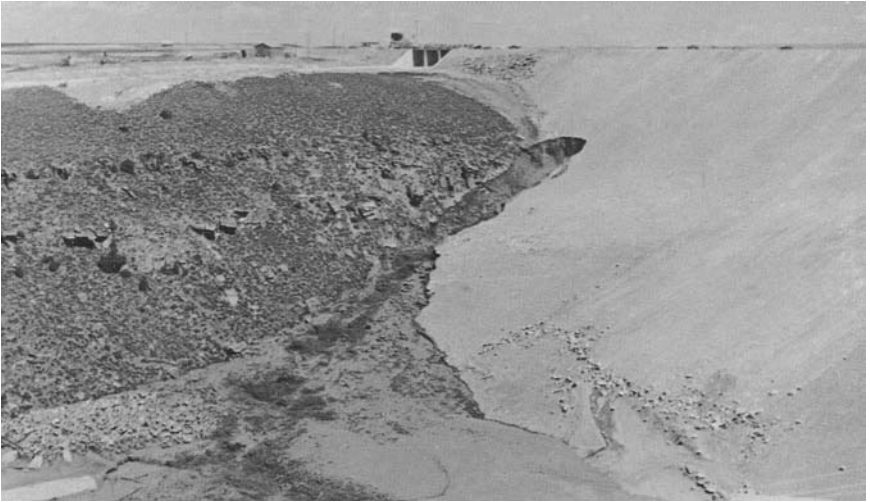
**Figure 7-3a.** Failure sequence, initial erosion.  
*Source:* Independent Panel (1976).

Figure 7-3a shows the location of the initial leak as it expanded up the dam. Between 11:15 and 11:30 A.M., a  $6 \times 6$  m ( $20 \times 20$  ft) chunk of dam fell into the whirlpool, and within minutes the entire dam collapsed (Independent Panel 1976). The failure sequence is illustrated in Figs. 7-3a through 7-3d.

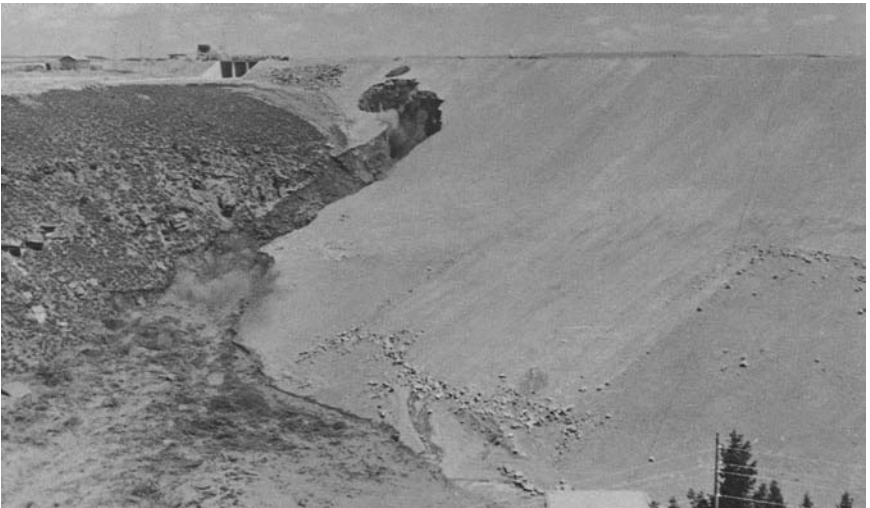
**Figure 7-3b.** Failure sequence, seepage widens.  
*Source:* Independent Panel (1976).

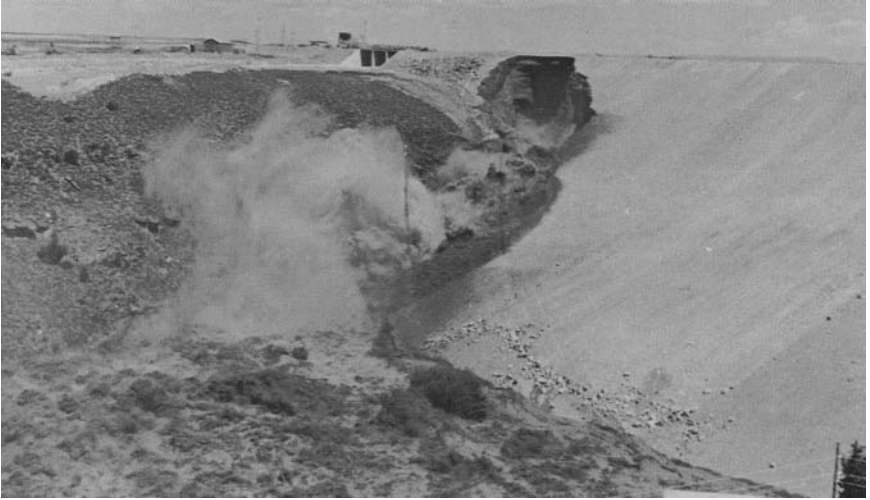
**Figure 7-3c.** Failure sequence, beginning of final failure.  
*Source:* Independent Panel (1976).

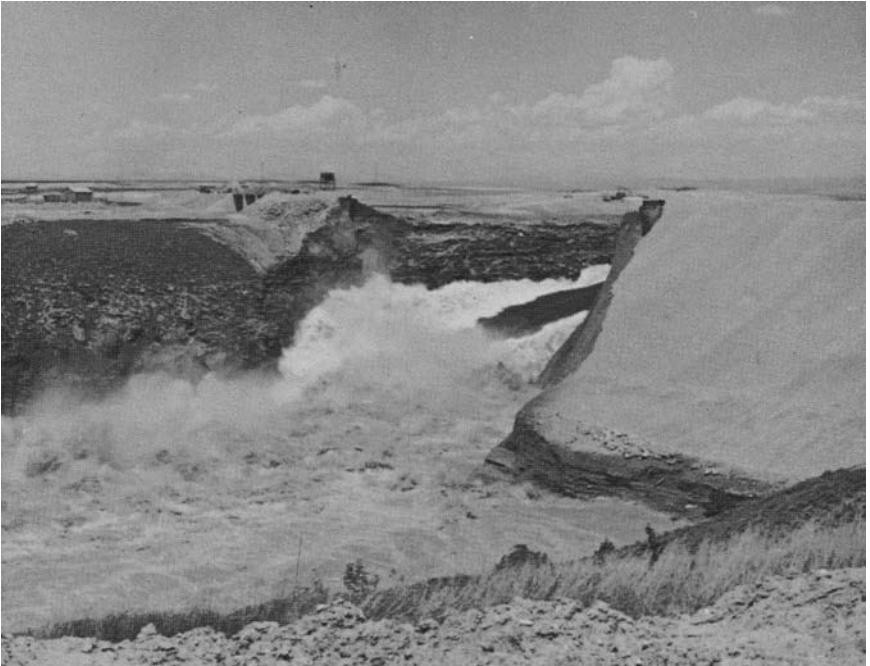
**Figure 7-3d.** Failure sequence, failure of dam.  
*Source:* Independent Panel (1976).

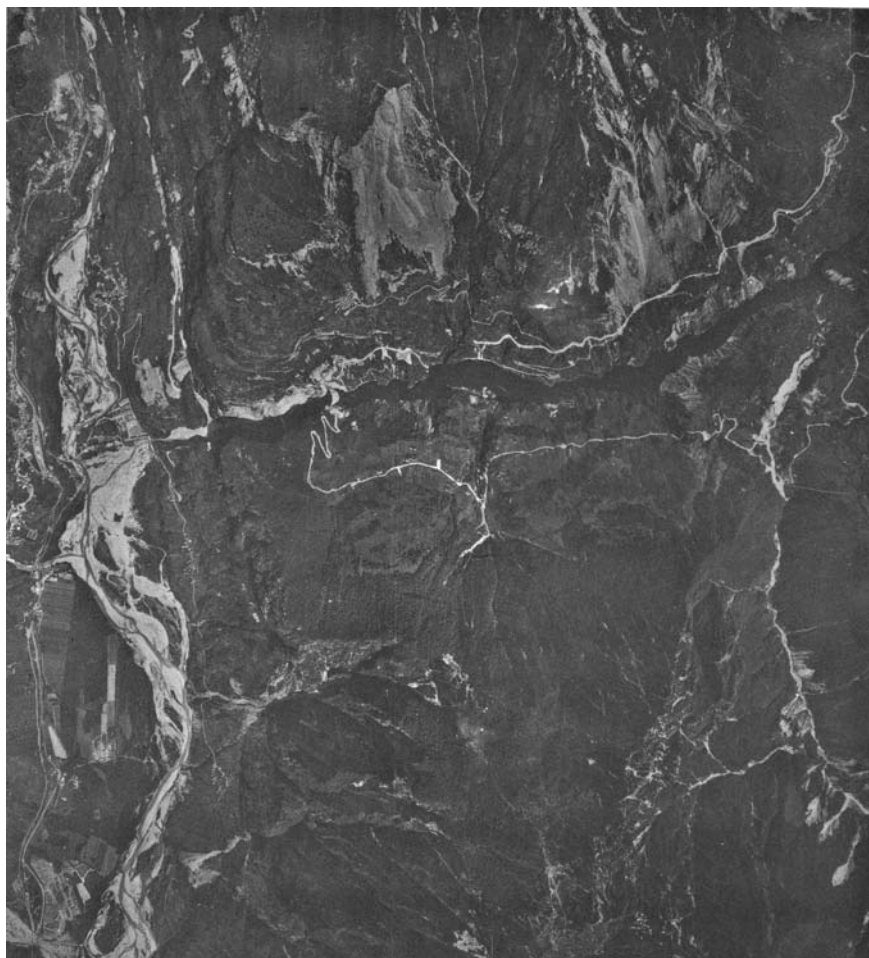
**Figure 7-5.** Aerial photograph of site before slide.

Using aerial photographs available at the time, Hendron and Patton (1985, p. 31) identified a pattern of apparent kettles or sinkholes, along with shallow slide areas. These are shown in Fig. 7-5. These features could have been used to identify a possible landslide area for further ground-based investigation.

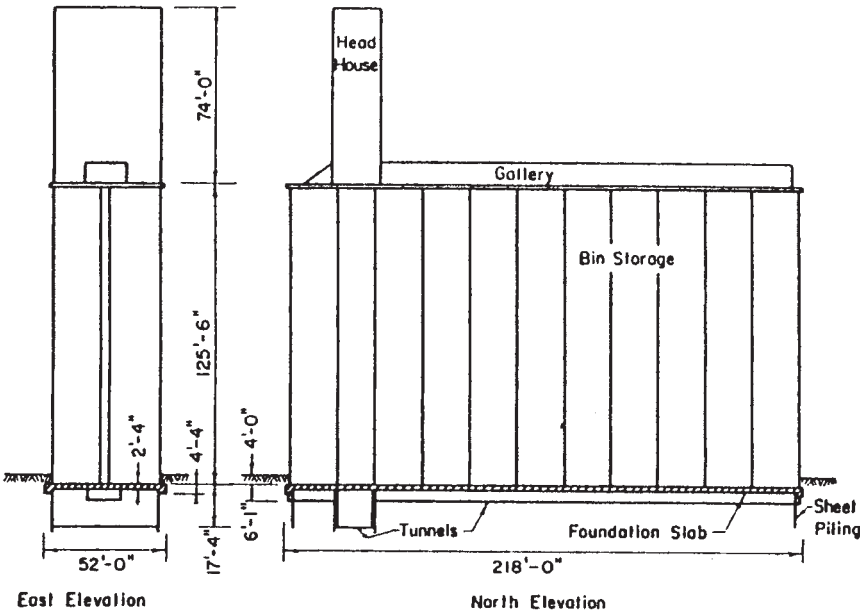
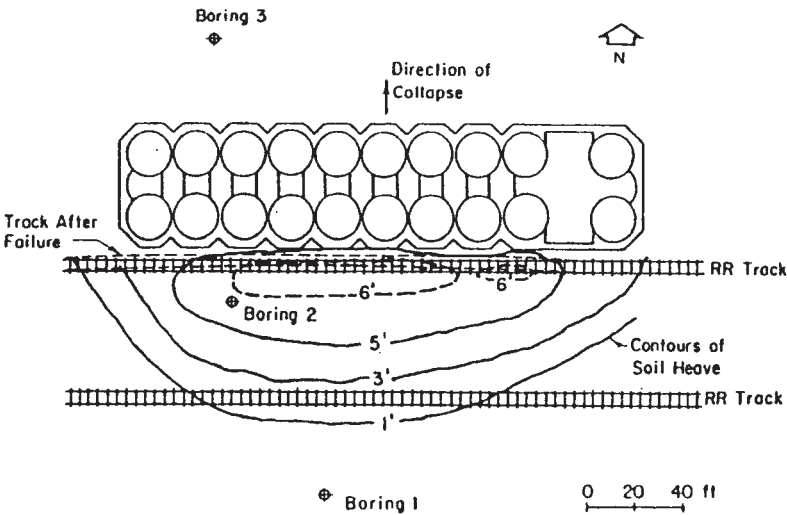
Figure 7-7. Fargo Grain Elevator.  
Source: Nordlund and Deere (1970).

ELEVATION VIEWS OF ELEVATOR

PLAN OF STRUCTURE AND SITE

The Fargo Grain Elevator collapsed 42 years after the Transcona Grain Elevator. Major filling began in April 1955, and the collapse occurred on June 12, 1955. The structure broke apart and was completely destroyed in the collapse. It collapsed in the northward direction, forming a mass of concrete rubble and grain with soil heaved up on the south side as much as 1.8 m (6 ft). Like the Transcona Grain Elevator, the Fargo structure was on part of the ancient Lake Agassiz clay deposits that stretch across much of the northern Great Plains of North America (Nordlund and Deere 1970). Figure 7-7 shows the elevation and plan of the failed grain elevator.

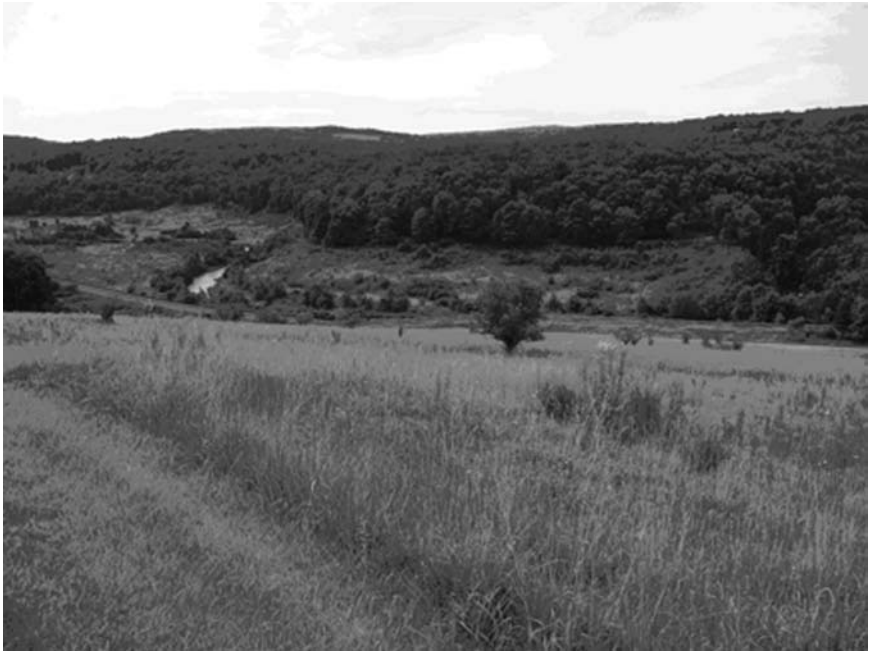
Figure 8-2. The basin of the former reservoir.

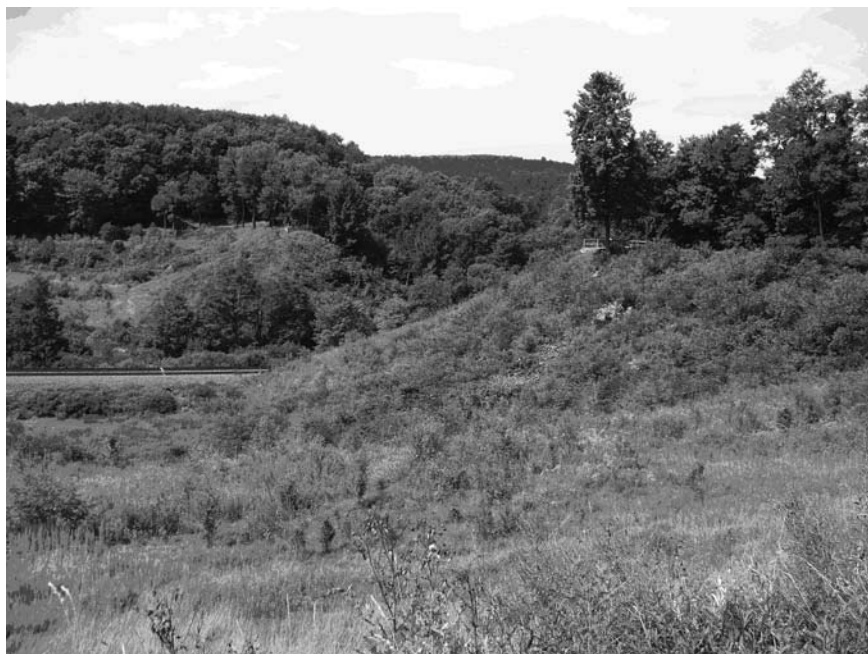
Figure 8-3. Remains of the South Fork Dam.

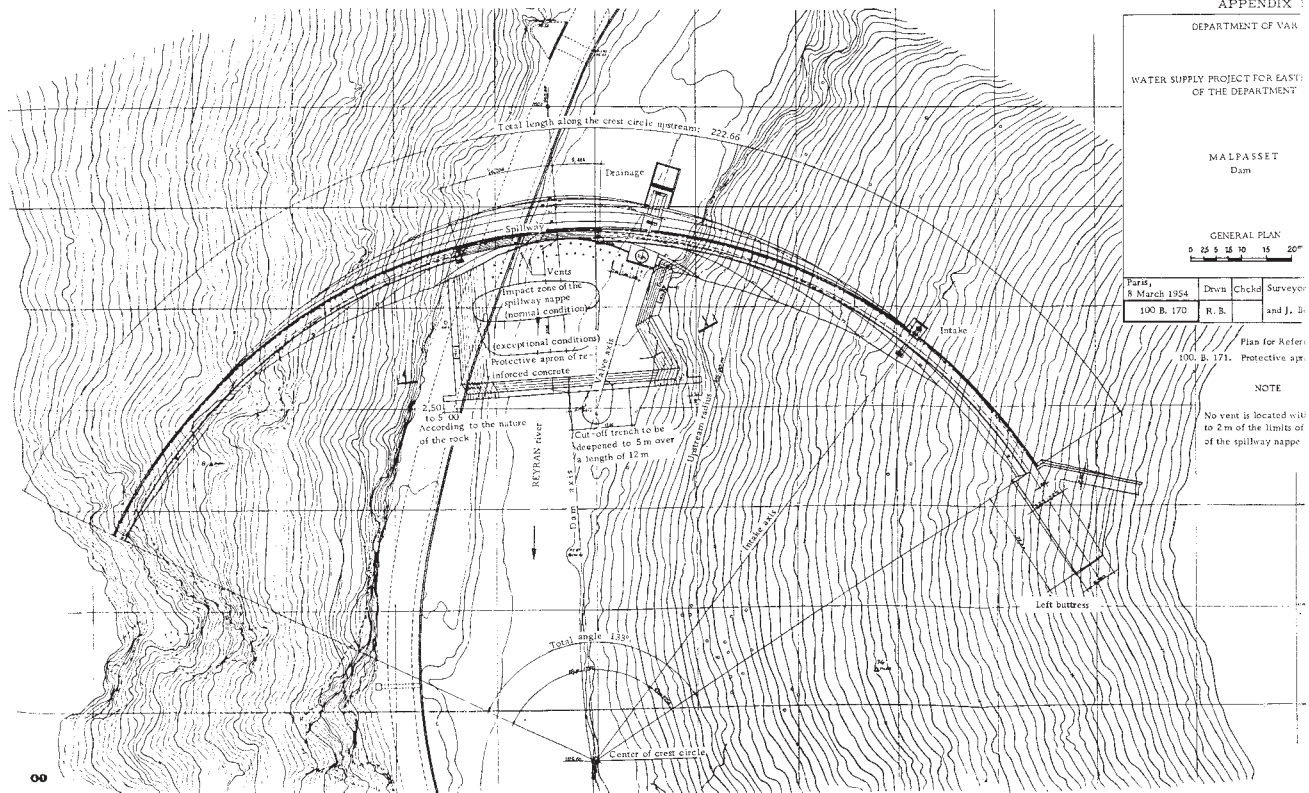
Figure 8-5. Plan view of the dam.  
Source: Ministère de l'Agriculture (1960).

The Malpasset Dam was a continuation of the work of the famed designer André Coyne, who had slowly been raising the allowable compressive stresses within arch dams. At Malpasset, the allowable compressive stress was increased from 2.4 MPa (355 lb/in.<sup>2</sup>) to 4.7 MPa (680 lb/in.<sup>2</sup>). When it was completed, Malpasset was the thinnest arch dam in the world (Ross 1984, p. 127). A plan view of the dam is shown in Fig. 8-5.

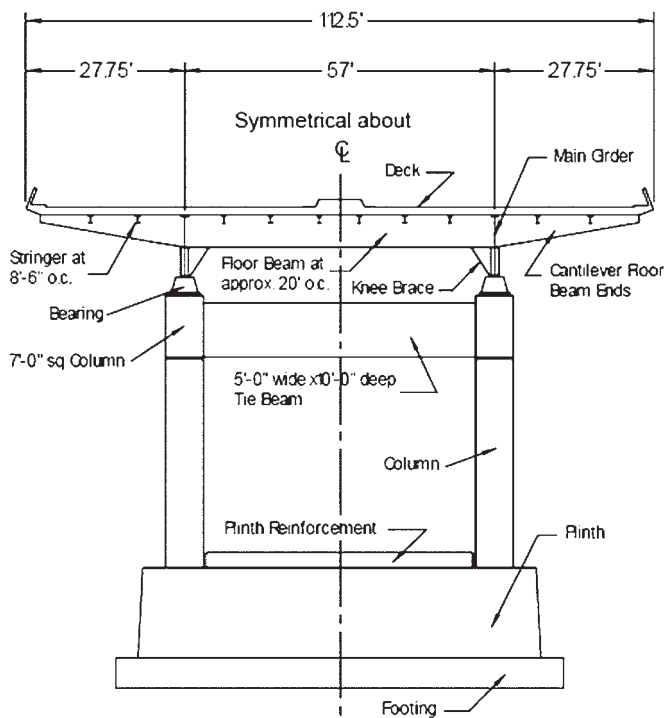
Figure 8-7. Schoharie Creek Bridge pier frames.

The New York State Department of Public Works (DPW), later named the New York State Department of Transportation (NYSDOT), approved the 165-m (540-ft) bridge for the crossing of the Schoharie Creek. The final design was submitted in January 1952 and consisted of five simply supported spans with nominal lengths of 30.5, 33.5, 36.6, 33.5, and 30.5 m (100, 110, 120, 110, and 100 ft). Concrete pier frames supported the bridge spans along with abutments at each end (Fig. 8-7).

The pier frames were constructed of two slightly tapered columns and tie beams. The columns were fixed within a lightly reinforced plinth, which was positioned on a shallow reinforced spread footing. The spread footing was to be protected by a layer of dry riprap. The superstructure was made up of two longitudinal main girders with transverse floor beams. The skeleton of the 200-mm (8-in.) thick bridge deck was made of steel stringers (WJE and MRCE 1987). A plan of the bridge spans is shown in Fig. 8-8.

Shortly after construction was completed, in the spring and summer of 1955, the Schoharie Creek Bridge pier plinths (shown in Fig. 8-7) began to

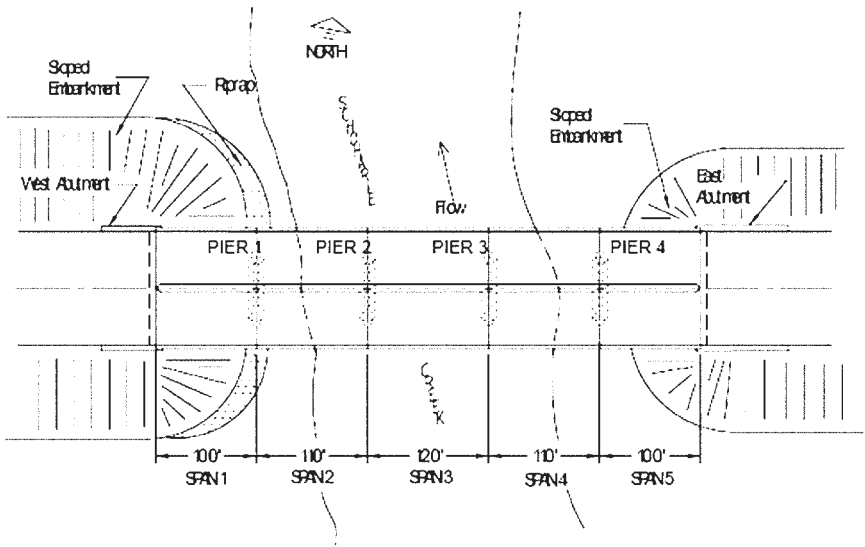
Figure 8-8. Schoharie Creek Bridge plan view.

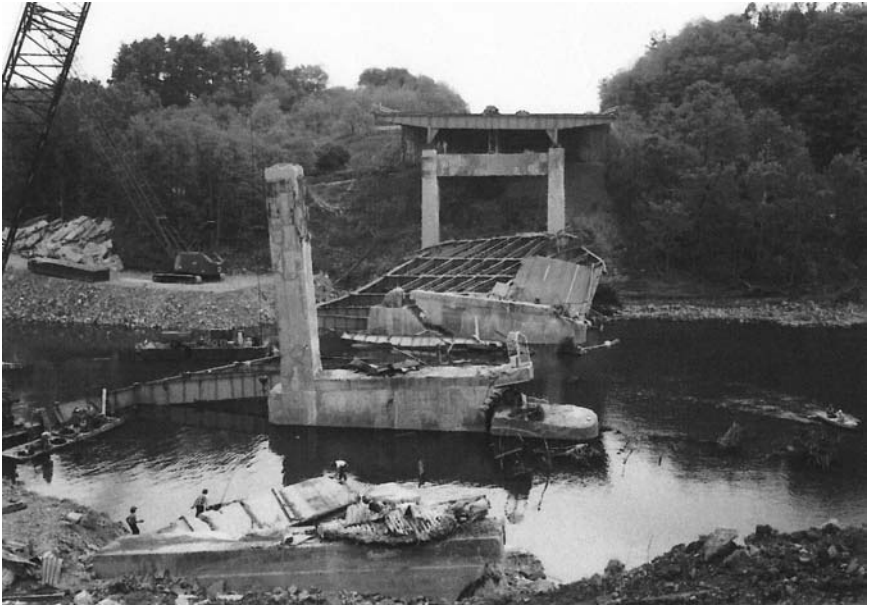
**Figure 8-9.** Schoharie Creek Bridge collapsed spans.  
Courtesy Howard F. Greenspan.

The collapse was initiated by the toppling of Pier 3, which caused the progressive collapse of Spans 3 and 4 into the flooded creek. The piers and spans are shown in Fig. 8-9. One car and one tractor-semitrailer were on the

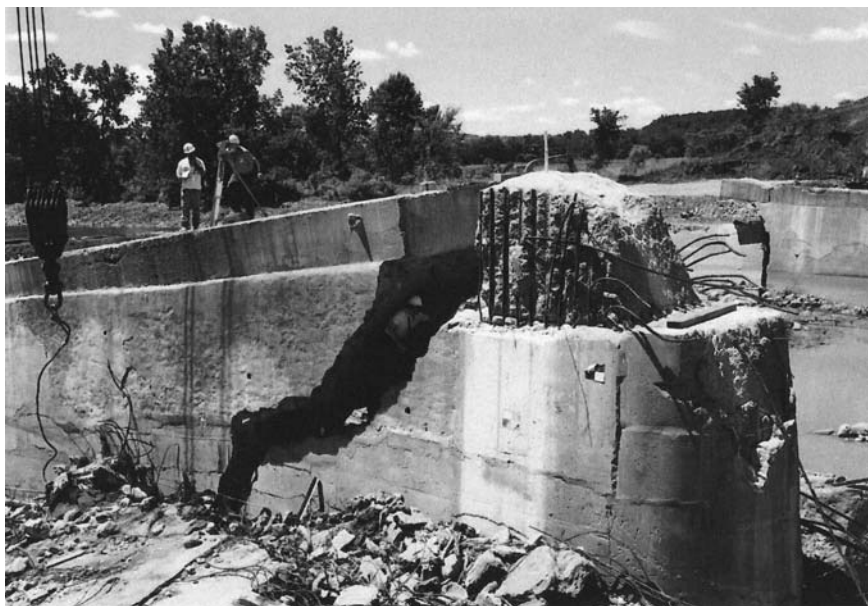
**Figure 8-10.** Schoharie Creek Bridge failed plinth.  
Courtesy Howard F. Greenspan.

Pier 2 and Span 2 fell 90 min after Span 3 dropped, and Pier 1 and Span 1 shifted 2 h after that (Thornton-Tomasetti 1987). The National Transportation Safety Board suggested that Pier 2 collapsed because the wreckage of Pier 3 and the two spans partially blocked the river, redirecting the water and increasing the stream velocity to undermine Pier 2 (NTSB 1988). The failed plinth is shown in Fig. 8-10.

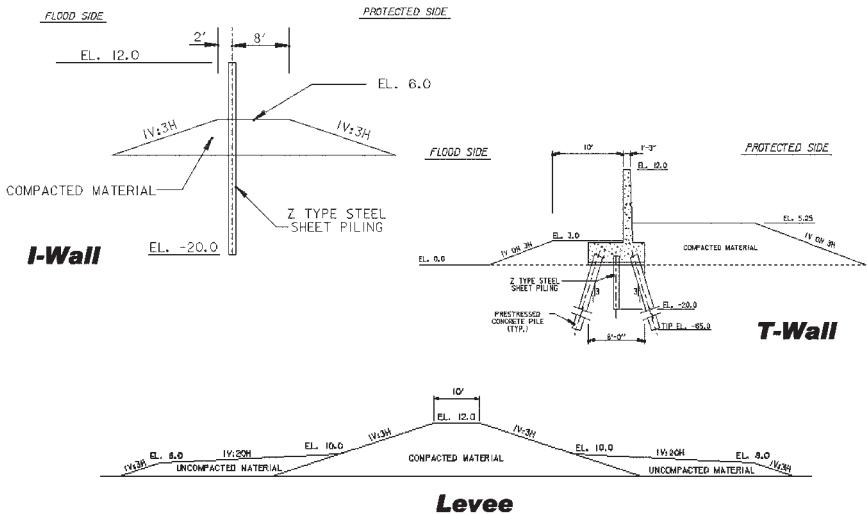
Figure 8-11. New Orleans floodwall and levee configurations.

The three types of flood protection structures designed and built by USACE were I-walls, T-walls, and levees. The levees were earthen dams made of compacted material or hydraulic fill, sloped at a rate of 1 vertical to 3 horizontal. As a result, a levee would need to be more than 6 times as wide as it was tall. Raising a levee, then, would require purchasing private property and demolishing buildings. Therefore, I-walls and T-walls were built on top of low existing levees to raise their height without widening them. I-walls were built from Z-type steel sheet piling, and T-walls were reinforced concrete structures shaped like an inverted T, supported by battered pilings. T-walls are much stronger than I-walls but also more expensive (ASCE Review Panel 2007, pp. 20–22). Figure 8-11 shows these flood wall and levee configurations.

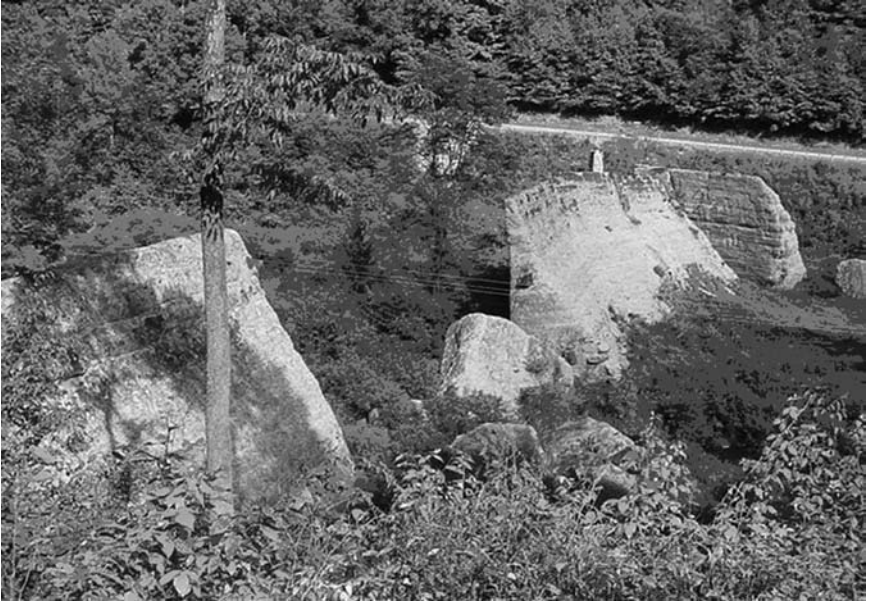
Figure 9-1. The failed Austin Dam.

The dam failed on the afternoon of Saturday, September 30, 1911. A hole opened at the west abutment, and the force of the water pushed out the blocks of concrete, which slid downstream. The water channeled as a large wave between the high vertical valley walls, and it smashed into the town of Austin (Freiman and Schlager 1995b, p. 208). The remains of the failed dam are shown in Figs. 9-1 and 9-2.

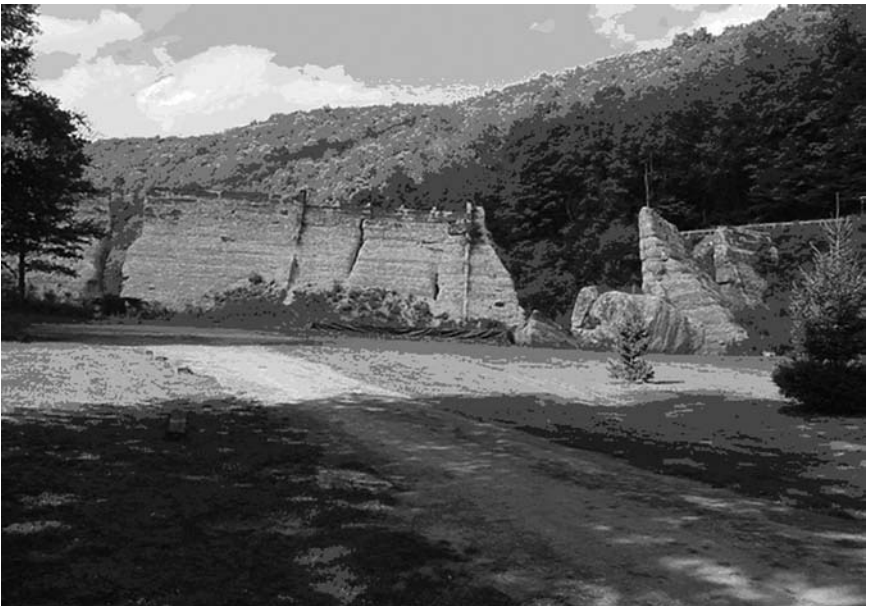
Figure 9-2. The failed Austin Dam.

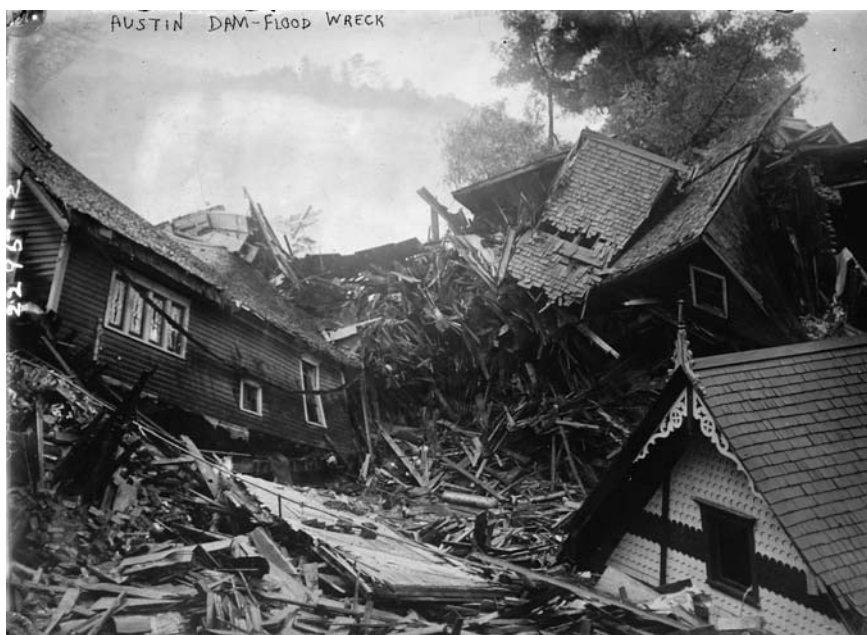
**Figure 9-3.** Damage from the Austin Dam failure.  
Courtesy Library of Congress.

As the water destroyed a lumber mill, it picked up the logs and lumber as debris. The mill's whistle blew, but for many the warning would be too late. Most of the buildings in the town were destroyed (Greene and Christ 1998, p. 10). Figure 9-3 shows the extent of the damage in Austin.

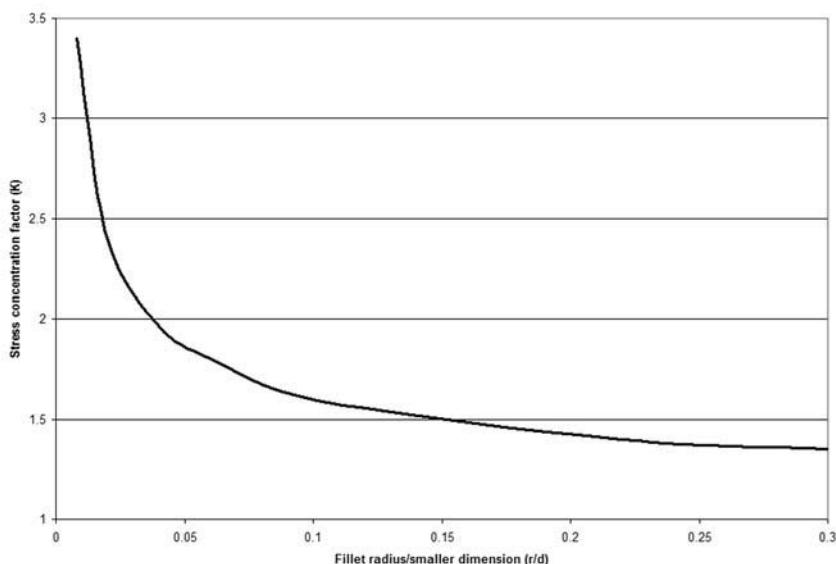
Figure 9-4. Stress concentration factors (Wider dimension  $D$  10% larger than smaller dimension  $d$ ).

Figure 9-4 shows a typical curve for determining stress concentration factors for fillets. The stress concentration factor  $K$  is a function of the radius of the fillet. The nominal average stress is multiplied by  $K$  to get the maximum stress:

Note that as the radius approaches zero, for a sharp corner, the stress concentration factor approaches infinity. The solution represented by this curve is based purely on elastic considerations and does not account for material yielding. The stress concentration factor remains the same whether the material is steel, concrete, wood, or silly putty.

With ductile materials, such as mild steel, stress concentrations are relieved as the steel yields. The theoretical maximum stress, shown in Fig. 9-4, does not occur because the steel at the stress concentration yields, and the stresses are redistributed.

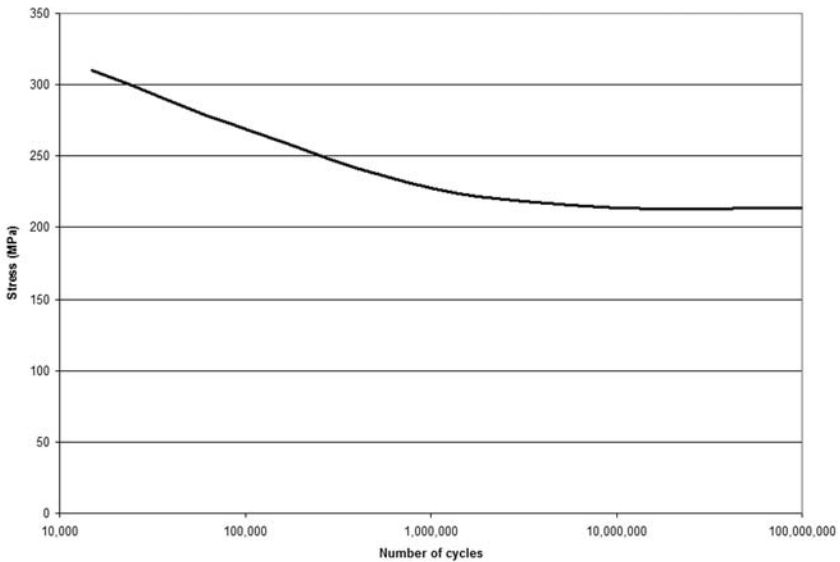
Figure 9-5. Fatigue S-N diagram (1 MPa = 145 psi).

Different materials have different  $S$ - $N$  curves describing the relationship between applied stress and number of cycles to failure. Figure 9-5 shows a typical  $S$ - $N$  curve for structural steel.  $S$  is the stress level, and  $N$  is the number of cycles to failure, which increases as  $S$  decreases. When  $S = 220$  MPa (32 kip/in.<sup>2</sup>), the material fails immediately with the first loading cycle. If  $S$  is sufficiently small, the material may theoretically sustain infinite load applications, and the stress is said to be below the material's endurance limit. If the approximate number of load cycles  $N$  can be predicted, the designer needs to merely ensure that all stress ratios are low enough so as to remain below the  $S$ - $N$  curve.

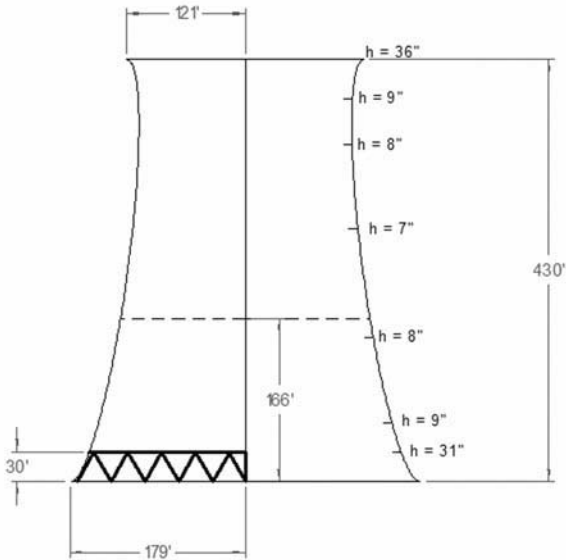
**Figure 9-6.** Willow Island Cooling Tower dimensions (1 in. = 25.4 mm, 1 ft = 0.305 m).

Two natural-draught hyperbolic cooling towers were to be built for the Pleasants Power Station, a coal-fired power station in Willow Island, West Virginia. These towers were designed to be large, chimneylike towers with a distorted hourglass shape, which would allow air to circulate without fans because the warmer air inside would rise naturally. The base diameter was 109 m (358 ft), but both diameter and shell thickness would change with the height of the tower (Schlager 1994). The cooling tower dimensions are shown in Fig. 9-6, and the two towers are shown in Fig. 9-7.

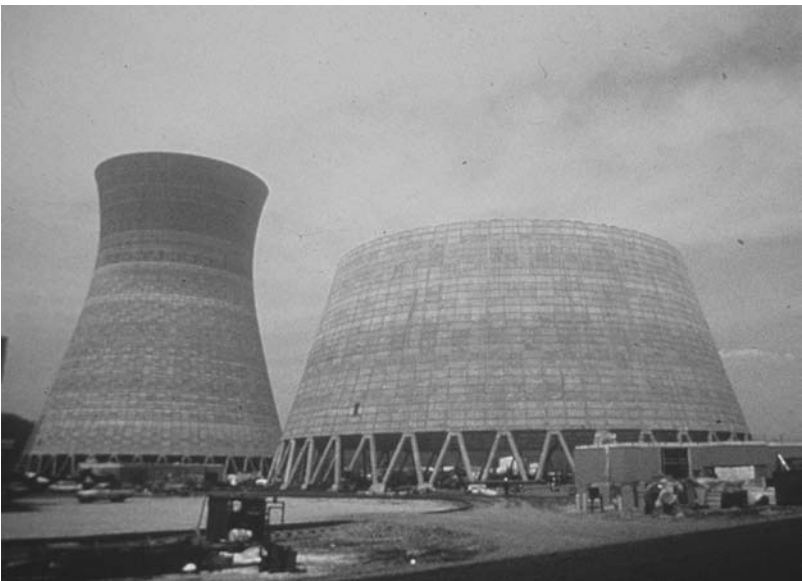
**Figure 9-7.** Willow Island Cooling Towers.

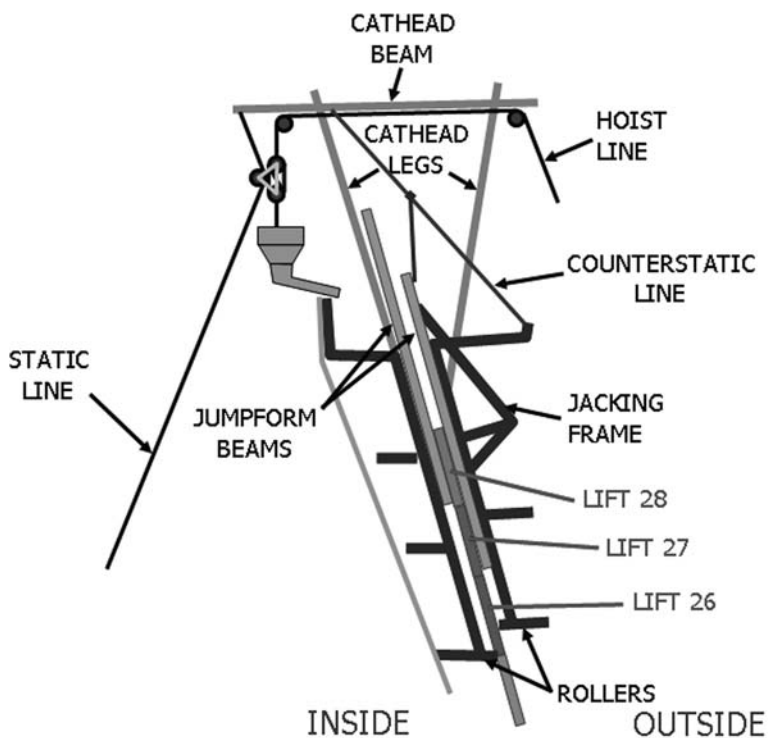
Figure 9-8. Willow Island Cooling Tower jump form system.

assemblies, jacking frames, formwork, and scaffolding platforms (Velivasakis 1997). Some of these components can be seen in Fig. 9-8.

A four-level-high system of scaffolding was used, and working platforms were suspended from the inside and outside jacking frames. At the top level, the construction materials were received by the hoisting system, steel reinforcement was distributed, and concrete was delivered. The second level was used only during the formwork adjustment process. Levels three and four of the scaffolding system provided access to the jumpform beams, and final surface preparation such as patching and grouting was done from these levels (Lew 1979). The scaffolding system was entirely supported by the previously completed portion of the tower. Each day, a 1.5-m (5-ft) lift was completed, and the entire scaffolding system moved with the jacking frame to the new elevation.

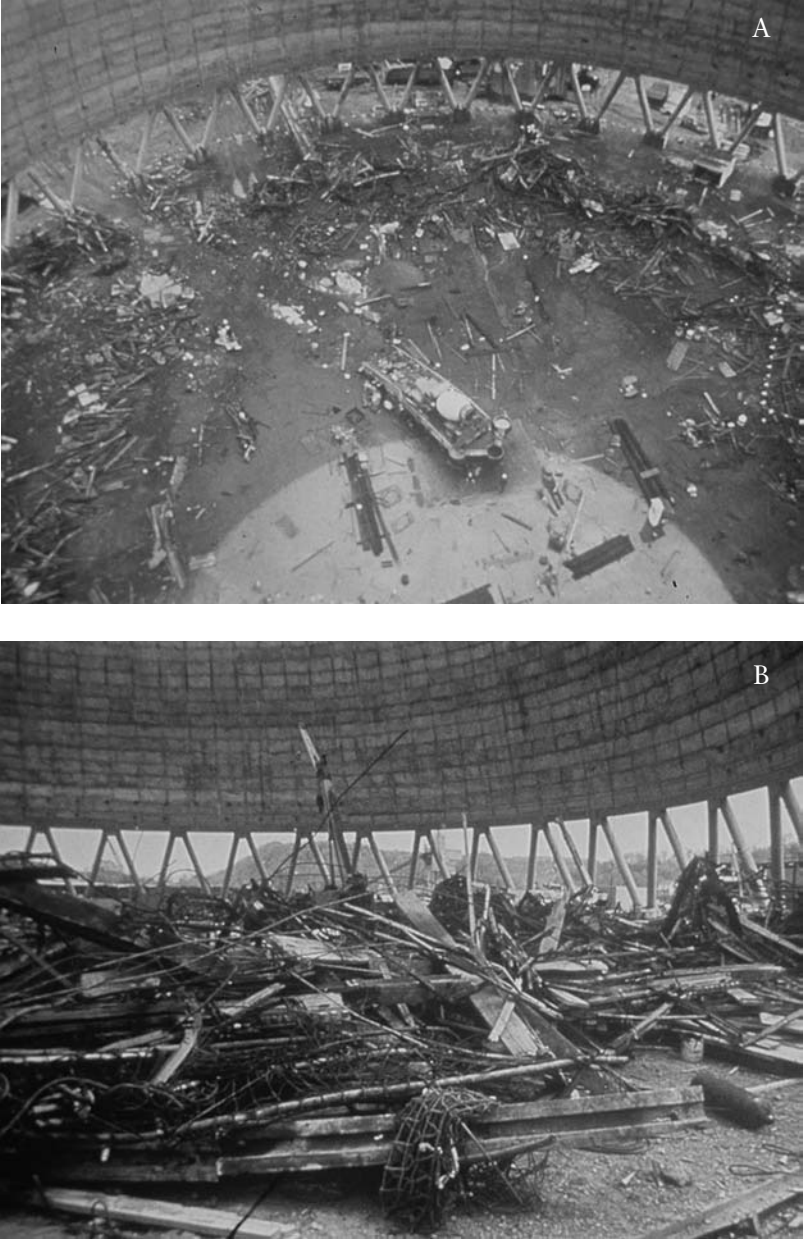
**Figure 9-9a, b.** Willow Island Cooling Tower collapse.  
Courtesy National Bureau of Standards/National Institute of Standards and Technology.

The first cooling tower was completed in August 1977, but on April 27, 1978, during construction of the second tower, the formwork system failed. While concrete was being placed for lift 29, 52 m (170 ft) above the ground, lift 28 collapsed, and 51 workers fell to their deaths. The scene of the collapse is shown in Fig. 9-9.

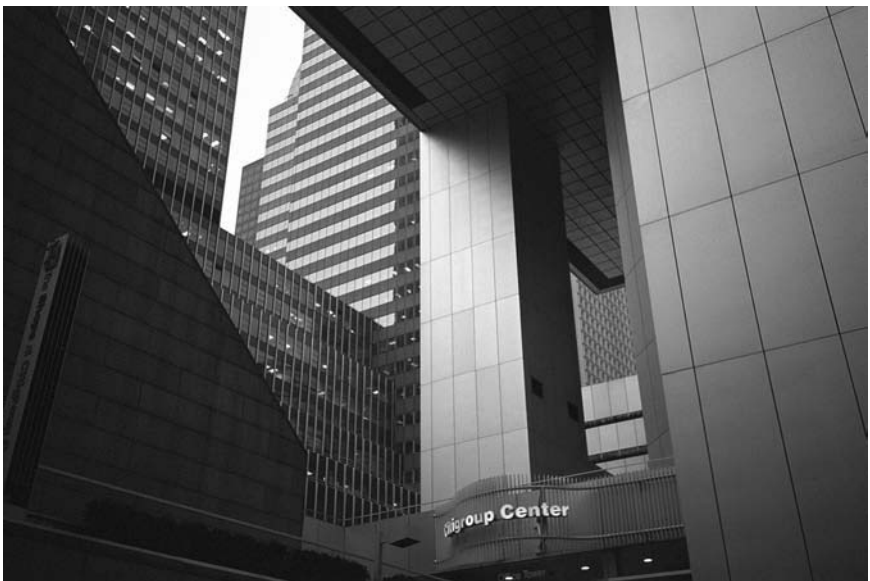
**Figure 10-1.** St. Peter's Church under the Citicorp Tower.  
Courtesy Bob Pitt, University of Alabama.

the block for this building was occupied by the historic St. Peter's Church, which did not want to move although it would have been replaced at the same place with a new church. Therefore, LeMessurier and Hugh Stubbins, the architect, decided to place the main load-bearing columns at the center of each side. Figure 10-1 shows the church under the building, on the left side of the photograph.

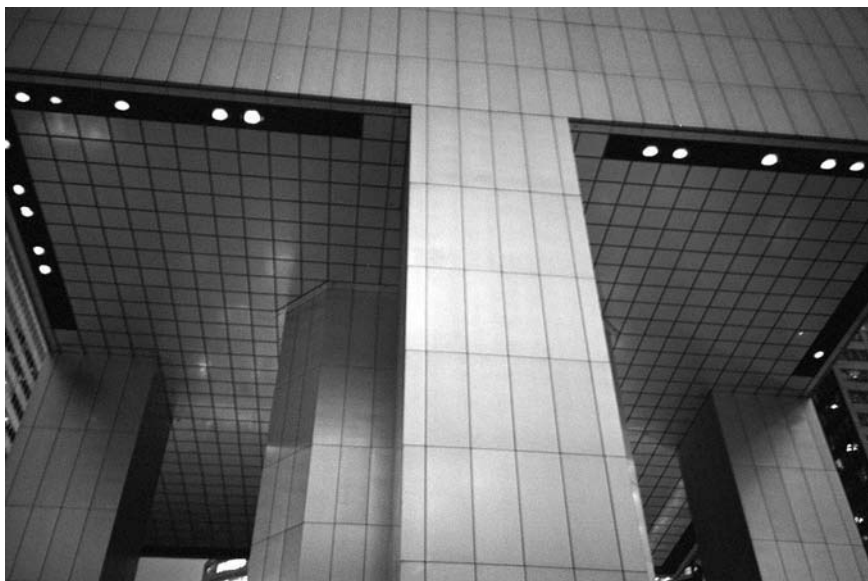
**Figure 10-2.** Citicorp Tower legs.  
Courtesy Bob Pitt, University of Alabama.

This design put the entire structure on four massive nine-story-high stilts, with the skyscraper appearing to hover over the block. To carry the gravity loads at the corners of the building, multistory diagonal chevron braces framed into the main columns. A total of 48 braces was arranged in six tiers of eight each. Figure 10-2 shows one of the tower legs.

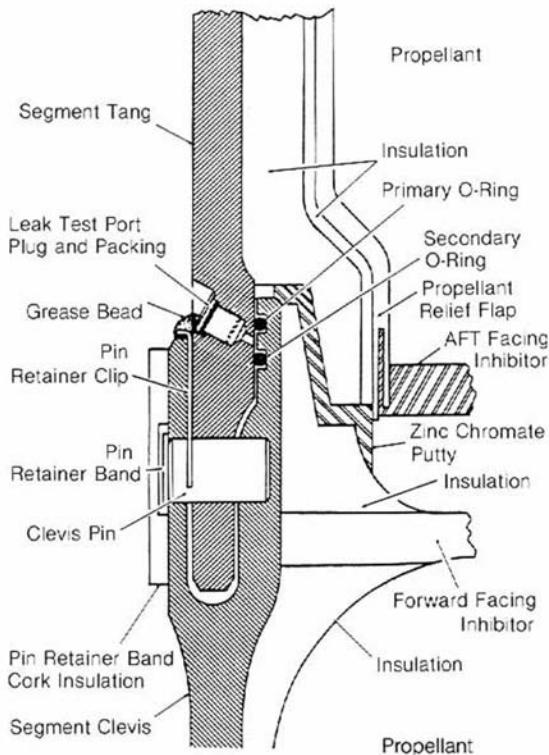
Figure 14  
Solid Rocket Motor cross section shows positions of tang, clevis and O-rings. Putty lines the joint on the side toward the propellant.

**Figure 10-4.** Space Shuttle *Challenger* O-ring joint.  
Courtesy National Aeronautics and Space Administration.

tect the ring itself from the gases. The gap between the tang and the clevis is adjusted with shims to reduce the gap and increase the compression of the O-ring (Space Shuttle *Challenger* Disaster 2007). The O-ring joint is shown in Fig. 10-4.

Several factors affect the size of the gap, including dimensional tolerances of metal cylinders and the tang and clevis assembly, the temperature, the O-ring diameter, the shims, and the loads applied to the joint. When the booster is ignited, internal pressure presses against the putty and forces the O-ring into the gap between the tang and clevis to form a seal (Space Shuttle *Challenger* Disaster 2007).
