FORENSIC ENGINEERING

**Damage Assessments for
Residential and Commercial
Structures**

**Edited by
Stephen E. Petty**

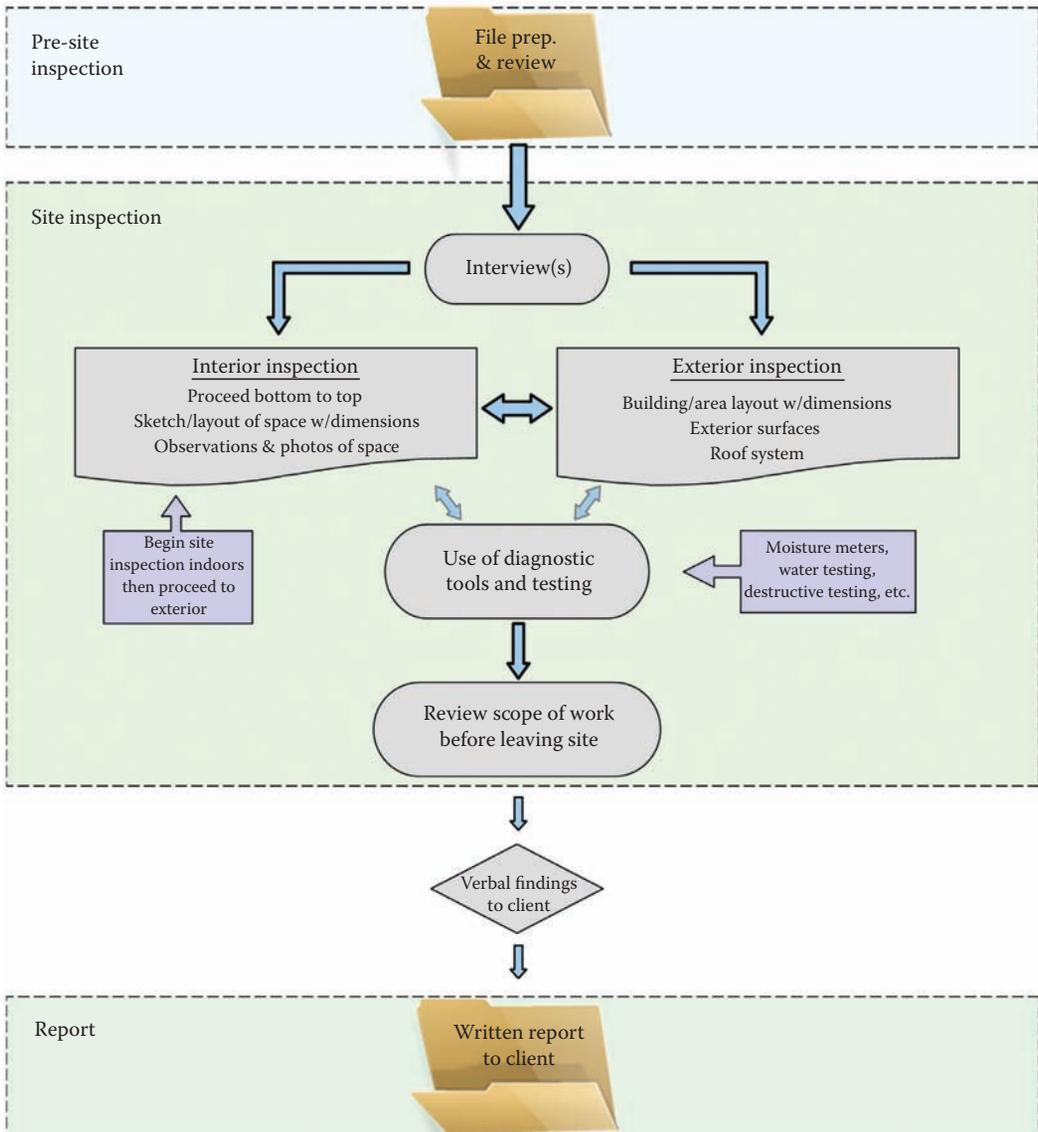
FIGURE 1.8

Generic forensic site inspection process flowchart.

In this section, the key elements of a generic forensic inspection are outlined and discussed. For specific types of inspections (e.g., hail, wind, water, structural), additional case-specific inspection recommendations are provided in that particular chapter. Based on thousands of completed field inspections, a recommended inspection process is illustrated in Figure 1.8; elements in Figure 1.8 are discussed in the text that follows.

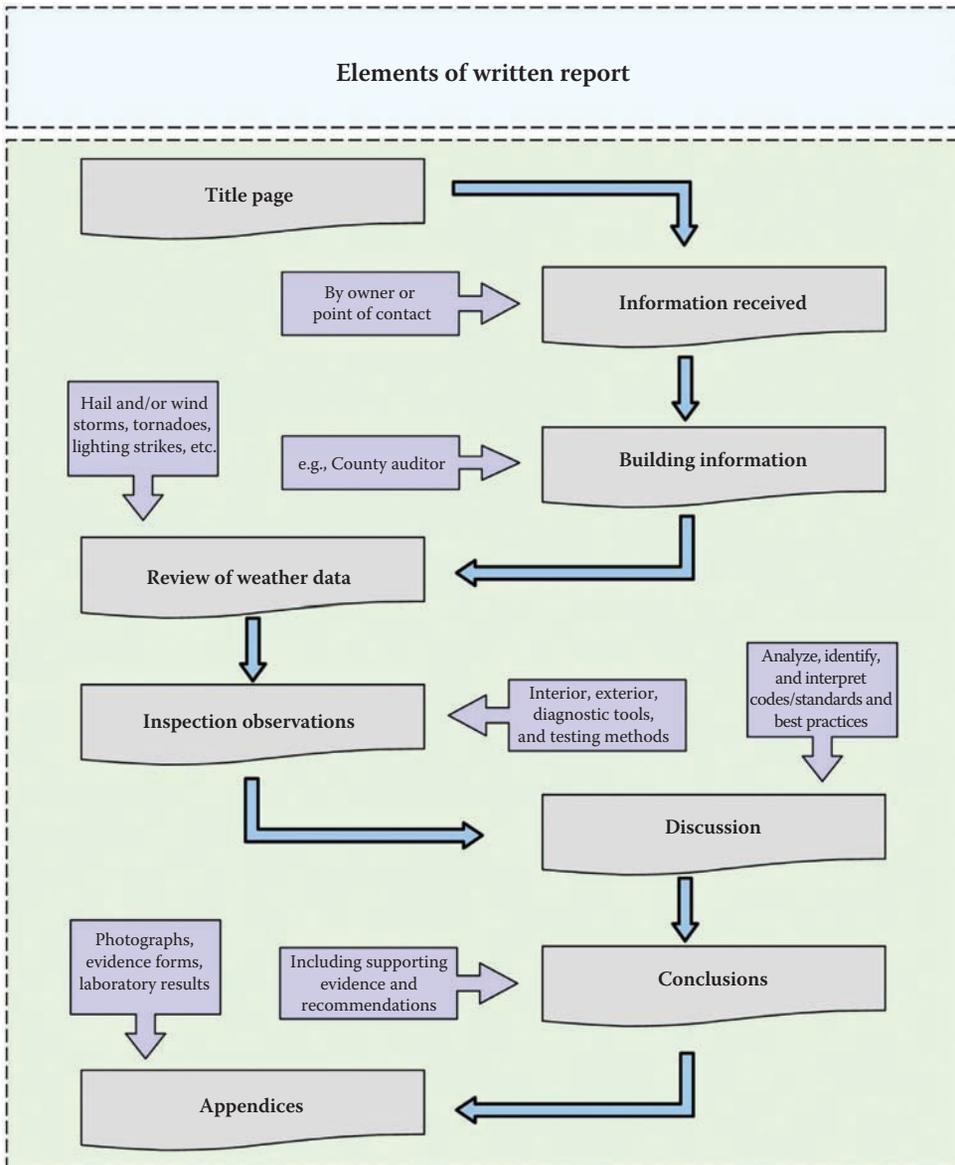
**FIGURE 1.9**

Report outline flowchart—key elements.

A recommended report outline flowchart with key elements is illustrated in Figure 1.9; these elements are discussed in the text that follows. Another example of how to prepare a written forensic report is provided in Chapter 11 of Dickenson and Thornton's textbook *Cracking and Building Movement*.³

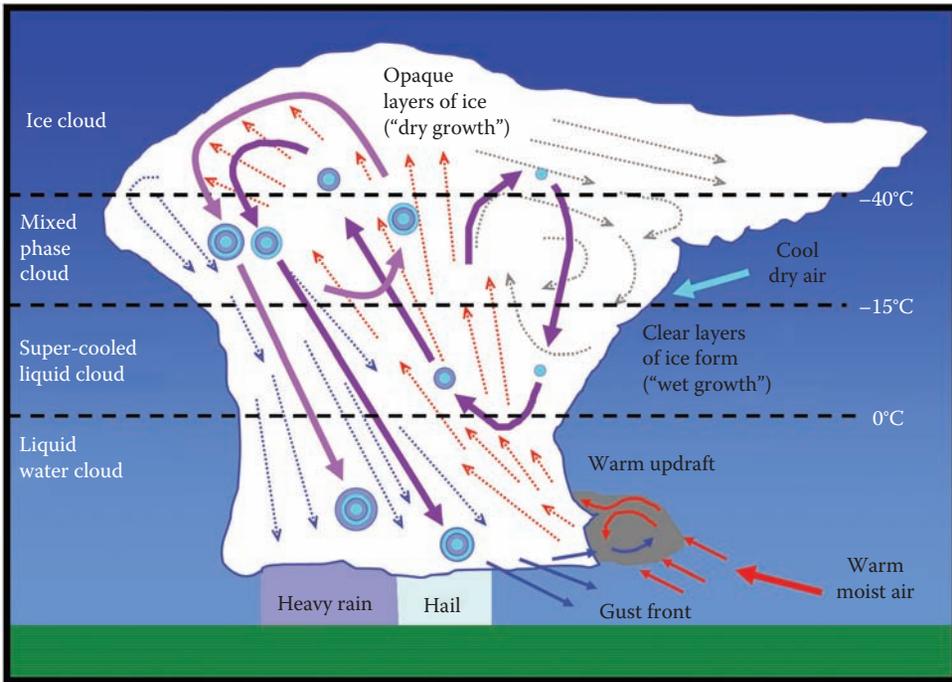
FIGURE 2.3
Hailstone formation within a thunderstorm cloud.

The formation of hailstones first begins with a hailstone “embryo” or “kernel,” which typically consists of supercooled water freezing on contact with frozen raindrops, ice crystals, dust, or other types of nuclei that have been drawn into the colder regions of the cloud and serve as a core for the hailstones’ initial growth.^{5,6} Then, due to the storm’s updraft, the newly formed hailstones are lifted and cycled through different elevations (and temperatures) within the cloud, which allows more supercooled water to freeze to the surface of the hailstones, creating layers of accumulating ice and increasing the size. The hail then falls to the ground by gravity when the updraft is unable to support the weight of the hail or the updraft intensity weakens (Figure 2.3).

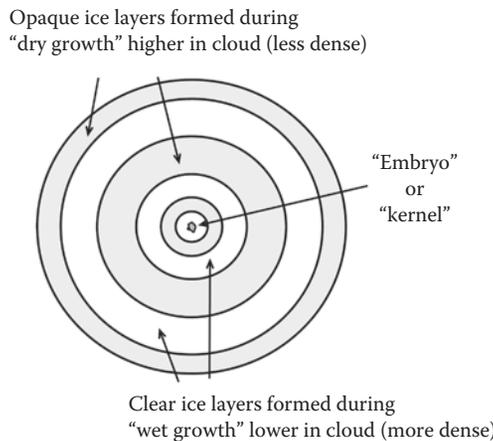
FIGURE 2.4
Cross-sectional view of hailstone—clear and opaque layers indicating location of ice formation.

The physical characteristics of falling hailstones are dependent on their formation processes within the thunderstorm cloud. As mentioned in the preceding section, the formation of hailstones occurs as frozen particles are cycled through different regions of the thunderstorm cloud, thus creating layers of ice. Examining the cross-section of a hailstone (Figure 2.4) typically reveals onion-like layers of clear and opaque ice.

The ice layers form on a hailstone in two ways: by “dry” growth and by “wet” growth. These layers indicate where in the thunderstorm cloud the ice formed.^{5,6} The opaque layers of ice are formed during dry growth processes high in the storm cloud where the air temperatures are well below freezing, causing water droplets to freeze instantly upon impact with the forming hailstone, trapping air bubbles, which is what gives it a cloudy or milky appearance.

The clear layers of ice are formed during wet growth processes lower in the storm cloud where the air temperatures are below freezing ($\leq 32^{\circ}\text{F}$) but are not super cold. The slightly

This same coefficient of restitution factor must be accounted for when comparing laboratory results using solid ice balls (or even steel balls) to simulate actual hail-strike damage to various materials, because actual hail is typically more of a composite material (see Figure 2.4) and more likely to break apart or absorb more energy on impact. This factor accounts for why hailstone size thresholds for actual hail-strike damage to materials tend to be greater than the results from laboratory tests using solid ice balls.

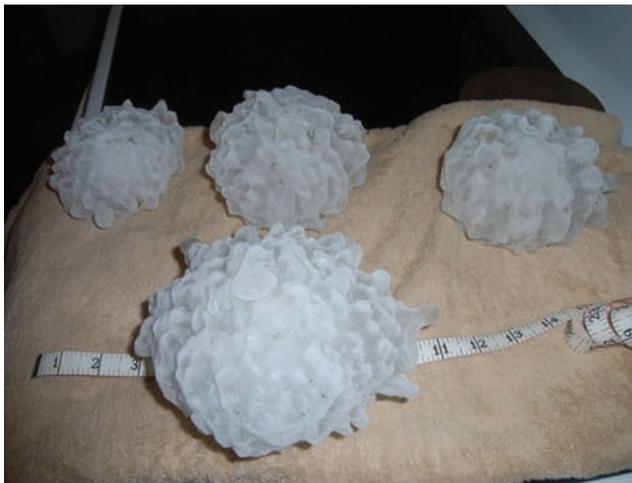
FIGURE 2.5

The largest hailstone recorded in the United States (to date)—Vivian, South Dakota, Hailstorm—July 23, 2010. (Courtesy of the NOAA, Aberdeen, SD, Weather Forecast Office and the Department of Commerce.)

As might be expected, giant hailstones form in high-intensity thunderstorms, with very high cloud tops capable of generating relatively large uplift forces. The greater uplift allows for larger hailstones to be cycled through the higher regions of the cloud more frequently, and as the wet hailstones from the lower region are pushed to the higher, colder regions at the top of the storm cloud, the conditions exist for the differing size hailstones to fuse together and form onto larger hailstones, creating the very “jagged” appearance of giant hailstones (Figure 2.5).

To date, the largest recorded hailstone to have fallen in the United States (Figure 2.5) fell in Vivian, South Dakota, on July 23, 2010; it was 8.0 inches in diameter, had a circumference of 18.62 inches, and weighed in at 1.94 pounds! The man who discovered the massive stone reported that, due to a six-hour power outage, the stone had even melted slightly!⁹

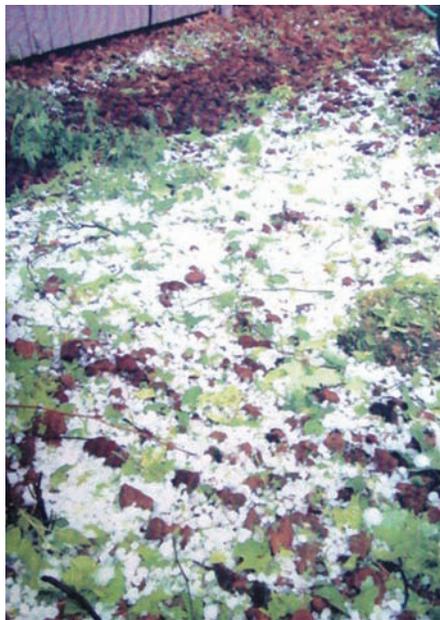
FIGURE 2.6

Distribution of various sizes of hailstones produced in hail swath.

Hail swaths vary in size and can range from just a few acres to 10 miles across and hundreds of miles long.¹¹ Various sized hailstones are produced from the thunderstorm as the hail swath is created (Figure 2.6).

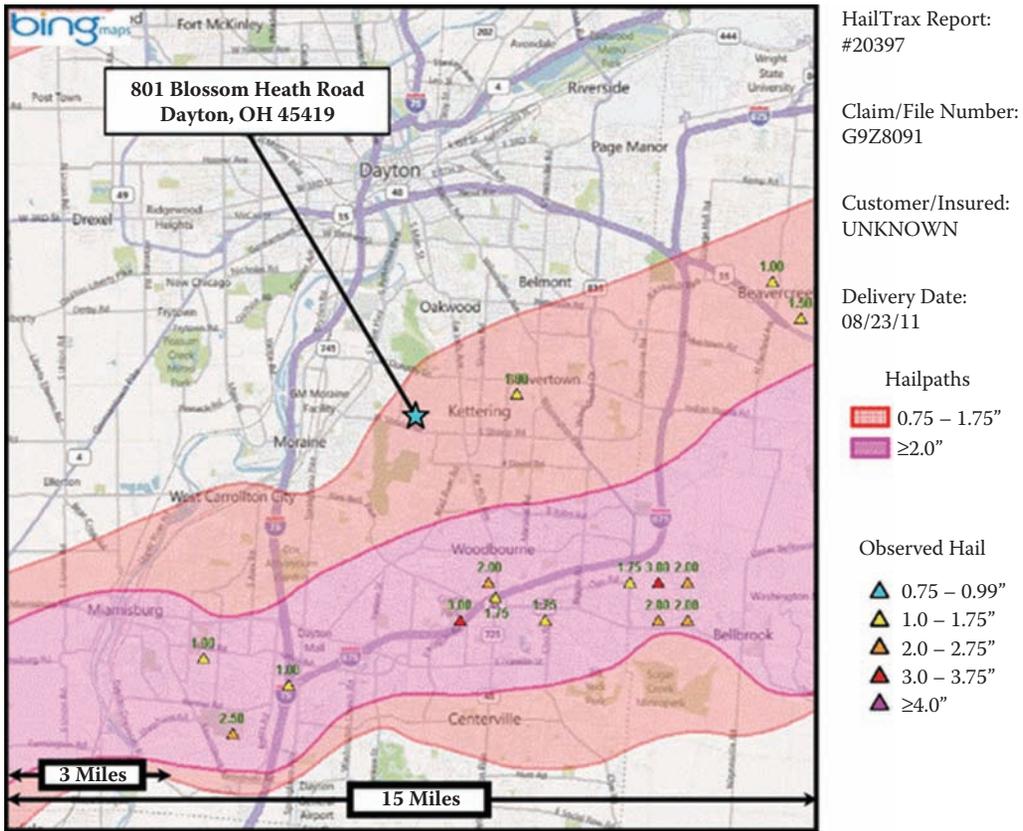
FIGURE 2.7 Hailstorm passing through southwest-central Ohio—May 25, 2011. (Courtesy of Weather Decision Technologies, Inc.)

The smallest hailstones are produced throughout the entire hail swath, whereas the largest hailstones produced by the storm fall in a smaller region of the hailstorm path. This is illustrated in Figure 2.7,¹² which shows that the largest hail tends to fall in the center of a storm path, with smaller hail on the edges (and often the beginning and ends of the hailstorm swath). Whether a residence or structure is in the center of the path, the edge, the beginning, the end, or outside of the storm path, along with the size of the hail at various locations within the swath, will determine the possibility and extent of hail-strike damage to surfaces in its path.

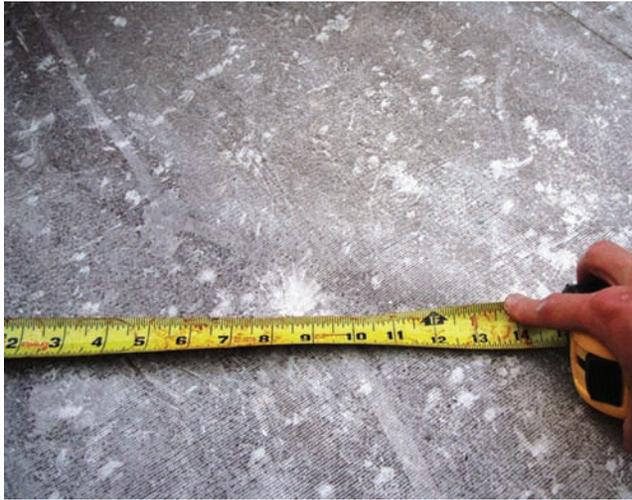
FIGURE 2.8
Spatter marks on PVC-covered awning.

Directionality can often be determined by onsite inspections of various surfaces of the building envelope that exhibit spatter marks. Spatter marks (areas similar in appearance to the marks created by insects or falling bird droppings after they have impacted the windshield of a moving automobile) correspond to the area where the impacting hailstone has removed the thin layer of oxidation or biological growth (Figures 2.8 through 2.10). Based on an inspection of the orientation and geometry of the spatter marks, the direction of a hailstorm and the fall patterns of hailstones can be determined (Figures 2.10 and 2.11). Hail-strike spatter marks, similar to those shown in Figures 2.8, 2.10, and 2.11, indicate hailstones that fell at an angle or with a certain degree of wind assistance. Spatter marks

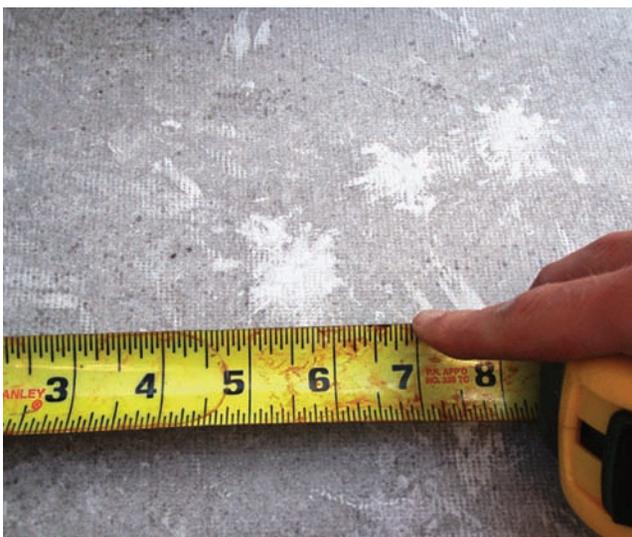
FIGURE 2.9
Spatter marks on PVC-covered awning.

that appear more circular in appearance with “tails” extending from nearly all sides, as shown in Figure 2.9, suggest a hailstone that fell relatively straight down and shattered upon impact with the surface. Additionally, by measuring the width of the initial impact area of the spatter mark (Figure 2.11), an estimation of the size of the impacting hailstone can be determined; however, other size indicators are more reliable (see Section 2.4.6). It should be noted that spatter marks, otherwise known as *burnish* or *skid marks*, only affect the surface and will disappear with time.¹³

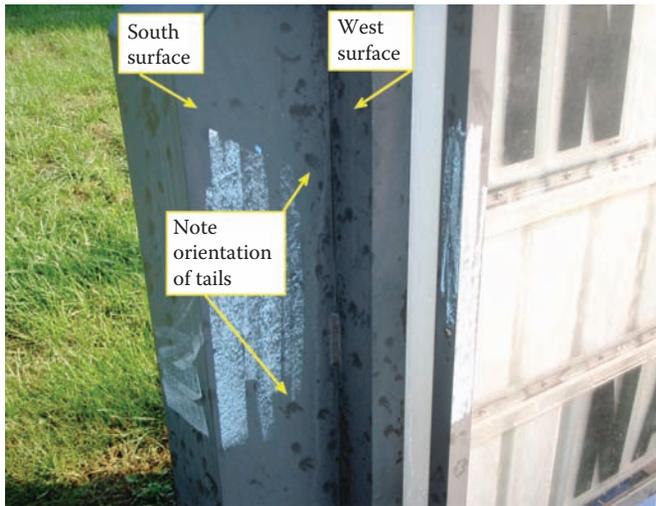
FIGURE 2.10
Spatter marks on west and south metal surfaces on home used to determine directionality.

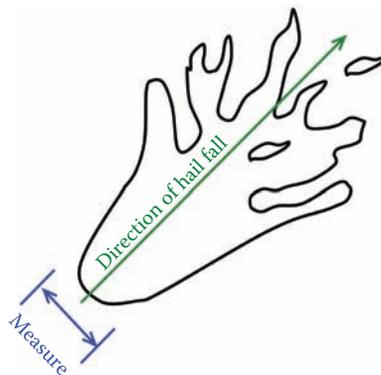
FIGURE 2.11
Spatter marks on west and south metal surfaces on home used to determine directionality.

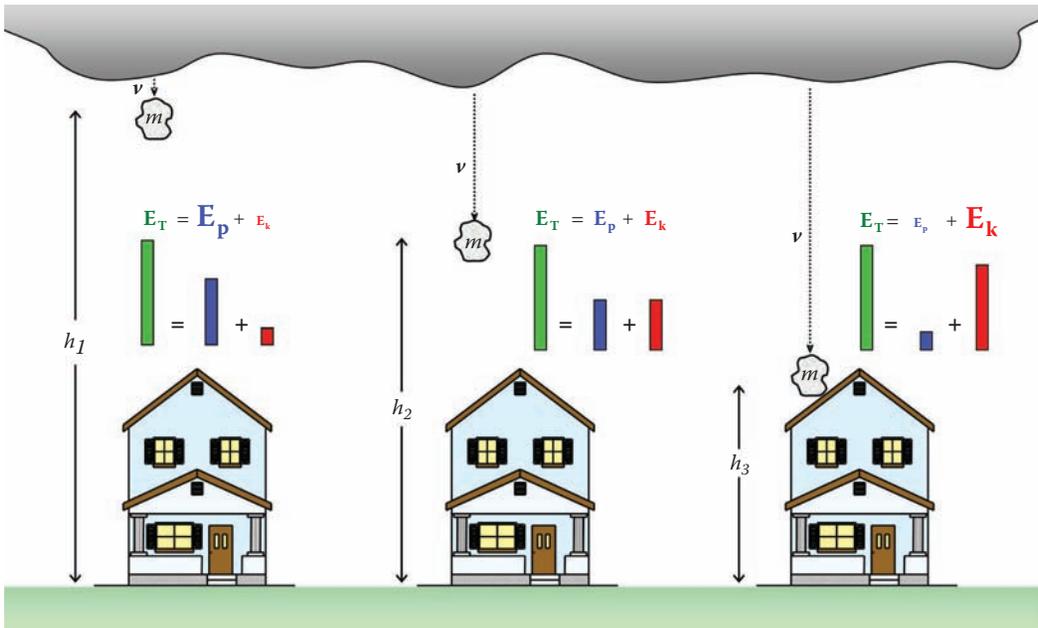
FIGURE 2.12

Law of conservation of energy for a falling hailstone—total energy stays the same while potential energy decreases and kinetic energy increases.

Taking a look again at Equation 2.1 for the law of conservation of energy and keeping in mind that the total energy of the system stays the same throughout the descent of the hailstone to the roof or ground, the following statements hold true, as shown in Figure 2.12:

1. Position 1 (left): The total energy of the falling hailstone is predominantly due to its potential energy with a slight component of kinetic energy since it is moving.
2. Position 2 (middle): The total energy is somewhat split between both energy forms.

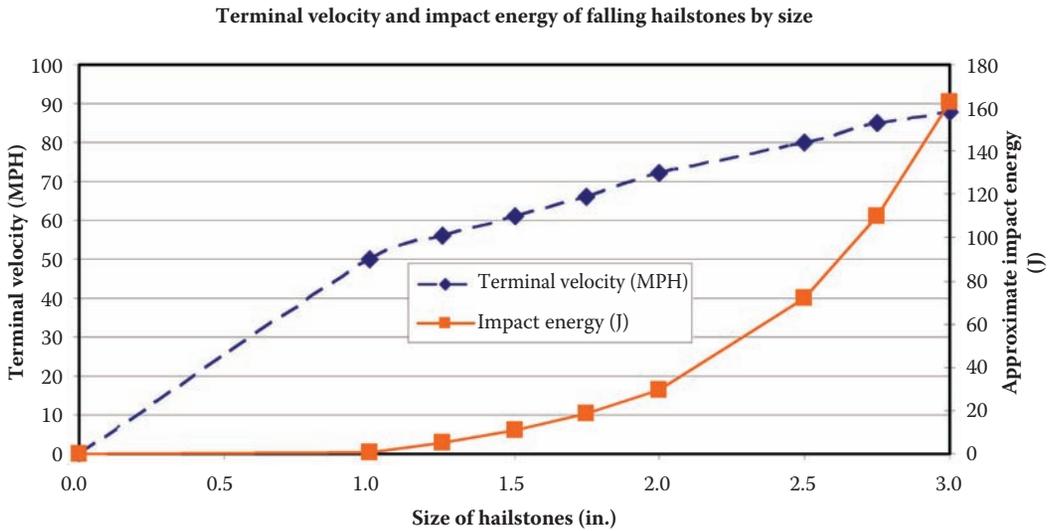
FIGURE 2.13
Approximate impact energies and terminal velocities of falling hailstones.

Now that the total energy of the hailstone just prior to impact with a roof surface has been determined to be essentially kinetic energy, further analysis of different size hailstones can be performed. In the 1960s, J. A. P. Laurie,¹⁵ an early hail researcher, analyzed data that had been collected and published by Bilham and Relf in 1937 and calculated the terminal velocities and approximate impact energies associated with hailstones of differing sizes.^{7,16} The information gathered from this analysis is summarized in Table 2.3 and Figure 2.13, from which we can conclude:

53%. This is primarily due to the slower rate of increase in terminal velocity as the size of the hailstone increases, which is related to the square of the impact energy, whereas the increase in mass only increases the energy linearly.

Note that the greatest increases in impact energy (i.e., kinetic energy), per quarter-inch increase in diameter, occurred for hailstones measuring 1.0 inch to 2.0 inches in diameter. This analysis predicts that the impact energy generated by the 1.25-inch hailstone is 698% (6.98 times) the impact energy for the 1.0-inch hailstone compared with the change in impact energy of moving from 1.0- to 2.0-inch diameter hailstones, where the impact energy increases by 2091% (20.91 times)!

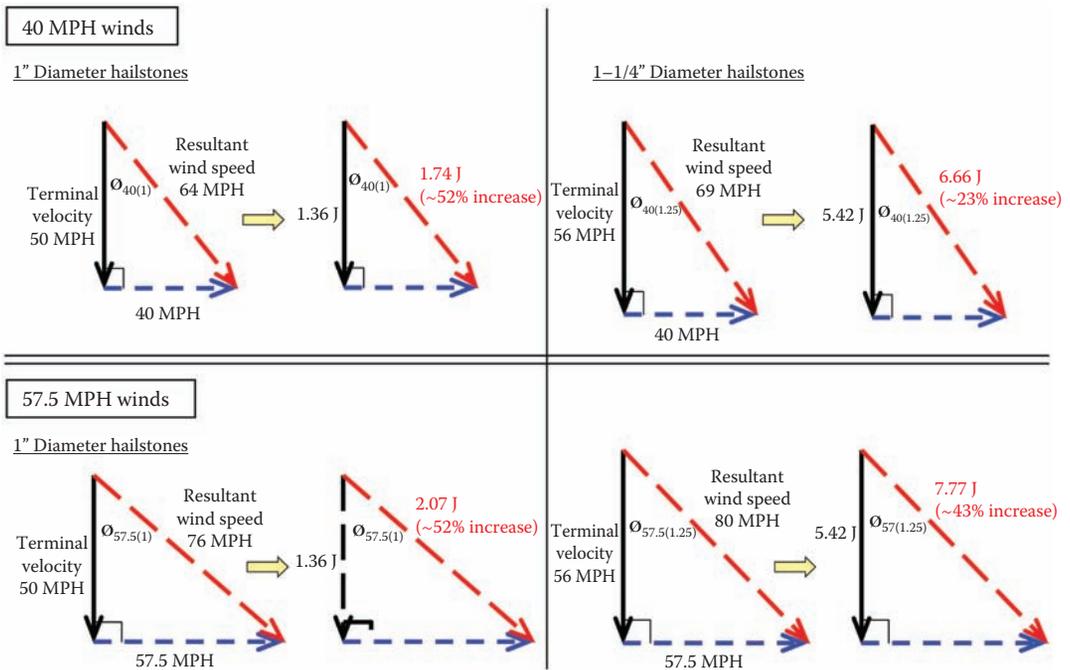
FIGURE 2.14
Wind effects on hail impact energies.

The energy calculations performed by Laurie¹⁵ used the terminal velocity of the hailstone as its vertical, free-fall velocity; however, hail generally does not fall straight down but rather has a horizontal wind component, thus the energy associated with actual falling hailstones (i.e., diagonal fall trajectory) should be approximated by the combination of the free-fall (vertical) and wind velocity (horizontal) components of the stone.¹⁷ In order to allow for the effect of wind on the impact energy of a hailstone, the following two conditions were evaluated: hailstones of 1.0 inch and 1.25 inches in diameter subjected to (1) 40 MPH and (2) 57.5 MPH (i.e., 50 knots used in the “severe thunderstorm” classification by the NOAA’s National Severe Storm Laboratory [NSSL]¹⁸) wind speeds. The increases in impact energy were calculated and compared to the impact energies associated with the free-fall terminal velocity of 1.5-inch diameter hail (typically the size threshold for functional damage to most common roofing materials). The results from this analysis are summarized in Figure 2.14. The vertical line in each drawing represents the falling (kinetic) energy without wind effects, the horizontal line the energy associated with the wind, and the diagonal line the energy and path associated with both effects. For a 40 MPH horizontal wind component acting on hailstones 1.0 inch and 1.25 inches in diameter, the increases in approximate impact energies were 28% and 23%, respectively. Note that the calculated impact energies (1.74 and 6.66 Joules, respectively) are less than the approximate impact energy

for the free-fall (vertical) terminal velocity of 1.5-inch hail (10.85 Joules, as shown in Table 2.3), which corresponds to a typical-sized hailstone for roof damage to asphalt shingles. For a 57.5 MPH horizontal wind component (i.e., conditions for a severe thunderstorm), acting on hailstones 1.0 inch and 1.25 inches in diameter, the impact energies increased approximately 52% and 43%, respectively, over a simply free-falling hailstone. Note, again that the calculated impact energies (2.07 and 7.77 Joules), accounting for wind forces, are less than the approximate impact energy for the free-fall terminal velocity of 1.5-inch hail (10.85 Joules). Based on this analysis of the effect of significant horizontal winds blowing during hailstorm events, hailstones below 1.5 inches in diameter would increase the impact energy of the hail but not to levels typically associated with threshold values for functional damage to common roofing materials (see Chapters 3 and 4, this volume, for these levels).

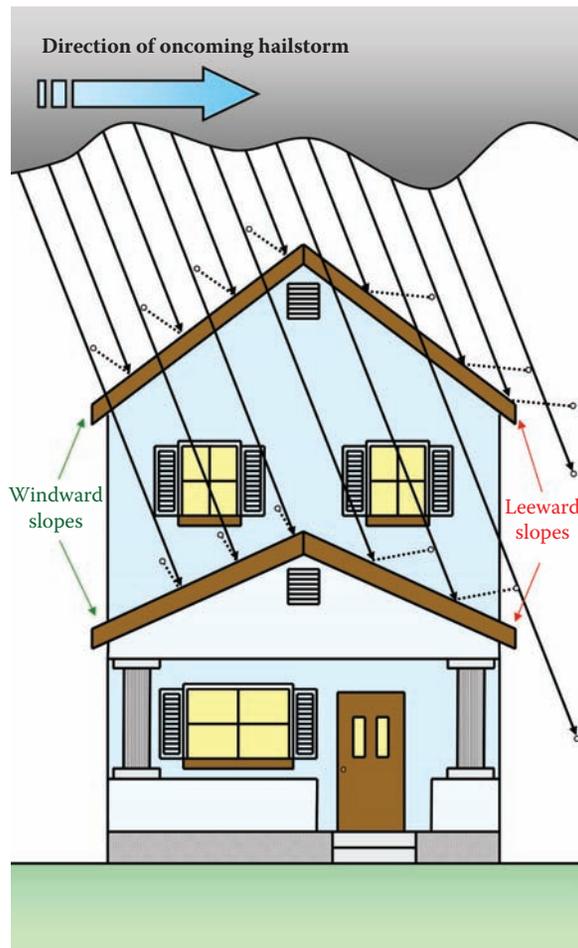
FIGURE 2.15
Hailstorm directionality and perpendicularity of impacts on roof slopes.

The amount of hail-caused functional damage to steep-sloped and low-sloped roof surfaces is dependent on the horizontal velocity vector for the prevailing winds and the pitch angles of the roof surfaces being evaluated. The combination of these parameters can lead to more perpendicular hail-strike impacts. These will be the elevations that sustain the most evidence of functional damage. Again, this correlation was included in the study performed by Petty et al.²⁷ that showed that the greatest number of hail-strike bruise counts were located on the shallow (<4:12 pitch) and steep (>9:12) roof slopes (see Chapter 3, this volume, for

information regarding this study) rather than intermediately sloped roof surfaces. Again, this condition is dependent on the fall pattern of the hailstone. If, from evidence gathered at the site, the hail appears to have been highly wind driven (best determined by spatter marks and dents to vertical surfaces), then there would be an expectation for the steeper-sloped roof surfaces to have an increased likelihood of damage. Conversely, if the hail is not wind driven, the greater damage would be observed on lower-sloped roof surfaces.

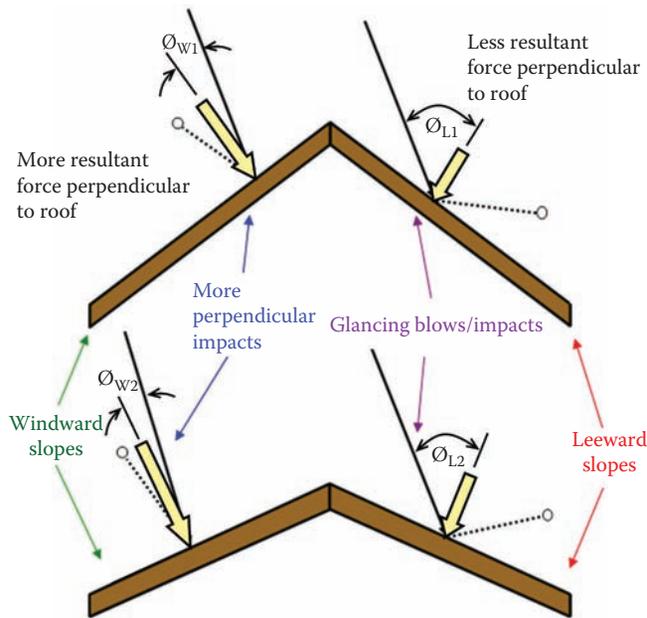
FIGURE 2.16

As further illustrated in Figure 2.16, greater perpendicularity allows for a greater resultant force, which transfers more of the kinetic energy associated with the falling hailstone into the roofing material, thus, increasing its likelihood for potential damage.

Greater perpendicularity of hailstone impacts on roof slopes increases likelihood for damage.

Referring to the examples of hailstone impacts in Figure 2.16, the degree of impact energies associated with them, in order from greatest to least impact severity, would be $\varnothing_{W2} > \varnothing_{W1} > \varnothing_{L2} > \varnothing_{L1}$. This is based on the angle of impact, \varnothing , from the perpendicular position.

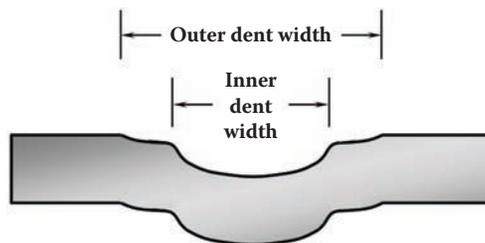
FIGURE 2.17

Hailstone impact dents in metal surfaces are typically circular to oval in shape and consist of two regions of deformations within the dent: an *inner dent* and an *outer dent*.^{7,25,28} The inner dent is located at about the center of the impact area and has well-defined slopes, whereas the outer dent has shallow slopes and surrounds the inner dent (Figure 2.17).

Cross-sectional view of dent to thin gauge metal.

The strongest correlation between the dent size and the diameter of the impacting ice ball was determined to be the smallest width of the inner dent.²⁵ According to Morrison and Scott,²⁵ “the most effective method involved examining the deformation, visually determining the demarcation between slopes of inner and outer dents, and measuring the least dimension of the inner dent.” Thus the diameter of the dent would be overstated if the outer ring or dent diameter was used, and this consequently would overestimate the size of the hailstone creating the dent.

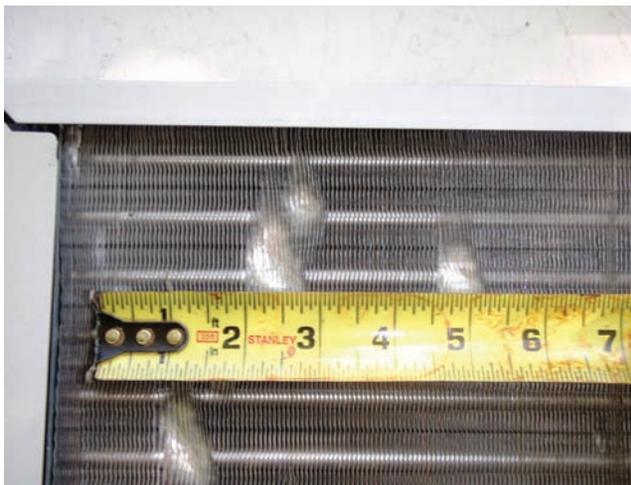
As an example, Figure 2.18 depicts the measurement of an impact dent on the coil fins of a south-facing window air conditioning unit. Two characteristics of the hailstorm can be identified in the photo: (1) based on the orientations of the marks, the impacting hailstones likely arrived from the left side (i.e., west side) of the photo, indicating the hailstones arrived from the west or southwest, and (2) the width of the impact mark measures approximately 0.75 inch, suggesting the diameter of the impacting hailstone was approximately 0.90 inch (0.75 inch \times 1.2 dent multiplier).

FIGURE 2.18
Measurement of impact dent in air conditioning unit coil fins.

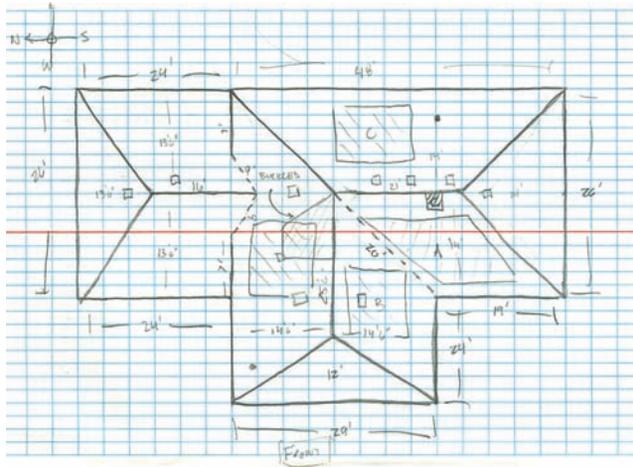
After all pertinent information regarding the building and the storm history has been gathered, the next step in the hail damage assessment process is to sketch out the roof surfaces in an inspection field notebook (Figure 2.19). The roof layout sketch is completed by drawing all hips and ridges as solid lines and all valleys as dashed lines. The plan view is a re-creation of the roof surfaces as if viewed from directly overhead. It is extremely useful to have this roof layout on hand during the inspection so that key observations, damaged areas, or other areas of concern can be easily documented and identified. Once the inspection has been completed, the rough sketch can be converted to a cleaner-looking, more formal computer-aided layout (Figure 2.20).

FIGURE 2.19
Example field notebook—plan-view sketch of roof.

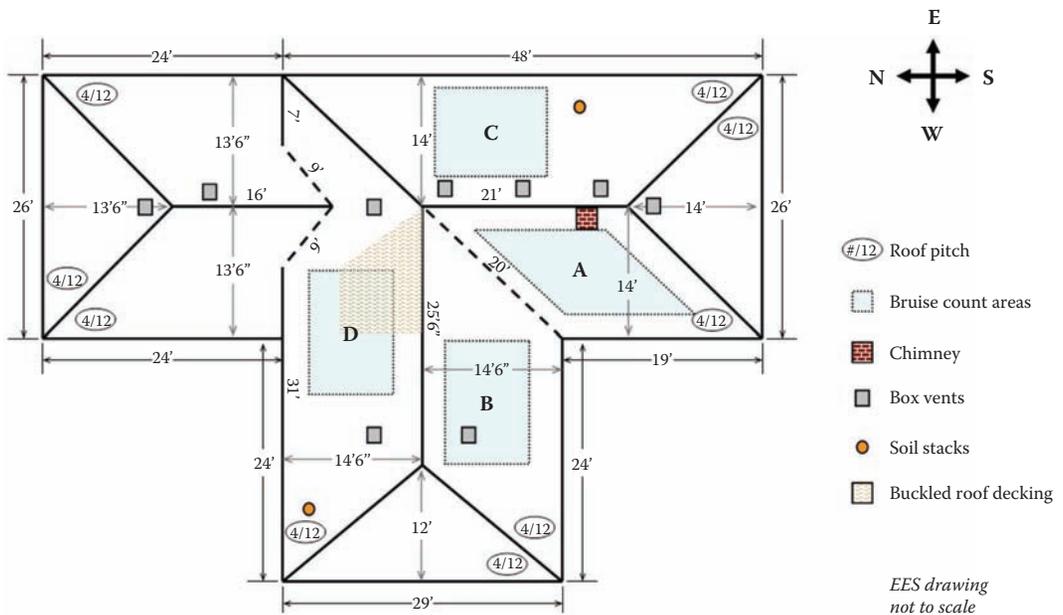
FIGURE 2.20
Typical computer-aided roof layout schematic (developed from onsite measurements).

Experience in the field of forensic engineering indicates that the use of drawings (e.g., Figure 2.20) and photographs within the inspection report, rather than a report simply containing text, is more effective in conveying inspection findings to interested parties.

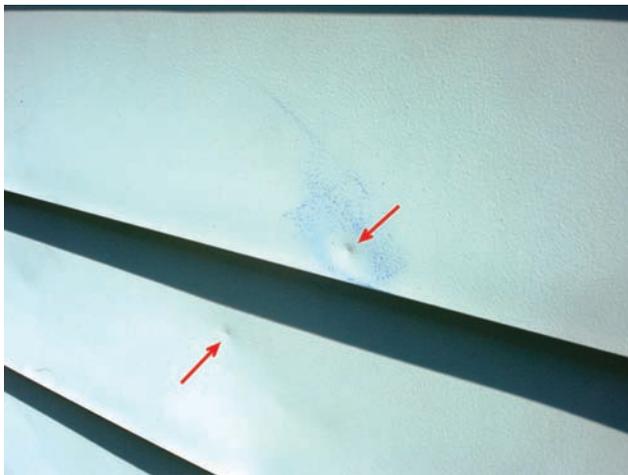
FIGURE 2.21

Punctured/creased mechanical dents in exterior metal siding.

Dents and damage to some of the metal building envelope components, such as siding and downspouts, are often debated and believed to be caused by hail strikes. In some of those cases, the observed damage is most likely attributed to mechanical damage. Clear indicators of mechanically caused damage are punctures or creases to the metal surface within the dent or scratches in the finished painted surface (Figures 2.21, 2.22, and 2.23).

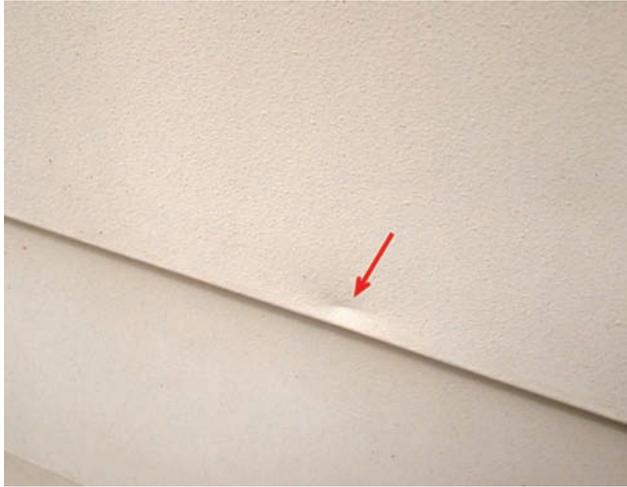
**FIGURE 2.22**

Punctured/creased mechanical dents in exterior metal siding.

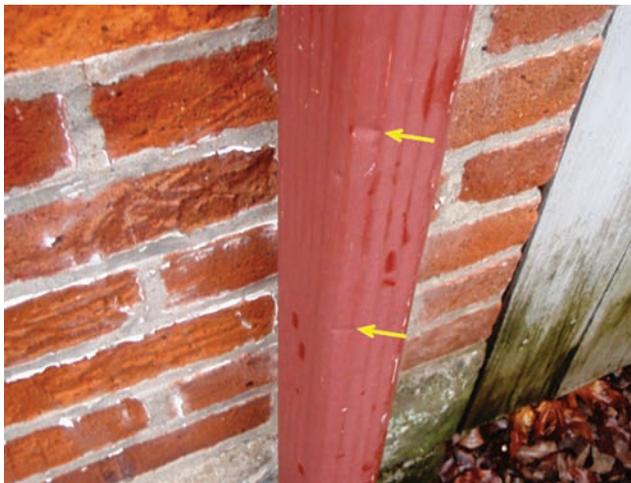
**FIGURE 2.23**

Creased mechanical dents in downspout.

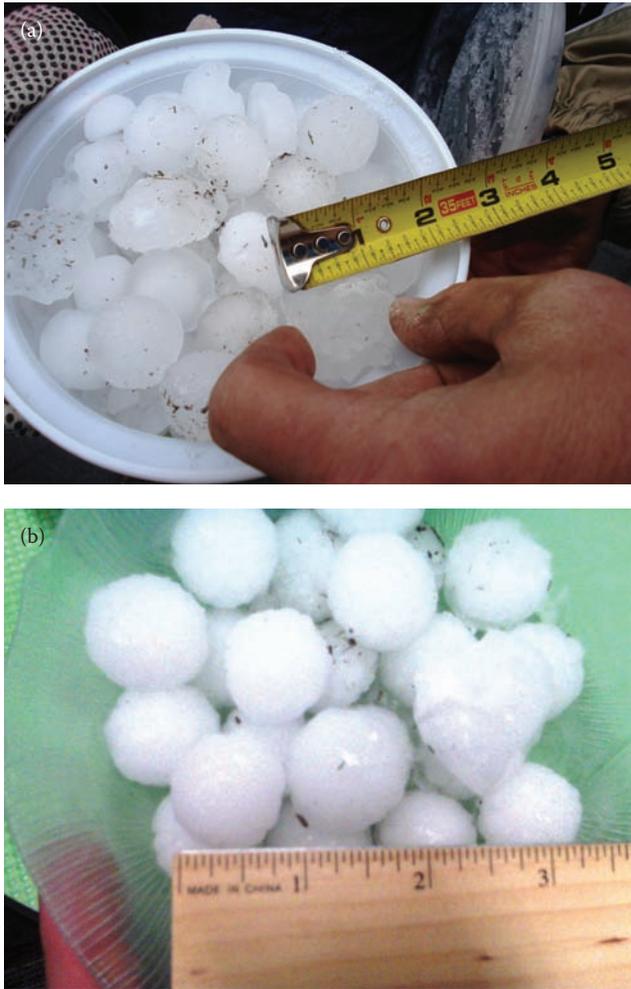
FIGURE 3.1
Hailstones 0.75 inch to 1.0 inch.

Hailstones, when of sufficient size, can damage building surfaces, including exterior finished components and roofing materials. Examples of hailstones between 0.75 and 1.0 inch are shown in Figure 3.1a and b.

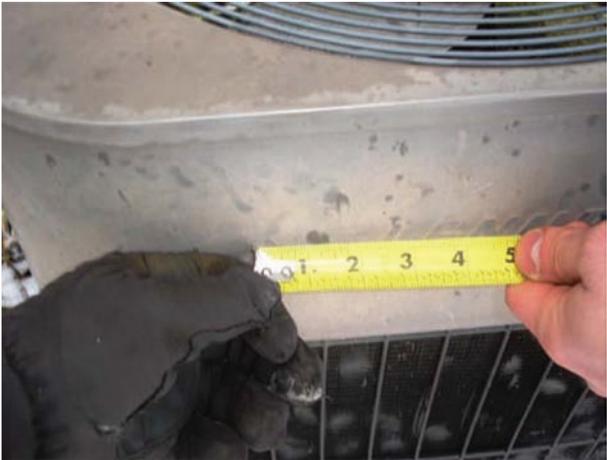
Exterior Surface	Photograph
<p>Air conditioner outdoor unit Burnish/spatter marks on sheet metal and bending of coil fins</p>

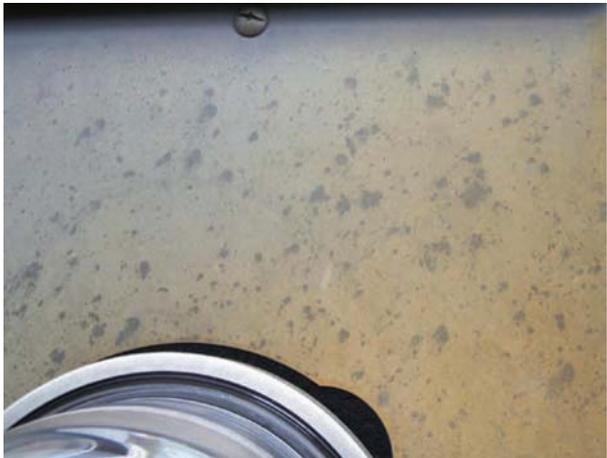
<p>Electrical box metal cover Typical hail-strike burnish/spatter marks</p>

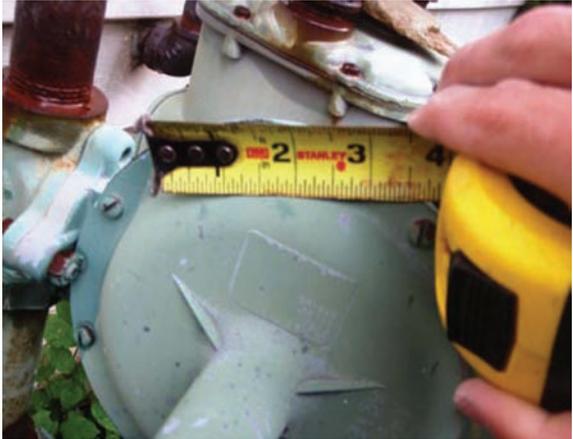
Exterior Surface	Photograph
<p>Gas metal cover Typical hail-strike burnish/spatter marks</p>

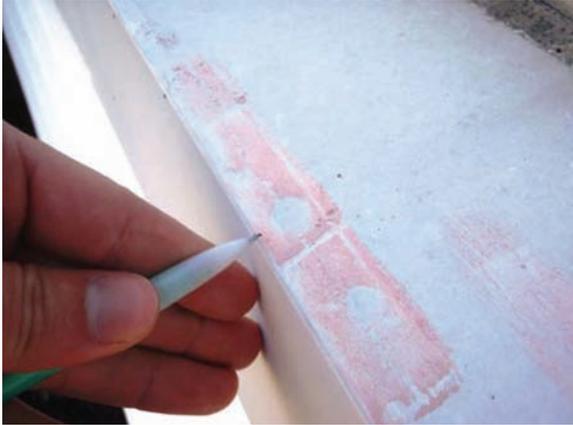
A close-up photograph of a light-colored metal gas cover. A yellow Stanley tape measure is held across the surface, showing a dent and surrounding burnish/spatter marks. The tape measure is positioned between the 2 and 4 inch marks.
<p>Metal window wrap—sill Hail-strike dent—illustrated using chalk</p>

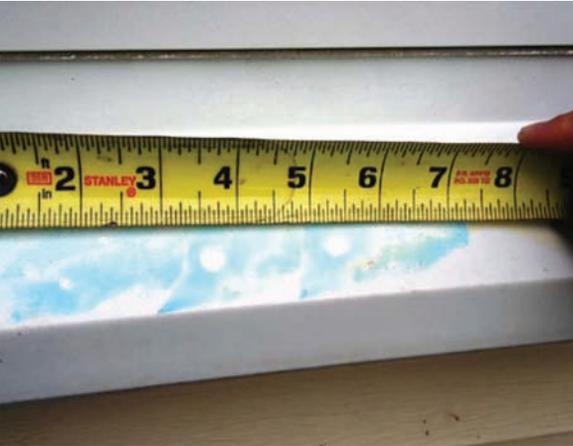
A close-up photograph of a white metal window sill. A hand is using a piece of white chalk to draw a circle around a small, circular dent in the metal. The dent is surrounded by a reddish-brown stain.
<p>Metal window wrap—sill Hail-strike dent—measured and illustrated using chalk</p>

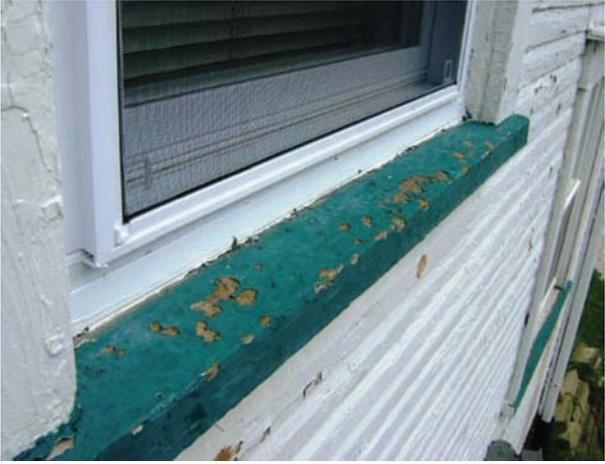
Exterior Surface	Photograph
<p>Painted wooden window sill Hail-strike damage—note freshness of wood at impact points</p>

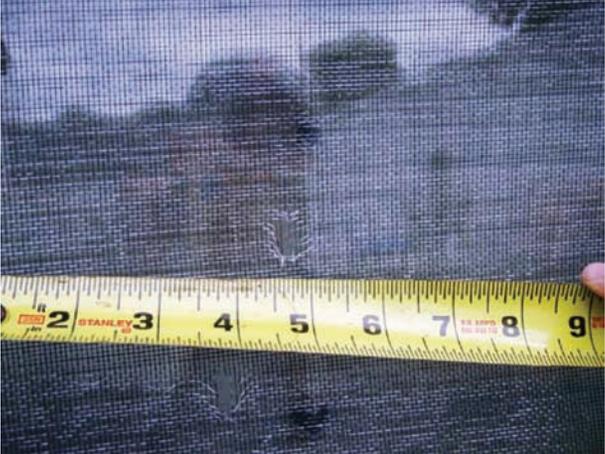
<p>A photograph showing a close-up of a white-painted wooden window sill. The paint is chipped and peeling away in several places, revealing the underlying light-colored wood. The damage appears to be from hail strikes. A white window frame is visible above the sill.</p>
<p>Window screen Hail-strike tear—measured</p>

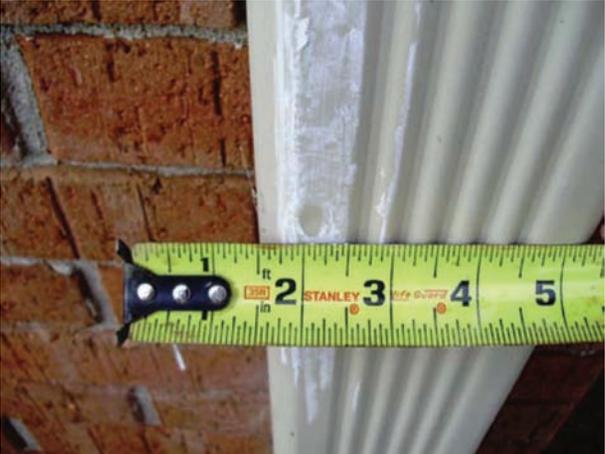
<p>A photograph of a dark grey window screen with a small, irregular tear in the mesh. A yellow Stanley tape measure is held horizontally below the screen to provide a scale. The tear is located between the 4 and 5-inch marks on the tape.</p>
<p>Downspout Hail-strike dent—measured</p>

<p>A photograph of a white, ribbed downspout attached to a brick wall. There is a distinct dent in the downspout. A yellow Stanley tape measure is held horizontally across the dent to measure its width, which is approximately 1.5 inches.</p>

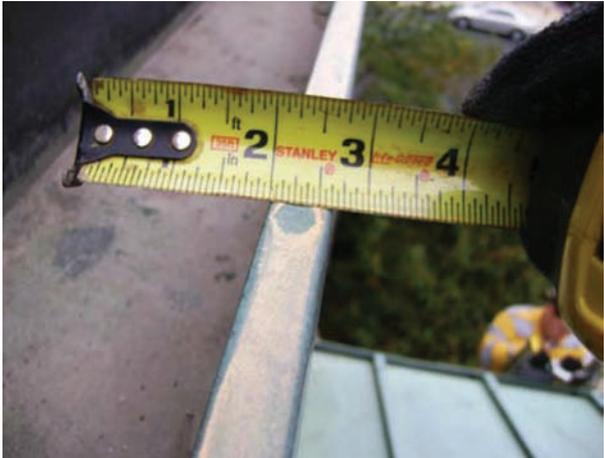
Exterior Surface	Photograph
Gutter Hail-strike dent—measured

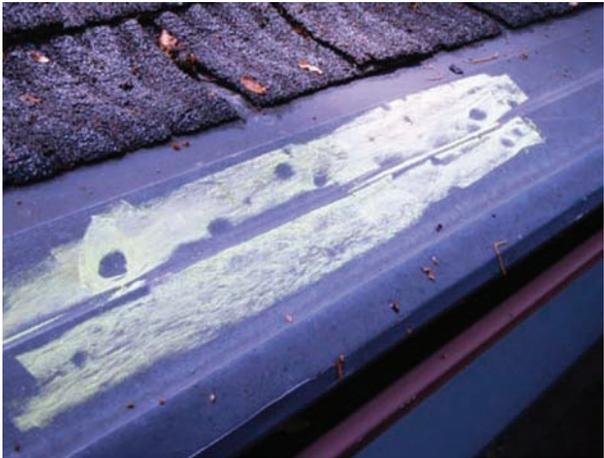
Metal gutter guard Hail-strike dents

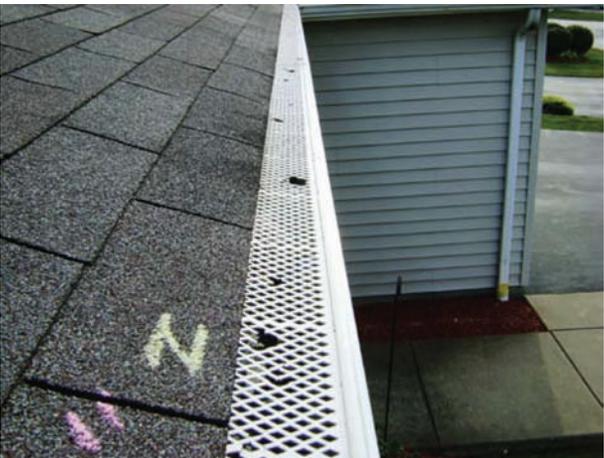
Vinyl gutter guard Hail-strike shatter marks

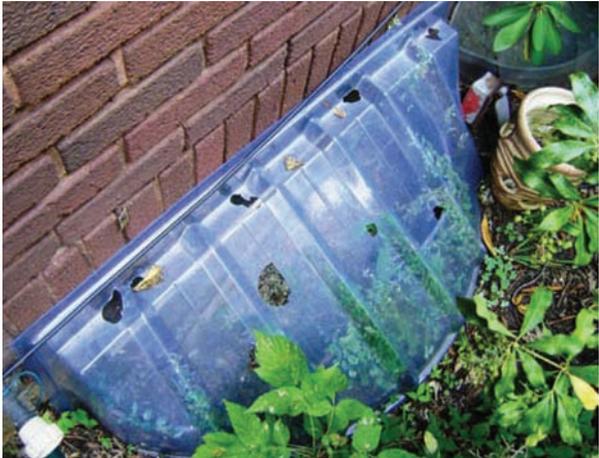
Exterior Surface	Photograph
<p>Plastic basement window well cover Hail-strike shatter marks</p>

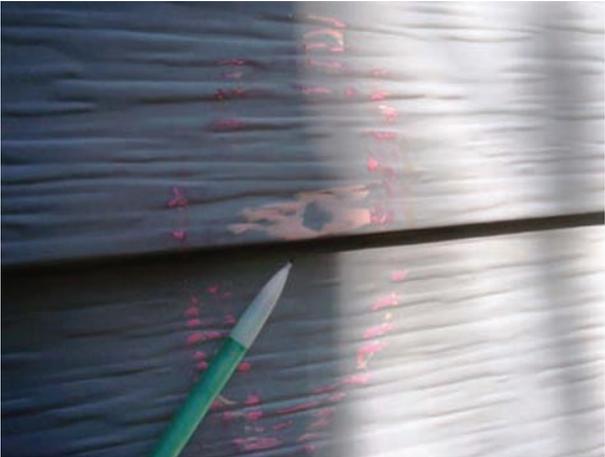
<p>Metal siding Hail-strike dent</p>

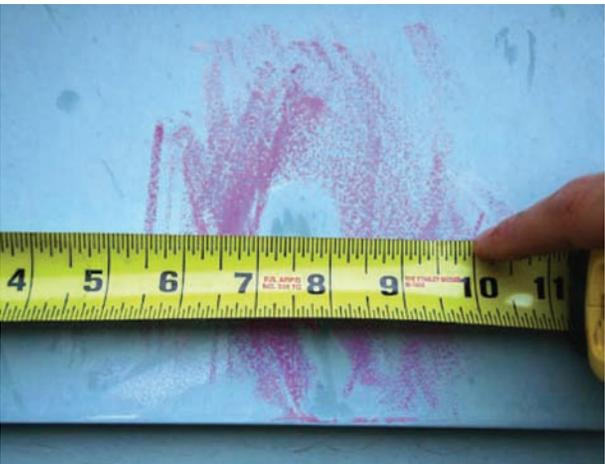
<p>Metal siding Hail-strike dent with large burnish/ spatter mark</p>

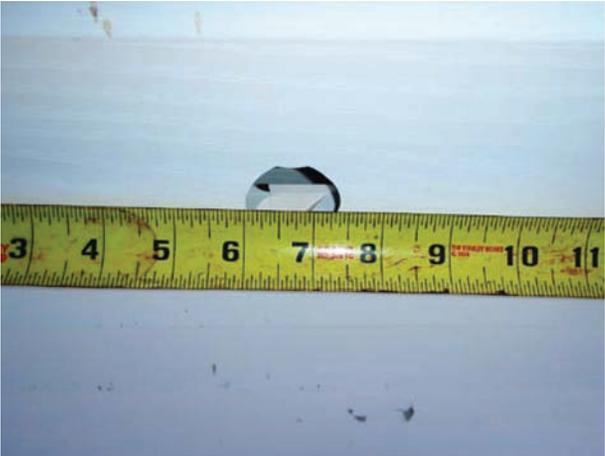
Exterior Surface	Photograph
Vinyl siding Hail-strike shatter mark

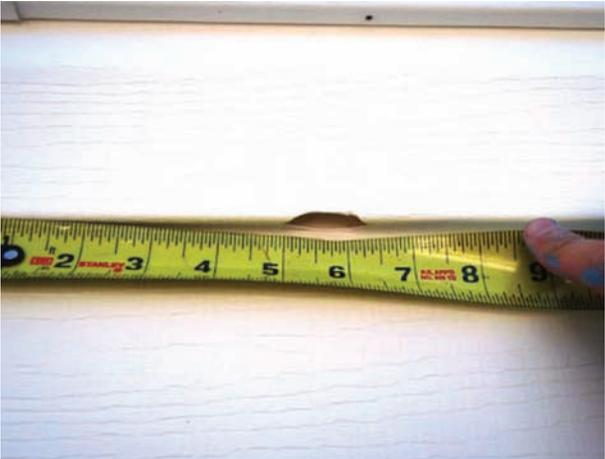
A close-up photograph of a white vinyl siding panel. A small, dark, irregular shatter mark is visible on the surface. A yellow measuring tape is held horizontally across the panel, with the shatter mark positioned between the 7 and 8-inch marks. The tape shows markings from 3 to 11 inches.
Vinyl siding Hail-strike shatter mark in lower protruding edge

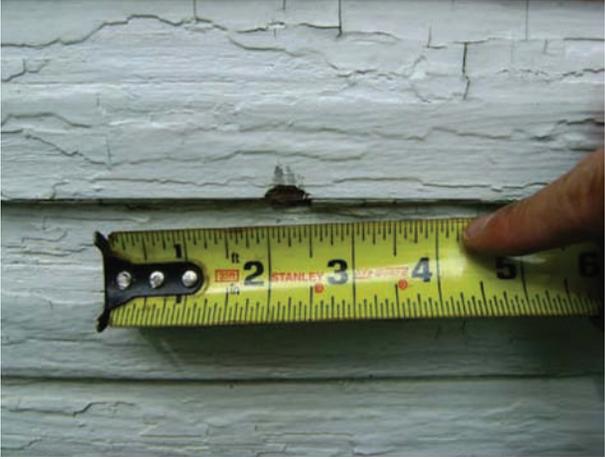
A photograph showing a white vinyl siding panel with a textured, wavy surface. A small, dark shatter mark is located in the lower protruding edge of the panel. A yellow measuring tape is held horizontally below the panel, with the shatter mark positioned between the 5 and 6-inch marks. The tape shows markings from 2 to 9 inches.
Painted wood siding Hail-strike chip

A photograph of a white painted wood siding panel. The surface shows significant cracking and peeling of the paint. A small, dark chip is visible in the center of the panel. A yellow measuring tape is held horizontally below the panel, with the chip positioned between the 3 and 4-inch marks. The tape shows markings from 1 to 6 inches.

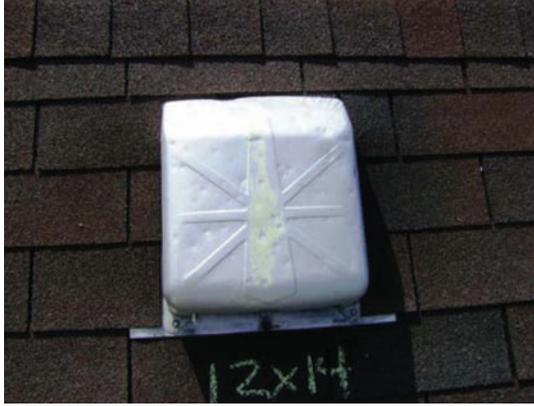
Hail-Caused Damage	Photograph
Hail-strike dents in metal box vent (12" × 14" slant-back)

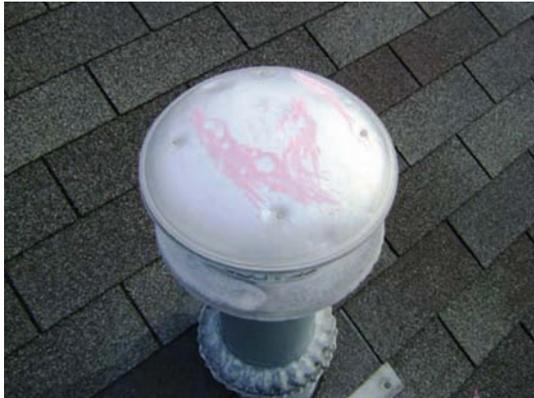
Hail-strike dents in furnace (flue) vent cap
