FORENSIC ENGINEERING

**Damage Assessments for
Residential and Commercial
Structures**

**Edited by
Stephen E. Petty**

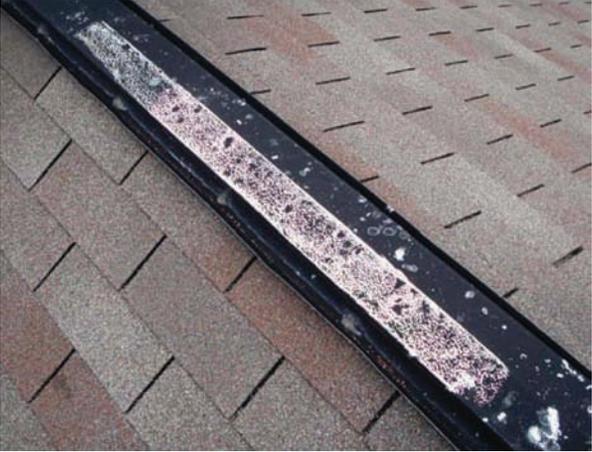
Hail-Caused Damage	Photograph
Hail-strike dents in metal ridge vent

A close-up photograph of a metal ridge vent on a roof. The vent is a long, narrow, dark-colored metal strip. It shows numerous small, white, circular hail strikes and larger, irregular dents. The surrounding roof is covered in asphalt shingles.
Hail-strike dents in metal soil stack flashing

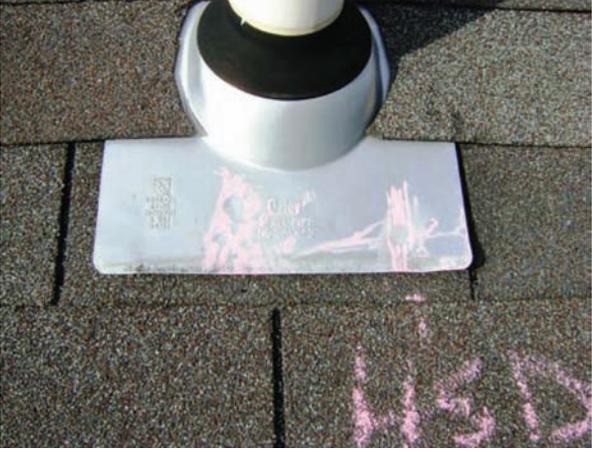
A photograph of a metal soil stack flashing on a roof. The flashing is a rectangular metal plate. It shows several distinct, circular hail strikes and larger dents. The surrounding roof is covered in asphalt shingles.
Hail-strike dents in south- and west-facing chimney counter flashings (helps with determining hailstorm directionality)

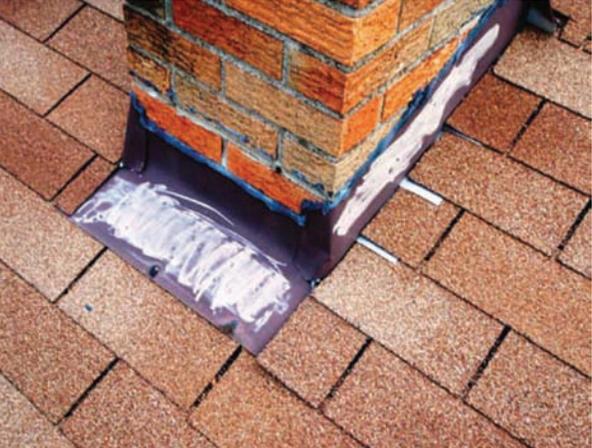
A photograph of a chimney counter flashing on a roof. The flashing is a metal plate that fits around the base of a brick chimney. It shows several distinct, circular hail strikes and larger dents. The surrounding roof is covered in asphalt shingles.

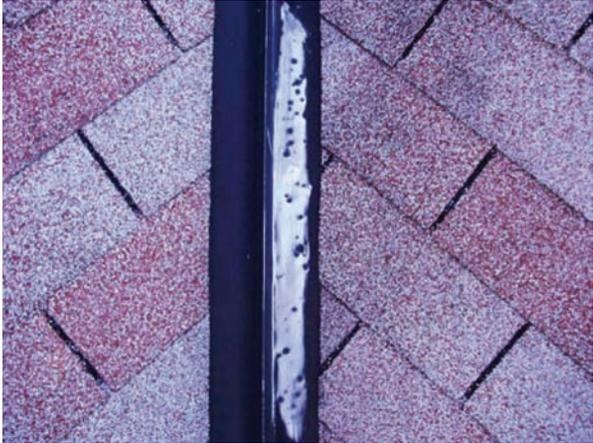
Hail-Caused Damage	Photograph
Hail-strike dents in metal valley flashing

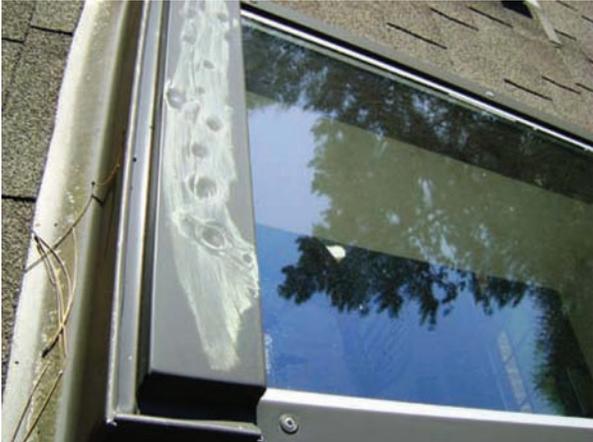
Hail-strike dents in skylight wrap/cladding

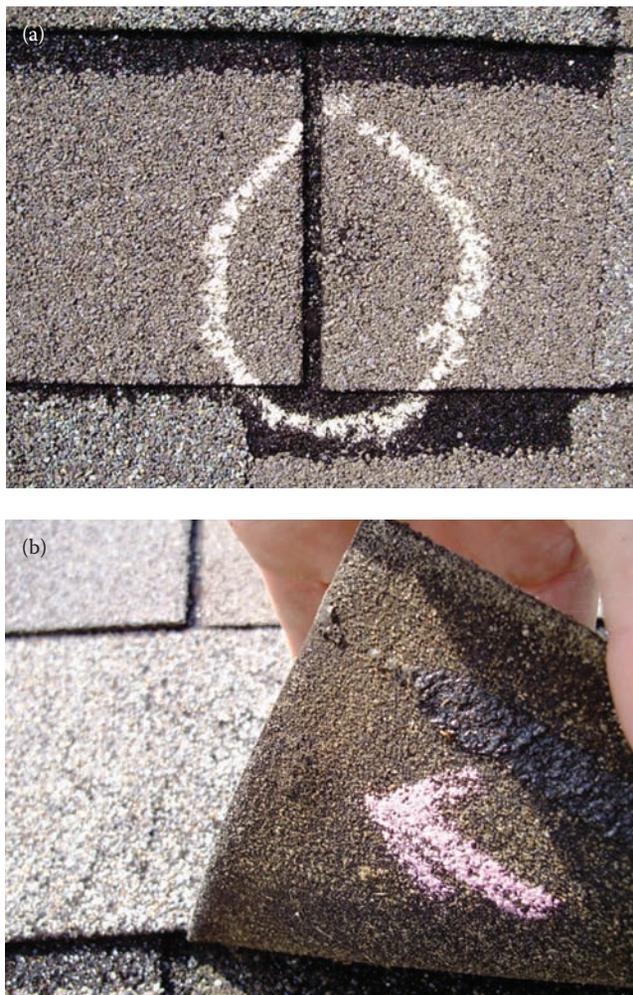
FIGURE 3.2

(a) Hail-strike bruise to asphalt shingle that ruptured fiberglass reinforcement—top side; (b) hail-strike bruise to asphalt shingle that ruptured fiberglass reinforcement—fractured mat.

shingles from hail impacts begins with a hailstone measuring 1.5 to 2.0 inches in diameter;³ others have reported thresholds of damage to light asphalt shingles (e.g., builder's grade 20- to 30-year warranty) from hailstones measuring down to 1.0 inch in diameter,⁴ but field experience⁵ suggests that the higher threshold is more representative for functional damage from actual hailstones. Typically, the number of hail-strike bruises will be minimal (i.e., 0, 1, or 2) as the size of the impacting hailstones reaches the functional damage threshold; then as size increases, the number of bruises increases exponentially and jumps to higher intensities (i.e., ≥ 10). These lower counts are questionable given the size of hail versus damage arguments, but cannot be ruled out because of the shape and size of the defect(s). Experience suggests asphalt shingle bruise counts for shingles not beyond their normal service life have thresholds associated with hail size; that is, the bruise counts are zero or very low until the hail reaches a sufficient size at which time the count jumps well above ten bruises per square. Examples of hail-caused rupturing of asphalt shingle mats are given in Figures 3.2a, 3.2b, 3.3a, and 3.3b.

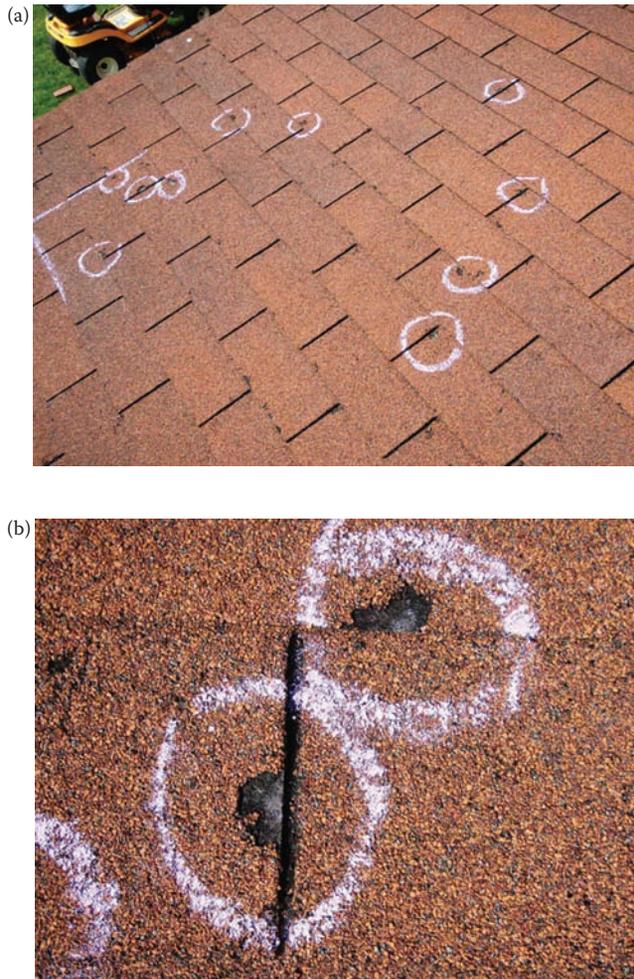
FIGURE 3.4

(a) Hail-strike bruise to older asphalt shingles—overview; (b) hail-strike bruise to older asphalt shingles—displaced chunks of granules.

Shingles that have exceeded their natural life (i.e., are degraded, brittle, and weathered) demonstrate a different type of damage than shingles not beyond their normal service life, as discussed above. In these situations, the shingle will be shattered with the damage reflected by chunks of granules being displaced (Figure 3.4a and b).

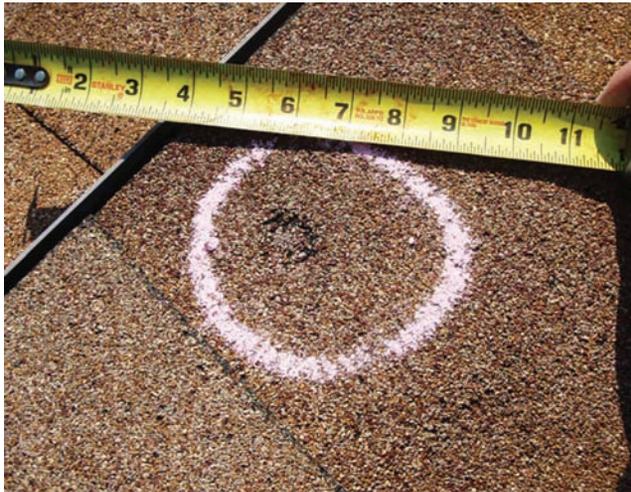
FIGURE 3.5

Hail-strike bruise to less-supportive ridge vent shingle.

Note that shingles more poorly supported (e.g., cap shingles and shingles covering ridge vents) will be damaged by smaller-sized hail than would result in damage to more supported shingle areas. Referring to Chapter 2, this volume, and discussions earlier in this chapter, a less-supported shingle reduces the coefficient of restitution of the shingle and allows for a greater transfer of energy into the shingle, thus making it more susceptible to functional hail damage below typical size thresholds (Figure 3.5).³

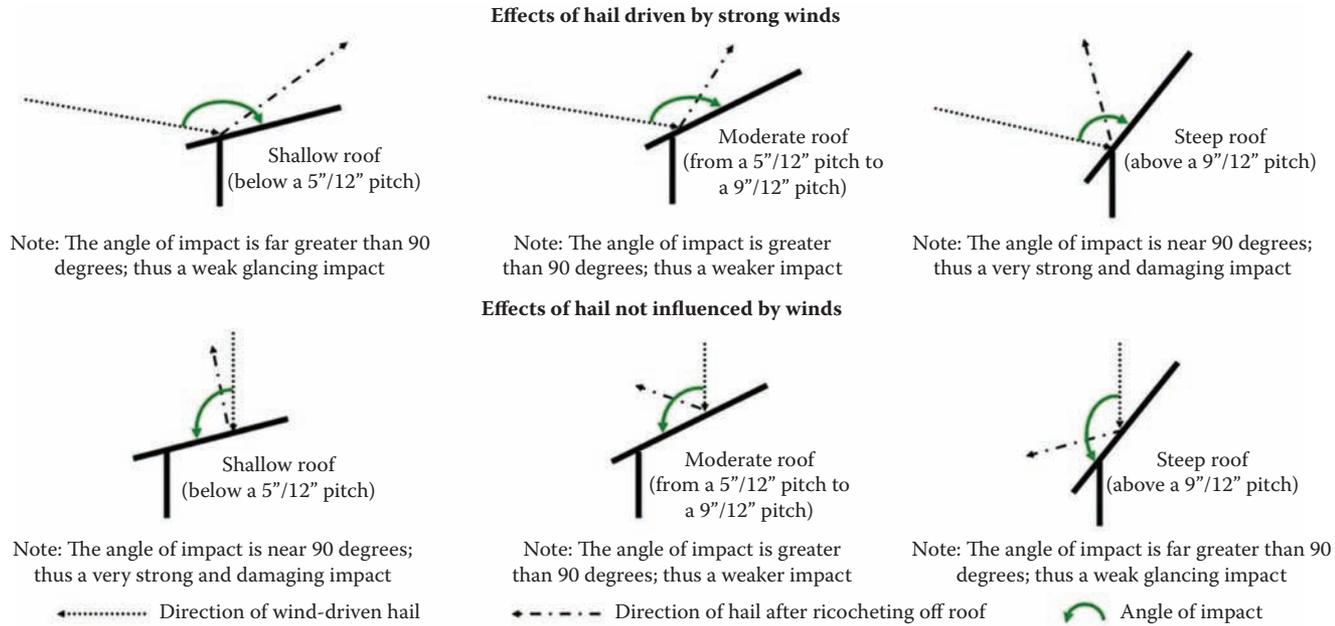
FIGURE 3.6 Effects of hail driven by strong winds and uninfluenced by winds on roof slopes of differing pitches.⁵

Of particular interest were the results from the second bulleted item: more hail-strike bruises were discovered on low-sloped (<4:12 pitch) and steeper-sloped (>9:12 pitch) roof elevations than moderately sloped roof elevations. One explanation for this result may be that hailstorms typically have either hail falling essentially vertically (not influenced by horizontal wind vector components) or have heavily wind-driven hail (heavily influenced horizontally by wind; Figure 3.6). Note the results from this analysis are consistent with earlier sections discussing the importance of hailstorm directionality, angle of impact, and perpendicularity of hailstone impacts (see also Section 2.4.5.1).

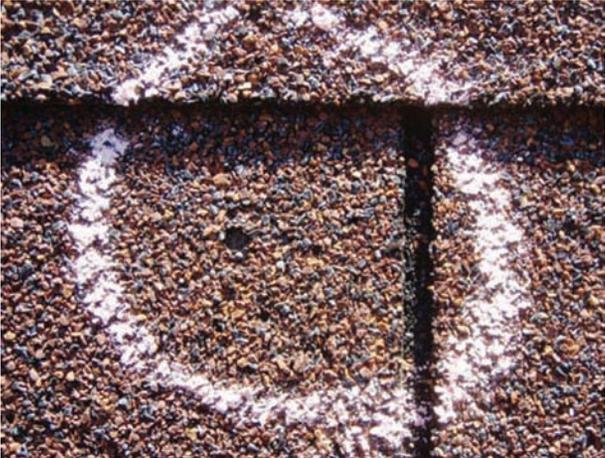
Non Hail Defect	Photograph
Blister

Blistering on the surface of a shingle is commonly mistaken for hailstone impact damage. These surface defects are caused by volatiles in the asphalt binder or moisture from the shingle mat being vaporized due to high temperatures. Although these may appear to be the result of a hailstone impact (to the untrained eye), the following physical characteristics deviate from those of a functional hail-strike bruise:

- There is a surface void in the shingle with missing granules and asphalt binder.
- The edges of the blisters are sharp to the touch and not smooth as with hail-strike bruises.
- The underlying mat will not contain a fracture indicative of an impact.

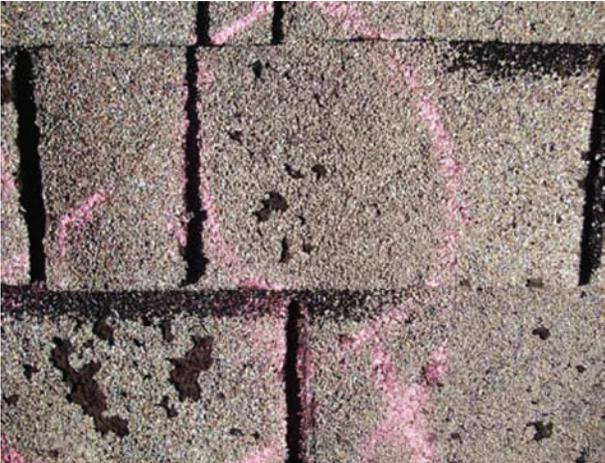
Flaking (lighter amounts)

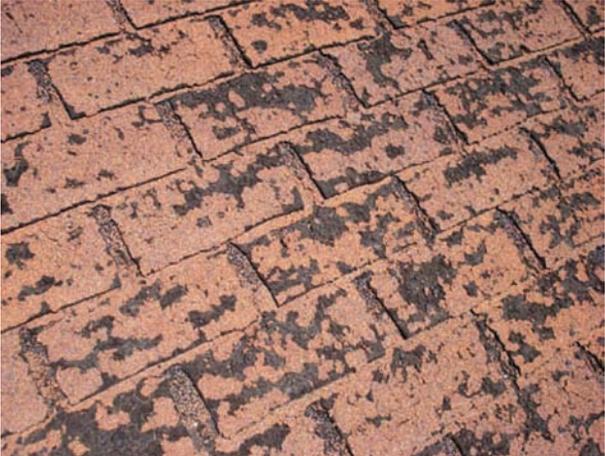
<p>Flaking (heavy amounts) Typically indicative of insufficient attic ventilation and/or aging of shingles (at or near end of effective service life)</p>

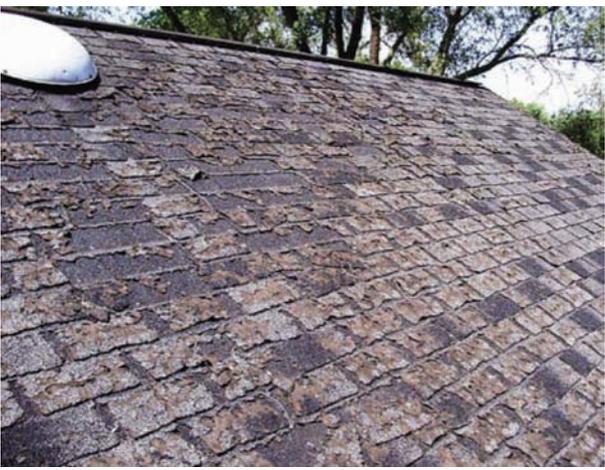
Non Hail Defect	Photograph
Aged and heavily degraded Typically indicative of insufficient attic ventilation and/or aging of shingles (at or near end of effective service life)

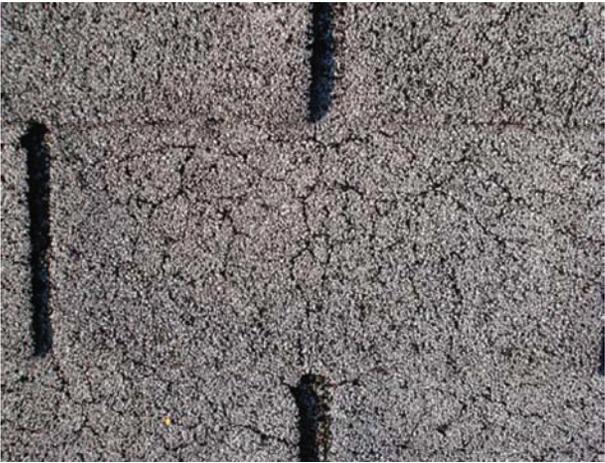
Craze cracking Typically indicative of insufficient attic ventilation

Cracking can be caused by hailstone impacts or exposure to ultraviolet light and resultant shrinkage and should not be attributed to hail when caused by the latter. Ultraviolet exposure causes the lighter hydrocarbons in the bitumen mix to break down, volatilize, and outgas. The loss of this material then causes the affected material to shrink, creating the cracked appearance.

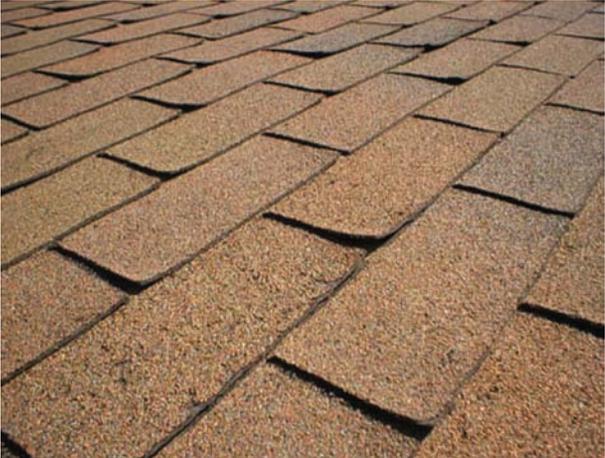
Non Hail Defect	Photograph
Curling/cupping

A close-up photograph of asphalt shingles on a roof. The shingles are brown and granular. Several shingles are curled upwards at the edges, creating a cupping effect. The background shows more shingles in a standard overlapping pattern.
Nail pop Result of a raised nail from decking movement during thermal cycling rubbing against underside of shingle

Curling and cupping is the drying out of the topmost layer of the shingle, resulting in an upward curling, which is exacerbated by exposure to ultraviolet light. The top layer dries, resulting in a reduction of mass that subsequently causes shrinkage. The differential shrinkage between the top and bottom layers creates tension that causes the shingle to curl or cup. The susceptibility of a shingled roof to cupping and curling is increased if the shingles are nailed too high, too far from the edge, or if too few shingle fasteners were installed. Shingles that are cupped or curled are more susceptible to hailstone impacts because the curled portion of the shingle is unsupported.

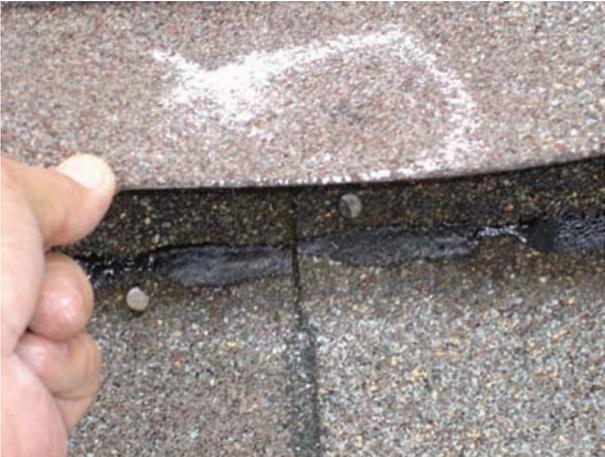
A close-up photograph showing a hand holding the edge of an asphalt shingle. The shingle is light-colored with a granular surface. A white, irregular mark is visible on the surface, indicating a nail pop. The underside of the shingle is dark and shows a raised nail head.
Vertical/diagonal cracking Created by internal forces due to thermal cycling at locations above adjoining shingles

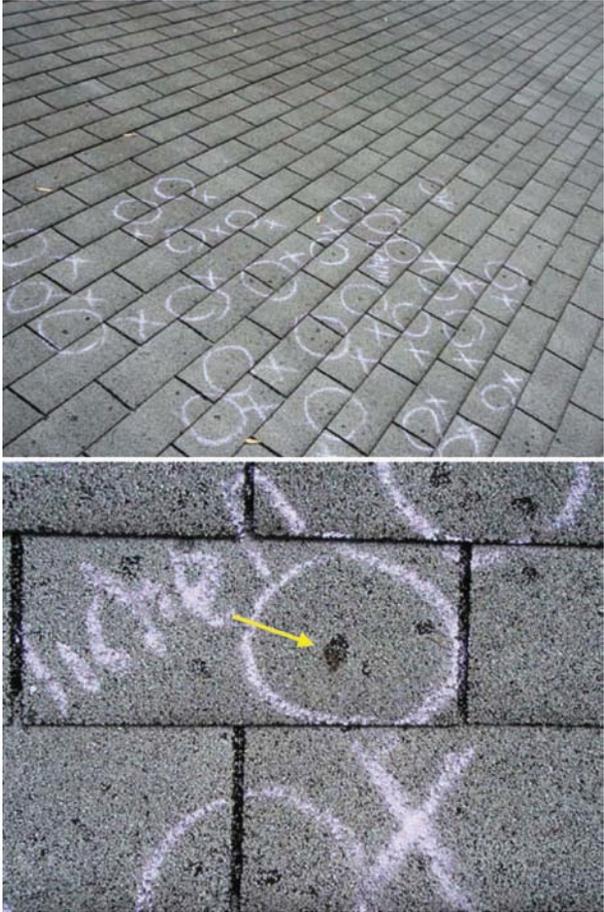
Non Hail Defect	Photograph
<p>Defects caused by lichen growth Created when lichen embeds and subsequently dislodges from shingle surface. Differentiated from percussive forces in that the underlying mat is not fractured.</p>

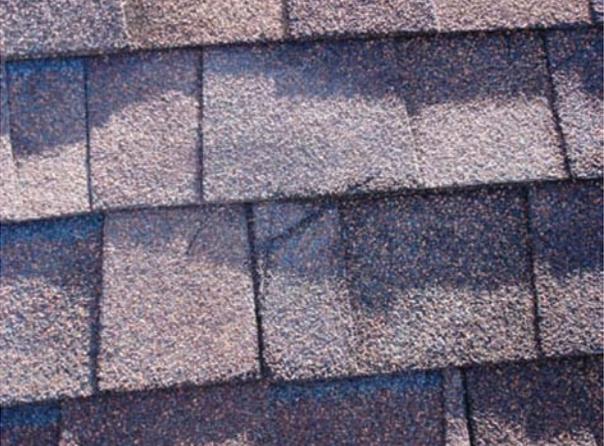
<p>Mechanical cuts Oftentimes the result of shingle cutting during installation.</p>

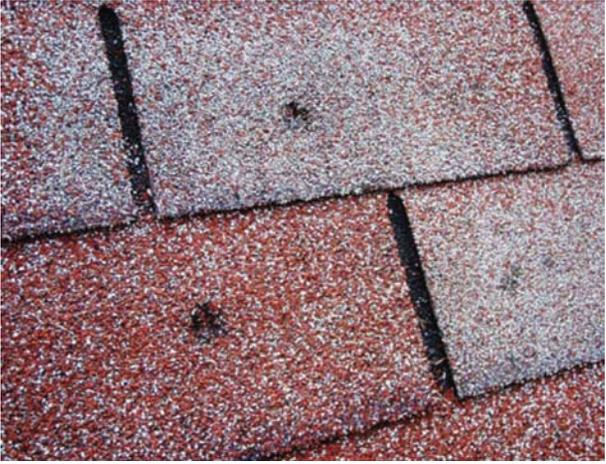
Non Hail Defect	Photograph
Artificial/synthetic hail damage (fraud) See Chapter 5, this volume

3.4.1.4.8 *Artificial or Synthetic Hail Damage (Fraud)*

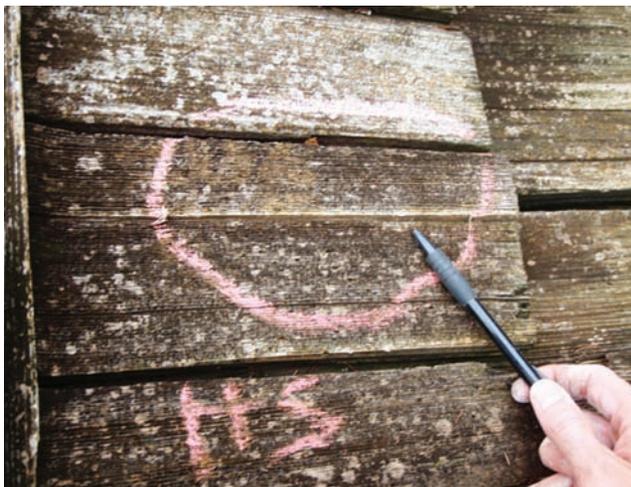
FIGURE 3.7
Hail-strike split to wood shake—impact damage.

Functional hail damage to wood shakes and shingles is characterized by a distinct impact mark (known as a peck mark) coincident with a fresh split in the wood. The fresh appearance of the impact mark and the internal surface within the split indicate it was caused by a recent hailstone impact (Figure 3.7).

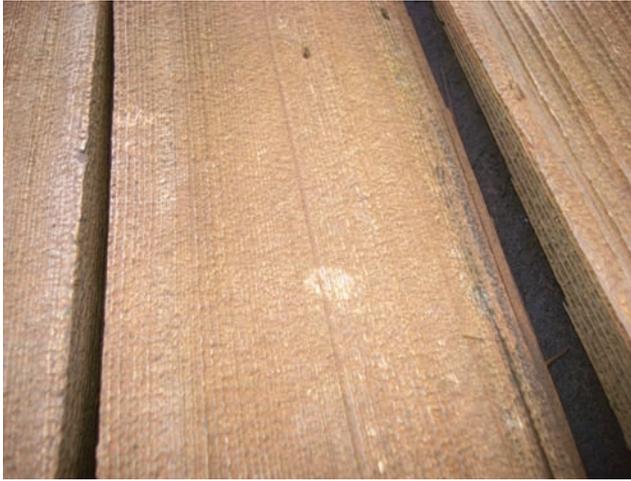
FIGURE 3.8
Hail impact mark with no split to wood shake.

Peck marks that do not split the wood initially will not cause delayed cracking, are not considered functional damage, and will not shorten the expected service life of a wood shake or shingle (Figure 3.8).

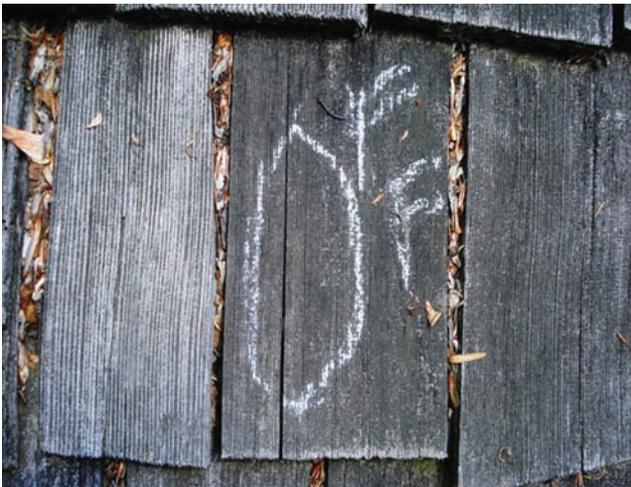
FIGURE 3.9
Fresh foot fall to wood shake (no evidence of impact mark).

Foot falls are defined as fresh splits in the shakes or shingles, which are caused by foot traffic, and not by hail (Figure 3.9). Foot falls are differentiated from hail-strike splits and characterized by the following:

- The wood surfaces within the split are fresher in appearance than the exposed surfaces; however, the shake or shingle can be pieced back together when manipulated by hand.
- There is no evidence of hail impacts (i.e., dents or impact marks) along the split.
- The affected shake or shingle is located on the roof in a typically trafficked area (e.g., along ridges and valleys).

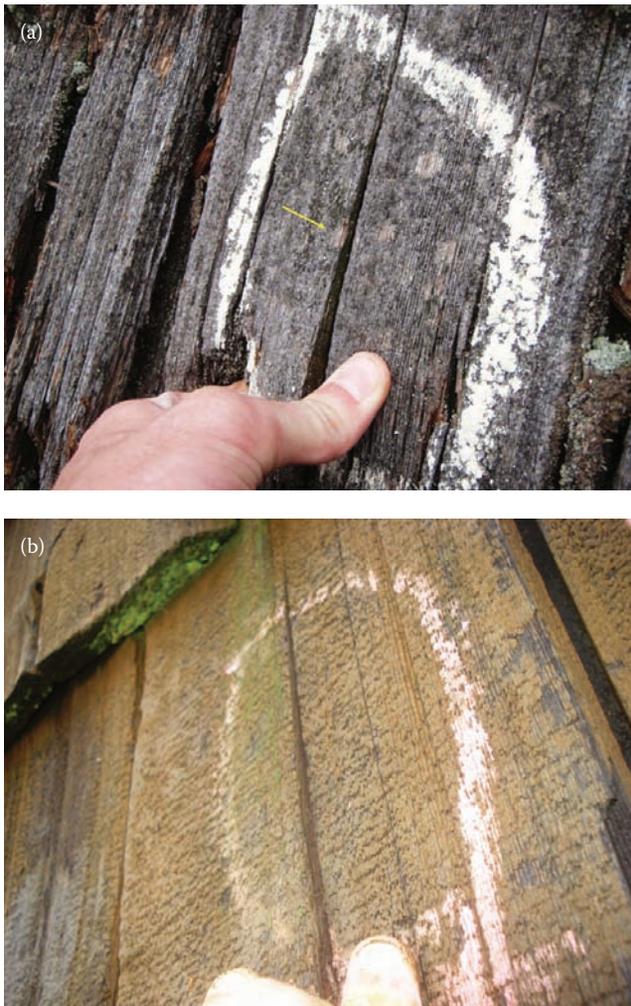
FIGURE 3.10
 (a) Weathered split wood shake with fresh impact mark; (b) weathered split wood shake without fresh impact mark.

- The weathered appearance (i.e., grayer color) of the wood surfaces within the split, which will be similar in appearance to the exposure of the shake or shingle.
- The chip or split will have rounded and weathered edges.
- There is no evidence of hail impacts (i.e., dents or impact marks) along the split. (During the course of the assessment, there may be evidence of a fresher hail impact mark along a weathered split in a shake or shingle. The rounded edges of the split and the weathered appearance to the wood within the split indicate that the split was not the result of the recent hail impact; Figure 3.10a and b.)

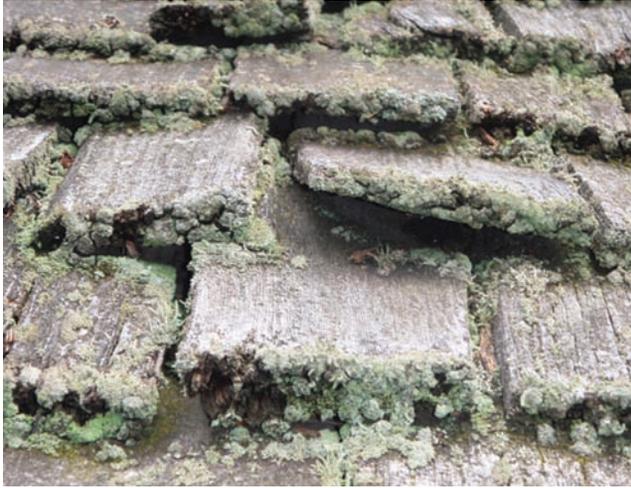
FIGURE 3.11
Heavy fungal growth along lower, butt edges of wood shake.

Of particular importance is the fungal growth that grows along the lower “butt” edges of shakes or shingles due to their nearly constant shaded condition (Figure 3.11). If left in place and not maintained, the fungal growth will soften the lower edges of the wood and cause it to become eroded, split, and brittle over time, creating a condition known as butt rot (Figure 3.12).

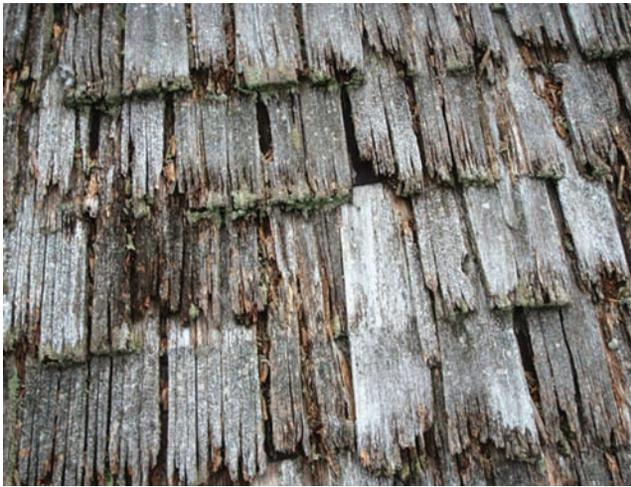
FIGURE 3.12
Severe “butt rot” to wood shakes.

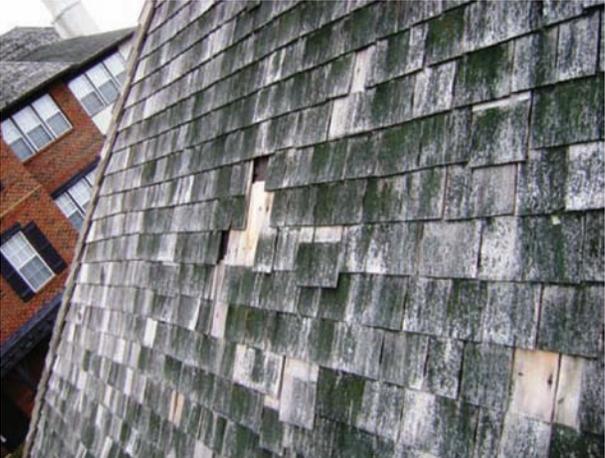
Non Hail Defect	Photograph
Displaced and missing wood shingles

A close-up photograph of a roof covered in weathered, greyish-brown wood shingles. Several shingles are missing or severely displaced, revealing the underlying wooden sheathing. The shingles show signs of aging and moss growth.
Curled wood shingles

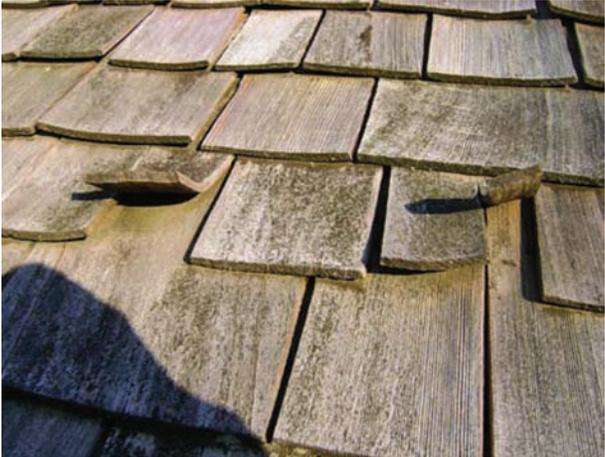
A close-up photograph of a roof with wood shingles. Several shingles are curled upwards, away from the roof surface, indicating water damage or rot. The shingles are a mix of light and dark brown colors.
Curled and cupped wood shingles

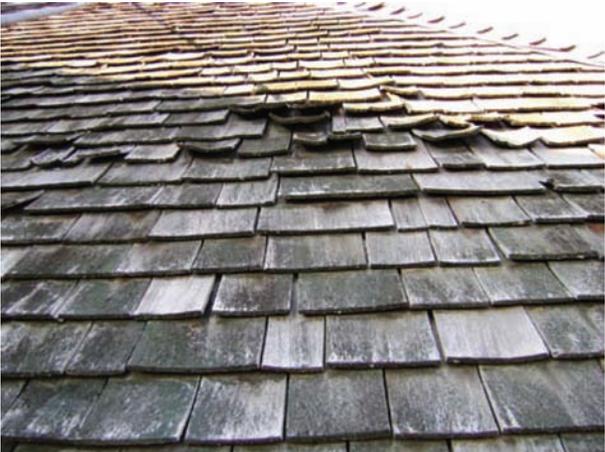
A wide-angle photograph of a roof covered in wood shingles. The shingles are heavily weathered and show significant damage, including curling and cupping. The roof surface is uneven and appears to be in poor condition.

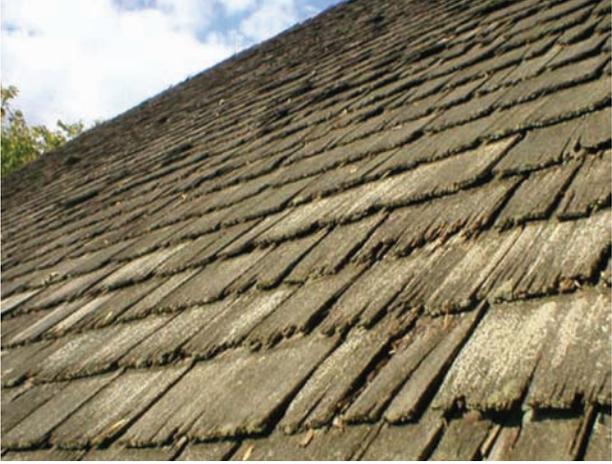
Non Hail Defect	Photograph
Rotted and eroded wood shakes

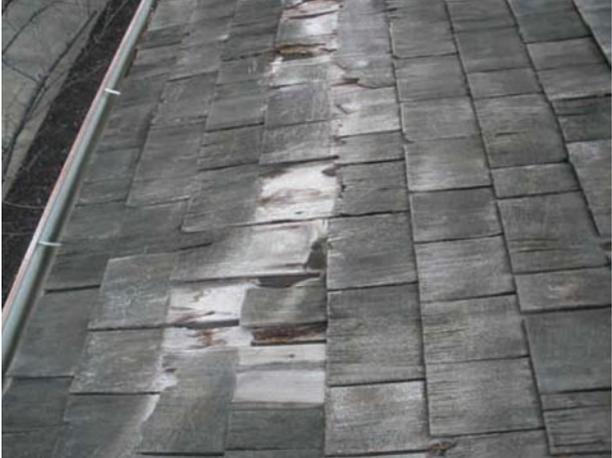
Eroded and missing wood shingles beneath an overhanging tree

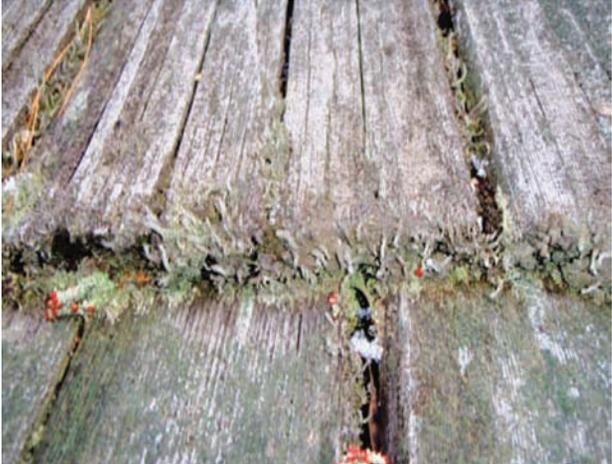
Heavy lichen and/or biological growth

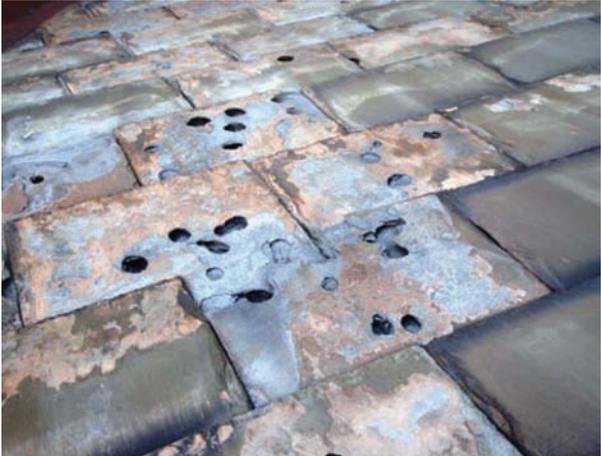
Hail Defect	Photograph
<p>Hail-strike penetrations and impressions to slate tiles Note heavier deterioration of damaged tiles</p>

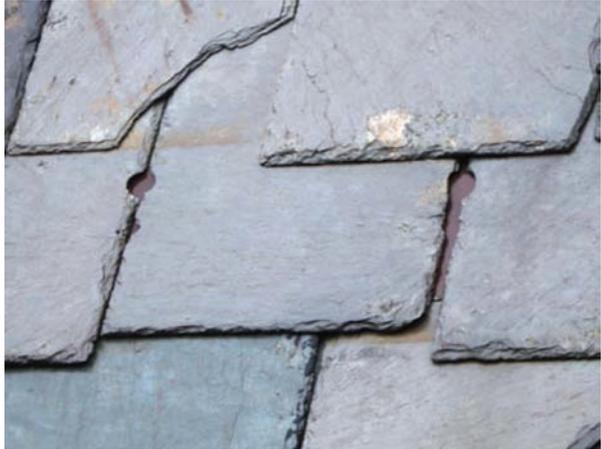
<p>Hail-strike chips to slate tile edges Repaired with metal bibs</p>

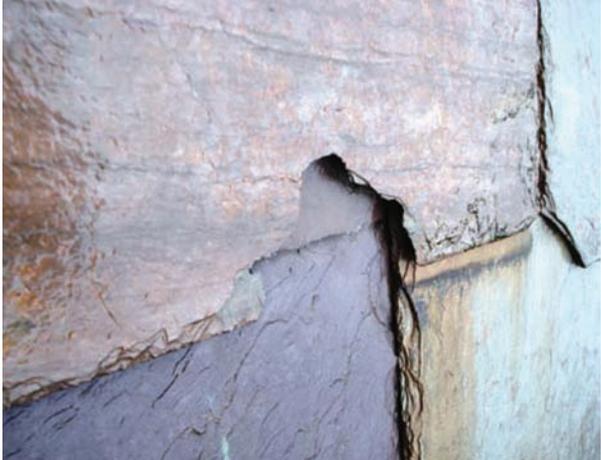
<p>Hail-strike split/fracture to slate tile Note impact point at top of split/fracture</p>

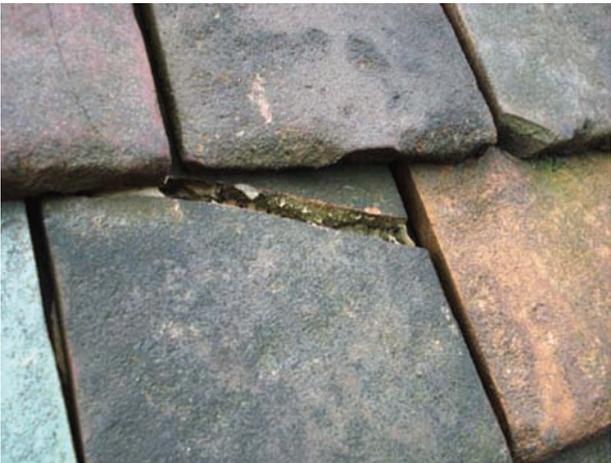
A close-up photograph of an asbestos tile. The tile is dark brown and has a distinct, lighter-colored mark on its surface, indicating a penetration by a hail strike. The surrounding tiles are also visible, showing some weathering and discoloration.
Hail-strike split to clay tile Note location of fresh impact mark along split

A close-up photograph of a clay tile that has been split by a hail strike. The split is jagged and runs diagonally across the tile. A fresh impact mark is visible along the split. The surrounding tiles are also visible, showing some weathering and discoloration.

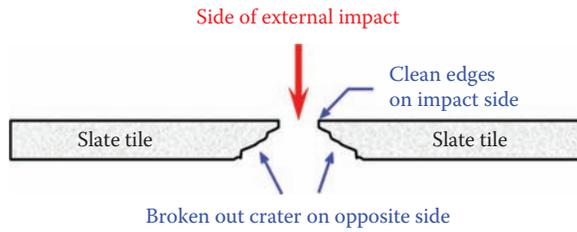
**FIGURE 3.13**

Punctured slate tile—clean hole on impact side and cratered hole on opposite side.

Oftentimes, upon examination of the tiles, there are holes observed in the face of the tiles, particularly with slate. A common misconception would be to consider these holes as hail-caused penetrations, since a hailstorm may have passed through the area recently; however, in order to determine whether they were created by an external impact, such as hail, or from beneath the tile, the hole must be closely examined. When slate is perforated or punctured, the impact leaves a hole with clean and sharp edges on the impact side of the tile and a cratered hole on the side opposite the impact (Figure 3.13).^{15,16}

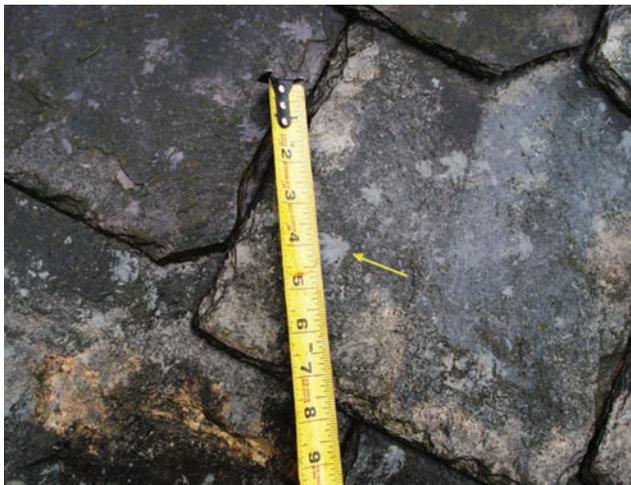
**FIGURE 3.14**

Hail impact spatter marks on slate tiles.

Oftentimes, when hailstones are not of sufficient size to cause functional damage to tile roof systems, spatter marks to the tile exposures will be observed, but neither penetrations, splits, chips, nor impressions will be present (Figure 3.14). This is *not* functional damage and will not likely shorten the expected service life of the tiles.

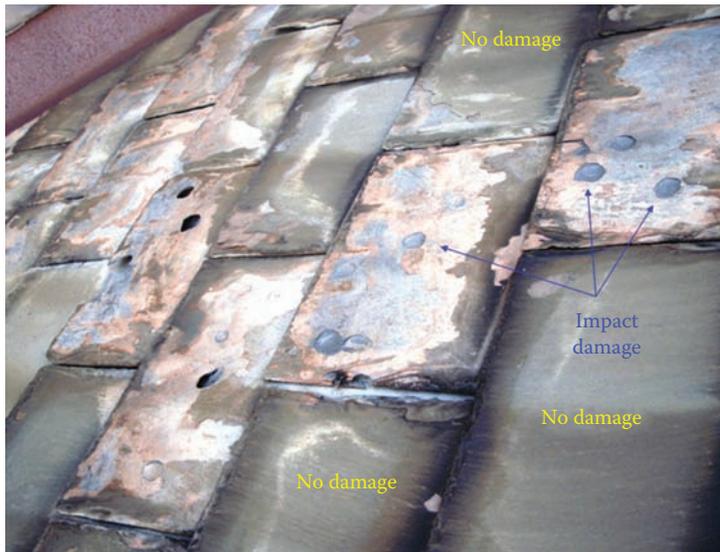
FIGURE 3.15
Hail damage to more deteriorated slate tiles.

In some instances when evidence of hailstones has not reached the size threshold to cause functional damage to tiles, penetrations, splits, or impressions can occur, but they are most likely present on tiles that exhibit higher levels of deterioration. The case in which this scenario appears to be most common is with the long-term delamination of slate tiles. Delamination is the process by which the surface silicate layers of the slate tile separate from the tile and are shed from the roof over time, thus, slowly thinning the tile, decreasing its impact resistance, and causing it to become more susceptible to functional hail damage from hailstone impacts. Typically, delamination is more prominent on south-facing roof surfaces due to the increased sun exposure (Figure 3.15).

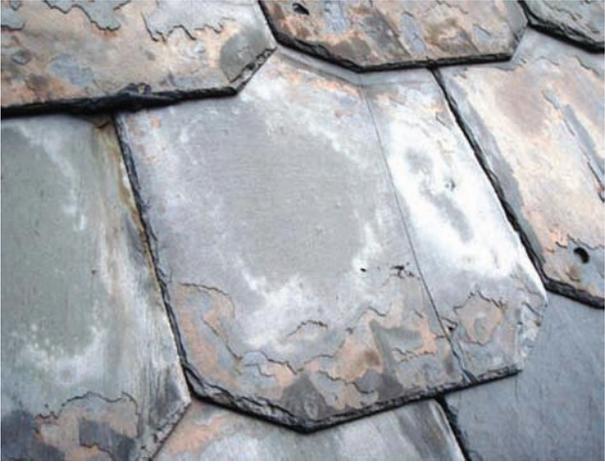
Non Hail Defect	Photograph
Non hail crack to slate tile Note no evidence of impact mark along crack

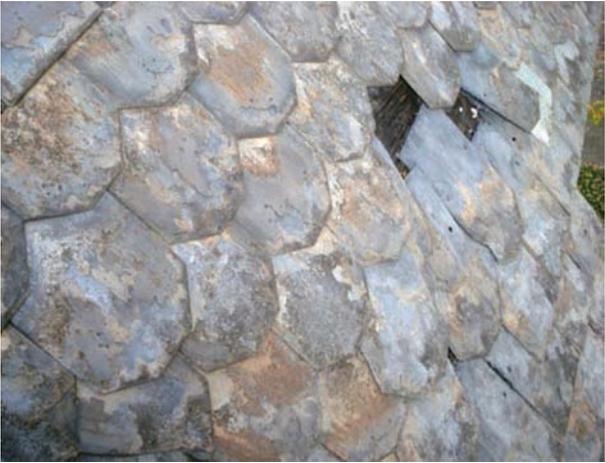
Eroded hole to slate tile Note location over nail head

Eroded holes are holes in the tile with eroded edges that were not, to a reasonable degree of probability, the result of hail. Oftentimes eroded holes will be located directly over a nail fastener of an underlying tile. Over time, the nail head rubs against the underside of the tile, wearing a hole into it.

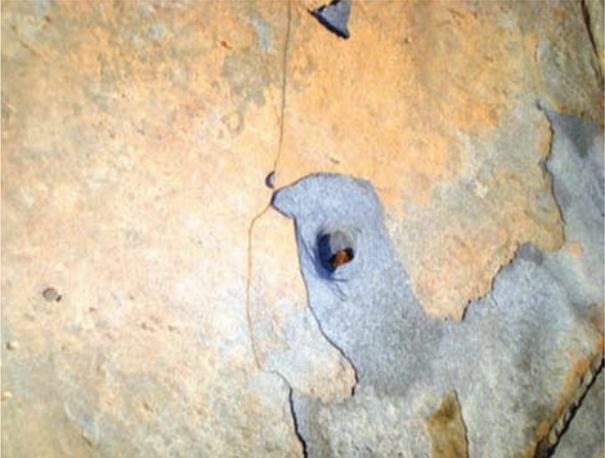
Non Hail Defect	Photograph
<p>Eroded hole to slate tile Note weathered appearance and no sharp edges</p>

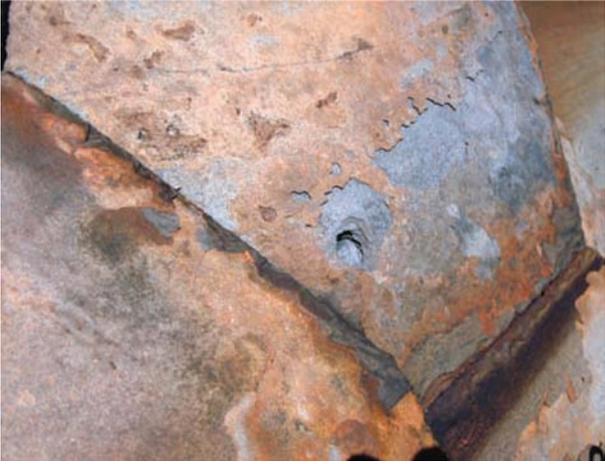
<p>Weathered chip to slate tile</p>

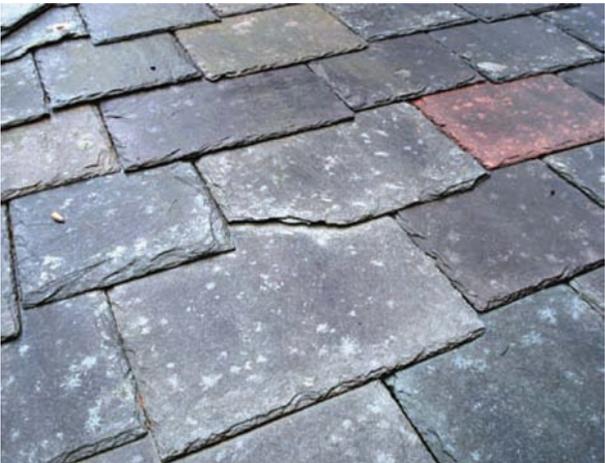
<p>Chip to clay tile Note weathered appearance</p>

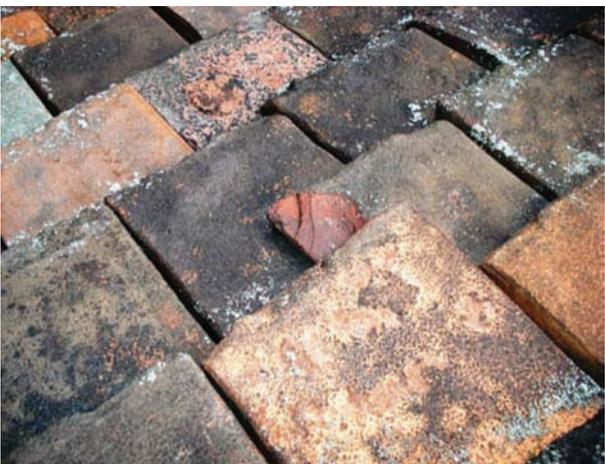
Non Hail Defect	Photograph
Surface pitting and spalling to clay tile Attributable to repeated freeze/thaw cycling

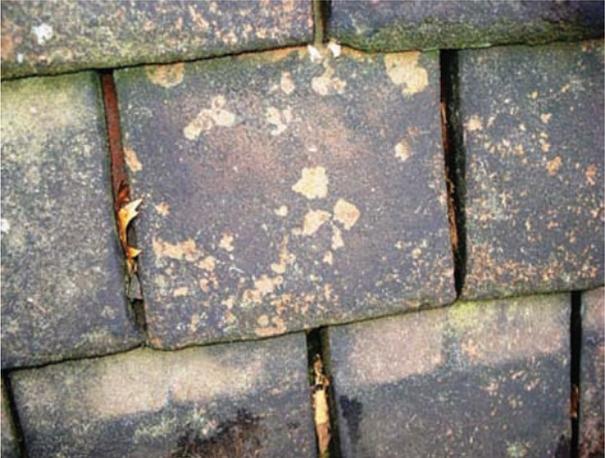
Foot fall to clay tiles Fresh cracks likely a result of foot traffic

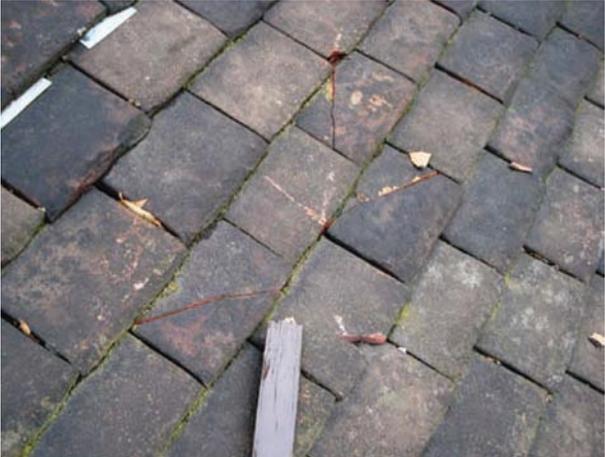
Eroded hole with weathered crack in clay tile

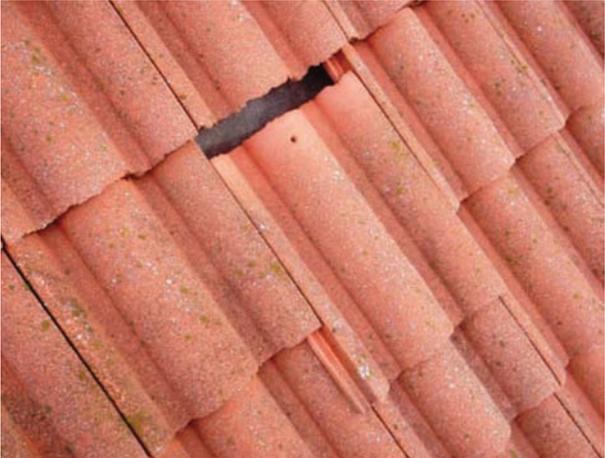
A close-up photograph of a roof with Spanish-style concrete tiles. One tile is significantly displaced, shifted upwards and to the right, creating a gap between it and the tiles below. The tiles are reddish-brown with some green moss or algae growth.
Weathered crack to concrete tile Note duller, rounded edges

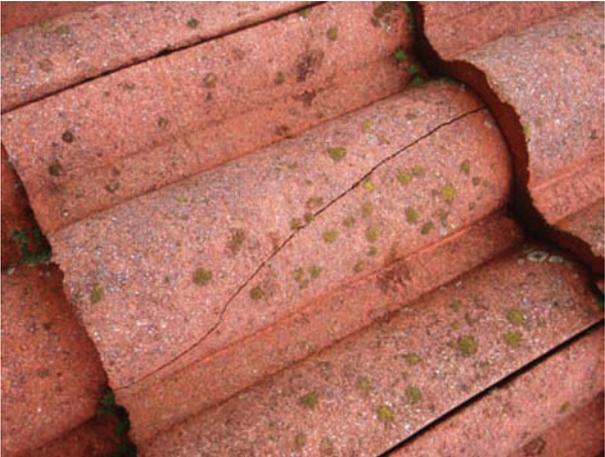
A close-up photograph of a single concrete tile. A prominent, dark, irregular crack runs across the middle of the tile. The edges of the tile are noticeably rounded and dull, indicating significant weathering. There is some green moss or algae growth on the surface.
Weathered chips to asbestos tiles Note weathered, rounded edges

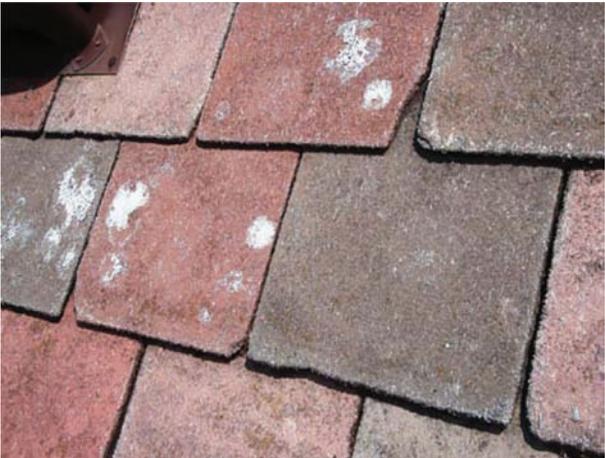
A photograph showing several asbestos tiles on a roof. The tiles are dark grey and reddish-brown. Many of the tiles have white, flake-like chips or areas of delamination on their surfaces. The edges of the tiles are rounded and appear weathered.

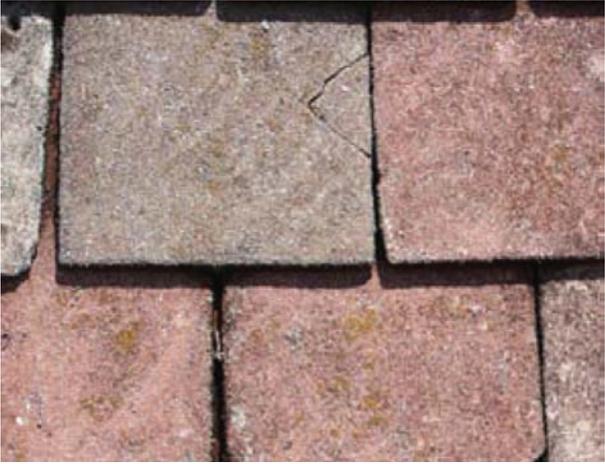
Hail removed biological growth from surface of asbestos tiles Not functional damage

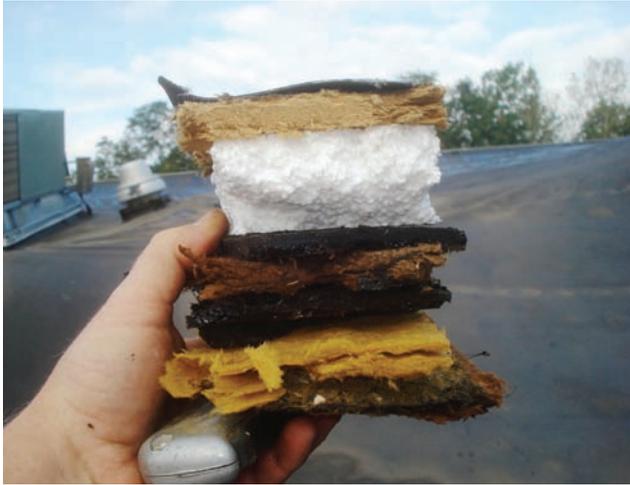
FIGURE 4.1
Multiple layers of a BUR system.

One of the key differences in a commercial low-sloped roof inspection and a steep-sloped roof inspection is that destructive testing is often needed on the commercial roof surface. A properly trained forensic investigator should be prepared to perform destructive testing (i.e., test cuts) to the roof surface and make necessary repairs afterward. Such test cuts can be self-performed or aided by a roofing contractor. In all cases, this should be completed with permission of the owner and possibly the insurance company (if applicable) to avoid future liability. The test cut can provide validation of the roof construction details and knowledge regarding the presence of moisture or damage to the underlying materials (i.e., number of roof layers for a built-up roof [BUR] system). Additional costs may also be incurred to properly repair the roof system or possibly bring the roof system up to current code. An example of a test cut revealing four layers of roof covering and insulation (three-layers of BUR with one layer of a single-ply membrane) is shown in Figure 4.1.

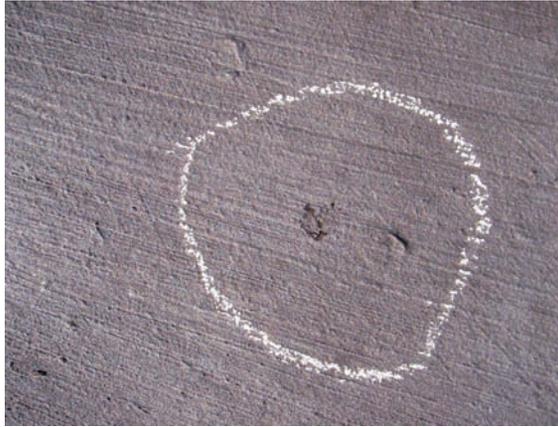
FIGURE 4.2
Hail chips in BUR reflective coating.

In this case study, a property was located in the path of a 2010 hailstorm. This particular inspection was conducted seven months after the hailstorm passed through the area. Inspections of the metal surfaces indicated the hail that struck the building and roof surfaces was up to 1.0 inch in diameter. The roof was covered with two layers of three-ply smooth-surfaced BUR with a reflective coating and was about 20 years old. The reflective coating was chipped and contained circular impact marks (Figure 4.2).

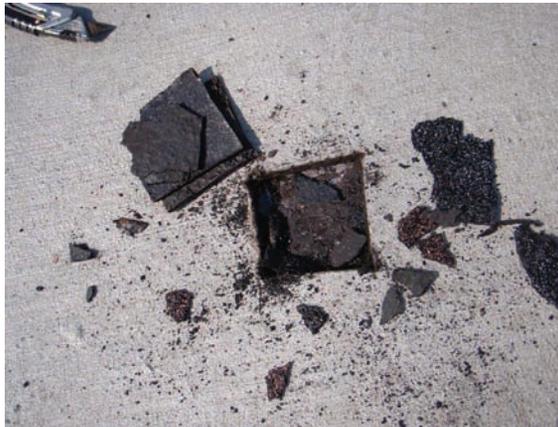
FIGURE 4.3
Test cut into BUR membrane.

Test cuts were made into the membrane at locations where the hailstones had impacted (i.e., circular marks) the roof surface; no cracks, penetrations, or punctures were present (Figures 4.3 and 4.4). Further, no evidence of moisture infiltration was present in the lower layers of the roof surface. In this case, the hail was not of sufficient size to compromise the membrane. Recommendations were made to clean the roof surfaces and reapply the reflective coating. Visually, the impact markings on the BUR surface suggested that the membrane may have been compromised by hail-strike damage; however, the test cuts revealed that this damage was surficial and cosmetic. Without performing test cuts to examine the bottom side of the membrane and the underlying substrates, it is likely the BUR surface would have been removed and replaced based simply on the cosmetic damage that had been observed.

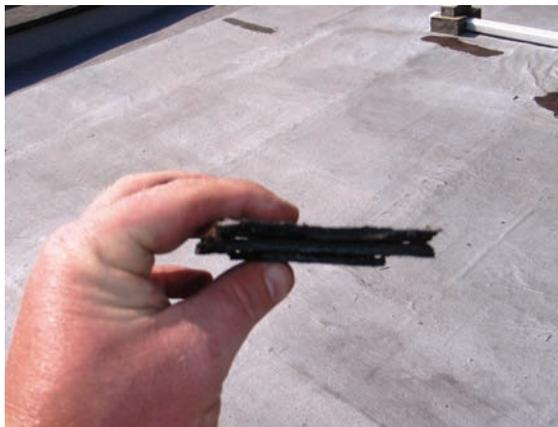
FIGURE 4.4
Lack of hail-strike impact damage to BUR plies.

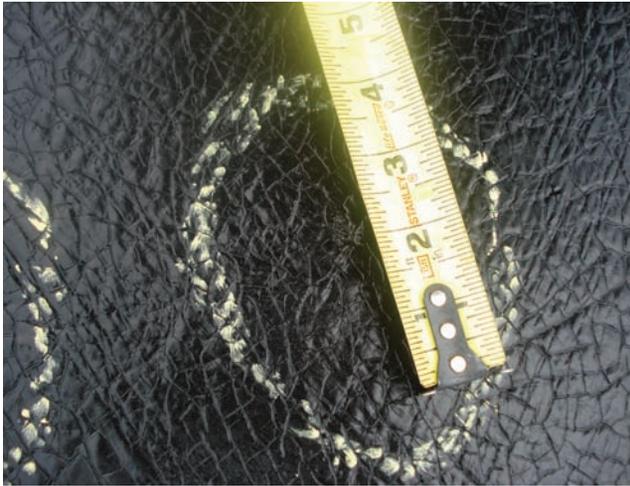
FIGURE 4.5
Hail damage to BUR flood coat and top ply.

A church building, with a roof surface that was partially covered with a BUR membrane, was located near the center of the hailstorm path. The hailstorm reportedly dropped hailstones up to 3.0 inches in diameter in the area. The inspection of the metal surfaces indicated that the maximum size of hail that struck the church was approximately 2.0 inches in diameter. Extensive hail damage, up to 10 hail strikes per 100 square feet, was present on the smooth-surface BUR. Photographs of the hailstone impacts are shown in Figures 4.5 and 4.6. In this case, the hail was of sufficient size to cause damage, and the BUR membrane was removed and replaced.
