FORENSIC ENGINEERING

**Damage Assessments for
Residential and Commercial
Structures**

**Edited by
Stephen E. Petty**

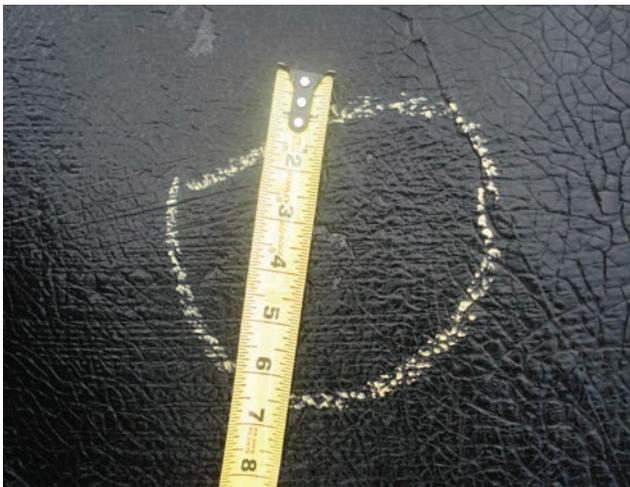
FIGURE 4.6
Hail damage to BUR flood coat and top ply.

A church building, with a roof surface that was partially covered with a BUR membrane, was located near the center of the hailstorm path. The hailstorm reportedly dropped hailstones up to 3.0 inches in diameter in the area. The inspection of the metal surfaces indicated that the maximum size of hail that struck the church was approximately 2.0 inches in diameter. Extensive hail damage, up to 10 hail strikes per 100 square feet, was present on the smooth-surface BUR. Photographs of the hailstone impacts are shown in Figures 4.5 and 4.6. In this case, the hail was of sufficient size to cause damage, and the BUR membrane was removed and replaced.

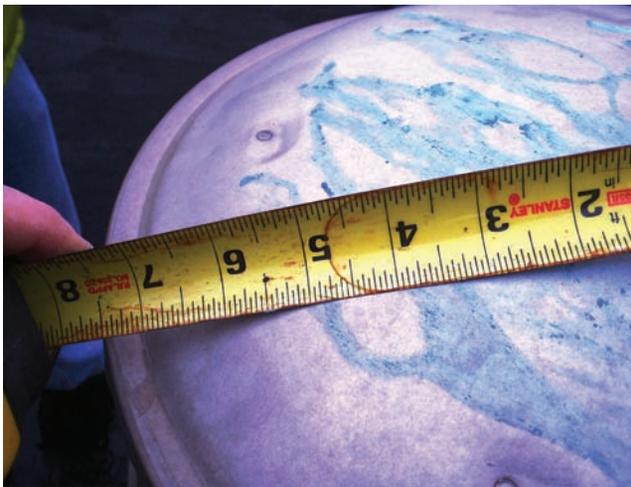
FIGURE 4.7
Hail dent in roof vent.

Numerous metal roof vents and appurtenances contained evidence of dents indicating that hailstones up to 2.5 inches in diameter had impacted the building (Figure 4.7). The finished surface of the BUR also contained circular indentations and penetrations consistent with hailstone impacts (Figure 4.8).

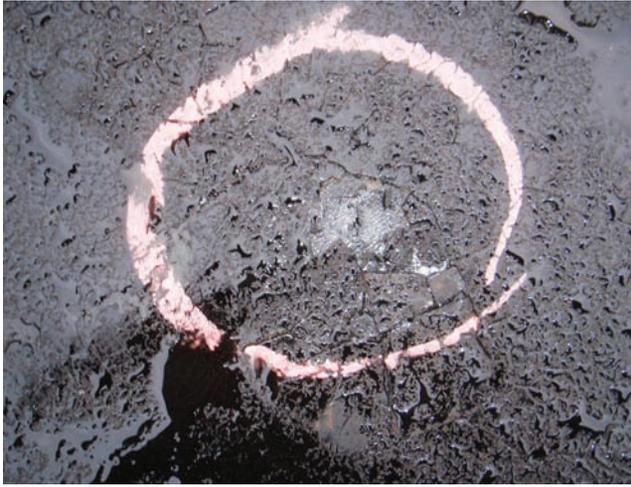
FIGURE 4.8
Hail penetration into BUR membrane roof surface.

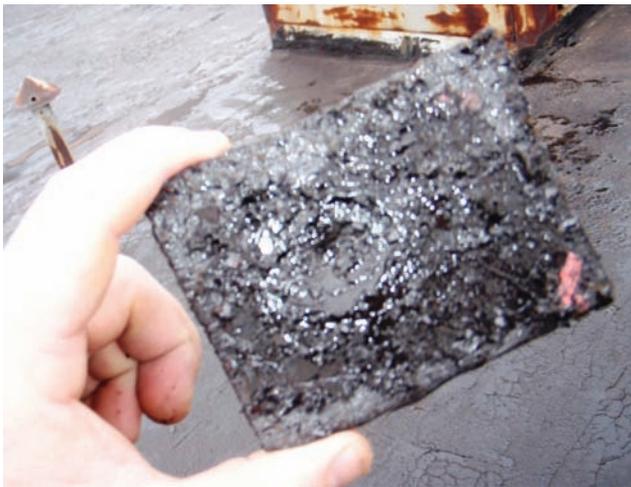
FIGURE 4.9
Hail penetration into BUR membrane layer.

A test cut indicated that there were two layers of BUR on the roof surface. The hailstone caused impact damage that had penetrated almost entirely through the top BUR layer (Figure 4.9). The hail strikes clearly caused damage to the membrane, warranting roof replacement. The review of weather data and correlation with the size of the dents to the metal surfaces confirmed that the hailstorm that caused the damage to the membrane occurred in 2007. Therefore, the forensic investigator was able to date the hailstorm likely responsible for the hail-strike damage, which fell outside of the policy coverage period for the current insurance carrier.

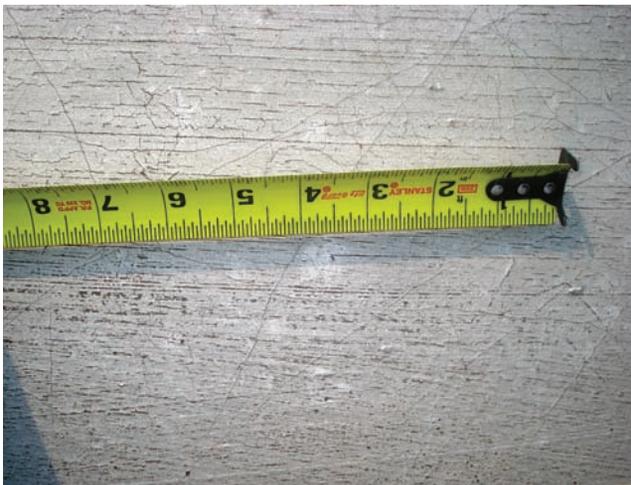
FIGURE 4.10

Burnish marks on mod-bit membrane surface.

A survey of the metal roof surfaces indicated that the hail that struck the building was up to 1.0 inch in diameter. The exact locations of where the hailstones struck the roof surface were readily visible in the form of burnish marks, which had removed the weathered oxidation layer from the mod-bit membrane surface (Figure 4.10). Other than cosmetic damage to the surfacing, no additional damage from hail-strike impacts was observed.

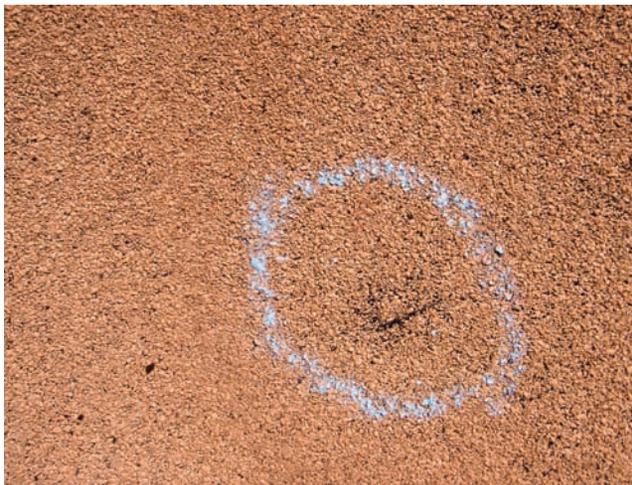
FIGURE 4.11

Hail fracture mark in mod-bit membrane roof surface.

A survey of the metal surfaces suggested that large hail, upward of 2.5 inches in diameter, had struck the building. The mod-bit membrane contained up to 10 circular fracture marks per 100 square feet of roof area that had punctured through the membrane (Figure 4.11).

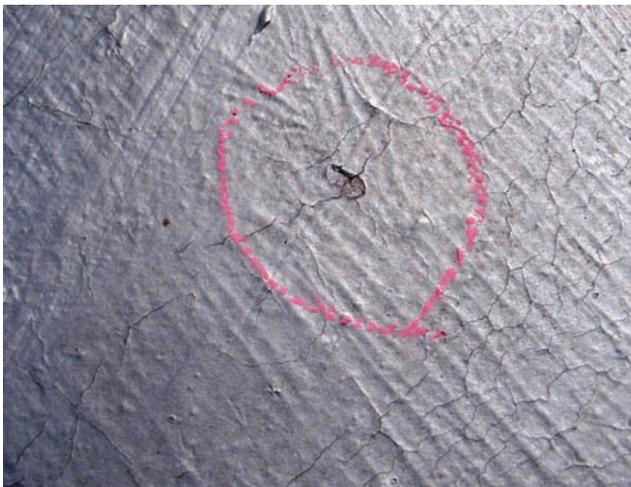
FIGURE 4.12

Chipped coating from probable hail-strikes to mod-bit roof surface.

Based on hail-strike dents in the metal surfaces on the building, the largest size hail to strike appeared to be upward of 2.0 inches in diameter. The membrane surfaces showed no visible evidence of hailstone fractures or indentations. In a few areas, some of the reflective coating was chipped away by probable hail-strike impacts (Figure 4.12).

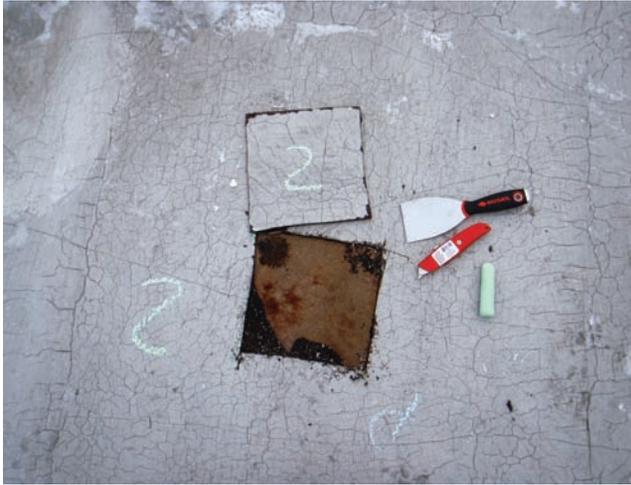
FIGURE 4.13
Overview of test cut to mod-bit roof surface.

Since the surface coating was damaged, the question was whether this damage extended through the membrane. To answer this question, six test cuts were made into the roof surface to investigate the back side of the membrane and substrates. In each case, the test panels were taken where evidence of surface damage was present. Neither the back side of the membrane nor the fiberboard insulation showed signs of hail-strike impacts, indentations, or fracturing (Figure 4.13). The samples were viewed offsite using a high-powered

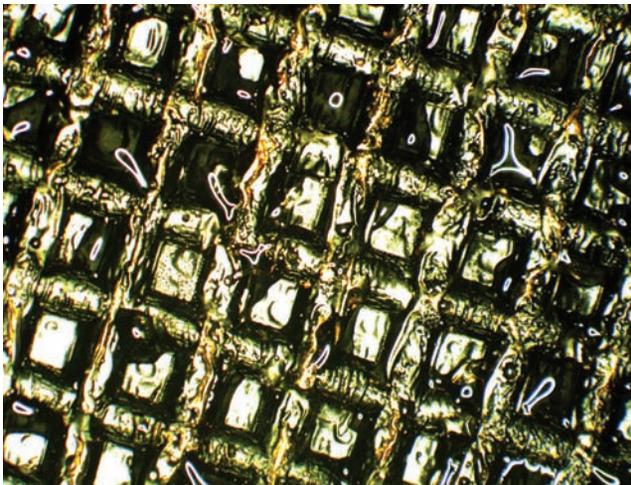
FIGURE 4.14
Back side of mod-bit membrane (high-power microscope).

microscope. No evidence of fracturing in the back sides of the membrane samples was observed (Figure 4.14). This indicated that the hail-strike damage was surficial.

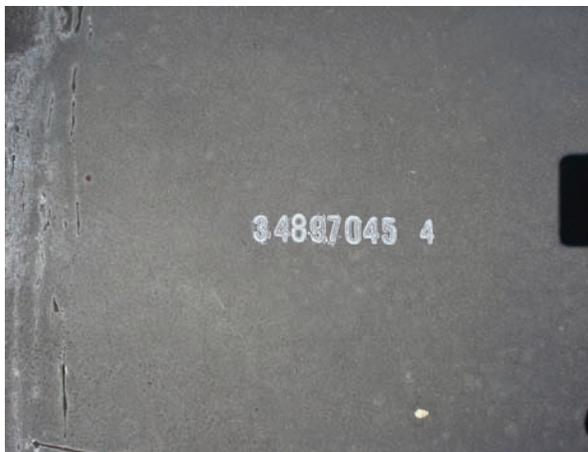
FIGURE 4.15

Example of a Firestone EPDM membrane stamp.

In Figure 4.15, the white linear stamp for a Firestone EPDM membrane is shown. The first three digits of the code represent the calendar day of manufacturing (348); the next two digits represent the year (97); the next three digits represent the material thickness (045 mil); and the last digit represents the shift in which the material was manufactured (4). Thus, this stamp indicates that this membrane was manufactured in mid-December 1997 during the first shift.

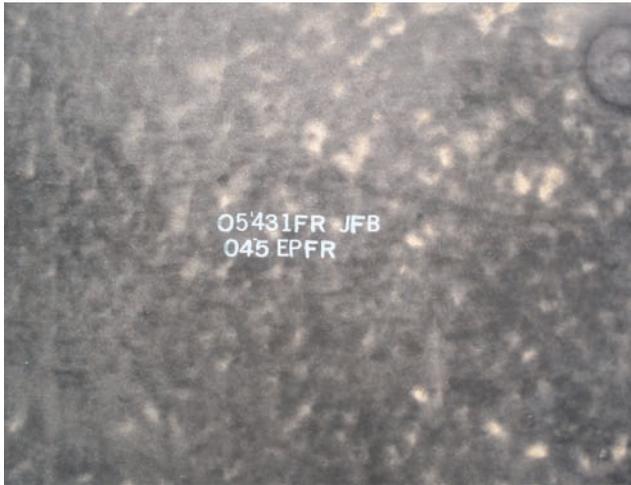
FIGURE 4.16
Example of a Carlisle EPDM membrane stamp.

In Figure 4.16, the Carlisle Syntec code is typically stamped with blue lettering, although the coloring fades to a lighter tint. The first two digits represent the month (05); the next digit represents the plant identification (4); the next two digits represent

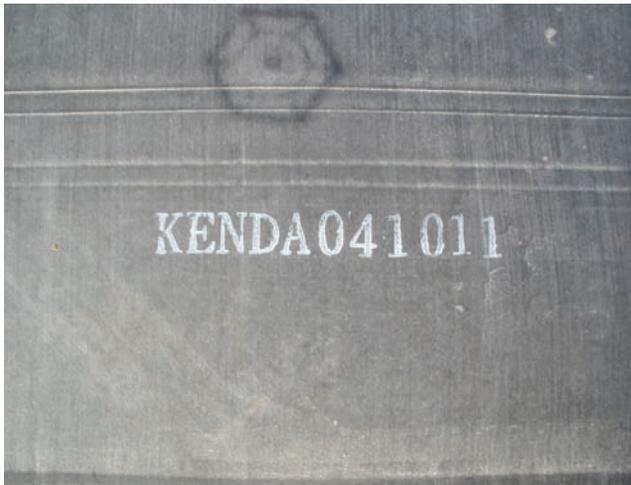
FIGURE 4.17
Example of a KENDA EPDM membrane stamp.

In Figure 4.17, the KENDA StaFast Roof Systems stamp is much simpler to decipher. The first two numbers represent the year (04); the next two numbers represent the month (10); and the last two numbers represent the day (11). Hence, the membrane was manufactured on October 11, 2004.

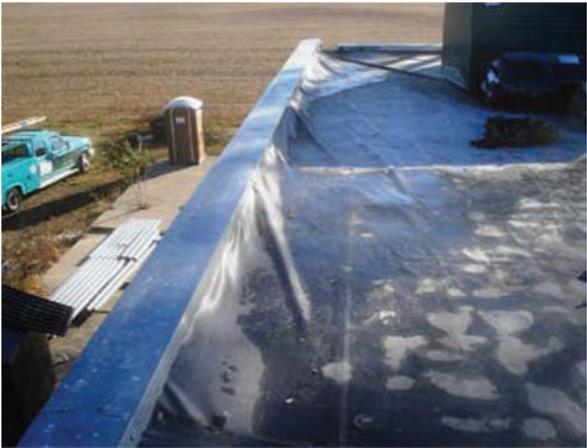
Defect Type	Probable Cause	Photograph
Membrane separation at perimeters	Expansion and contraction of membrane due to lack of perimeter attachment.

A photograph showing a dark EPDM membrane on a roof edge. The membrane is peeling away from the concrete curb, creating a gap. In the background, a blue car and a portable toilet are visible on the ground.
Membrane separation at perimeter	Shrinkage and improper perimeter fastening.

The most common defects to EPDM membranes are shrinkage and defective seam laps. The defects can occur as a result of manufacturing, installation, weathering, or age-related issues. Examples of common types of defects to EPDM roof surfaces, along with their probable causes, are illustrated in Table 4.3.

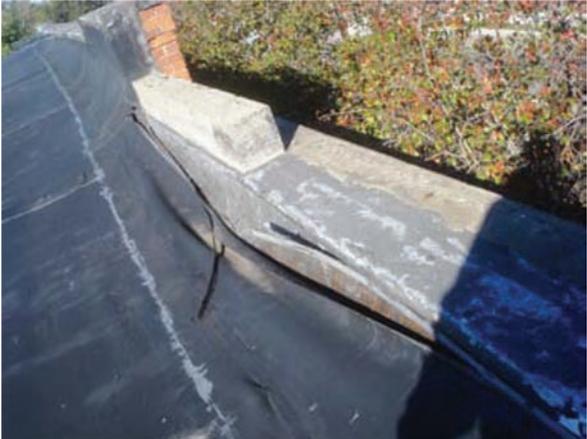
A close-up photograph of a roof edge where the EPDM membrane has pulled away from the concrete curb. The membrane is wrinkled and the fasteners are not properly secured, illustrating shrinkage and improper fastening.

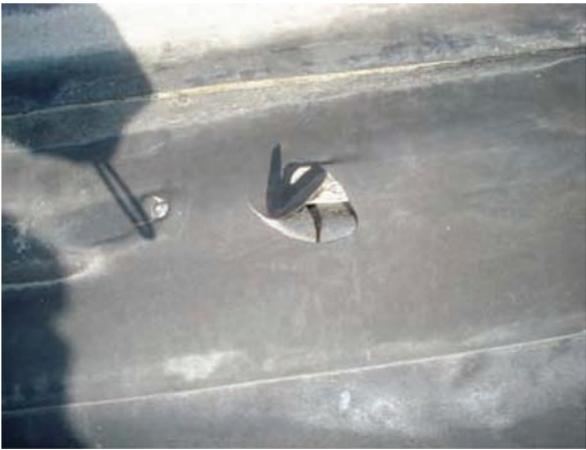
Defect Type	Probable Cause	Photograph
Protruding fasteners causing membrane tears	Movement of the structure, or moisture intrusion from preexisting conditions, roof leaks, or ponding water.

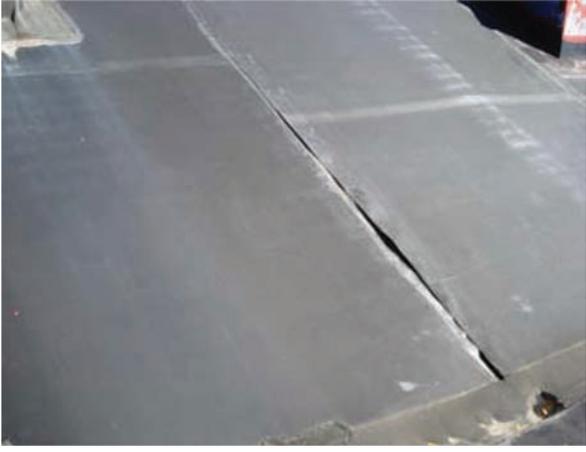
Loose seam	Shrinkage or improper installation.

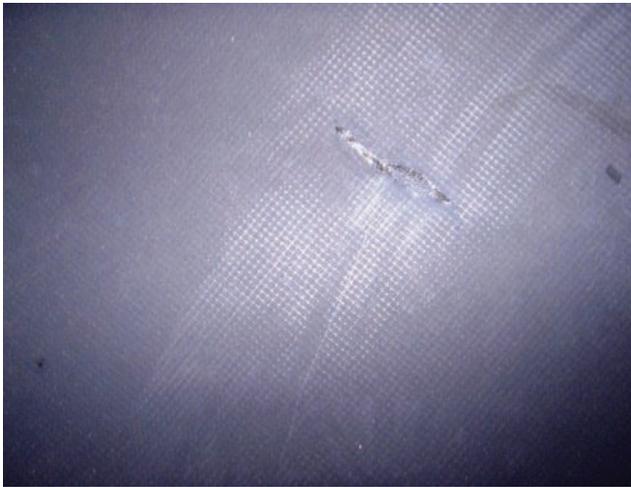
FIGURE 4.18
EPDM scrim visible through top side of EPDM membrane.

surface was finished with a mechanically attached EPDM membrane that was reported to be over 20 years old and was heavily weathered. Roof leaks had been occurring intermittently for the past few of years. The owner reported that the leaks appeared to worsen following the hailstorm and that a hail-strike damage claim was filed. Hundreds of pinholes were found across the surface by the owner's contractor, which were thought to have been caused by hailstone impacts. The reinforcement scrim was also visible through the top of the membrane (Figure 4.18). The pinholes were heaviest where the scrim was more exposed. In many cases, the holes were filled with ice, suggesting that moisture infiltrated and was beneath the membrane (Figures 4.19 and 4.20).

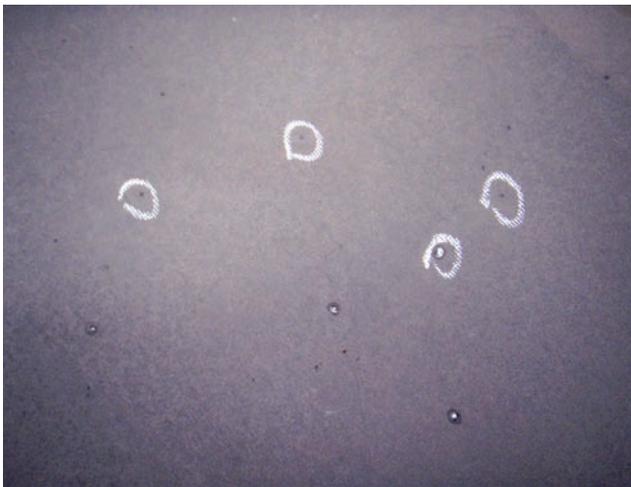
FIGURE 4.19
Pinholes in EPDM membrane.

Destructive testing illustrated that the membrane was not fractured around the pinhole defects and indentations were not present in the insulation board below the defects. This supported the hypothesis that the pinholes observed in the EPDM surface were not a result of hail-strike impacts but were the result of long-term aging or chalking. Further, it was observed that the maximum size of hail to have struck the roof surface was not likely of sufficient size to cause damage to an EPDM roof surface.

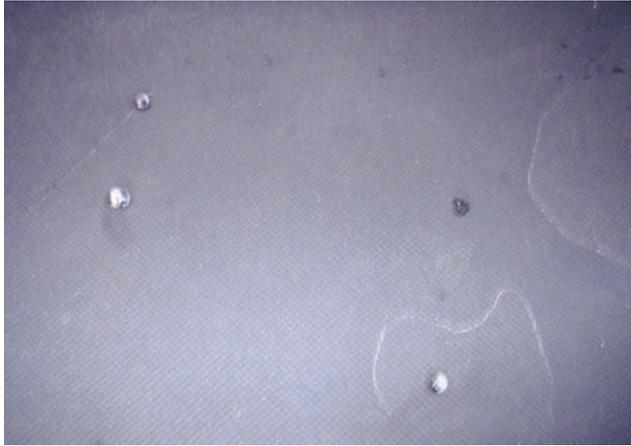
FIGURE 4.20

Pinholes in EPDM membrane filled with ice.

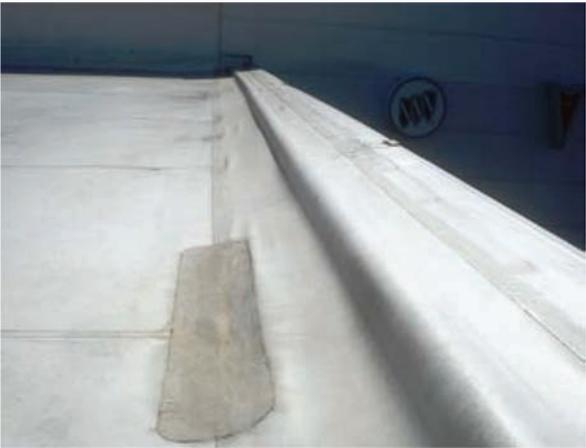
Defect Type	Probable Cause	Photograph
Membrane separation at perimeters	Expansion and contraction of membrane due to lack of perimeter attachment.

<p>A photograph showing a white TPO membrane edge that has separated from a concrete substrate. A wooden board is placed over the gap to illustrate the lack of proper attachment at the perimeter.</p>
Protruding fasteners causing cracks to membrane	Movement of the structure, or moisture intrusion from preexisting conditions.

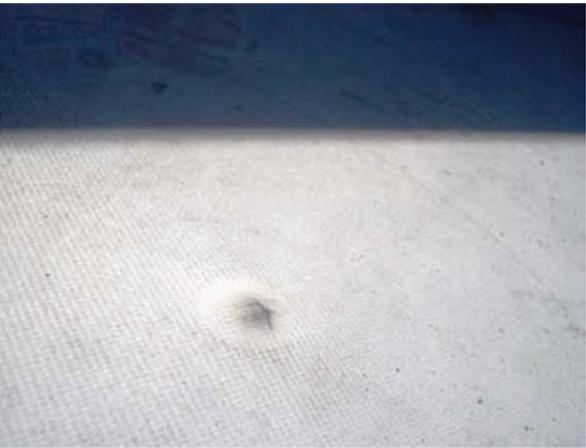
<p>A close-up photograph of a white TPO membrane with a small, circular hole or indentation. This is caused by a protruding fastener or nail that has punctured the membrane.</p>
Separated seams	Expansion and contraction of membrane due to lack of perimeter attachment.

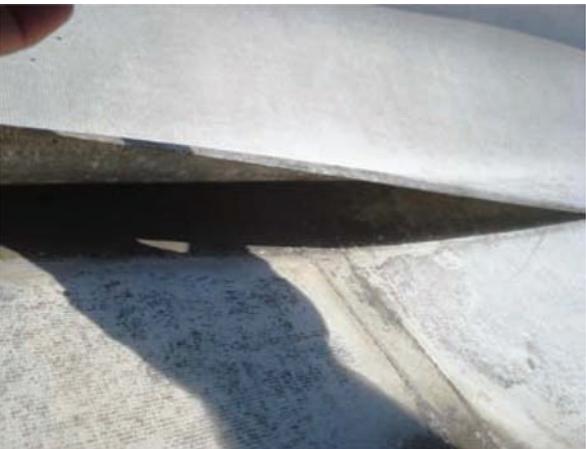
<p>A photograph showing a white TPO membrane seam that has separated from the substrate. The membrane is peeling away, revealing the underlying surface and the gap between the membrane layers.</p>

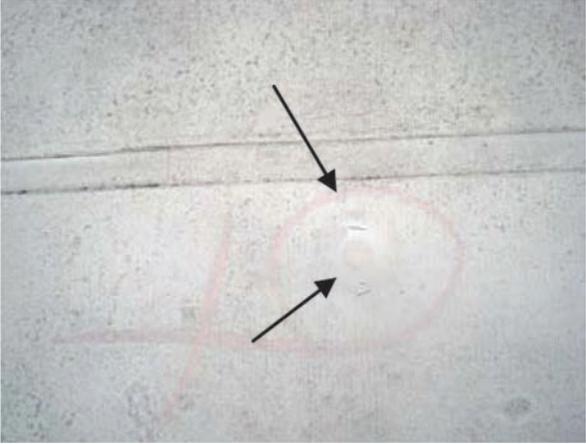
Defect Type	Probable Cause	Photograph
Fractures around fastener plates	Age-related stress fracturing due to a loss of plasticizer.

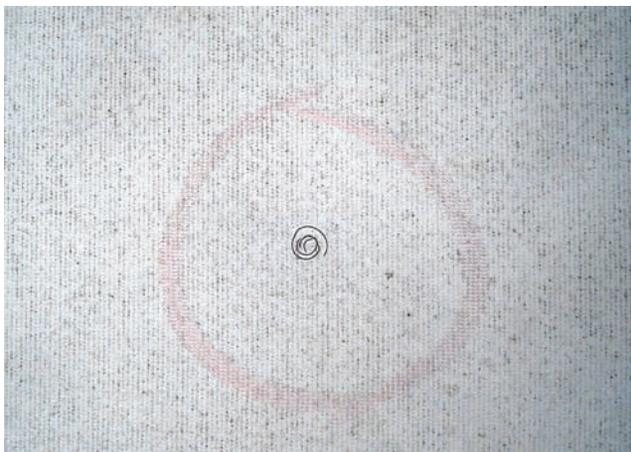
**FIGURE 4.21**

Hail-strike fracture in PVC membrane roof surface.

During the subsequent forensic inspection, small dents up to 0.5 inch in diameter were found on the metal surfaces of the building that were consistent with hail-strike impacts. These dents suggested that hail up to 1.0 inch in diameter had struck the building. A review of past weather data from the area indicated that at least six hailstorms, spanning a four-year period, had dropped hailstones up to 1.0 inch in diameter in the vicinity of the building. These weather data confirmed site-specific hail sizes based on hail-strike dent observations. The PVC roof surface contained hundreds of circular fractures consistent with hailstone impacts (Figure 4.21).

The number of fractures ranged from 5 to 13 per 100 square feet of roof surface area. Four test cuts were made into the membrane to verify that the fractures were caused by exterior impacts (i.e., hailstones). At each test cut location, the membrane had been fractured, the indentations penetrated through the PVC membrane, and the insulation below the membrane was wet. This suggested the fracturing of the membrane surface was likely a result of hail-strike damage that allowed water to enter the roof system substrates (Figure 4.22).

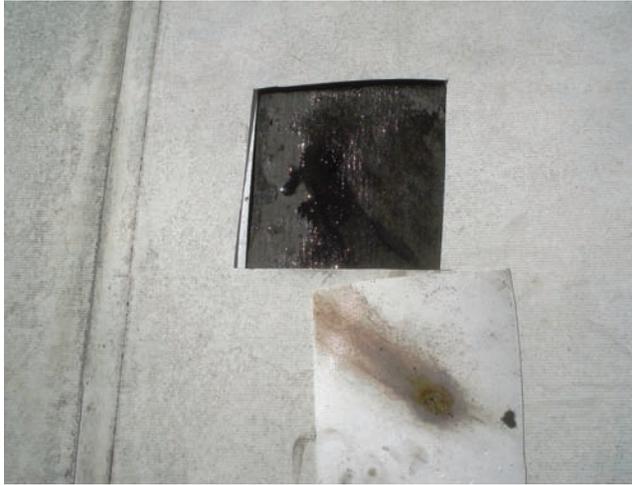
**FIGURE 4.22**

Test cut into hail-struck damaged PVC membrane—moisture on insulation below.

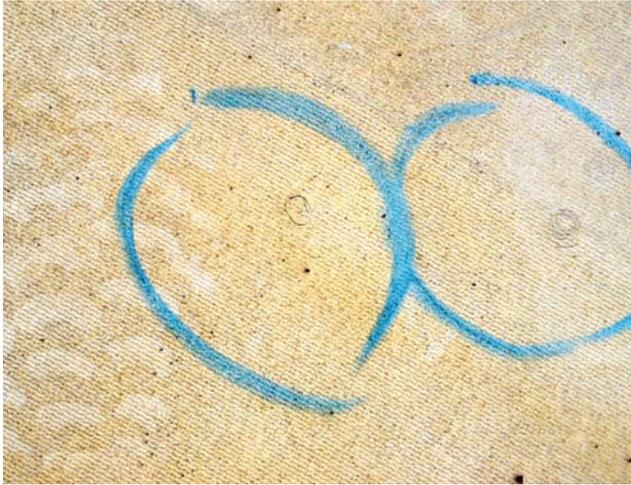
FIGURE 4.23
Hail-strike fractures in PVC membrane roof surface.

During the forensic inspection, surveys of the metal surfaces indicated the size of the hail that struck the building was up to 1.0 inch in diameter. This maximum size of hailstone was consistent with weather data records from hailstorms reported in the area. Distinct circular fracture marks and indentations were present throughout the surface of the membrane (Figure 4.23). These hail-strike marks penetrated through the membrane.

to 36 hail-strike fracture marks per 100 square feet; the newer PVC membrane over the pool contained 10 hail-strike fracture marks per 100 square feet of roof surface area. This investigation confirmed a hailstone threshold of 1.0 inch in diameter was capable of causing functional damage to PVC membrane roof surfaces and confirmed research by Foley et al.¹³ that the degree of hail-strike damage increases with roof age for PVC membrane roof surfaces.

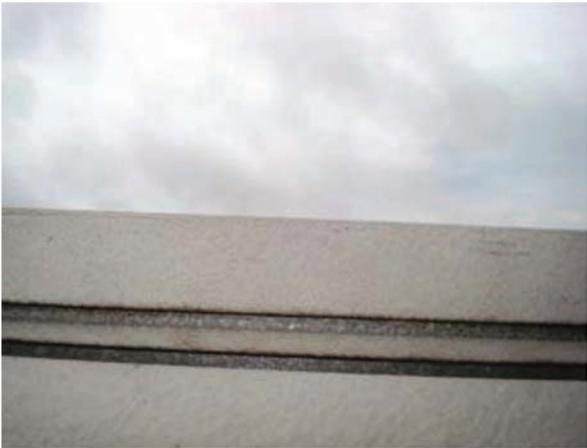
Defect Type	Probable Cause	Photograph
Gaps forming at crimp seams	Differential movement causing abrasion through the seam.

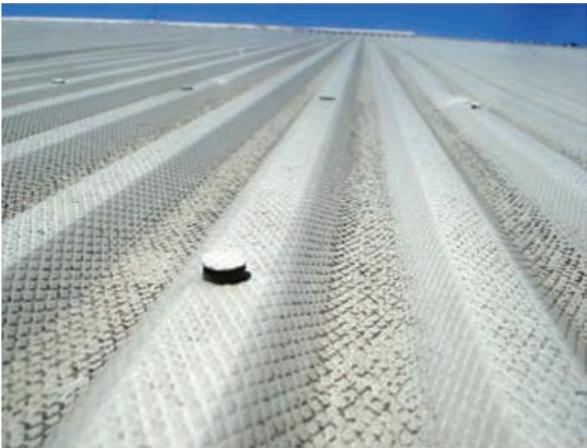
Fastener pullout	Thermal movement elongating holes.

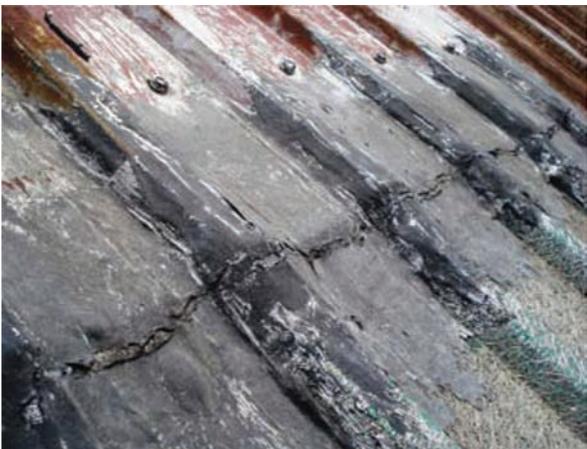
Fastener pullout and separated end lap seams	Aging and degradation of the metal panels.

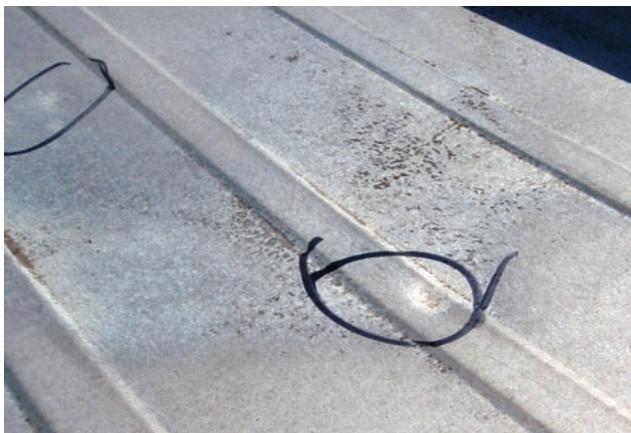
FIGURE 4.24

Hail-strike dents in standing seam metal panels.

During repairs around one of the pipes, a contractor noticed dents in some of the metal surfaces and the owner subsequently filed a claim with their insurance carrier for hail-strike damage to the roof system. During a subsequent forensic investigation, the size of the probable hail-strike dents in the exterior and roof surfaces of the building suggested that hail up to 2.5 inches in diameter had struck the building. Numerous dents were observed across the metal panels (Figure 4.24).

The dents did not harm the protective coating or cause seam separation when the integrity of the seams were tested. Thus, the hail-strike damage was concluded to be cosmetic since the dents would not cause loss of the water shedding capability or shorten the life of the roof system.

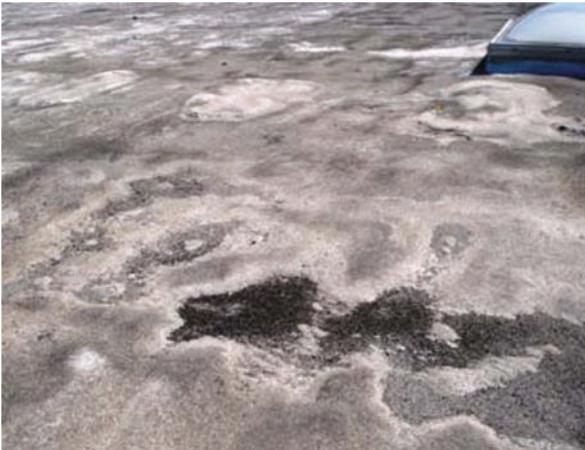
Defect Type	Probable Cause	Photograph
Severe degradation	Heavy ponding water causing coating and foam degradation.

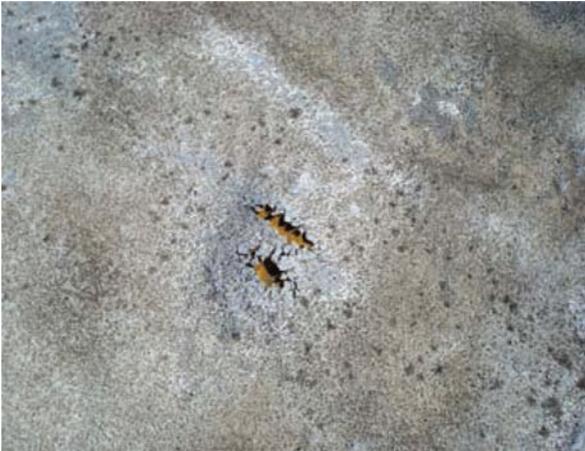
Surface cracking	Moisture entrapment and degraded coating. Lack of proper maintenance to coating system.

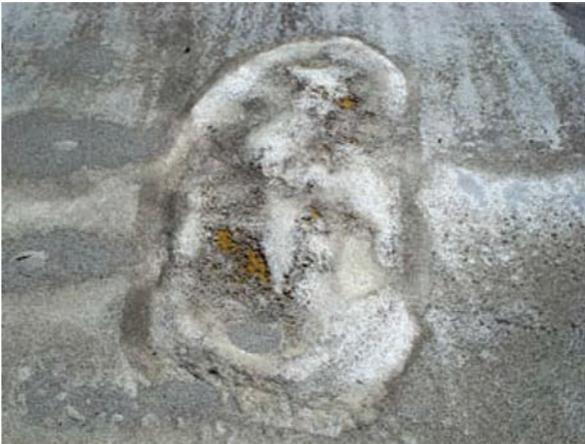
Blisters and bubbling	Moisture entrapment due to wet substrates or water intrusion.

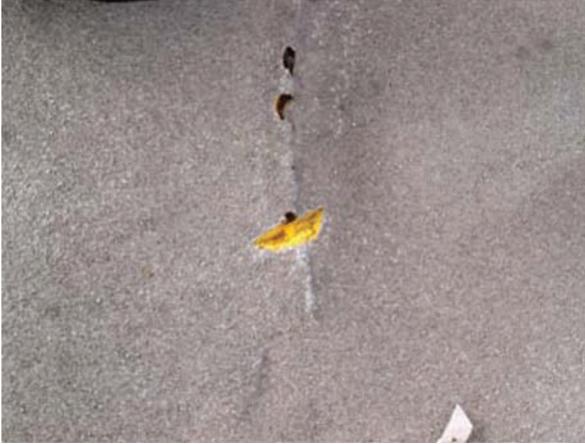
Defect Type	Probable Cause	Photograph
Splitting	Improperly fastened/ adhered insulation causing movement of the substrate.

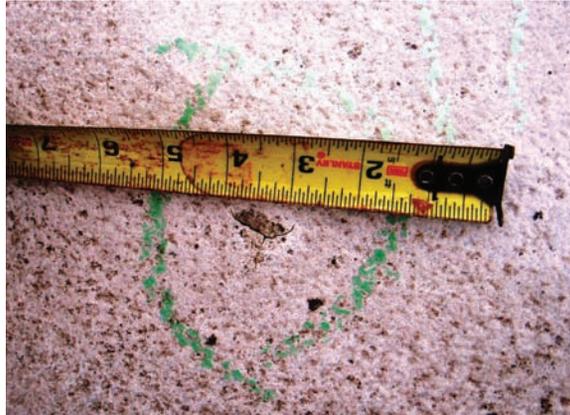
FIGURE 4.25
Probable hail-strike damage to SPF roof surface.

In this case study, the SPF roof surface on a commercial building was determined to have been impacted with hail measuring up to 1.5 inches in diameter. The roof was covered with a SPF roof system that was approximately 2.0 inches thick. The roof system was approximately 20 years old, was not drained well, and the surface coating was deteriorated in appearance. Numerous apparent hail-strike dents and cuts, measuring up to 0.75 inch in diameter, were present in the roof surface (Figures 4.25 and 4.26).

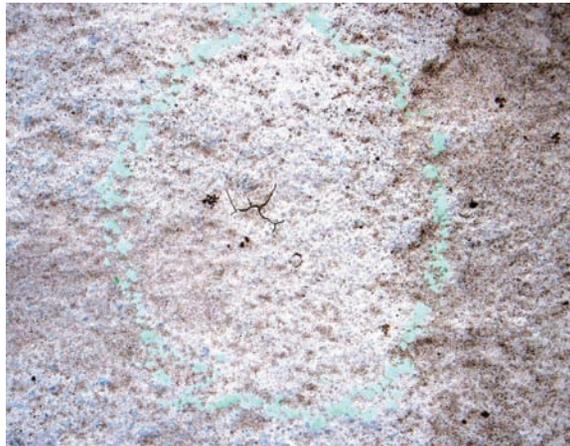
FIGURE 4.26
Probable hail-strike damage to SPF roof surface.

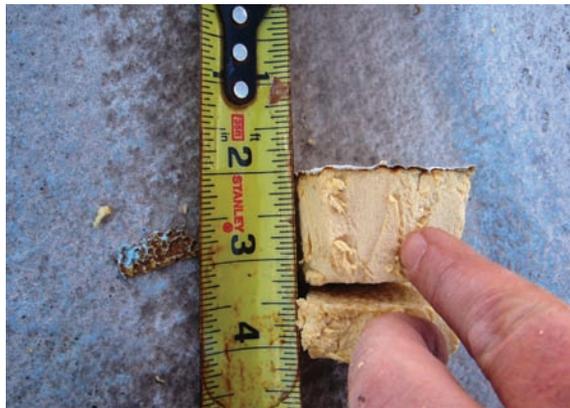
FIGURE 4.27
Test cut into SPF roof system.

The average hail-strike damage equaled 23 impacts per 100 square feet of roof surface area. Two test cuts were made at the largest impact marks and indicated the hail penetrated no more than 0.5 inch into the foam (Figures 4.27 and 4.28).

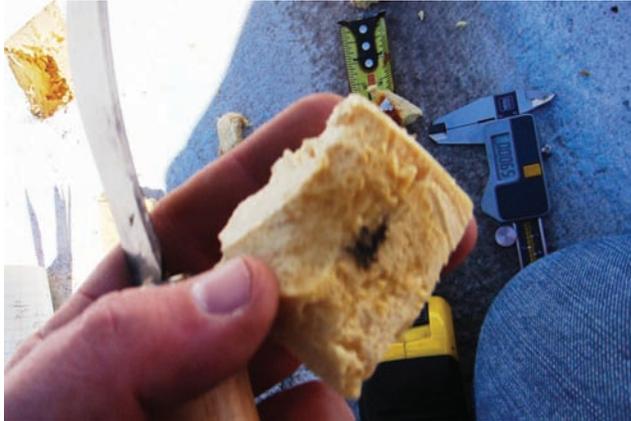
FIGURE 4.28
Hail-strike impact depth into SPF roof system.

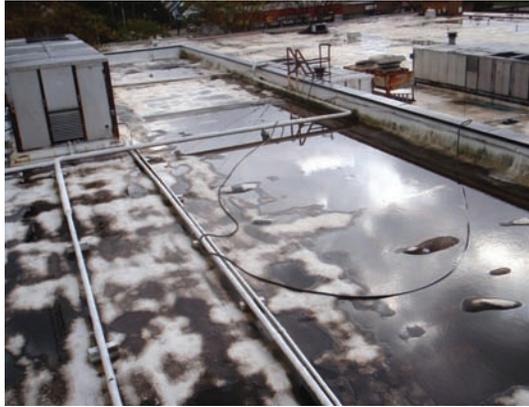
FIGURE 4.29
Water ponded on SPF roof surface.

A review of the hailstorm history in the area indicated that the last hailstorm that passed over the area occurred four years prior, at or near the timeframe when the roof began leaking. The SPF roof surface was in very poor condition, and heavy precipitation events caused severe ponding of water on the roof surface, which required maintenance personnel to use pumps to remove the water (Figure 4.29).

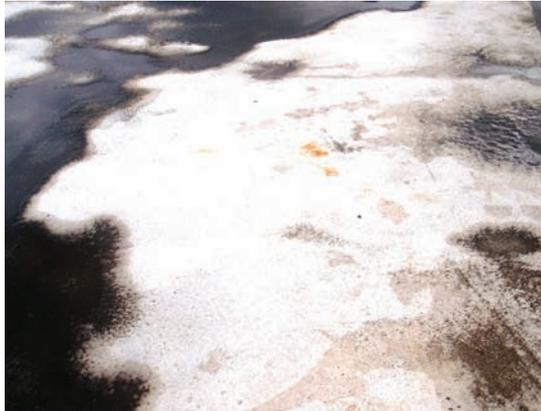
FIGURE 4.30
SPF floating on ponded water.

The SPF roof surface was heavily blistered and contained numerous surface splits. In four areas, the SPF was observed to be floating on the roof. When walking on the roof surface, it felt as if you were walking on a waterbed (Figure 4.30).

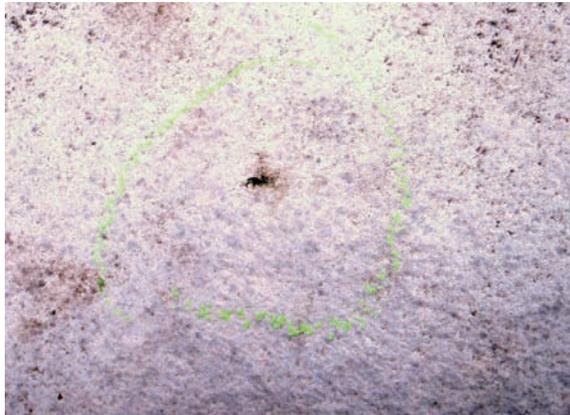
FIGURE 4.31
Probable hail-strike damage to SPF roof surface.

The size of the hail that struck the building was about 1.0 inch in diameter. The membrane surface contained numerous circular impact marks that were consistent with hailstone impacts (Figure 4.31).

The intensity of probable hail-strike impacts was measured and determined to be four to five hits per 100 square feet of roof surface area. Using the SPFA criteria in Table 4.7, this level of damage would be characterized as light to moderate. The repair recommendations

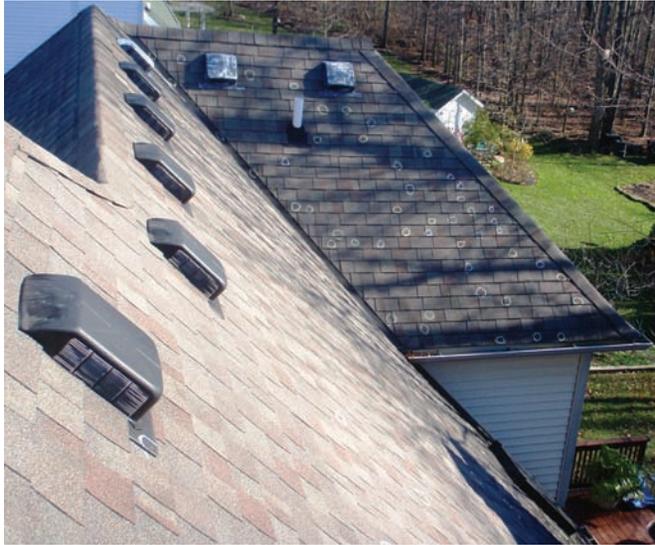
**FIGURE 5.2**

Probable hail fraud damage to asphalt shingle roof—damage near accessible location(s) and back of home.

The concentration of fraudulent hail damage in more easily accessible roof areas is an indication of possible fraud (Figure 5.2).

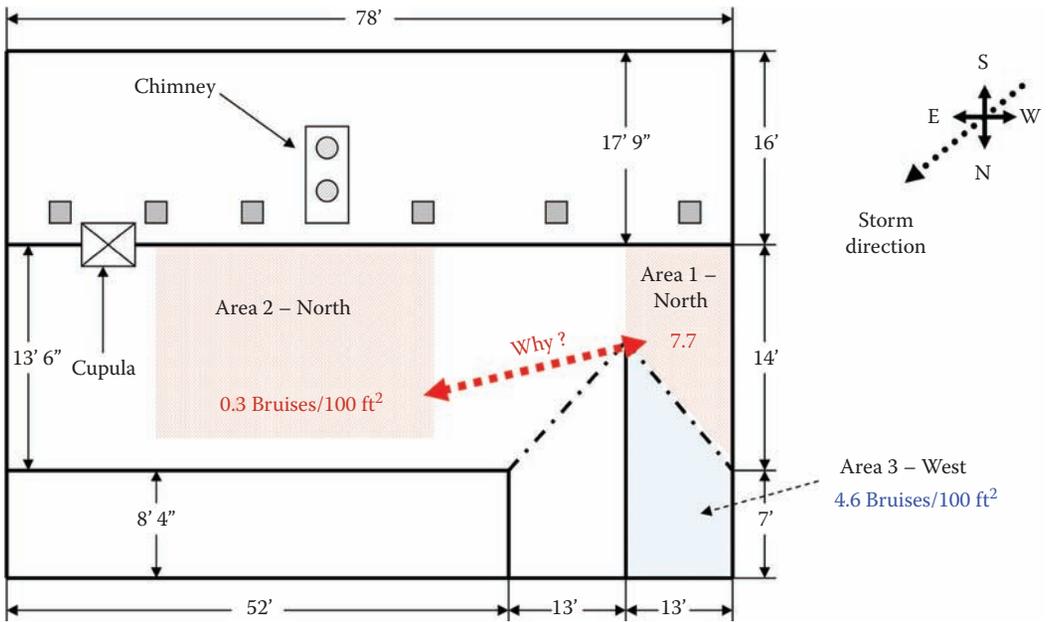
FIGURE 5.3
Inconsistent location of extent of hail damage to roof shingle surfaces.

1. The defects occur, or are more numerous on, roof elevations opposite the direction from which the hailstorm arrived (Figures 5.3 and 5.4). Figure 5.3 is a schematic of an example of a roof with bruise counts (defects per 100 square feet of roof area), and Figure 5.4 is a photograph of the actual roof area. As illustrated in Figure 5.3, in a situation where the hailstorm arrived from the southwest, one would expect the greatest defects to occur on the south and west roof elevations, as was observed to exterior finished surfaces, gutters, and downspouts. However, in this case, the defect counts on two north-facing elevations were inconsistent (0.3 and 7.7) with those on the west elevation (4.6; elevation facing the storm should be the highest). The suspect area 1 is also readily accessible from a nearby valley.

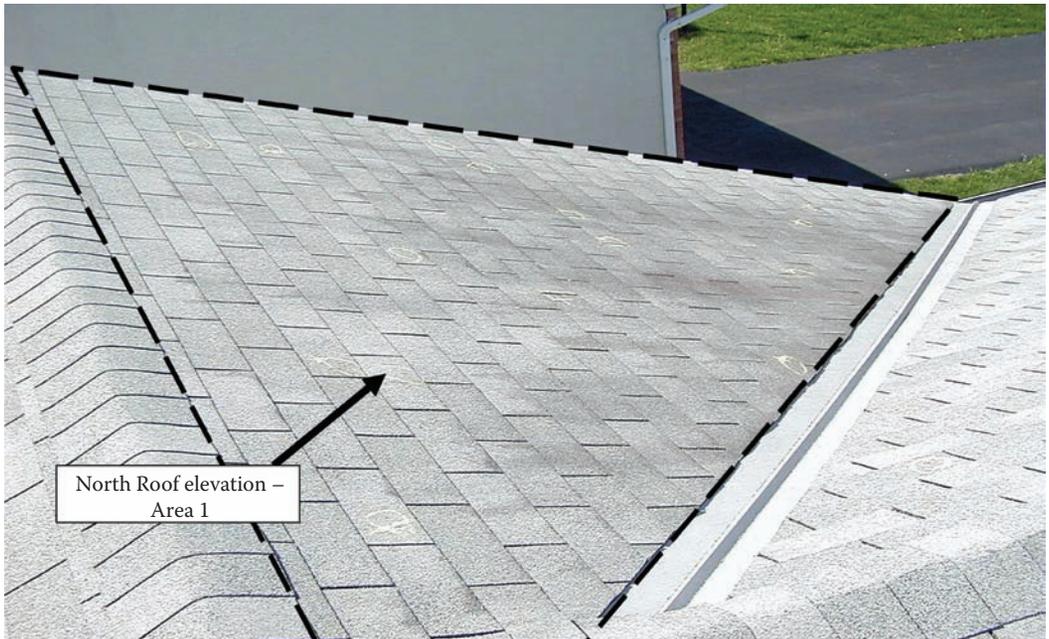
FIGURE 5.4
West end of north roof elevation—high number of shingle defects.

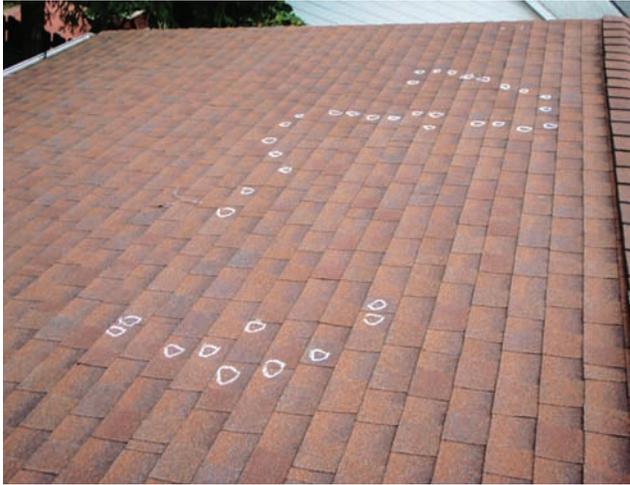
FIGURE 5.5
Zigzag defect pattern.

2. The damages or defects are oriented in linear, wavy, or zigzag patterns rather than random (Figure 5.5).

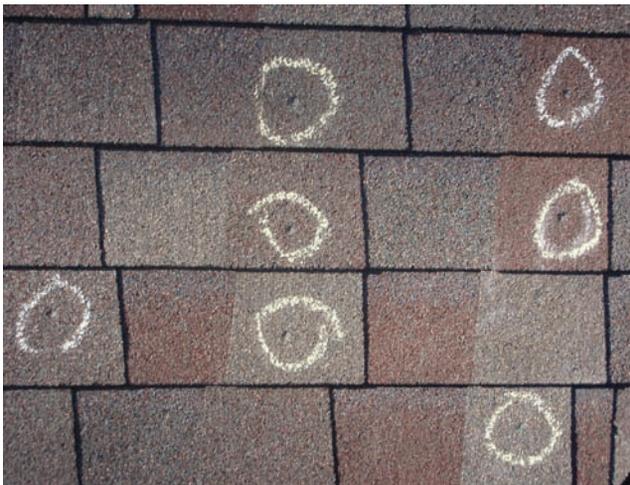
FIGURE 5.6
Defects centered on shingle tabs—ball-peen hammer.

3. The defects are centered on shingle exposures (Figure 5.6).
4. The defects are consistent in size, orientation, or appearance (Figure 5.7; see also Section 5.2.2.4).

- Spinning coins such as dimes and quarters (i.e., using the edge of the coin; Figure 5.9)
- Ball-peen hammer (Figures 5.6 and 5.10) direct impact
- Handle end of a screwdriver—twist and spin
- Golf ball in a sock—direct impact
- Scrape from spinning the end of a key or a utility knife blade
- Using the end of a wooden cane
- Spikes from golf shoes

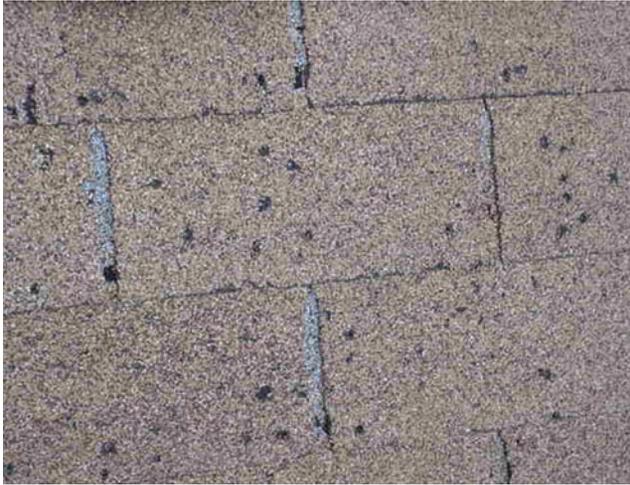
FIGURE 5.7

Consistent and localized mechanical damage.

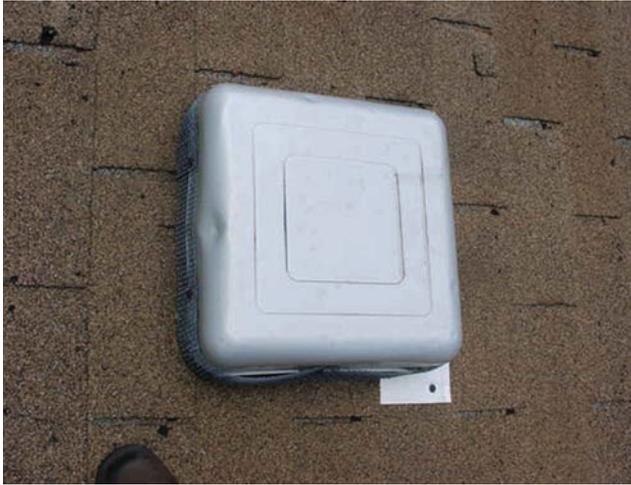
FIGURE 5.8
Heavy damage to shingles inconsistent with denting in top of box vent.

If significant hail-strike roof damage is observed, it is reasonable to expect to find records of a storm in the area with the maximum size(s) of hail that struck the area large enough to cause such damage (Chapters 3 and 4, this volume). Experience with hailstone size information from these services, versus actual site visit hail investigations, suggests that they are conservative (i.e., maximum size of hail estimated to have fallen in an area is slightly greater than actually observed or occurred) regarding the maximum size of hail for a given area. Therefore, if the weather data do not indicate the size of the hail that fell onto the residence or structure being inspected was large enough to cause the observed damage, the claim of hail-strike damage should be questioned. Also, the bruise-count damage to shingles should be consistent with the size of the hailstones causing hail-strike dents in metal surfaces on the roof, gutters, downspouts, window screens, siding (both metal and vinyl), and outdoor air conditioner coil fins (Figure 5.8). If not, then claims regarding hail-strike damages to such surfaces should be questioned.

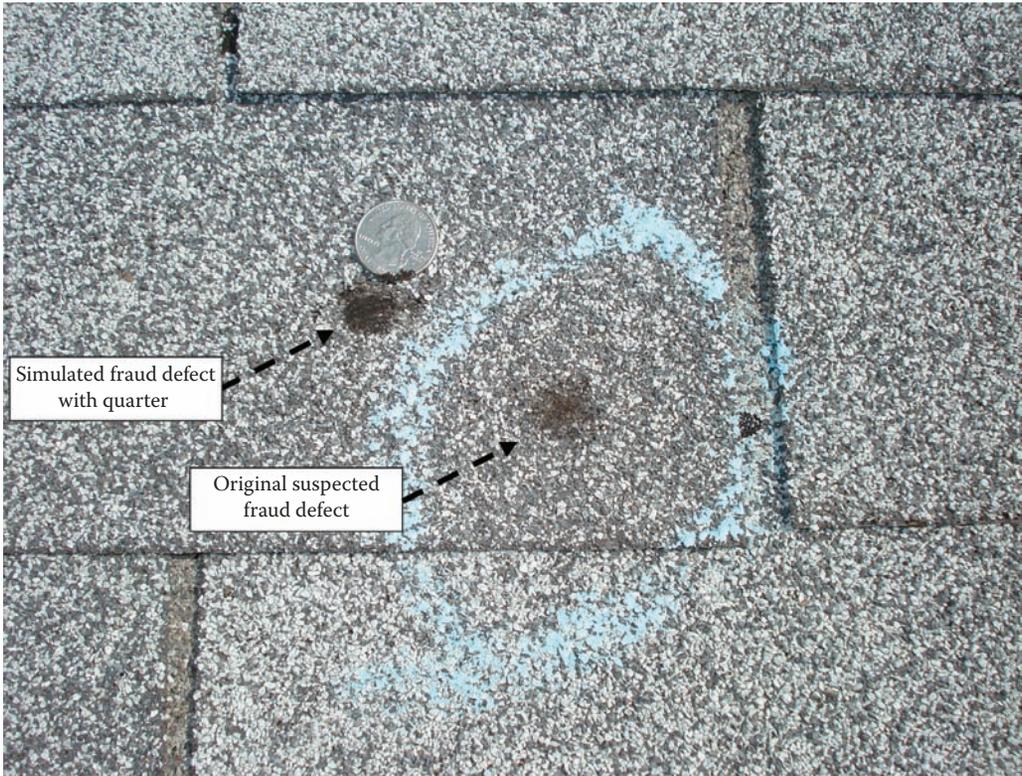
FIGURE 5.9
Field fraud damage versus simulated damage using a spun quarter.

As illustrated in Table 5.2 and Figure 5.9, spinning coins provided the most realistic simulated hail-strike bruises to asphalt shingles. The key to identifying potential fraud, provided that the asphalt shingles were not past their service life, is the observation that actual hail-strike bruises tend to leave granules in the center of the defect (Chapter 3, this volume), whereas with spun coins, the granules are missing from the

center of the defect. Also, the spun coin defect is more circular in shape and is less diffuse looking than actual hail-strike bruises.

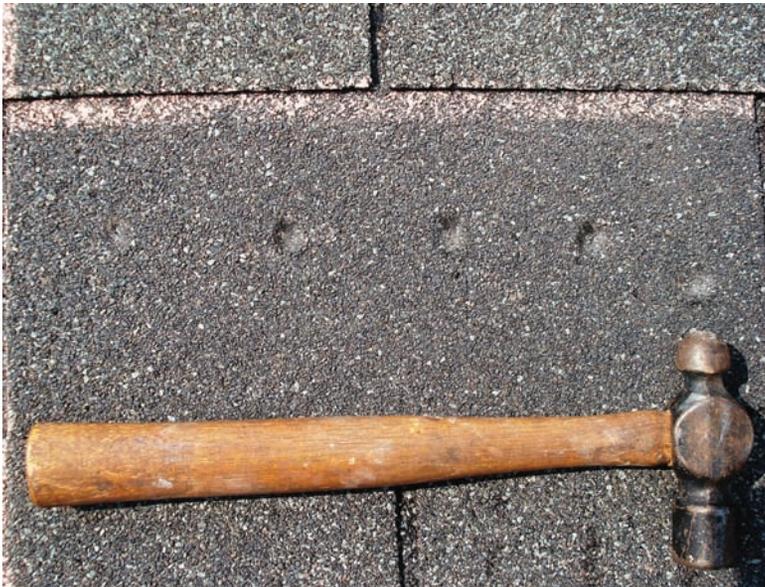
FIGURE 5.10
Simulated damage using a ball-peen hammer.

Ball-peen hammer damage is distinctive, with circular defects and crushed granules. With these defects, nearly all the granules are present in the defect, albeit crushed, unlike an actual hail-strike bruise.

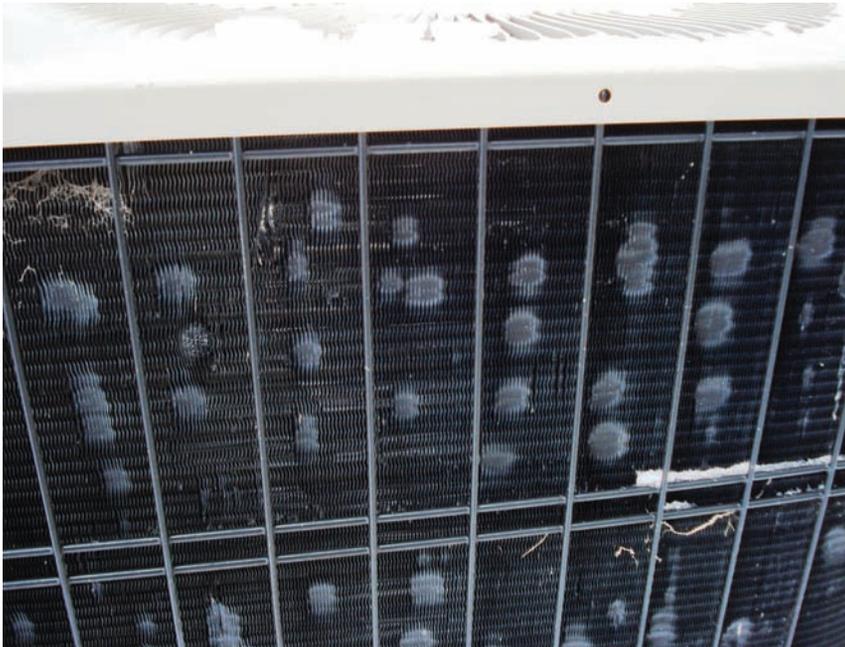
FIGURE 5.11

Likely fraud damage to an HVAC outdoor unit coil fins.

Typically the fraud damage to metal siding, downspouts, and sometimes gutters is accomplished by using a pressing action with a thumb, finger, or golf ball.⁴ Damage to HVAC outdoor unit coil fins (Figure 5.11) is typically accomplished using either a thumb, hammer, or back of a tool like a screwdriver and is normally quite obvious due to patterning.

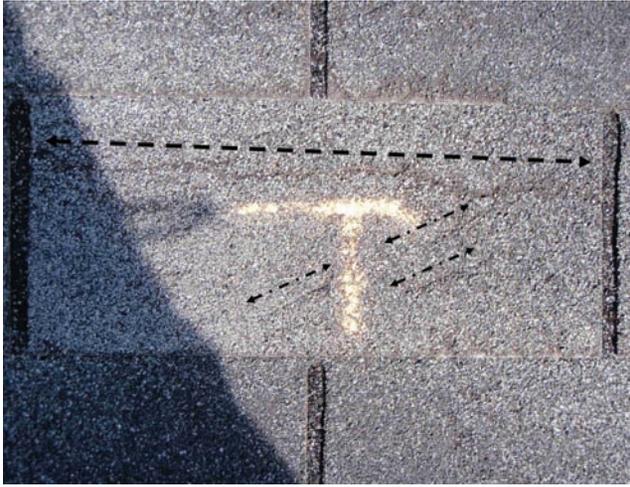
FIGURE 5.13

Likely wind fraud damage to asphalt shingle tab—multiple crease lines (tab mechanically lifted from bottom right).

2. Creased shingle tabs or multiple crease lines and directions: If the shingles are generally well seated, evidence of multiple crease lines to the overlying tab (Figure 5.13) and scrapes, scratches, and partially delaminated adhesive strips to the underlying or overlying shingle tabs (Figure 5.14) suggests fraudulent mechanical activities intended to dislodge the shingle tab. Note in this figure, based on the crease-line pattern, that the shingle tab appears to have been lifted mechanically from the bottom right corner. Debris under the shingle tab may also be an indicator of fraudulent activities, depending on when it may have occurred.

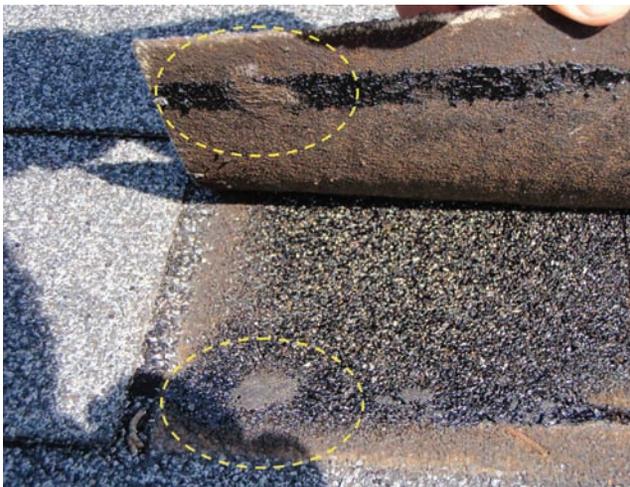
FIGURE 5.14

Likely wind fraud damage to asphalt shingle tab—partially detached adhesive strip.

4. Missing creased shingle tabs or scrapes, scratches, and delamination of the adhesive strips: Again, if the shingles are generally well seated and the missing tabs are outside the typical wind damage areas, evidence of scrapes, scratches, and partially delaminated adhesive strips to the underlying or overlying shingle tabs (Figure 5.14) suggests fraudulent mechanical activities to dislodge the shingle tab.
