FORENSIC ENGINEERING

**Damage Assessments for
Residential and Commercial
Structures**

**Edited by
Stephen E. Petty**

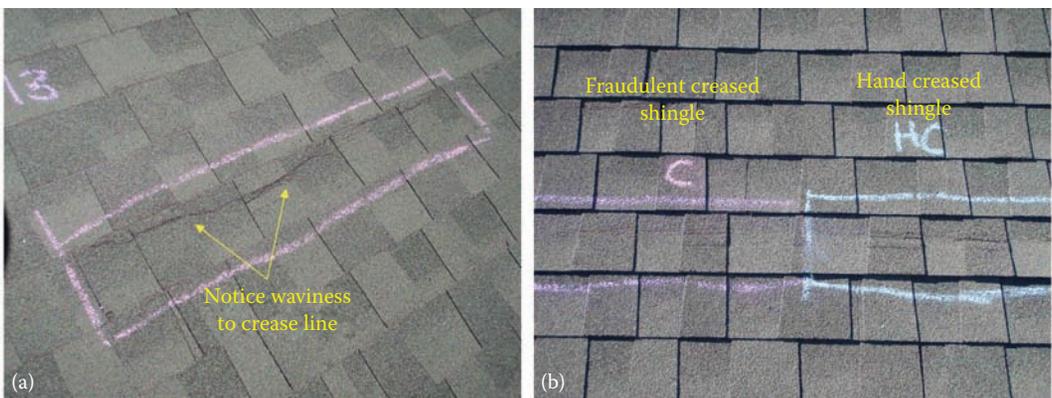
FIGURE 5.15

Likely wind fraud damage to dimensional shingle (a) and hand creased shingle adjacent to fraudulent creased shingle; notice similarities in the creasing pattern (b).

3. Creased dimensional shingles: Due to the stiffness, design, and dynamics associated with the creasing of a dimensional shingle (typically ~36" or wide), any visible creasing, especially creasing of the entire shingle, suggests fraudulent mechanical activities (Figure 5.15). A simple test to replicate the suspected fraudulent damage consists of creasing the shingle by hand to an undamaged shingle and comparing the two forms of damage. Similarities between the two could suggest intentional mechanical damage.

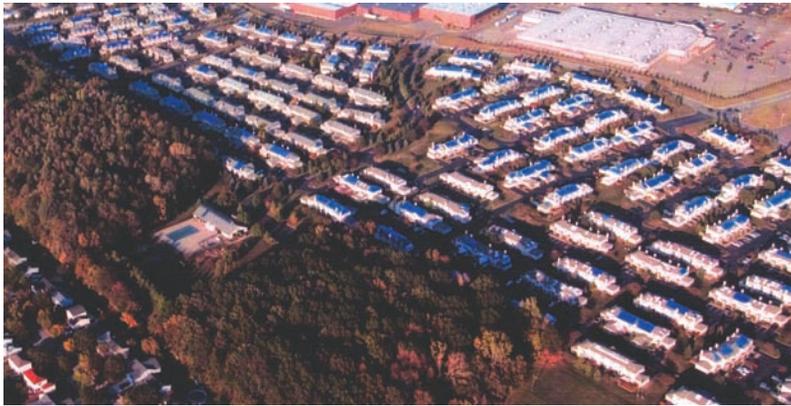
FIGURE 5.16
Apartment complex—aerial view of tarps on buildings.

On one particular wind damage assessment associated with an 88-building apartment complex (Figure 5.16), nearly every roof elevation within the complex was blanketed with tarps following Hurricane Ike.

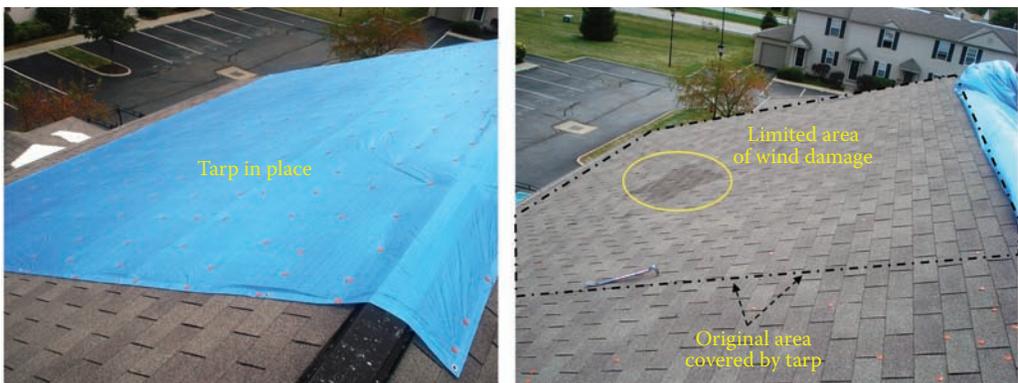
FIGURE 5.17
Before and after removal of large tarp—notice limited amount of wind damage beneath large and excessive tarp.

In this case, apparently a contractor at some point in time assumed that some insurance claims adjusters accept tarped roof areas as wind damaged without looking underneath the tarps. This is probably a good assumption on the part of less than reputable contractors since wind events can lead to large numbers of claims limiting the time available to the claims adjuster to verify that damage exists below tarped areas. In this example illustrated in Figures 5.16 and 5.17, when the smaller tarps were removed, some legitimate wind damage was uncovered. However, when several other larger blue tarps were removed, little to no visible evidence of wind damage was found. This fraudulent activity created an appearance of much greater amounts of wind damage than what actually existed. It was assumed that the ultimate goal of the person(s) installing tarps on the roof surfaces was to ensure that the insurance company would replace the entire roof surface rather than repairing small areas.

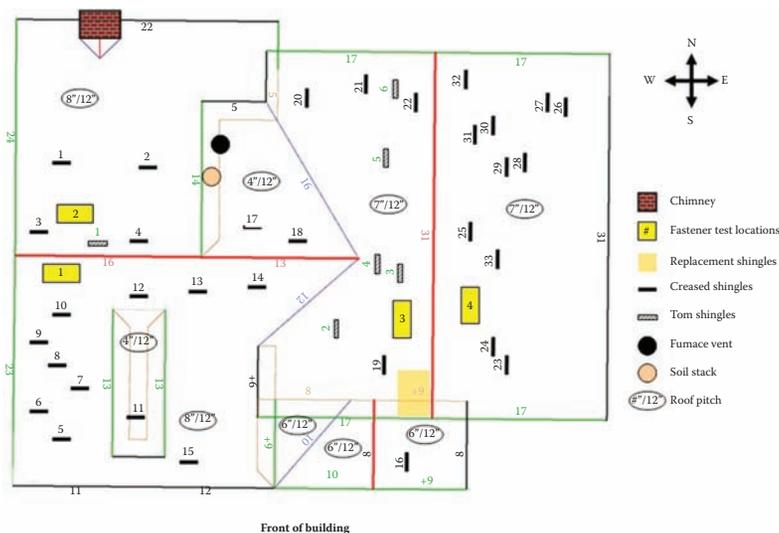
FIGURE 5.18
Example roof schematic with creased and torn asphalt shingle locations.

Wind speeds for the times near the date of loss were documented to be below 90 MPH. For this example, Figure 5.18 illustrates a plan-view schematic of an asphalt-covered roof evaluated for potential wind and wind fraud damage.

Creased and torn shingles are illustrated and damaged shingle tab observations by tab identification number are summarized in Table 5.3. Observation categories (i.e., questions raised and answered) used in Table 5.3 during the inspection of the shingle tabs were:

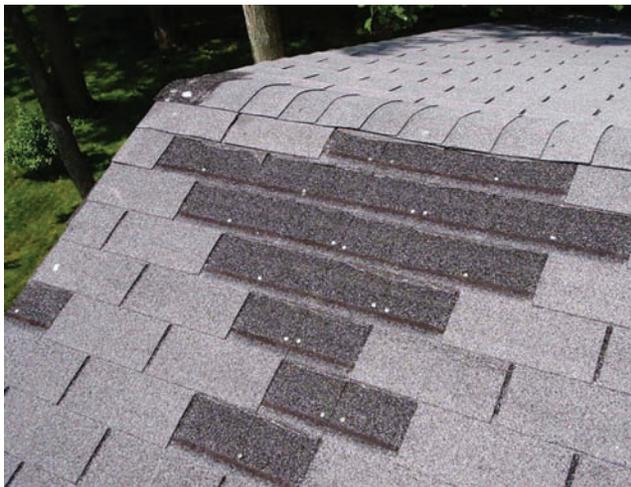
FIGURE 6.1

Wind damage to asphalt shingles.

High winds have the potential to cause considerable damage to steep-sloped roof systems and exterior finishes that cover residential and light commercial structures. High winds passing over a roof can create uplifting forces on the entire roof system and potentially remove individual pieces or, in more severe cases, remove entire sections of the roofing system. A photograph of wind damage to an asphalt shingle roof is illustrated in Figure 6.1.

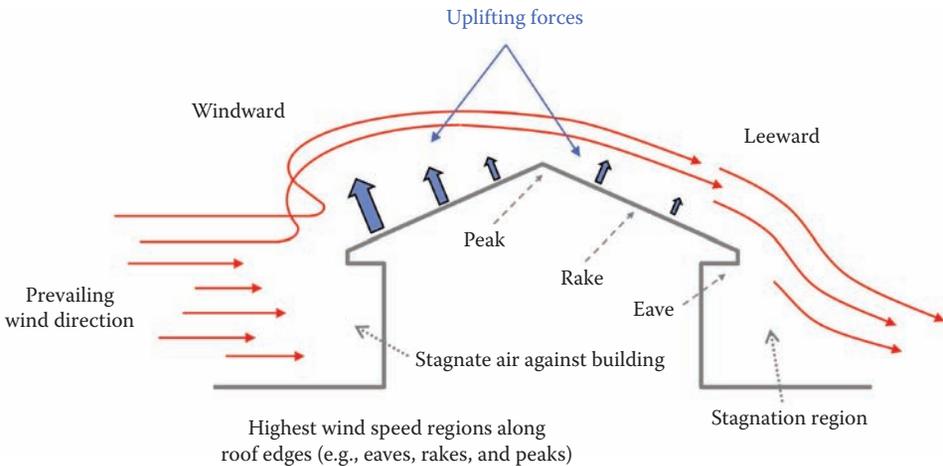
FIGURE 6.2 Wind-generated forces acting on a pitched roof.

As wind gusts pass over the roof surface of a building, aerodynamic forces are formed that cause uplifting forces and pressures on the various roofing and building components. Wind damage to roof systems and building components typically occurs at the points on the home or building where the greatest uplifting forces are present. For roof systems and finished surfaces, these most vulnerable locations include the windward roof edges as well as the leeward side of ridges (e.g., peaks, rakes, and eaves). Figure 6.2 illustrates the dynamics of wind forces acting on a pitched roof surface.

In order to fully understand the effects of wind gusts on a structure, we present a discussion of these forces and pressures associated with these wind gusts. As shown in Figure 6.2, the prevailing wind imposes a force, or load, on the structure, and this wind load is directly related to the wind velocity. The relation between load or force and pressure is given in Equation 6.1:

Attention is directed to wind gusts blowing over a structure due to the creation of a pressure differential between a vertical side wall and a sloped roof surface. For example, if a 30 MPH wind gust blows against the side of a building or residence, similar to Figure 6.2 and according to the equation above, an average pressure of 2.3 pounds per square foot (psf) would be acting against the side wall. As wind flows across the eave of the building, the

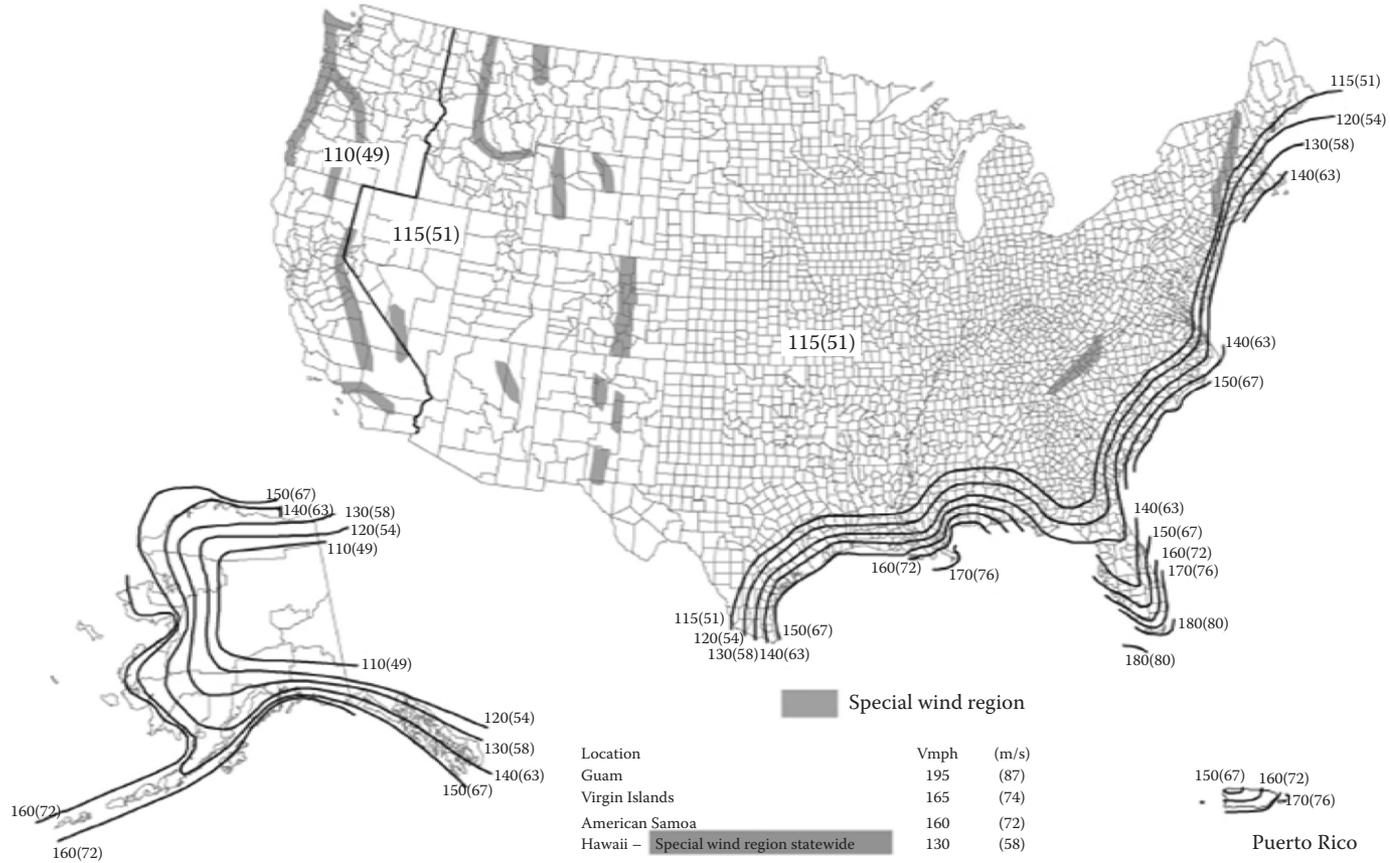
FIGURE 6.3

Ultimate design wind speeds—Risk Category II. Notes: (1) Values are nominal design 3-second gust wind speeds in miles per hour (m/s) at 33 ft. (10 m) above ground for Exposure C category; (2) linear interpolation between contours is permitted; (3) islands and coastal areas outside the last contour shall use the last wind speed contour of the coastal area; (4) mountainous terrain, gorges, ocean promontories, and special wind regions shall be examined for unusual wind conditions; (5) wind speeds correspond to approximately a 7% probability of exceedance in 50 years (annual exceedance probability = 0.00143, MRI = 700 years). (From IBC, International Building Code, Figure 1609A, 2012. With permission.)

Modern building codes such as the International Building Code (IBC)³ require that roof systems be able to withstand the uplift pressures associated with minimum basic straight-line wind speeds. The ultimate design wind speeds vary in magnitude and are dependent on the geographic location of the structure and other factors such as the *risk category* of the building. These minimum requirements are ultimately based on the American Society of Civil Engineers (ASCE) Standard 7 "Minimum Design Loads of Buildings and Other Structures."⁴ Code requirements for minimum wind loads for typical residences and light commercial buildings (defined as Risk Category II in the IBC) are shown in Figure 6.3.

For much of the Midwest, the ultimate, or strength, design wind speed is 115 MPH, whereas the design wind speeds for coastal areas can be up to 180 MPH. When necessary, these ultimate design wind speeds presented in the IBC can be converted into nominal wind speeds (90 MPH and 140 MPH, respectively) used for cladding and building components (by Equation 16.33 in Section 1609.3.1 of the code). Additional information on design wind speeds can be found in Chapter 7, this volume.

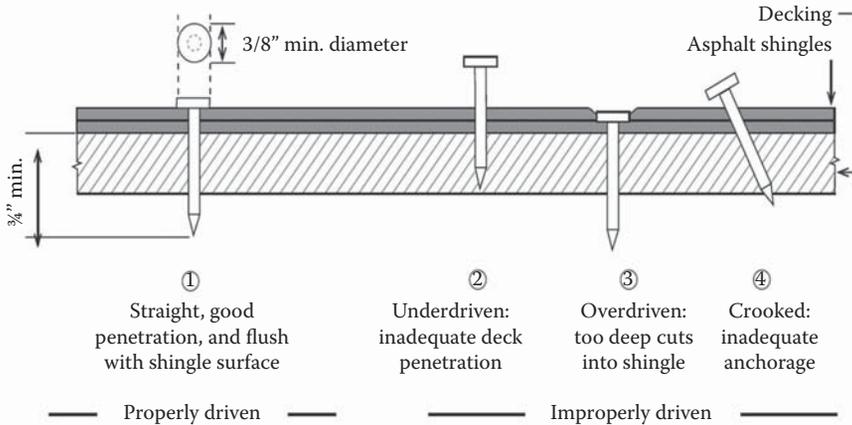
FIGURE 6.4

Fastener application for asphalt shingles. (From Asphalt Roofing Manufacturers Association, Inc., Technical Bulletin, Form No. 221-RR-94, 2007. With permission.)

Proper techniques and installation methods must meet the requirements of local building codes and the recommendations of various manufacturers (e.g., CertainTeed and Elk-GAF) and trade associations (e.g., ARMA, National Roofing Contractors Association [NRCA], APA—the Engineered Wood Association). The proper method for installing fasteners for asphalt shingles is illustrated in Figure 6.4.

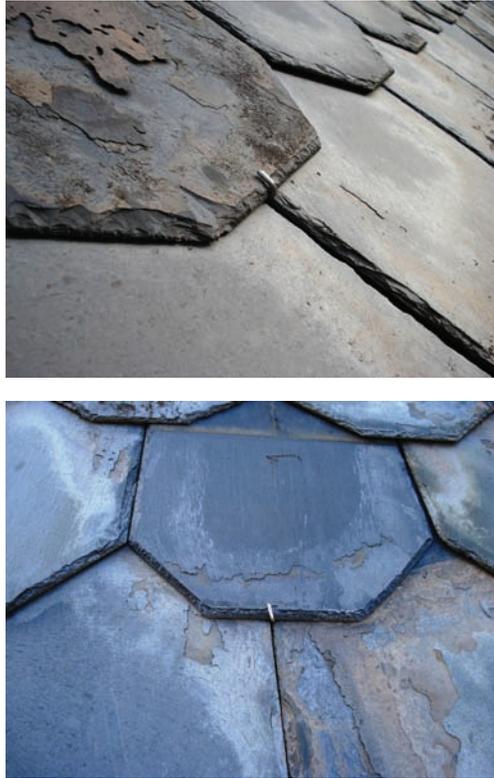
FIGURE 6.5
Use of nose clips on slate tile.

- For slate tile, fastener best practices are summarized in *The Slate Roof Bible* and other publications by Jenkins.¹⁷⁻¹⁹ Figure 6.5a and b illustrates nose clips used to help fasten replacement tiles.

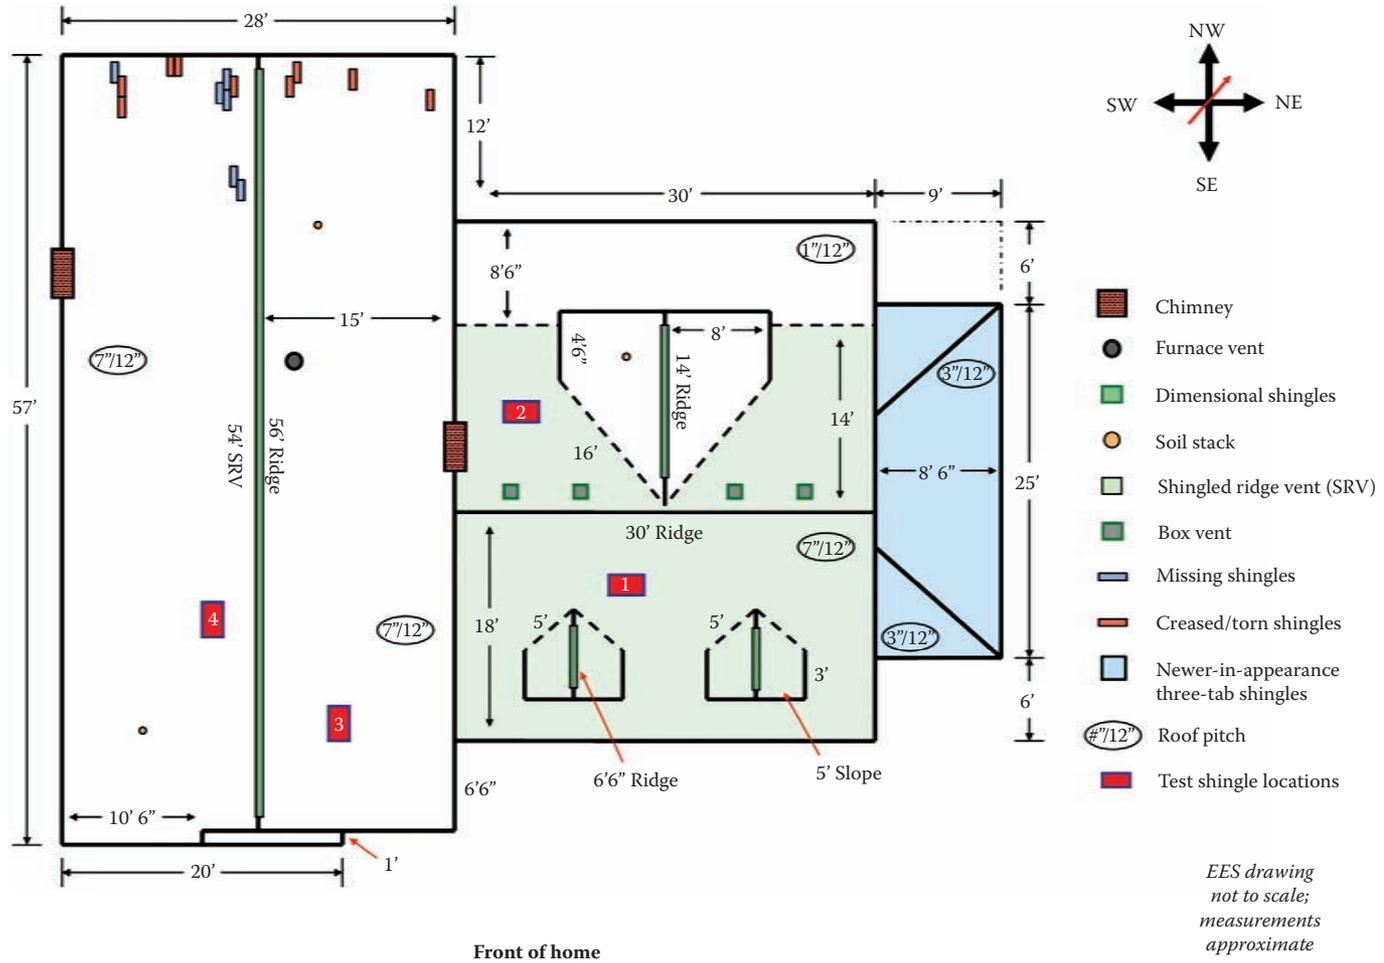
FIGURE 6.6
Typical roof schematic (developed from onsite measurements).

A plan-view sketch of the residence or structure should then be completed or validated. As outlined in Chapter 2, this volume, a recent trend in the roofing and insurance industries has been the use of satellite imagery technology for roof layouts, slopes, and dimensions from commercial services such as EagleView™ Technologies and Pictometry® (formerly GeoEstimator®). These organizations provide roof drawing schematics with pertinent roof information needed for its replacement (i.e., ridge/valley lengths, rake/eave lengths, roof areas, and pitches). If a satellite-based plan view of the roof was not previously obtained, a layout of the roof surface should be sketched in a field notebook, as detailed in Chapter 2, this volume. If an image was obtained from a commercial service, verify measurements and slopes on roof surfaces. Insert information on types of finished roof surfaces, locations of box vents, plumbing vent stacks, furnace stacks, chimney(s), and other prominent roof features. Also record key elements such as locations and numbers of shingles, or tiles that have been replaced or repaired or are missing, creased or torn, areas of heavily deteriorated surfaces, areas covered with tarps, and other information that may be helpful regarding the storm history (e.g., missing gutters, downspouts, detached siding, fascia, or soffit, etc.). An example of a typical roof layout with roof appurtenances and key details is provided in Figure 6.6.

Test Shingle Observations for Three-Tab Shingles (See Figure 6.6)

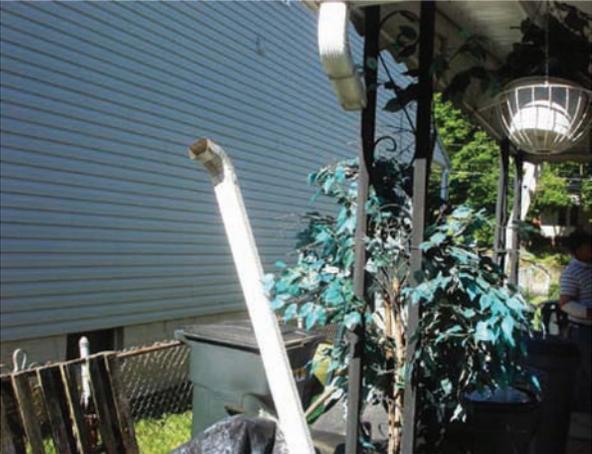
Exterior Component	Photograph
Downspout Detached from upper elbow

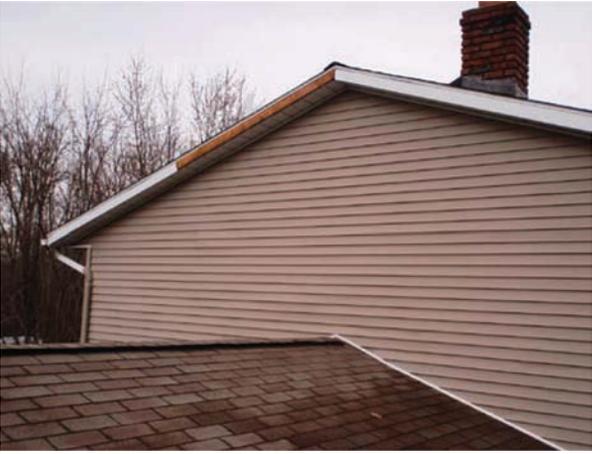
Metal fascias Missing sections of fascia on rake

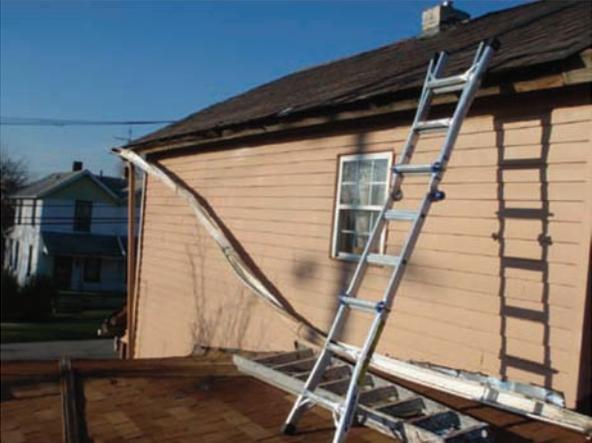
Gutters Displaced gutter along eave

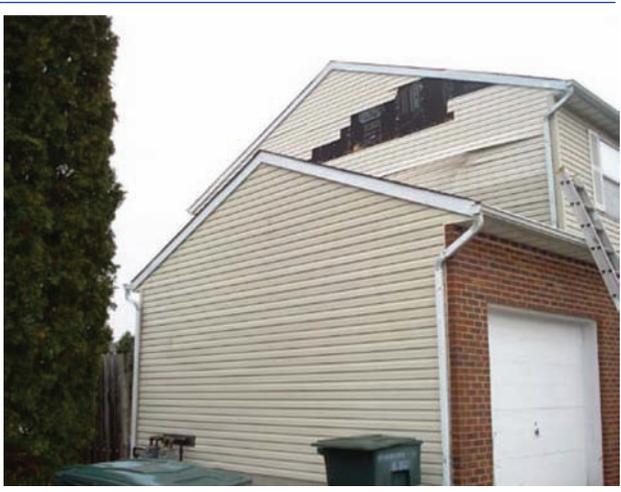
Exterior Component	Photograph
<p>Vinyl siding Multiple missing sections of siding</p>

A photograph of a two-story house with beige vinyl siding. The upper level shows significant damage where several sections of siding are missing, exposing the dark roof sheathing. A white garage door is visible on the lower level, and a ladder is leaning against the side of the house.
<p>Undereave soffits Missing pieces of vinyl soffits of gable</p>

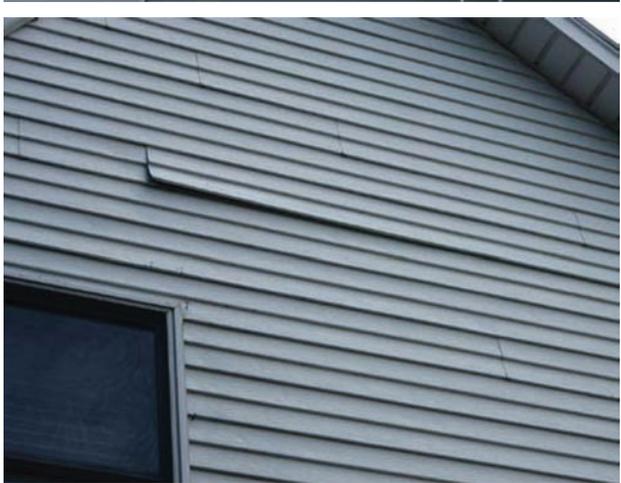
A close-up photograph of a gable end of a house with light blue vinyl siding. The vinyl soffits under the eaves are missing in several places, revealing the wooden rafters and sheathing underneath. A window is visible on the side of the gable.
<p>Vinyl siding Partially displaced piece of siding</p>

A close-up photograph of light blue vinyl siding. One piece of siding is partially displaced and bent upwards, showing the underlying structure. A portion of a window frame is visible in the lower left corner.

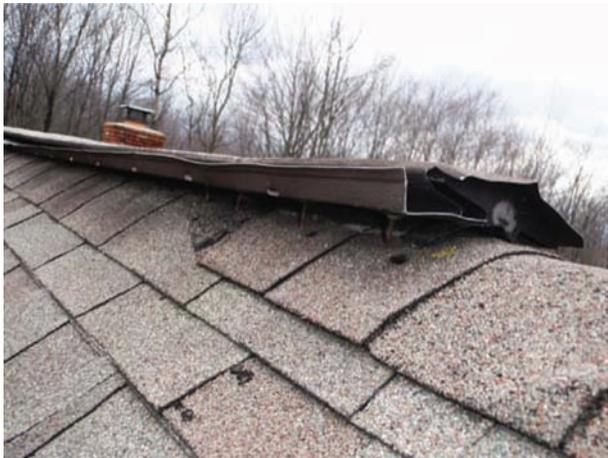
Roof Appurtenance	Photograph
<p>Metal ridge vent Displaced/loose end</p>

action; however, it should also be checked for proper installation (e.g., the type, number, and type of fasteners should be recorded) for later analysis. If the nail shanks are not long enough to penetrate into the decking as directed by the manufacturer, this discrepancy can reduce the resistance of the component to wind-related forces. Wind gusts might have contributed to the damaged component, but in a particular instance, the nail fasteners may not have been properly secured or attached. Table 6.3 illustrates examples of damage to roof appurtenances.

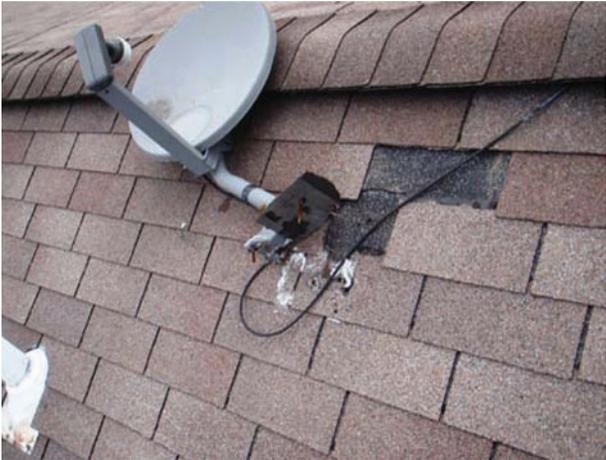
Roof Appurtenance	Photograph
Satellite dish Damaged/displaced from roof

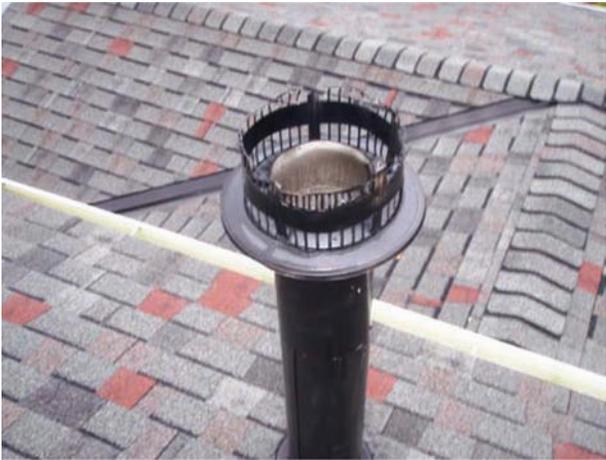
Furnace vent Missing cap

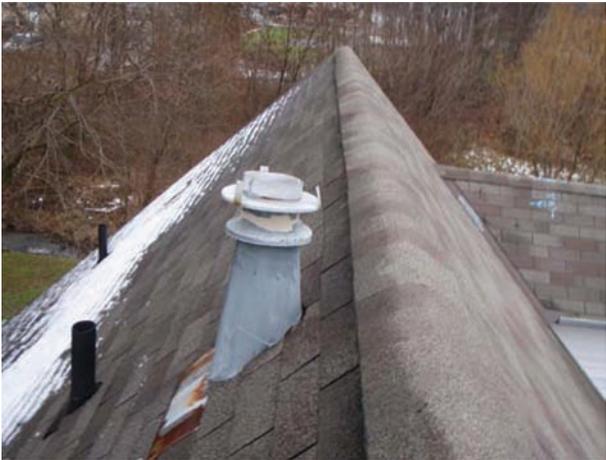
Furnace vent Missing cap

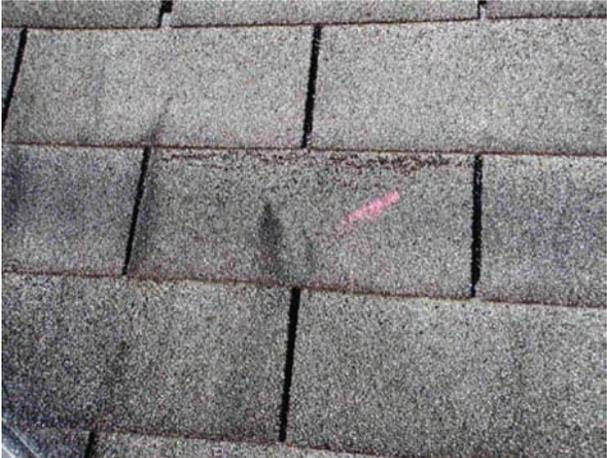
Description	Photograph
<p>Creased three-tab shingles The result of continuous flapping of the shingle tab from wind uplift. Unsealed or unadhered tabs are more susceptible. The crease is typically linear and along the top portion of the tab. This mechanism is typically associated with three-tab shingles.</p>

<p>A close-up photograph of asphalt shingles. A red arrow points to a distinct linear crease running across the top portion of a shingle tab.</p>
<p>Torn three-tab shingle The eventual tearing of a creased shingle.</p>

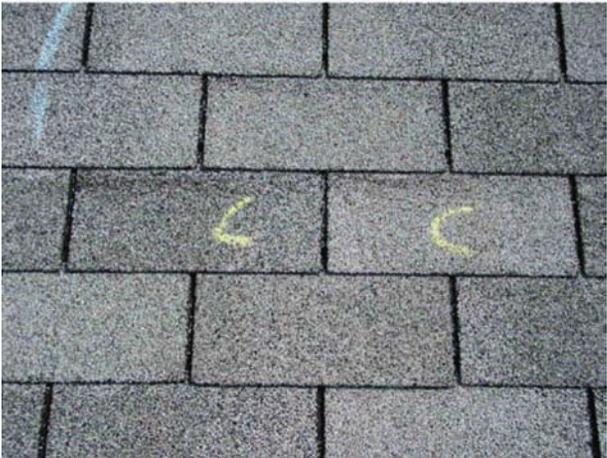
<p>A photograph of asphalt shingles showing two yellow 'C' marks drawn on the surface, likely indicating the location of creases.</p>

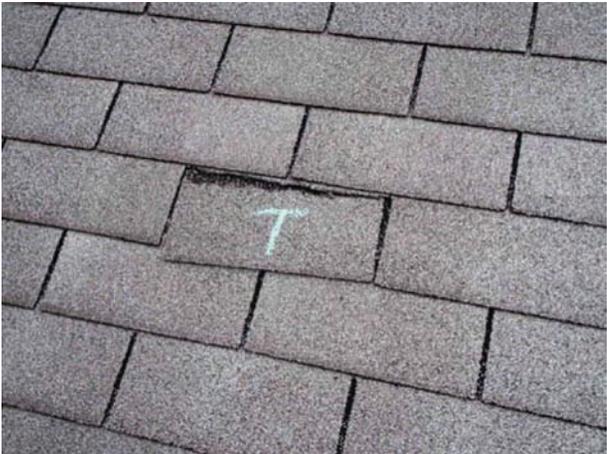
<p>A photograph of asphalt shingles showing a torn shingle. A green 'T' is drawn on the remaining portion of the shingle to indicate the tear.</p>

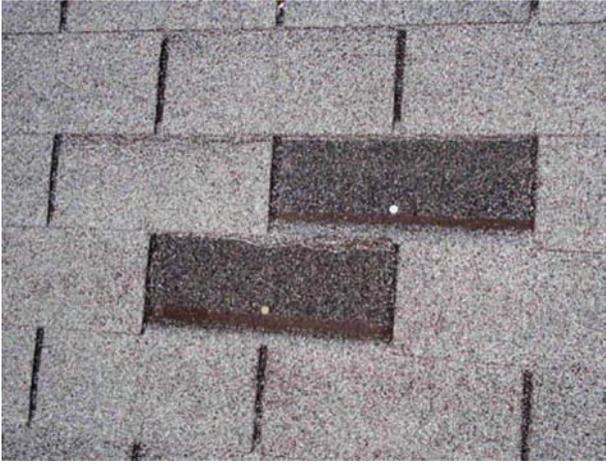
Description	Photograph
<p>Missing three-tab shingles Exposed nail fasteners driven through the gray and weathered adhesive strip.</p>

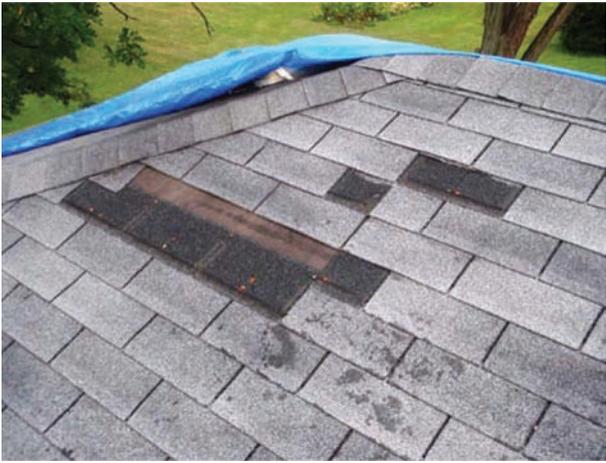
<p>Missing, torn, and creased three-tab shingles A group of damaged shingles near the roof ridge. Notice the exposed felt underlayment and the potential source of water intrusion.</p>

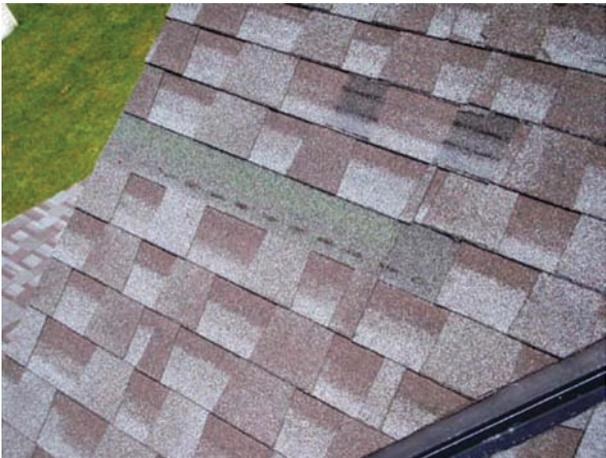
<p>Missing dimensional shingle</p>

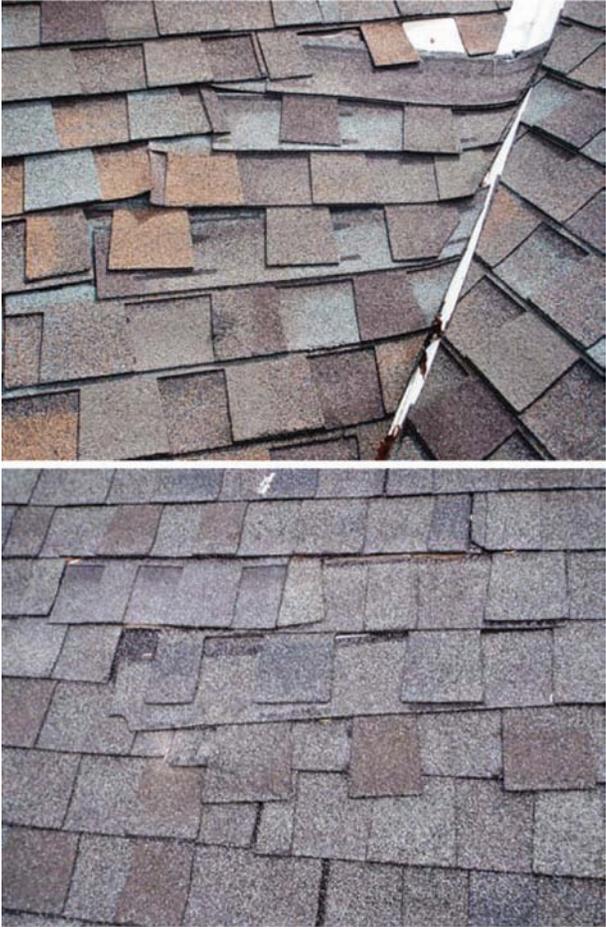
Description	Photograph
<p>“Slipped” dimensional shingles Shingle “slippage” likely the result of improper installation (i.e., spacing) coupled with gravitational forces (i.e., nails likely driven above recommended location) allowing the shingles to be more susceptible.</p>

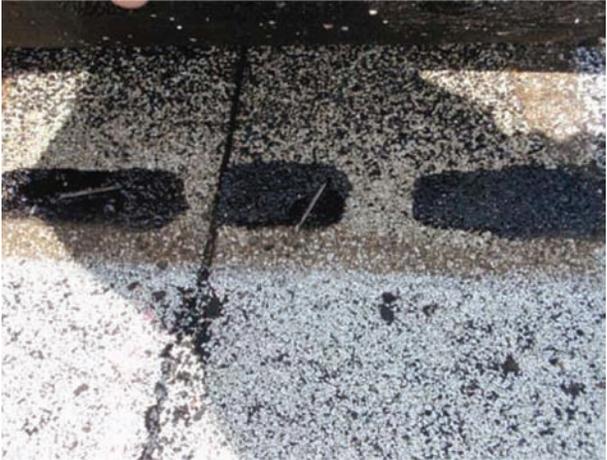
Description	Photograph
<p>Three-tab shingle Staple fastener (~1" in crown width) driven flush into surface of shingle and driven through the adhesive strip. Staples should be driven parallel to the long edge of the shingle (i.e., horizontally).</p>

After documenting and photographing the roof construction, general roof conditions, and areas of shingle damage(s) on the roof surfaces, the installation method and fastening patterns for each roof elevation should be documented. As illustrated in Table 6.5, asphalt shingles are often improperly fastened.

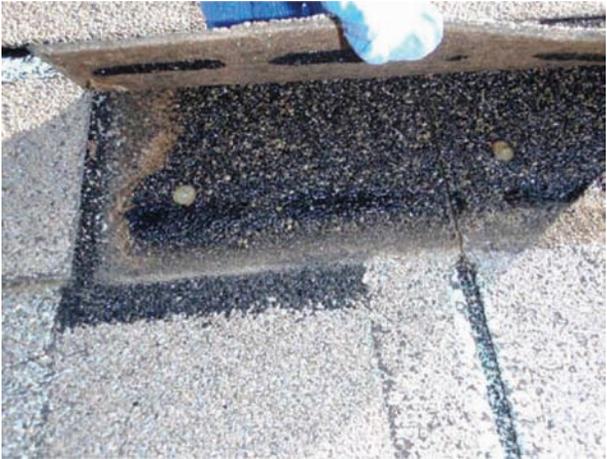
<p>Three-tab shingles The end nail fastener is spaced too far from the right edge of the shingle. Nails should be driven ~1 inch from the side edge.</p>

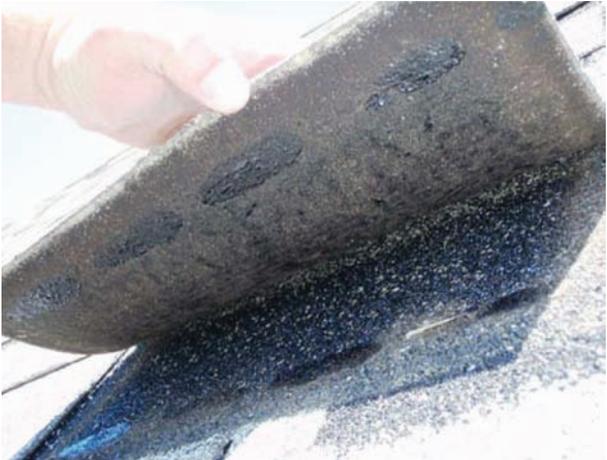
<p>Three-tab shingle Evidence of insufficient adhesion between shingles demonstrated by sealant residue—staple in right adhesive strip.</p>

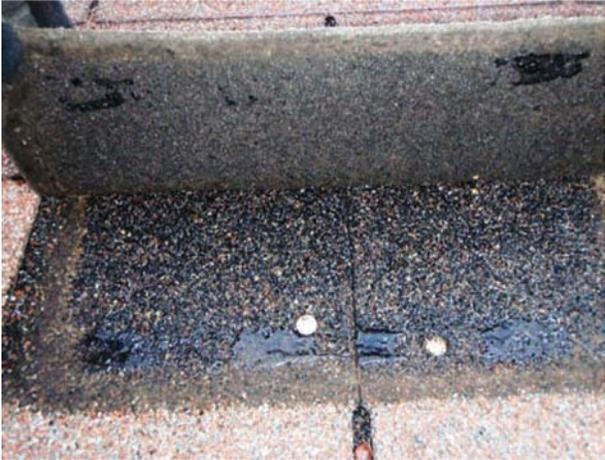
Description	Photograph
<p>Three-tab shingle Nails driven through and above shiny and glossy sealant strip. Notice little adhesive residue on underside of overlying shingle likely indicating poor contact/adhesion between shingles.</p>

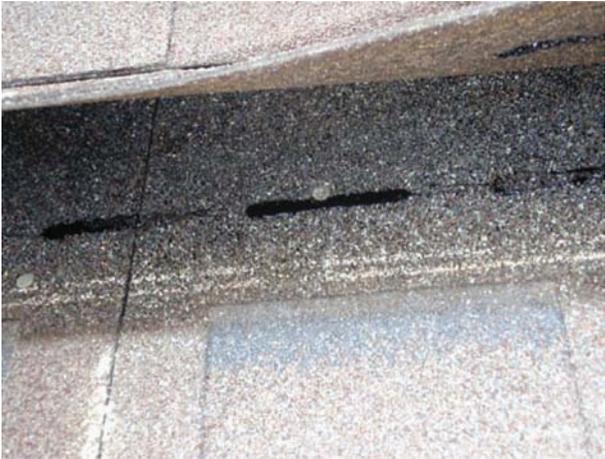
<p>Dimensional shingle Nail fastener driven flush into surface of shingle yet driven above the sealant strip. In addition, the nail is driven well above the recommended "nailing zone" as indicated by the set of horizontal white lines beneath the sealant strip.</p>

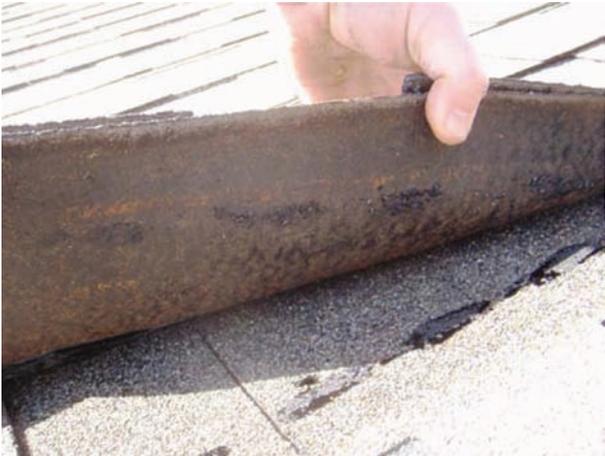
<p>Dimensional shingle Little to no adhesive residue on underside of overlying shingle suggesting adhesive failure.</p>

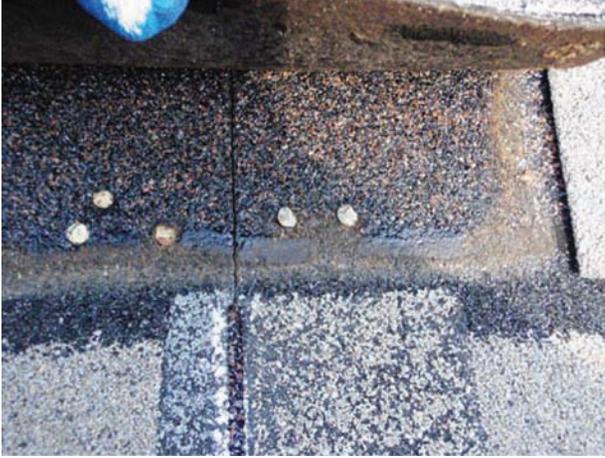
Description	Photograph
<p>Dimensional shingle Multiple improperly driven nails located above and through the sealant strip. Notice the top underlying surface of the lifted shingle; little contact residue is present indicating the nails prevented full adhesion at those locations.</p>

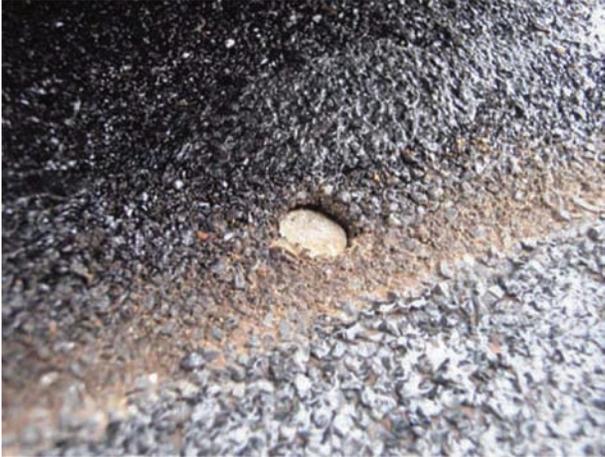
<p>Dimensional shingle Nail fastener overdriven through the surface of shingle. In this instance, the nail completely penetrated through the shingle creating a clean edged hole. These situations, often encountered with weighted dimensional shingles, provide less support from the nails and can lead to shingle "slippage."</p>

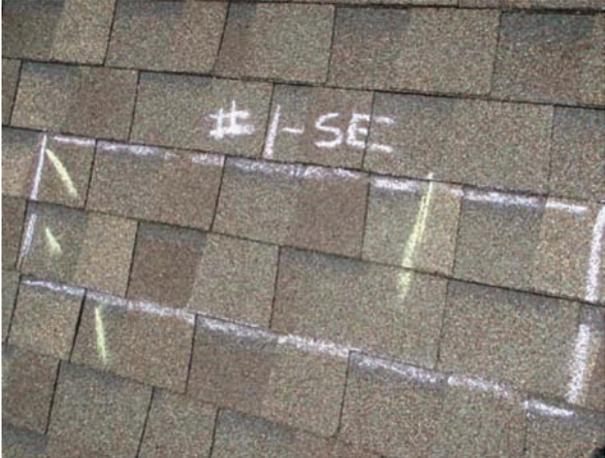
<p>Fastener test shingle 1—southeast elevation Overview of shingle fastener test (see Figure 6.6 for approximate location).</p>

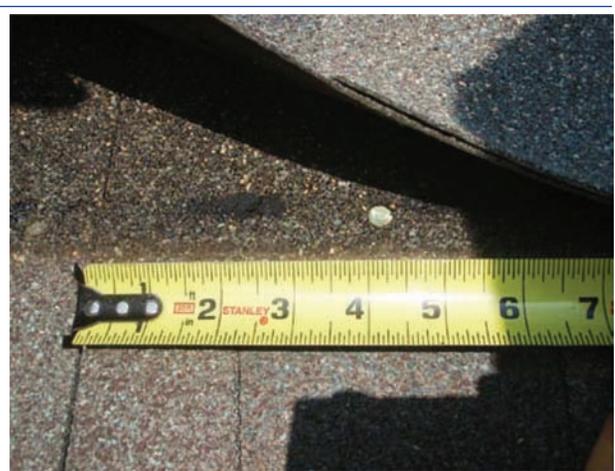
Description	Photograph
<p>Fastener test shingle 1—southeast elevation Nail driven flush through the adhesive strip yet driven too far from side edge. The nails should be driven 1 inch from the side edges.</p>

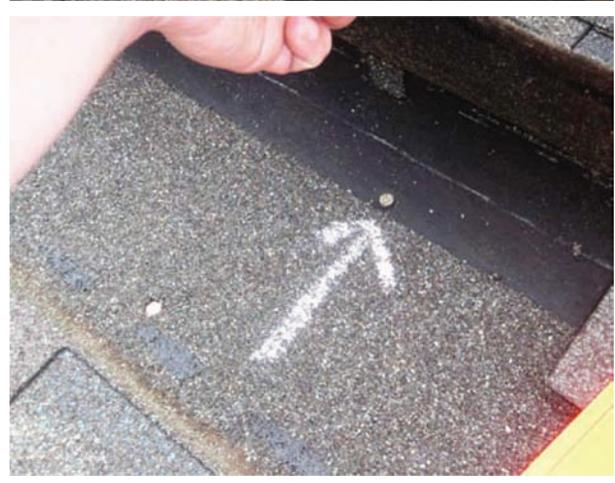
<p>Fastener test shingle 1—southeast elevation The bottom nail is overdriven above the adhesive strip. This condition is called high nailing and results in shingles that are not secured through the double-ply area (often denoted as the nail zone) and leaves the shingles bound to a roof with only half the recommended number of fasteners (four nails instead of eight).</p>

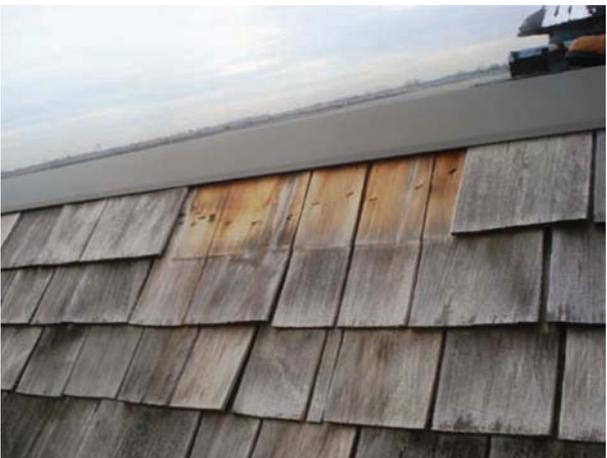
Description	Photograph
<p>Wood shingle Missing shingles exposing bright underlying surface</p>

Examples and descriptions of damage to wood, slate, and clay roof systems are illustrated in Table 6.6.

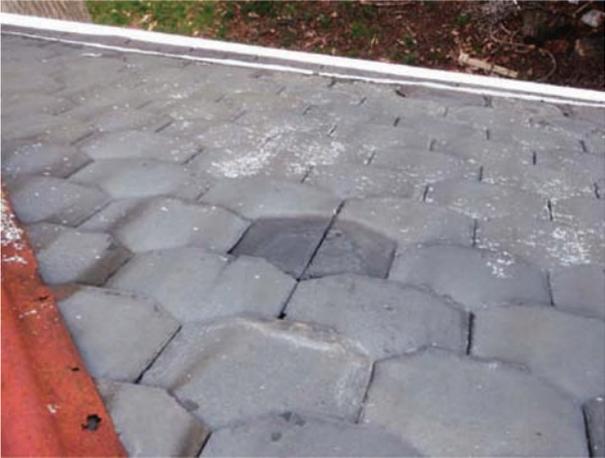
Description	Photograph
Slate tile Missing tile exposing bright underlying surface

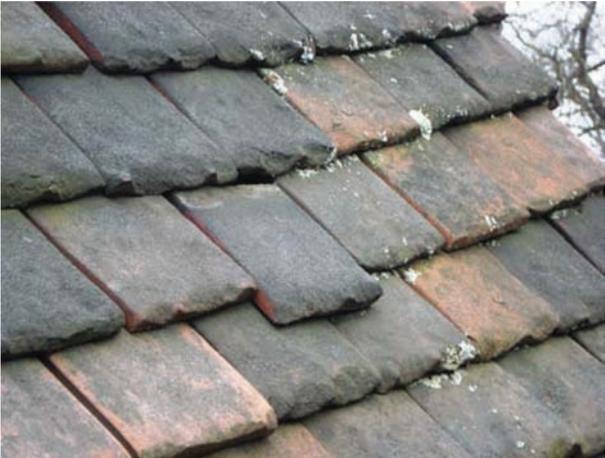
A close-up photograph of a slate tile roof. The tiles are dark grey and arranged in a staggered pattern. One tile is missing, revealing a bright, light-colored surface underneath. A red metal edge is visible on the left side of the frame.
Clay tile Displaced tile

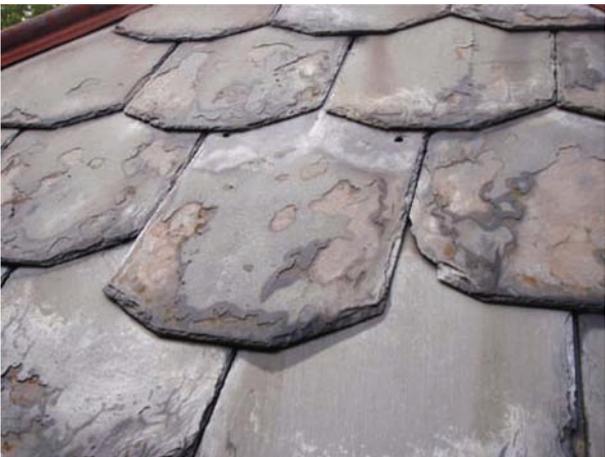
A close-up photograph of a clay tile roof. The tiles are reddish-brown and arranged in a staggered pattern. One tile is displaced, leaning against the one above it, creating a gap. There is some white residue or debris on the tiles.
Slate tile Displaced tile

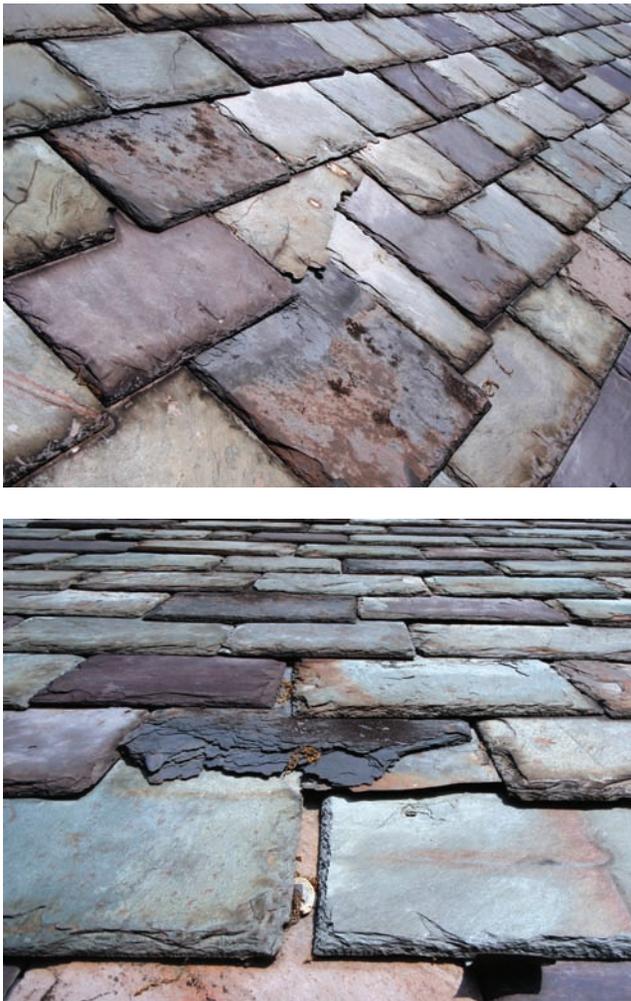
FIGURE 6.7
Missing and degraded slate tiles.

Due to these complexities, experience in the determination of whether damages are wind-related on a 75-year-old slate or clay tile finished roof surface, for example, is essentially a requirement. For instance, does the presence of missing or displaced tiles on the roof surface indicate a direct result of wind forces, or could these damages also be attributed to the age of the fasteners and tiles? Thus, the age and overall condition of the roof system cannot be overlooked and must be considered a factor in the damages present. A combination of ambient wind gusts, which are likely below the design threshold for wind resistance, coupled with the age and overall condition of the roof system would contribute to the presence of missing and displaced tiles. Additionally, metal valley and flashing components may become degraded to the point where water infiltrates and degrades the underlying roof system, allowing the tiles to be dislodged or missing. The wind may have finally caused the tiles to move, but the underlying cause of damage was a result of water intrusion from the deterioration of the metal components. Figure 6.7 shows missing slate tiles attributable to age and natural deterioration (e.g., delamination) as well as forces of wind action.

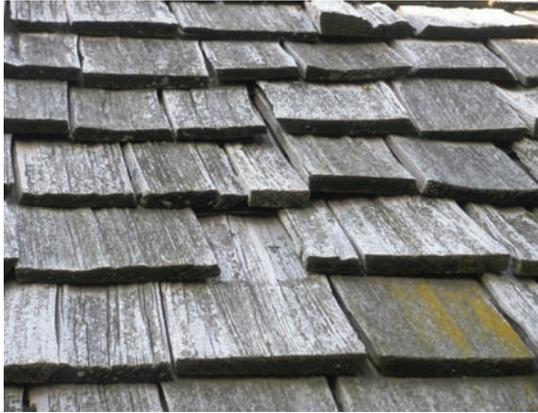
FIGURE 6.8
Missing wood shake exposing a weathered and dull underlying surface.

For damage reported as having occurred recently, a helpful tool in providing a time frame of when the damage(s) could have occurred is visually inspecting the underlying shake or shingle surface of the missing or displaced component for color patterns or presence of debris. For example, an exposed underlying or damaged surface that is weathered, dull, or darker in appearance would indicate that the wood or tile component has been missing or displaced for quite some time (months/years vs. days/weeks). On the other hand, a missing wood shake or shingle or tile that exposes a bright colored or fresher-in-appearance underlying surface would suggest the damage occurred recently (days/weeks). These types of inspection details could also help the forensic investigator date damage from specific storms. Examples of missing and detached wood, slate, and clay tiles attributable to forces of wind action are shown in Figures 6.8 through 6.10.

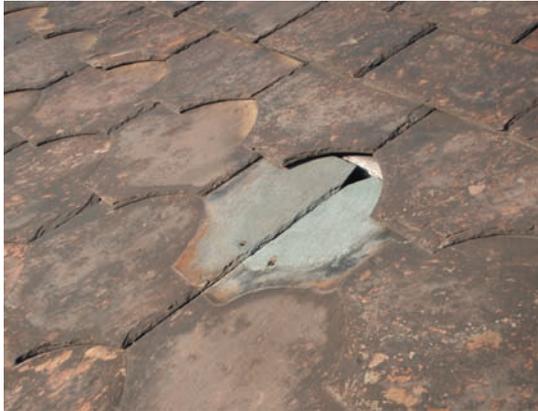
FIGURE 6.9
Missing slate tile exposing a bright underlying surface.

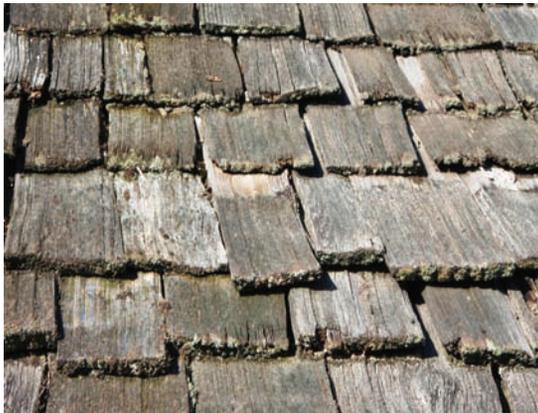
FIGURE 6.10
Recently displaced or loose wood shake.

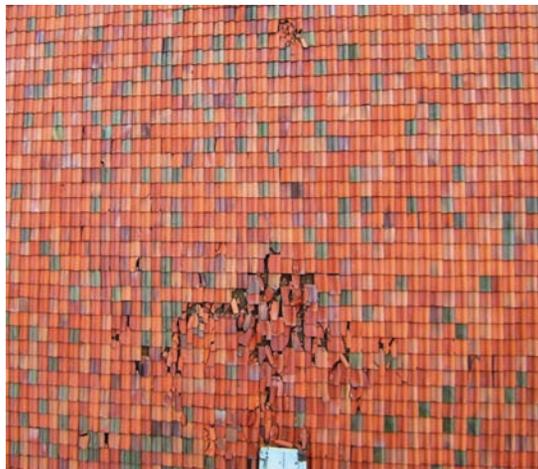
FIGURE 6.11

Cascading failure of clay tiles from debris (tiles from church steeple fell onto lower roof elevation tiles).

Unlike wood roofing materials, slate, clay, and other tile systems are somewhat brittle and more susceptible to cracking, chipping, and shattering. These types of defects are attributable to weathering anomalies, inspection practices (i.e., walking on the surface), severe weather, or even windborne debris. Even clay and concrete tile roof systems that are well attached to a roof surface can be easily broken by windborne debris, or “missiles.”²⁰ A single failed tile can initiate a cascading failure of other tiles on the roof surface. Figure 6.11 illustrates a cascading failure as viewed from above, and Figure 6.12 depicts two clay tiles that were likely damaged from windborne debris.

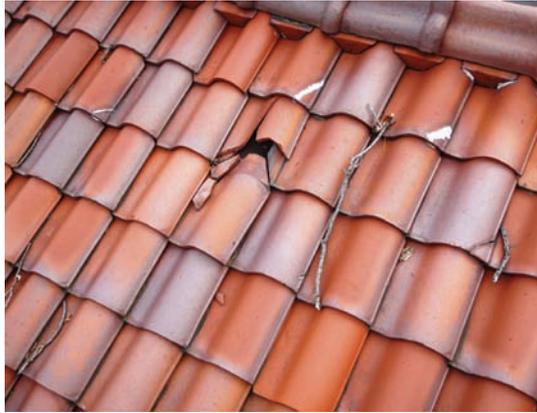
FIGURE 6.12

Damaged clay tiles from falling debris (tree limbs/branches).

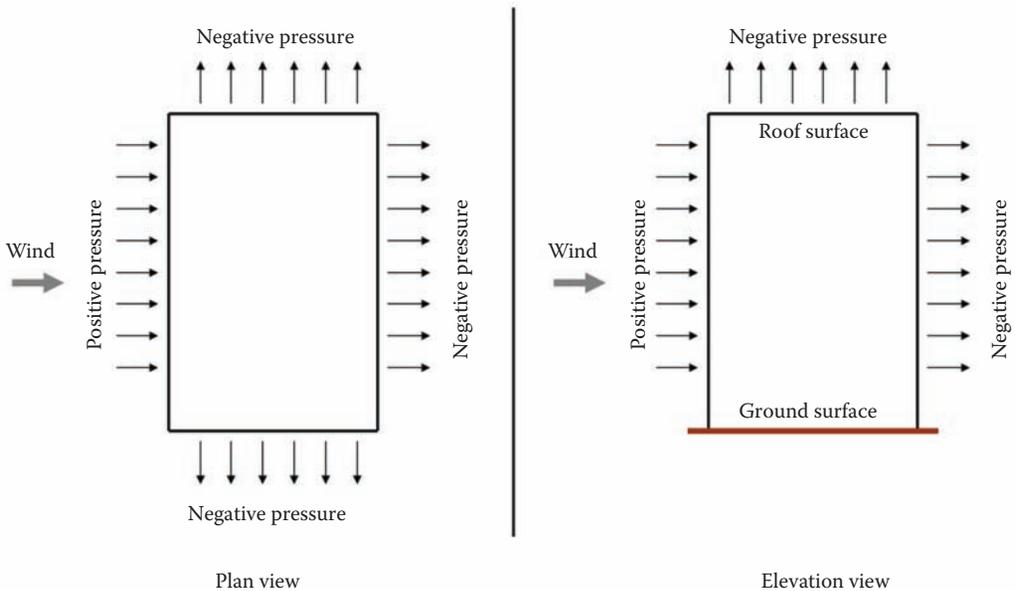
FIGURE 7.1
Pressure interaction on a building.

Wind forces can exert both positive and negative pressures on buildings. As previously discussed in Chapter 6, this volume, the pressure acting on an area generates a force (i.e., force = pressure × area), which in turn can create a force acting on the surface or side walls of a building. The variation in wind speed and direction (i.e., gustiness or turbulence) results in pressures or forces that do not remain constant and can exert both positive and negative pressures on the surface of a structure over time. Usually there will be a dominance of pressure exerted on a surface that will be either positive or negative pressure. For example, when wind strikes a rectangular building, positive pressure will be exerted on the windward side of the building, while negative pressure will be exerted on the leeward side and across the roof surface. A schematic illustrating wind pressure interaction on a rectangular building is shown in Figure 7.1.
