FORENSIC ENGINEERING

**Damage Assessments for
Residential and Commercial
Structures**

**Edited by
Stephen E. Petty**

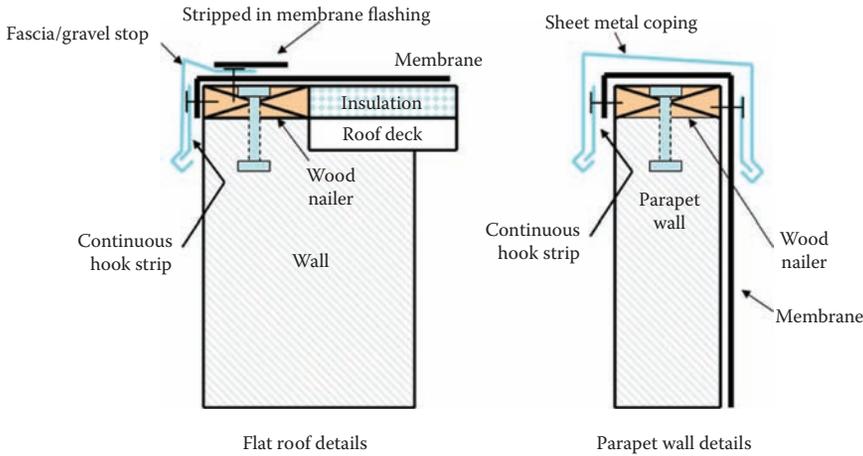
**FIGURE 7.2**

Recommended edge metal flashing details.

A second common perimeter low-sloped roof failure mode is the blow-off of edge metal such as fascia, gravel stops, and copings. This usually occurs as a result of insufficient anchorage or lack of continuous hook strips to provide additional reinforcement along the perimeters. Figure 7.2 illustrates recommended details for typical flat roof and parapet wall perimeter terminations.

- Gravel guards and hook strips should not be heavier than 24–26 gauge. Hook strips should be one gauge heavier than the fascia.
- Gravel guards should be installed in lengths of 8' to 10', lapped 2" at side joints, and covered with a 4" wide cover plate. The guard should be set in cement and nailed 1" back from the edge with fasteners spaced 4" on centers.
- The horizontal part of the guard should be set in roofing cement and nailed 1" from the back edge with fasteners spaced 4" on centers.
- The top of the gravel guard should be stripped with membrane and lap the nail heads by at least 2". A second 9" wide membrane should be stripped in to provide 4" overlap of the metal and provide at least 4" of overlap over the base membrane.

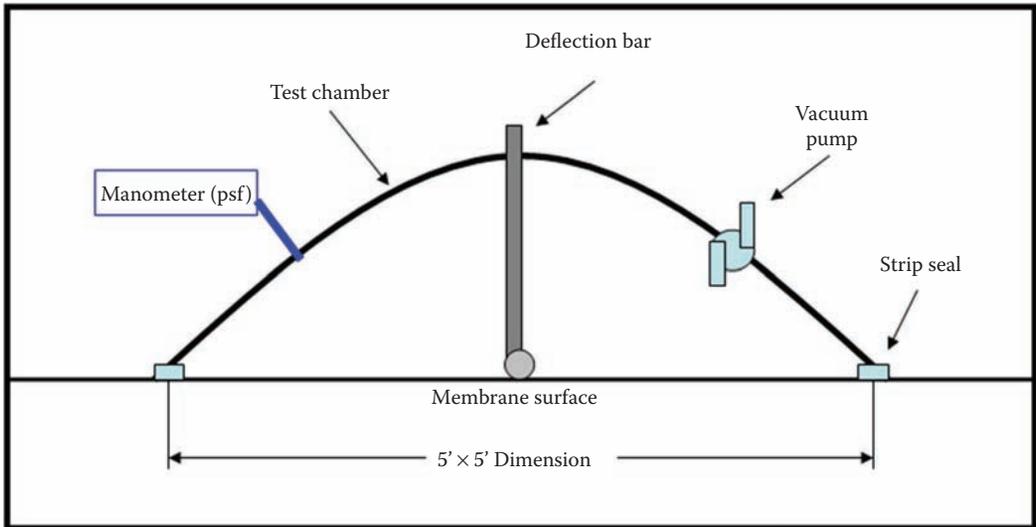
FIGURE 7.3
Negative pressure test apparatus.

The test apparatus consists of a vacuum pump within a 5-foot by 5-foot dome or compartment, which is capable of creating negative pressure inside the test chamber. With the compartment sealed, a deflection bar is used to measure the degree the membrane "lifts" up. A basic schematic of a negative pressure test apparatus is shown in Figure 7.3.

To perform the test, the apparatus is placed and sealed onto the membrane surface. Negative pressure is then applied to the dome, starting at an initial pressure of 15 psf. The pressure is increased in increments of 7.5 psf, with each increment held for one minute until the design test pressure is reached or failure occurs. Failure of the roof system is defined when the membrane balloons up or when the deflection of the bar is greater than 0.25 inch.

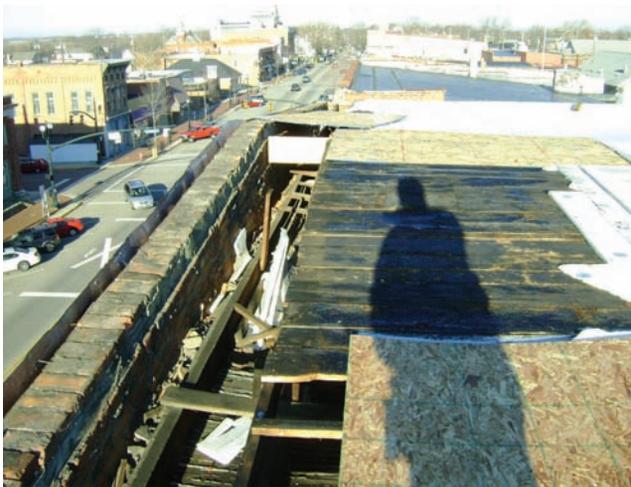
FIGURE 7.4

South perimeter membrane failure.

The roof membrane failed at the southwest corner and south perimeter of the building. The wind forces had blown off sections of the perimeter fascia, and over half of the membrane that was covering the roof surface was torn off. Sections of the sheathing and trusses were also damaged as a result of the uplift exerted from the forces of the membrane peeling back across the roof surface. A photograph of the damage is shown in Figure 7.4.

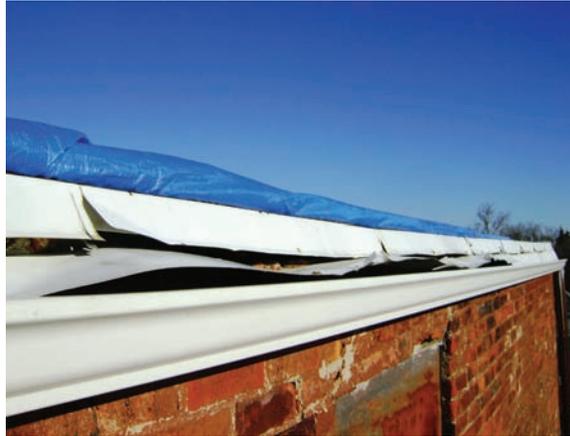
**FIGURE 7.5**

Overview of perimeter securement.

During the forensic investigation, it was determined that the membrane and perimeter metal was fastened to a nominal 2 × 10 inch wood nailer. The wood nailer was quasi-fastened into the two-wythe masonry wall with screws. Many of the screws within the wood nailers were either not screwed or anchored into the degraded brick or penetrated into or through the hollow cores of the brick masonry. In addition, the fascia was not fastened along the perimeter with a continuous cleat (Figure 7.5).

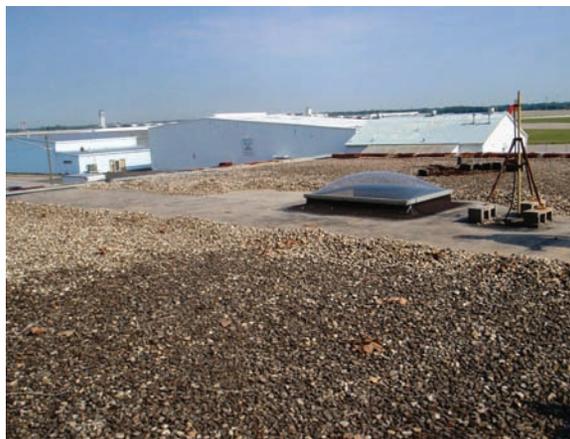
**FIGURE 7.6**

Ballast removed throughout center of roof.

During the forensic investigation of the roof surface, the ballast was observed to have been removed throughout the center of the roof system (Figure 7.6). The area of removed ballast exposed at least three repair patches, evidently from where the fallen tree limb had punctured the membrane roof surface (Figure 7.7).

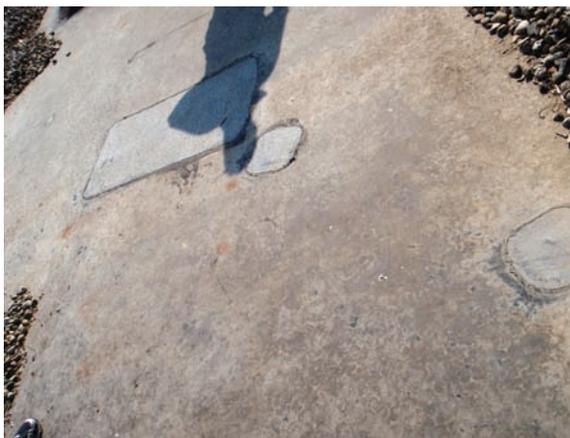
FIGURE 7.7
Membrane repairs.

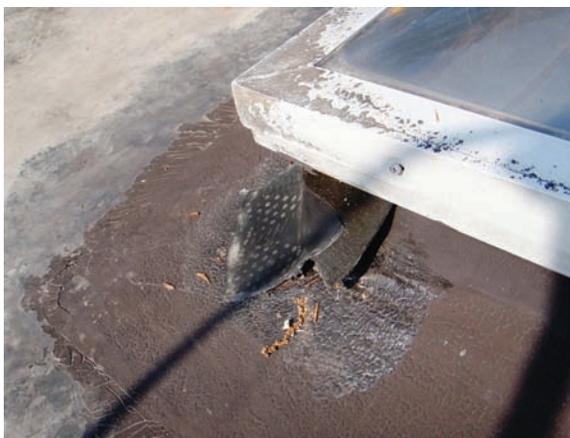
FIGURE 7.8
Repairs around skylight.

More recent membrane repairs were observed at each corner of the skylight. The membrane in these areas was pulled away at the corners of the skylight, providing openings for potential water intrusion (Figure 7.8).

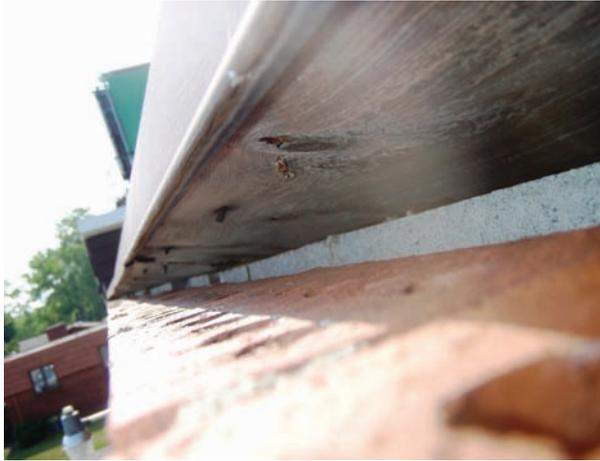
**FIGURE 7.9**

Improperly installed nailer.

Lastly, the wood nailer along the perimeters was fastened on top of the brick masonry parapet wall with nails. However, the nails were not fully engaged into the brick wall, thus leaving an approximate 2-inch-wide gap. This in turn allowed air from high winds to infiltrate into the space beneath the wood nailer and membrane (Figure 7.9).

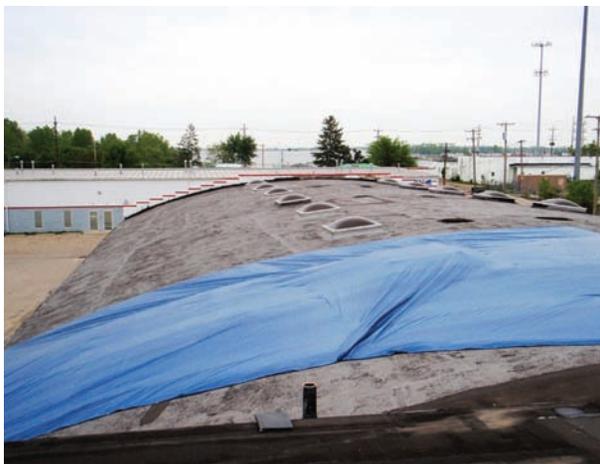
**FIGURE 7.10**

Tarp on area of damaged BUR.

A 10,000 square foot, barrel-shaped BUR roof membrane reportedly failed along the west windward perimeter as a result of a windstorm that produced peak wind gusts of 66 MPH. The multilayer BUR membrane roof was reported to be at least 20 years old. A large strip of the BUR had peeled back from its support along the eave all the way to the ridge of the barreled roof. At the time of the inspection, a large blue tarp was secured over the top of this damage area (Figure 7.10).

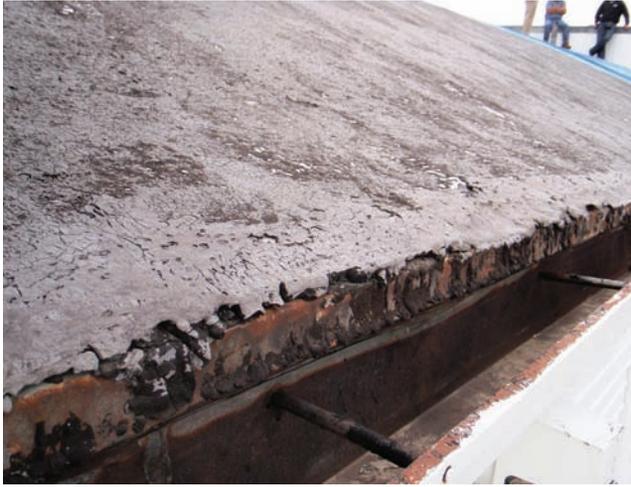
FIGURE 7.11
Perimeter edge detail.

A test cut into the BUR revealed that the top layer consisted of a three-ply membrane applied over an older existing four-ply layer of BUR. Edge metal was present along the older original layer of BUR; however, the newer layer of BUR was adhered to the roof edge (over the existing layer) with no perimeter securement (Figure 7.11).

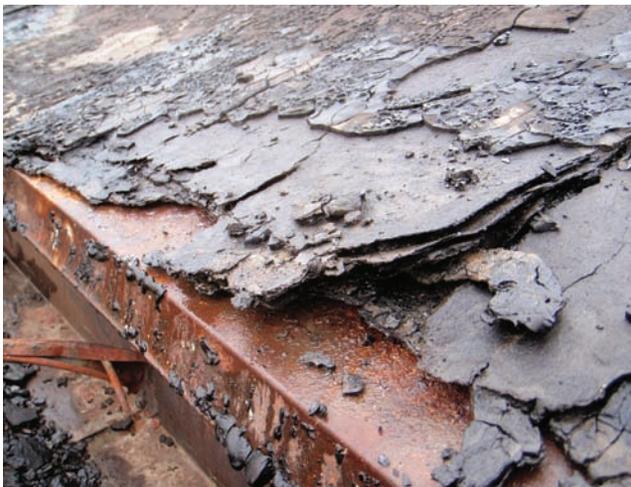
FIGURE 7.12
Degraded membrane.

At the failure area, the newer and unsecured BUR layer was peeled away, exposing the heavily degraded older (bottom) BUR layer (Figure 7.12).

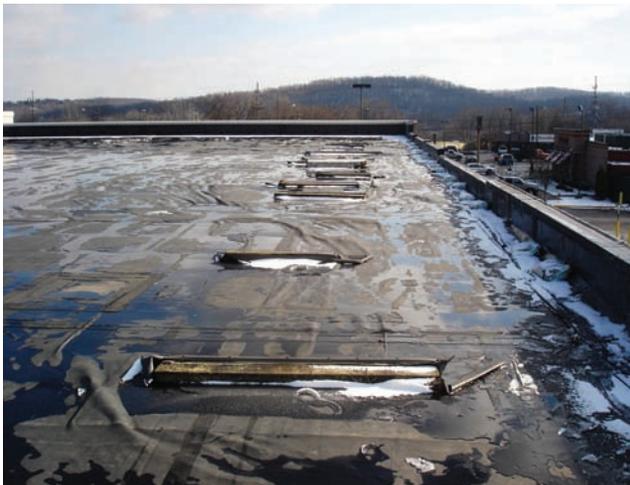
FIGURE 7.13
Overview of failure area.

A fully adhered EPDM membrane roof installed on a two-story strip mall was reportedly wind damaged during a windstorm that produced peak wind gust speeds of 53 MPH. The fully adhered membrane had been installed two years prior to the reported date of failure. The failure occurred within the field and along the southern edge of the roof (windward side of the building) at the south parapet wall (Figure 7.13).

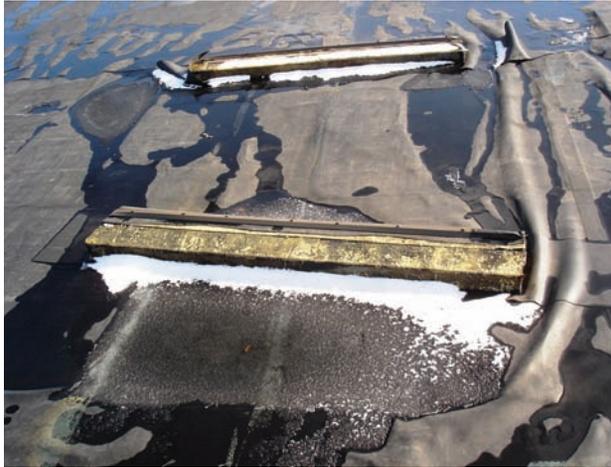
FIGURE 7.14
Capstones securing roof membrane.

The membrane throughout the center of the roof was loose and oscillating during periods of light winds. Sections of the coping stones had been displaced along the south parapet wall. Temporary repairs appeared to have been made to secure the membrane to the remaining sections of the parapet wall. Linear sections parallel to the parapet wall on the roof were actually sections of the capstones (also covered with light snow), which were left on the roof surface to aid in securing the loose membrane onto the decking until permanent repairs could be completed. A close-up picture of the capstone section is shown in Figure 7.14.

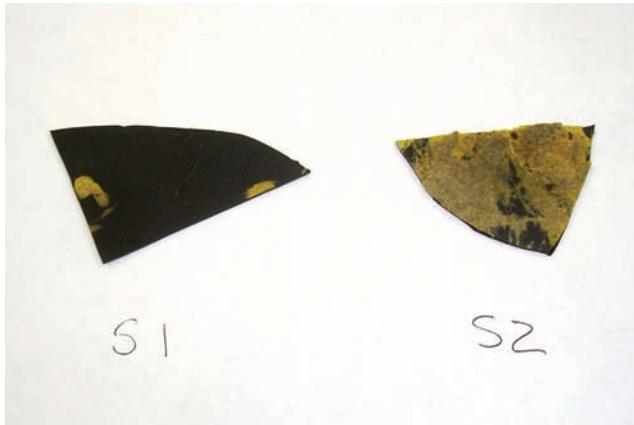
FIGURE 7.15
Back sides of membrane showing incomplete adhesive application.

Through destructive testing, it was found that the initial failure likely occurred throughout the field of the roof due to a lack of application of sufficient adhesive. Consequently, the field portion of the membrane loosened with time, worsening with each wind event and ultimately pulling the capstones off the top of the parapet wall and onto the decking. At this point, the roof system catastrophically failed. Test cuts revealed that the fully adhered membrane was not actually fully adhered. Spotty adhesive coverage had been applied between the membrane and insulation boards (Figure 7.15).

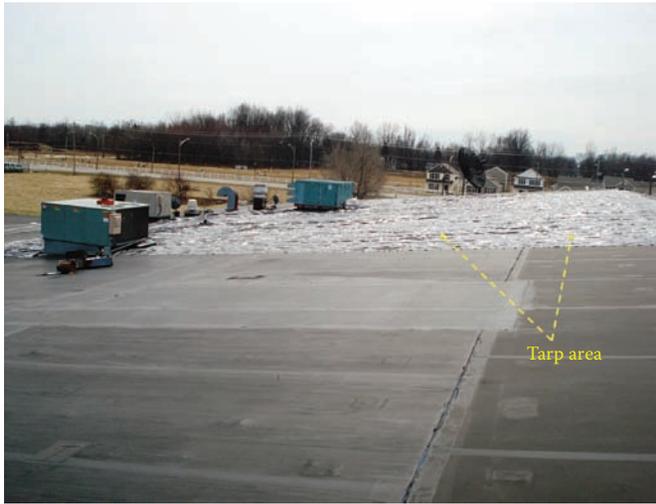
**FIGURE 7.16**

Overview of damaged EPDM roof.

The roof surfaces of a bowling alley were covered with a fully adhered EPDM membrane and portions of standing seam metal roof panels; the age was unknown. The gable-style roof sloped east and west toward the perimeter gutter system and contained numerous penetrations (i.e., the heating, ventilation, and air conditioning units and vent stacks). The membrane was installed over a plywood substrate and was heavily degraded. A windstorm with peak wind gust speeds of 54 MPH reportedly passed over the building. The building owner claimed wind damage to the membrane led to multiple water leaks and damage to the interior of the building. An approximate 90-foot-by 100-foot section of the EPDM membrane was covered with tarps on the east (leeward side) of the building (Figure 7.16).

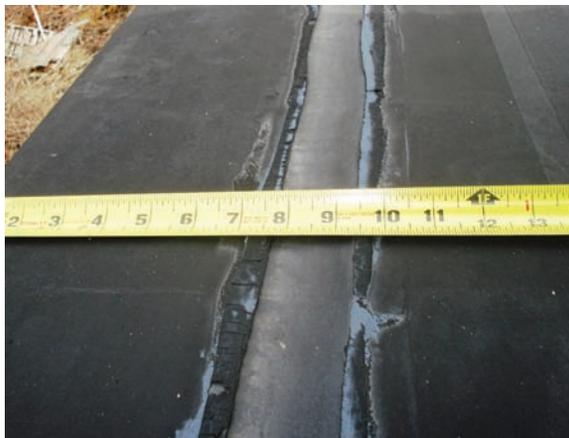
**FIGURE 7.17**

No flashing tape at seam lap.

Tests cuts into the membrane were completed in areas not containing a tarp and in other areas by removing sections of the tarps. Results from the test cuts revealed the following installation deficiencies: (1) the seam laps were adhered to the roof surface, but contained no splice flashing tape along the seams and (2) there was little or no adhesive present to bond the membrane to the plywood substrate. These deficiencies are shown in Figures 7.17 and 7.18.

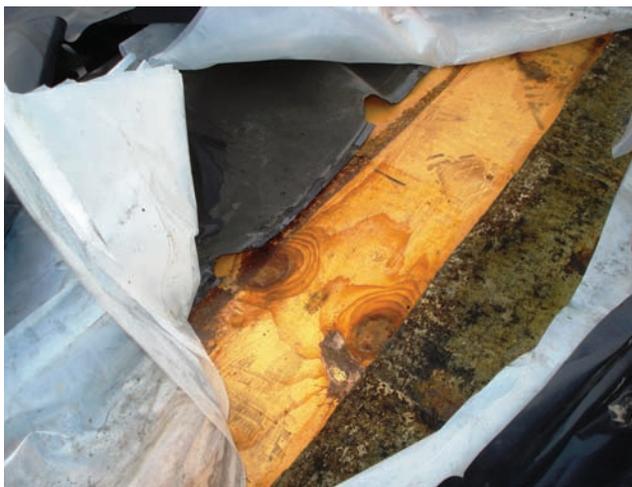
**FIGURE 7.18**

Adhesive at seam, no adhesive under membrane.

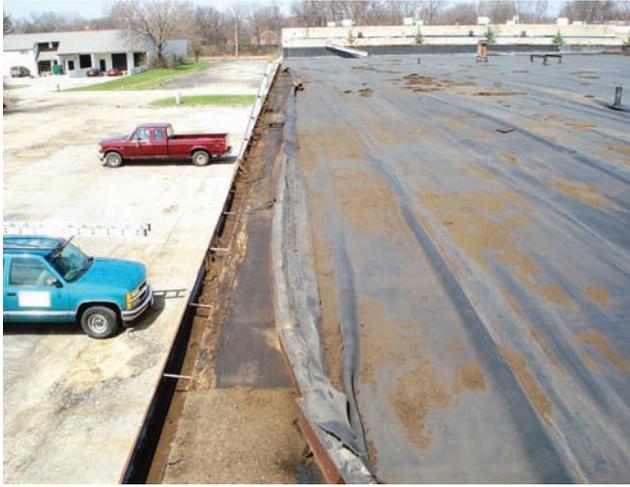
FIGURE 7.19

Overview of membrane damage along west perimeter.

Once inspected, it was observed that the membrane had torn from the west roof edge and most of the membrane was detached along the perimeter. Under this area, the exposed wood fiber insulation boards were degraded and contained heavy water damage. The membrane throughout most of the field of the roof was detached, loose, and rippled (Figure 7.19). The edge metal was detached, but still connected to the membrane (Figure 7.20).

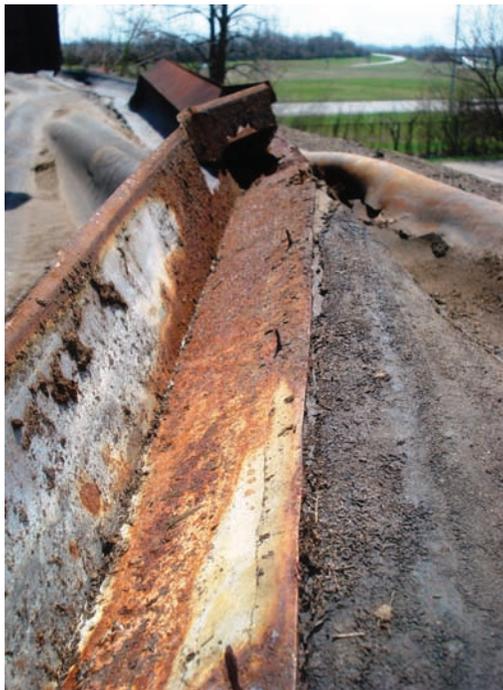
FIGURE 7.20

Detached edge metal.

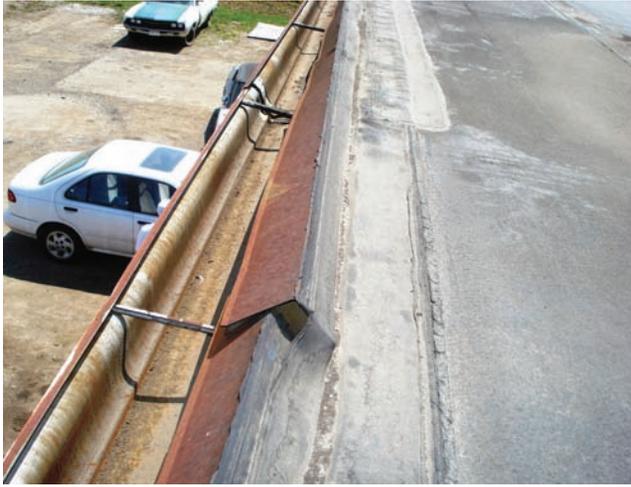
FIGURE 7.21
Lifted edge along east perimeter.

The edge metal was fastened with 5/8-inch nails spaced approximately 5 feet to 7-1/2 feet on center. The nails were fastened into the wood fiberboard sheathing but were not of sufficient size to fully engage into the wood nailer. The edge metal was not fastened with continuous hook strips, and nails were found to have only been used along the horizontal edge of the metal (no vertical fasteners). The edge metal along the east perimeter revealed the same installation details and was also found to be lifted or pulled up from the insulation board (Figure 7.21).

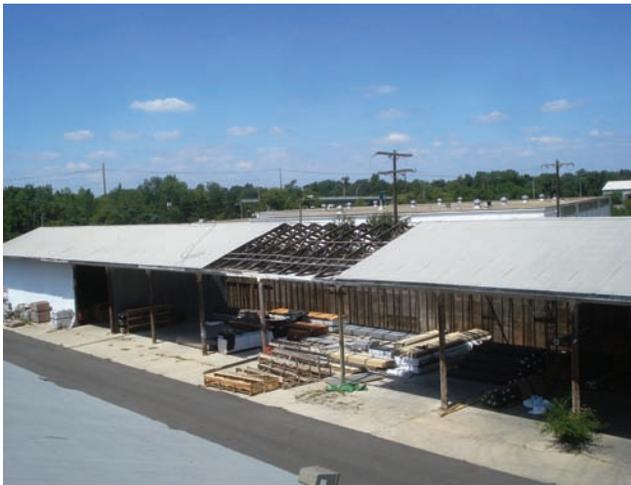
FIGURE 7.22
Overview of roof damage.

Upon investigation, it was found that a large section of the metal panels and associated wood purlins were broken and torn away from the structure. Figures 7.22 and 7.23 provide overview pictures of the roof damage.

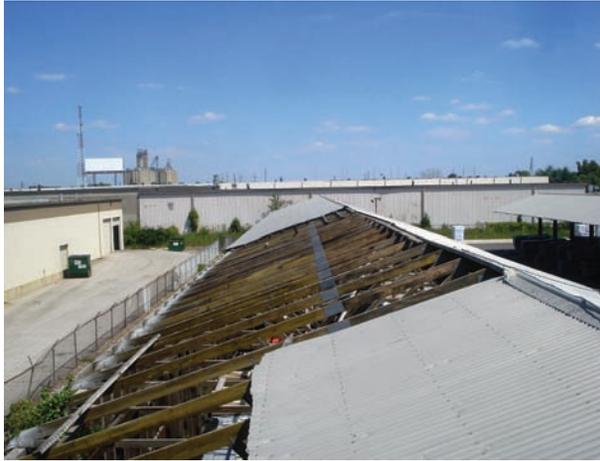
FIGURE 7.23
Overview of roof damage.

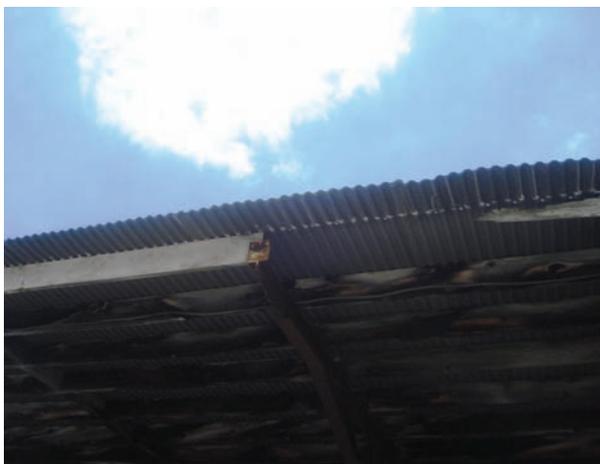
FIGURE 7.24
Water damaged and rotted purlins.

Forensically, the primary cause of this roof system failure was due to the lack of building maintenance. Long-term water intrusion caused significant damage to the purlins, which weakened the metal panel support members. This allowed for wind forces well below the code criteria and design wind speeds for this location to lift and blow off the metal panels. This failure could have been avoided had the roof system been properly maintained and any water-damaged structural members been promptly replaced.

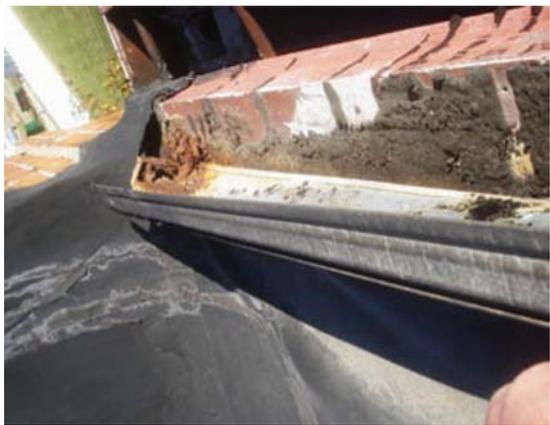
Description	Photograph	Deficiency
Lifted/ corroded edge metal

Water intrusion occurring near the roof edge caused corrosion to edge metal and fasteners. The membrane was not properly flashed at the corner termination.
Protruding fasteners and batten strips

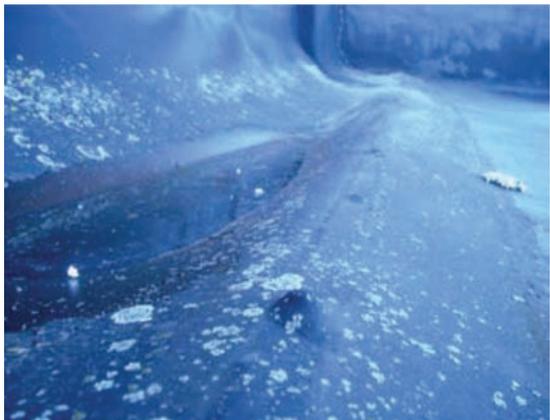
Heavy water infiltration was occurring at the membrane termination with the masonry wall. This led to severe degradation of the roof decking causing the fasteners to release. In many cases, the protruding mechanical attachment pieces produced tears in the membrane.

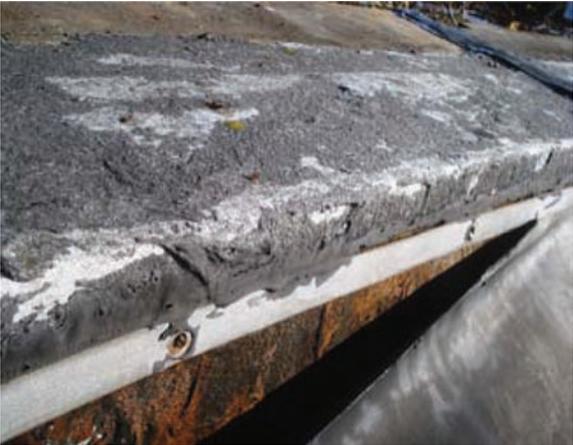
Description	Photograph	Deficiency
Improper termination at parapet wall

The membrane was fastened to the vertical edge of the parapet wall, which was covered with bitumen. No copings or flashings were used to prevent water from entering between the wall and membrane. Instead, caulk (heavily degraded) was the only means of attachment. Heavy water damage and rotting were observed to the decking below this intersection (see Chapter 8, this volume, for proper details).
Improper membrane attachment to masonry wall

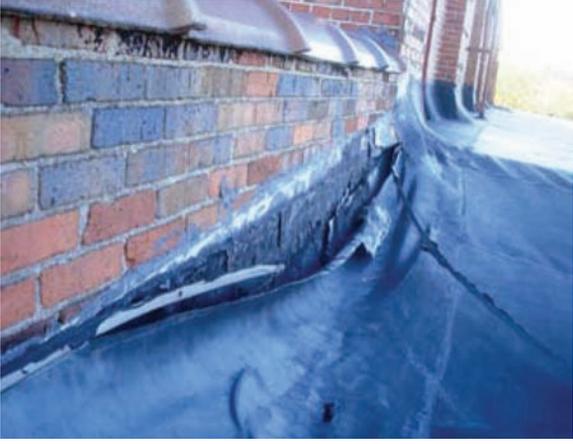
The membrane was fastened to the wall with a batten bar, but no counter flashing was installed to prevent water migration between the interface. Best practices recommend the installation of counter-flashing tucked into the masonry for proper water management. Heavy water damage and rotting were observed to the decking.
No base tie-ins at corners

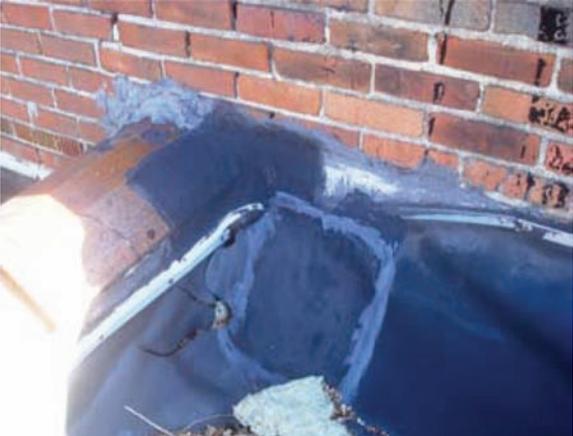
The membrane was pulled away from the wall, causing tears in the corner. The patch at this corner serves as a temporary bandage. Best practices require base tie-ins to secure the membrane to the wall surface.

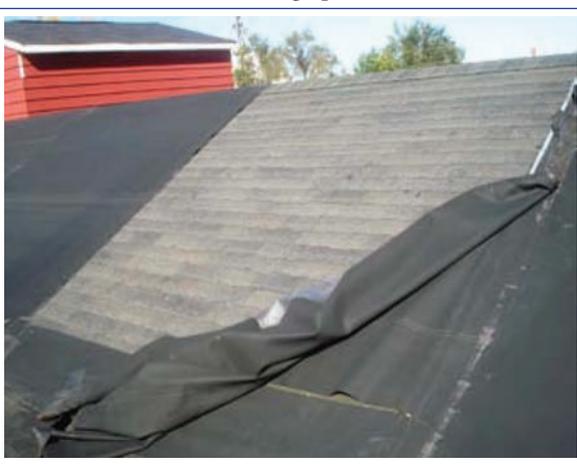
Description	Photograph	Deficiency
Torn membrane on steep dormer roof

The membrane tore loose at the seams. EPDM membranes are limited to 4:12 slopes. The excess slope in this case (7:12) put stress along the membrane seams, eventually causing them to tear loose.

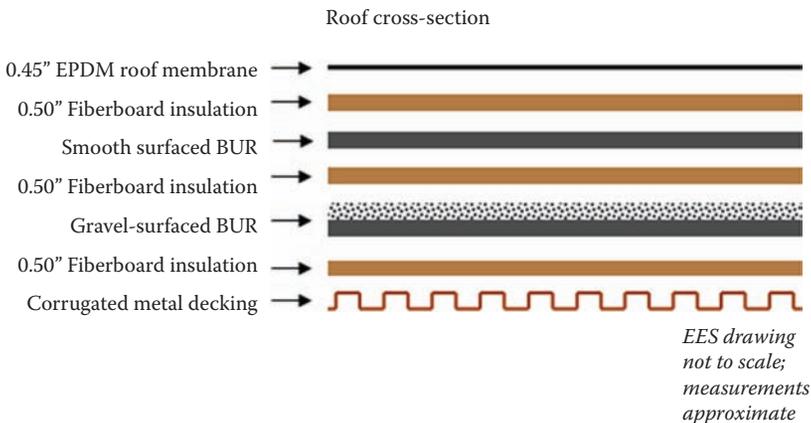
FIGURE 7.25
Roof cross-section.

During the subsequent forensic investigation, the failed roof membrane was being removed and replaced, which allowed for detailed observations of the original roof installation. It was observed that the EPDM was installed over the top of several layers of roofing and insulation materials. A drawing of the cross-section of the roof system is provided in Figure 7.25.

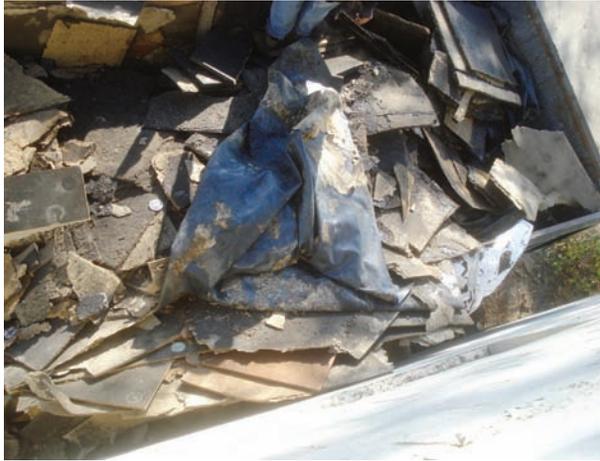
FIGURE 7.26

No adhesive on back side of membrane.

Portions of the recently removed sections of EPDM were lying in the worksite dumpster. It was found that little to no adhesive residue was present on the underside of the membrane surface (Figure 7.26). A section of the EPDM membrane that was still present on the roof surface was also pulled back and revealed similar conditions (Figure 7.27).

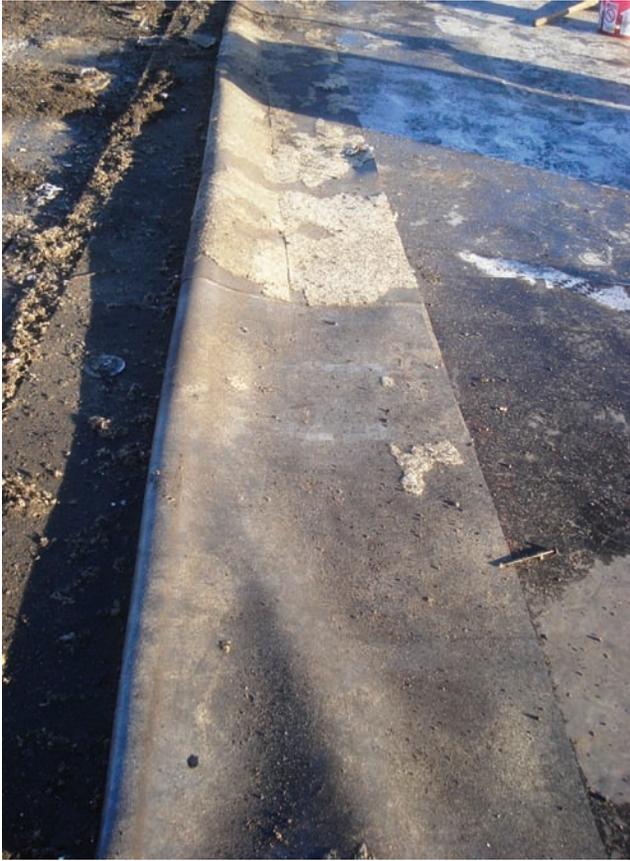
FIGURE 7.27
Nonuniform adhesive application along edge.

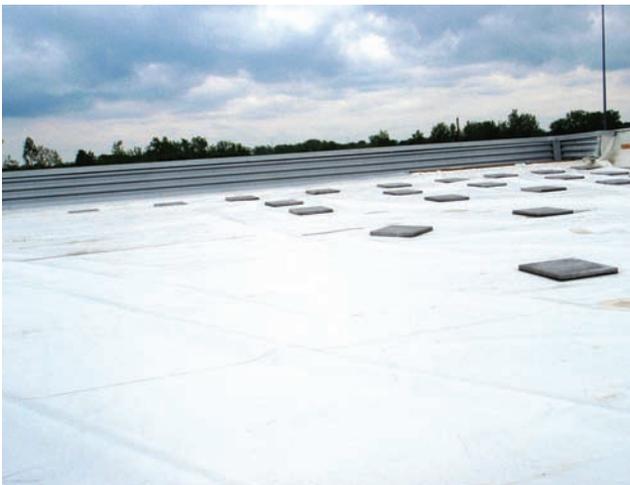
FIGURE 7.28
Overview of roof area damage.

Video evidence and photographs from the owner showed that the roof was ballooning up through the entire central portion. The initial failure appeared to have started at the southwest corner of the building, where the highest wind forces were directed. An overview of the roof surface is provided in Figure 7.28.

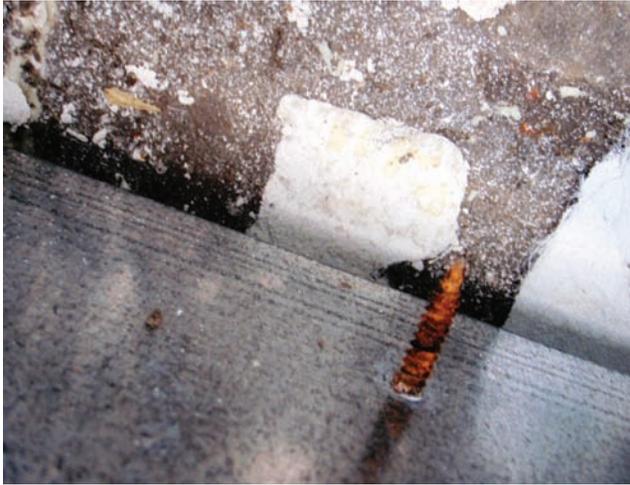
FIGURE 7.29
Corroded screw fastener.

strip, with a sufficient number and length of fasteners. In most cases, the screws were almost entirely corroded (Figure 7.29). The perimeter test cut also revealed that the vapor barrier stopped at the deck and was not continuous at the interface with the parapet wall. Moisture staining was observed on the insulation boards along the perimeter and corner; a strong chlorine odor was detected at the deck and wall interface.

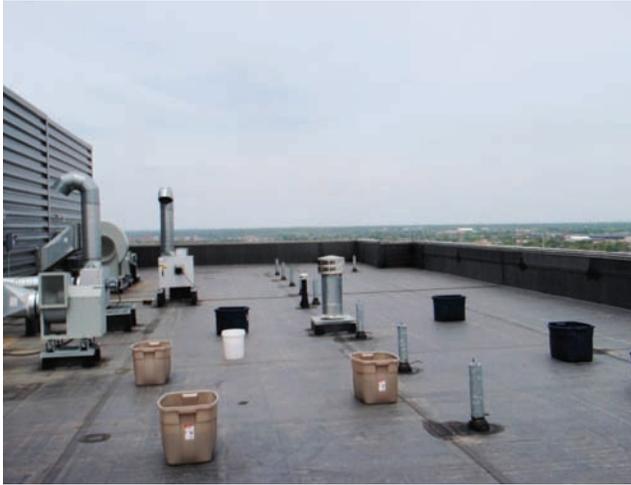
FIGURE 7.30
Overview of roof area.

A 260-foot-tall building was covered with a fully adhered EPDM membrane over the top of isocyanurate insulation boards and a concrete deck. The membrane was found to have been properly installed and fastened along the perimeters. Plastic totes or containers were filled with water and placed on the roof to provide uplift resistance over the damaged area (Figure 7.30).

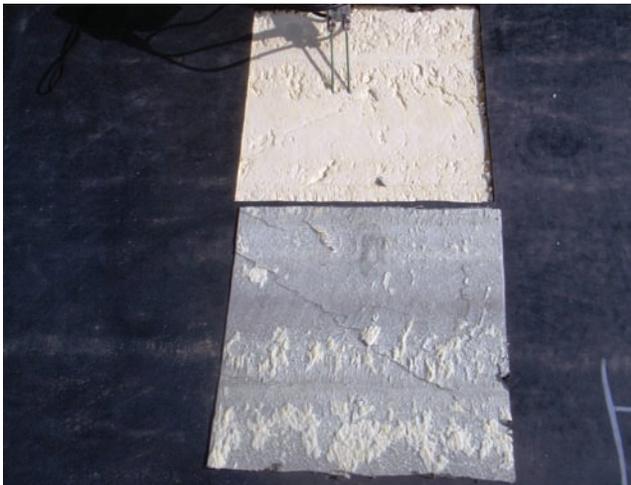
FIGURE 7.31
Separation of facer from insulation board.

The field portion of the membrane had failed or become detached from the insulation boards reportedly as a result of a storm with 66 MPH winds. Ultimately, it was discovered that the roof failure was due to detachment between the membrane and insulation board facer (Figures 7.31 and 7.32).

Forensically, the cause of roof failure was the separation between the insulation facer and insulation. Facer delamination has been reported to be caused by several factors, including heavy traffic during construction, moisture intrusion, and sometimes manufacturing defects. As a result of many similar failures throughout the industry, the National Roofing Contractors Association (NRCA) began recommending in 2000 that cover boards

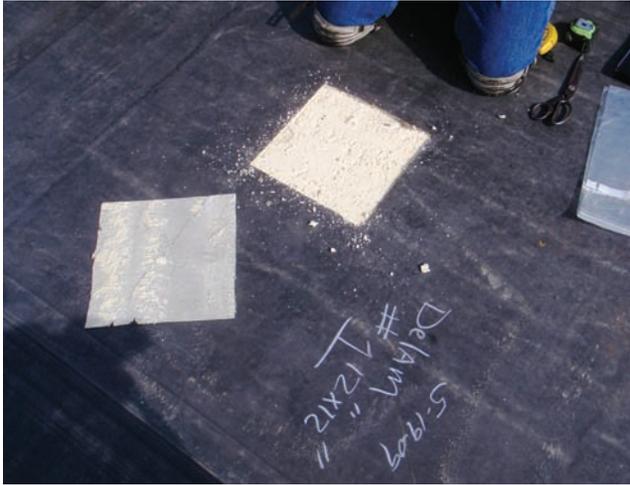
FIGURE 7.32
Separation of facer from insulation board.

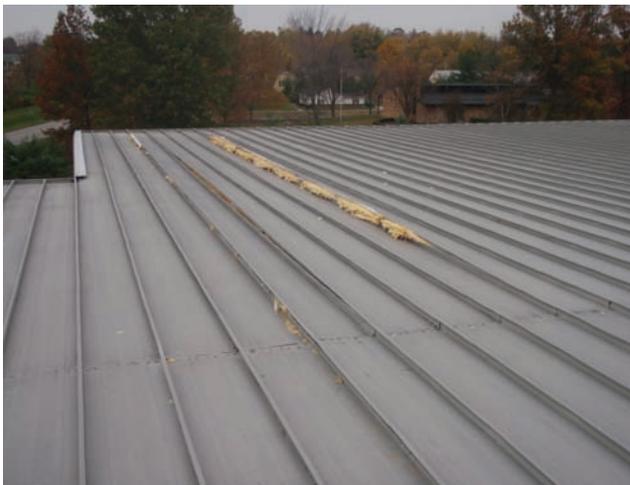
FIGURE 7.33
Overview of roof damage.

A large warehouse distribution center was covered with a standing seam metal roof (SSMR) system. A storm, reportedly producing 63 MPH winds, passed over the building and caused widespread displacement of the metal panels (Figure 7.33).

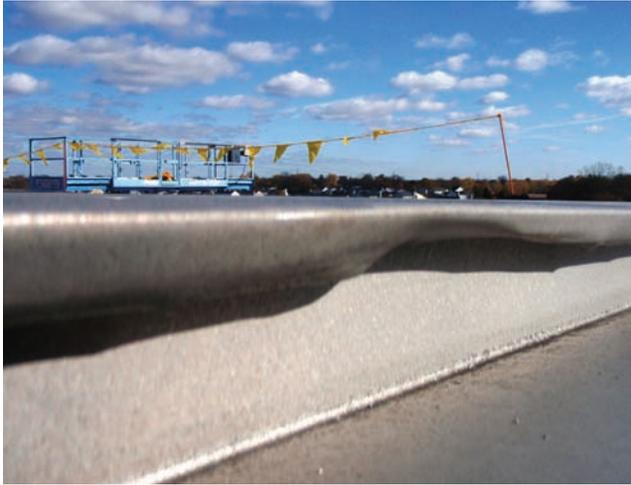
FIGURE 7.34
Locked seam at securement clip.

The panels were secured to the roof with Z-clips that appeared adequately sized and spaced. The panel seams were typically manually seamed or locked at the locations of the securement clips (Figure 7.34). The remaining portions of the seams were open and had not been manually or mechanically seamed (Figure 7.35).

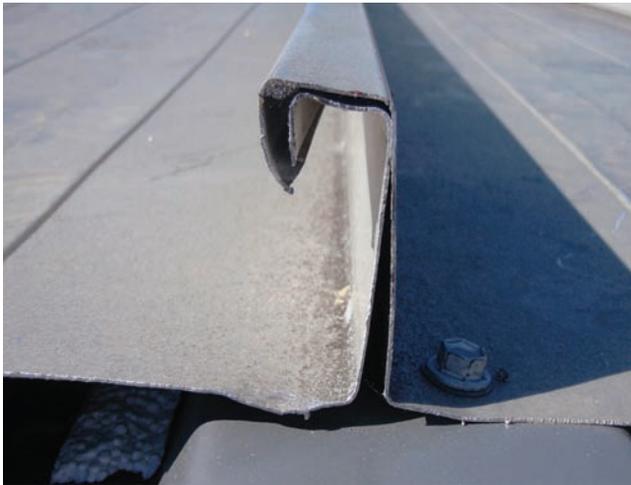
FIGURE 7.35
Unlocked seam.

Forensically, it was concluded that the cause of this roof failure at less than design wind speeds was because the panels had not been fully seamed as required by industry best practices.

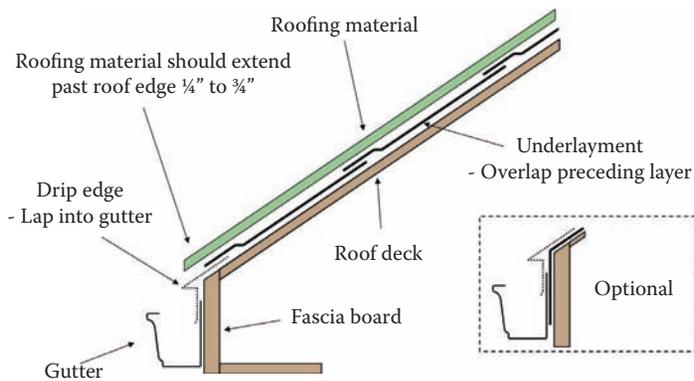
FIGURE 8.1
Eave construction details.

Starting at the bottom edge of the roof system, the application of drip edge molding allows any water traveling down the steeped roof surface to be diverted away or collected into the gutter system. Figure 8.1 depicts a simple construction detail of the eave of a steep-slope application.

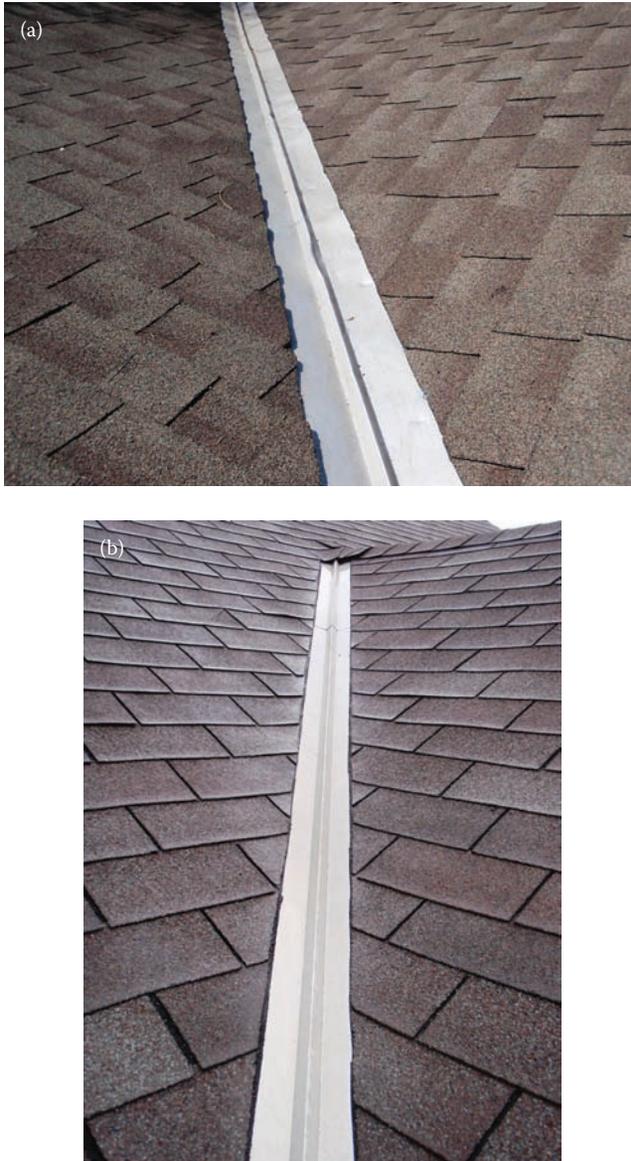
FIGURE 8.2

(a) Example of open valley with dimensional shingles; (b) example of open valley with three-tab shingles.

Photographs of open valleys for three-tab and dimensional shingles are illustrated in Figure 8.2a and b. Recommended flashing details from NRCA for an open valley installation are shown in Figure 8.3.¹

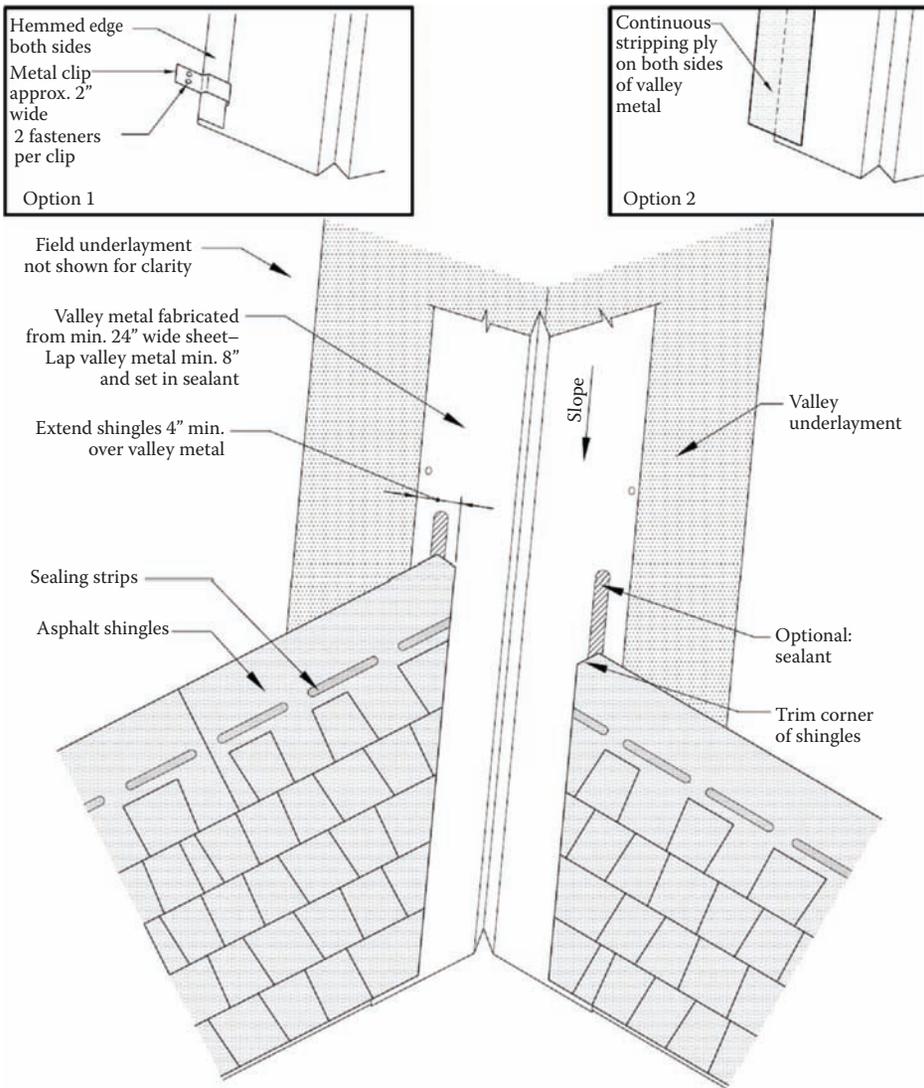
FIGURE 8.3

Open valley details. (Reprinted from National Roofing Contractors Association, *The NRCA Roofing Manual: Steep-Slope Roof Systems*, NRCA, 2009. With permission.)

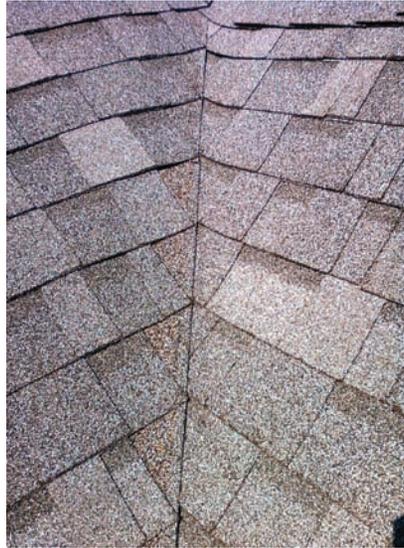
FIGURE 8.4
Example of closed-cut valley with dimensional shingles.

An illustration of a closed-cut valley is shown in Figure 8.4. Specific recommended best practices for installation of closed-cut valleys follow:

- For closed-cut valleys, the shingles on the elevation with the smaller roof area intersecting the valley should be laid across the valley a minimum of 12 inches and left uncut.
- The shingles from the adjoining elevation (the elevation that drains a larger volume of water runoff) should be laid over the centerline of the valley and be trimmed back from the valley centerline approximately 2 inches.

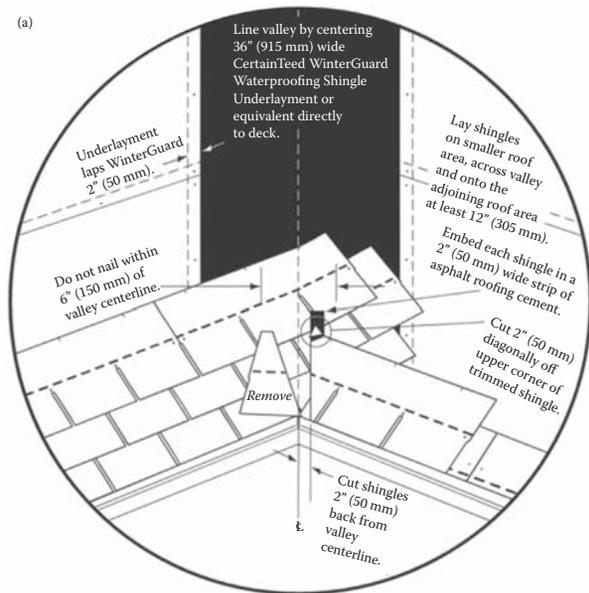
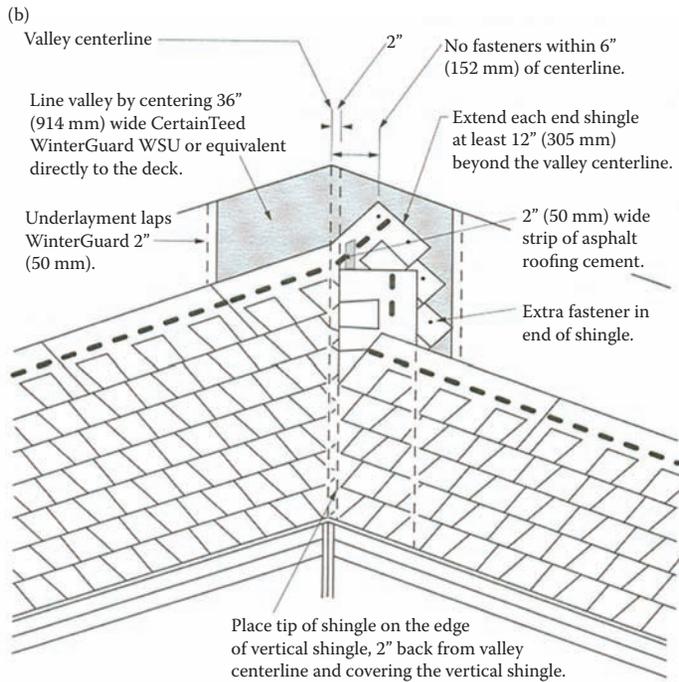
FIGURE 8.5
(a) Proper installation of closed-cut valley with three-tab shingles; (b) proper installation of closed-cut valley, alternative method, with dimensional shingles. (From CertainTeed Corp, *CertainTeed Shingle Applicator’s Manual*, CertainTeed, 2009. With permission.)

An alternative method for closed-cut valleys is to install an additional course of shingles vertically (this method of installation is commonly referred to as a “California Valley”) prior to applying the shingles on the larger area elevation. Proper installation details for a closed-cut valley with three-tab asphalt shingles, provided by CertainTeed Corporation, along with an alternative approach for dimensional shingles are illustrated in Figure 8.5a and b.

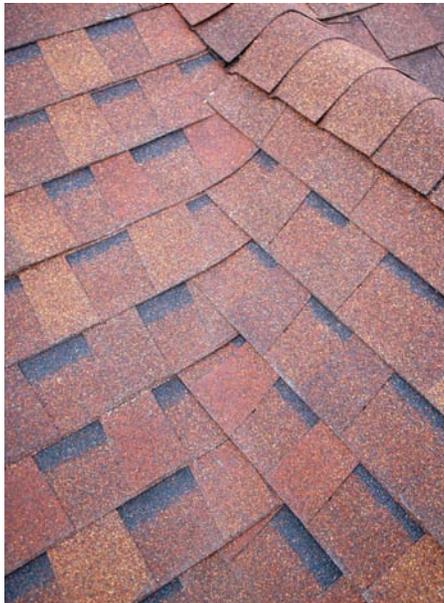
FIGURE 8.6

Example of closed-woven valley with dimensional shingles.

An illustration of a closed-woven valley is shown in Figure 8.6. Specific recommended best practices for installation of closed-woven valleys follow:

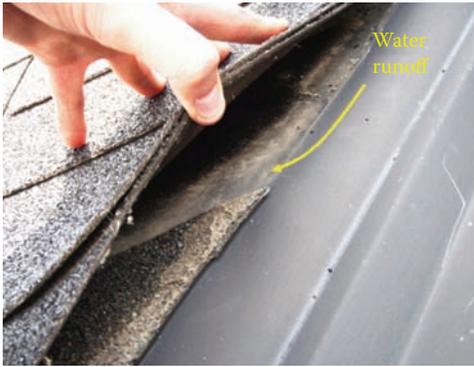
Description	Photograph
<p>Efflorescence patterns and dirt on valley metal flashing indicating draining water traveling back beneath shingles at untrimmed corner location.</p>

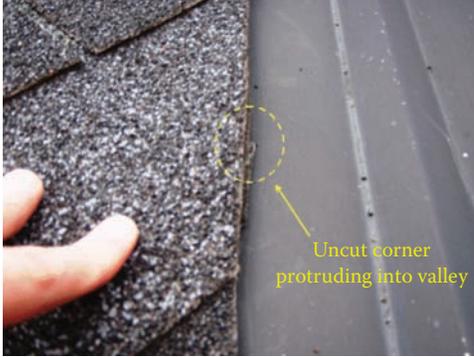
<p>Untrimmed shingle corner protruding past the cut edge of the shingles and into the valley. This corner can "catch" water runoff and direct it underneath the shingles.</p>

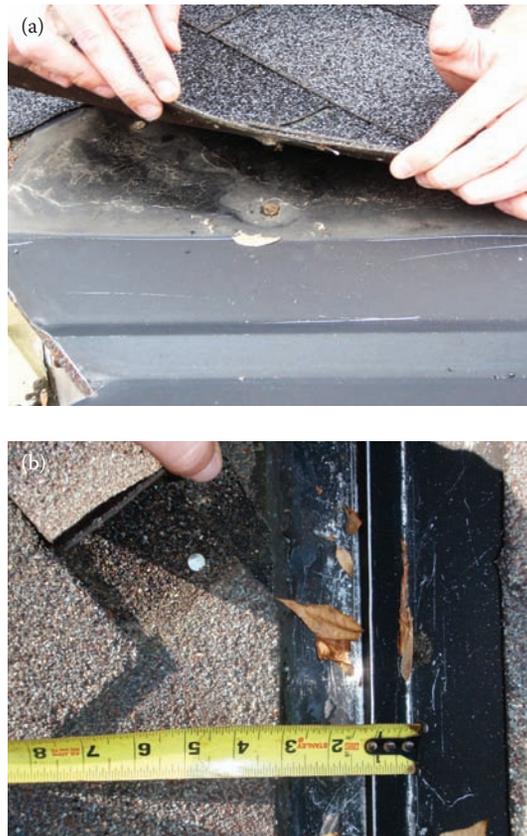
FIGURE 8.7

(a) Evidence of water presence at nail depression; (b) nail driven too close to centerline of open valley.

The metal flashings should only be secured along the outer edges and not pierced by nail fasteners. Driving nails through the valley flashing, especially close to the cut edge of the shingles along the valley centerline or the open valley metal, creates pathways for water to enter the structure. Figure 8.7a and b illustrates situations where an open valley flashing was secured by nails very close to the cut edge of the shingles.

Upon lifting the shingles along the valley, evidence of drip staining, efflorescence, and dirt or debris was found on the top side of the flashing at the location of this nail depression (Figure 8.7a). Also note the lack of asphalt plastic cement sealing down the cut edges of the shingles.

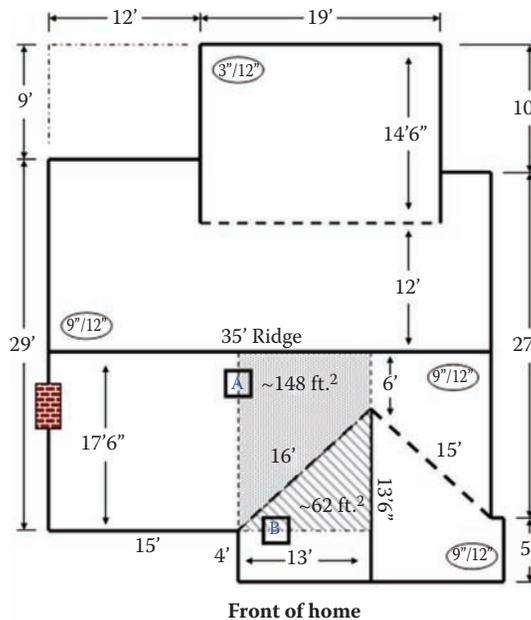
FIGURE 8.8 Drainage area calculated along a closed-cut valley.

Based on interior measurements and observations, water intrusion was thought to be originating along a closed-cut valley on a residential building. As shown in Figure 8.8, a closed-cut valley was installed along the intersection of roof elevation A and

roof area elevation B. The surface area of roof elevation A, which drained into the valley, was calculated to be approximately 148 square feet compared to elevation B, which was calculated to contain a drainage area of approximately 62 square feet. Considering elevation A has the potential to drain a greater volume of water runoff, the shingles from elevation B should be installed first (lower layer) and the shingles from this elevation should be trimmed back from the centerline. This helps to ensure that the larger amount of water from elevation A cannot breach or infiltrate underneath the shingles from the adjoining valley.

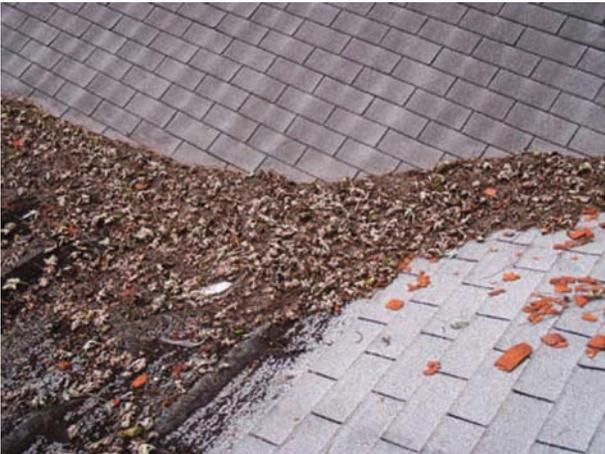
Description	Photograph
Heavy tree and leaf debris at termination of valley
