FORENSIC ENGINEERING

**Damage Assessments for
Residential and Commercial
Structures**

**Edited by
Stephen E. Petty**

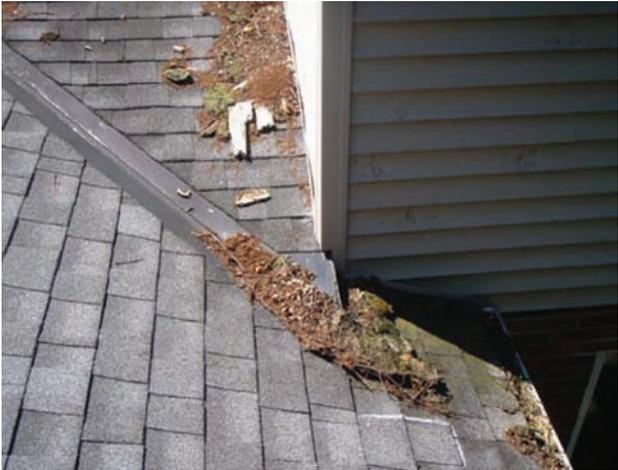
Description	Photograph
Heavy debris at termination of valley

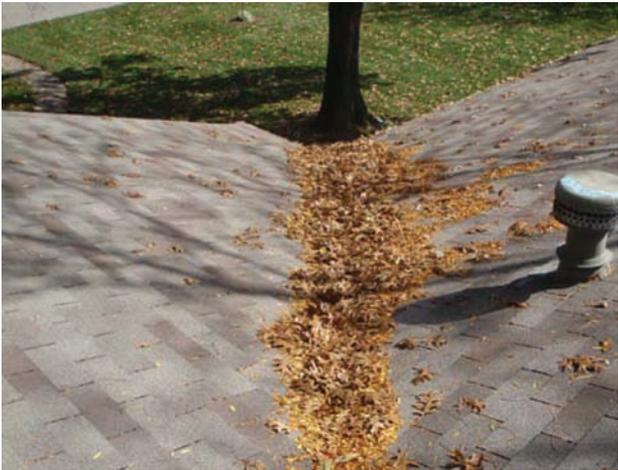
Heavy amount of tree debris in valley

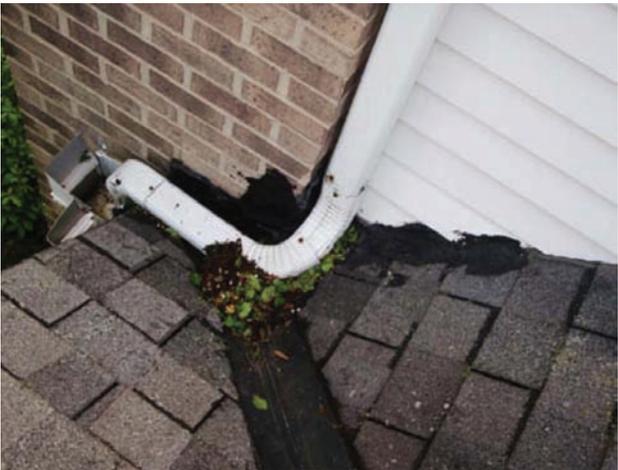
Build-up of debris and vegetation at intersection of exterior wall and masonry chimney

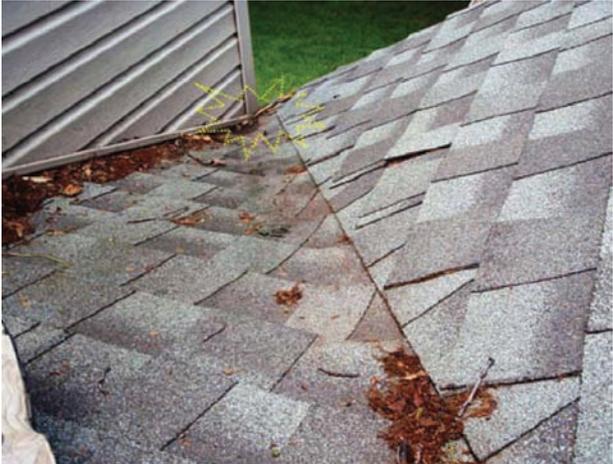
Description	Photograph
<p>Case Study A: Overview of roof valley above interior water damage Centerline of valley improperly terminates directly into corner interface</p>

Photographs in Table 8.3 depict two situations associated with water intrusion that ultimately led to the discovery of an improperly designed or constructed roof valley. In both cases, the interior wall and ceiling surfaces directly below an exterior corner contained heavy water-damage staining. In addition, water damage and standing water were found in the basement directly below these areas.

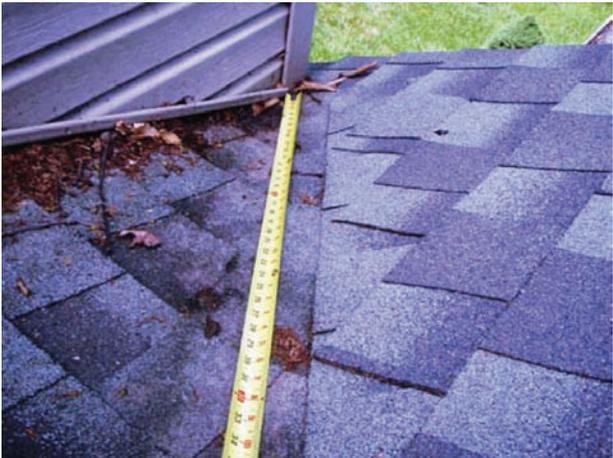
<p>A photograph showing a close-up of a roof valley on a grey shingled roof. The valley is formed by two roof planes meeting at a corner. The centerline of the valley is visible, but it does not properly terminate into a metal flashing. Instead, it ends abruptly at the corner interface. Yellow arrows are drawn on the image to highlight this improper termination point. There is some brown leaf debris accumulated in the valley.</p>

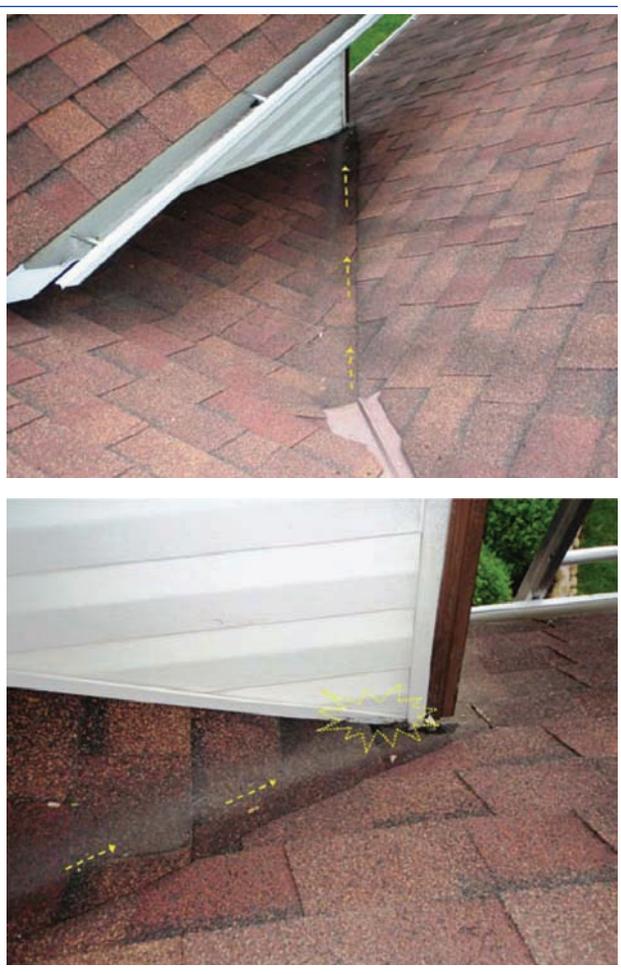
Description	Photograph
Case Study B: Overview of valley draining water run-off directly against corner of exterior wall Potential water entry point if proper flashing details not followed

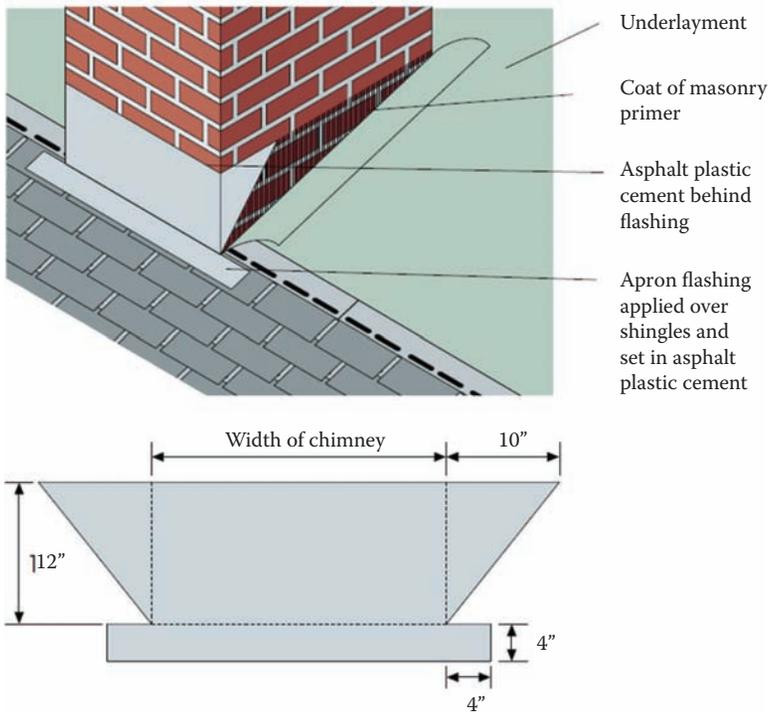
FIGURE 8.9

Apron flashing for downslope portion of masonry chimney. Underlayment shown pulled away from chimney.

Installation of apron flashing. (From APA–The Engineered Wood Association, *Build a Better Home: Designing Roofs to Prevent Moisture Infiltration*, APA–The Engineered Wood Association, 2008. With permission.)

- **Chimney Flashing**: APA—the Engineered Wood Association² prepared a publication that provides excellent details and best practices for preventing water infiltration into residential homes. Within this publication (Figure 8.9), recommended details for apron flashing on a masonry chimney were provided. From experience, key installation deficiencies associated with apron flashing occur along the bottom, or downslope, side of a masonry chimney. These deficiencies do not meet the following criteria: (1) the flashing should extend at least 4 inches onto the roof surface and 6 inches up the wall surface and (2) the flashing should be set in or sealed with roof cement. It is also common for the bottom edge of the apron flashing to be slightly hemmed to ensure water runoff does not wick underneath the flashing.

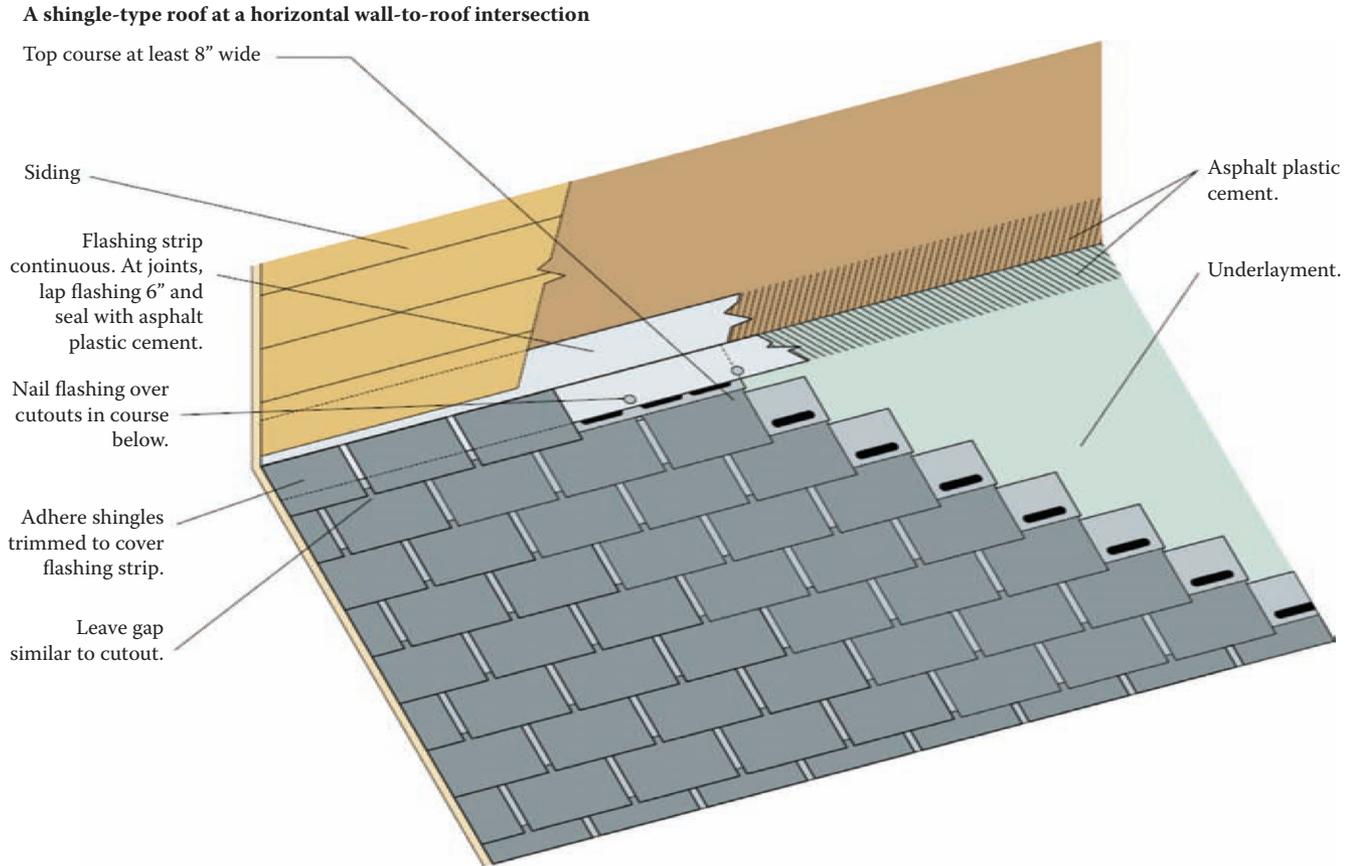
FIGURE 8.10

Installation of head flashing. (From APA–The Engineered Wood Association, *Build a Better Home: Designing Roofs to Prevent Moisture Infiltration*, APA–The Engineered Wood Association, 2008. With permission.)

- **Front (or Head) Wall Flashing**: Again, APA—the Engineered Wood Association's² publication provides excellent details and best practices for installation of flashing at vertical head walls. Figure 8.10 illustrates the fact that the flashing used at the horizontal wall-to-roof intersection should be a continuous piece of flashing sealed down with asphaltic cement. The flashing should be installed and nailed over the felt underlayment and cutouts in the penultimate course of shingles. The last course of shingles should be trimmed and adhered to the flashing.

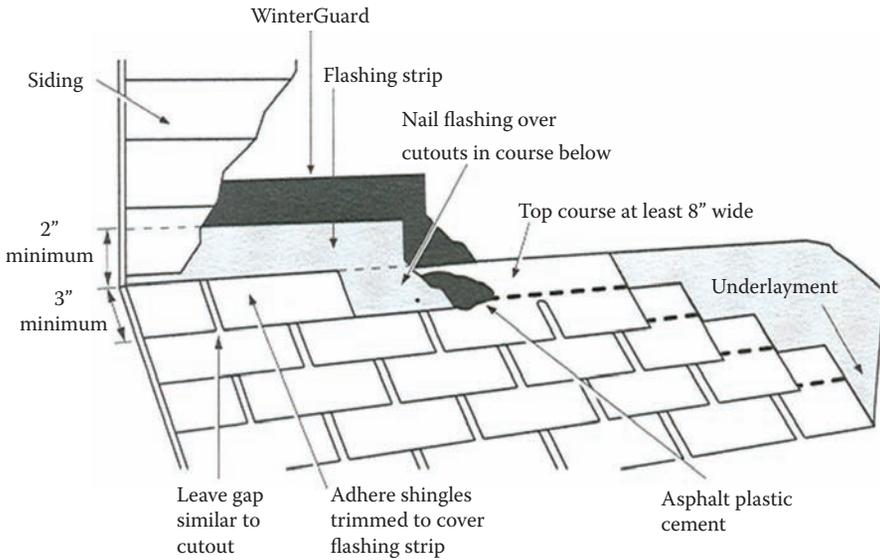
**FIGURE 8.11**

Installation of head flashing. (From CertainTeed Corp, *CertainTeed Shingle Applicator's Manual*, CertainTeed, 2009. With permission.)

Figure 8.11 from CertainTeed also illustrates an industry-based installation technique for flashing along a front vertical wall/lower roof interface.⁴

Similar to the recommendation set forth by APA, CertainTeed first recommends that underlayment be lapped up the vertical wall (for colder climates, the use of waterproof ice guard underlayment is encouraged). Then the metal flashing should extend up the vertical wall at least 2 inches and overlap the last shingle by at least 3 inches. Note that this distance up the vertical wall, 2 inches, is much less than recommended by APA (6 inches). Experience suggests that the 2-inch value is too low at many locations where ice and snow can build up at these interfaces and then melt, allowing water to get behind the flashing. The metal flashing should not be nailed to the vertical wall but secured by embedding it in asphalt roofing cement at the roof surface. However, it is recommended that the metal flashing in this situation be nailed above the cutouts of the underneath course of shingles. For both three-tab and dimensional shingle applications, if any nail heads are exposed, a dab of caulking or sealant must be applied to cover the nail head.

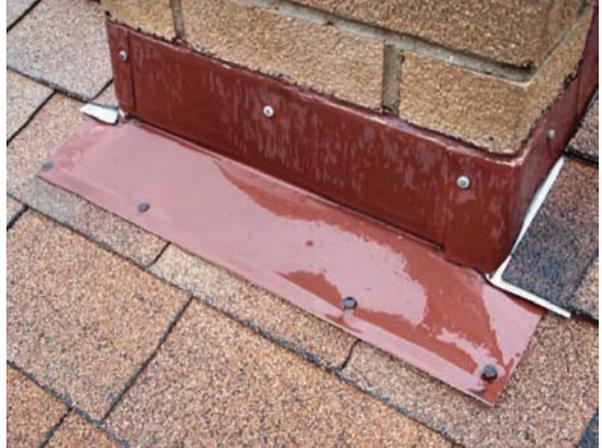
Apron flashing on the down slope side of a masonry chimney. Notice nail fasteners not covered with roofing cement/sealant.

Table 8.4 provides examples and descriptions of improper apron flashing installations encountered during onsite inspections.

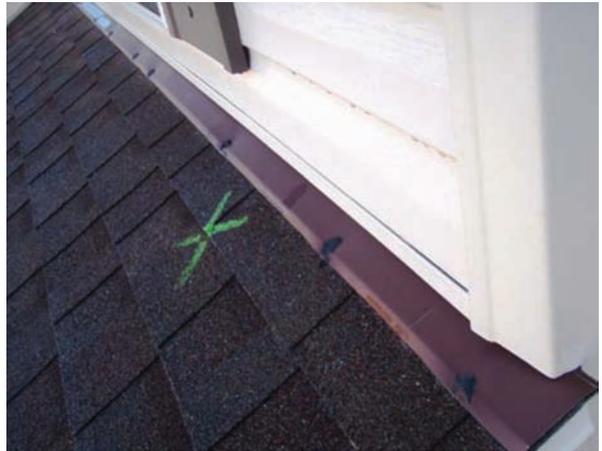
Apron or head wall flashing secured with nails covered with dabs of roofing cement. Notice the wall cladding in this situation is vinyl siding.

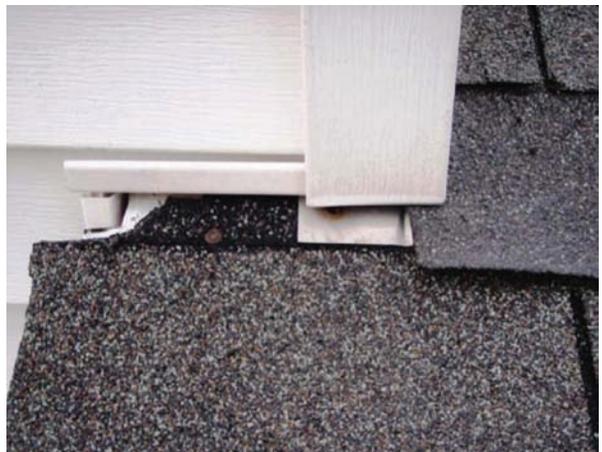
No apron flashing present along intersection. Notice face-driven nail heavily rusted.

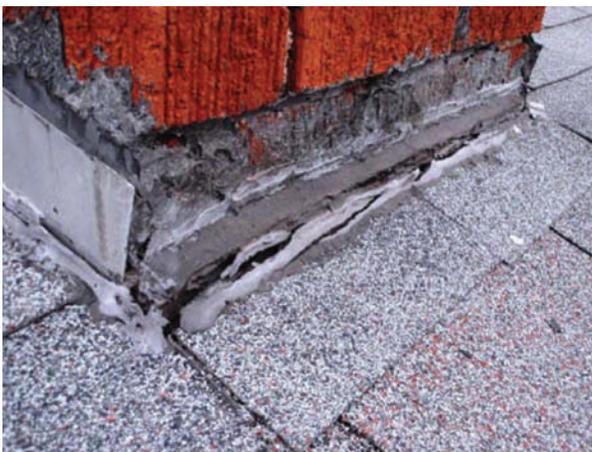
Description	Photograph
Apron flashing along flat surface with use of no counter-flashing or nail fasteners. Apron flashing is not secured and tucked into masonry wall.

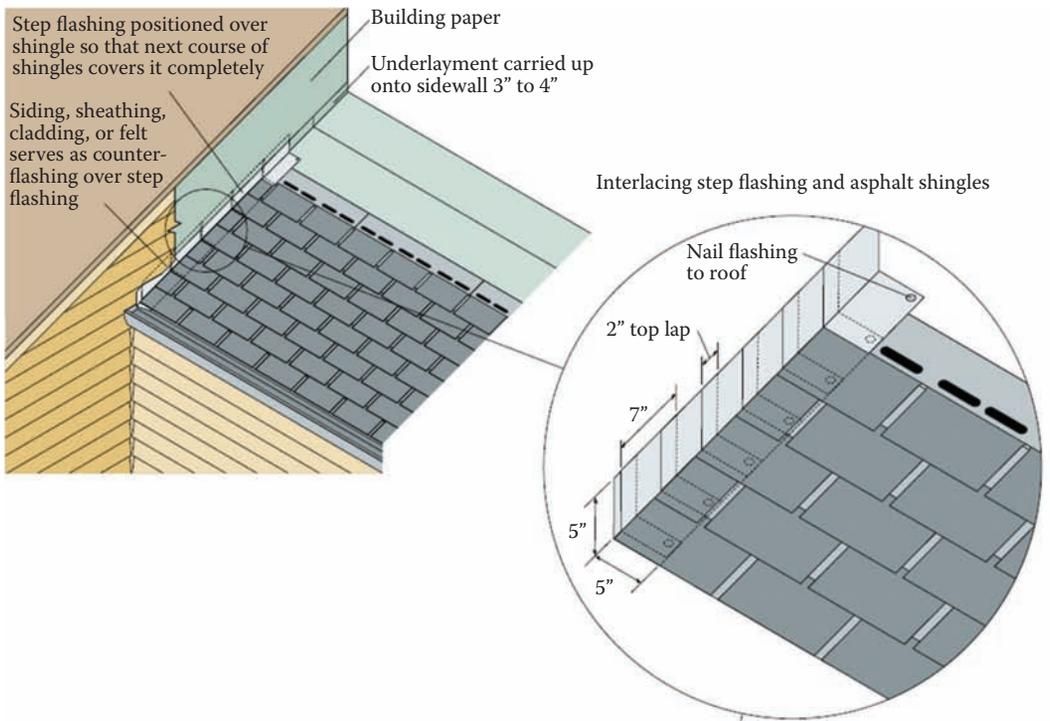
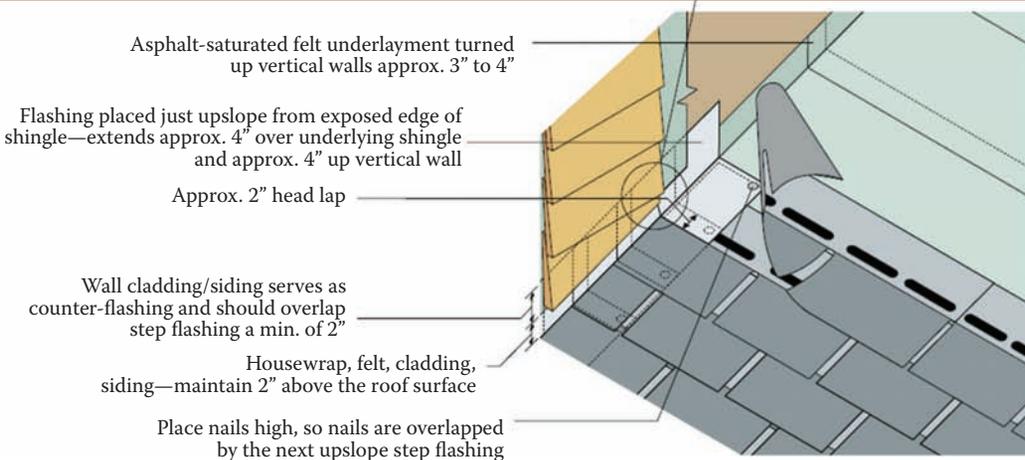
FIGURE 8.12

(a) A shingle-type roof at a sloped wall-to-roof intersection

(b) Close-up of flashing detail

Step flashing details along wall-to-roof interface. (From APA–The Engineered Wood Association, *Build a Better Home: Designing Roofs to Prevent Moisture Infiltration*, APA–The Engineered Wood Association, 2008. With permission.)

The application of step flashing applies to any vertical or side wall and sloped roof interface. In the process of flashing a chimney, step flashing in conjunction with the installation of asphalt shingles would follow the installation of the apron flashing and framing of the cricket. Examples of industry best practices for step flashing installation are provided by the APA² and the NRCA.¹ Installation details from both references are shown in Figures 8.12 and 8.13.

Note that these best practices recommend that the roof underlayment should be turned up the wall 3 to 4 inches beneath the building wrap or paper. This is often not done. Also, best practices suggest that step flashing be installed vertically up the wall 4 to 5 inches and horizontally along the roof and below the shingles 4 to 5 inches. Some debate exists on the distance step flashing should extend vertically and horizontally. This debate probably arises due to many suppliers and roofing contractors continuing to use narrow (L-shaped) step flashing pieces (5 inches wide), which would only allow 2-1/2 inches of coverage up the wall and out onto the underlying shingles. This type of coverage may work in mild climates, but experience has shown that to work successfully (keep water out), the step flashing should extend 4 to 5 inches underneath the intersecting steep-slope materials in areas of moderate and severe weather climates, areas of heavy rainfall, or areas with the potential for snow and ice accumulation. The flashing should be installed flush against both surfaces. Additionally, the nail fasteners should be placed high so the nails are overlapped by the next upslope piece of step flashing.

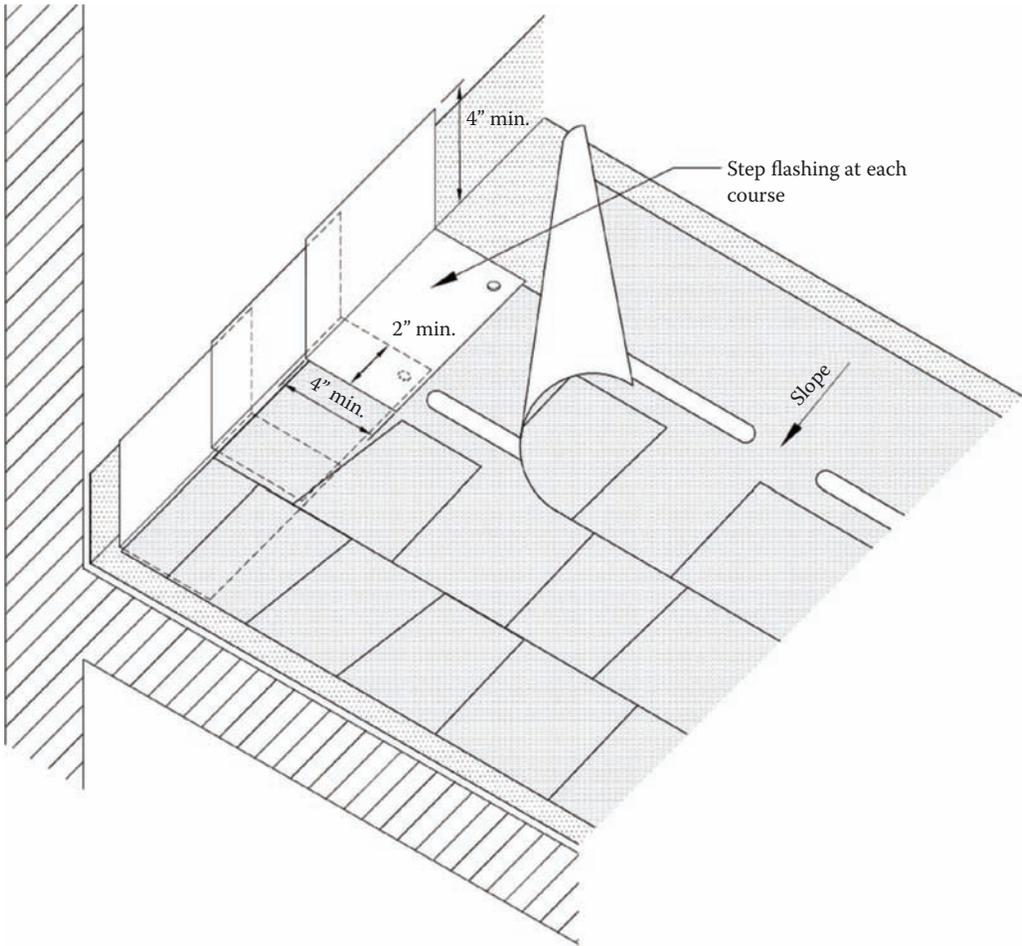
FIGURE 8.13

Step flashing at a vertical wall. Note: Wall siding/cladding and building wrap not shown for clarity. (Reprinted from National Roofing Contractors Association [NRCA], *The NRCA Roofing Manual: Steep-Slope Roof Systems*, 2009. With permission.)

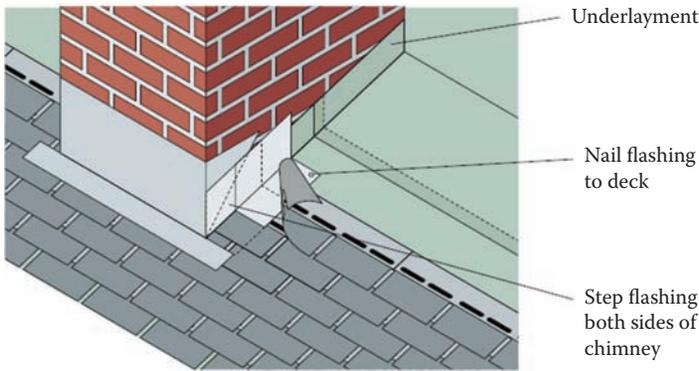
FIGURE 8.14

Interlace step flashing with shingles. Set step flashing in asphalt plastic cement.

Step flashing along a side masonry chimney wall. (From APA–The Engineered Wood Association, *Build a Better Home: Designing Roofs to Prevent Moisture Infiltration*, APA–The Engineered Wood Association, 2008. With permission.)

The step flashing details for the side walls of chimneys are installed in a similar manner as described above. Illustrations from the APA,² presenting general guidelines for the proper best practices installation of step flashing for a masonry chimney, are shown in Figure 8.14.

- The flashing component in conjunction with appropriate roofing underlayment should lap up the side wall and be installed underneath the building paper or wrap when applicable.
- For interlaced step flashing, the flashing should extend up the wall surface and onto the roof surface beneath the shingles at least 4 to 5 inches.

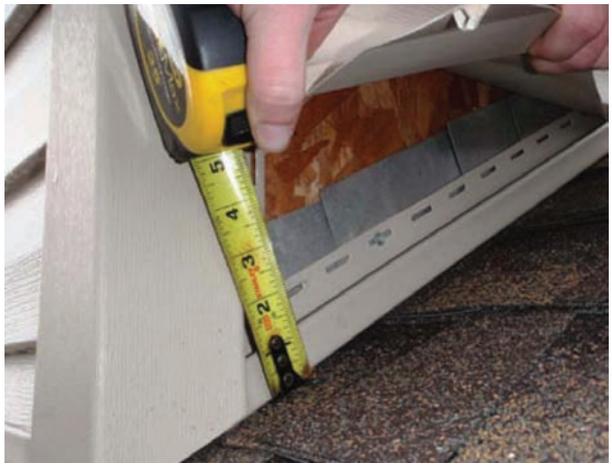
Description	Photograph
Interlaced step flashing extending ~3-1/2" up vertical side wall covered with vinyl siding as counter-flashing.

Table 8.5 provides examples and descriptions of step flashing installations encountered, both proper and improper, during onsite inspections.

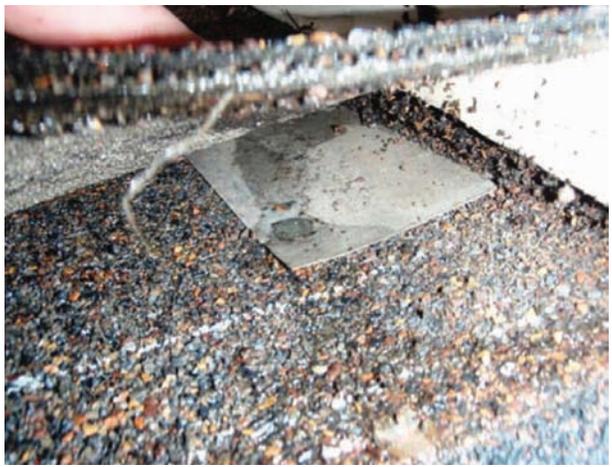
Step flashing extending underneath shingles with nail fastener driven "low." Nails should be driven high and overlapped by the preceding piece.

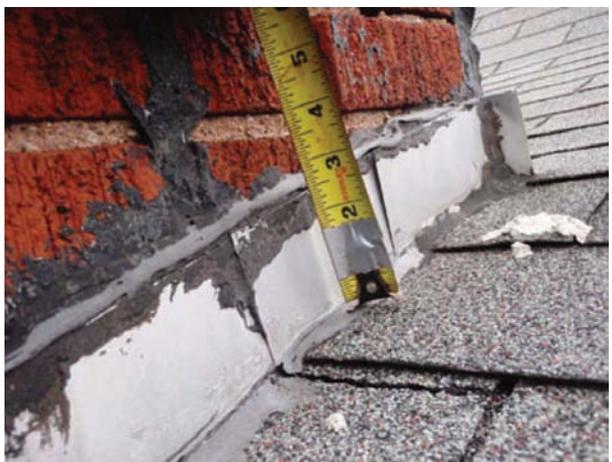
Apron flashing along flat surface with use of no counter-flashing. Apron flashing not secured and tucked into masonry wall.

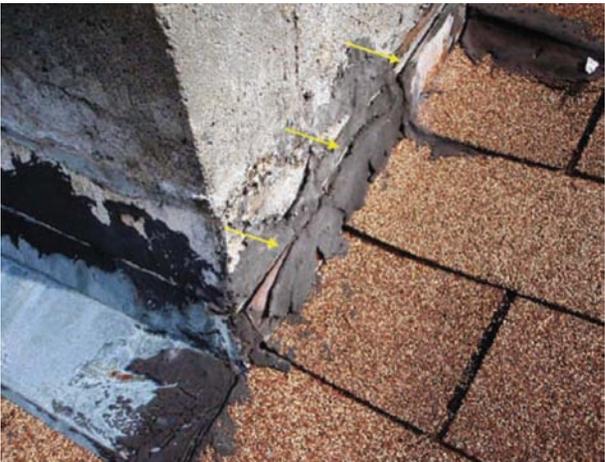
Description	Photograph
Step flashing alongside masonry wall of chimney not tucked into mortar joint exposing large gap.

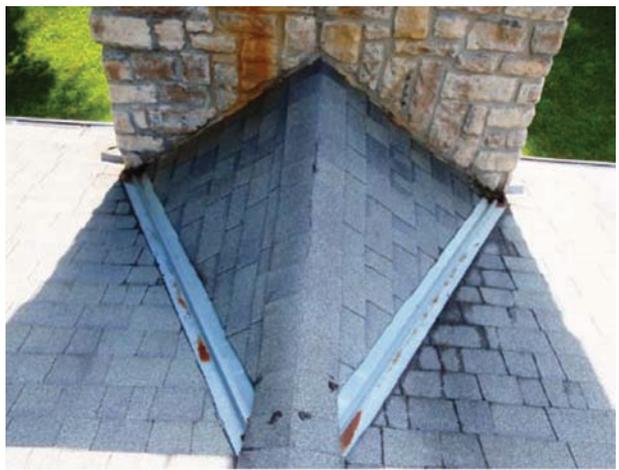
Description	Photograph
Metal valleys along shingled cricket direct water runoff against corners of masonry chimney. For this particular inspection, water entry was found to occur at both of these corners.

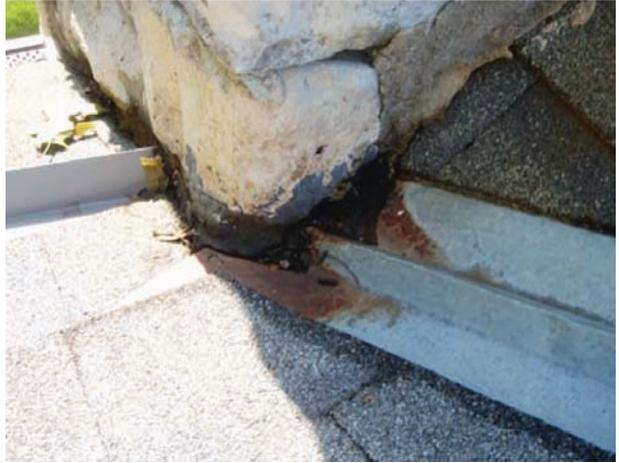
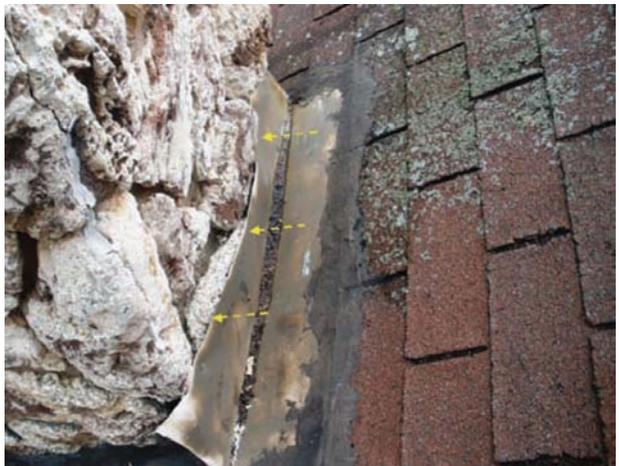
Large gaps along interface with stone masonry and backer flashing. Since counter-flashing is not employed, backer flashing should be tucked into chimney.

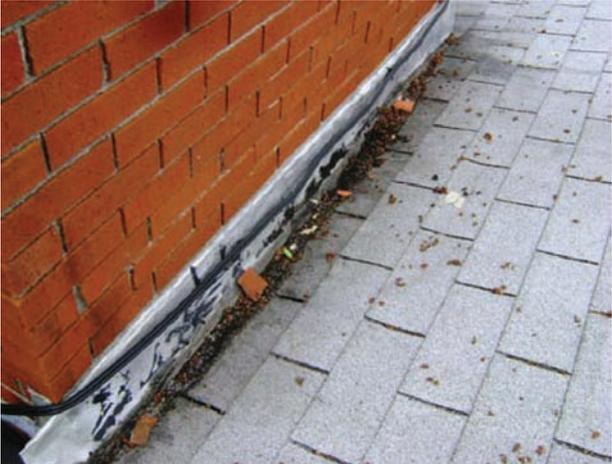
Description	Photograph
The upslope width measurement of the chimney parallel to ridge far exceeds 30". Therefore, a cricket should be installed rather than backer flashing.

A “cricket” or saddle is utilized to prevent the buildup of ice and snow at the upslope side of a chimney and to divert water around the chimney. Modern building code states a cricket or saddle is required when the upslope width measurement of the chimney parallel to the ridgeline exceeds 30 inches in width.³ However, industry best practices and experience has shown that crickets should be employed when any of the following criteria are met:¹

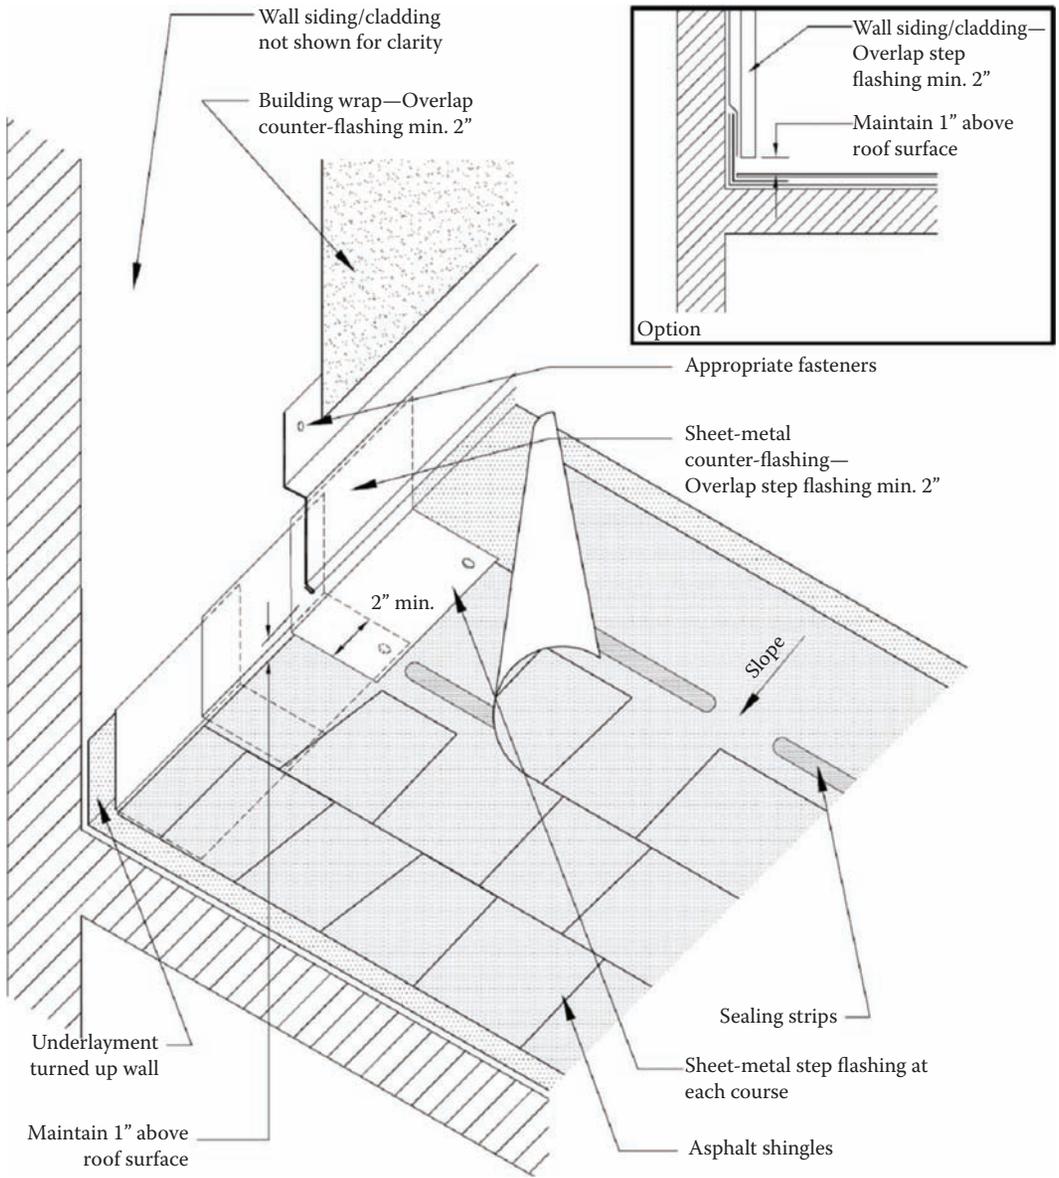
FIGURE 8.15 Sidewall flashing. (Reprinted from National Roofing Contractors Association (NRCA), *The NRCA Roofing Manual: Steep-Slope Roof Systems*, 2009. With permission.)

In the case of masonry chimneys or walls and therefore the absence of a wall covering, a piece of counter-flashing is typically inserted into the masonry to protect the exposed top edge of the apron, step, cricket, or backer flashing. Based on experience, counter-flashing installed along a vertical masonry wall should be tucked into or behind the masonry. Simply applying sealant or caulking along the leading edge is not a permanent method for water prevention. Remember, sealant or caulking should only be used as a secondary means of waterproofing because sealant or caulking will degrade over time, thus requiring a reapplication to provide adequate protection. This is often not done by owners out of lack of knowledge or other reasons, which can ultimately lead to later water entry issues. Figure 8.15 illustrates an industry best practice method (NRCA) for installation of flashing at a side wall.¹ Table 8.7 illustrates common deficiencies with counter-flashing and masonry walls.

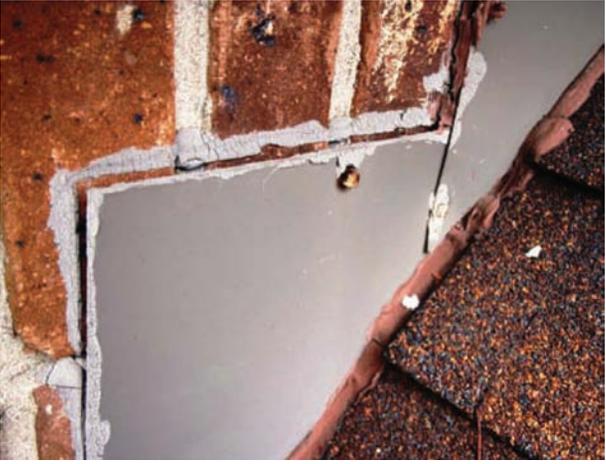
Description	Photograph
Heavy deterioration of sealant along edge of counter-flashing, resulting in large gaps for water entry.

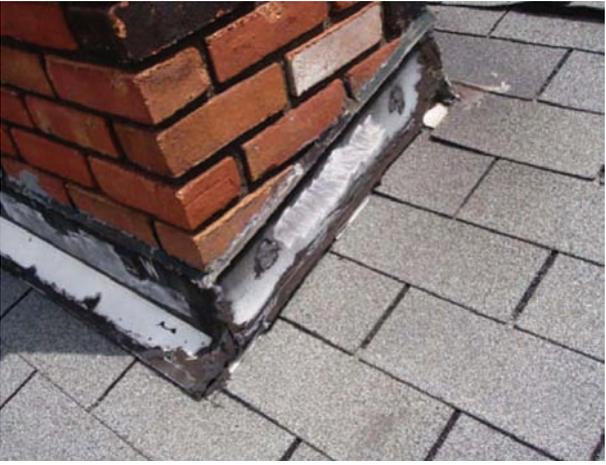
Continuous flashing along side wall of chimney. However, leading edge of flashing only protected by sealant and not secured into the masonry.

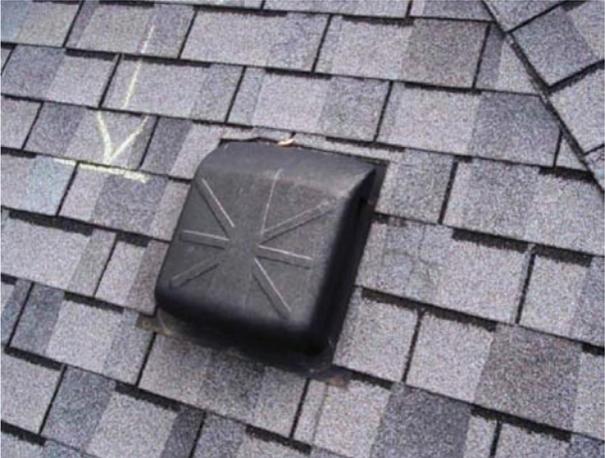
Description	Photograph
Slant-back metal box vent

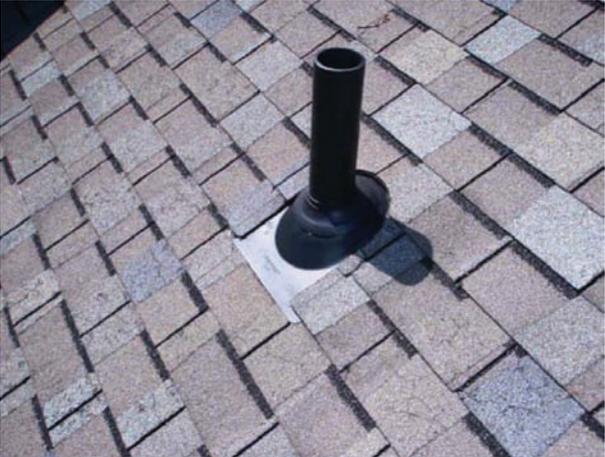
Soil stack pipe with rubber boot flange

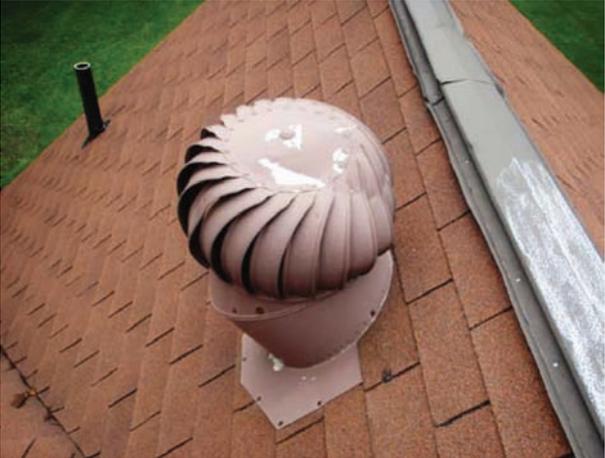
Turbine exhaust vent

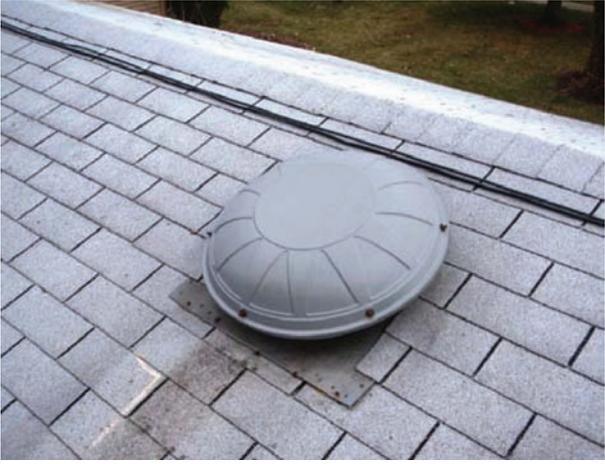
Description	Photograph
Power vent with plastic cover

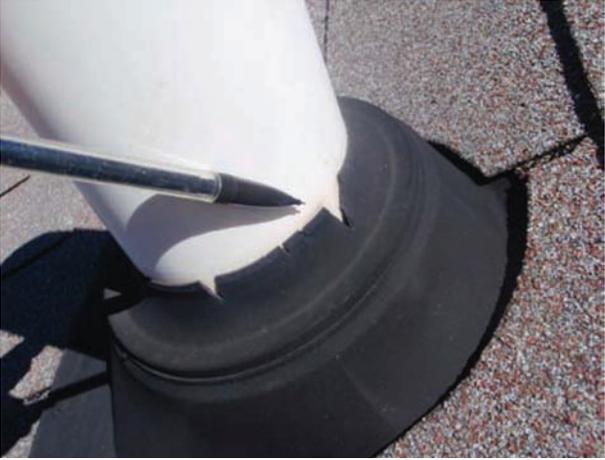
Description	Photograph
Cracked and degraded rubber gasket around boot flange leading to potential water intrusion

In the construction of newer buildings, vent stacks utilize an elastomeric, or rubber-based, gasket or boot flange at the base of the penetration or pipe stack. Unfortunately, these materials can undergo degradation caused from environmental factors such as heat and ultraviolet radiation. From experience, the first signs of cracking and splitting appear around the 8- to 12-year range. This aging and deterioration of the boot has the potential to allow water intrusion along this interface. Also, furnace and plumbing vents on older homes oftentimes only contain a metal boot flange or collar near the base of the stack near the interface of the roof. During construction, these intersections or joints on the stacks can be either soldered or welded together or sealed with caulking or sealant. As with most items exposed to the elements, the materials along these intersections can weather, age, and weaken over time, allowing for possible gaps at these interfaces. Table 8.9 illustrates examples of deteriorated sealing materials around plumbing and furnace stacks.

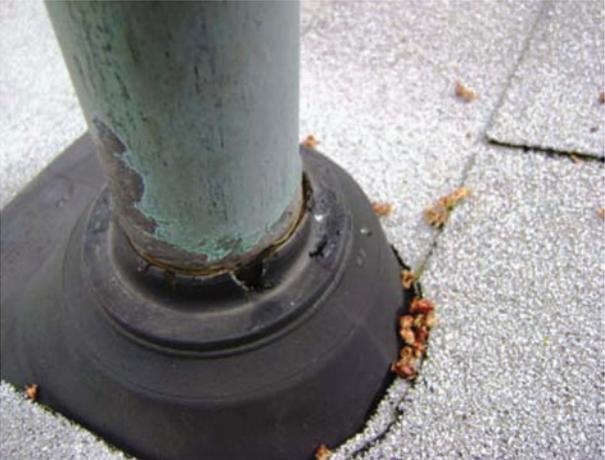
Cracks and deterioration to rubber gasket around older soil stack vent

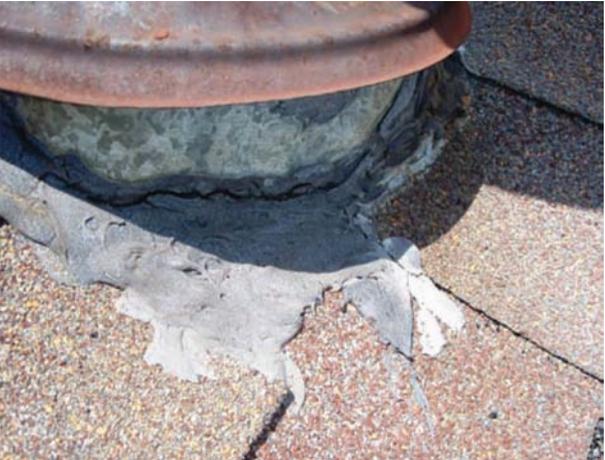
Large visible crack in roofing cement along intersection of furnace vent stack and roof surface

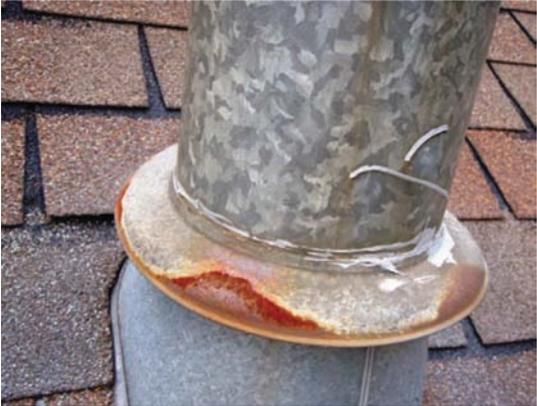
Description	Photograph
Degraded caulking around intersection of rain collar of furnace vent stack

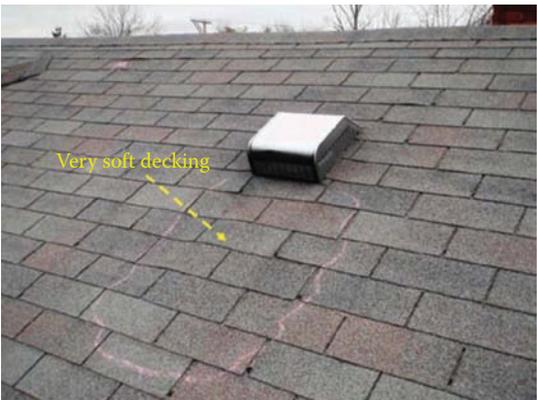
Description	Photograph
Overview of improperly installed box vent; notice area of soft decking likely due to water intrusion. Bottom flange tucked underneath the shingles on down slope side of the vent directs water beneath shingles.

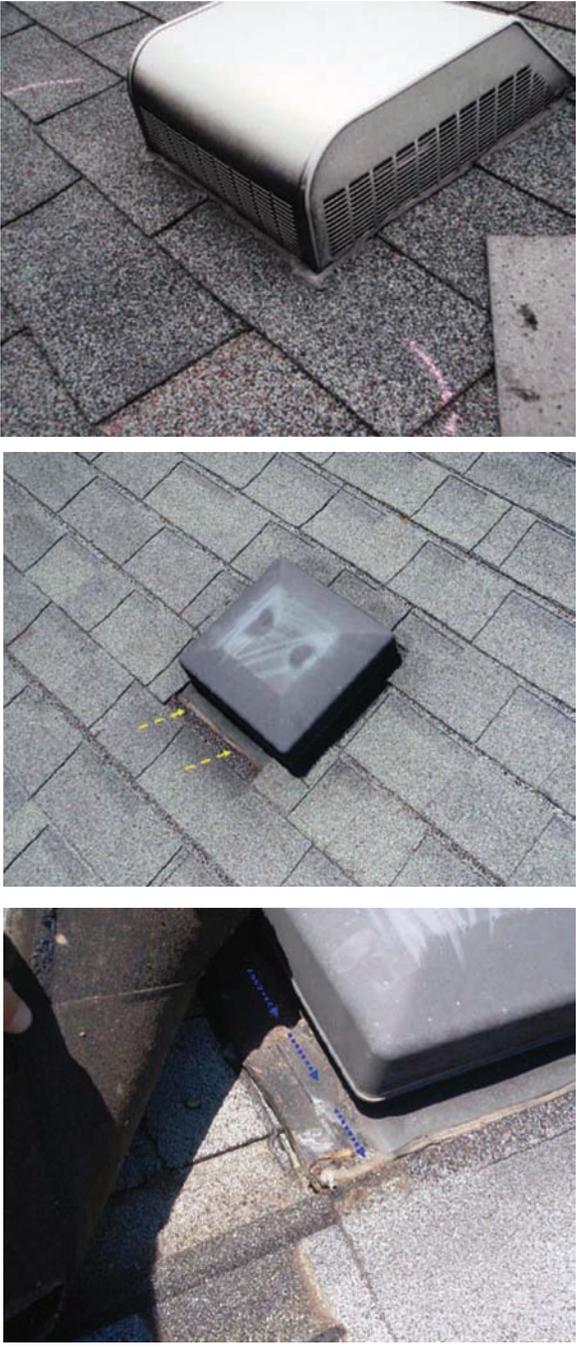
Description	Photograph
<p>Plastic square box, or static, vent with bottom plastic flange sealed beneath bottom shingles. However, water run-off traveling down can penetrate degraded sealant and enter the building.</p>

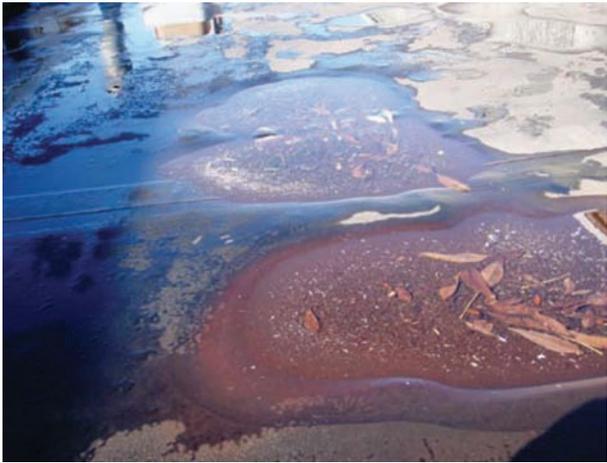
Description	Photograph
Standing water with heavy sediments and tree debris.

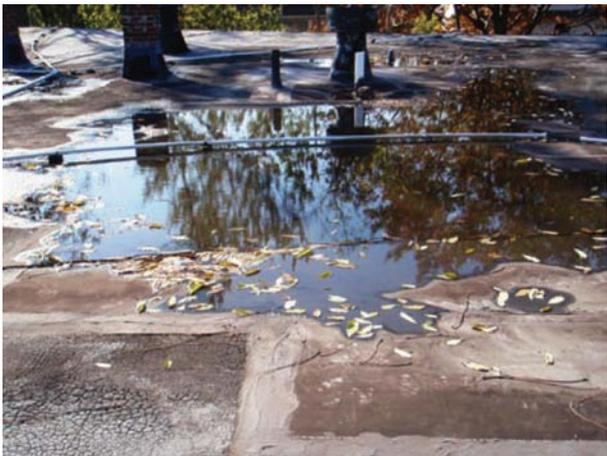
Large, widespread ponding water throughout roof surface.

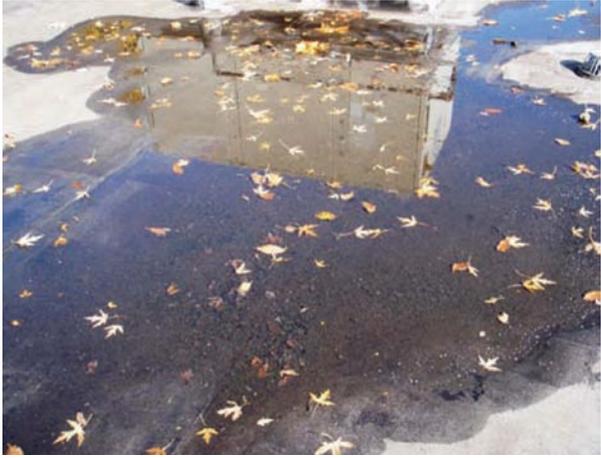
Description	Photograph
Ponding water with heavy sediment suggesting negative drainage.

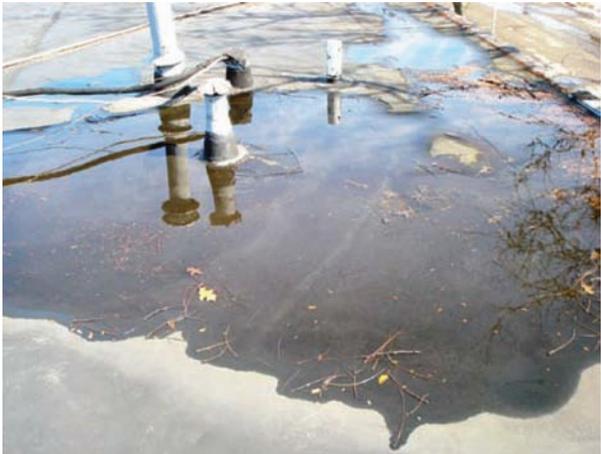
Ponding water around roof penetrations.

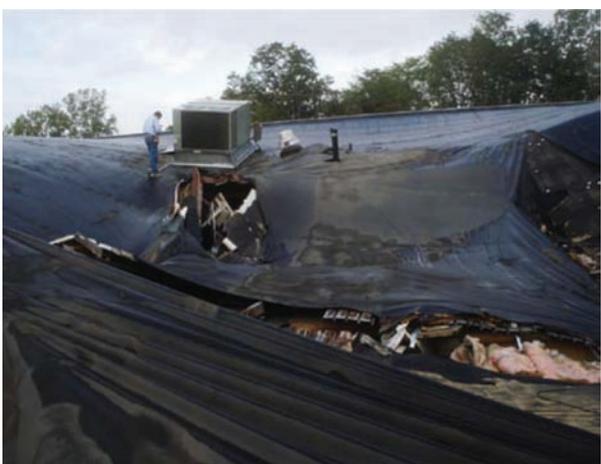
A roof collapse due to excessive ponding water. The ponding water was the result of clogged primary roof drains and absent emergency (or secondary) drains

- Periodically, structural roof collapses are caused by ponded water following heavy rains. This is typically the result of the progressive increase of ponding water exceeding the structural capacity of the roof deck due to increased deflection spans.
- Ponding water has the ability to infiltrate through the membrane by any imperfections from natural aging and weathering such as cracks and splits to unsealed lap seams. These sources of water entry can be a result of typical weathering defects or poor workmanship issues. In areas of colder temperatures, these issues become more of a concern because during colder months the formation of ice can cause

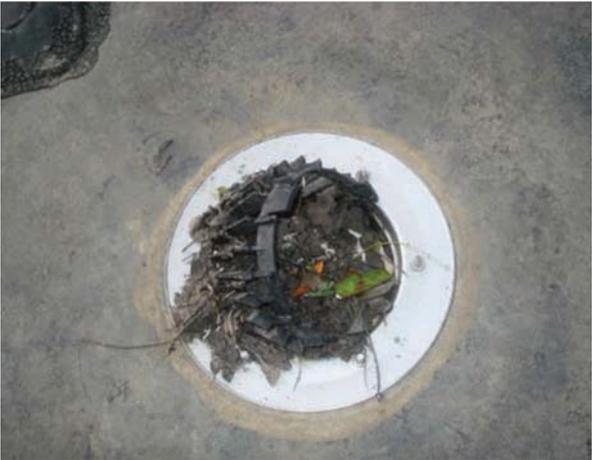
Description	Photograph
No strainer on roof drain. Debris build-up rendering the drain non-effective.

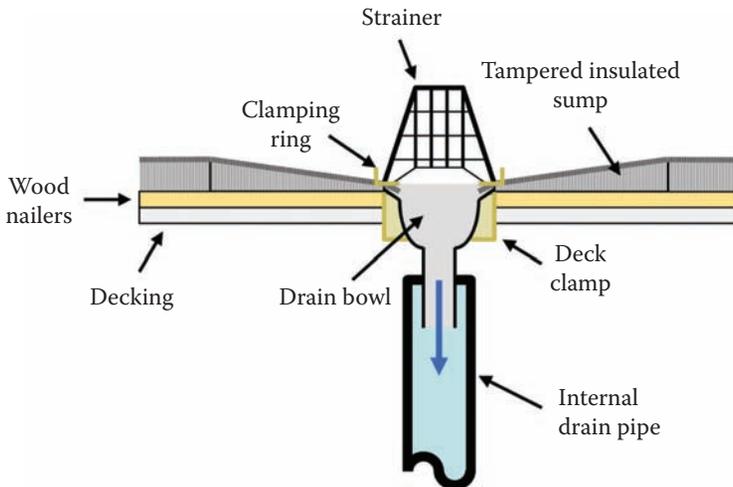
FIGURE 8.16
Side profile of an interior roof drain.

Although there are numerous installation details for each type of roof drain and roofing material, the same general principle typically applies to ensure a watertight seal. The flashing should be continuous and absent of seams through or near the mouth or opening of the drain. This is typically accomplished by installing components in a “shingled” fashion based on the direction of the water flow. The application of appropriate sealants around the interface of either the wall or roof surface and drain flange is only intended for additional protection (i.e., secondary seal). An important point often neglected is positive drainage at the intersection of the scupper and membrane. The thickness of seams in conjunction with flashing components can create a small lip or hump, which can prevent positive drainage at the lower end of the scupper opening. The use of tapered insulation or roof saddles in these areas should be considered to provide additional slope at these locations. Figure 8.16 provides a cross-section of a typical interior roof drain.

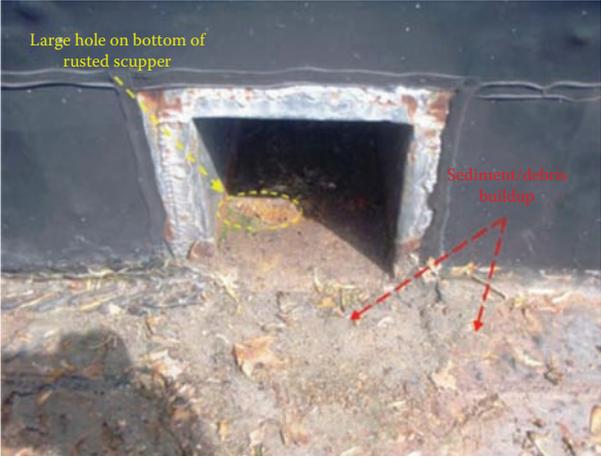
Description	Photograph
Through-wall scupper with heavy rusting conditions and a large rust hole in the bottom of the unit. Evidence of sediment and debris around the mouth of the opening coupled with rusting conditions suggests the presence of long-term ponding water.

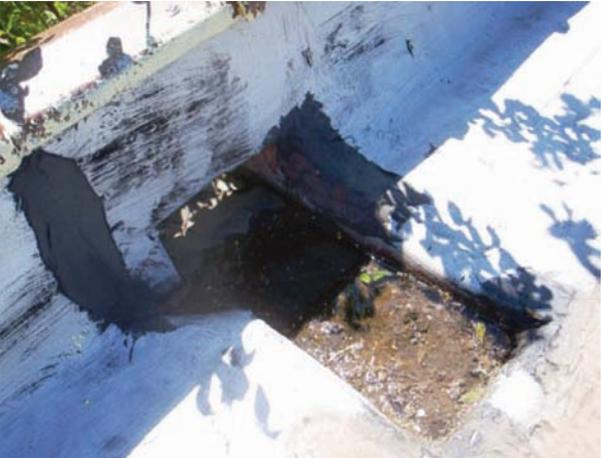
A close-up photograph of a through-wall scupper. The metal is heavily rusted and discolored. A large hole is visible at the bottom of the scupper. The area around the opening is filled with sediment and debris. Yellow dashed lines point to a hole in the bottom of the scupper, and red dashed lines point to a sediment/debris buildup.
Heavy build-up of debris and ponding water inside cavity of through-wall scupper suggesting inadequate slope and positive drainage around unit.

A photograph showing a through-wall scupper on a roof. The scupper is surrounded by a large amount of debris and ponding water, indicating inadequate slope and positive drainage around the unit.

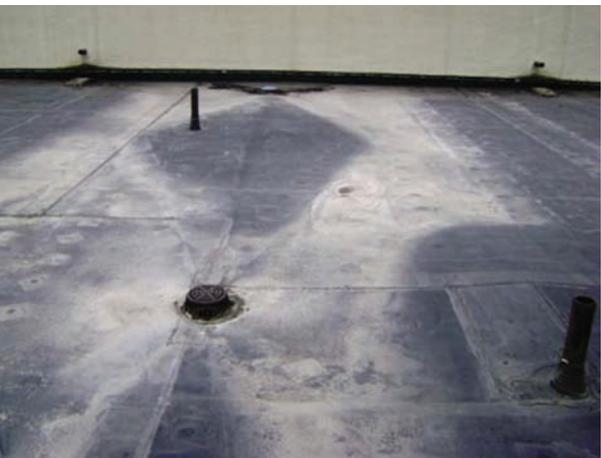
Ponding water sediment and dirt outlining elevated roof cricket that appears to provide positive drainage toward interior roof drains.

A photograph of a roof cricket. The roof surface is covered with ponding water, sediment, and dirt, which outlines the elevated roof cricket. The cricket appears to provide positive drainage toward interior roof drains.
