FORENSIC ENGINEERING

**Damage Assessments for
Residential and Commercial
Structures**

**Edited by
Stephen E. Petty**

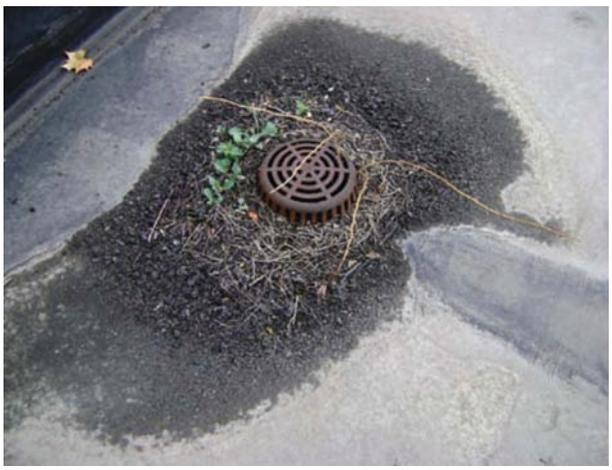
Description	Photograph
Roof drain partially clogged and blocked due to accumulation of vegetation, sediment, and debris. This buildup can restrict the flow and drainage of the roof surface creating potential water entry issues.

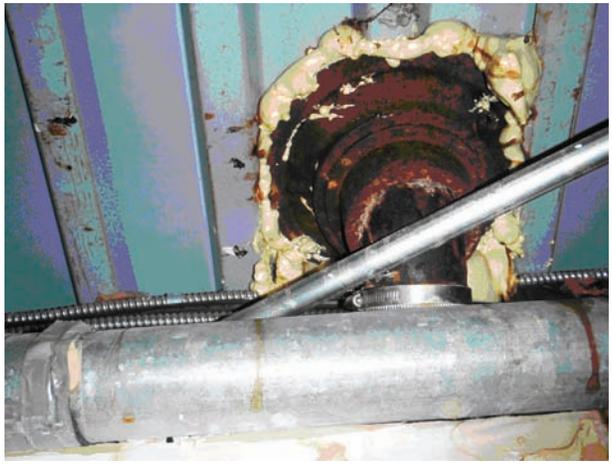
A close-up photograph of a roof drain. The drain is a circular metal grate set into a concrete surface. It is almost completely covered by a thick layer of dark, granular sediment and a mass of dry twigs and debris. A few small green plants are growing through the debris in the center of the drain.
Heavy rusting and repairs to interior surface of roof drain along with drip stains on horizontal drainage pipe, suggesting long-term water entry issues.

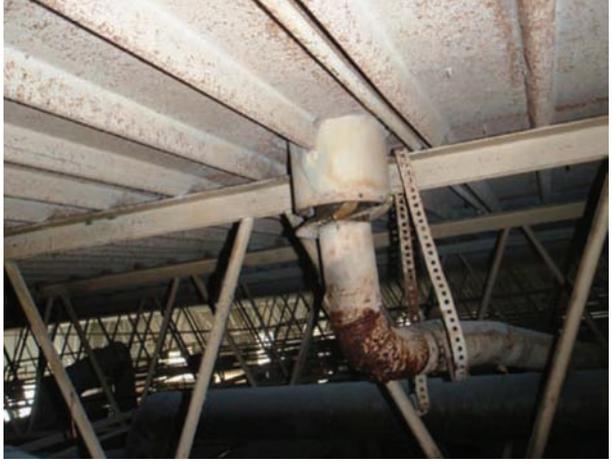
Rusting conditions to elbow of vertical conductor and horizontal pipe of interior drainage system.

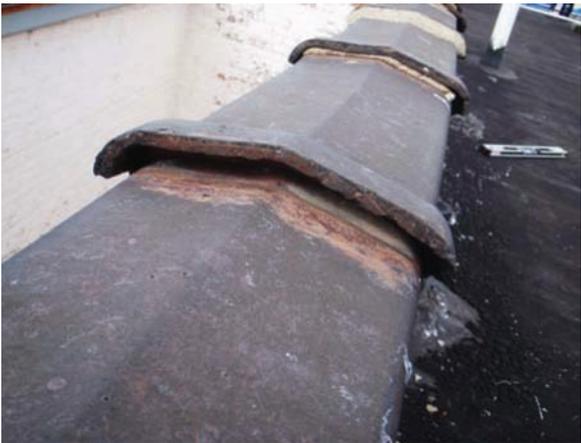
Description	Photograph
Large gaps between joint of clay tile coping allowing for potential water entry.

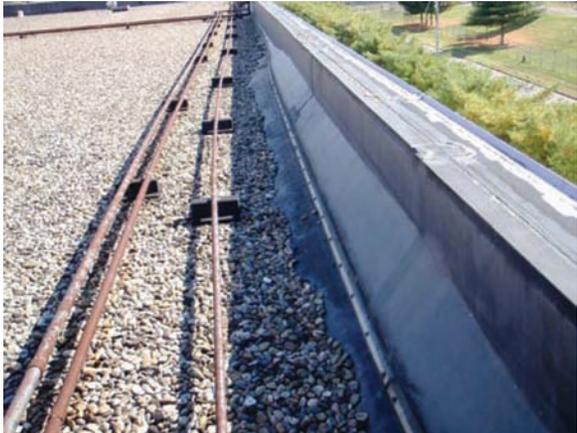
Heavy tenting or pull-out of base flashing along parapet wall. Termination bar was not fully anchored to wall.

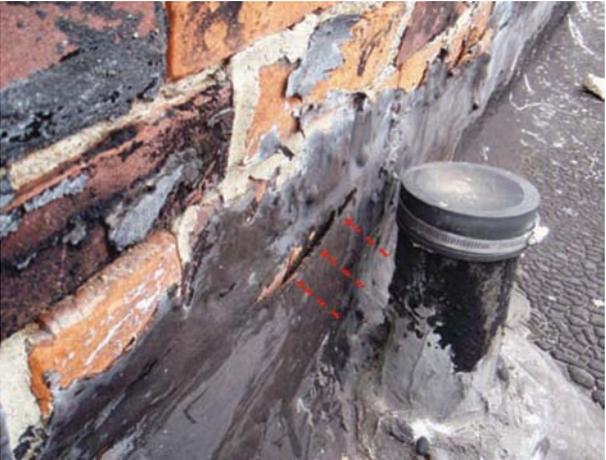
Description	Photograph
Large gaps along base flashing lapped up masonry wall absent of either a termination bar or counter-flashing.

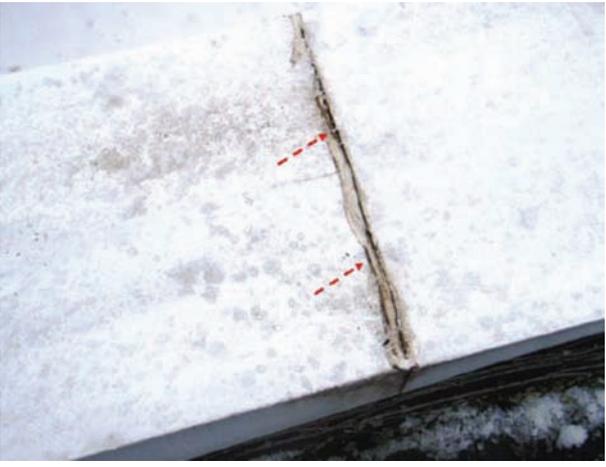
Heavy degraded caulking or sealant along joint of metal coping. No means of mechanical attachment.

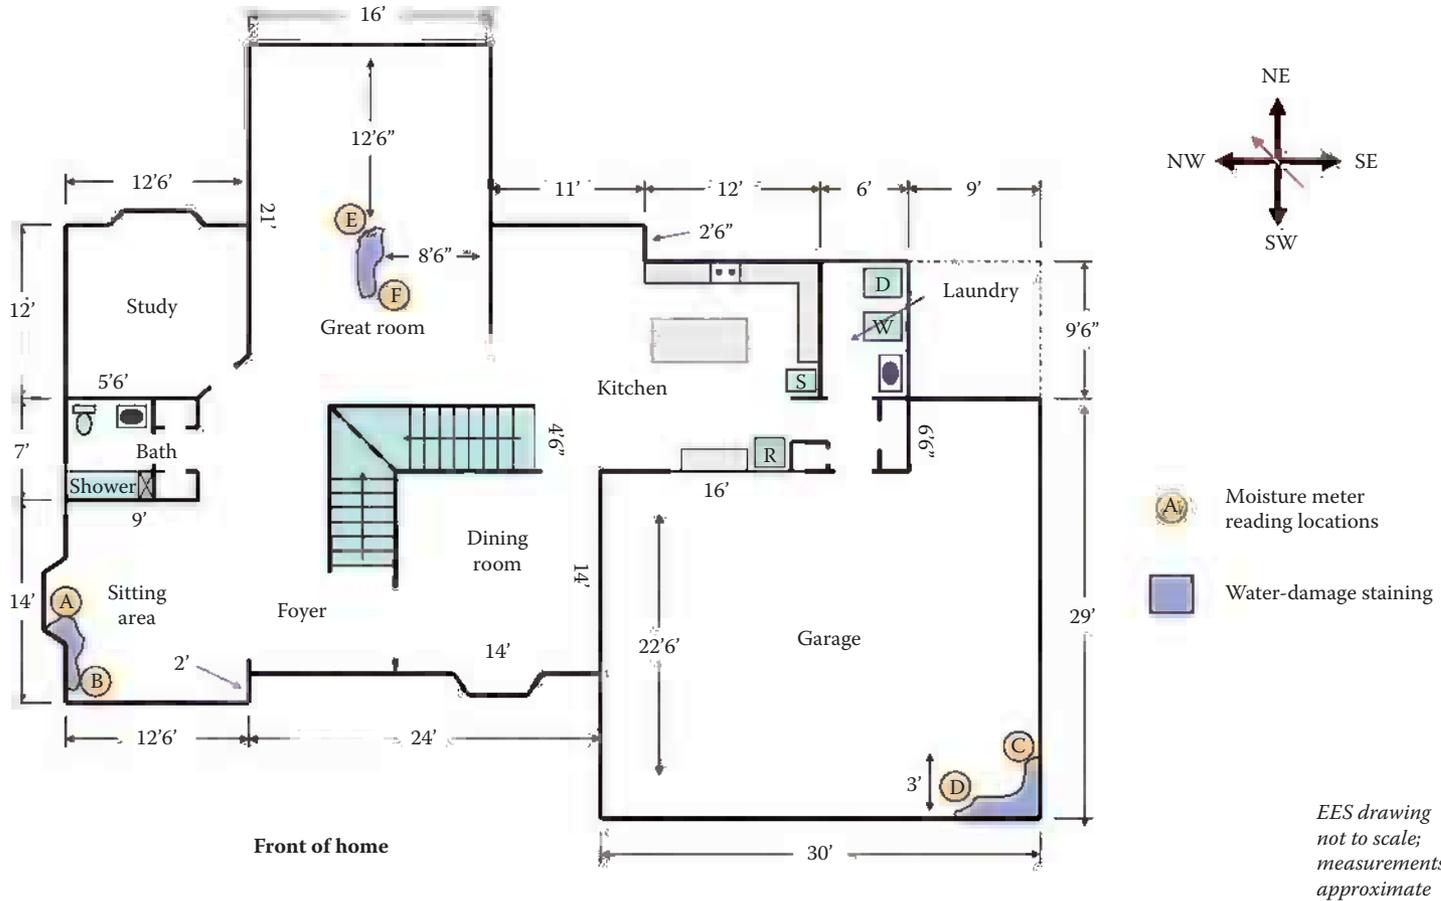
FIGURE 8.18
Computer-aided plan view of interior floor with key observations.

For each elevation inspected, a floor plan is sketched to scale as closely as possible and then measurements are made of each space on the elevation to be inspected. Throughout the inspection, specific areas of damage and other important observations should be identified within the sketch. An example of an interior floor plan sketch for a residential home, coupled with areas of observed water-damage staining and the location of diagnostic tools used (i.e., moisture meter), is shown in Figure 8.18.

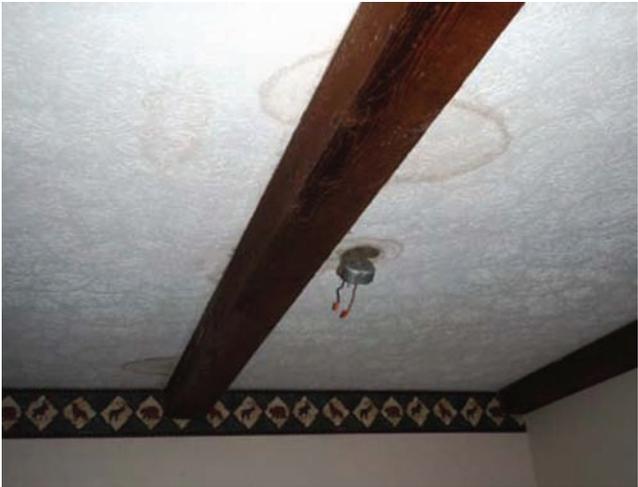
Description	Photograph
Several circular water-damage stains on ceiling surface

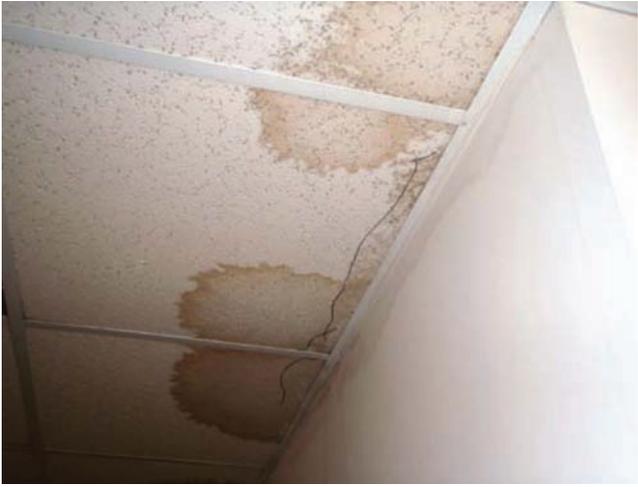
Water-damage staining to acoustic ceiling tiles

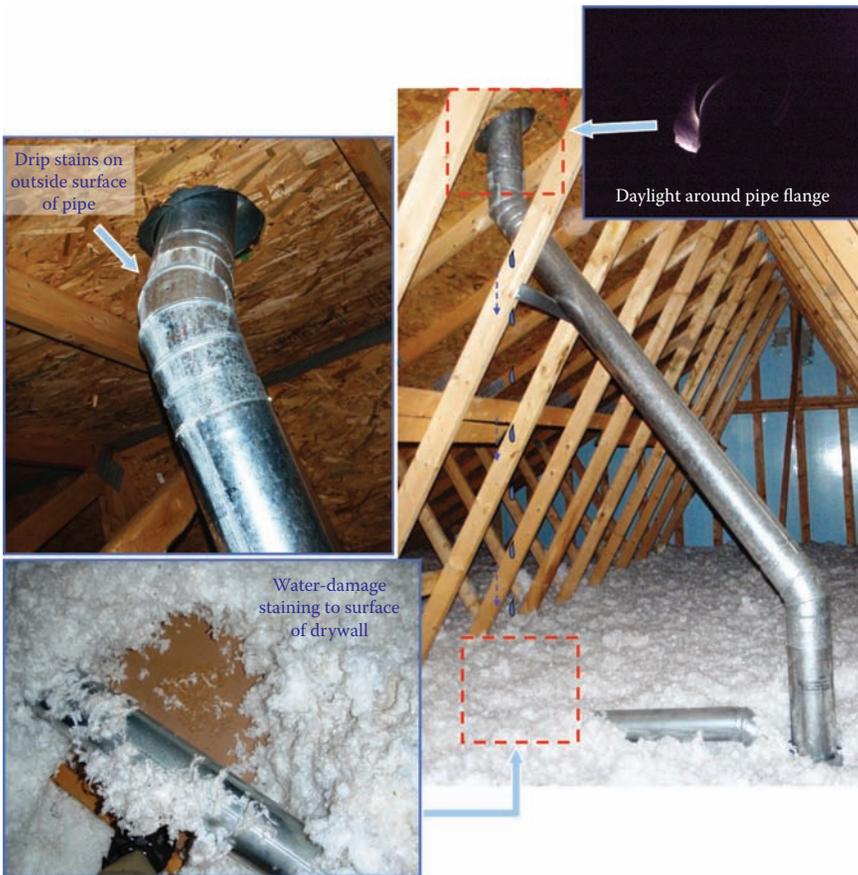
FIGURE 8.19
Evidence of water intrusion around furnace pipe.

Remember, water follows with the force of gravity and flows from higher elevations to lower elevations, so the drip and staining patterns should always be followed back to their source(s). A sketch of the attic should be drawn to illustrate key dimensions and findings. For example, Figure 8.19 illustrates a situation where water intrusion was observed around a furnace vent pipe.

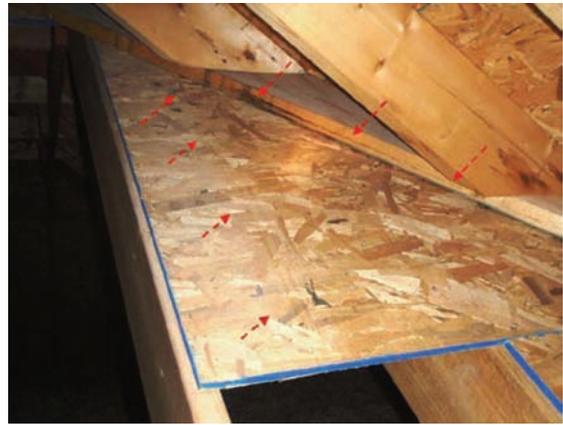
Description	Photograph
Drip patterned staining originating from a valley

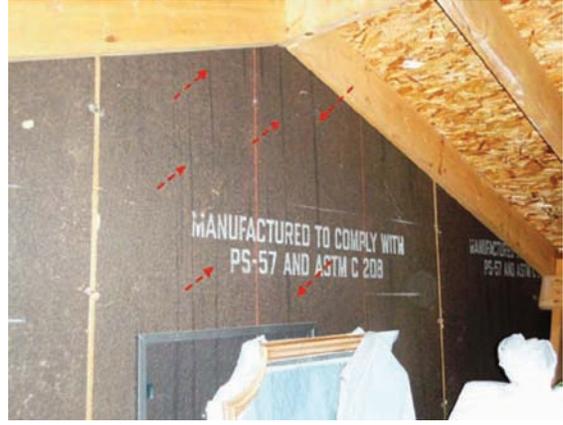
Drip patterned staining on face of side wall originating from roof or wall intersection

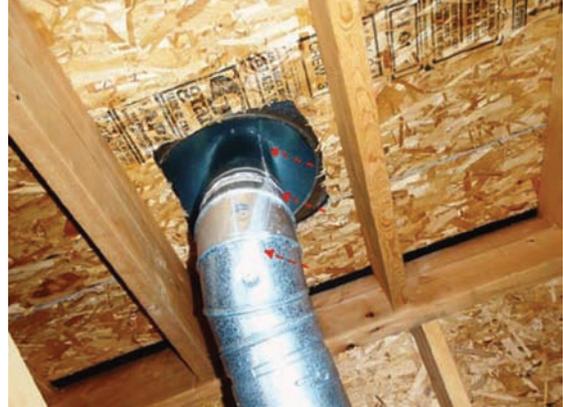
Drip stains down furnace vent pipe originating from metal collar on roof surface

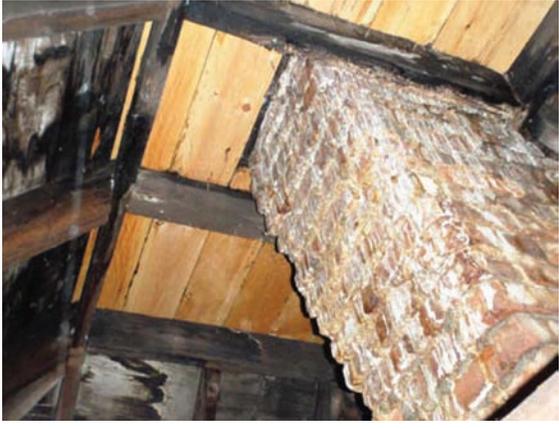
Description	Photograph
Heavy historic and active staining patterns along face of brick chimney

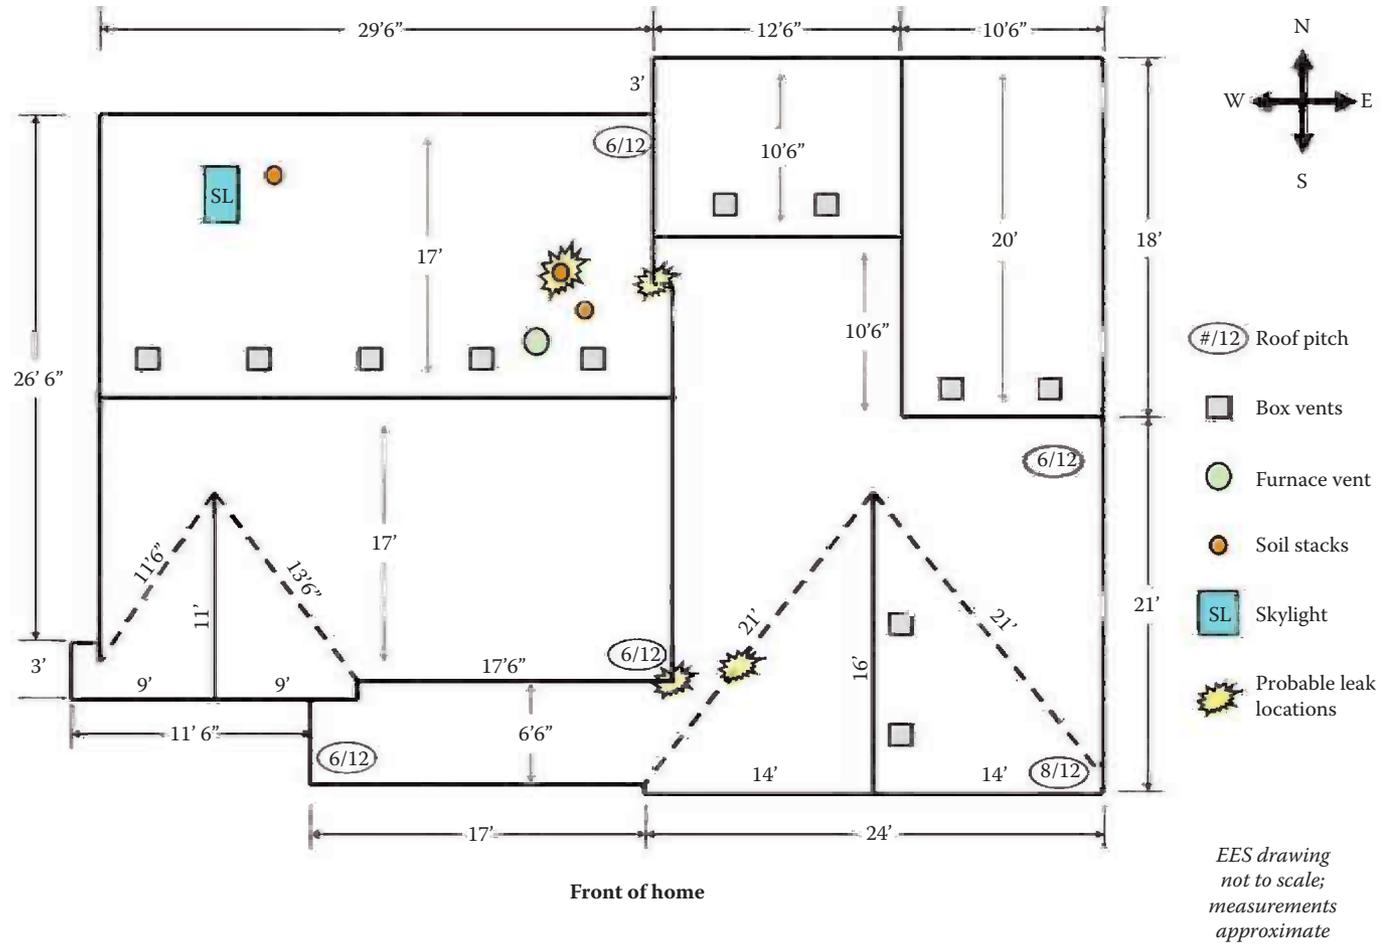
FIGURE 8.20
Roof schematic drawing.

Next, the roof system is inspected for evidence of areas where water infiltration may be occurring. This portion of the inspection should also be initiated by drawing a schematic of the roof with measurements and key observations. An example of a roof schematic is shown in Figure 8.20.

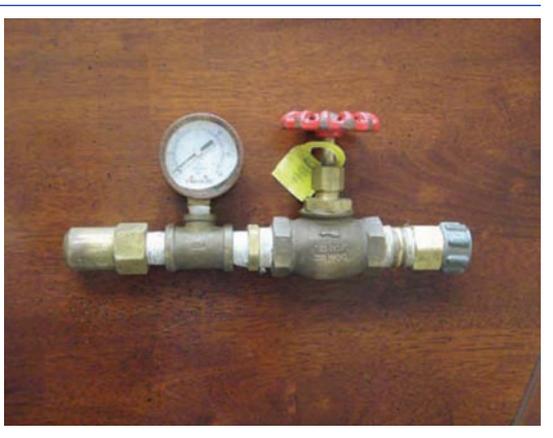
Description	Photograph
Spray nozzle with pressure gauge calibrated according to AAMA 501.2

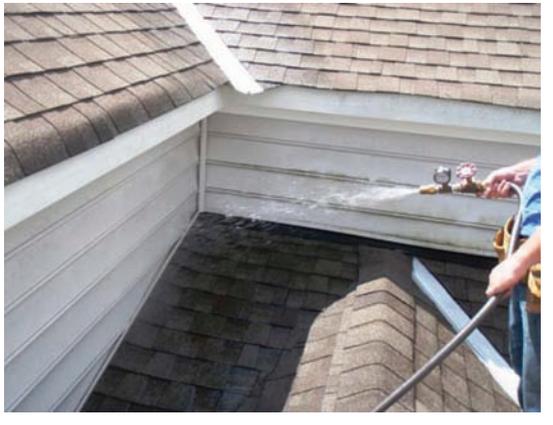
Water being sprayed at the interface of the shingled roof surface and vertical wall covered with siding

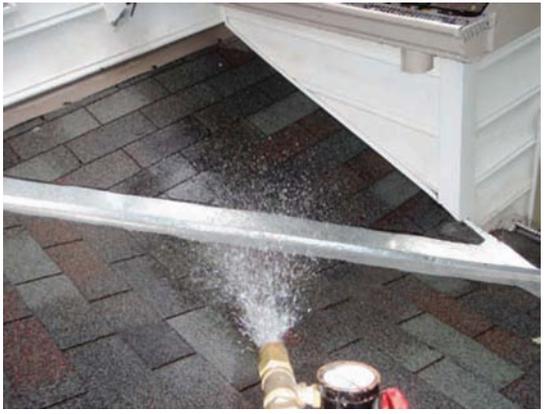
Water being sprayed along the open metal valley to determine possible entry points

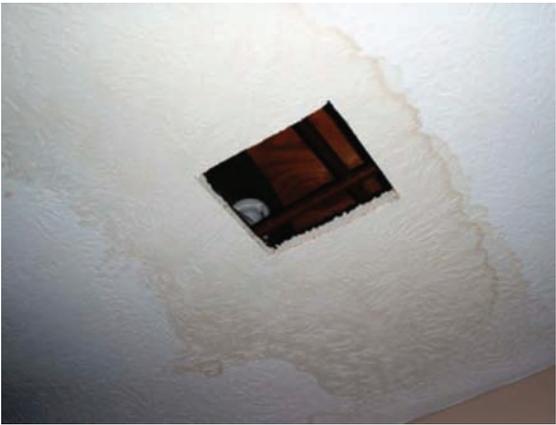
Description	Photograph
A precise test cut in the water-damaged drywall ceiling exposing leaky plumbing lines.

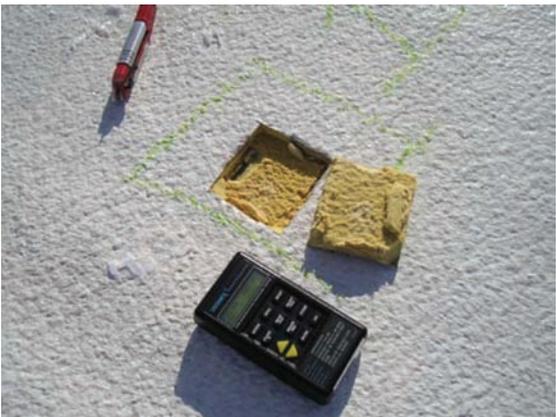
Test cut into spray polyurethane foam (SPF) material. A Tramex® survey encounter moisture meter was used to measure moisture content.

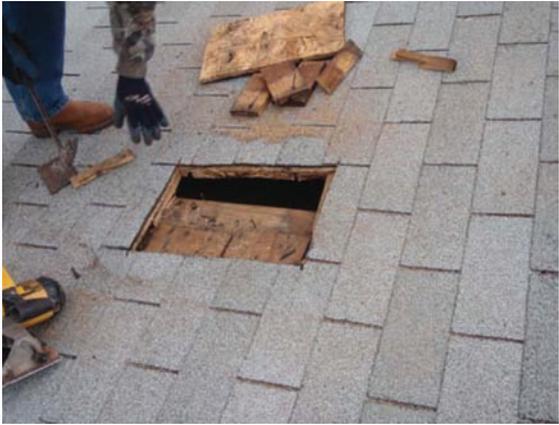
Description	Photograph
Test cut into roof surface covered with three-tab asphalt shingles.

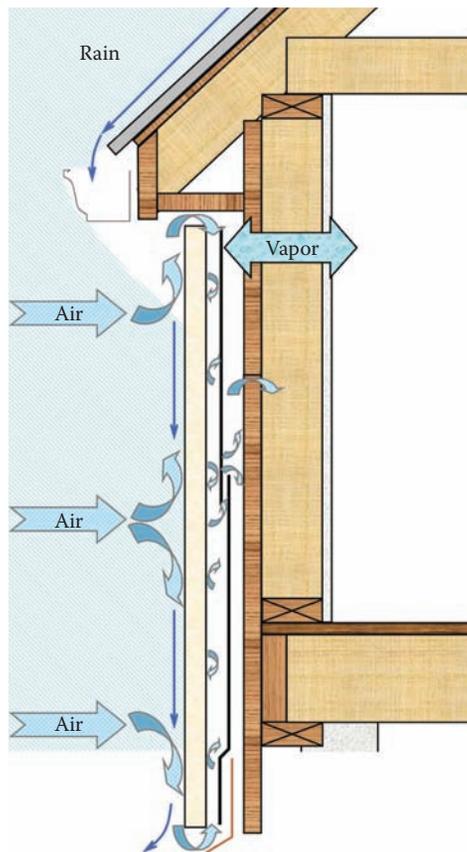
FIGURE 9.1
Sources of moisture and transport mechanisms.

Precipitation (i.e., rain and melting snow, sleet, ice, etc.) is the primary source of water or moisture that can infiltrate the exterior building envelope and has the most significant potential for water damage to construction materials associated with building envelopes. Other moisture sources that can affect the exterior walls include water vapor-laden air, either from the exterior or the interior of the building, which can condense on wall cavity surfaces under conditions where these surfaces are at or below the dew point temperature of the moist air (Figure 9.1).⁵

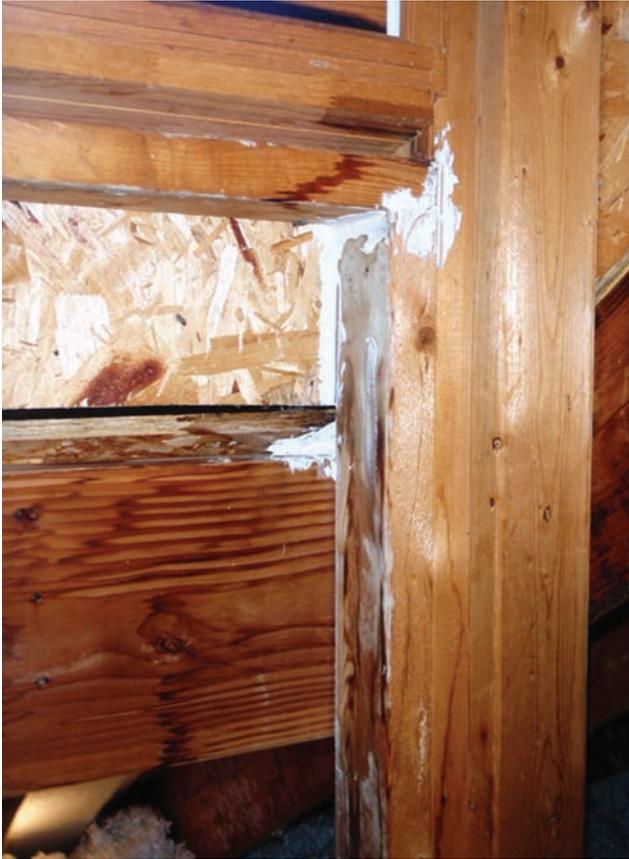
FIGURE 9.2
Intermittent light water staining to framing below window leak.

Conventional wood-frame construction can typically allow for a small amount of intermittent water infiltration for the life of the structure. Intruding water or moisture can be absorbed, distributed, and dissipated throughout a wooden structure without causing any structural deficiencies (Figure 9.2). Where water-damage problems tend to occur is when design, construction, or maintenance issues allow water or moisture to enter the wall cavity at a rate that exceeds the capacity of the wood to dissipate or eliminate the water.^{5,9} When wood is subjected to prolonged periods of continual wetting that raises the moisture content levels of the wooden members at or above the decay threshold, damage ensues (Figure 9.3).

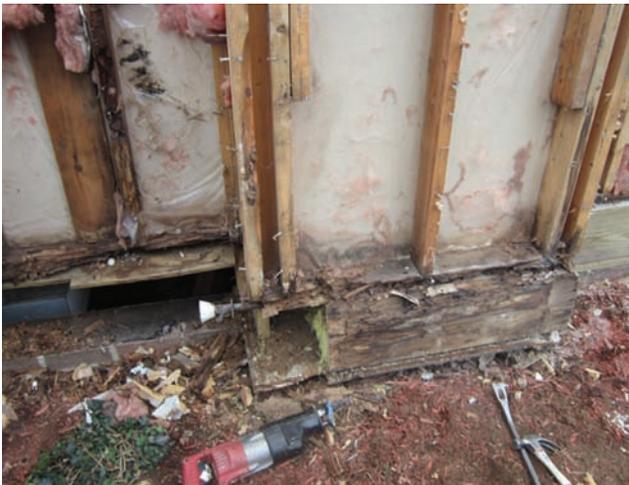
FIGURE 9.3
Prolonged wetting or rotting to lower framing of Tudor-style home.

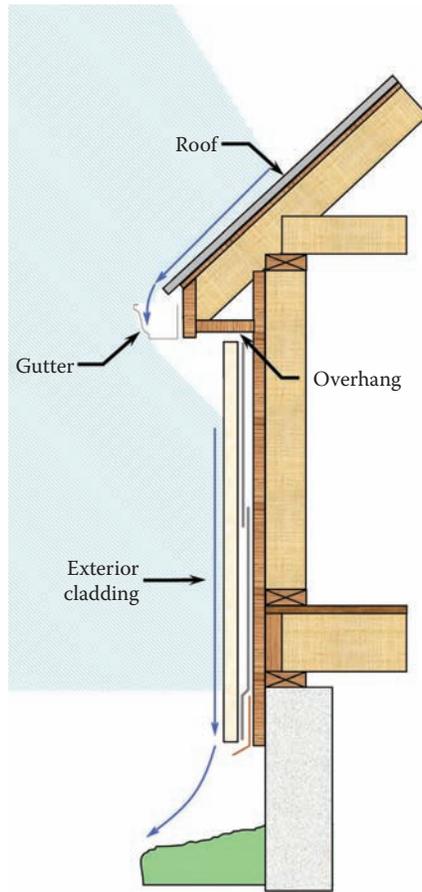
FIGURE 9.4
Water management principle—deflection.

The first and foremost principle of water management involves the deflection of potential water or moisture from contacting or penetrating through the exterior wall envelope. Studies^{10,11} (Straube¹² provides a simplified summary) and experience have shown that designing and constructing building features and details that limit the exposure of exterior walls to moisture sources can significantly aid in accomplishing the other principles, particularly drainage and drying, as they deal with water that has incidentally infiltrated the wall envelope.^{3,9} Common architectural and building design features that provide deflection include (also refer to Figure 9.4)^{3,9}:

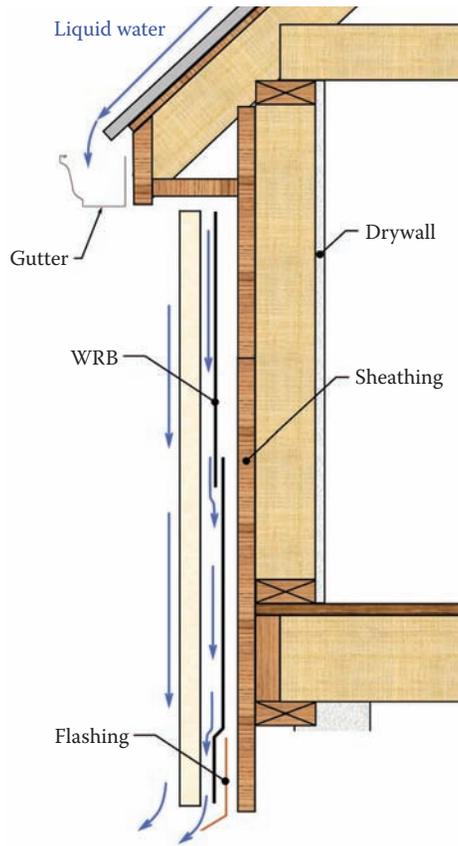
FIGURE 9.5
Water management principle—drainage.

Incidental moisture that is getting beyond the deflection components and infiltrating the exterior wall assembly (for drainage plane or cavity walls) must be adequately managed so as not to create a problem to the interior or structural components of the wall. Second only to the principle of deflection, drainage ensures that the bulk incidental moisture is collected and then properly returned to the exterior side of the wall, via gravity, where it can then be carried away from the building by site drainage. In conventional wood-frame construction, drainage of the exterior wall envelope is generally accomplished through the use of a drainage plane or an air cavity within the wall assembly (Figure 9.5).

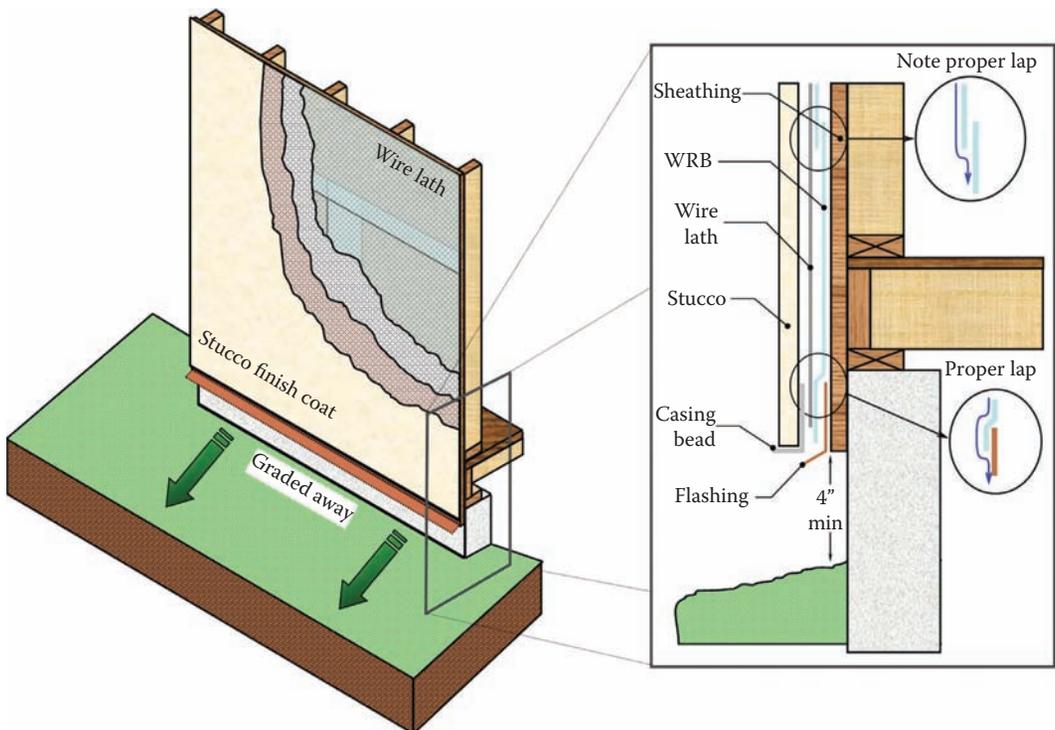
FIGURE 9.6

General construction and water management details—typical stucco-clad wall.

There are two methods that can typically be used to apply stucco to an exterior wall. The first method, known as traditional or “three-coat” stucco, involves the application of three separate layers of stucco: a scratch layer, a brown layer, and a finish, or “color,” coat. The other method is known as “two-coat” (sometimes referred to as “one-coat”) stucco. It involves the application of a base coat and then the addition of a finish coat, which can utilize conventional cement color finish or synthetic acrylic color finish. Modern-day construction of a stucco-clad wall is illustrated in Figure 9.6.

- A WRB is fastened to the exterior wall sheathing. Current IRC requires that the WRB for “exterior plaster” (i.e., stucco) over wood-based sheathing and in compliance with ASTM C926 and ASTM C1063 be water resistant and vapor permeable with “a performance at least equivalent to two layers of Grade D paper.” The WRB is allowed to be a single layer when its water resistance is “equal to or greater than that of 60-minute Grade D paper and is separated from the stucco by an intervening, substantially nonwater-absorbing layer of designed drainage space.”²
- A metal or wire lath (which may or may not contain a water-resistant paper backing) is secured to the sheathing directly over the WRB and holds the stucco coats in place on the wall.

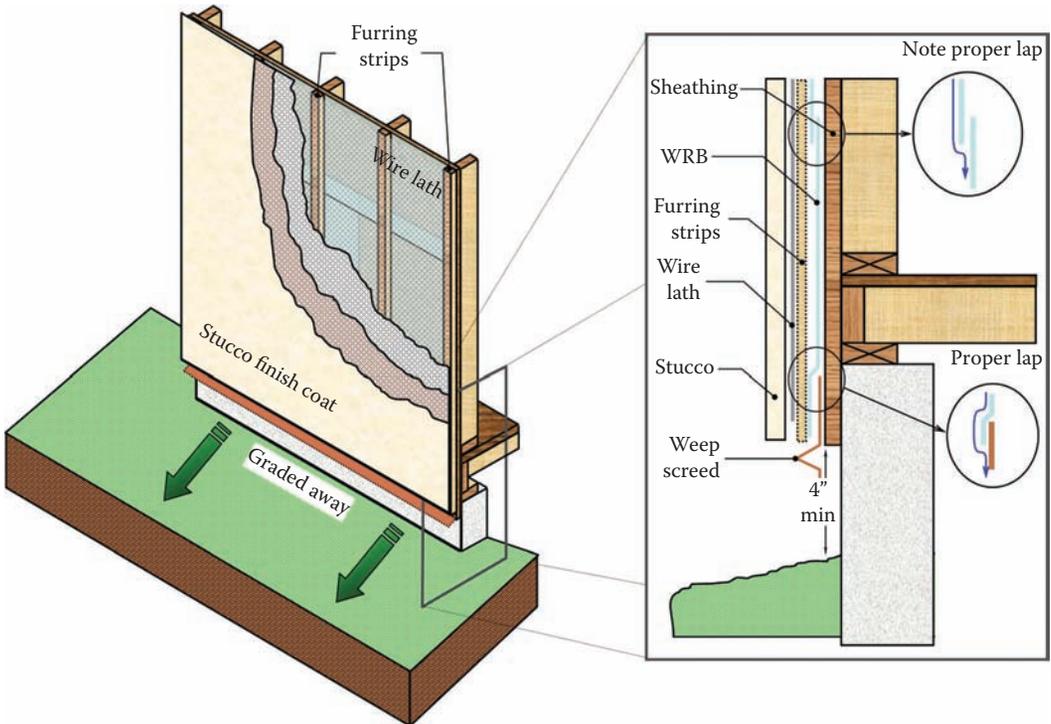
FIGURE 9.8

General construction and water management details—stucco-clad wall (rain screen construction detail).

The final construction method is the utilization of a rain screen wall (Figure 9.8). Essentially, this type of construction introduces a well-defined cavity between the back side of the stucco and the drainage plane (WRB) by installing preservative-treated wood furring strips vertically (coinciding with the studs) between the wire lath (typically paper-backed) and the WRB. This allows for more complete gravity-induced drainage of any incidental water that may infiltrate the stucco-clad finish.

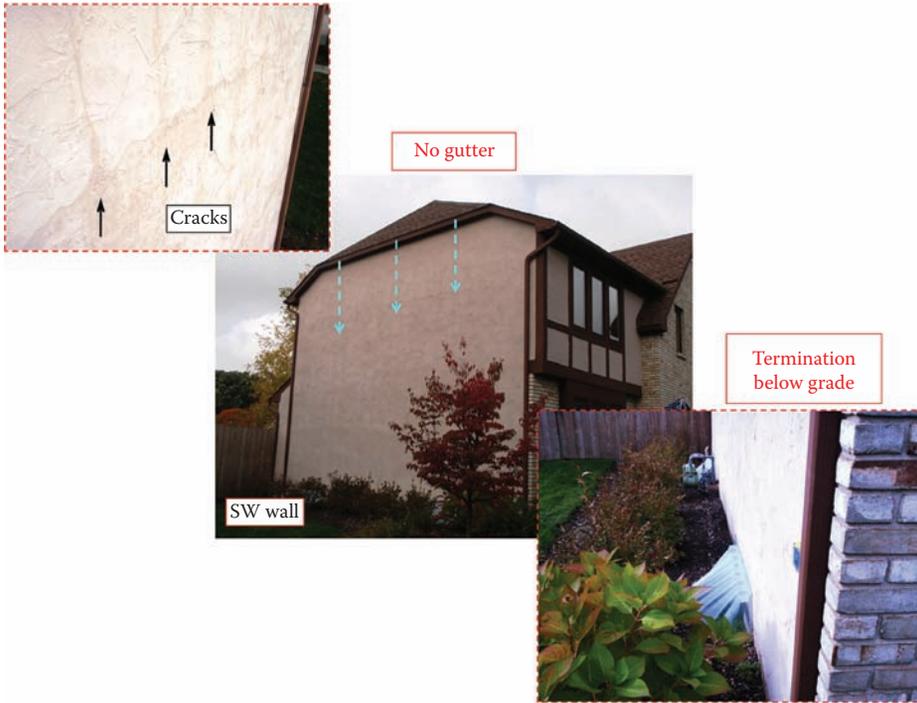
FIGURE 9.9 Stucco wall (SW elevation)—no gutter along roof eave, stucco termination below grade, and crack patterning to stucco finish coat.

In the case study shown in Figure 9.9, the owners of the home had noticed a small amount of what appeared to be mold on the lower baseboard of their family room wall after moving a bookshelf. Subsequent remediation activities involved removing the interior drywall, which then led to the discovery of widespread water-damage staining, mold, and deterioration of the framing members. A site investigation was completed in order to find the source of the water or mold.

Following the initial interior inspection of each floor, it was evident that the condition noticed on the first floor was widespread and present throughout the entire southwest exterior wall. An exterior inspection revealed the following:

- The affected wall faced southwest (i.e., direction of predominant wind and weather patterns).
- No gutter was attached to the roof eave and drip lines were visible in the local landscaping along the foundation.
- The lower edge of the stucco was terminated below the local landscaping.
- Distinct and discernable cracks were present in the finish coat. The patterning of the cracks corresponded with the sill plate and wall studs of the wood-frame construction. Evidence of moisture staining was present along the cracks.
- The lower portion of the wall, finished just above grade, appeared to bulge outward.

In the case of this home, the lack of adequate deflection mechanisms (i.e., wall's exposure to prevailing wind and weather patterns and lack of gutter) likely exacerbated exterior water to infiltrate the stucco finish where it was obstructed from draining back to the exterior due to the termination of the stucco below finished grade. This led to a lack of a properly functioning drainage mechanism, which allowed for the accumulations of water within the wall assembly, leading to cracks in the stucco and widespread water staining, mold, and deterioration to the wooden wall framing of the home. A complete lack of a WRB between the sheathing and stucco also contributed significantly to the conditions. The entire situation caused major headaches and worries for the homeowners who were distraught at the time of inspection and had to pay for the repairs since the damage was associated with poor workmanship by the builder. The solution was to remove the existing stucco system, including damaged wall members, and then replace wall members, add a gutter and downspout system, and properly reinstall the stucco cladding.

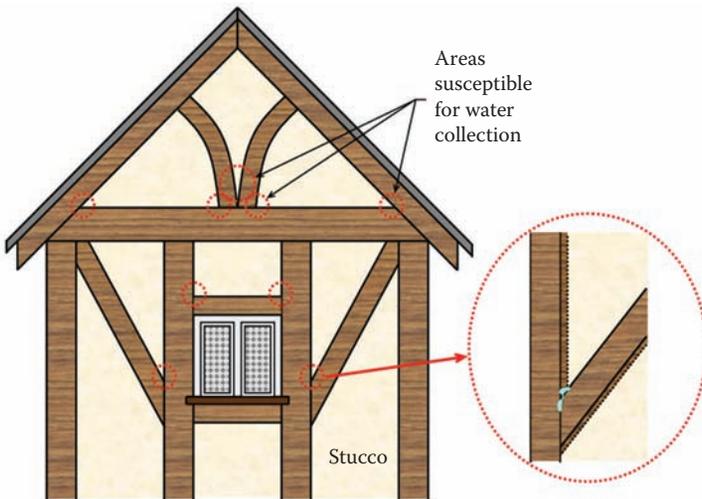
FIGURE 9.10 General construction and water management details—points of water collection on Tudor-style stucco.

components can create areas that are susceptible to water collection and potential intrusion behind the stucco (Figure 9.10). For this reason, the intersections between the stucco and the wooden boards (of which there are many) must be properly sealed and continually maintained to help deflect water from entering behind the stucco.

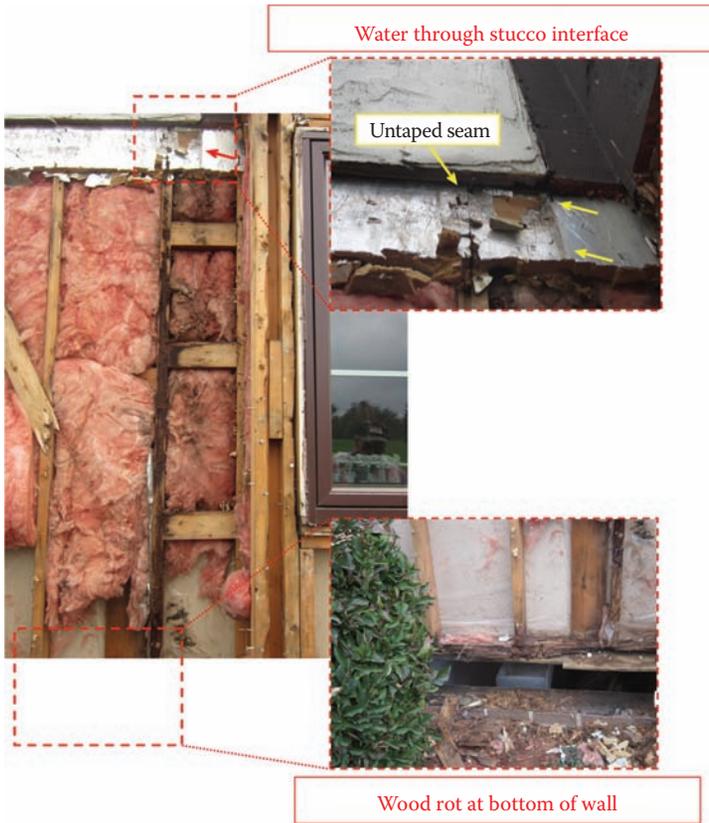
FIGURE 9.11

Tudor-style home—water damage and rot to wall framing below stucco–wood intersection and untaped foam sheathing seam.

In the case study illustrated in Figure 9.11, the owner of the home was in the process of replacing the wooden trim boards on the front of his Tudor-style home when he discovered heavy water damage and rot to the lower portions of the exterior wall framing. However, no evidence of water damage had been noticed on interior portions of the home.

A site investigation was completed to determine the cause of the damage. At the time of the site inspection, the exterior wall on the front of the home (west elevation) was in the process of being replaced with new framing, stucco, wood trim, and the appropriate WRB and flashings, so it was not possible to determine the original conditions for that wall at that time. However, inspecting other elevations around the home revealed that the sealant along the intersections between the stucco and the wooden trim boards was heavily weathered, degraded, and cracked, which provided potential pathways for water to infiltrate behind the stucco.

- Double-sided, foil-faced foam sheathing was used as the water-resistive barrier behind the stucco and wooden boards. However, the foam sheathing panels were butted up against one another and the resulting seams were not taped or covered in any way.
- Evidence of water staining was present on the foil-faced surfaces of the foam sheathing at the vertical seams between the stucco and wooden trim boards.
- The wall stud directly below the vertical, untaped seam in the foam sheathing contained heavy water-damage staining and light rotting conditions.
- The water damage to the stud continued down toward the bottom of the wall, where it was not properly flashed, causing long-term rot to the lower portions of studs, the sill plate, and even the band board.

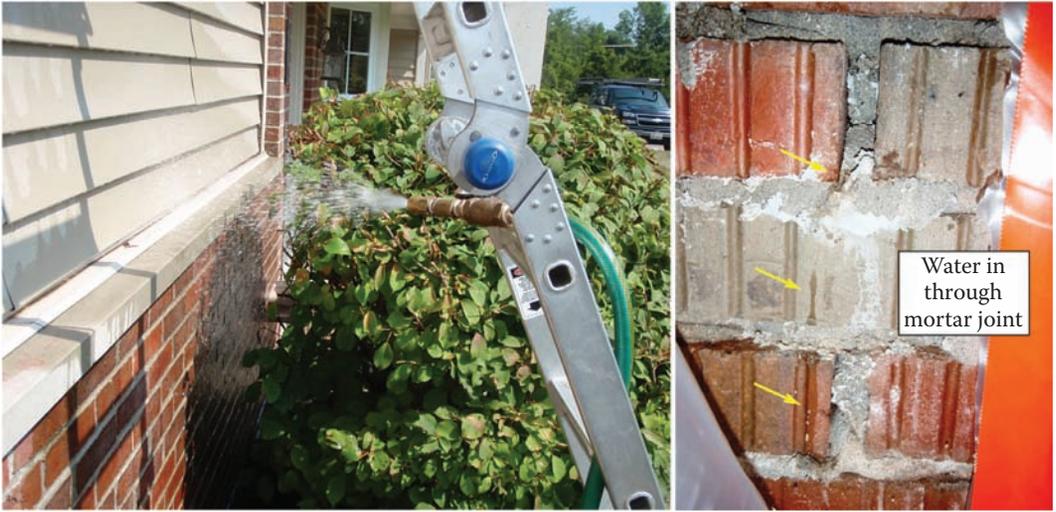
FIGURE 9.12
Water penetration through brick veneer during water test.

Modern-day masonry veneer walls are generally constructed of a single wythe of brick or stone and only provide aesthetic appeal and *some* water deflection. In fact, under normal service life conditions for many masonry veneer walls, it is nearly impossible to provide the necessary deflection components needed to keep a heavy wind-driven rain from penetrating masonry to some degree.²⁷ Figure 9.12 shows water penetration through a brick veneer wall (at a mortar joint) during a water test. Water was visible on the interior side of the wall after just a few minutes of spraying.

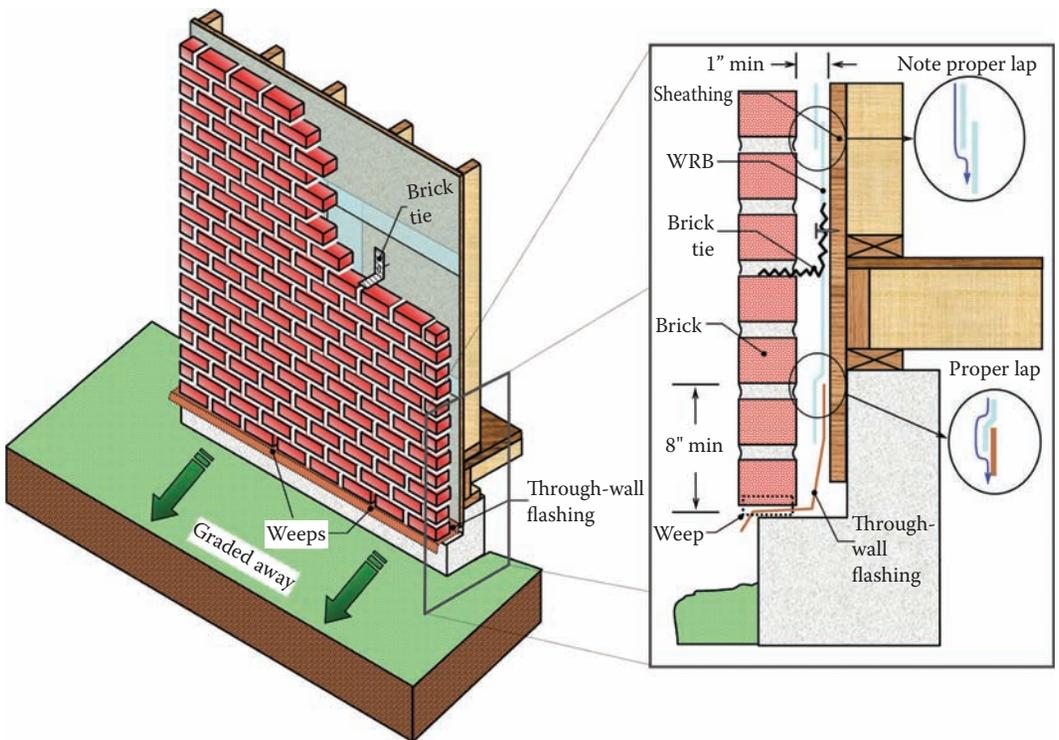
FIGURE 9.13
General construction and water management details—typical brick masonry veneer wall.

Effective water management for anchored brick veneer walls is typically obtained by using the rain screen method, thereby utilizing a drainage plane and an air space between the brick and the wooden wall sheathing (Figure 9.13).

Water that penetrates through the single wythe of brick reaches the drainage cavity (i.e., air space) where it then flows down the back face of the brick toward the bottom of the wall until it encounters the through-wall flashing, which then redirects it back to the exterior through the weeps.

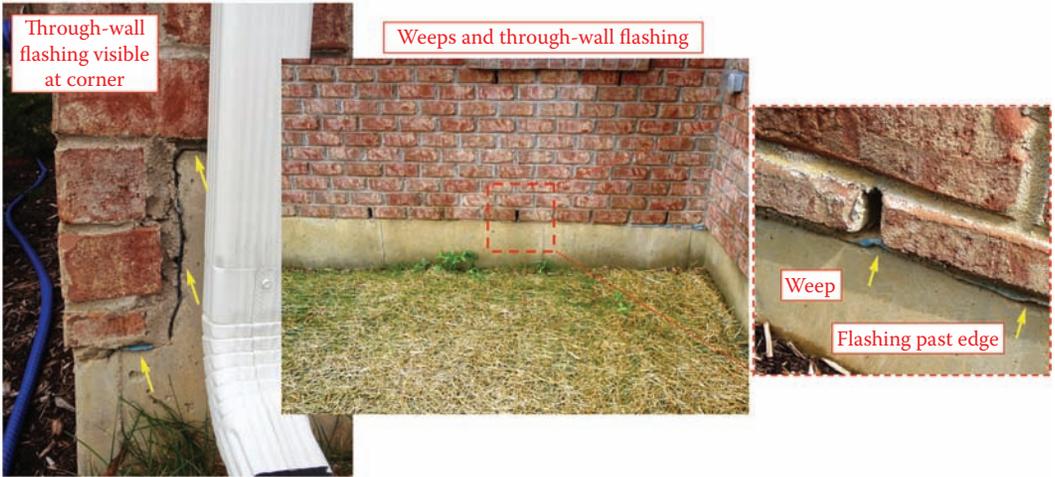
FIGURE 9.14

Example of proper installation and incorporation of through-wall flashing and weeps in a brick veneer wall.

Figure 9.14 illustrates an example of proper installation and incorporation of through-wall flashing and weeps at the lower termination of brick veneer above finished grade. As noted earlier, however, the construction details shown in Figure 9.14 are rarely encountered when problems with water infiltration are discovered with brick veneer.

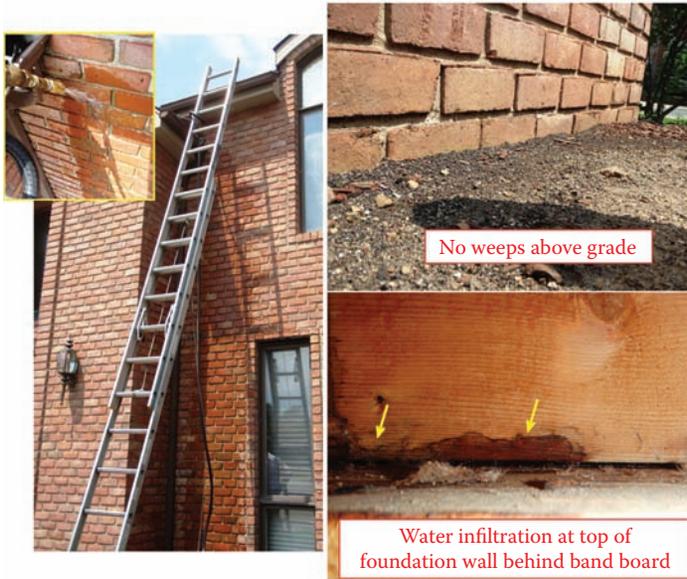
FIGURE 9.15

Water test of brick veneer: clogged gutter, no weeps, water infiltration.

In the case study shown in Figure 9.15, the owners of this brick home had discovered that water was present within the wall cavity of the first floor dining room and in the basement area below the dining room. Further, it was determined through a comprehensive interview that the brick veneer adjacent to and below a gutter opposite the affected interior areas was wet or saturated with water after rain events.

- The gutter along the brick wall was clogged with debris, particularly around the inlet for the downspout.
- Evidence of soil washout was present in the ground surface directly below the gutter, suggesting past overflows of water.
- No weeps were observed along the lower courses of brick above the local finished grade surfaces. It was probable that through-wall flashing was not present, however, destructive testing of the wall would be needed in order to verify if that was the case.

As depicted in Figure 9.15, a water test was conducted on the exterior and set up in a fashion to re-create conditions when the gutter would overflow, spilling water onto the brick wall. It took a fair amount of time, but evidence of water infiltration was discovered in the basement at the top of the concrete masonry unit foundation wall. Water began to seep out from under the wooden band board in an area where patterns of water-staining were observed during the inspection of the basement.

From this investigation, it was readily apparent that the lack of a proper drainage system, including weeps for the brick veneer, led to the interior areas of concern. Of course, proper maintenance of the gutter (i.e., removing debris) would have lessened the severity of the issue, but an adequate drainage system for the wall would have prevented water from entering the home.

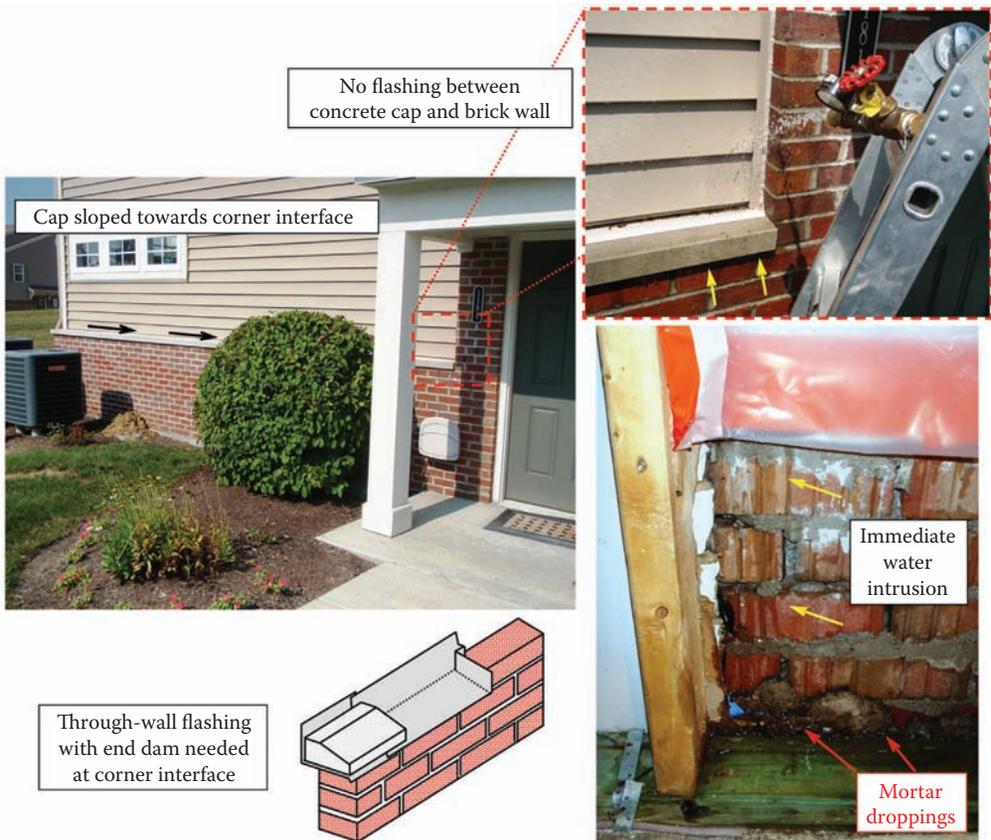
FIGURE 9.16 Water test of through-wall flashing with an end dam needed beneath concrete cap at corner interface with brick veneer and vinyl siding—lack of flashing.

In the case study shown in Figure 9.16, a site investigation was conducted to determine the cause of water infiltration and subsequent mold growth that was discovered after this homeowner noticed water on the floor of the kitchen pantry and had the interior side of the wall removed.

that appeared to likely obstruct the ability of the wall to drain incoming water sufficiently to prevent interior intrusion and damage. Given enough time and *only intermittent* water infiltration, the wall drainage may have functioned adequately, but in the case of this particular home, large amounts of water seemed to be entering due to the lack of through-wall flashing and end dam between the brick veneer and the concrete cap.

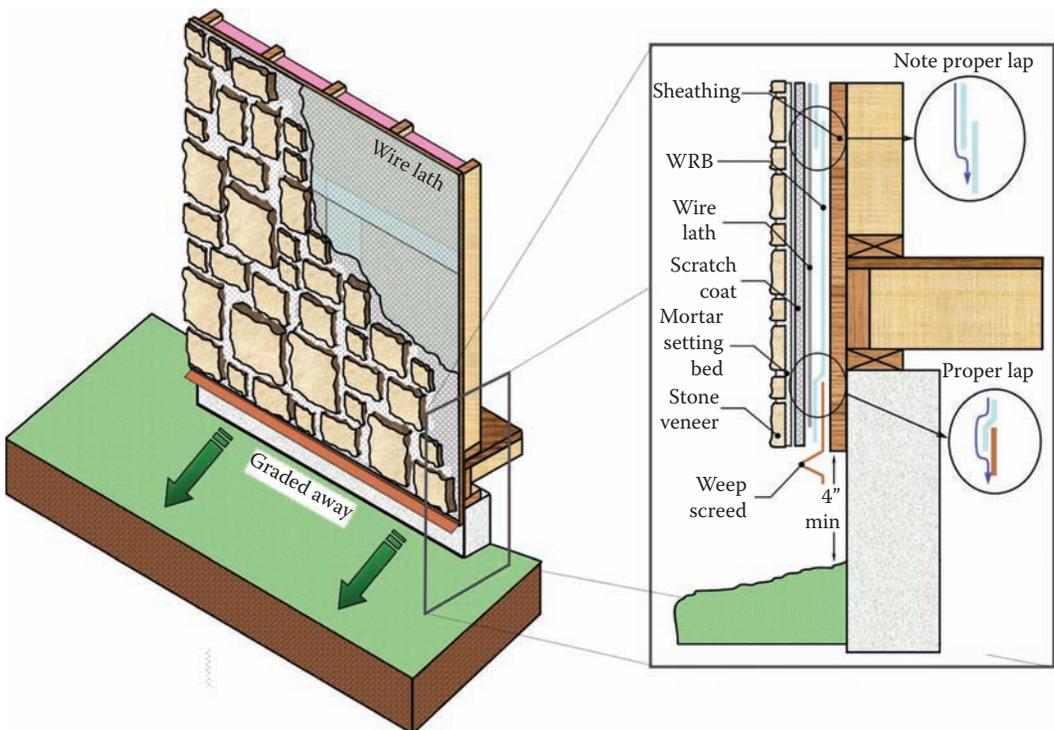
FIGURE 9.17

General construction and water management details—typical manufactured stone or adhered natural stone veneer wall.

For manufactured stone and adhered natural stone veneer over wood-frame construction (Figure 9.17), best practices recommend that the stone veneer be set into a mortar scratch coat and setting bed that has been applied to a wire lath over a suitable WRB.
