FORENSIC ENGINEERING

**Damage Assessments for
Residential and Commercial
Structures**

**Edited by
Stephen E. Petty**

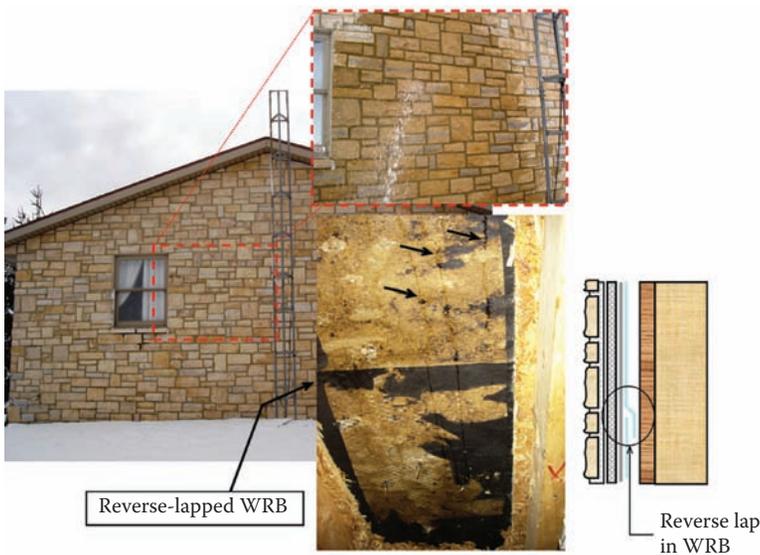
FIGURE 9.18 Improper lapping of WRB causing interior water damage through manufactured stone veneer wall.

One of the disadvantages of manufactured stone veneer is its higher absorption of water (by weight), since it is made using rather porous cement.³¹ Thus, the drainage plane behind the veneer is heavily relied on to protect the wall sheathing and interior portions of the home. In the case study shown in Figure 9.18, the owners of the home noticed dampness in the carpeting along the north wall of their master bedroom, opposite a manufactured stone veneer exterior wall. When the interior drywall was removed, wet conditions were discovered in the insulation and oriented strand board (OSB) sheathing.

During the site investigation, destructive testing was conducted from the interior side of the subject wall and included the removal of a portion of the exterior OSB sheathing, thereby exposing the WRB and the back side of the stone veneer. This revealed a critical deficiency in the installation of the WRB, where the upper course of the black felt paper was reverse lapped behind the lower course of paper, allowing for water to travel down the drainage plane until it encountered this improper lap, causing it to drain through the lapped seam and onto the OSB sheathing. Recall from earlier discussions of water-resistive barriers that they must be shingle lapped with the upper course overlapping the lower course.

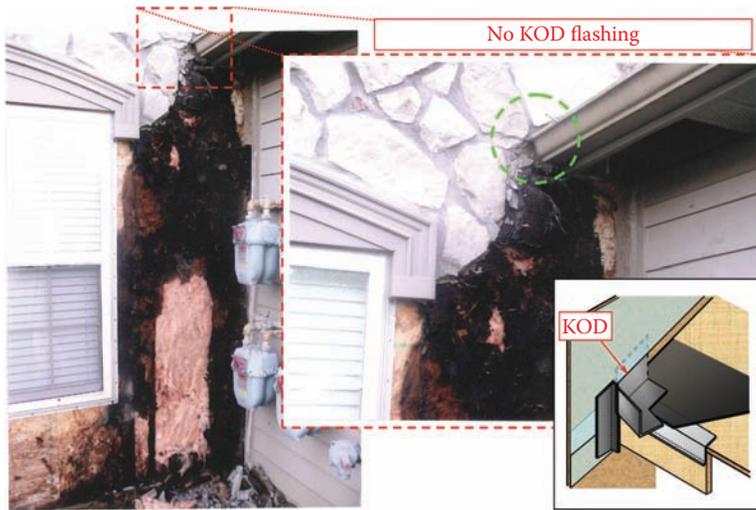
FIGURE 9.19
Heavy water damage, rot, and mold to sheathing behind manufactured stone veneer.

In the case study shown in Figure 9.19, an entire condominium complex was experiencing water infiltration problems, opposite the exterior manufactured stone veneer. A contractor for the condo association took it upon himself to remove portions of the stone veneer. When he did, he discovered heavy water damage, rot, and mold to the OSB sheathing. The patterning of the damages traced back to where the roof eaves intersected the stone veneer.

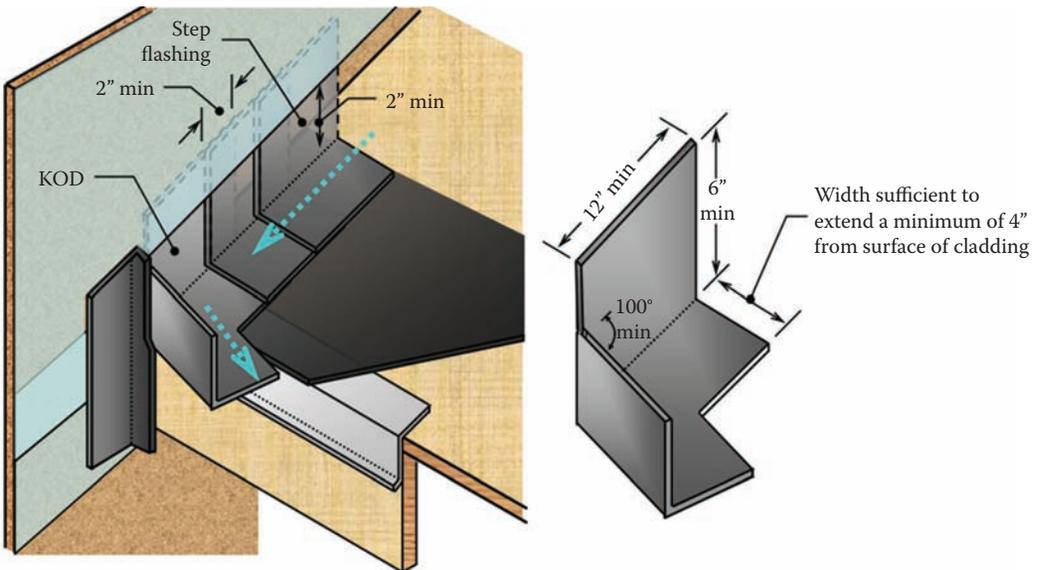
FIGURE 9.20
Kick-out flashing details.

Best practices and manufacturers of stone veneer, such as Owens Corning^{®32} and Centurion[®] Stone,³³ realize the need for KOD flashing and provide necessary requirements for its dimensions and incorporation into the water-resistive system of a building (i.e., adjacent sections of flashing and WRB). Experience gained from field assessments and these best practices³²⁻³⁴ are illustrated in Figure 9.20.

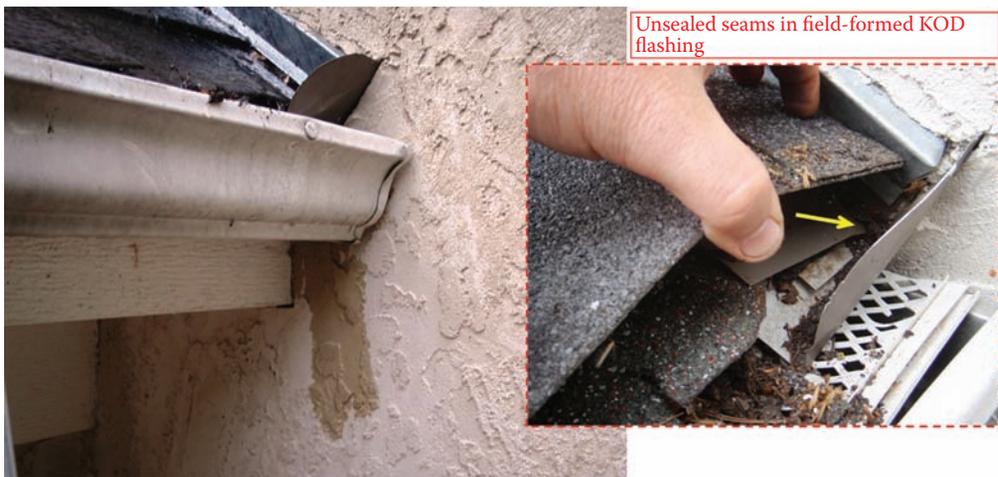
FIGURE 9.21

Improper KOD flashing causing draining water to funnel into the exterior wall assembly behind the stucco cladding.

In the case study depicted in Figure 9.21, the owners of this stucco-clad home noticed water and buckled hardwood flooring on the first floor and water in the basement below this area following heavy snow accumulation and subsequent warmer periods, causing the snow and ice to melt. During the course of the inspection, it was apparent that the source of the moisture originated near the intersection between the stucco and the roof line where KOD flashing *was* present.

In this particular scenario, the field forming of the KOD flashing created a type of funnel, channeling water behind the stucco cladding and into the exterior wall assembly. Had flashing been constructed and installed properly (i.e., proper angle, watertight seams, or a seamless flashing component, etc.), water would have been diverted into the nearby gutter and properly drained away.

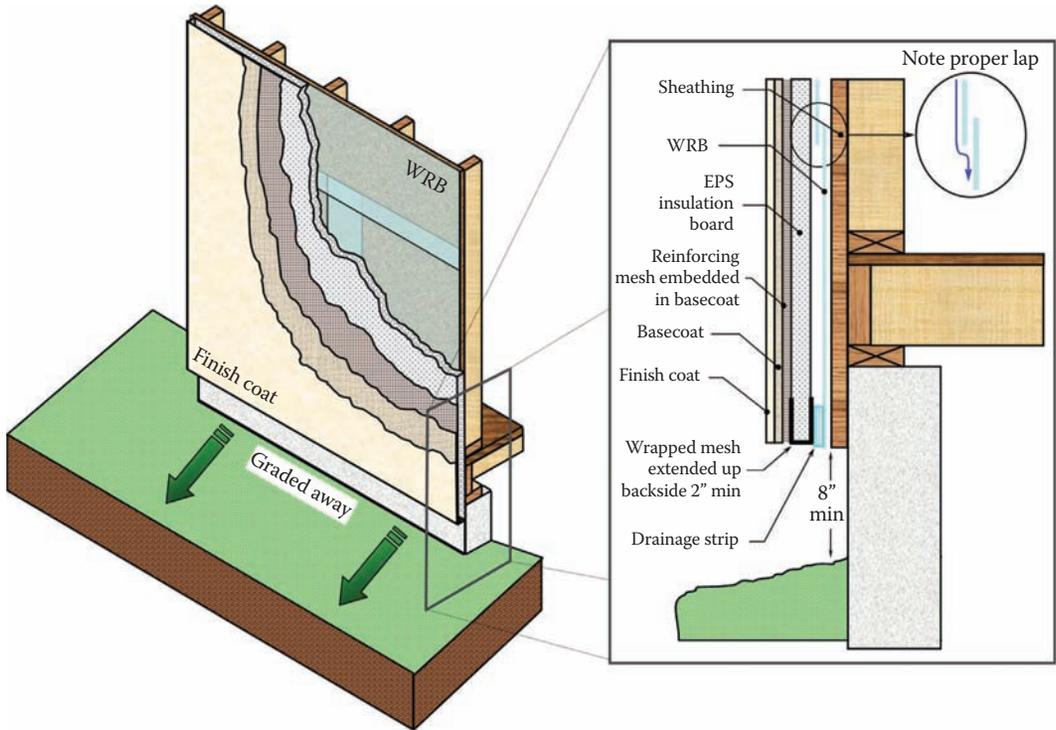
FIGURE 9.22
General construction and water management details—typical EIFS-clad wall.

Specific details regarding proper water management details for EIFS are provided by manufacturers such as Dryvit[®],³⁴ which happens to be the company that introduced EIFS in the United States in the late 1960s, and from best practices organizations such as the EIFS Industry Members Association (EIMA).³⁷ It is beyond the scope of this book to introduce and analyze the wide variety of interface and joint details that are needed for EIFS-clad buildings. Therefore, recommendations from these best practices should be consulted in order to determine proper detailing for site-specific conditions. However, some important points regarding modern EIFS water management details are illustrated in Figure 9.22. These EIFS water management details are summarized as follows:

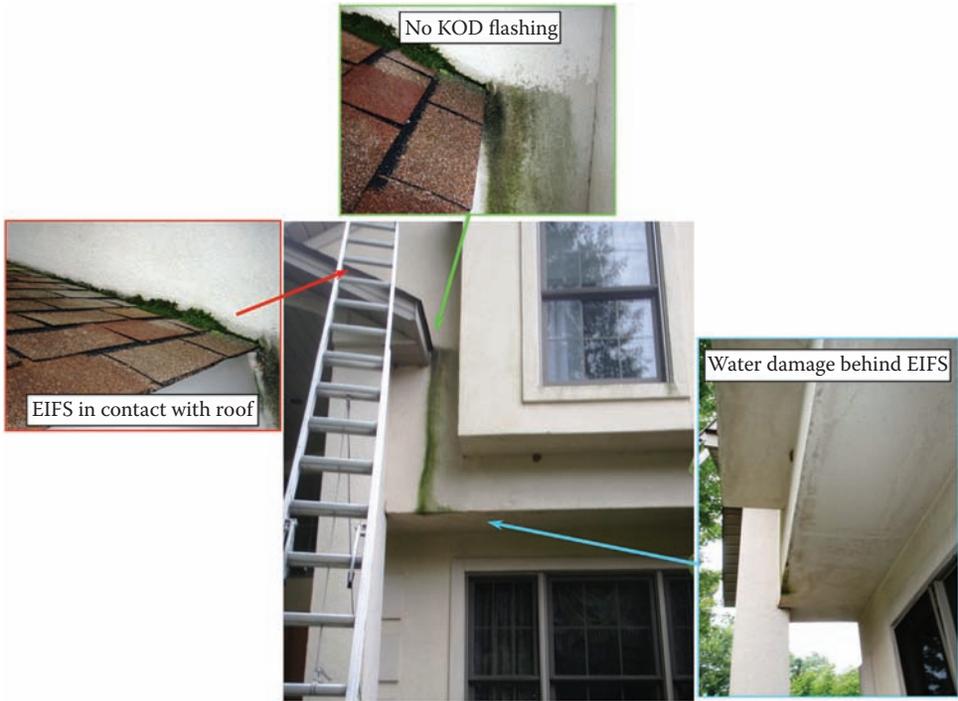
FIGURE 9.23
Lack of proper water management details leading to water damage behind EIFS cladding.

A site investigation was performed to determine the possible cause(s) for water damage and cracking to the exterior EIFS of the home. It did not take long to see that many critical details pertaining to water management were not followed during the installation of the EIFS, as shown in Figures 9.23 and 9.24:

- No KOD flashing was present where the roof eave intersected the exterior EIFS-clad walls. Consequently the EIFS at and below these locations was heavily discolored, stained, and damaged (i.e., cracked).

- The EIFS finish coat on the window sills was cracked and stained. The sills were flat and not sloped away from the windows for proper drainage.
- Especially in the area of the front porch stoop, the EIFS in contact with the concrete was heavily stained and deteriorated, exposing the mesh reinforcement. Best practices require a 3/4-inch minimum gap between the EIFS and concrete to allow for drainage and to prevent water from possibly wicking up into the EIFS.

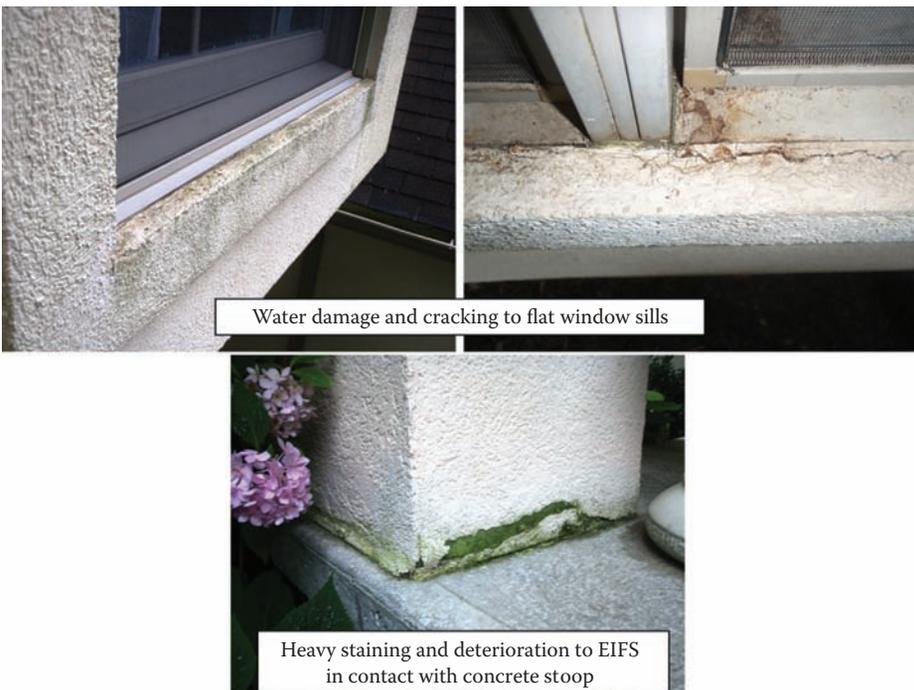
FIGURE 9.24
Water-damage staining, cracking, and deterioration to EIFS due to improper water management details.

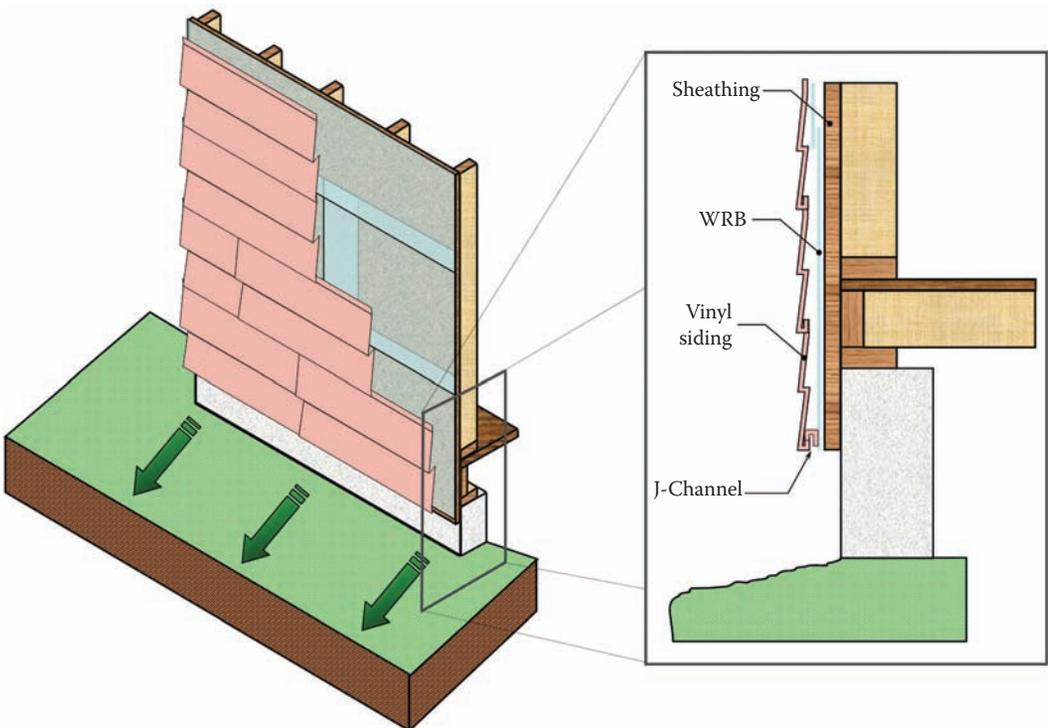
FIGURE 9.25
General construction and water management details—vinyl siding.

The installation of the various types of siding may differ somewhat from product to product based on the specific material, manufacturer, and style, but the water management details are generally the same.^{39–42} Each siding system incorporates a water-resistant barrier and integrated flashing behind the cladding in order to maintain a continuous drainage plane (Figure 9.25).

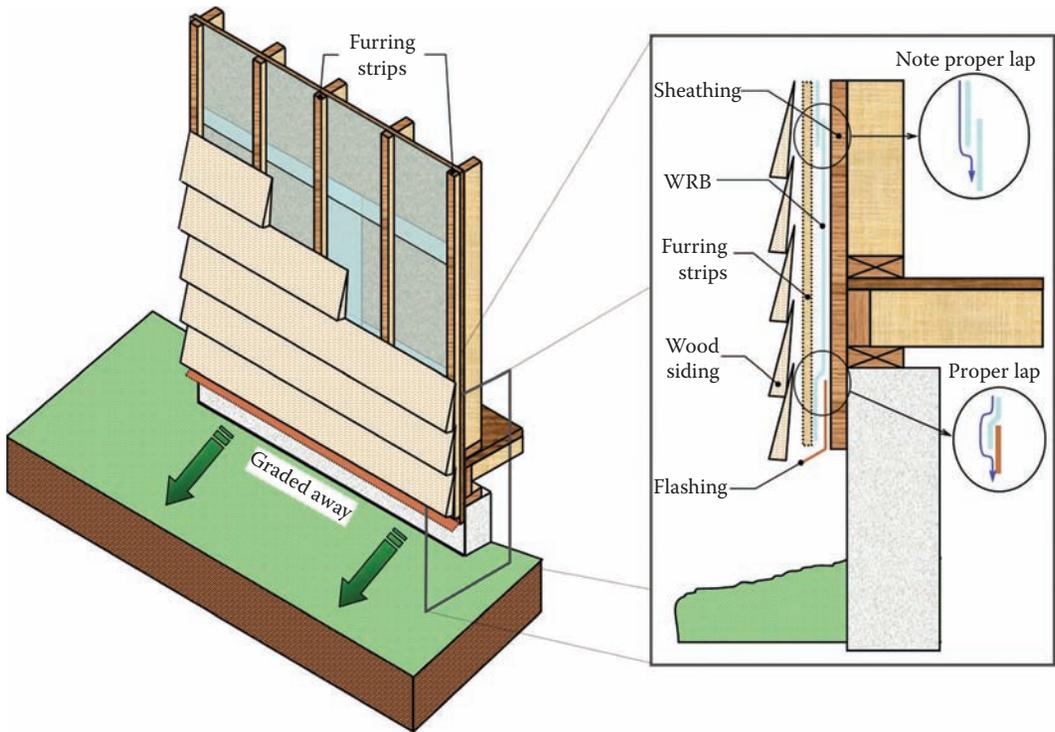
FIGURE 9.26

General construction and water management details—wood siding utilizing rain screen wall construction.

Wood siding differs slightly in that it utilizes a rain screen wall construction with treated, vertically oriented wood furring strips.^{26,40} Creating this air space between the back side of the siding and the WRB with the furring strips helps to ensure that the wood will dry evenly after becoming wet (Figure 9.26).^{26,40}

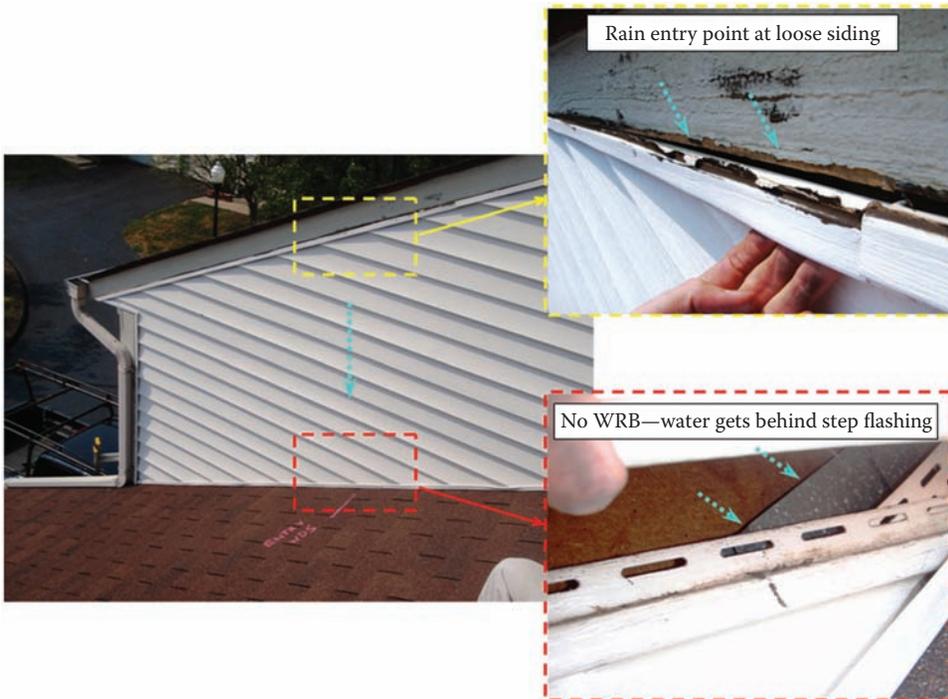
FIGURE 9.27

Rain water infiltrating through loose siding interface along fascia travels downward and enters behind roof step flashing due to no WRB.

The condominium unit shown in Figure 9.27 was experiencing water intrusion issues at a couple of different locations. The first location was along a ceiling-wall interface above the staircase leading to the second floor of the unit. Based on inspection observations and subsequent water testing, the source of the water was determined to originate between a loose section of vinyl siding and wood fascia above the lower roof line. From there, the water traveled downward over the surface of the exterior sheathing until it encountered the interlaced metal step flashing along the sloped roof-wall interface. Normally this would not be cause for concern. However, in this situation, no water-resistive barrier was present over the sheathing. Therefore, the water traveling down the sheathing continued down and behind the vertical leg of the step flashing, since an overlapped WRB was not present to redirect it onto the flashing where it could have been properly drained out onto the roof surface. Note the chalk markings on the shingled surface indicating the location of the interior stain.

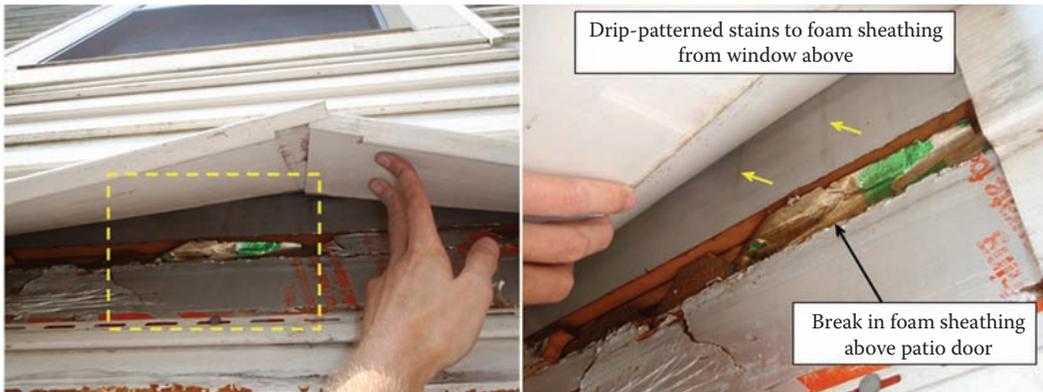
FIGURE 9.28

Water infiltration through second-story window travels downward and enters behind gap in foam sheathing.

deficiency. Water testing was conducted and directed along the top of the door to induce a leak. However, these attempts were unsuccessful. An inspection of the window above the patio door revealed historic sealant along the wooden trim interfaces. The decision was made to water test the window. After a few short minutes, droplets of water began forming along the top of the door. In order to determine exactly what was occurring, the siding immediately above the door was temporarily loosened for observations. Once loose, the problem was evident (Figure 9.28).

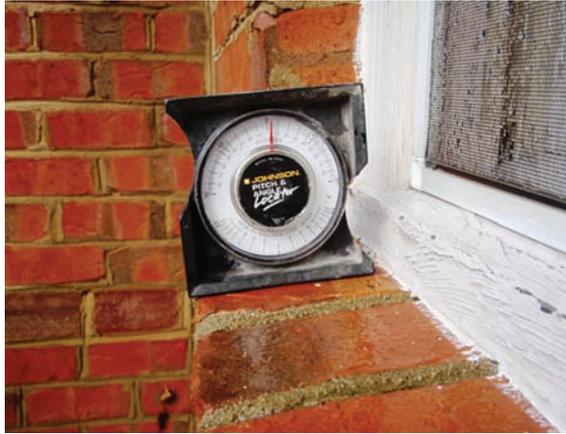
FIGURE 9.29
Brick window sill improperly sloped.

Another best practices design detail is the creation of a groove on the underside of the sill or threshold roughly an inch from its outside face, which serves as a capillary break, or drip edge, and stops the continuation of water (due to surface tension) along the underside of the sill and back to the exterior wall.²⁵ Figure 9.29 provides an example of an improper sloping of a brick window sill, where the slope was only 3 to 4 degrees, well below the BIA recommended value of 15 degrees.

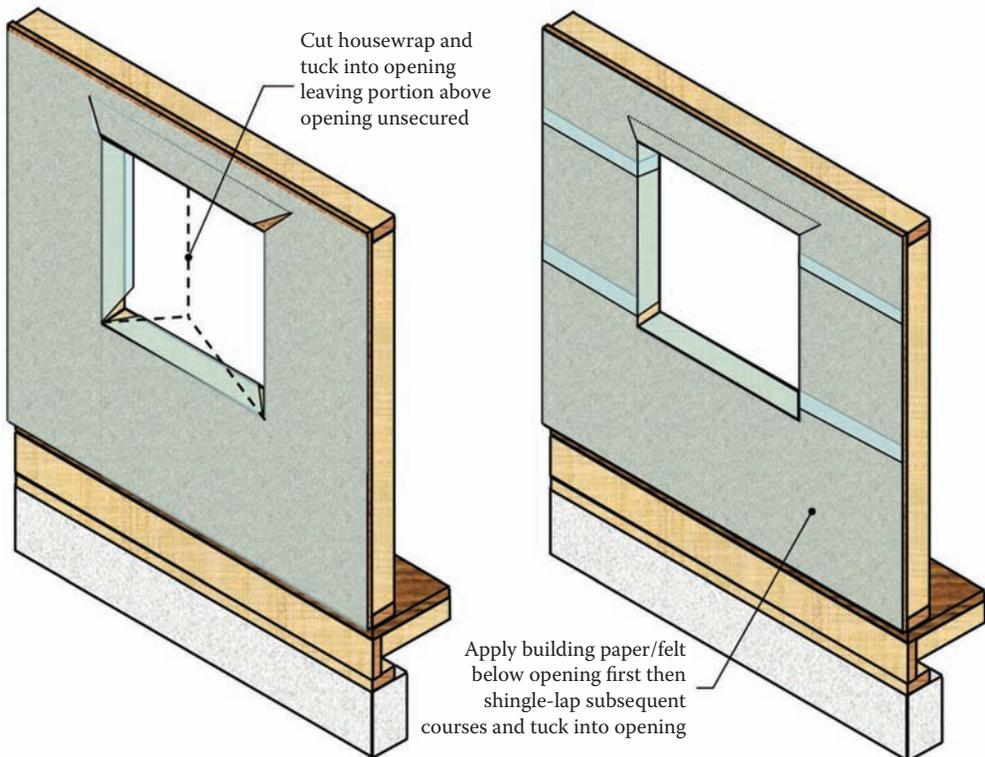
FIGURE 9.30
Window opening preparation using house wrap and building paper or felt.

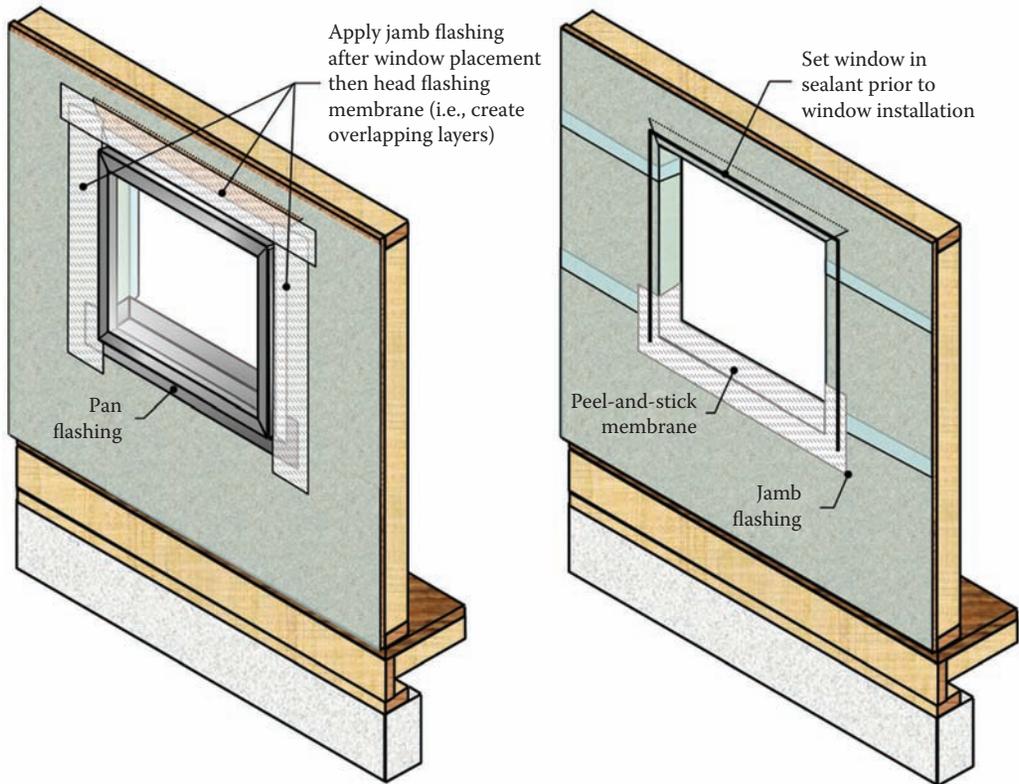
FIGURE 9.32

Jamb and head flashing membranes applied after window placement into rough opening.

a minimum of 6 inches, paying particular attention to work it into the corner interfaces between the sill and jambs (see Figure 9.32 for example).⁴⁵ This eliminates the potential for condensation formation created by the typical metal pan flashings. However, no rear leg is created with the use of peel-and-stick membrane flashings. To help combat this issue, oftentimes installers will provide a rectangular or beveled material beneath the membrane, creating a dam or sloped surface to divert water to the exterior side of the opening.²⁶

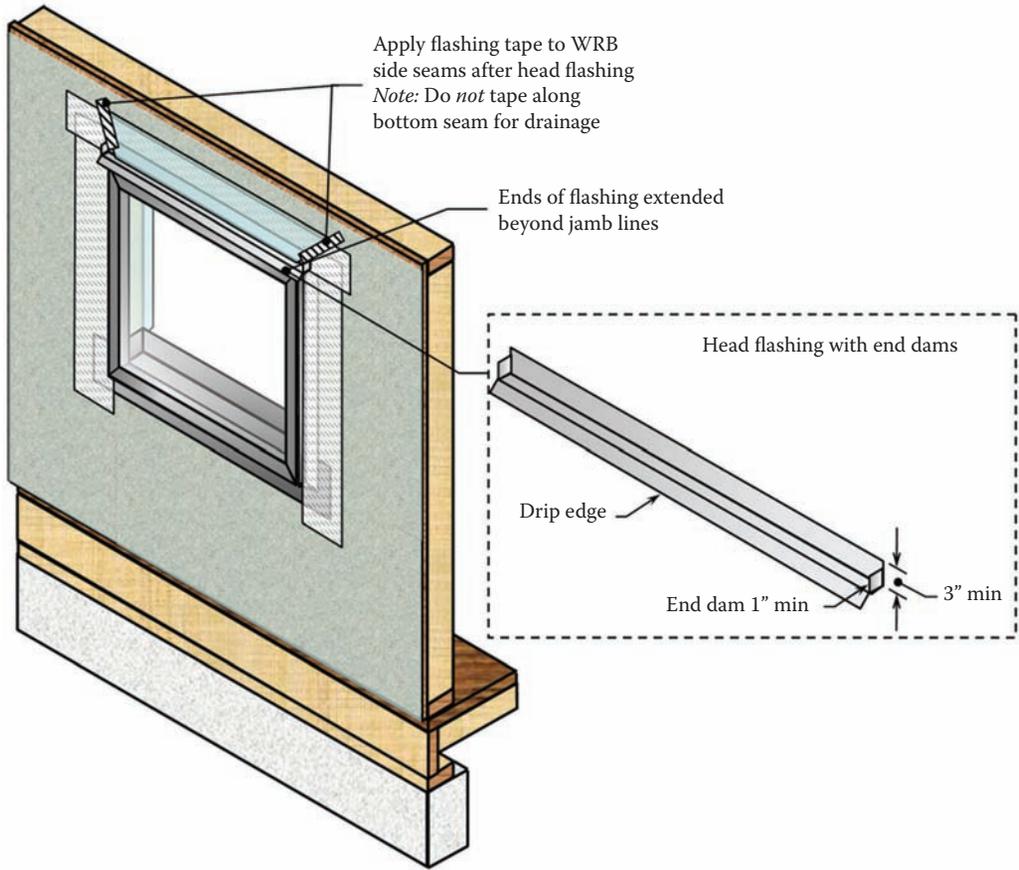
FIGURE 9.33 Installation of rigid head flashing with end dams and taping of WRB seams overlapping head flashing.

Following the placement of the window (or door) unit, strips of peel-and-stick membrane flashing are applied over the nailing fins along both window jambs. This jamb flashing is recommended by best practices to be a minimum of 9 inches in width and extend a minimum of 8-1/2 inches above and below the rough opening, making sure to extend past the lower edge of the sill flashing.⁴⁴ After the installation of the jamb flashings, a strip of peel-and-stick membrane flashing along the window head should be applied (Figure 9.33).

This head flashing is recommended by best practices to also be a minimum of 9 inches in width and extend a minimum of 1 inch beyond the outer edges of both jamb flashings.⁴⁴ Following the application of the peel-and-stick membrane head flashing along the top of the window or door, best practice is to install a rigid, typically metal head flashing over the peel-and-stick flashing. The vertical leg of this rigid head flashing is then overlapped by the WRB, which was originally left unsecured above the window or door. In order to resecure the WRB, flashing tape is applied to the side seams after it has been properly lapped over the flashing. Note that the bottom seam of the WRB is not taped, thus allowing for drainage should it be needed.

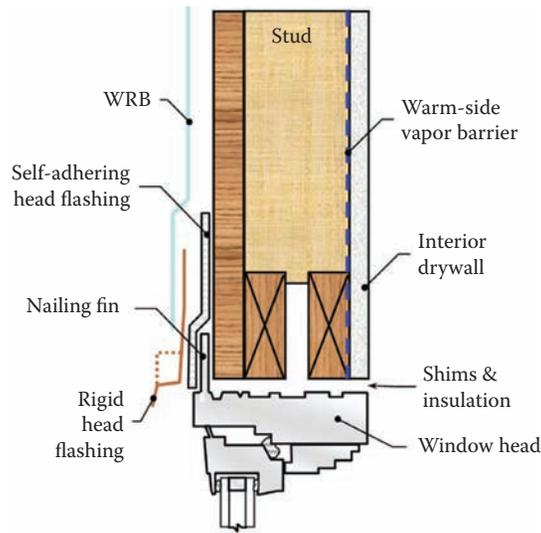
FIGURE 9.34
Side view of water management details along window head.

Best practice recommends that the vertical leg of the rigid metal head flashing extend up a minimum of 3 inches from the top of the window or door opening, extend beyond the surface of the exterior cladding, and be formed to provide a drip edge. Prior to its installation, the ends of the rigid head flashing are turned upward in order to create end dams, which are then soldered to create water-tight seams (Figure 9.34).

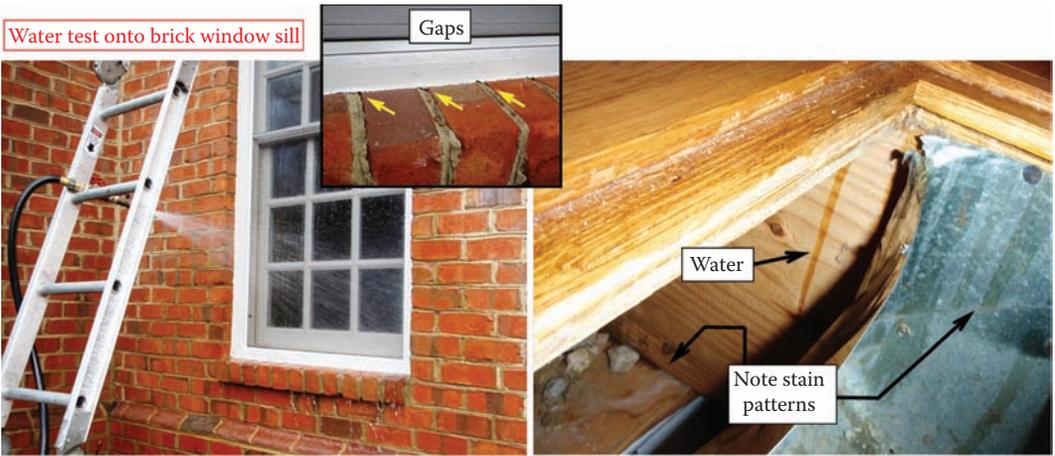
FIGURE 9.35
Water infiltration through brick window sill interface.

This site investigation began as an investigation to determine the cause of warped and buckled hardwood flooring along the entire west wall of a home in a particular upscale suburb known to have had homes constructed with poor brick veneer water management details (two masonry companies went bankrupt due to complaints about workmanship). Through the course of the investigation, diagnostic moisture meter testing of the water-damaged flooring indicated that the heaviest affected areas were located in close proximity to exterior windows. An inspection of the exterior revealed historic, weathered, and deteriorated caulking along the brick sill interfaces. A water test was conducted to simulate wind-driven rains onto the subject windowsill. Shortly after commencement of the water test, visual observations through a heating, ventilation, and air conditioning (HVAC) supply air register in the floor revealed water dripping down the surfaces of a floor joist directly below the window and near areas where historic drip-patterned water staining was present. Efflorescence was present to the HVAC duct and the sill plate (Figure 9.35).

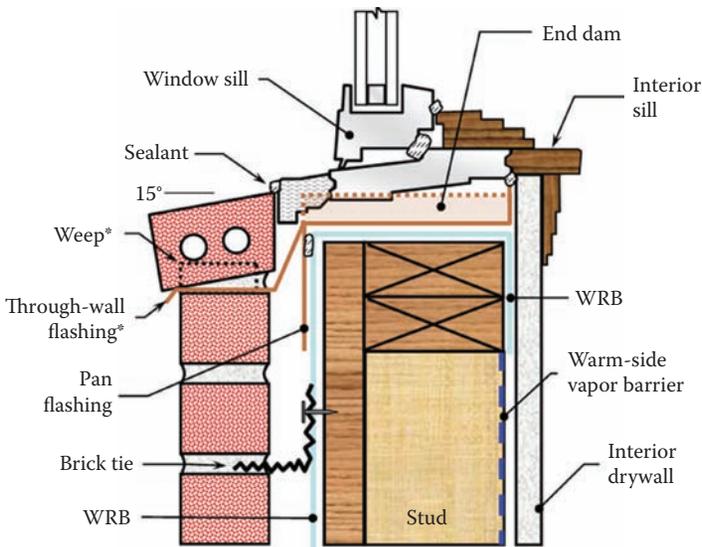
FIGURE 9.36
Cross-sectional view of brick window sill—proper water management details. *Weeps and through-wall flashing below sill in place of pan flashing draining water onto WRB and drained at bottom at wall.

windows and the brick wall. Although destructive testing of the wall would be needed to determine the exact construction details, it is a sure bet that pan flashing or through-wall flashing was not present beneath this window. Further, the brick sill was not adequately sloped away from the window (i.e., 15 degrees, according to best practices²⁷) and no evidence of weep holes or through-wall flashing was present below the brick sill or above finished grade. Thus, no means was provided to discharge any water that would inevitably get into the wall. As might be expected, water infiltration around this window (west elevation) and those on the south elevation were the first to show water entry issues, since they faced the predominant wind and weather patterns. The cross-sectional view of the brick window sill in Figure 9.36 depicts two options of subsill drainage.

As discussed earlier, pan flashing with formed, water-tight end dams that drain water onto the surface of the WRB below the window would suffice, but this is dependent on whether through-wall flashing and weeps are present at the base of the exterior wall assembly. Another option would be to extend the through-wall flashing through the veneer just below the brick sill. Of course if this detail were utilized, weeps would be needed to provide drainage. Regardless of which subsill drainage element is used, through-wall flashing and weeps are required at the base of the wall; neither was used in this case, leading to rotting of the wood members in the wall cavities.

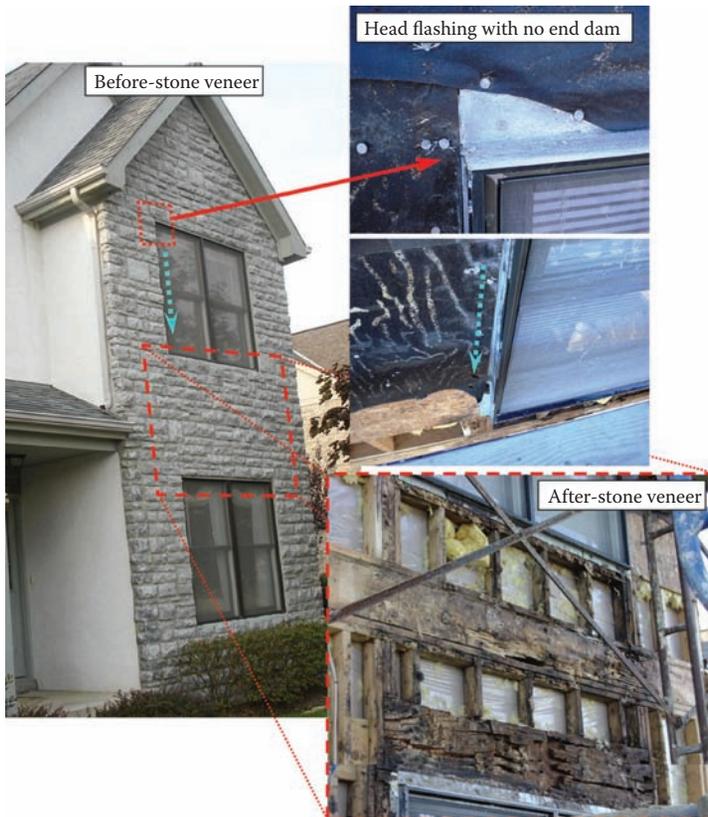
FIGURE 9.37

Lack of end dam on metal flashing—head flashing with no end dam.

This site investigation for the home shown in Figure 9.37 provides a classic example of the importance for extending the rigid metal head flashing past the window jamb and the need for an end dam formed at the end of the flashing. This particular house was experiencing problems for over a year in the form of water dripping down from the dining room windows. During the original site investigation, it was determined that the source of the water was occurring at the interfaces between the manufactured stone veneer and the second-story window above the dining room. Two months later, a return visit to the home was scheduled, coinciding with the removal of the stone veneer. This remediation immediately gave a visual explanation where the source of the water was coming from, as the wooden framing between the first- and second-story windows was heavily water-damaged and rotted.

- No evidence of subsill flashing or jamb flashing was present. The wooden sill plate for the window and studs directly below were heavily rotted from years of water infiltration.
- Staining patterns clearly indicated that water had traveled down the jamb lines for the window toward the sill.
- The rigid metal head flashing terminated at the jamb lines for the window.
- No end dams were formed at the ends of the rigid head flashing.

The lack of end dams in the rigid metal head flashing along the top of the second-story window allowed for water, which inevitably infiltrated through the manufactured stone, to travel horizontally and empty out directly onto the window jambs where no jamb flashing was present. From there, the water likely traveled downward along the jamb lines for the window opening and settled on the window sill plate, where no form of subsill flashing or drainage mechanism was present. Based on the level of water damage and deterioration to the wooden framing below the window, there was a significant imbalance between the rates of wetting and drying of these wooden members and likely dated back to the original date of construction of the home 10 years earlier. The builder of this home went out of business and is no longer building homes.

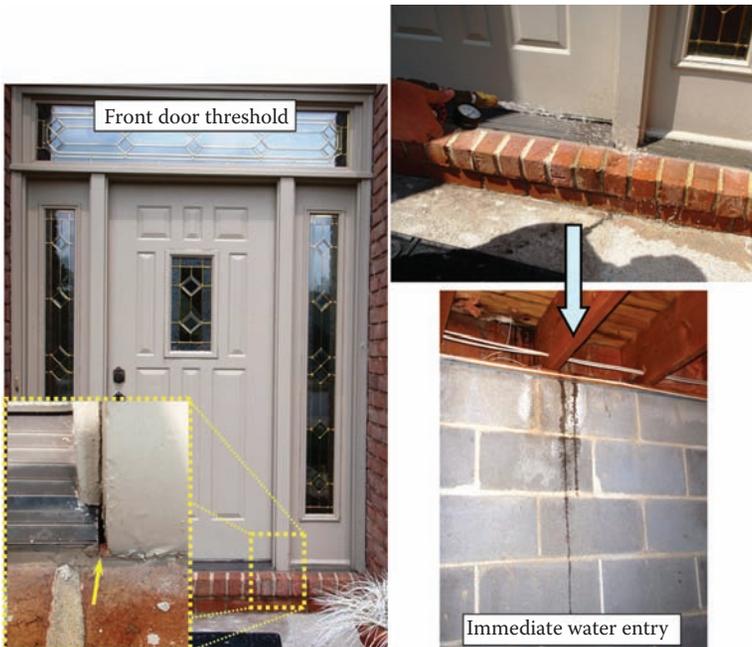
FIGURE 9.38
Gap at corner of front door brick threshold.

This site investigation for the home shown in Figure 9.38 emphasizes the need for pan flashings or through-wall flashings for doors. First, as is often the case, sealant appeared to

have been relied on as the primary means for deflecting water from the interfaces between the front door threshold, framing, and brick sill. When the sealant reached the end of its useful service life and began to deteriorate, cracks and gaps formed and revealed a complete lack of subsill drainage for this front door and sidelight unit. Gaps, measuring up to 1/4 inch wide, were present between the metal threshold and the jamb for this door.

Water testing was conducted with the water spray directed toward the lower corner of the door where this gap was located. Immediately, water began to pour into the basement, over the band board, and onto the foundation wall. The water test was terminated and the owners of this home were notified of the deficiency.

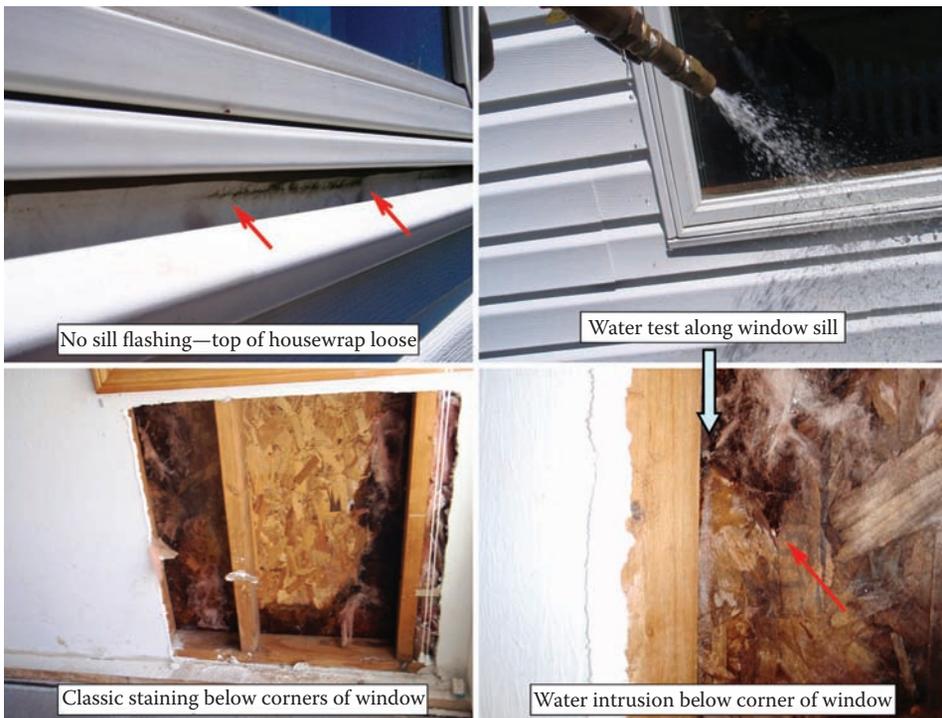
FIGURE 9.39

No sill flashing beneath window.

This site investigation for the home shown in Figure 9.39 again emphasizes the need for proper flashing details around windows, this time with vinyl siding. The owner of this home noticed water on the garage floor below south windows whenever rain came from that direction.

Approved destructive testing was performed on the drywall below one of the windows and revealed classic staining patterns on the OSB sheathing below the lower corners of the window. From the exterior side of the window, the loose J-channel just below the

windows showed that no form of sill flashing was present. Further, the upper edge of the house wrap was loose and showed evidence of moisture and water staining. A water test directed along the J-channel–sill interface produced water infiltration on the sheathing below the lower corner of the window.

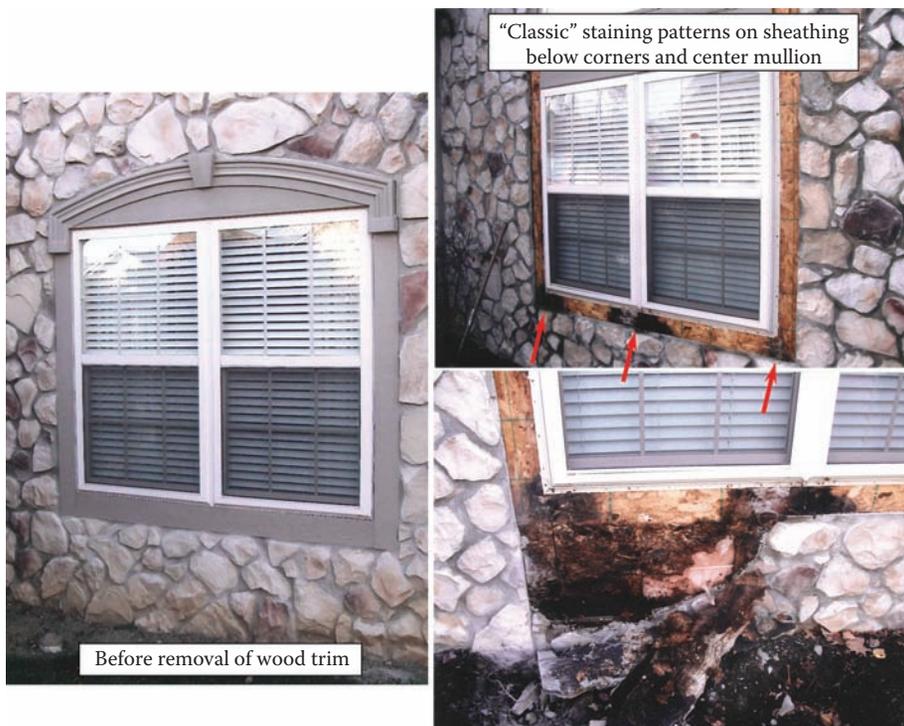
FIGURE 9.40

Classic staining patterns on OSB sheathing below lower corners of window and center mullion.

This site investigation, as shown in Figure 9.40, again shows these classic staining patterns below windows. This particular field investigation was discussed in a previous section on KOD flashing, but issues regarding the proper water management details around the windows were also of concern.

During the construction of the condominiums in this particular complex, there was a lack of coordination between the trade personnel (i.e., window, window trim, and stone veneer installers), which led to the installation of the window trim around the windows prior to the application of the WRB and manufactured stone veneer. Due to this mishap in scheduling, no form of flashing or WRB was present around the windows. Then, once the stone veneer installation contractors started their work, they attached WRB to the sheathing around the windows up to the edge of the window trim and then applied the cultured stone veneer. To make matters even worse, no form of sealant was applied along the interfaces between the windows and the window trim. This allowed for water to infiltrate

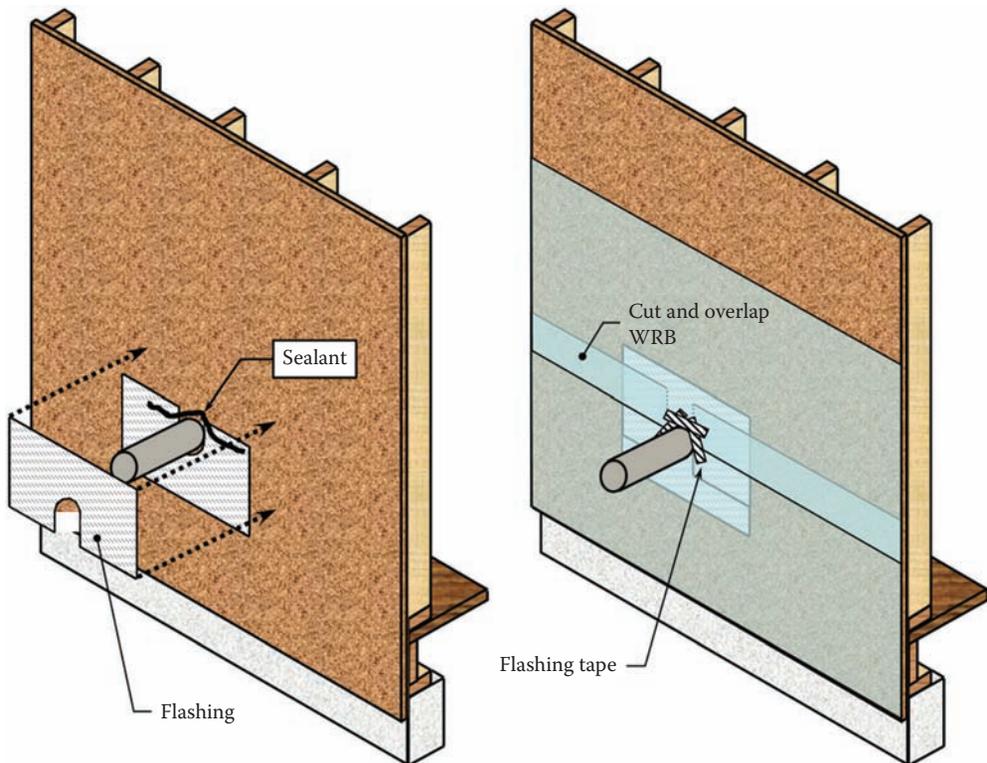
FIGURE 9.41
General flashing guidelines for typical wall penetration.

A typical residential or light commercial building will contain one or more of many different types of miscellaneous wall penetrations, including dryer vents, bathroom exhaust fans, exterior light fixtures, and gas lines, to name a few. Figure 9.41 gives the typical flashing instructions for a general wall penetration.

As illustrated, with the use of a little common sense and the knowledge gained thus far, these penetrations can be properly flashed in order to maintain the continuity of the drainage plane.

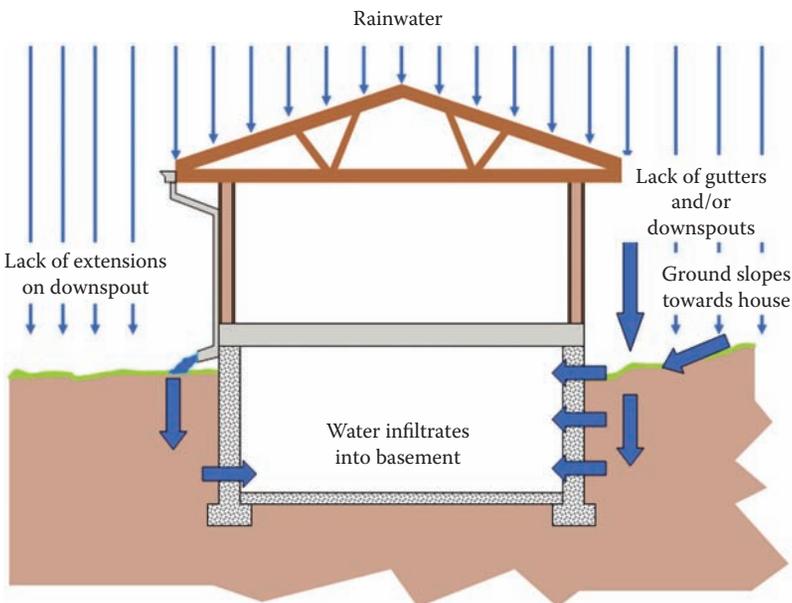
FIGURE 10.1

Basement water intrusion pathways.

Experience has shown that the most common cause of basement water intrusion is due to poor drainage. During precipitation events, water can accumulate against a basement wall from the ground, roof, or from poorly designed or missing gutters and downspouts. This can result in surface and groundwater flowing against, and through, foundation walls and then into the basement of a structure. Figure 10.1 illustrates basement water intrusion pathways.

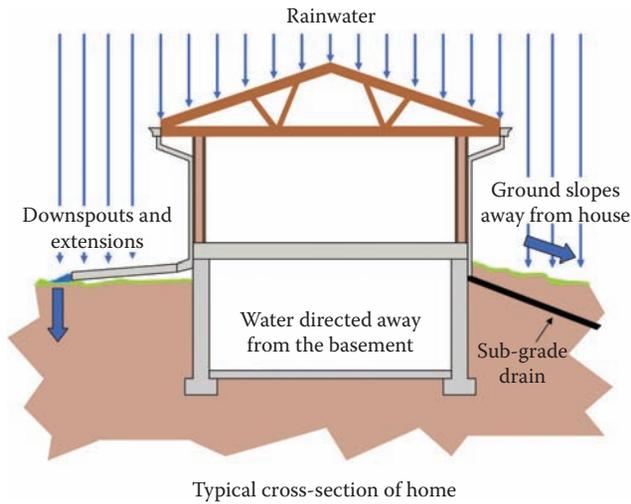
**FIGURE 10.2**

Drainage directed away from the home.

To minimize drainage against and through foundation walls, surface water and groundwater must be collected and drained away from the foundation walls of a structure. The term used for this process is water management. Figure 10.2 illustrates some basic water management methods to move water away from the foundation walls of a structure.

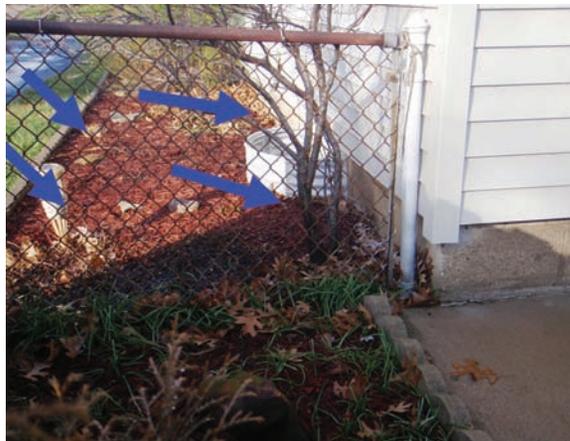
**FIGURE 10.3**

Landscaping bed against foundation trapping water and creating a grade toward the home.

- When backfill is placed around a structure, it is often not sloped away from the structure or is sloped away but was not well compacted, which will settle and form low spots near the foundation walls.
- When landscaping around a home alters the designed drainage patterns of the ground slope near the foundation walls (Figure 10.3).
- Improper surface ground slope when a driveway, sidewalk, or patio is installed directly against the foundation. When these structures (typically concrete) are not poured so they slope down and away from the foundation wall or settle so they slope toward the building, surface water will flow toward the foundation walls (Figure 10.4).

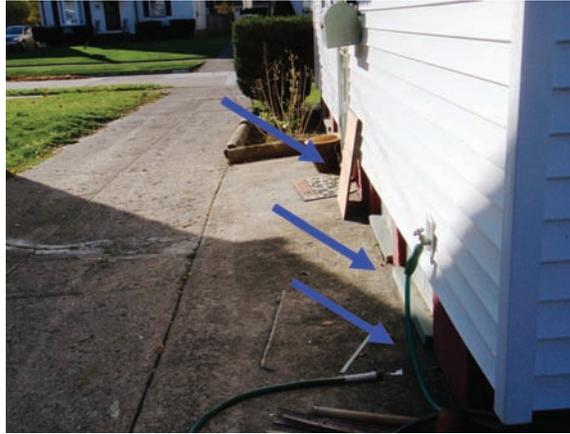
FIGURE 10.4
Water intrusion occurring at driveway or wall interface.

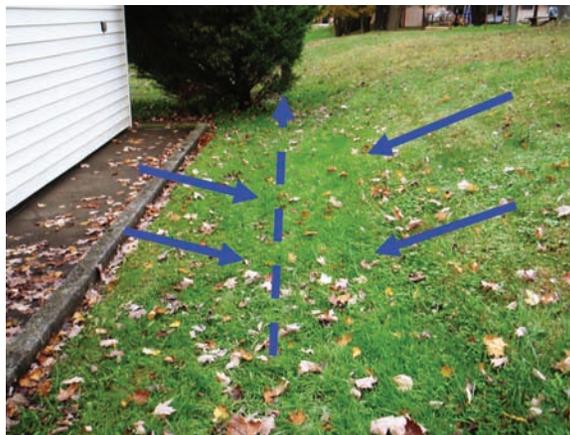
FIGURE 10.5
Neighboring property at higher elevation—drainage swale catching water.

Sometimes the location of the structure, combined with the higher elevation of a neighboring property, does not allow for the surface grade to be properly sloped away from the foundation of the structure. In these cases, the installation of a swale (Figure 10.5) can be an effective method to divert water away from a foundation wall. A swale is essentially a trench that creates a low spot to collect surface water that would otherwise be directed toward the structure.

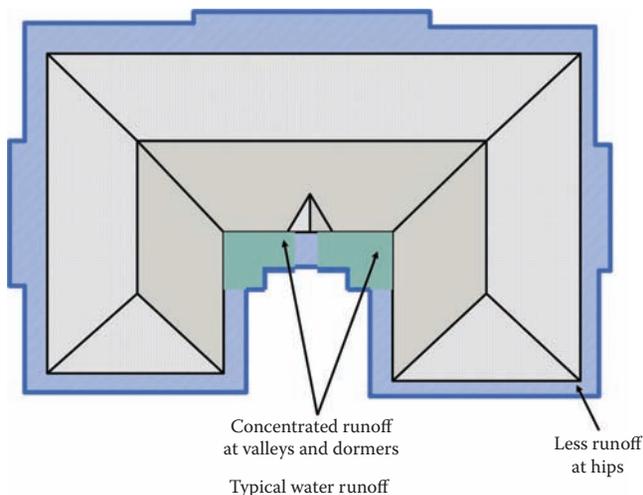
FIGURE 10.6
Roof drainage patterns.

Different types of roof construction lead to different water runoff and water management systems and issues. Gable roofs (two-elevation roofs) concentrate the roof water typically toward two eaves, whereas hip-style roof surfaces will typically have four roof elevations that distribute water more evenly toward the four eaves. Areas near dormers will also concentrate roof water. The types of roof areas and varying roof drainage patterns or loadings at eaves are illustrated in Figure 10.6.

As illustrated in Figure 10.6, a large amount of roof water will be directed toward roof valleys during heavy periods of rainfall or snow or ice melt. The resulting flow of water in the valleys can result in water spilling over the front edge of the gutter onto the ground surface below. Figure 10.8 illustrates water pouring over the front edge of a gutter and onto the ground due to water draining around a large chimney cricket valley. To avoid this situation, diverter baffles can be installed to keep the roof water from the valley from flowing onto the ground near the foundation. Best practices suggest that the installed diverter baffle should extend to a height of four to six inches above the front edge of the gutter.

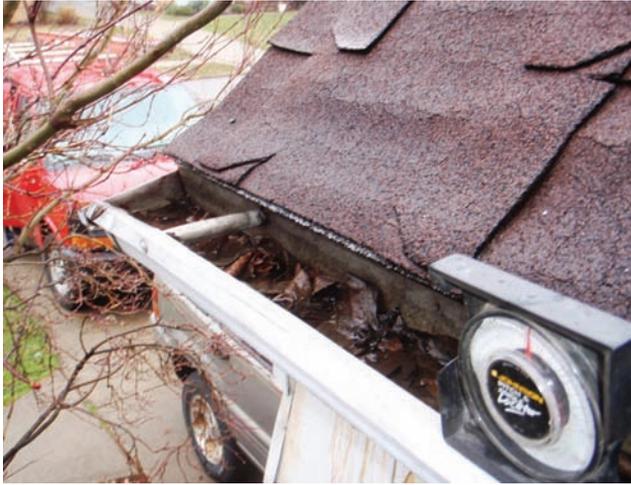
FIGURE 10.7
Improperly sloped gutter containing standing water and debris.

Best practices recommend that gutters slope down toward the downspout opening 1 inch for every 40 feet of run (0.12 degrees) to ensure adequate drainage.³ This slope is also intended to prevent standing water and debris from accumulating in the gutter, which will restrict or stop roof water flows and can cause sagging and displacement of the gutter (Figure 10.7).
