FORENSIC ENGINEERING

**Damage Assessments for
Residential and Commercial
Structures**

**Edited by
Stephen E. Petty**

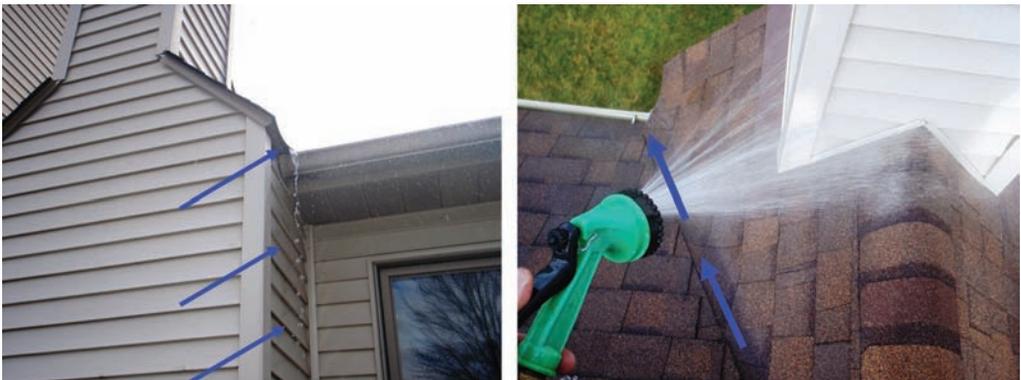
FIGURE 10.8
Water running over gutter at valley onto ground surface.

As illustrated in Figure 10.6, a large amount of roof water will be directed toward roof valleys during heavy periods of rainfall or snow or ice melt. The resulting flow of water in the valleys can result in water spilling over the front edge of the gutter onto the ground surface below. Figure 10.8 illustrates water pouring over the front edge of a gutter and onto the ground due to water draining around a large chimney cricket valley. To avoid this situation, diverter baffles can be installed to keep the roof water from the valley from flowing onto the ground near the foundation. Best practices suggest that the installed diverter baffle should extend to a height of four to six inches above the front edge of the gutter.

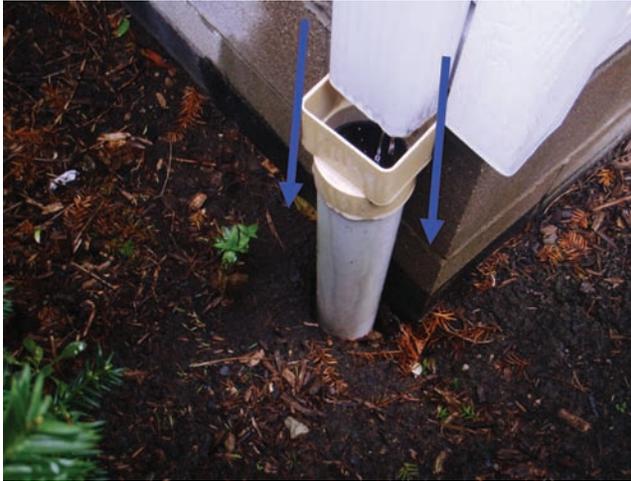
**FIGURE 10.10**

Roof water partially missing subgrade drain and flowing against foundation walls.

this type of system can be subject to problems. Settling of soils where the drainage piping is buried near the foundation walls often occurs. This settlement can cause separation, breaking, and even clogging of the subgrade drain piping. Figure 10.10 illustrates a subsoil drain that settled in relationship to the downspout leader, allowing for roof water to partially miss the subgrade drain and pour against the foundation walls. Significant basement water intrusion was observed on foundation walls in the corner of this basement. It is also not unusual for tree roots or vegetation to clog, break, or dislocate subgrade drains. This condition can be difficult to determine and oftentimes requires the use of a boroscope with a camera to locate the cause of damage to the subgrade drain. Figure 10.11 shows a still photograph from footage taken during a forensic investigation where the subgrade drain was broken.

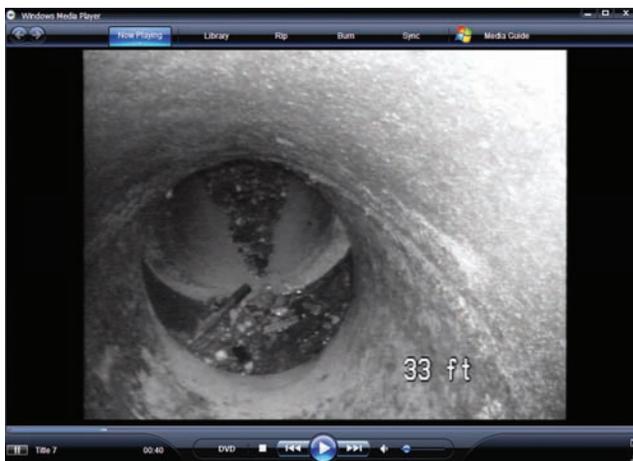
**FIGURE 10.11**

Linear camera photograph showing subsoil line breakage.

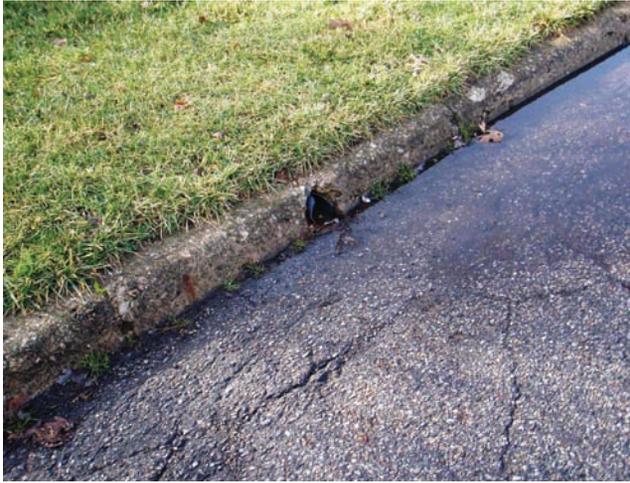
**FIGURE 10.12**

Water flowing from subgrade drain outlet at the street—no apparent blockage present in the line.

Another method used to determine if a blockage is present in a subgrade drain is to simply run water through a garden hose into the suspected blocked drain (Figure 10.12). If water

flows freely from the subgrade drain outlet at the street, then blockage of the line is unlikely. If, on the other hand, water backflows out of the subgrade line near the downspout entrance, the subgrade drain line is likely blocked. The difficulty here is that the exact location or nature of the blockage may not be known without using either a boroscope or excavating the line. A useful indicator in providing the approximate location of a blockage or a break in the subgrade drain line would be more robust or darker green spots in the lawn or vegetation when not dormant.

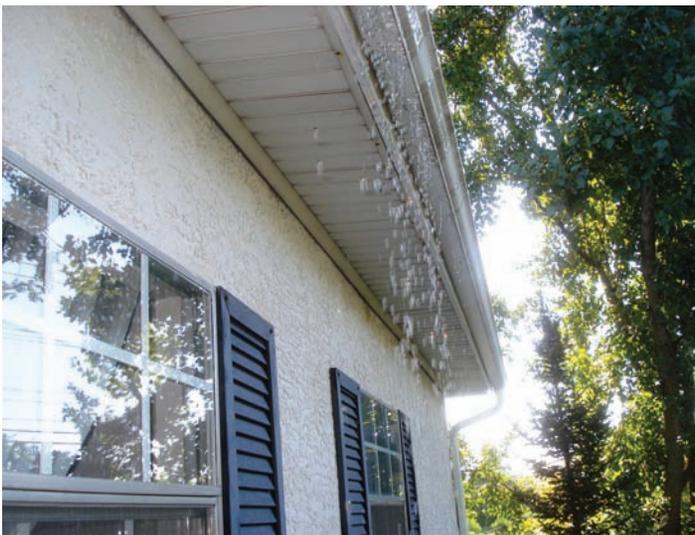
**FIGURE 10.13**

Water pouring over clogged gutter.

the ground surface below, near the foundation walls (Figure 10.13). Backed up water from the gutters can also flow into and behind the fascia, causing degradation of the gutter and wall system. Long term debris accumulation can even lead to active growth of vegetation in the gutters (Figure 10.14). In colder climates, standing water in the clogged gutters freezes, adding weight and additional blockage. This in turn can cause the gutter to sag and detach, leading to further water-related damage such as that from ice damming conditions. Ultimately, lack of maintenance can result in detachment or collapse of the gutter system (Figure 10.15). To prevent these consequential issues, gutters should be cleaned out once every year at a minimum, preferably at the end of fall. However, when structures are located near trees, the gutters

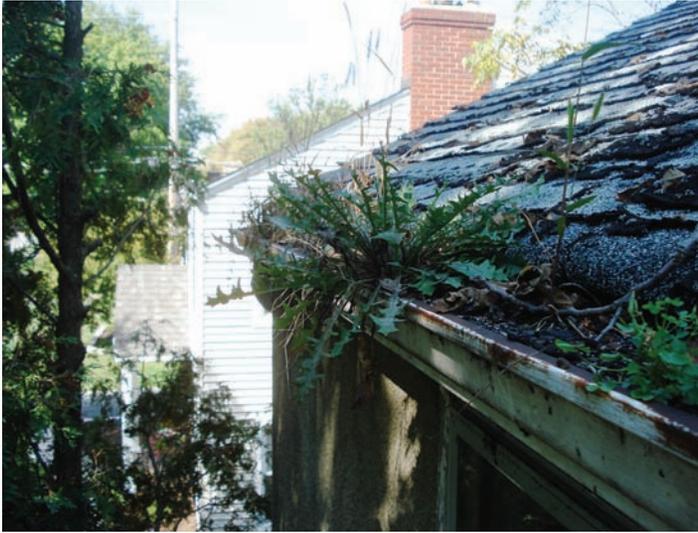
FIGURE 10.14
Vegetation growing in gutter.

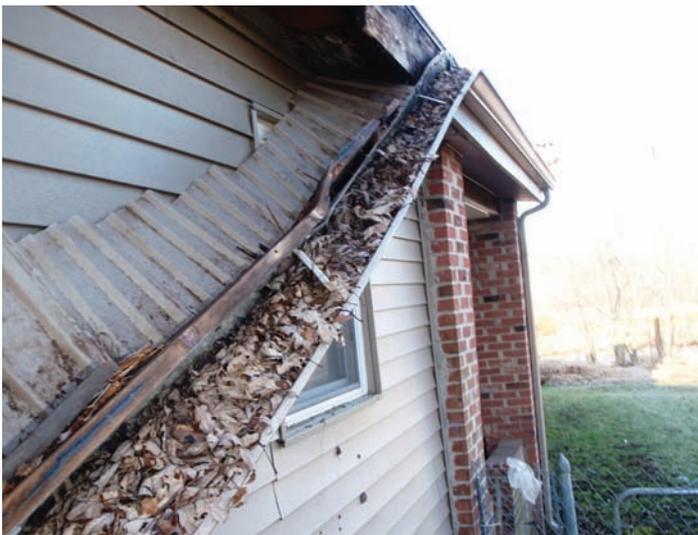
FIGURE 10.15
Collapsed gutter due to weight of water and debris and fascia rot.

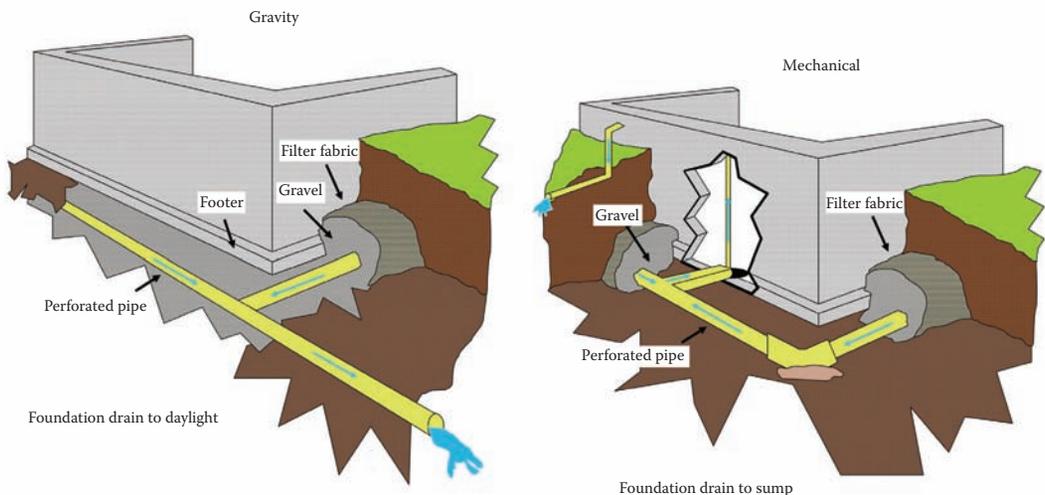
FIGURE 10.16
Foundation drainage—gravity versus mechanical methods.

storm-water drain, the collected water can be drained away by gravity or (2) through the use of mechanical means such as a sump pump located in a basement. These two types of drainage discharge methods for foundation drains are shown in Figure 10.16.

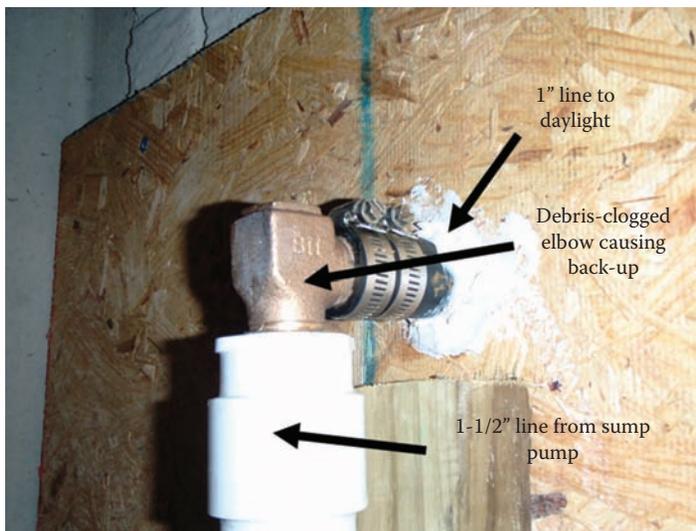
FIGURE 10.17

A 1-1/2-inch discharge line from sump pump reduced to 1-inch line at elbow resulted in debris clogged elbow and water backup.

sump pump backup occurred in a home undergoing new construction as a result of debris blocking a 90-degree fitting that reduced the 1.5-inch pump line to a 1-inch discharge line. This situation probably could have been avoided had the debris been cleaned from the sump and the same size or larger elbow been used (Figure 10.17).

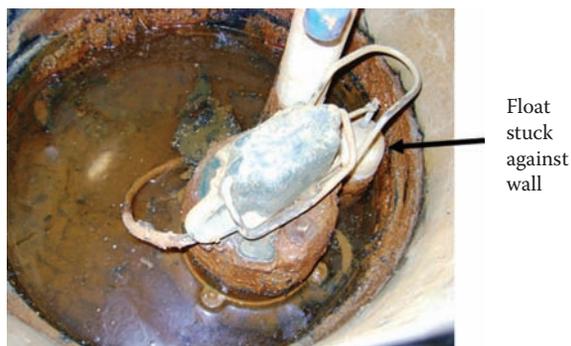
**FIGURE 10.18**

Sump pump float stuck against wall.

Sump pump failures can also occur if a sump pump float switch is not positioned in a manner to allow for free movement of the float. An interesting case occurred where a homeowner performed major renovations in the basement, which included replacing the sump pump. Within days of installation, the sump pump quit working and caused extensive water damage in the newly finished basement. It was later determined that the sump pump was positioned too close to the pit wall, which prevented the float from rising with the incoming water, therefore, the float switch could not be activated to turn on the motor to remove the water (Figure 10.18).

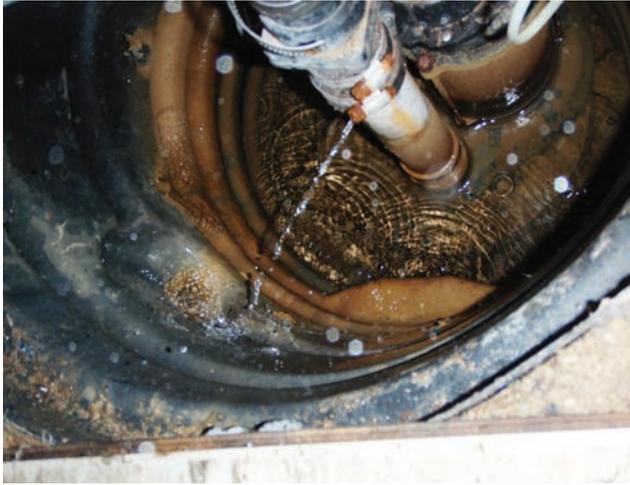
FIGURE 10.19

Water spraying relief hole during cycling.

Mechanical failures can also occur as a result of air lock. Air lock occurs when air builds up between the pump discharge outlet and check valve, thus causing cavitation of the pump. In order to eliminate air lock issues, some sump pump manufacturers recommend drilling a 3/16-inch hole between the outlet and check valve to relieve air.⁷ When drilling this hole, it is important that the hole be placed at a downward angle so the water that sprays from the hole during its cycle will be directed down into the pit. During one inspection, the relief hole was drilled at an upward angle, which caused water to spray or splash around the cover (Figure 10.19). The owner had thought the water was a result of the pump malfunctioning.

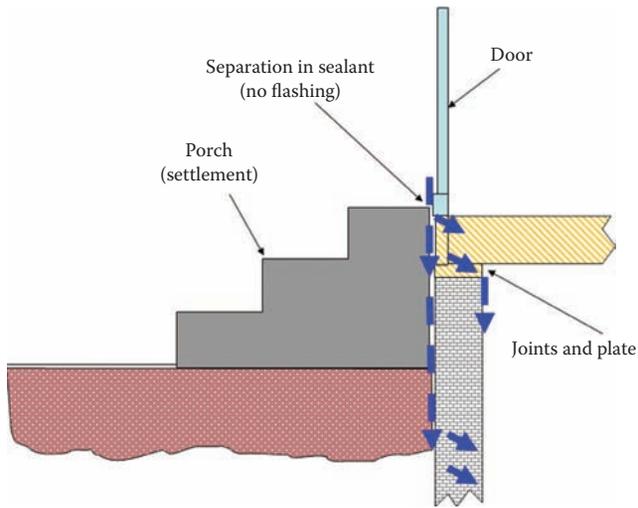
FIGURE 10.20
Water intrusion pathway at porch interfaces.

Another problem often seen in this area is related to settlement, especially with concrete porches. The settlement results in a separation along the sealant. If the porch sinks toward the home, surface water will run toward the interface; if the porch sinks away from the home, a larger separation occurs, allowing for larger volumes of water to infiltrate into the wall cavity (Figure 10.20).

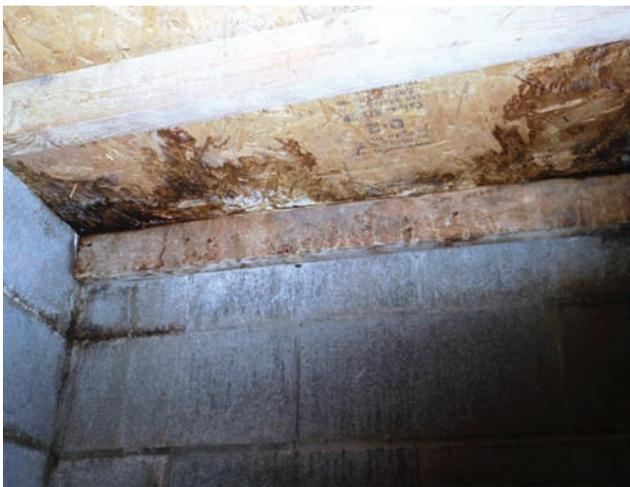
FIGURE 10.21
Water damage to flooring and framing below stoop.

Since the elevation of porches or decks is typically higher than the beginning of the structure's wood-frame construction, the water can damage or rot the top plate, joists, and subflooring of the main structure (Figure 10.21). Additionally, the water that does not enter at the top of the wall will essentially be trapped behind the appurtenance, resulting in water accumulation and hydrostatic pressure against the foundation wall.

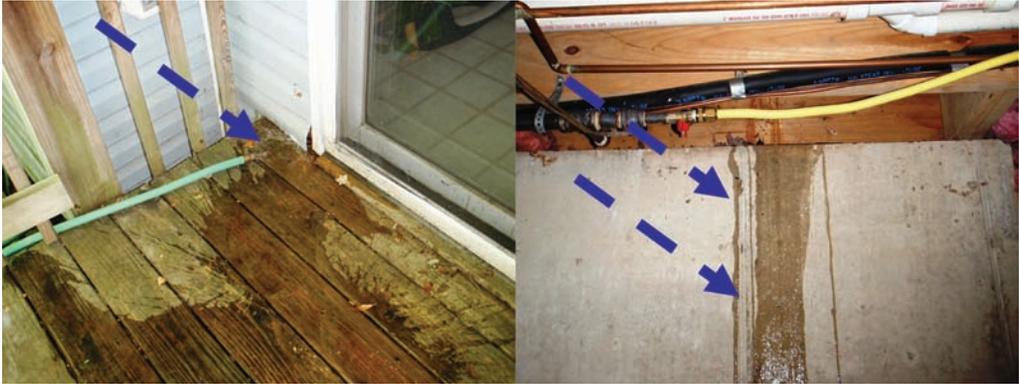
FIGURE 10.22
Water test resulting in water intrusion at deck attachment.

In one particular case, a wood deck was attached directly to the rim joist of a vinyl-sided home. Water reportedly poured into the basement during periods of rain. The homeowner's contractor believed this was occurring due to groundwater intrusion. A water test was performed on the deck surface and water was observed flowing down the foundation wall and onto the floor of the basement (Figure 10.22). This water intrusion situation could

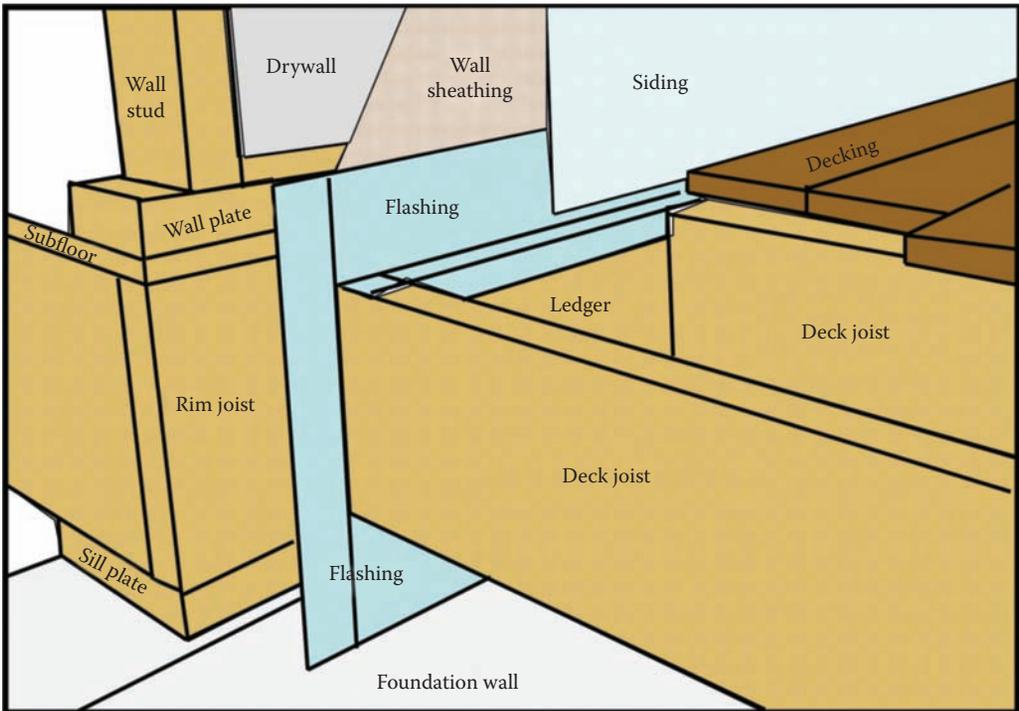
FIGURE 10.23
Flashing detail at deck attachment.

have been prevented had a section of sheet metal flashing been installed where the deck attached to the porch (Figure 10.23).

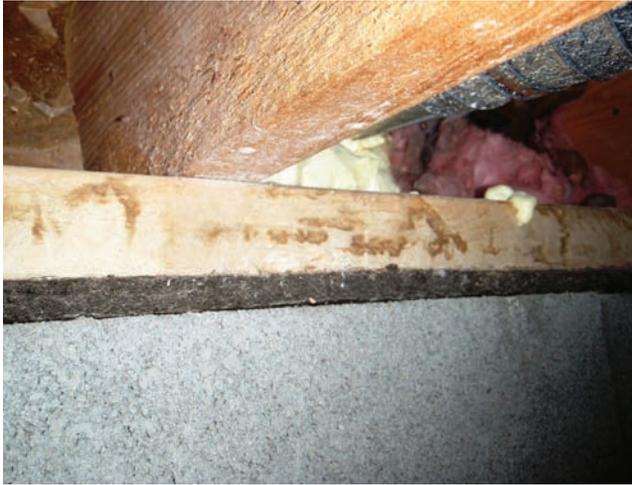
FIGURE 10.24
Water staining to top plate below window.

and top plate below these openings (Figure 10.24). This occurs when windows do not contain proper sill flashings to drain water from the cavity. This condition can also occur with almost any type of siding, but seems to be most commonly observed with vinyl siding and with masonry wall surfaces, such as brick and stucco.

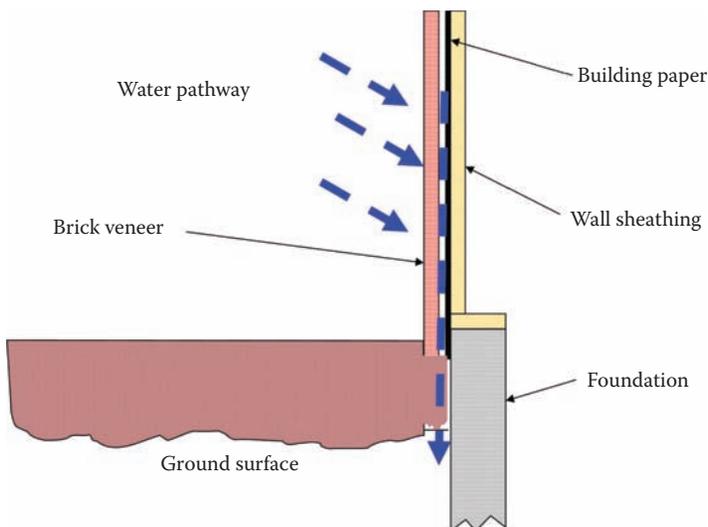
FIGURE 10.25
Water pathway when brick is terminated below grade.

stucco should terminate above the grade to provide adequate drainage. Oftentimes these claddings are terminated below the grade. Thus, the water drains out near the foundation. An illustration of this condition is shown in Figure 10.25. If the brick veneer in Figure 10.25 had been terminated above the grade and weeps were present at the base of the wall, the water would have been directed out to the ground surface rather than against the foundation wall.

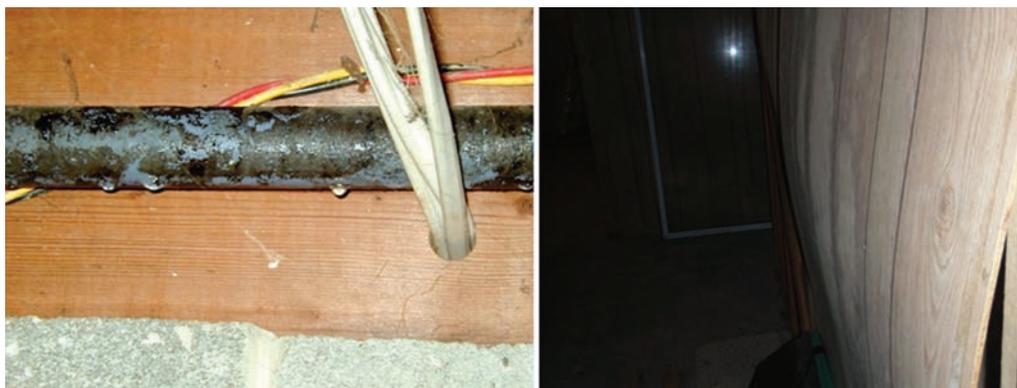
FIGURE 10.26

Indicators of moisture issues—condensate on water line and warped paneling.

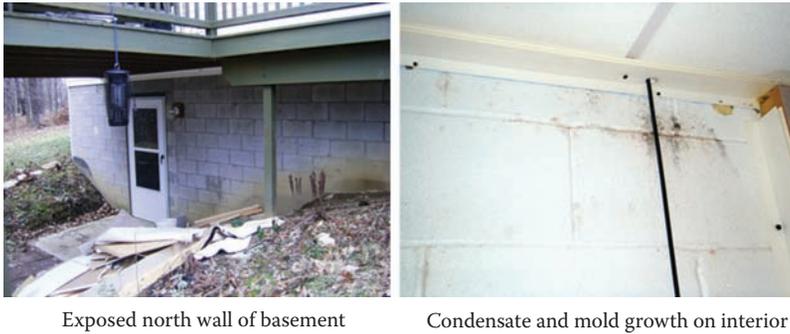
FIGURE 10.27

Exposed north wall of basement

Condensate and mold growth on interior

Moisture issues are typically accompanied with surficial mold growth on walls and ceiling surfaces. This is especially the case with walk-out basements. The exposed walls on the walk-out portions become an ideal condensing surface for the trapped moisture (Figure 10.27). Two methods to control this problem would be to add a dehumidifier or to add insulation and a vapor retarder to the wall surfaces (see Chapter 9, this volume).

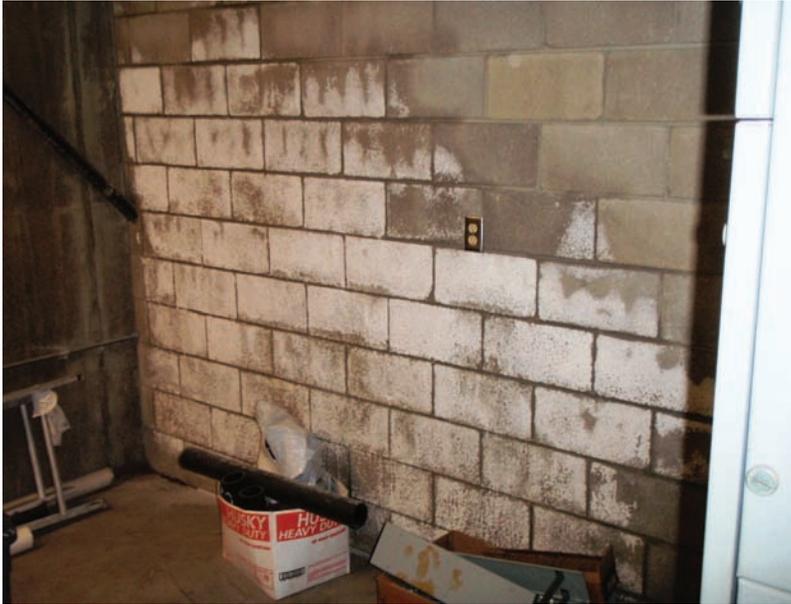
FIGURE 10.28
Heavy efflorescence to concrete masonry unit wall.

The best indicator of surface or groundwater intrusion through masonry foundation walls is the presence of efflorescence. Efflorescence is light-colored crystalline deposits that are left behind from evaporated water or moisture (Figure 10.28). Efflorescence typically forms in porous masonry construction from water movement through the wall cavity. This can be associated with moisture wicking through masonry construction or in more serious cases where water is entering through openings, such as windows. The presence of efflorescence on wall surfaces is typically indicative of long-term water or moisture intrusion events. In most cases, efflorescence is harmless and can be cleaned using mild acid solutions. In more severe cases, efflorescence can lead to spalling or damage to masonry wall surfaces.

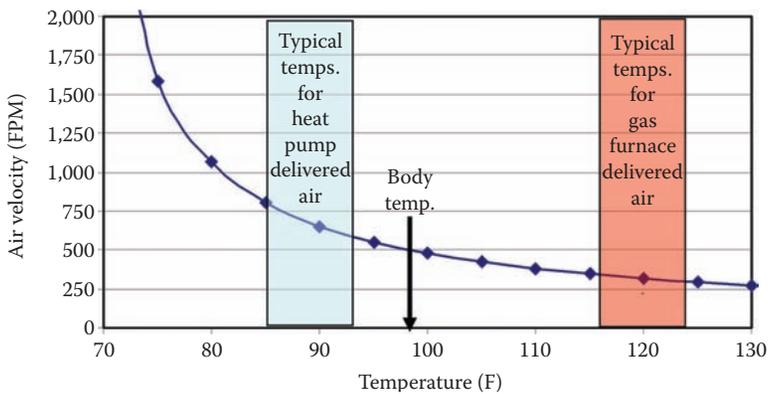
FIGURE 11.1

Residential setting—typical delivered air temperature and velocity for delivered heated air into a space.

One example of IEQ is illustrated by examining the often heard marketing slogan, “gas heat is warm heat.” In homes, the temperature of the heat delivered at the register by a gas furnace is typically above the body temperature of 98.6°F, whereas the temperature of heat delivered by an electric heat pump is below the body temperature (Figure 11.1).

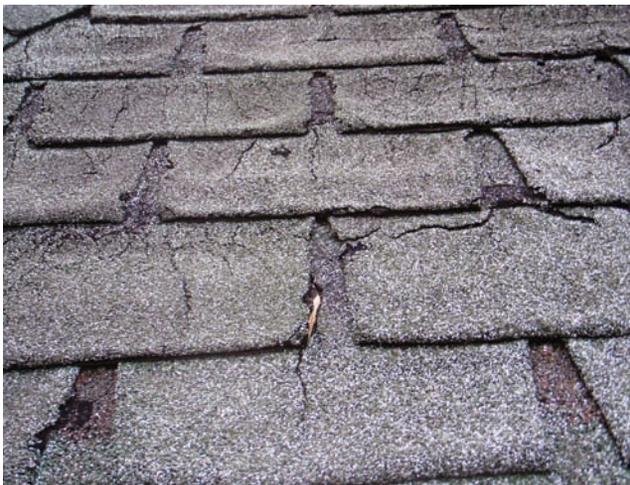
FIGURE 12.1

Illustration of thermally degraded asphalt shingles caused by inadequate attic ventilation.

Ventilate comes from the Latin word *ventilo*, meaning “to fan.” Proper ventilation of an attic and crawlspace is important because, if inadequate, it can lead to premature failure or reduction of the life of a roofing system, amplification of mold growth on attic and crawlspace surfaces, and degradation of structural members in attics and crawlspaces, which may negatively impact the life of roof and interior structural systems.¹⁻³ For example, when attic ventilation is inadequate, it is common to observe thermal degradation (i.e., shrinkage, cracking, and blistering) of asphalt roof shingles on the south- and west-facing elevations (Figure 12.1), resulting in reduced life of the shingles.

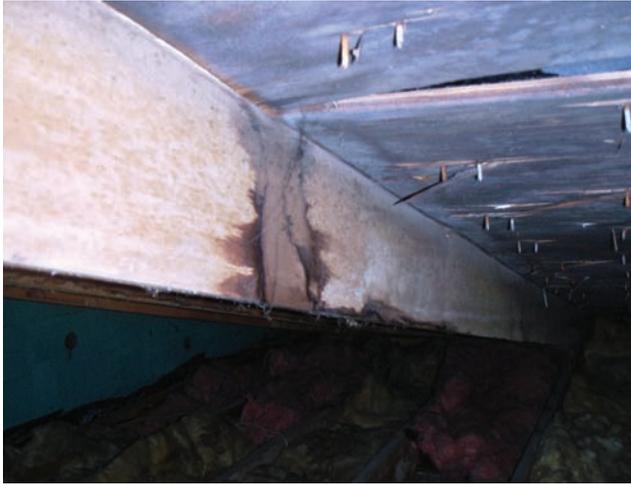
**FIGURE 12.2**

Illustration of visible mold on attic roof decking caused by inadequate attic ventilation.

10%. Conversely, attic temperatures can approach outdoor temperatures during the colder months, which helps to prevent ice damming. Additionally, it is very common to observe probable visible mold and water-damage staining on attic roof wood decking and rafter members (Figure 12.2) when attic ventilation is inadequate. It is also common to observe condensation droplet splatter marks on attic floor surfaces (Figure 12.3) when attic ventilation is inadequate.

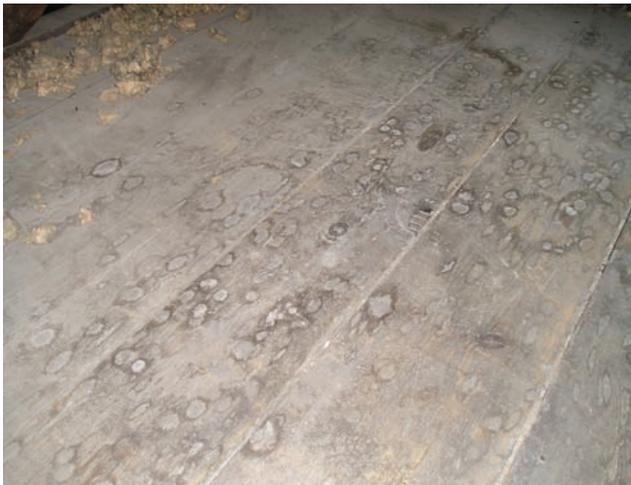
**FIGURE 12.3**

Illustration of water condensation drip staining on attic floor boards caused by inadequate crawlspace ventilation.

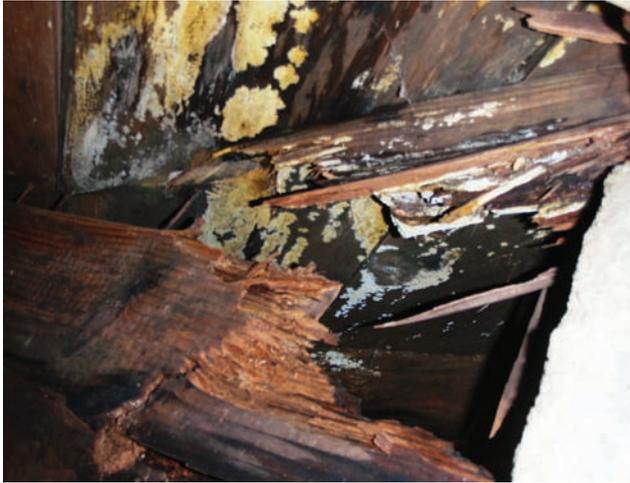
FIGURE 12.4

Illustration of visible mold and wood joist and wood sub-floor degradation caused by inadequate crawlspace ventilation.

or failure of crawlspace wood joists and subfloor decking (Figure 12.4). Such conditions encourage the presence of wood-destroying insects such as ants and termites that accelerate the destruction of structural support members in homes and commercial buildings.

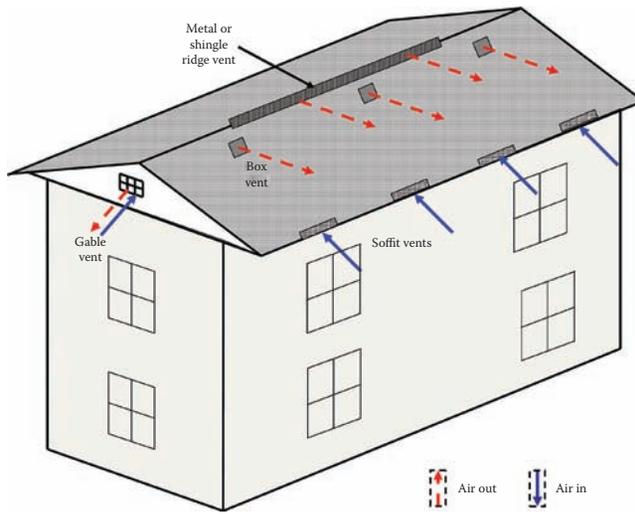
FIGURE 12.5
Illustration of passive ventilation openings for a typical attic.

Attics are typically passively vented using a variety of vent types or openings. These are illustrated in Figure 12.5. The concept of passive ventilation is to introduce cooler outside

air at intake positions lower in the attic and discharge warmer air near the peak of the roof to take advantage of the chimney effect associated with heated air. Typically, the intake fresh (cooler) air is introduced at the soffit (i.e., soffit vents) of a building or sometimes through gable vents. Conversely, exhaust (warm) air is typically discharged from an attic through box vents, ridge vents (metal or shingle covered), or gable vents. Mechanical exhaust ventilation is occasionally observed in residential and light commercial buildings; typical vents include power vents and turbine vents. Examples of each of these vent types are illustrated in Tables 12.1, 12.2, and 12.3.¹⁻⁹

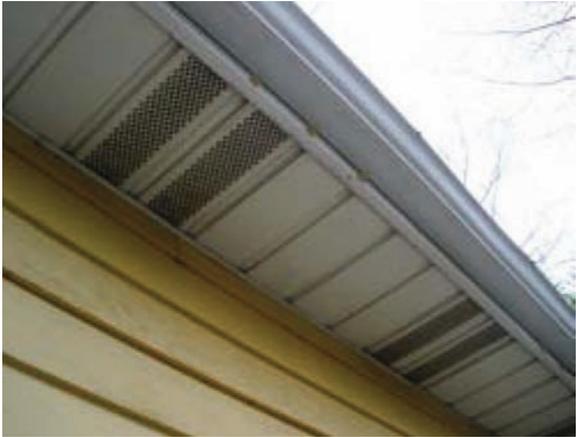
Intake Vent Types	Photograph
Lance soffit vents—approximately 4" × 16" panels

A photograph showing lance soffit vents installed in a roof soffit. The vents are rectangular panels with a mesh screen, set against a background of white horizontal siding. A white gutter is visible at the top right of the frame.
Strip soffit vents (note these have been partially painted over)

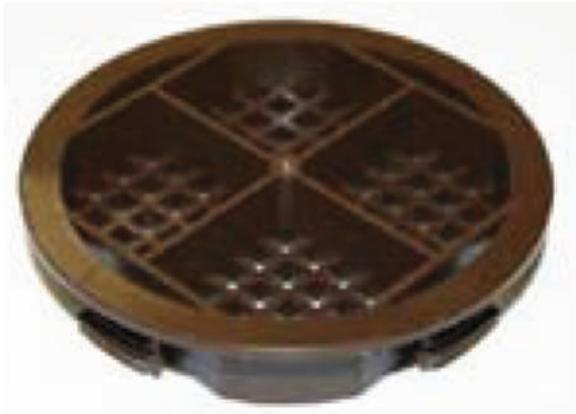
A photograph of strip soffit vents. The vents are white plastic strips with vertical slats. Some of the vents are partially covered with white paint, which is visible as a solid white area on the left side of the image.
Round soffit vent plugs

A photograph of a round soffit vent plug. The plug is circular and has a dark brown or black finish. It features a grid pattern of small square openings in the center, surrounded by a raised rim.

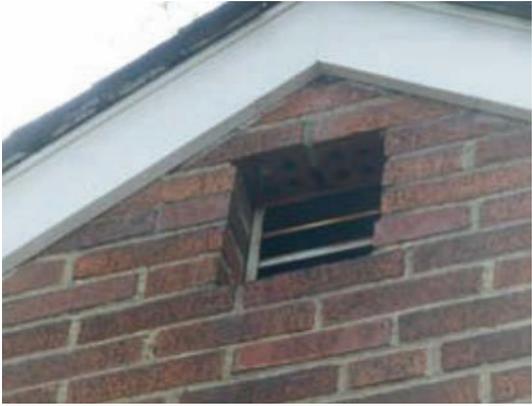
Intake Vent Types	Photograph
Gable vent (can be either an intake or an exhaust vent)

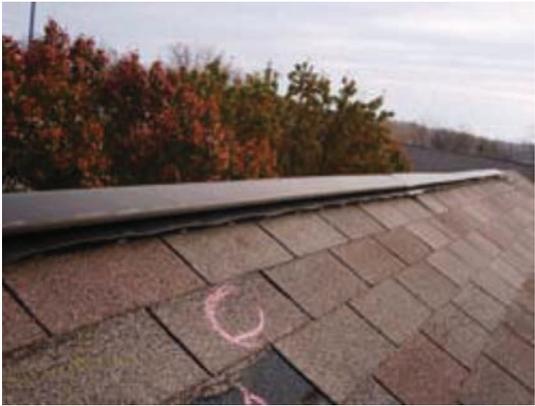
Exhaust Vent Types	Photograph
Metal ridge vent

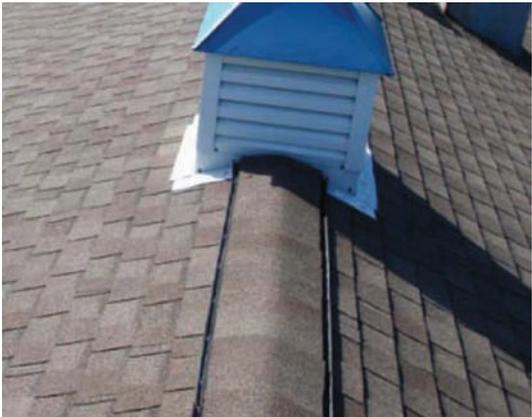
Shingled ridge vent

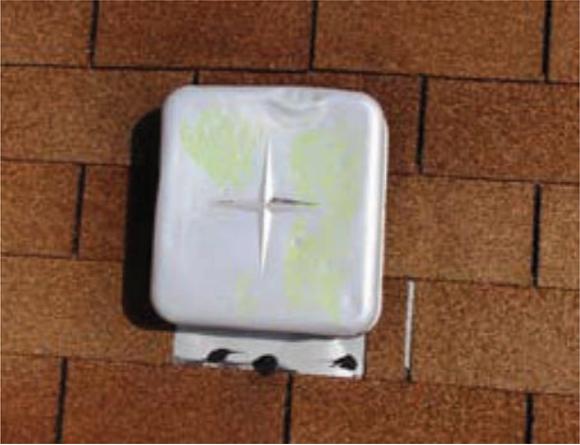
Exhaust Vent Types	Photograph
Box vent—square

A square white box vent with a cross-shaped vent cover is mounted on a brown shingled roof. The vent has a white metal base with two screws visible.
Box vent—slant backed

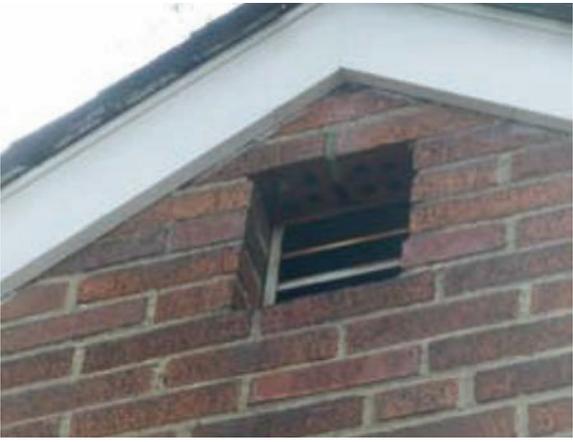
A white slant-backed box vent is mounted on a brown shingled roof. The vent is rectangular with a slanted top surface and a white metal base.
Gable vent (can be either an intake or an exhaust vent)

A gable vent is installed in a brick wall under a roofline. The vent is a dark rectangular opening with a white frame, set within a gable end of a brick structure.

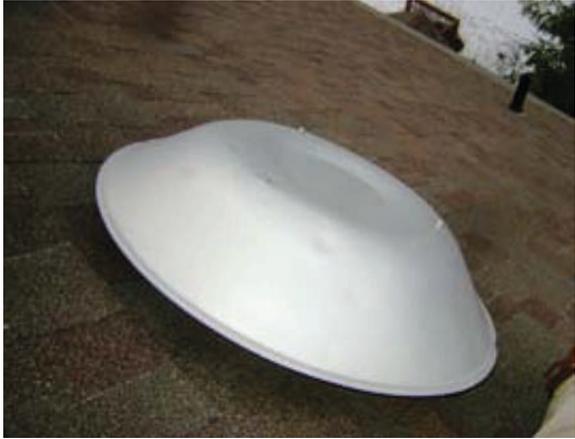
Mechanical Exhaust Vent Types	Photograph
Power vent

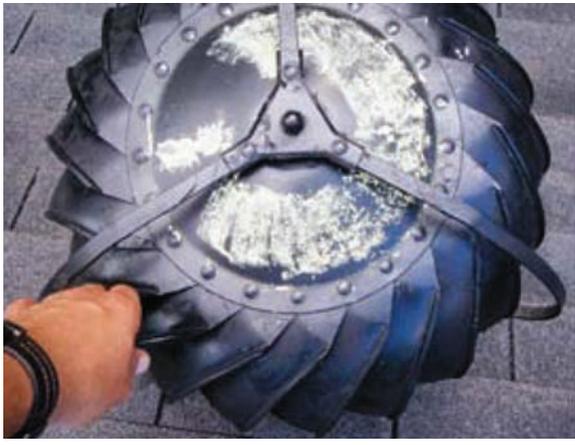
Turbine vent

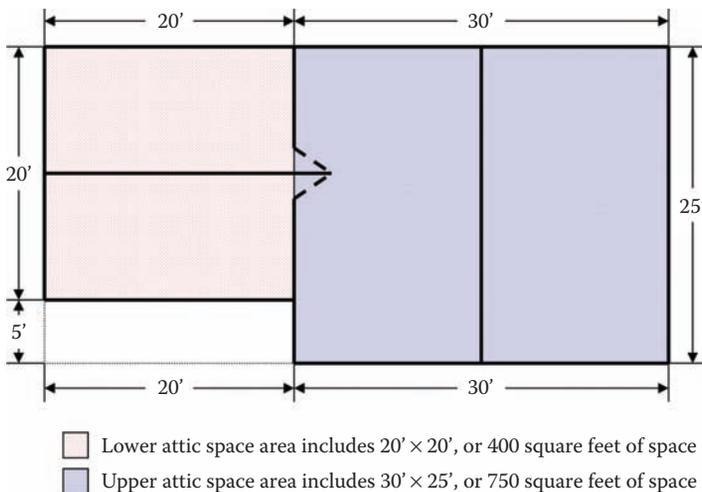
FIGURE 12.6

Example calculation of attic area.

The plan (i.e., floor) dimensions of an attic space must be measured or obtained from drawings to determine the proper NFVA. This area calculation is the basis for intake and exhaust ventilation considerations. An example attic for use in this example is shown in Figure 12.6.

Assuming the attic spaces are continuous and a vapor barrier is not present, the total plan area of the attic from Figure 12.6 is 1,150 square feet (i.e., $750 + 400$). Using a ratio of 1:150 for NFVA, the total NFVA for the attic space would be approximately 7.67 square feet ($1150/150$). If split equally between intake and exhaust areas, the intake and exhaust NFVA needed would be approximately 3.83 square feet ($7.67/2$) each.

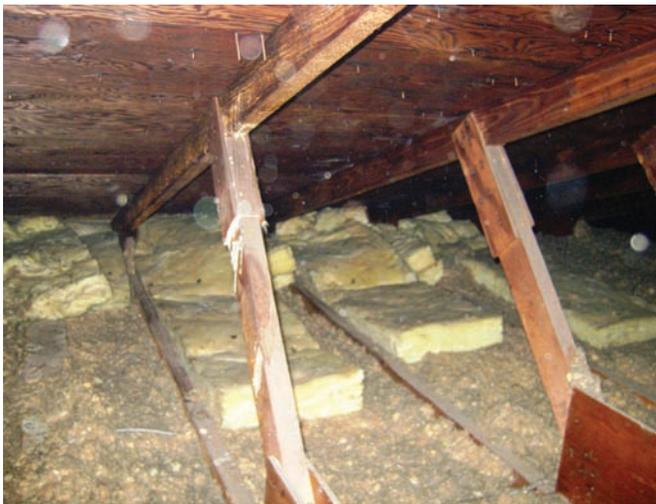
FIGURE 12.7

Attic eaves clogged with insulation.

Attic insulation that is blown in or rolled into the eaves (Figure 12.7) will strongly reduce intake ventilation flow into an attic. When adding blown-in insulation, baffles should be installed to keep the insulation back from the eaves.

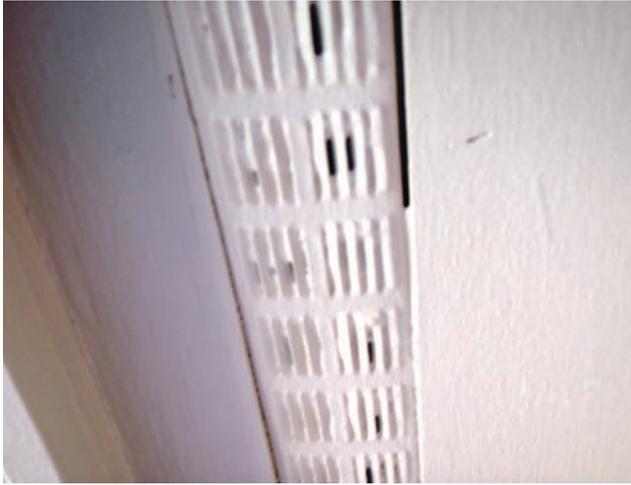
FIGURE 12.8
Soffit intake vents partially painted closed.

Two other factors that often reduce attic intake ventilation are when (1) soffit vents are painted or partially painted closed during maintenance activities (Figure 12.8) and (2) soffit vents are eliminated by additions, such as a closed-in porch or an added garage.

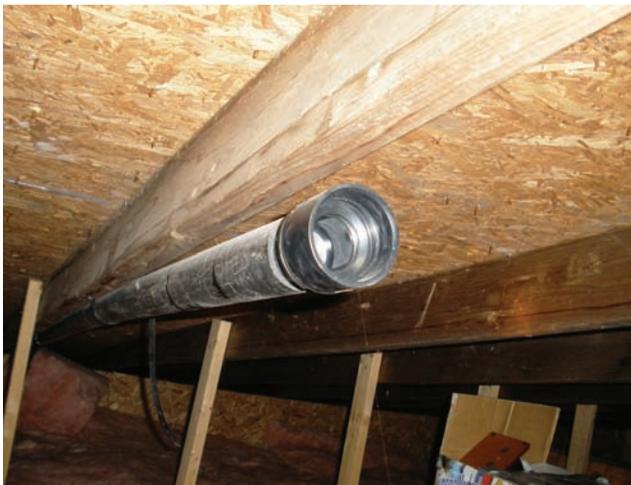
FIGURE 12.9
Soil stack vented to an attic space.

Ventilating plumbing (soil stack pipes; Figure 12.9), bathroom vents (Figure 12.10), clothes dryer vents, and flue vents exhausting into an attic space generally result in moisture loads that cannot be handled by typical natural convection attic ventilation and often lead to mold formation on the roof decking. These situations should be noted during the inspection and recommendations made to extend these vents to the outdoors.

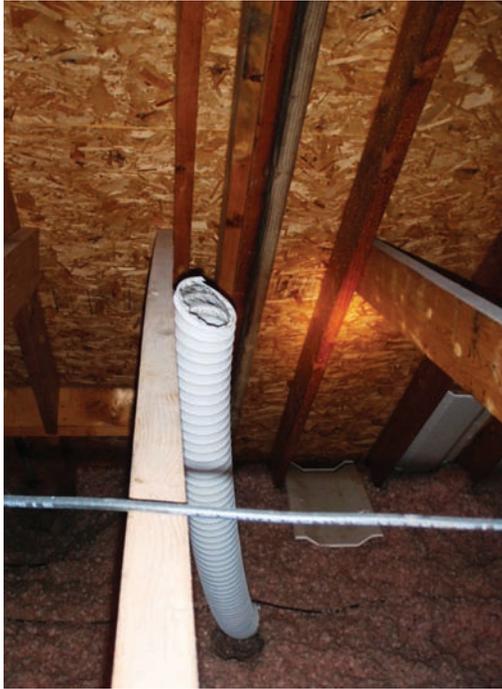
FIGURE 12.10
Bathroom vent vented to an attic space.

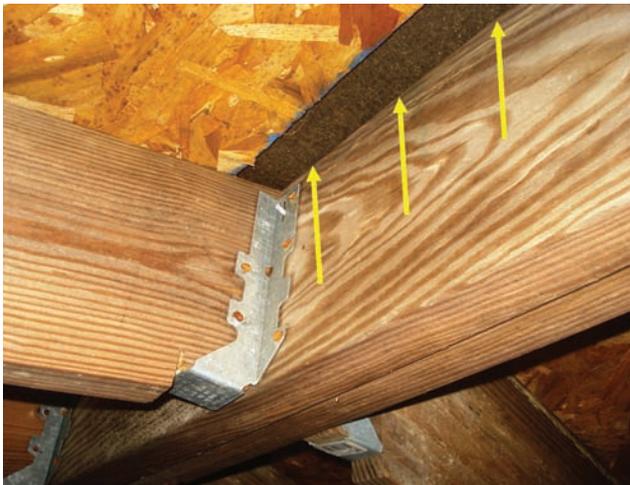
FIGURE 12.11
Ridge vent opening covered with shingles.

A final issue that has been surprisingly often encountered during several cases has been the installation of false exhaust and intake vents. For example, one home had continuous ridge vents installed along every ridge on the exterior of the home. However, the newly installed roof sheathing developed extensive mold growth in a three-month time frame. When the attic space was inspected, the ridge vent opening had been cut into the

sheathing, but the shingles and underlayment were installed over the opening (Figure 12.11). In a similar case with attic mold growth, the eaves of a home contained continuous vents around the entire perimeter of the exterior of the home that appeared to provide adequate ventilation, yet no light or insulation blockage was observed in the attic. Some of the soffit vents were removed, and it was discovered that no openings had been cut into the soffit area (Figure 12.12).

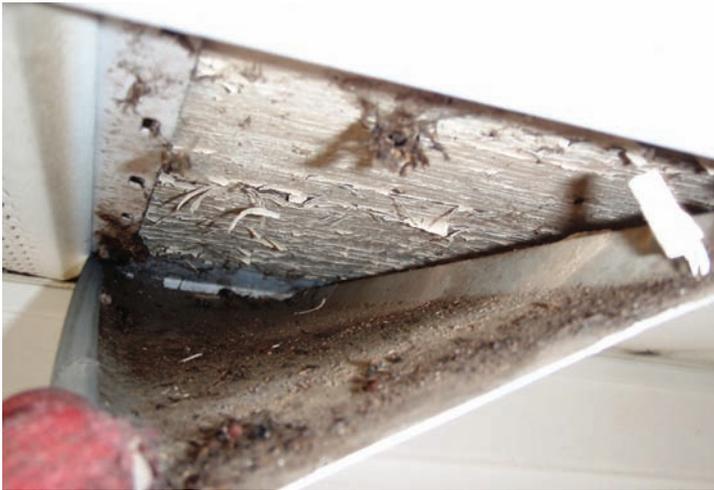
FIGURE 12.12
No opening cut into soffit for vent.

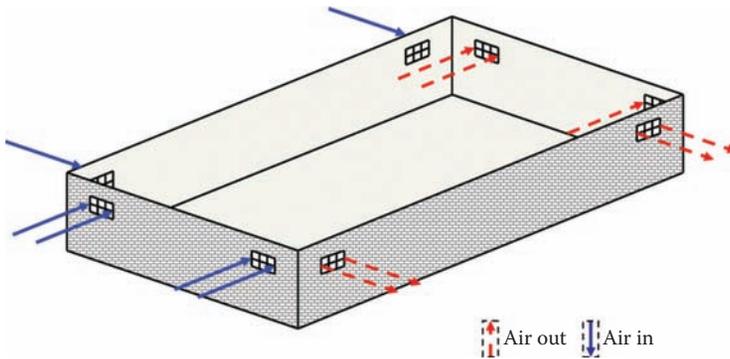
FIGURE 12.13
Illustration of passive ventilation openings for a typical crawlspace.

Crawlspaces are typically passively vented using screened rectangular openings in the upper foundation walls. This type of ventilation is illustrated in Figure 12.13. Note that in this case, those vents that serve as intake vents and those that serve as exhaust vents typically depend on the pressurization of the home and the wind direction or speed.

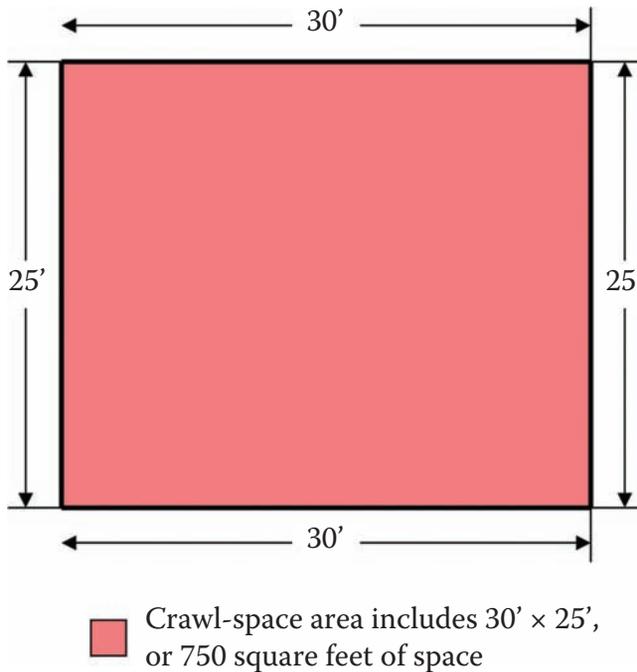
**FIGURE 12.14**

Example of a crawlspace area calculation.

The plan (i.e., floor) dimensions of a crawlspace must be measured or obtained from drawings to determine the ventilation area. An example of a simple crawlspace is shown in Figure 12.14. Assuming the crawlspace area is continuous and a vapor barrier is not present, the total plan area of the crawlspace from Figure 12.14 is 750 square feet. Using a ratio of 1:150, the total ventilation opening needed for this crawlspace would be approximately 5.0 square feet (750/150). Assuming the screen type was approximately 1/16-inch mesh, the effectiveness factor of the opening would be 0.5 (Table 12.5), resulting in an effective vent opening area needed of 10 (5/0.5) ft². A variety of combinations for the number of openings and area per opening can be used to satisfy this total ventilation requirement. Regardless, it is best to have at least one opening on each elevation (and preferably two), each spaced as evenly as possible around the perimeter of the building.

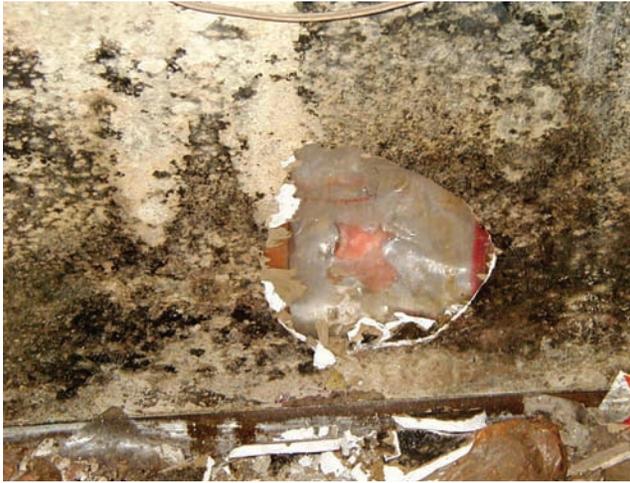
**FIGURE 13.1**

Probable visible mold on dining room wall surface—hole into wall cavity.

Of course, the extent to which given taxa are found for a given location is highly dependent on local environmental conditions. Examples of surfaces contaminated by mold and bacteria are illustrated in Figures 13.1 and 13.2.

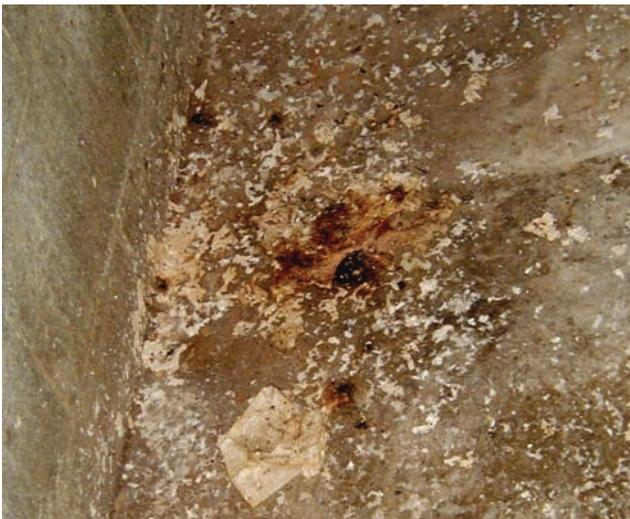
**FIGURE 13.2**

Sewage spill on basement floor below failed sanitary line.

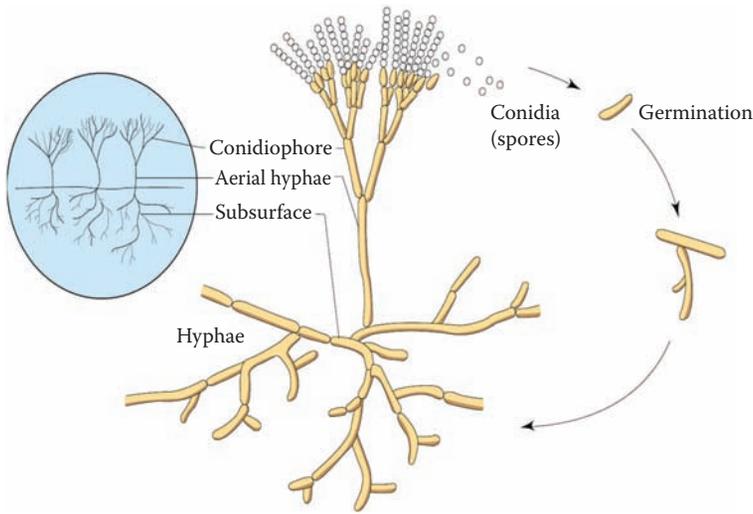
FIGURE 13.3
Mold life cycle.

Molds, mushrooms, mildews, and yeasts are all classified as fungi, a kingdom of organisms different from plants and animals.²³ Molds (fungi) are present almost everywhere,²³⁻²⁷ with hundreds of types of different molds found indoors. The kingdom fungi has been estimated at around 1.5 million species, with about 5% of these having been formally classified. For the purposes of this book, the less informal, but more common term *mold* will be used to describe fungi, although fungi is the more proper term scientifically. Of interest, the word mold is derived from the word “fuzzy” in the obsolete Old Norse language, which is how mold appears on surfaces when it amplifies to levels where it is readily visible. The mold life cycle and common mold terminology are presented in Figure 13.3.

The structure of mold contains subsurface elements called hyphae, surface elements called aerial hyphae, stem-like elements called conidiophores, and seed-like materials for reproduction known as conidia, or more commonly, spores. The release of spores allows for procreation or amplification of mold when environmental conditions are conducive for growth. Common molds and where they are often found are summarized in Table 13.2.

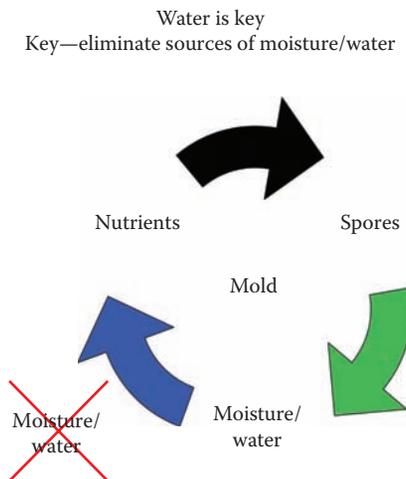
FIGURE 13.4
Environmental factors affecting the amplification of mold.

As illustrated in Figure 13.4, the presence of water or excess moisture levels is critical^{23–26,29} to the amplification of mold, since all other elements (i.e., right temperature range, food, mold spores, and areas with limited air velocity and light) are typically present somewhere in the indoor environment.

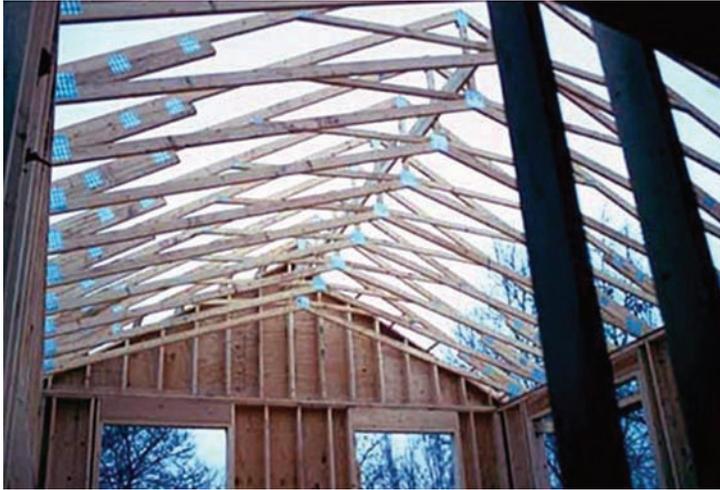
FIGURE 14.1
Roof framing system—pre-engineered press-plated wood trusses.

This framing system utilizes pre-engineered press-plated wood trusses uniformly spaced across the structure. These trusses are typically constructed with nominal 2x (two-by) dimensional lumber for the top and bottom members called chords and the diagonal members called webs. The members are typically held together with metal gusset plates at each joint. The plates are secured to the wood members by rolling the entire assembly through a hydraulic press. The trusses with this type of framing system typically span from bearing wall to bearing wall with no intermediate support. An example of a pre-engineered press-plated wood truss roof framing system is shown in Figure 14.1.

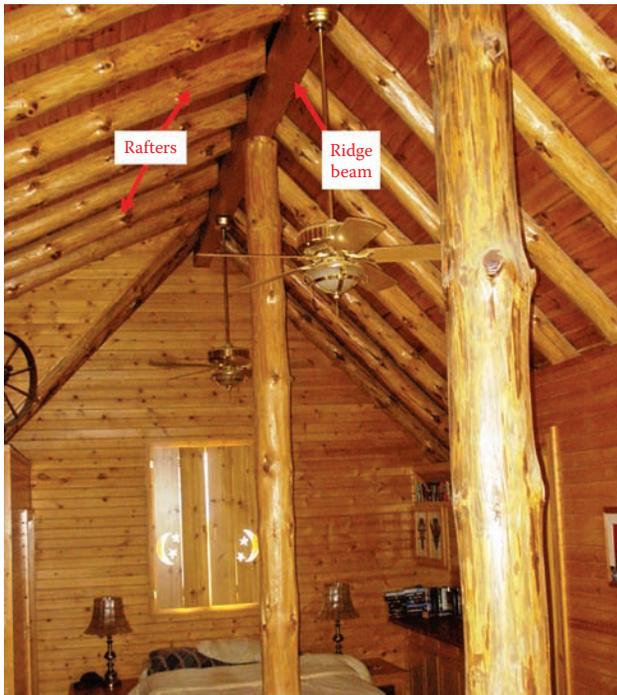
FIGURE 14.2
Roof framing system—ridge beam and rafters.

Ceiling joists may or may not be present; however, if joists are present they are typically not sufficiently attached to the rafters to resist any thrust (horizontal force) created at the bottom of the rafters (see discussion in the next section). This type of construction is generally referred to as stick framing. An example of a roof framing system consisting of a ridge beam and rafters is shown in Figure 14.2.
