FORENSIC ENGINEERING

**Damage Assessments for
Residential and Commercial
Structures**

**Edited by
Stephen E. Petty**

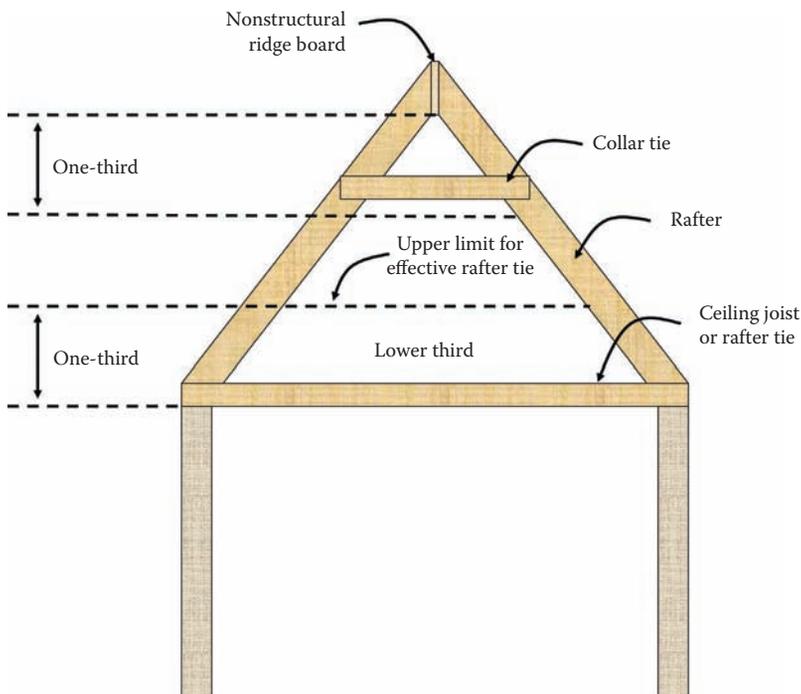
FIGURE 14.3

Roof framing system—rafters with ceiling joists or rafter ties and collar ties.

A common misconception is to refer to the rafter ties as collar ties. Collar ties and rafter ties are both horizontal framing members typically found in roof stick-framed construction; however, each has a different purpose, location, and attachment requirement. Rafter ties are designed to tie the bottoms of opposing rafters together.⁵ When a sloped roof is framed with rafters butting against a ridge board and subjected to loads, vertical and horizontal forces are created at the bottom of the rafters. The vertical forces are resisted by the exterior bearing walls. However, the exterior bearing walls cannot resist the horizontal forces (thrust) exerted on them. The thrust must be resisted through adequately connected continuous ceiling joists or ties across the building. Rafter ties form the bottom chord of a simple triangular roof truss. They should be placed as low as possible in the roof framing, ideally in the lower third of the roof rafter. Collar ties are designed to tie the tops of opposing rafters together. This helps brace the roof framing against uplift caused by wind. Collar ties must be placed in the upper third of the roof rafters.⁵ An example of a roof framing system consisting of rafters and ceiling joists and rafter ties along with collar ties is shown in Figure 14.3.

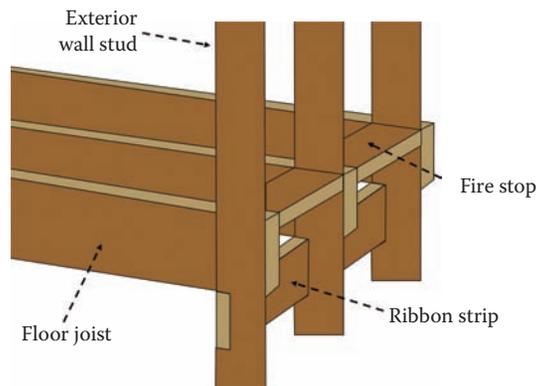
FIGURE 14.4
Balloon wall framing.

The studs in balloon walls are continuous from the sill plate supported by the foundation wall to the top plates of the second story walls supporting the roof framing members. The second floor joists are typically supported by members called ribbon strips that are “let-in” or inserted into notches cut in the inside edges of the studs.¹ This type of construction results in continuous cavities between the wall studs from the first floor sill plate to the second story ceiling unless completely sealed fire blocking is installed between the studs at the second floor joists. Figure 14.4 shows the detail of balloon wall framing.

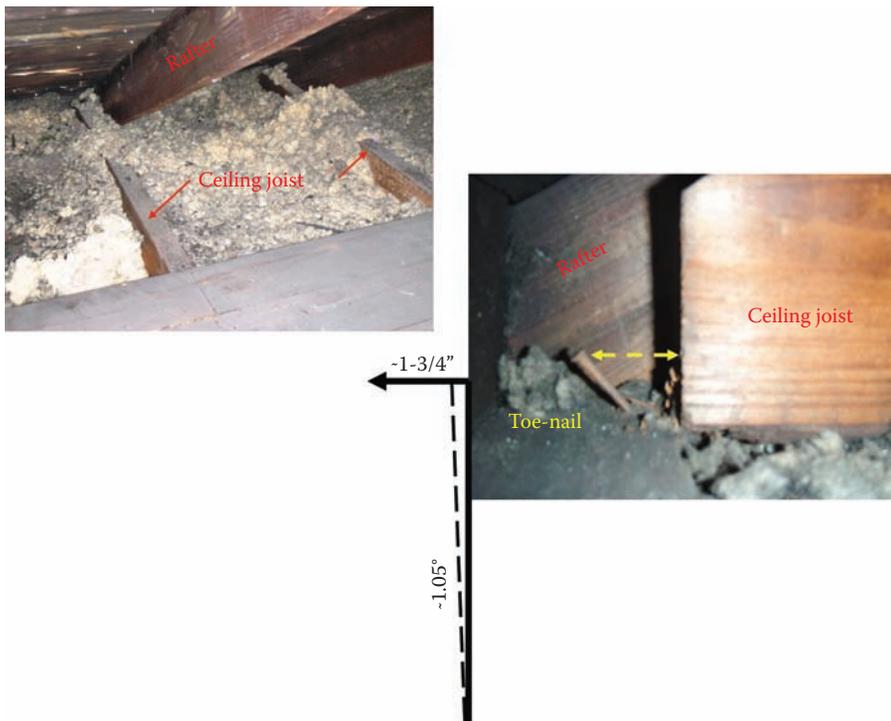
FIGURE 14.5

Failure of ceiling joist connection and resulting displacement of exterior bearing wall.

As noted above, when a sloped roof is framed with rafters butting against a ridge board and subjected to loads, vertical and horizontal forces are created at the bottom of the rafters. The vertical forces can be resisted by the exterior bearing walls, but the exterior bearing walls cannot resist the horizontal forces (thrust) exerted on them. However, this thrust can be resisted by using continuous ceiling joists or ties across the building that are adequately attached to the rafters. If continuous ceiling joists or ties are not present, a ridge beam must be provided to support the ends of the rafters at the ridge, eliminating the thrust at the bottom of the rafters. If adequately attached continuous ceiling joists or ties across the building or a load-bearing ridge beam are not provided, the rafters tend to push out the exterior bearing walls (Figure 14.5), and the nonload-bearing ridge board becomes a load-bearing ridge beam. The ridge board is usually not sufficient or intended to carry any load and therefore deflects (sags) excessively or fails as a result.

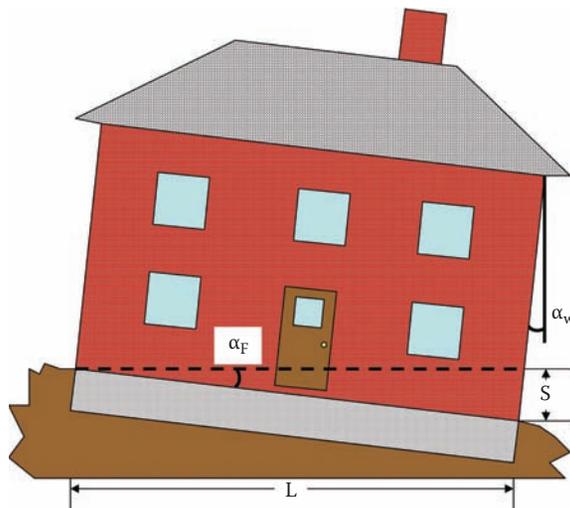
FIGURE 14.6
Wall tilt schematic.

The question arises when completing forensic investigations as to when the tilt or out-of-plumb of a wall is within tolerance, could be visibly observed, or may be unstable (Figure 14.6). In other words, at what point does the tilt of a wall transition from being merely a cosmetic issue that is readily visible yet does not greatly impact the structural stability of the wall to one that is out of tolerance and affects the structural stability of the wall? Dickinson and Thorton stated that an out-of-plumb wall (i.e., tilted wall) will not be noticeable (cosmetically) until the angle of the tilt compared to a vertical line (expressed as a ratio of L/#) is in the order of L/200 to L/250 (~0.23 to 0.29 degree).¹⁰ On the other hand, many sources (see Chapter 15, this volume, for detailed information on this topic) cite wall slope tolerances of up to 0.59 degree or approximately 0.6 degree. Therefore, from a cosmetic or tolerance standpoint, walls out-of-plumb or tilted less than or equal to 0.6 degree are acceptable.

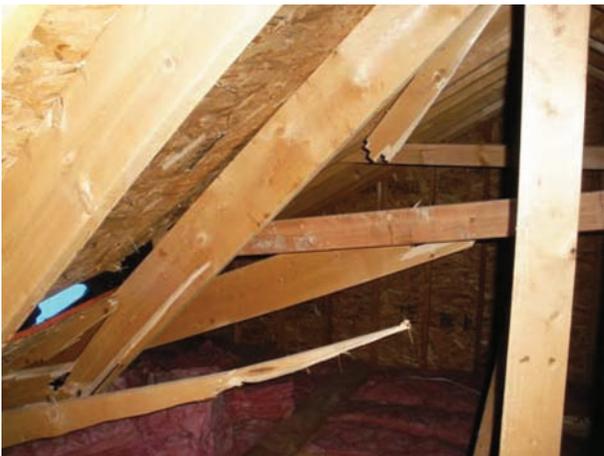
Structural Damage	Photograph
Impact damage due to fallen tree (note hole in decking and broken upper rafter members). Always check all members, including ridge members the entire length of the attic space, not just where the impact occurred. Subtle breaks of main beams can be determined using a change in slope between rafters and an electronic level.

The investigator is cautioned not to just inspect and document the damage at or near the impact zone, but to include the entire framing system as well. Due to the interconnectedness of most framing systems, damage can occur at distances well beyond the impact zone. For example, in one case where a roof system was damaged due to impact from a fallen tree, the

main structural composite wood ridge beam was visibly damaged at the impact location. However, during further investigation the ridge beam was also found to be cracked approximately 25 feet away from the direct impact zone. The roofing contractor, owner, and insurance agent had not observed this crack. The consensus prior to the engineering inspection had been to reinforce the main beam at the impact location and remove or replace damaged rafters and roof decking in the impact zone. Had this been done, a roof system with a cracked ridge beam would have been left in place. The key was to inspect the entire attic for any damaged members; in this case the ridge beam contained damage far away from the impact zone.

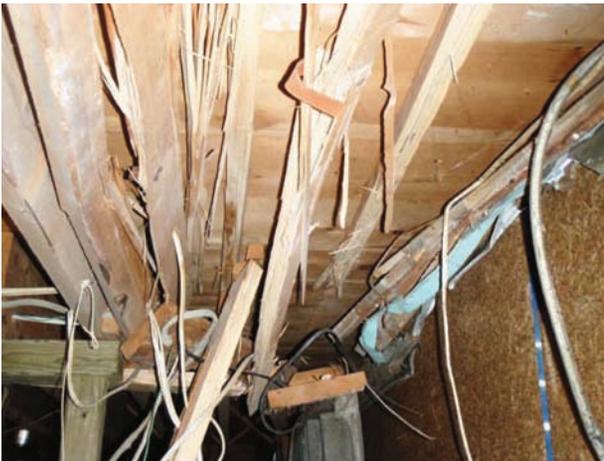
Impact damage due to vehicle striking a structure

Damage due to the impact of a vehicle is discussed in further detail in Chapter 18, this volume.

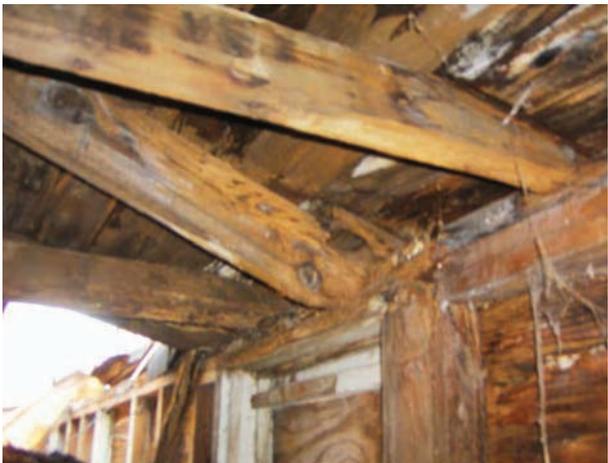
Structural Damage	Photograph
Water infiltration and rot damage to wood members

Structural framing members can become damaged through decay due to water infiltration. Water weakens wood framing members by providing the needed moisture for colonies of bacteria and fungi to grow, which digest the organic material (e.g., lignin) within the wood. This is known as wood rot. Additionally, wet or moist wood framing members are more susceptible to insects, which are attracted to wood in these conditions. The insects bore into the members and feed on the organic materials within the wood.¹¹

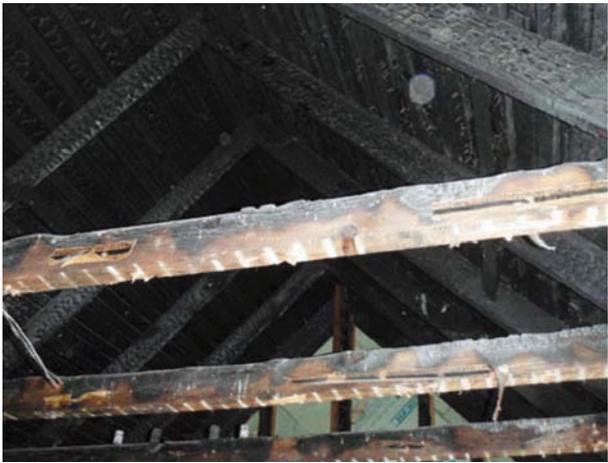
A photograph showing the interior of a structure with significant water damage. The wooden framing, including joists and rafters, is heavily discolored, warped, and shows signs of rot. The wood is a dark, mottled brown color, and there are visible signs of decay and structural weakening.
Fire damage to roof framing system

When structural framing members are damaged due to fire, the exposed outer layers of the member are oxidized away by the fire. In cases where a structural member is only partially consumed by fire, an insulating char layer will have formed that protected the core of the member. The relative extent of the char layer determines whether a significant portion of the original strength of the member has been lost due to fire. Heavy timbers (members 5 inches by 5 inches or greater) with larger cross-sections are more likely to be structurally adequate after a fire than a member with a smaller initial cross-section.¹⁴ The fire-damaged member will have a smaller than original cross-section (i.e., remaining core) and therefore less load-carrying capacity. Depending on the original design, this capacity may or may not be sufficient to carry the imposed loads, resulting in a member deflecting excessively or failing. Model building codes do not have provisions that require residential framing systems to be sustainable after exposure to fire. Therefore, the rule of thumb in structural forensic investigations of residential structures is that any charred wood members should be removed and replaced (see Chapter 17, this volume, for further discussion on this topic).

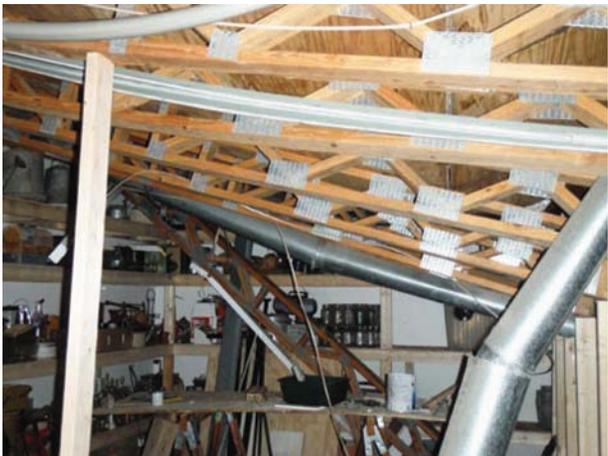
A photograph showing the interior of a structure with significant fire damage to the roof framing. The wooden members are charred, blackened, and heavily damaged. The structure appears to be a roof truss system, with the wood showing a dark, charred appearance and significant structural degradation.
Damage to floor framing system due to propane gas explosion within residence

Structural framing members or systems can become damaged from blasts and explosions. This type of damage primarily occurs from one of three events: (1) blasts from nearby quarrying (surface) operations, (2) blasts from nearby mining (surface and subsurface) operations, or (3) propane and natural gas explosions. Damages to nearby residential structures from blasts associated with any of these three events can be minimal to catastrophic (see Chapter 20, this volume, for further discussion on this topic).

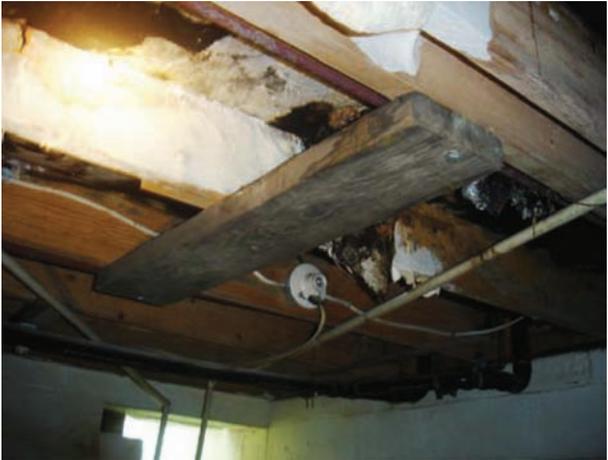
Structural Damage	Photograph
Localized failure of floor framing system (improper repairs/modifications)

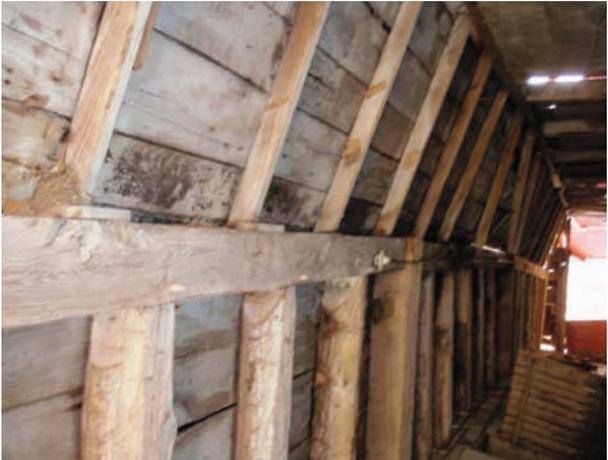
Tilting wall (inadequate lateral support/bracing)

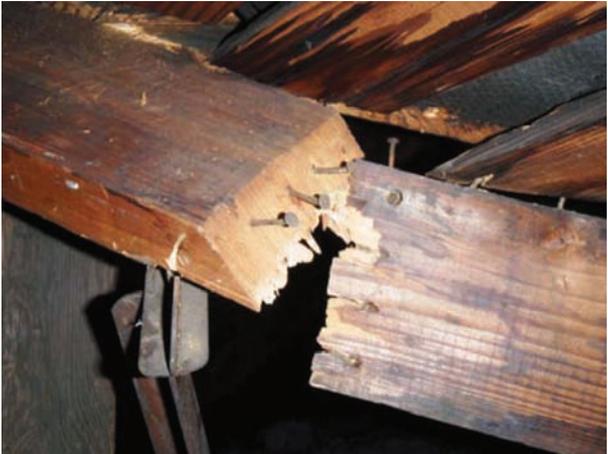
Failed roof rafter system due to improper construction (inadequate splice in hip beam member)

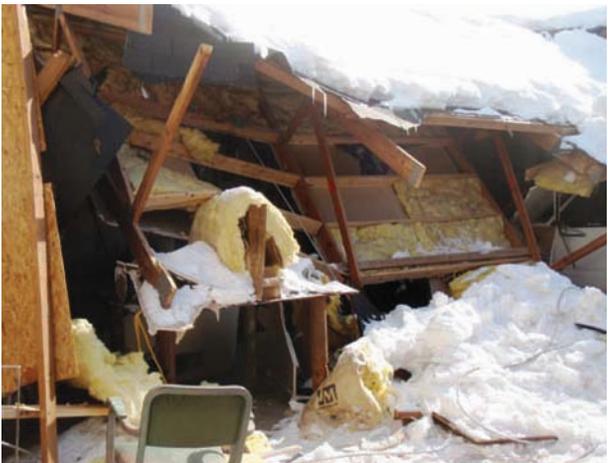
Structural Damage	Photograph
Failed under-designed roof truss framing system

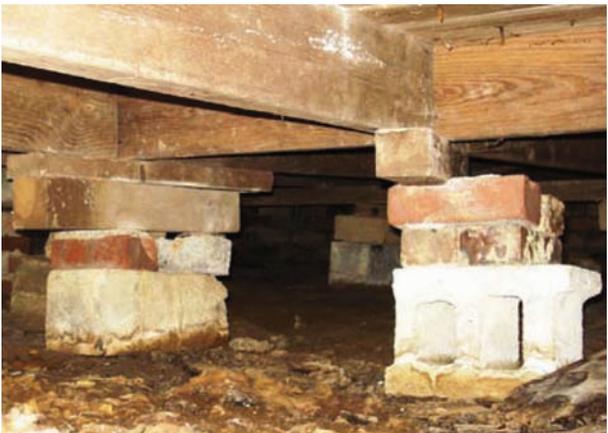
Sagging floor system (improper support piers)

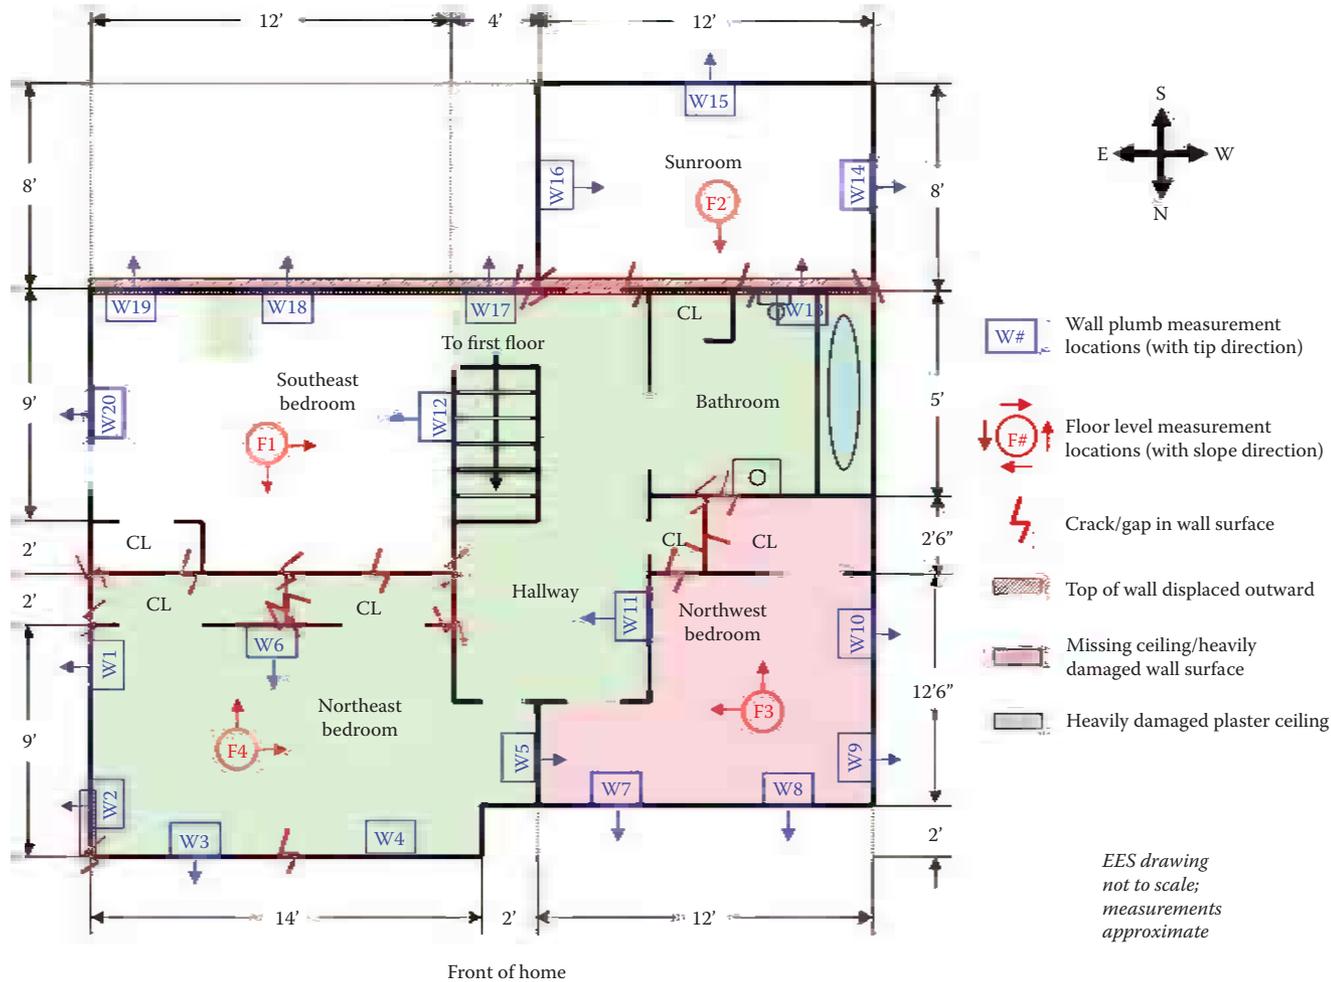
FIGURE 14.7 Computer-aided schematic—floor plan with key observations (developed from onsite measurements).

computer-aided schematic for an interior floor plan, along with identifiers indicating key observations applicable to the subject structure, is shown in Figure 14.7.

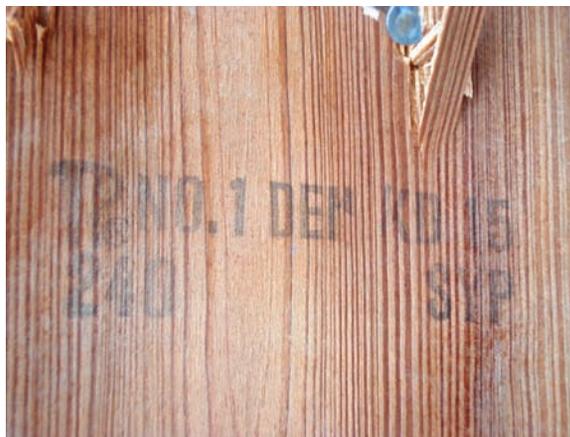
FIGURE 14.8

Typical identification stamp on newer wood framing member.

In newer construction, the species, grade, seasoning condition at time of manufacturing, producing mill number, and grading rules writing agency will be stamped periodically onto the wide face of the wood members.¹ An example of this stamp is shown in Figure 14.8.

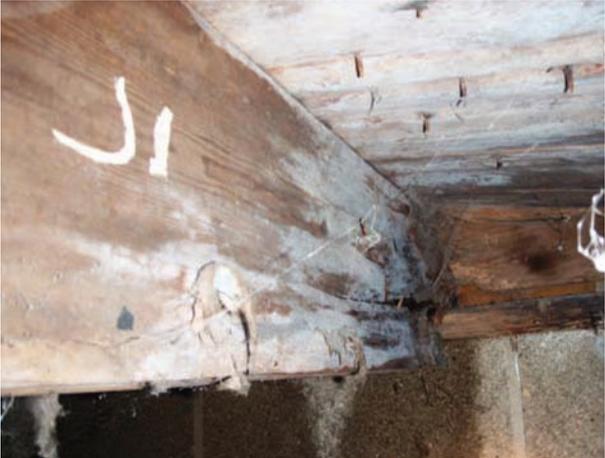
Type of Damage	Photograph
Water-damage staining and heavy rotting conditions to floor framing member

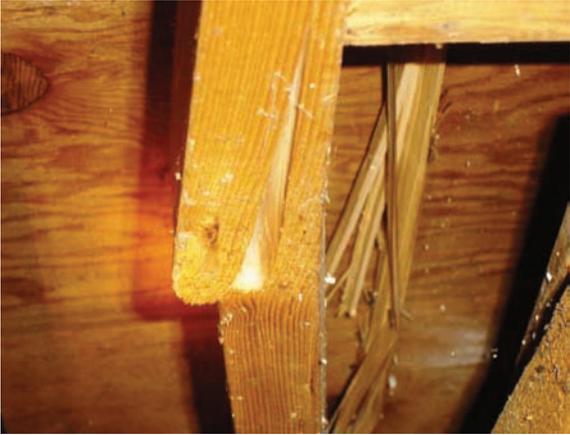
Structural Damage	Photograph
Cracked basement joist

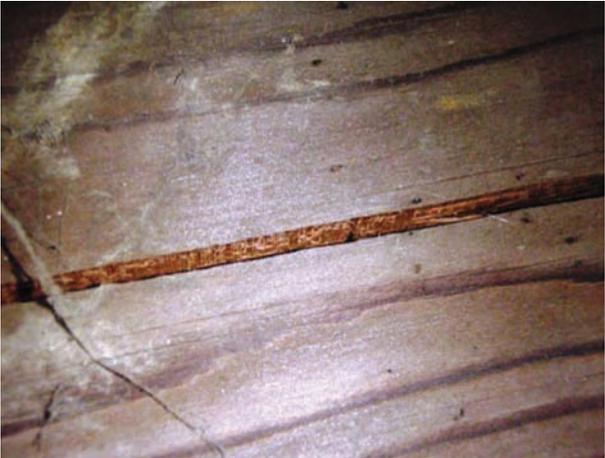
A photograph showing a corner of a wooden ceiling joist system. The wood is dark and shows signs of age and wear. A crack is visible in the wood, and the overall appearance is that of an older, possibly water-damaged or weathered structure. A metal rod or pipe is visible running across the joists.
Fresh in appearance split in framing member

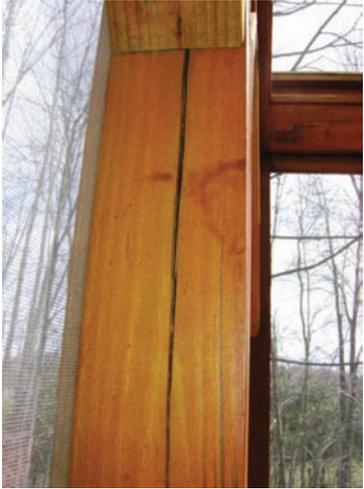
Structural Damage	Photograph
Check in support post

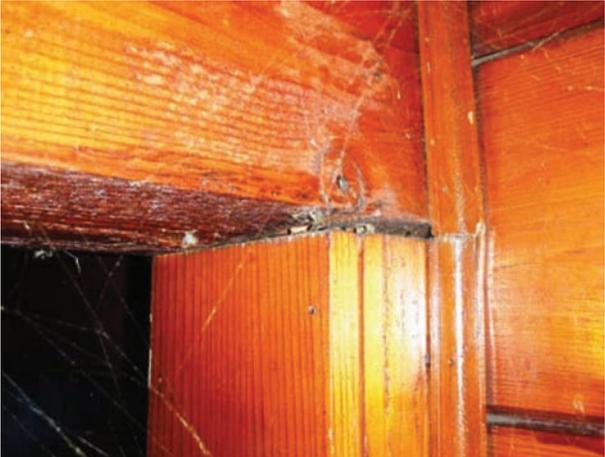
Gap between support beam and support post

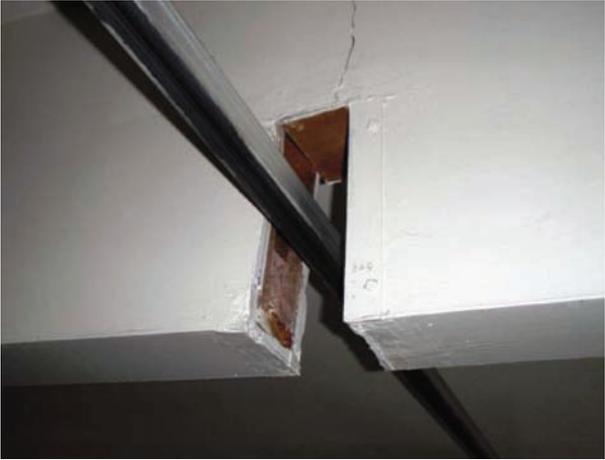
Modification to framing member (notch cut out of box beam)

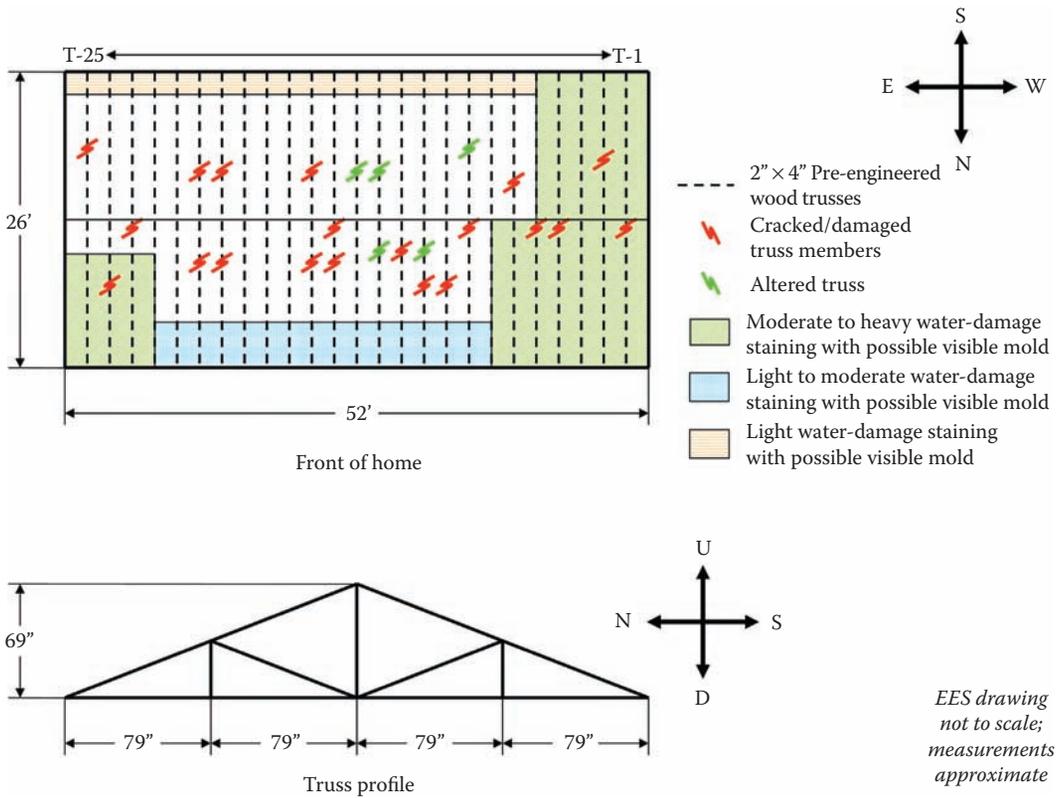
FIGURE 14.10 Computer-aided schematic—roof framing plan (roof truss system) with key observations (developed from onsite measurements).

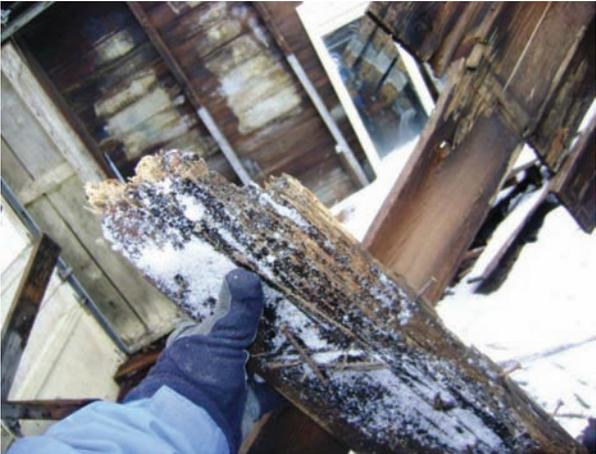
Structural Damage	Photograph
Heavy rotting conditions to roof framing member

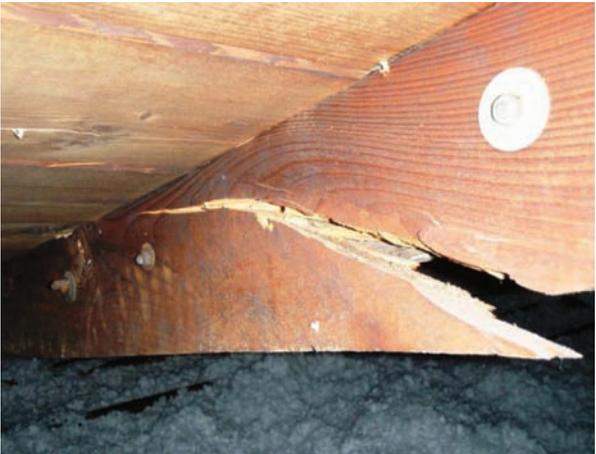
Broken roof rafter

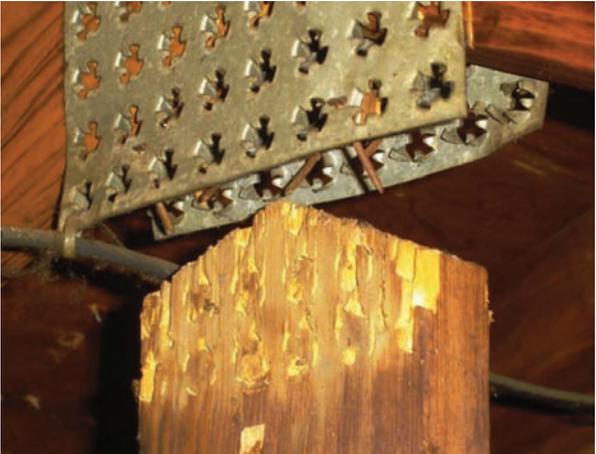
Separation of roof truss member at gusset plate

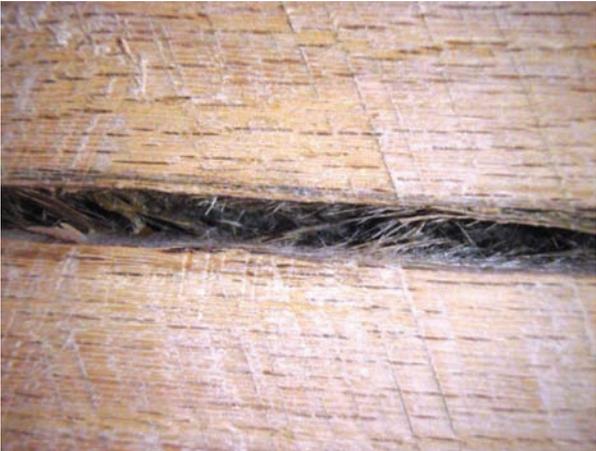
Structural Damage	Photograph
Check in roof framing member

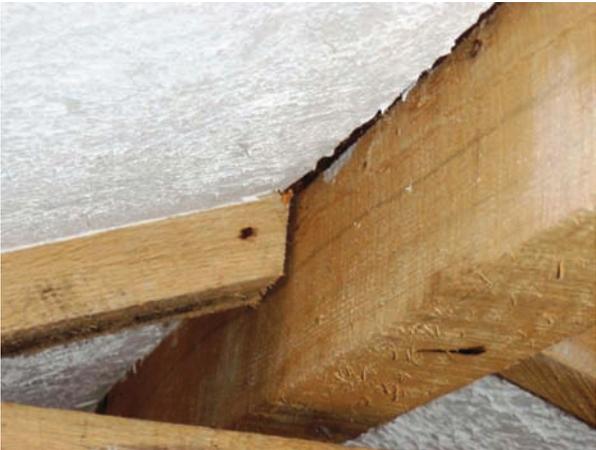
Gap between rafter and ridge beam of roof framing system

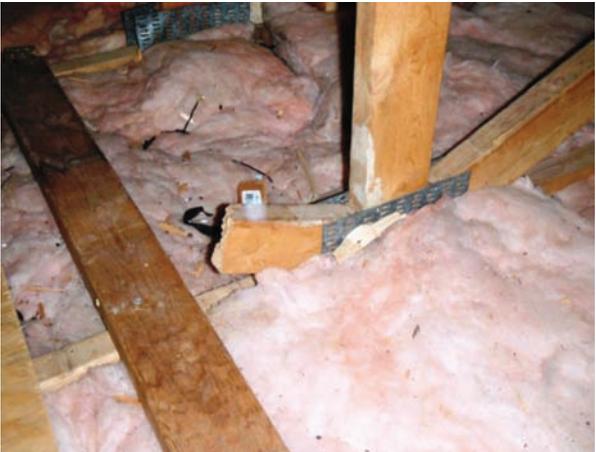
Modification to roof framing member (pre-engineer press-plated truss web cut and removed)

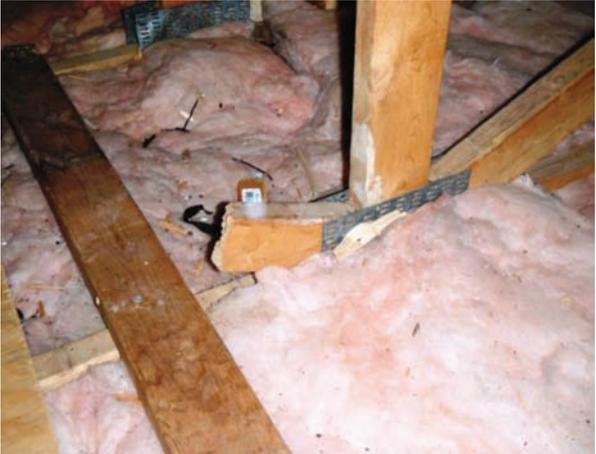
Structural Damage	Photograph
Modification to roof framing member (pre-engineer press-plated truss web cut and removed)

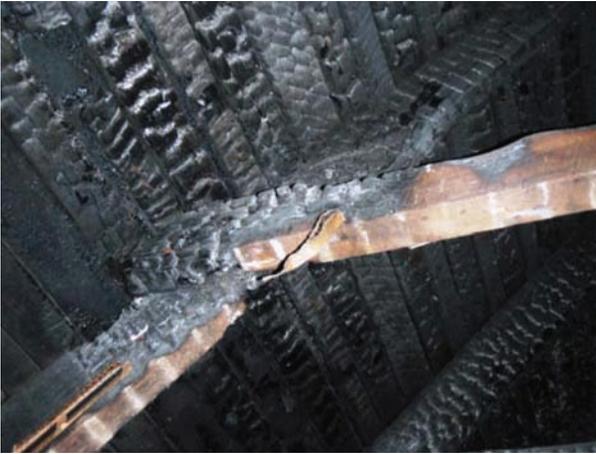
Fire damage to roof decking and framing members

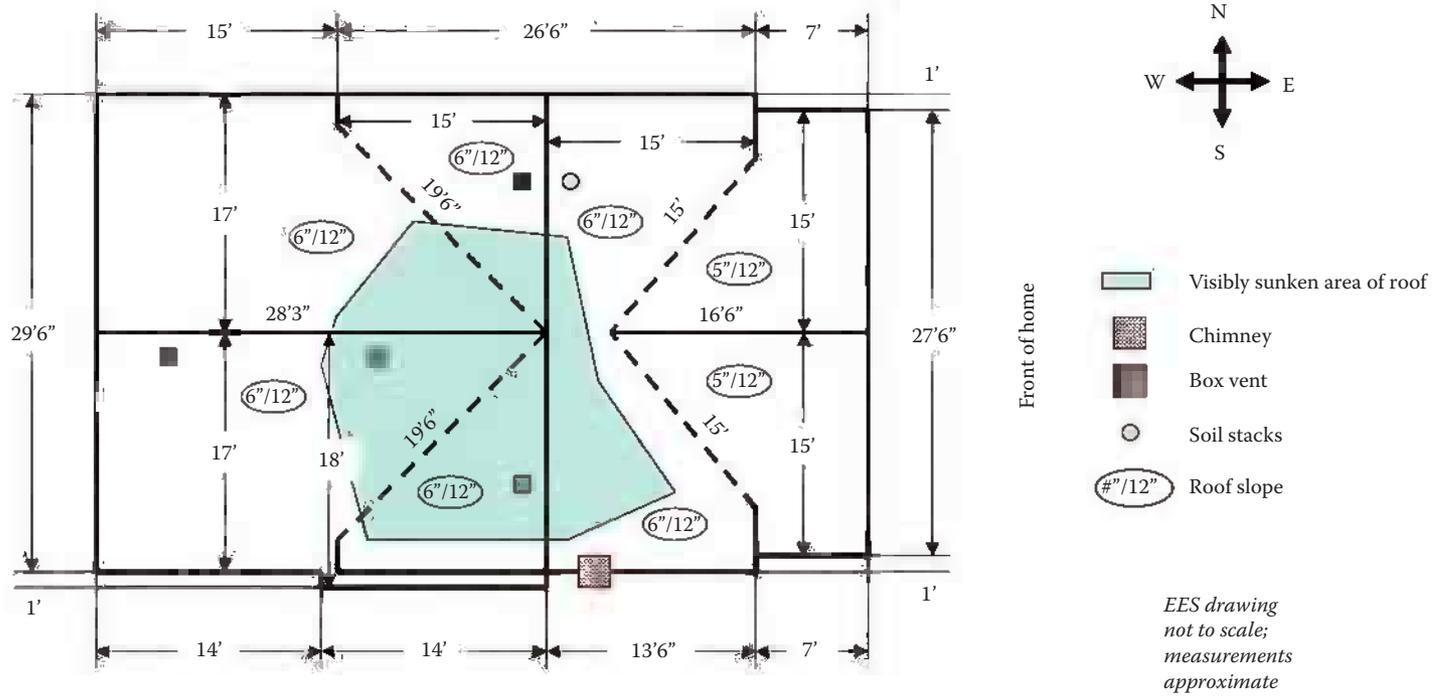
FIGURE 14.11
Computer-aided schematic—roof plan with key observations (developed from onsite measurements).

vents, soil stacks, and chimneys, are included in the sketch. The structure is drawn to scale as closely as possible and approximate exterior measurements are performed. Typically, the required exterior measurements include all ridge lengths, eave lengths, valley lengths, elevation slopes, and elevation pitches (measured in inches of rise per linear foot). An example of a computer-aided schematic of a roof plan, along with identifiers indicating key observations applicable to the subject residence, is shown in Figure 14.11.

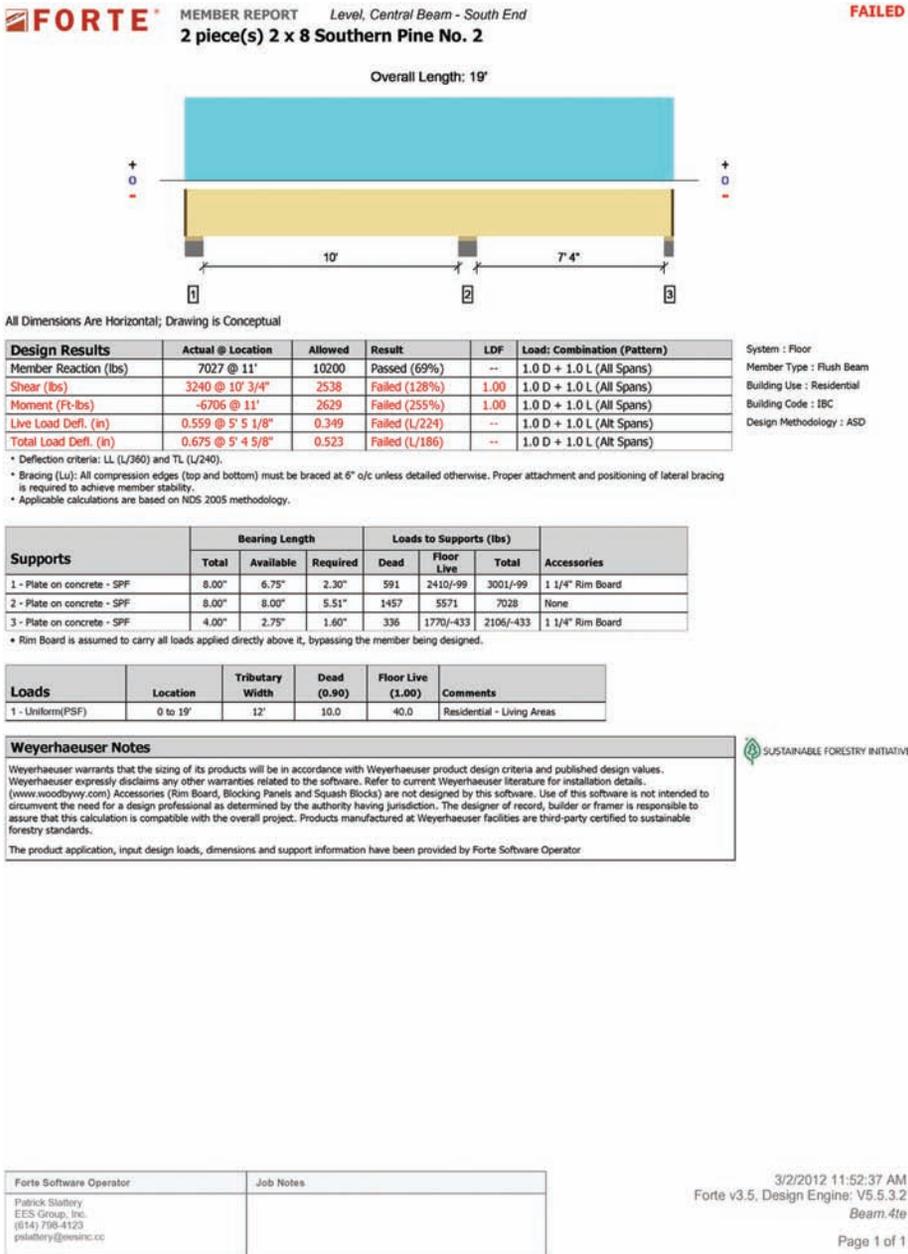
FIGURE 14.12 Example output from Forte Software. (Courtesy of Weyerhaeuser.)

Output from the Forte Software version 3.5 for this example is shown in Figure 14.12.

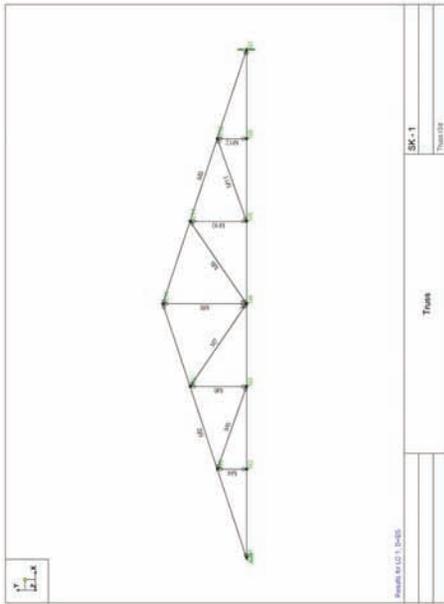
FIGURE 14.13 Example RIS-3D program output. (Courtesy of RISA Technologies.)

Output from the RISA-3D program version 9.0.1 for this example is shown in Figure 14.13.

The analysis indicated that the pre-engineered roof trusses above the original portion of the subject building were inadequate to support the current code minimum design

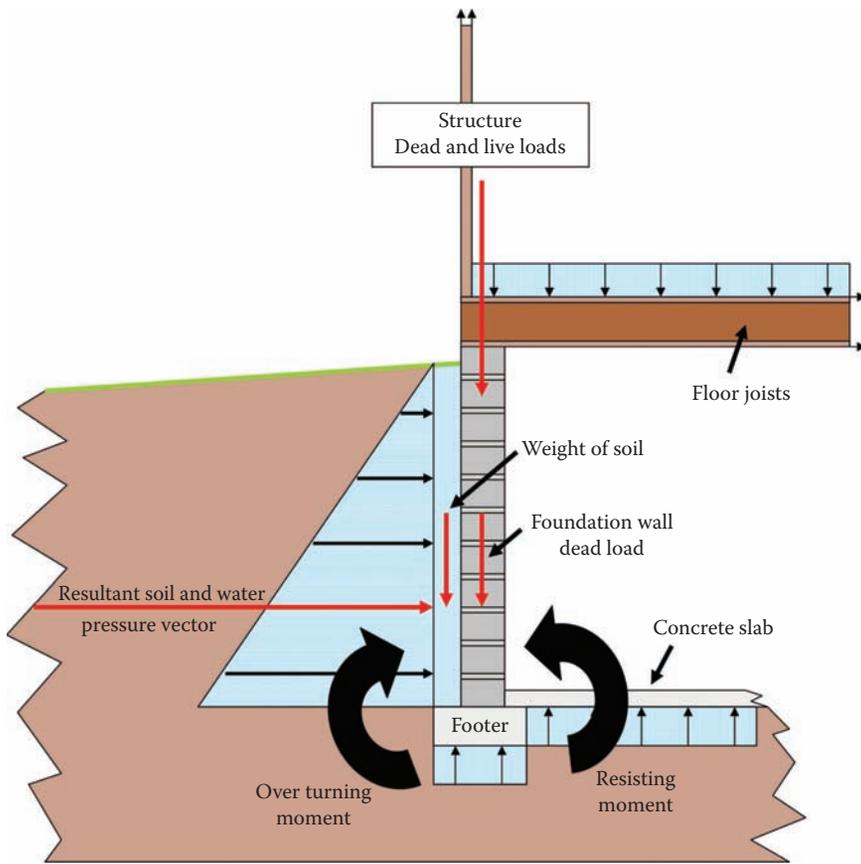
FIGURE 15.1

Typical foundation wall

Lateral soil pressure is the horizontal load generated by the weight of the soil retained by the wall. The lateral soil pressure increases linearly with depth, producing a triangular horizontal pressure gradient pattern, as illustrated in Figure 15.1.

Foundation wall distortion occurs when the overturning moment of the soil or water pressure is greater than the resisting moment of the wall. The resisting moment must be greater than the overturning moment to avoid foundation wall failures. The resisting moment typically depends on the physical properties of the wall (e.g., width, reinforcement), dead load and vertical loads imposed on the wall, and the interaction with the footing at the bottom of the wall and floor framing at the top of the wall. The overturning moment is any combination of lateral, surcharge, and/or hydrostatic pressures along with any other form of stress on the soil around the foundation wall. Figure 15.1 depicts the respective resisting and overturning forces on a typical foundation wall.

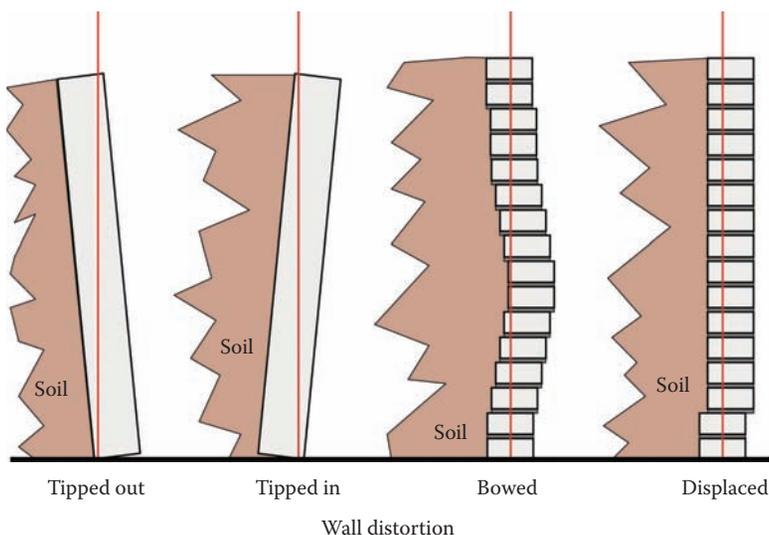
FIGURE 15.2

Four typical types of wall distortion.

As illustrated in Figure 15.2, the overturning forces exceeding the resistive forces can cause a wall to lean/tilt, bow, and/or shear/displace; in a worst case scenario, these forces will cause the foundation wall to collapse. Bowing and displaced walls are typically of more concern than tilted walls unless the wall tilt is approaching the recommended stability limit.

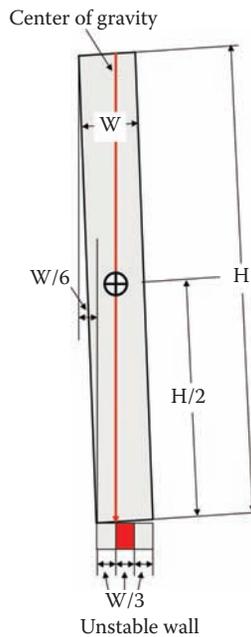
**FIGURE 15.3**

Visual depiction of the one-third rule for wall tilt.

a wall is deemed dangerous when a plumb line is attached to the top of a wall and the displacement of the plumb bob from the wall is greater than one-sixth of the wall's bearing width. Figure 15.3 depicts a wall that is deemed dangerous due to the center of gravity falling outside the middle third of the bearing area.

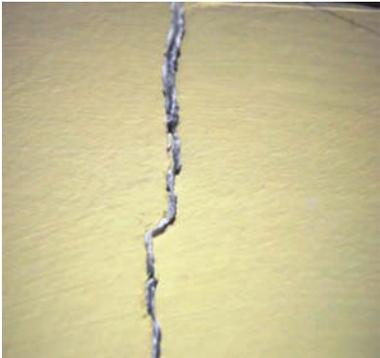
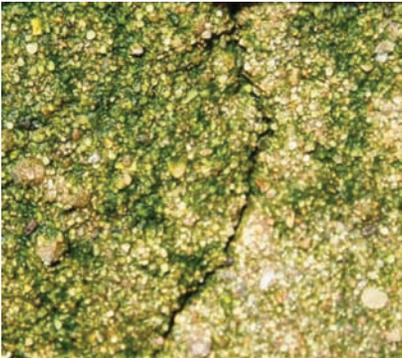
Crack Description	Fresh/New Crack	Older Crack
Vertical crack

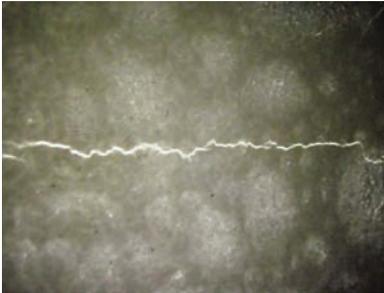
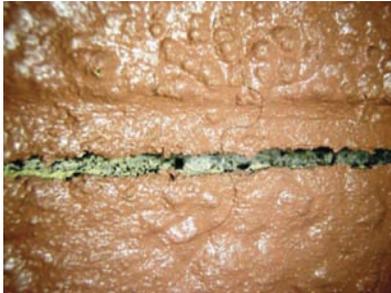
Crack Description	Fresh/New Crack	Older Crack
Horizontal crack

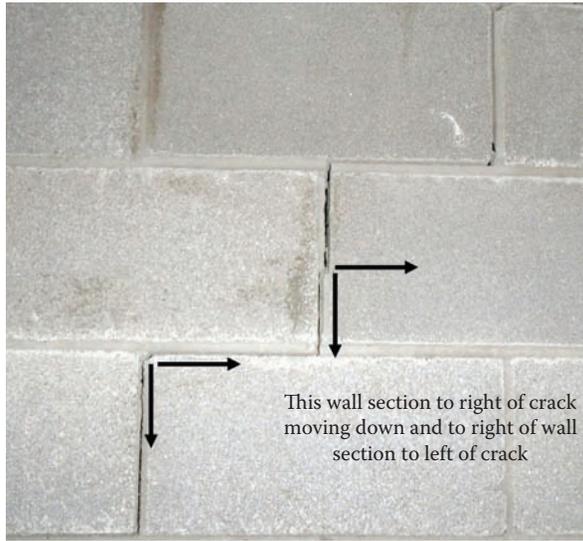
FIGURE 15.4
Relative movement of wall sections on either side of crack.

Note that a shear crack, such as a vertical or stair-stepped crack, will have a relative displacement along the crack with similar features on either side of the crack, whereas a compressive crack will show spalling and flaking of the masonry surface at the edges of the crack.¹¹ Hence, another aspect of crack analysis is to determine the relative movement of wall sections comparatively on either side of the crack. This provides information regarding settlement or movement of the wall. For example, it is common for the downhill (relative to outside ground slope) wall section to be settling or lower than the uphill wall section when comparing wall sections on either side of a crack. The ideal location for obtaining this information is where the crack changes direction (e.g., the change from vertical to horizontal direction in a stair-stepped crack). This is illustrated in Figure 15.4.

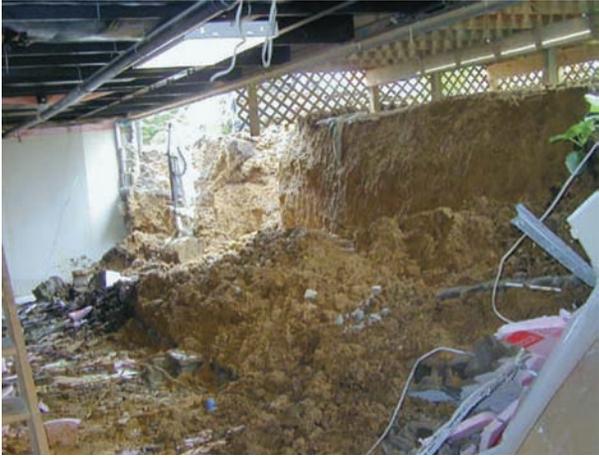
Cause of Damage	Photograph
Collapsed CMU Foundation Caused by a combination of poorly drained silty-clay soil and a lack of steel in the wall.

A photograph showing a collapsed concrete masonry unit (CMU) foundation wall. The wall has crumbled into a large pile of rubble and soil. The interior of the structure is visible, showing wooden framing and debris. The ground outside the structure appears to be silty-clay soil.
Impending Failure of CMU Foundation Caused by water intrusion due to undersized gutters, local ground slopes toward the structure, and lack of steel in the wall system.

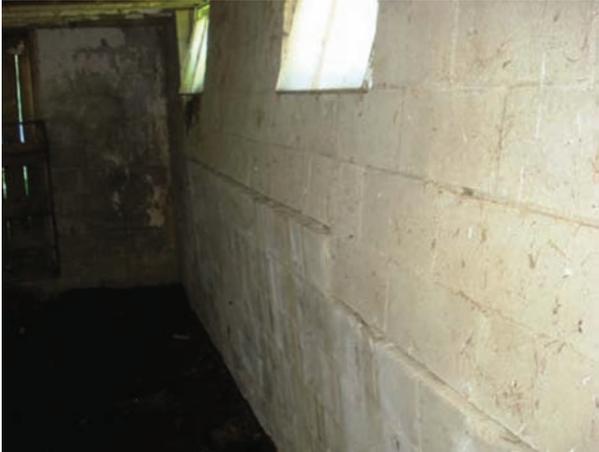
A photograph showing a CMU foundation wall in a state of impending failure. The wall is made of large, light-colored concrete blocks. There is significant water intrusion and staining on the wall, particularly near the top. The interior of the structure is dark and appears to be a crawlspace or basement.

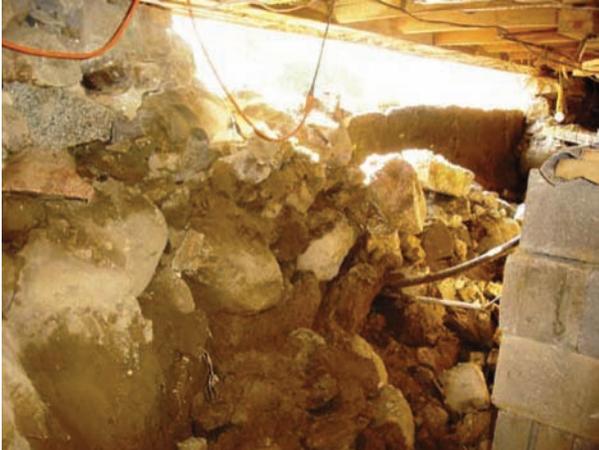
Collapsed Stone Rubble Foundation Caused by the improper construction of the foundation wall.

A photograph showing a collapsed stone rubble foundation. The wall is made of irregular, light-colored stones and rubble. The wall has crumbled into a large pile of rubble and soil. The interior of the structure is visible, showing wooden framing and debris. The ground outside the structure appears to be silty-clay soil.

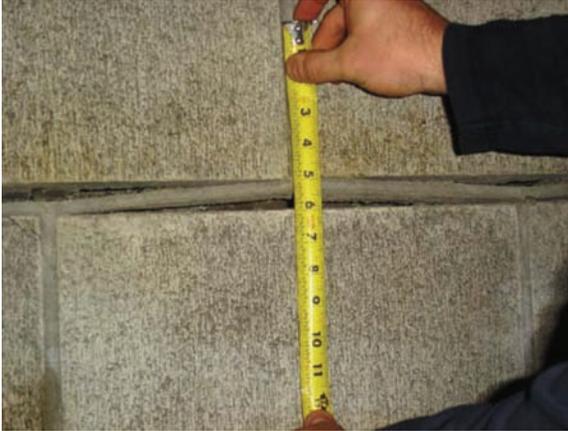
Cause of Damage	Photograph
Severe Buckling/Bowing Crack (~1" wide) to CMU Foundation Wall

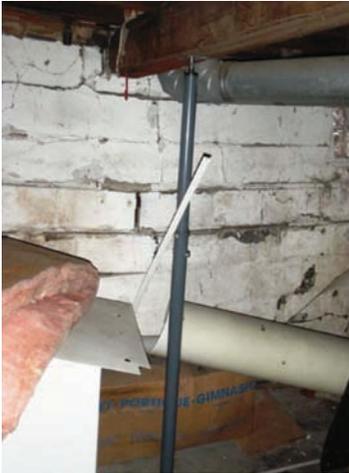
Bulged/Tilted CMU Foundation Wall Caused by lateral pressure exerted on the exterior side of the walls exceeding the resistive strength of the walls which bowed/displaced them inward.

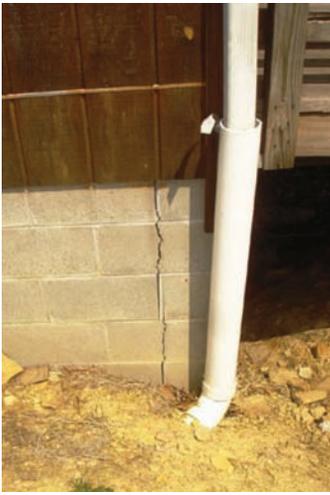
Vertical Crack Caused by local ground subsidence.

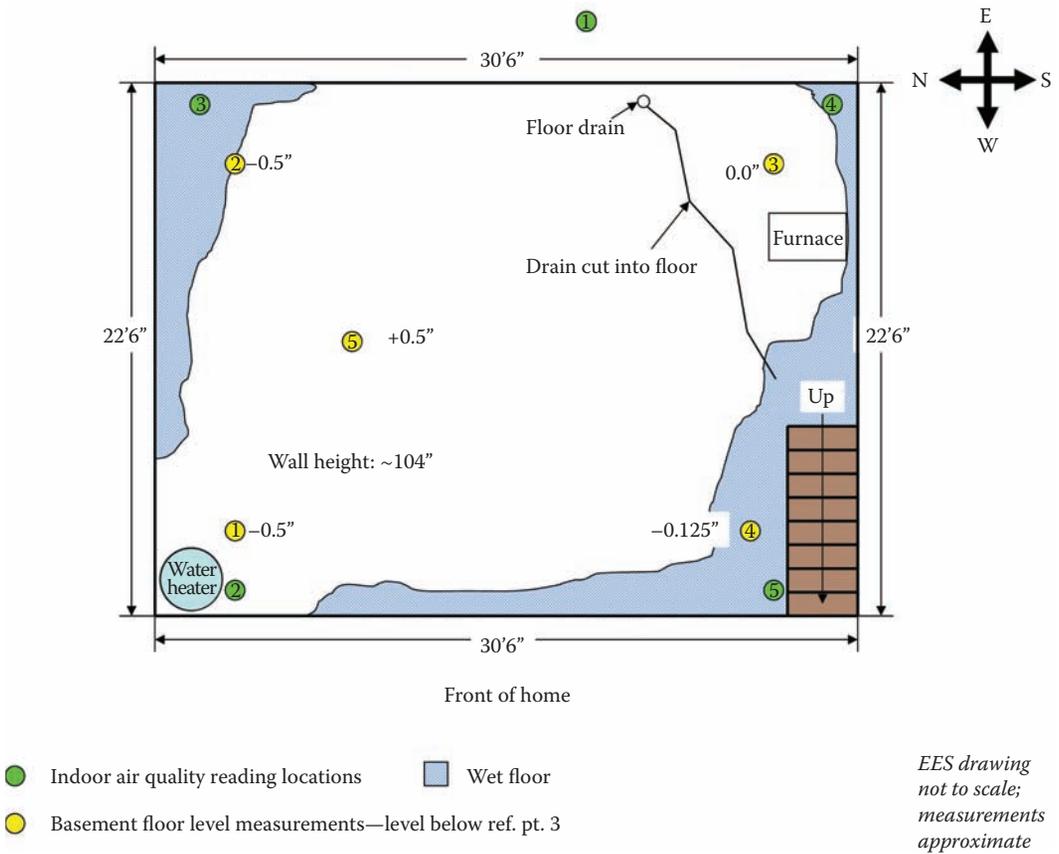
**FIGURE 15.5**

Illustration of documenting floor crack observations.

The methodologies for recording and analyzing cracks discussed earlier in this chapter should be followed. For illustration purposes, two example drawings of crack observations are shown in Figures 15.5 (floor crack observations) and 15.6 (wall crack observations).
