FORENSIC ENGINEERING

**Damage Assessments for
Residential and Commercial
Structures**

**Edited by
Stephen E. Petty**

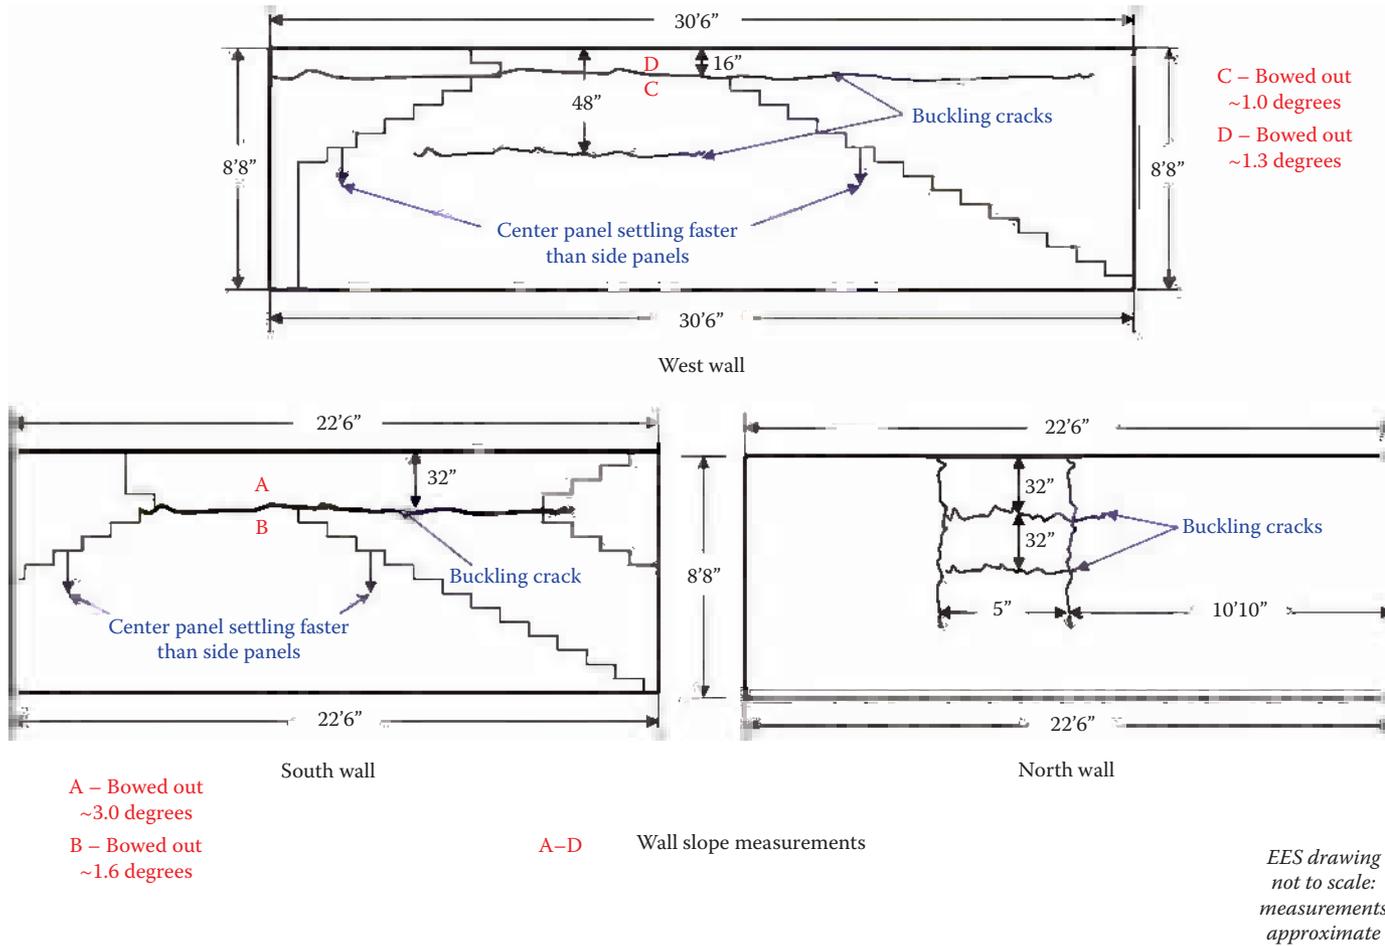
FIGURE 15.6
Illustration of documenting wall crack observations.

The methodologies for recording and analyzing cracks discussed earlier in this chapter should be followed. For illustration purposes, two example drawings of crack observations are shown in Figures 15.5 (floor crack observations) and 15.6 (wall crack observations).

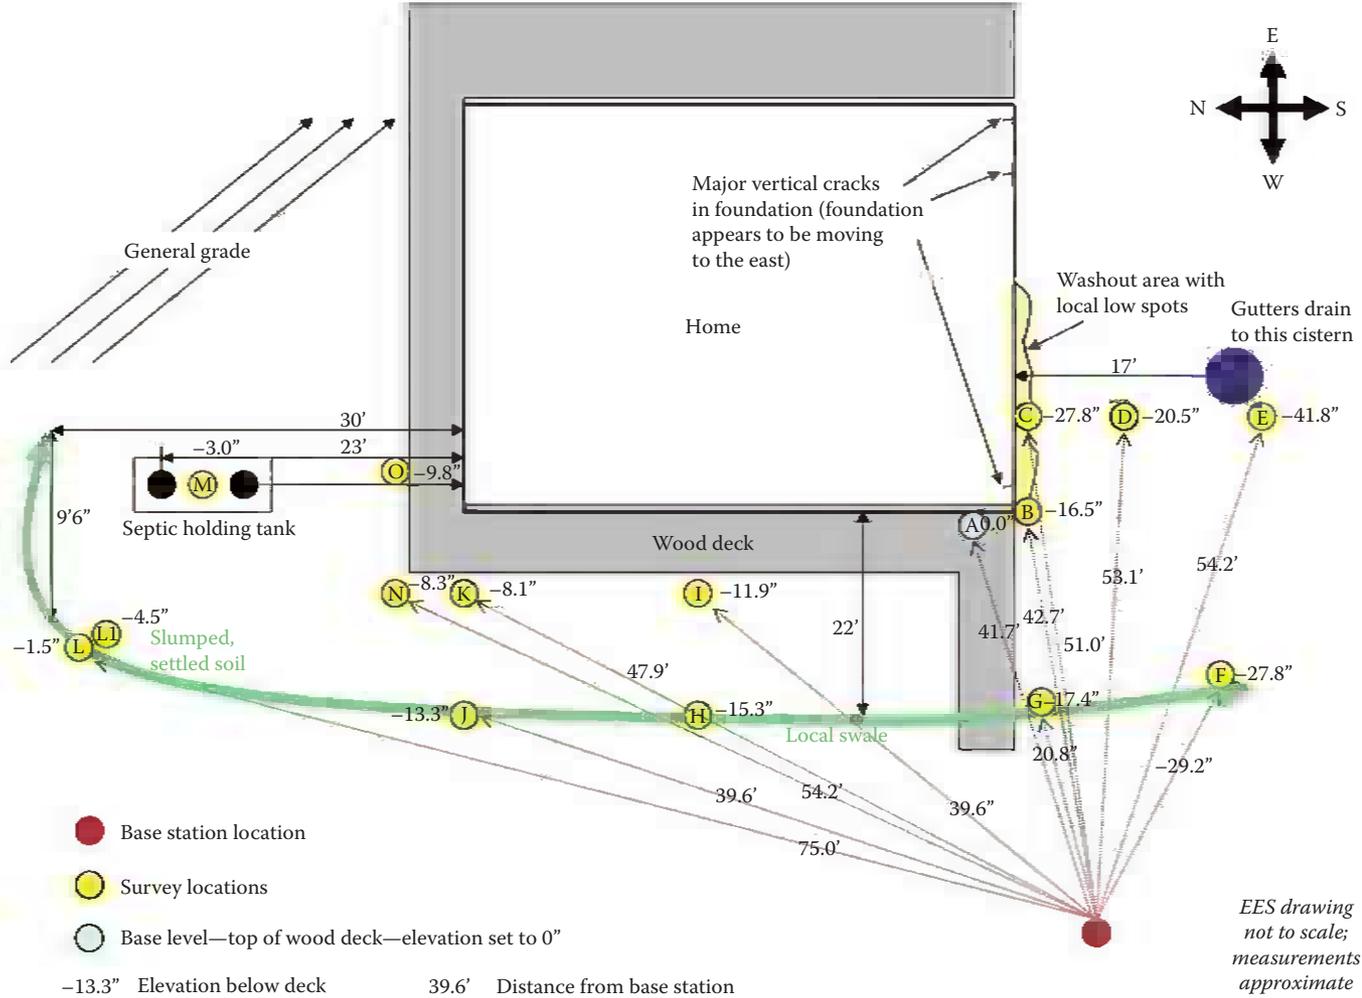
FIGURE 15.7 Illustration of exterior ground elevation and slope observations.

Next, information on the ground slope should be recorded. As illustrated in Figure 15.7, surveying equipment (e.g., level, transit, or total station) can be used to determine the change in elevation around the structure.

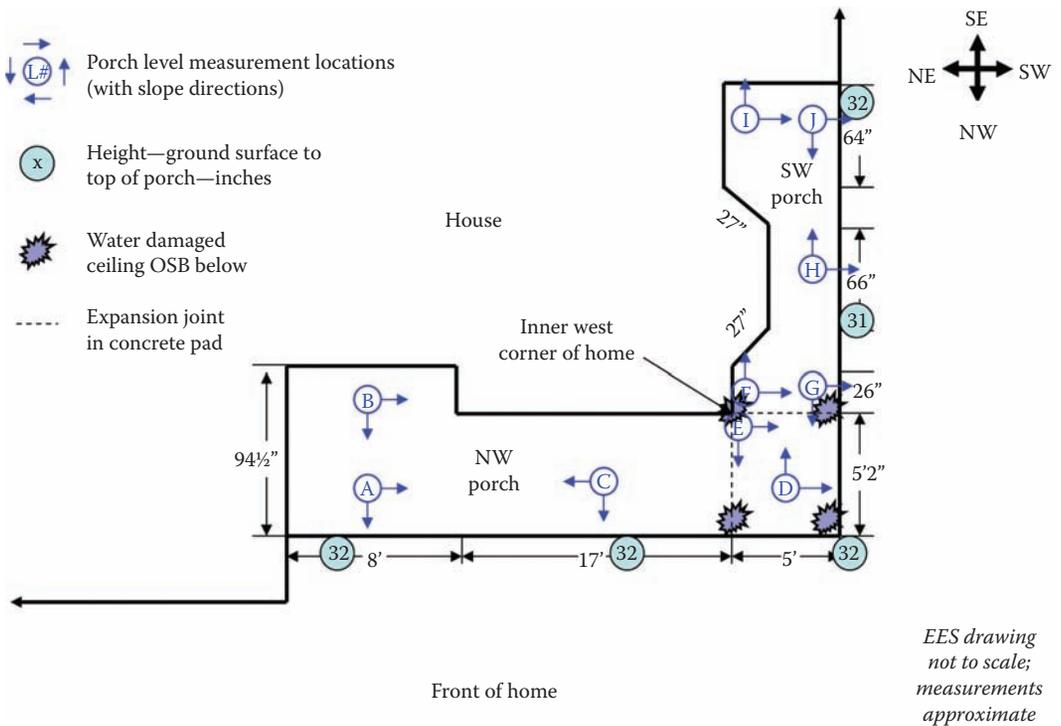
FIGURE 15.8
Illustration of floor level measurements.

An example of floor level measurement recordings for analysis is illustrated in Figure 15.8 and Table 15.11. In this example, the following conclusions were drawn regarding the floor level measurements:

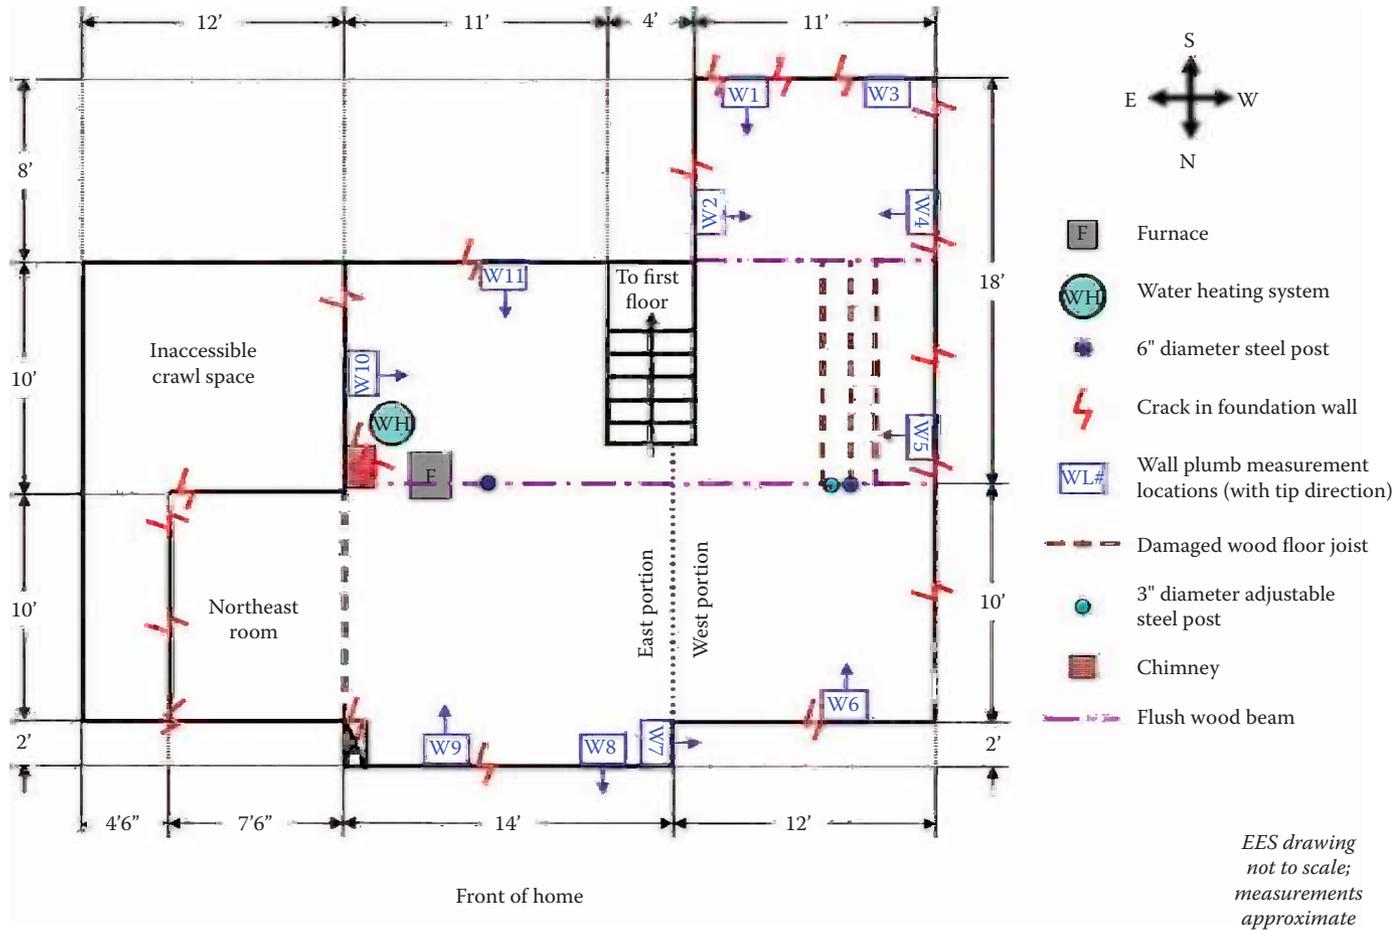
FIGURE 15.9
Illustration of wall plumb measurements.

An example of wall plumb measurement recordings for analysis is illustrated in Figure 15.9 and Table 15.12. In this example, where questions were raised as to whether tree impact had caused damage to the foundation walls, the following conclusions were drawn based on a combination of wall plumb measurements and crack analysis:

The measurements indicated that the foundation walls were predominately rotated/leaning into the home. Observations of the cracks present in the foundation walls suggested that this rotation/leaning most likely occurred over a long period of time as a result of the lateral earth and hydrostatic pressure pushing on the exterior surfaces of the foundation walls rather than attributable to the impact of the fallen tree striking the home.

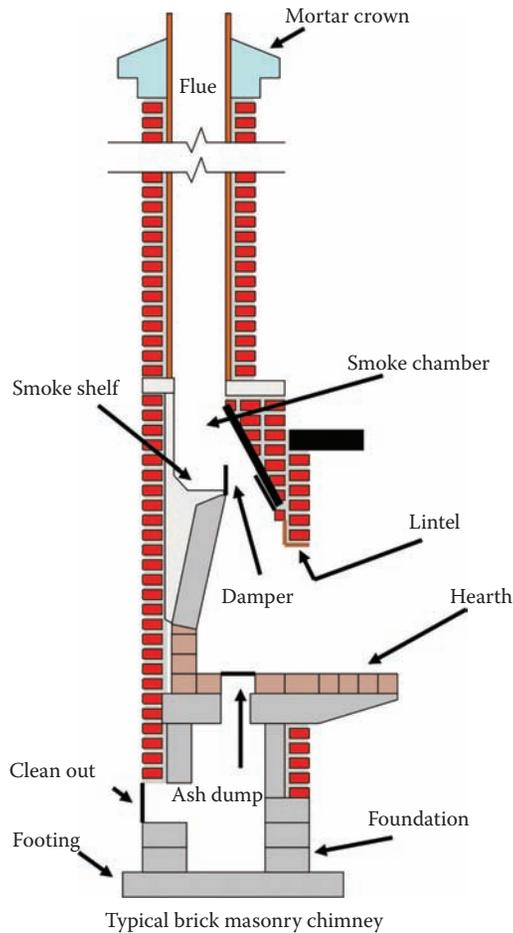
**FIGURE 16.1**

Illustration of typical brick masonry chimney.

The word chimney comes from the Latin word *caminus*, which means “furnace.”³ Man’s desire to stay warm and remove combustion by-products caused evolution of the chimney. Chimneys are designed and constructed to provide fire protection and safely convey combustion by-products to the exterior of the structure at a rate that does not unfavorably influence the combustion process.⁴ Several typical chimney elements are listed and depicted in Figure 16.1.

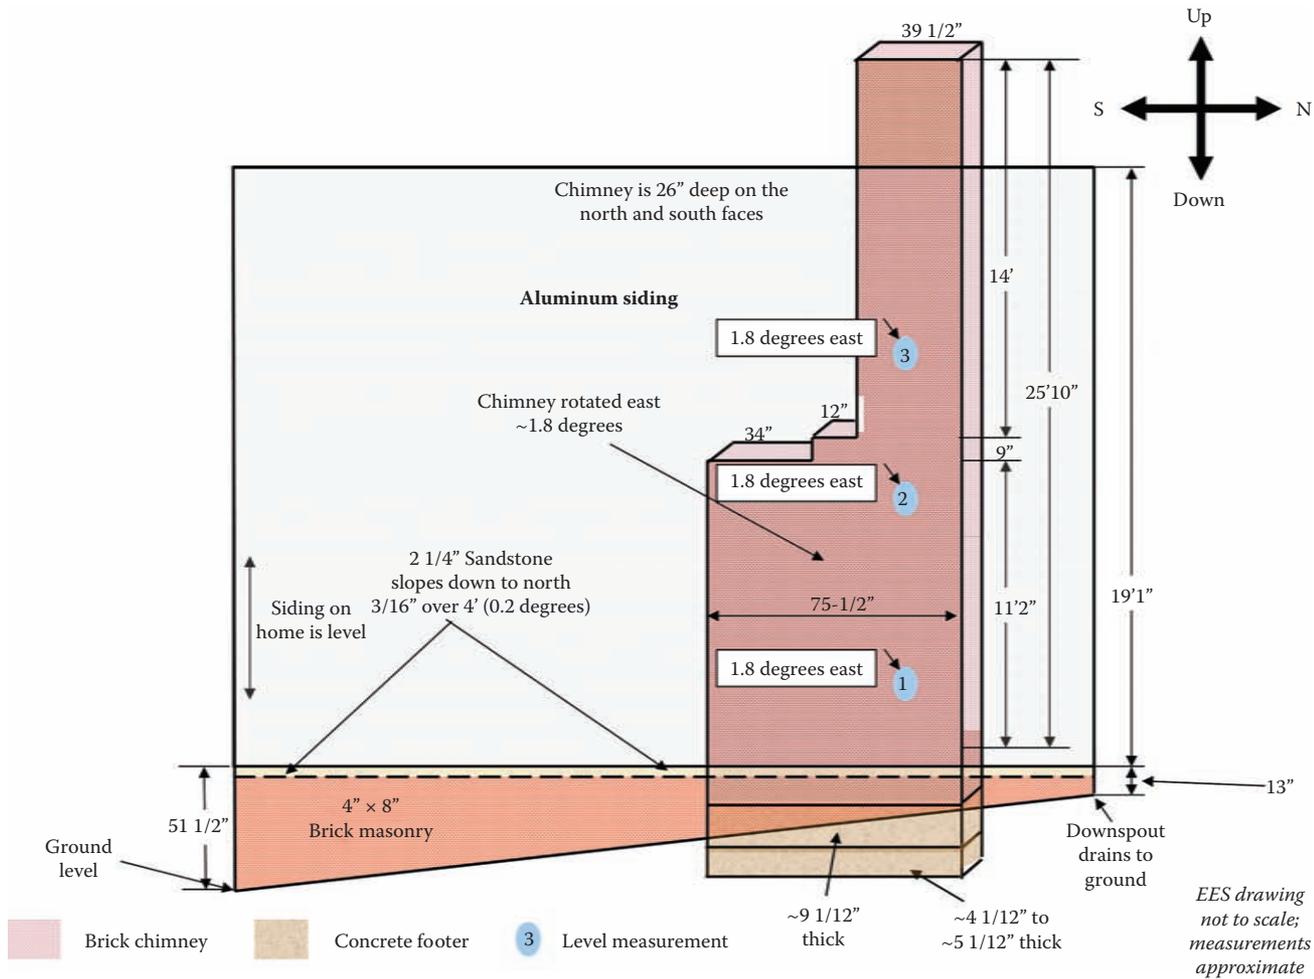
FIGURE 16.2
Typical chimney schematic (developed from onsite measurements).

Plumb measurements were taken on the east, south, and north chimney faces, at elevations of approximately 3 feet, 10 feet, and 16 feet above the footer. These locations were defined as "1," "2," and "3," respectively, and are illustrated in Figure 16.2. Note that the chimney was monotonically tipped or rotated to the east. The uniformity of the slope (1.8 degrees) along the east elevation of the chimney informs the inspector that the focal point of rotation is at the footer beneath the chimney.

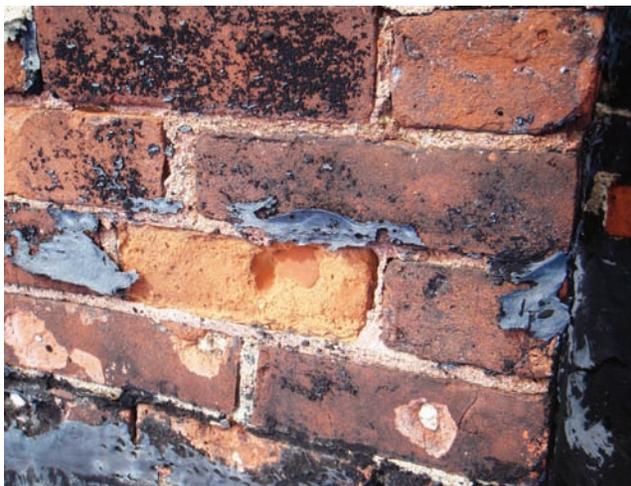
FIGURE 16.3
Spalled brick and mortar.

Notice the lighter color of the spalled brick in comparison to the surrounding bricks in Figure 16.3.

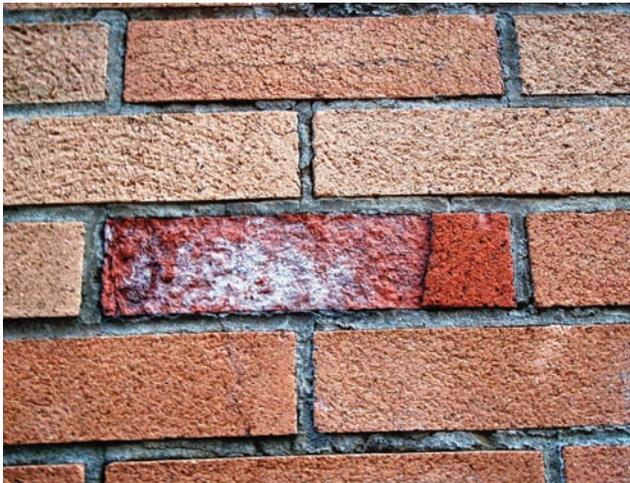
FIGURE 16.4

Efflorescence (white deposits) and spalling on brick masonry unit.

Efflorescence is evidence of moisture wicking through masonry construction, or in more serious cases, water entry through openings. The presence of efflorescence on a wall is typically indicative of long-term water or moisture intrusion. In most cases, efflorescence is harmless and can be cleaned using mild acid solutions. In more severe cases, efflorescence can lead to spalling or damage to masonry wall cavities.⁹ Figure 16.4 depicts an example of light-colored efflorescence deposits on the exterior of a spalled brick.

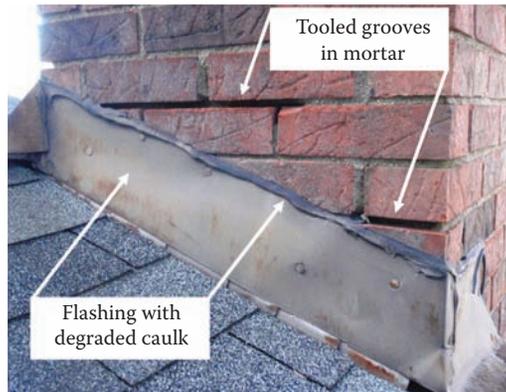
FIGURE 16.5
Improperly installed chimney flashing.

Another factor often found on field inspections of chimneys is improperly installed flashing. According to the Engineered Wood Association,¹⁰ to prevent moisture infiltration into roof structures, the roof/chimney flashing should extend at least 6 inches up the sides of the chimney, with counter-flashing embedded into the mortar joint at least 1 1/2 inches. The counter-flashing is then sealed with Portland cement mortar.¹⁰ Chapter 9, this volume, illustrates these proper flashing methods. Figure 16.5 depicts an example of improperly installed chimney flashing. Notice the grooved mortar joints above the installed flashing. According to the American Plywood Association, the counter-flashing should be embedded into the mortar joint.

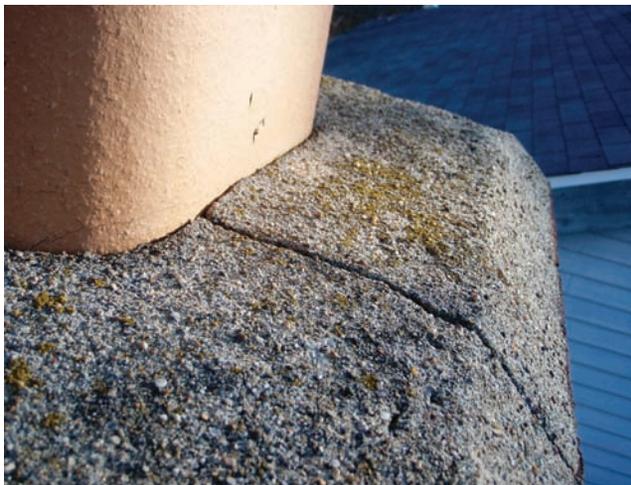
FIGURE 16.6
Crack in mortar chimney cap.

Cracks around the chimney cap and flue liner are other factors often found on field inspections of chimneys. The chimney cap (crown) is sloped to keep rain from seeping down into the masonry and deteriorating the chimney. Most mortar crowns crack almost immediately after installation because of shrinkage and become vulnerable to freeze–thaw actions. Figure 16.6 depicts an example of a cracked mortar chimney cap.

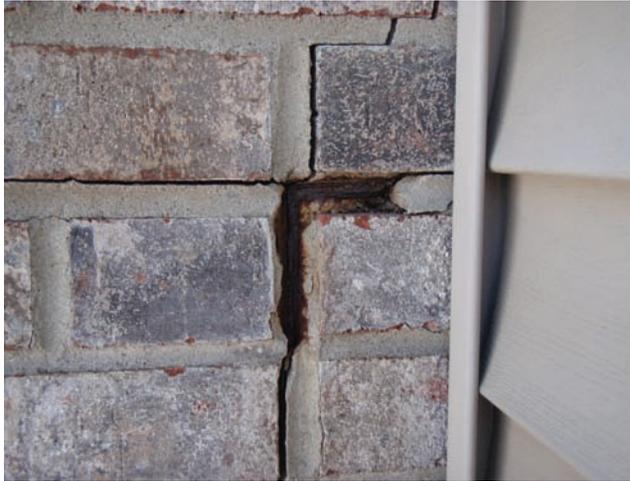
FIGURE 16.7
Chimney—oxide jacking to metal lintel.

liner and into the fireplace. When a structural element comprised of steel or ferroalloy is exposed to water/moisture, the iron atoms within the structural element undergo an oxidation process and are converted into iron oxides (oxide scale). Oxidation (rusting) of the lintel over the fireplace opening leads to a process that culminates in oxide jacking. This oxide scale can grow up to 10 times the thickness of the original structural element.¹¹ In other words, a steel lintel embedded in a masonry wall and supporting the brick above an opening can grow in height from 0.375 (3/8") inch to nearly 3.75 inches. As the oxide scale grows or expands, it places very large forces on surrounding materials. The upward or outward growth of the ferrous scale can easily move entire veneer sections, or if restricted, crush the masonry in contact with it. This movement of the masonry by the structural elements is called oxide jacking. Once oxide jacking has begun, the only way to stop it is to remove the masonry and replace the steel or ferroalloy structural element. Oxide jacking

is a long-term process that can be spotted well in advance of catastrophic failure of the masonry system. Unfortunately, since this process takes a long time to occur, it is often ignored or missed.¹¹ Figure 16.7 depicts an example of oxide jacking to a metal lintel above a fireplace opening.

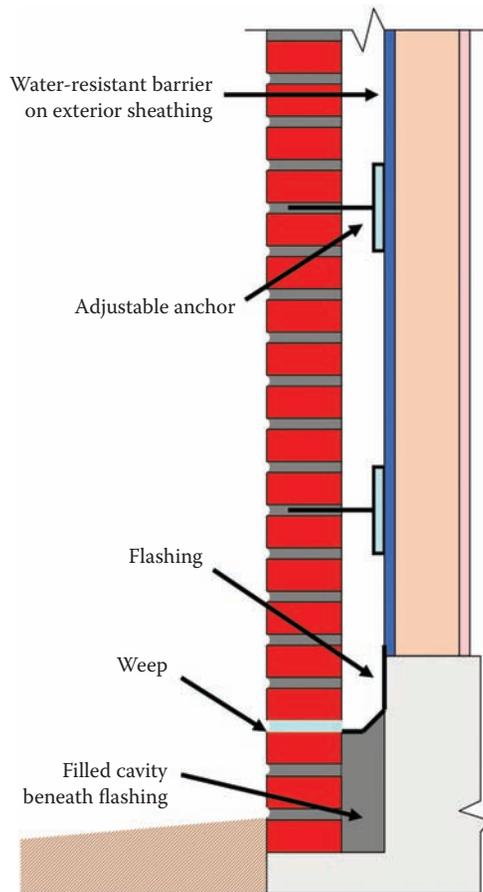
FIGURE 16.8
Illustration of typical brick masonry veneer wall cross-section.

A veneer wall is constructed of masonry units or other weather-resisting, noncombustible materials, securely attached to the backing, but not so bonded as to intentionally exert common action under load to the backing. Brick veneer is designed to carry the load of its own weight and is not designed to resist other loads.¹² Several typical brick masonry veneer wall elements are listed and depicted in Figure 16.8.

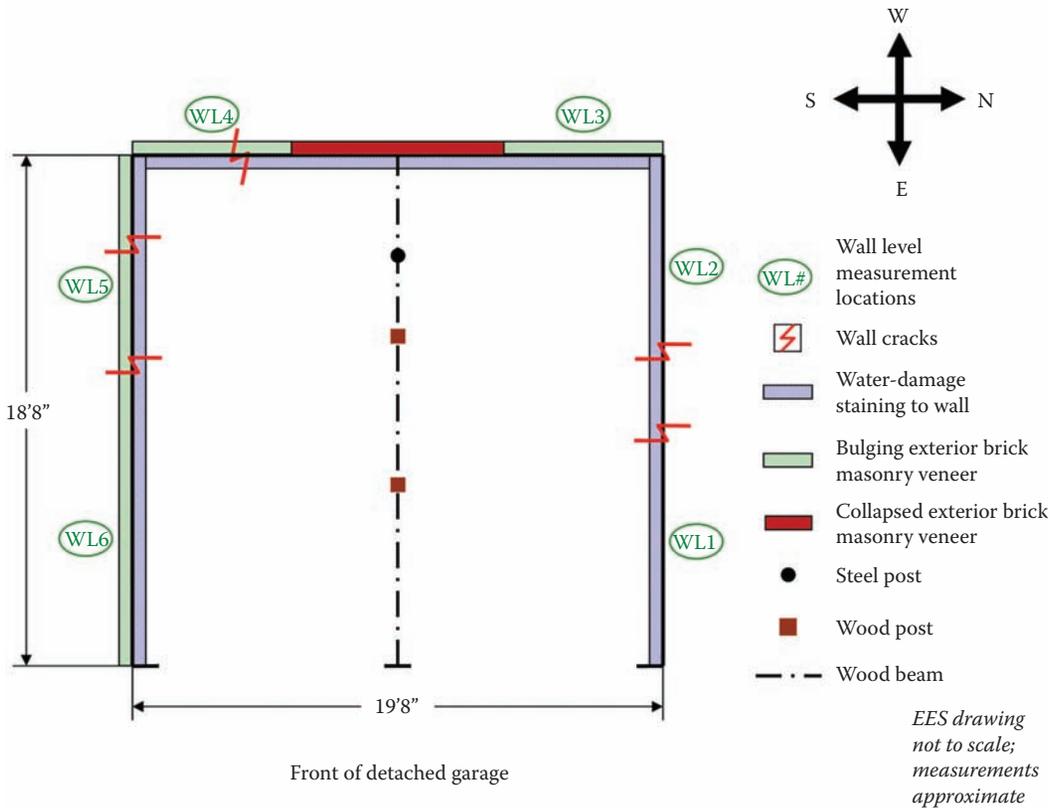
FIGURE 16.9 Typical brick masonry veneer wall schematic (developed from onsite measurements).

After interview-related information regarding the structure has been gathered, the brick masonry veneer wall assessment process begins by sketching out a plan view of the building in an inspection field notebook. The dimensions of the building, cracks, bulges, missing bricks, and other issues should be indicated on the sketch and noted in the field notebook. Key observations should also be documented with photographs. An example of a typical brick masonry veneer wall layout, with key details included, is provided in Figure 16.9.

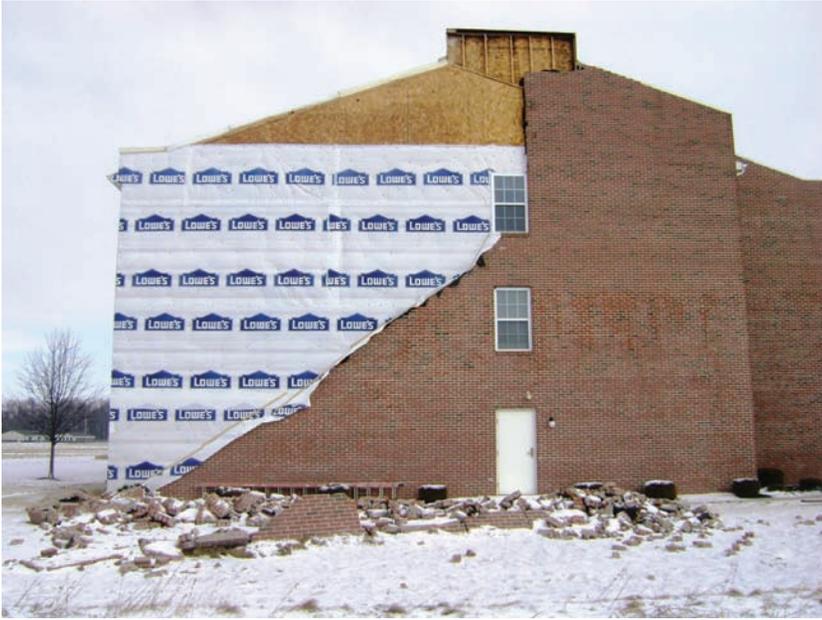
FIGURE 16.10
Veneer wall failure due to improperly spaced brick ties.

Lack of brick ties and/or sporadic spacing causes an uneven distribution of lateral support for the brick masonry veneer wall. The proper construction of an anchored brick veneer wall ensures that the wall functions as a complete system with the backing structure. Commonly, water management issues cause the metal brick ties to corrode, weakening their designed strength. Then, when a lateral load (e.g., wind load, seismic load) is applied to a wall with improperly spaced and/or corroded brick ties, the brick masonry has an increased chance of failure. Figure 16.10 depicts an example of a brick masonry veneer wall system that failed due to improperly spaced brick ties, approximately 32 inches on centers both vertically and horizontally, or approximately 7.11 square feet of brick veneer wall area per tie.

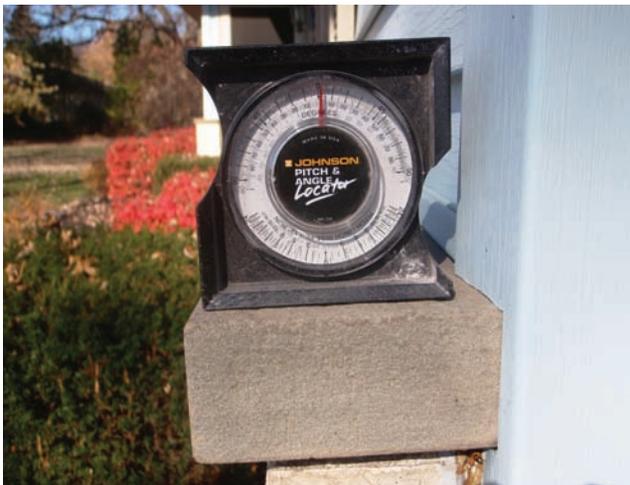
resistance, through-wall flashing should be installed before the window is installed.¹⁵ The brick masonry sill should be sloped down and away from the structure a minimum of 15 degrees to drain water away from the window opening. Figure 16.11 depicts an example of a masonry sill that is sloped less than 15 degrees. Note that the slope is approximately two degrees down and away from the structure.

FIGURE 16.11
Low-sloped sill (<15 degrees).

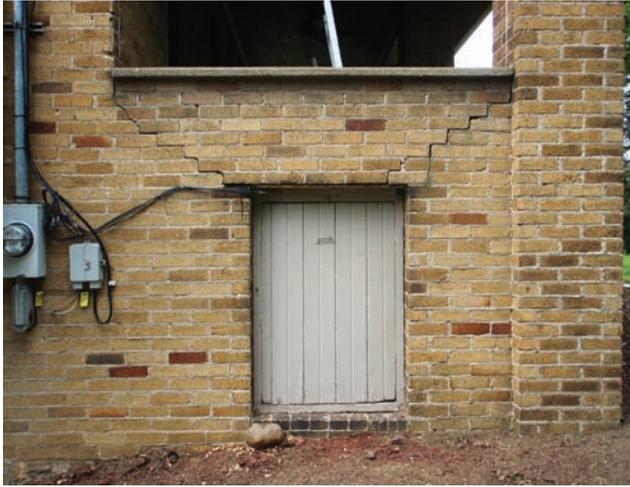
FIGURE 16.12
Oxide jacking to metal lintel.

Figure 16.12 depicts an example of oxide jacking to a metal lintel above an opening in the brick masonry wall. Note the stair-stepped cracks at the top left and right corners of the lintel.

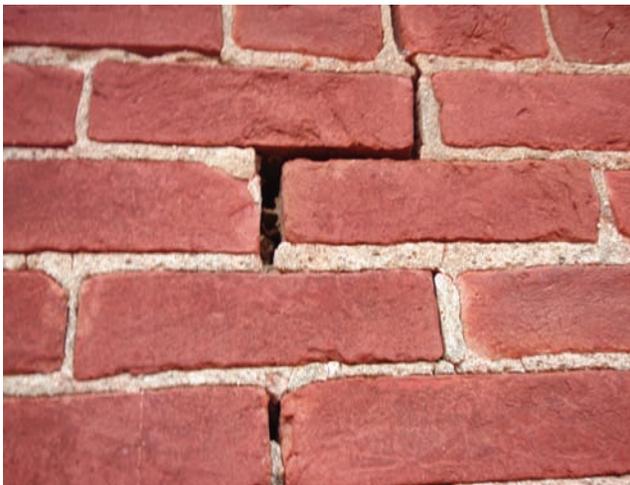
FIGURE 16.13
Cracks at corner probably due to lack of expansion joints.

Expansion and contraction of the brick masonry units are other factors that cause issues with brick masonry veneer walls. Bricks absorb moisture due to the natural permeability of brick masonry. The expansion process commences once the brick masonry is exposed to atmospheric moisture. The magnitude of the expansion depends on the nature of the raw materials, the method of manufacture, and the temperature and duration of the firing.¹⁶ The vertical cracks caused by expansion or contraction are likely near the midpoint of the brick veneer wall or near the corner of the structure. Figure 16.13 depicts an example of cracking near the corner of a brick masonry wall due to a lack of expansion joints.

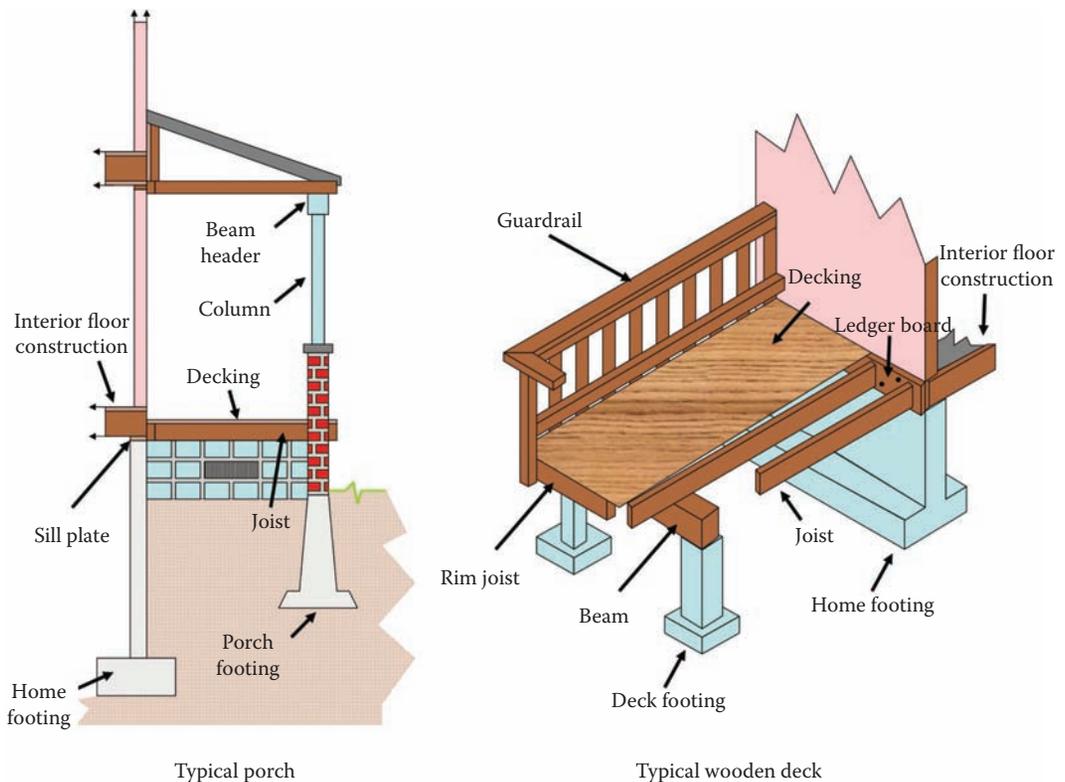
FIGURE 16.14
Illustration of typical porch or deck.

Decks, another exterior structure attached to a building at an entrance point, are slightly different by design. Decks typically are not covered by a roof and are usually raised slightly above grade level. The flooring system is open to allow water to pass through the floor and onto the ground surface. The flooring system of a deck is commonly supported by posts, a house wall, and/or a foundation.¹⁸ Several typical porch or deck elements are listed and depicted in Figure 16.14.

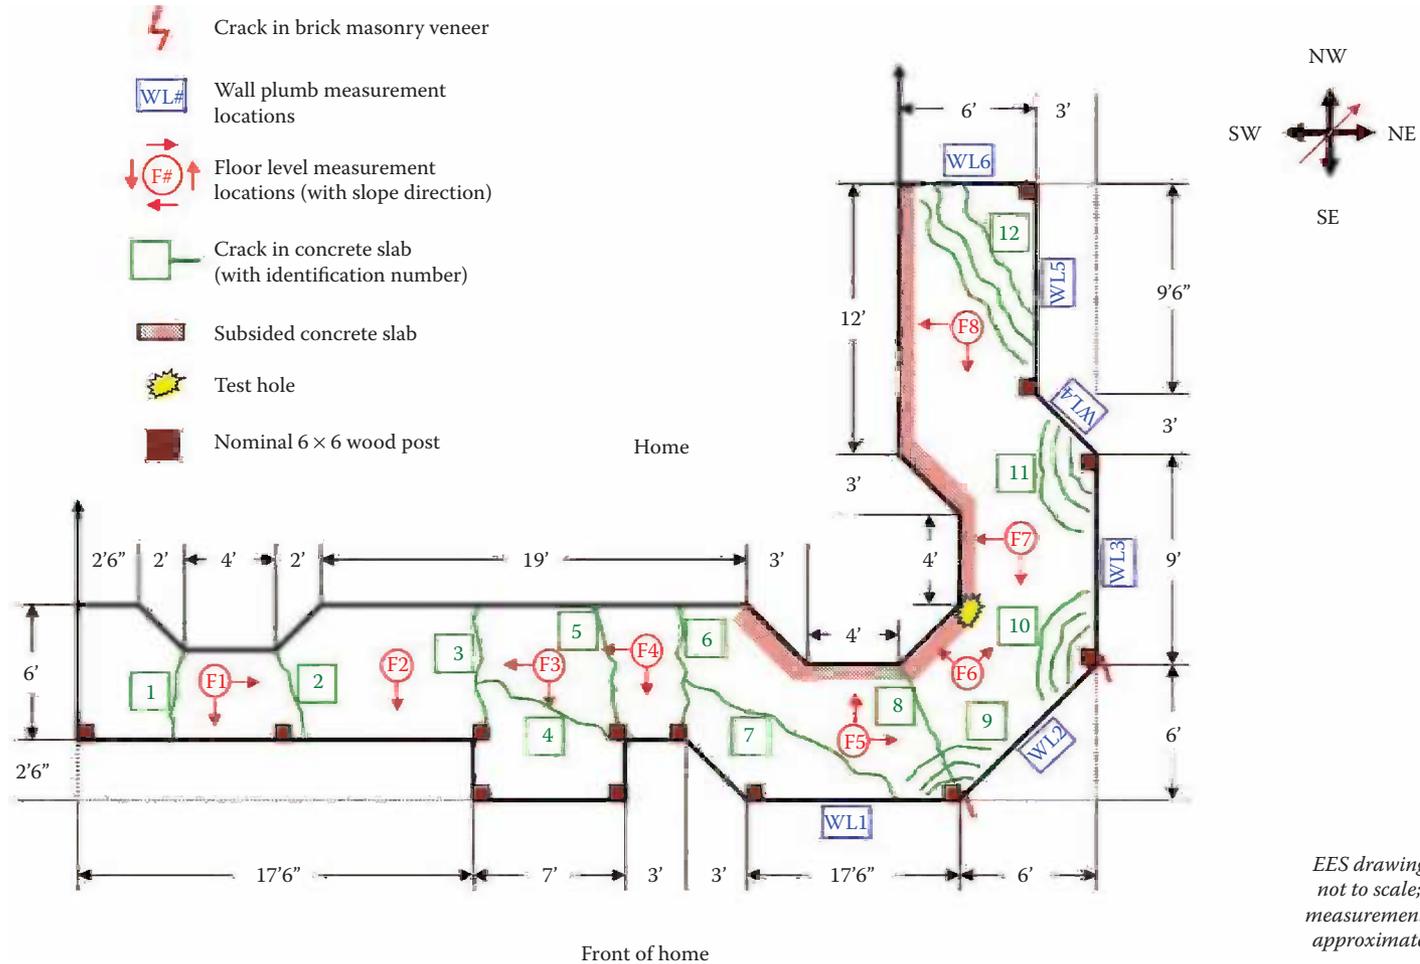
FIGURE 16.15
Typical porch or deck schematic (developed from onsite measurements).

After interview-related information regarding the structure has been gathered, the porch or deck assessment process begins by creating a plan-view sketch in an inspection field notebook (Figure 16.15).

In the example, the measurements indicated that the floor surface at the southwest portion of the front porch sloped down to the southeast or away from the home, while the floor surface at the northeast portion of the front porch sloped down heavily to the northwest and southwest or toward the home (see Figure 16.15 for visual).

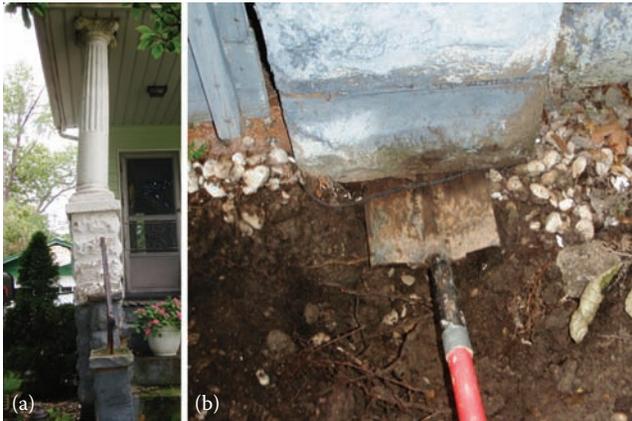
FIGURE 16.16
Tilted porch column (a) and lack of footing coupled with insufficient depth (b).

The lack of a solid footing, coupled with insufficient depth for frost protection, causes differential movement due to freeze-thaw. The proper construction of a footing below frost depth reduces the probability that a porch column or deck post rotates or tilts out of plane. Figure 16.16 depicts an example of a porch column that rotated/tilted out of plane due to the lack of a footing with sufficient depth. Note that the shovel is at the base of the rotated/tilted column with essentially no footer or foundation.

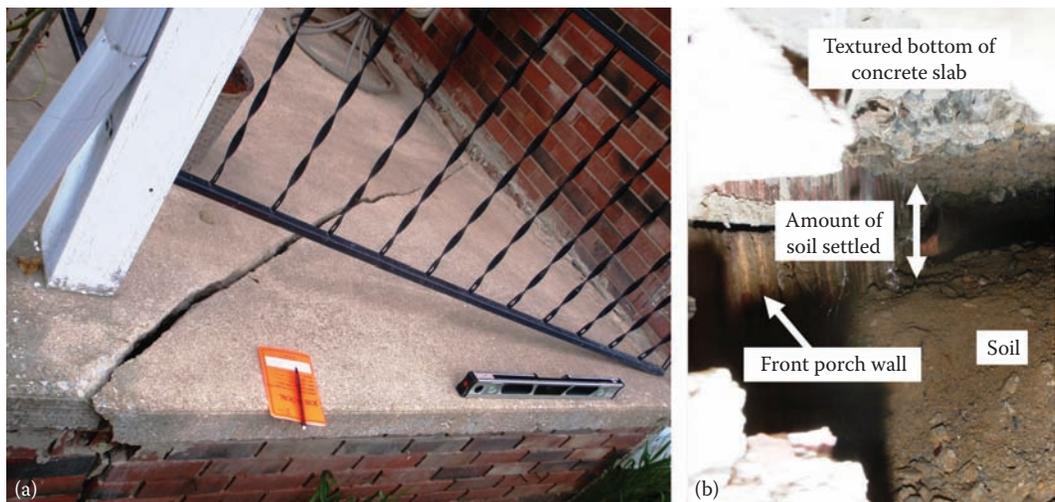
FIGURE 16.17
Cracked porch slab (a) and settled gravel below slab (b).

Another factor often found on field inspections of porches or decks is differential settlement due to improperly compacted soils. The fill material for a concrete slab on grade needs to be free of vegetation and compacted to ensure uniform support of the slab. Figure 16.17 depicts an example of a porch slab that cracked due to an improperly compacted

gravel base. Note that the base of the concrete floor slab is textured brown with soil residual, suggesting that the concrete slab had originally been poured on grade.

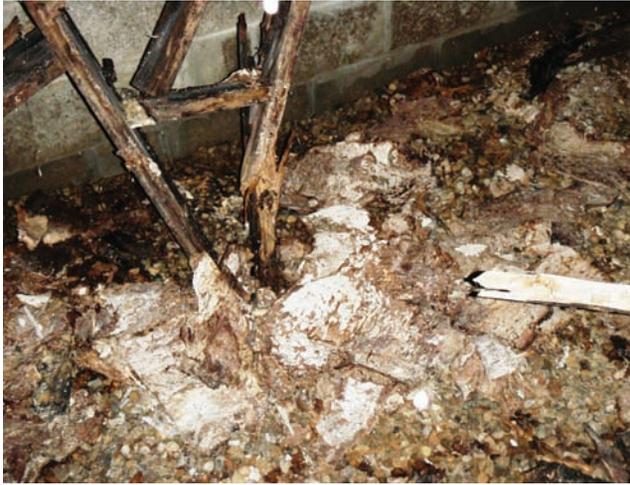
**FIGURE 16.18**

Subsided porch due to a lack of ventilation that caused degradation to wood framing members.

large quantities of water or moisture can be forced up into the underfloor space. The conditions typically found in enclosed underfloor spaces (a combination of high moisture levels, lack of air movement, and lack of light) provide an environment conducive to the amplification of mold growth. The long-term result of mold growth on wood-based materials is a significant reduction in the strength and ultimately complete degradation of these materials. Underfloor space moisture issues can normally be controlled by reducing moisture or providing adequate ventilation. Figure 16.18 depicts an example of subsidence to a porch due to a lack of ventilation for the enclosed space beneath the porch that caused degradation and collapse of wood framing members supporting the concrete porch slab.

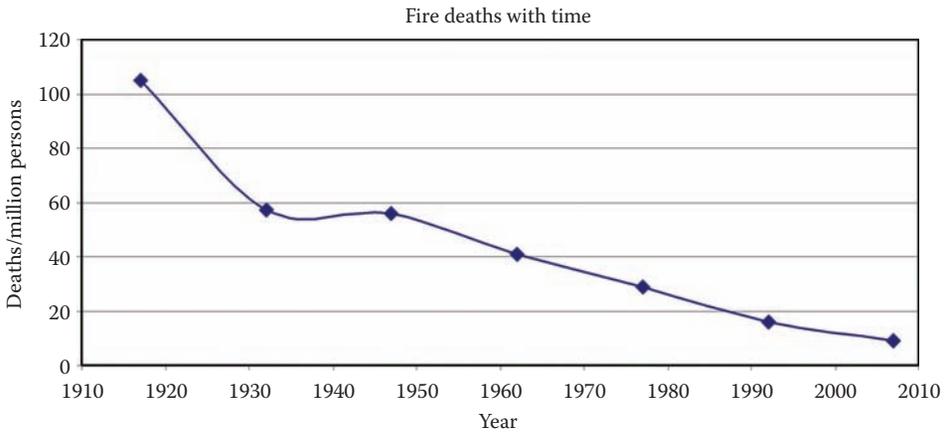
FIGURE 17.1
Risk of dying in a fire (no./million persons) with time.

The good news is that the risk of dying in a fire has dropped dramatically with time, from over 100 per 1 million persons in 1917 to less than 10 per 1 million persons today (Figure 17.1).

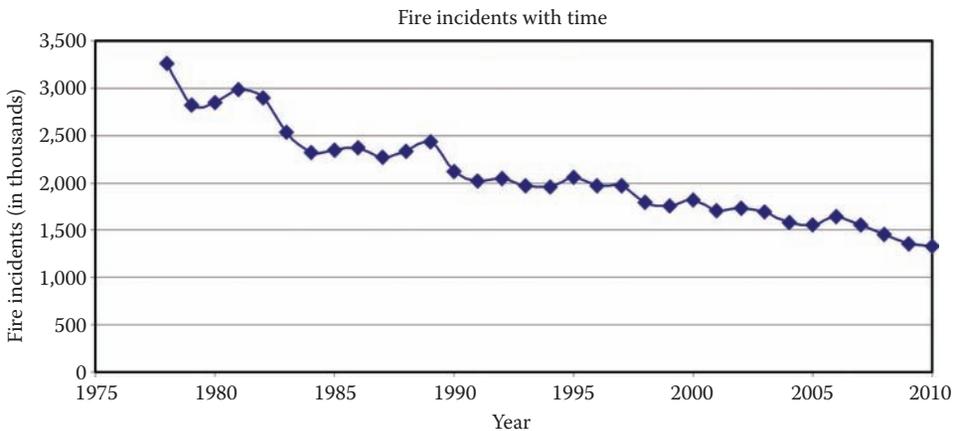
FIGURE 17.2
Fire incidents (in thousands) with time.

Of the total fire deaths, 71% were associated with individuals living in one- and two-family structures. As with death rates from fires, the rates of reported fire incidents has also dropped with time (Figure 17.2).⁵ The number of fire incidents has dropped by about 65% over the past 30 years.

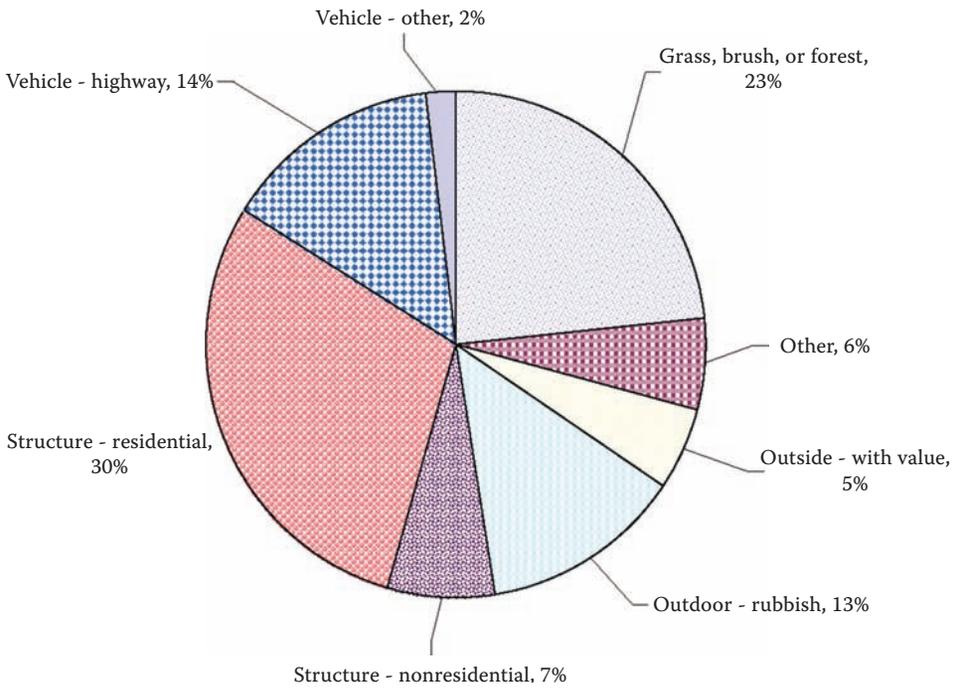
FIGURE 17.3
Fire incidents by major property class.

As illustrated in Figure 17.3, structural fires account for about 37% of all fires; 482,000 in 2010. Of the total structural fires reported, 30% (372,000) were associated with residential structures and 7% (110,000) with nonresidential structures. Structural property damage for 2010 totaled \$9.7 billion, or 83.6% of the total of \$11.6 billion of fire-related losses. As illustrated, the vast majority of the direct property losses were associated with residential and light commercial structures (Figure 17.4).

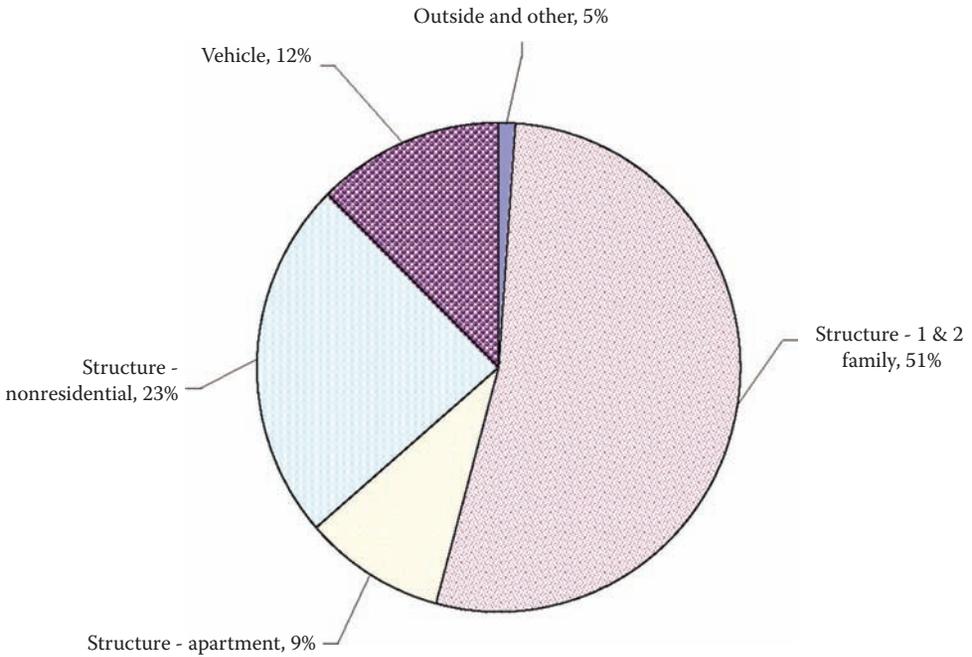
FIGURE 17.4
Fire losses by major property class.

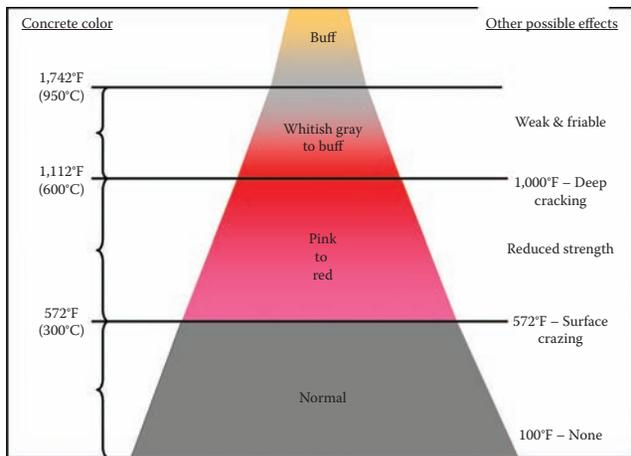
FIGURE 17.6
Visual color change of concrete with temperature of fire.

Regarding color change, the color of concrete surfaces will change as the temperature to which it was exposed increases (Figure 17.6).¹⁴⁻¹⁹

In general, concrete is affected little and retains at least 90% of its strength until temperatures reach 550°F (300°C) (see Table 17.1). Once the temperature reaches 550°F (300°C) and until about 1,100°F (600°C), the surface of the concrete will change from a pink to a deep red color. In addition, surface craze cracking begins to occur near 550°F, with deep cracking present when temperatures reach 1,100°F. Discussions on the significance of cracks can be found in Chapter 15, this volume. Spalling of the concrete surface also occurs between temperatures of about 572°F (300°C) to 788°F (420°C); quartz does not spall until 1,100°F (593°C). Spalling can be either explosive or nonexplosive, depending on the thickness of the member (cracking), moisture, and the compressive stress level in the concrete. The moisture level (lower is better) and stress levels (lower is better) are generally believed to be the main factors associated with spalling of concrete in a fire. Concrete

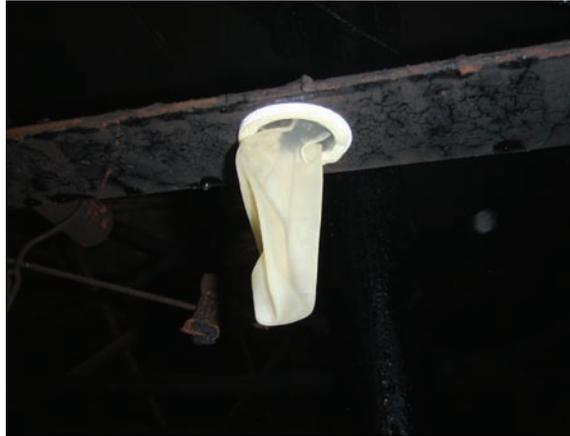
FIGURE 17.7
Chloride or sulfate test extractor on steel beam.

Another area often overlooked in steel structural inspections is the delineation of soot and smoke fume deposits on steel members. These deposits often contain chlorides and sulfates that are corrosive and must be removed to eliminate future longer-term degradation of steel members or surfaces. Portable test kits are available (e.g., Chlor-Rid Field Test Kit) to perform this testing and should be utilized during the investigation to delineate areas with these deposits. An illustration of this test on a beam, affectionately known as the “Condom Test,” and the results and interpretation values are shown in Figure 17.7 and Table 17.3.

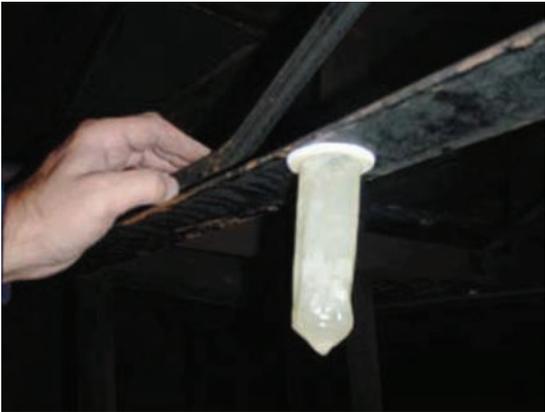
ID	Location	Chlorides ($\mu\text{g}/\text{cm}^2$)	Sulfates ($\mu\text{g}/\text{cm}^2$)	Photograph
A	East roof-E2- south end	1-2	8

In this example (Table 17.3), the chloride sample results for the steel member D was above (7 $\mu\text{g}/\text{cm}^2$), the minimum standards set forth in the Society for Protective Coatings standard SSPC-SP 12/NACE.²² Two of the sulfate sample results (D and E) were also at or above the minimum standards (17–50 $\mu\text{g}/\text{cm}^2$) for sulfates. As normally occurs, the sample results with high values were on the opposite end of the building from where the fire originated. This is because the smoke cools as it gets farther from the fire, at which point portions of the smoke fumes begin to condense out on surfaces. Thus, more smoke deposits will normally be found farther from the origin of the fire.

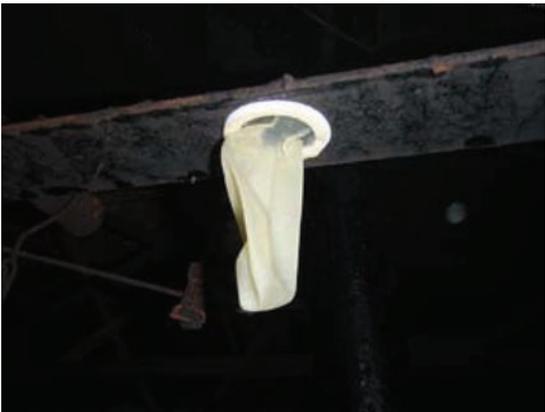
B	East roof-E2- north end	5-6	14

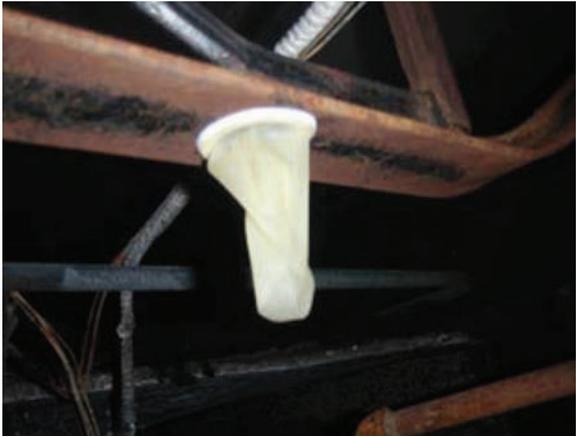
ID	Location	Chlorides ($\mu\text{g}/\text{cm}^2$)	Sulfates ($\mu\text{g}/\text{cm}^2$)	Photograph
C	East roof-E8- north end	1-2	2

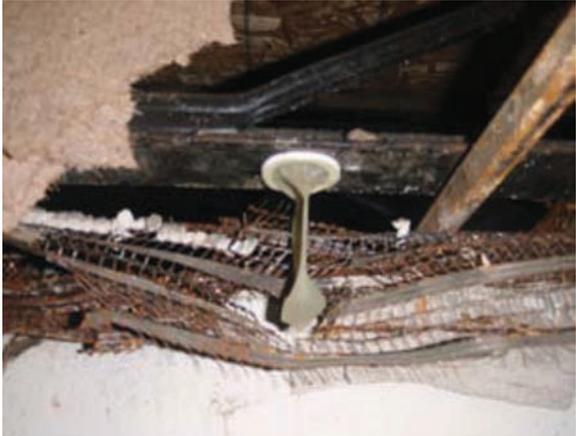
D	West roof-north end	11-12	85

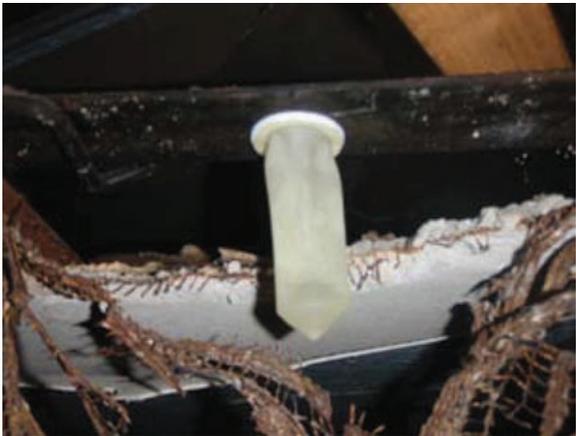
E	West roof-south end	4	26
