FORENSIC ENGINEERING

**Damage Assessments for
Residential and Commercial
Structures**

**Edited by
Stephen E. Petty**

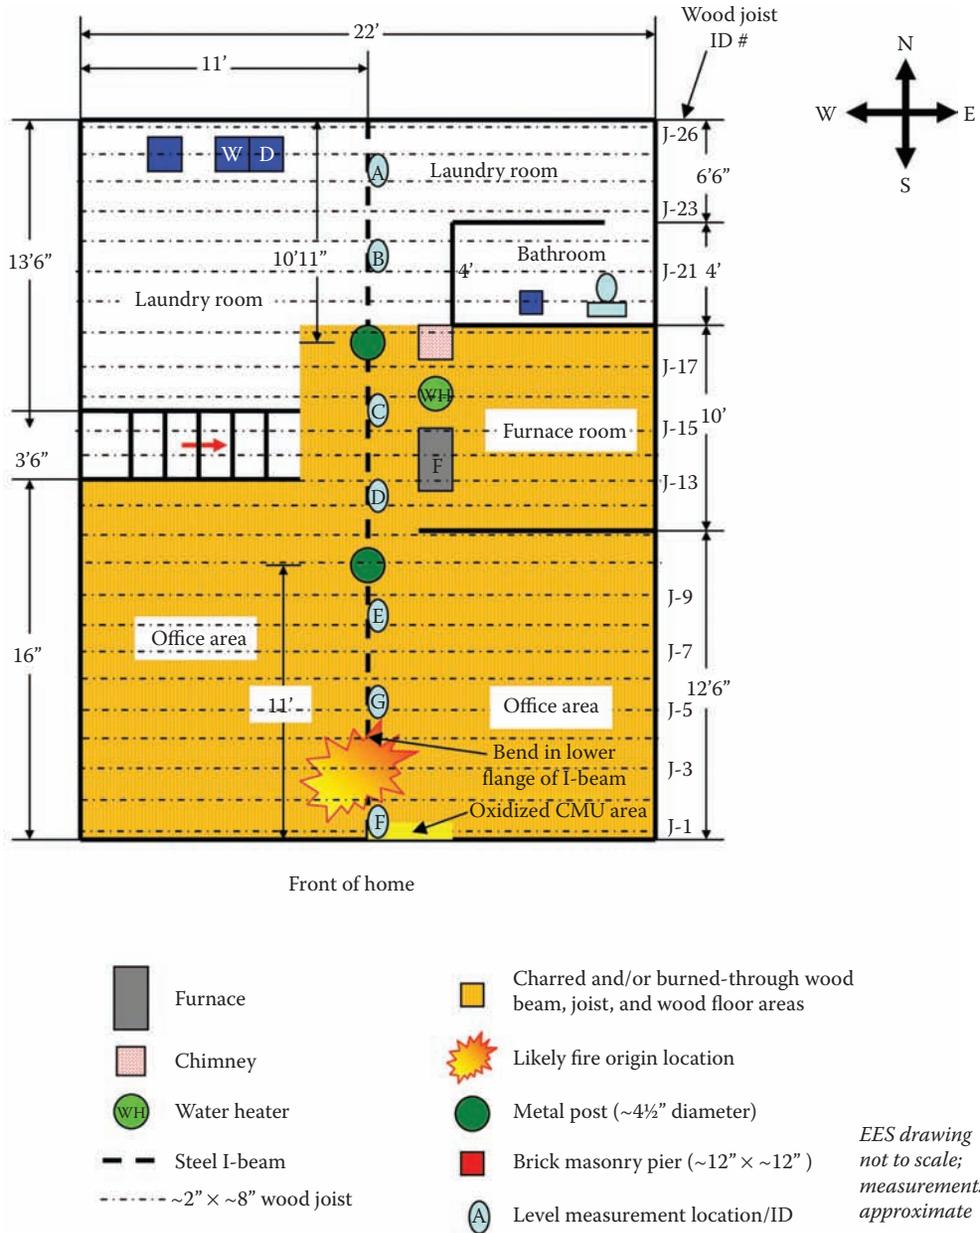
Information from the example basement fire schematic in Figure 17.8 illustrates the location of the origin of the fire, the area of fire charred wood members, and areas of fire-damaged CMU. Note that a designation for joists is provided so damage can be identified by joist number. The photographs in Table 17.4 illustrate damage to items such as plastics and aluminum, which helps to identify the temperature of the fire. In addition, fire damage to concrete, CMU, steel structural members, and metal decking, char damage to wood framing members, and fire damage to roofing materials are illustrated in Table 17.4.

FIGURE 17.8
Fire damage assessment basement layout schematic.

During the inside portion of the visual inspection for structural fire damage, soot deposits, fresh cracks in finished surfaces, distortion of steel members or support posts, and charring of wood framing members should be documented for the floor, walls, and ceiling of each room, beginning in the basement or crawlspace (if present) and moving up until the attic inspection is completed. Steel surfaces should be tested for the presence of chlorides and sulfates as described in Section 17.3. Once the indoor visual inspection is completed, a visual inspection of the exterior surfaces of the building should be completed, by elevation, followed by a visual inspection of the roof. An illustration of the types of documentation taken and reported during these types of inspections is shown in Figure 17.8 and Table 17.4.

For reference, these example analysis conclusions and recommendations are associated with the basement office room shown in Figure 17.8. In this example, the steel I-beam, or portions of the I-beam, was recommended for removal and replacement. Other items were either recommended for replacement, repair, or cleaning and sealing.

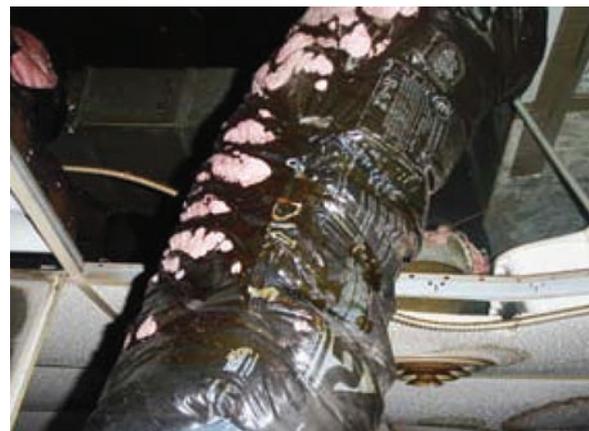
Item	Photograph	Photograph
Melted plastic on HVAC duct and melted PVC plumbing

A close-up photograph of a large, cylindrical HVAC duct. The duct is heavily damaged, with a large section of its outer plastic jacket melted and peeling away, revealing a charred and distorted inner core. The surrounding area is dark and appears to be a fire-damaged interior.

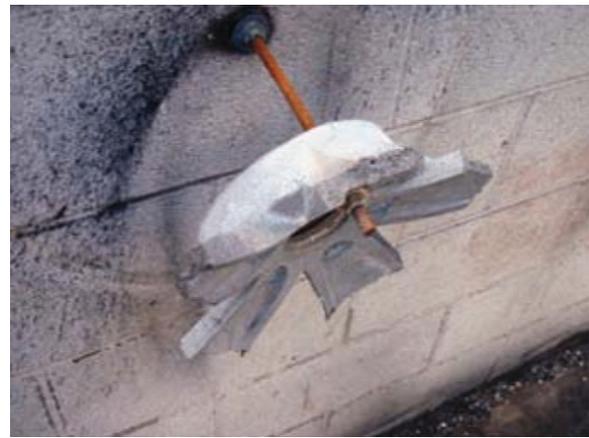
A photograph showing a melted aluminum wheel and melted solder on copper plumbing. The wheel is severely distorted and fused to the copper pipe. The surrounding area is dark and appears to be a fire-damaged interior.

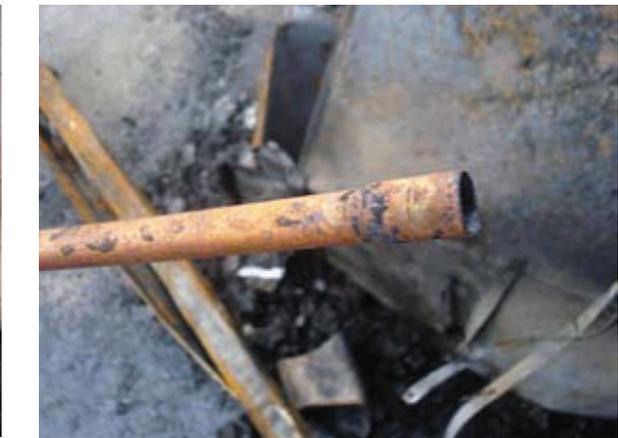
A close-up photograph of a severely damaged copper pipe. The pipe is heavily charred and distorted, with a large section of its outer jacket missing, exposing the inner core. The surrounding area is dark and appears to be a fire-damaged interior.

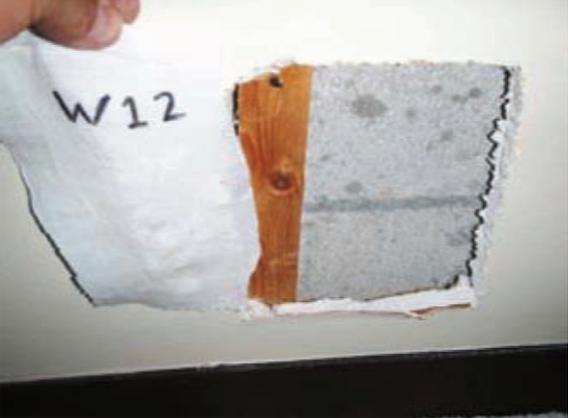
White Cloth (W) Sample ID	Description of Sample Location	White Cloth Sample Results			Photograph
		Deposit: None, Light, Medium, Heavy	Deposit Colors	Smoke Odor	
12	Apartment 207: Bedroom–W. wall cavity–Low	L to M	Yellow/tan dust	No

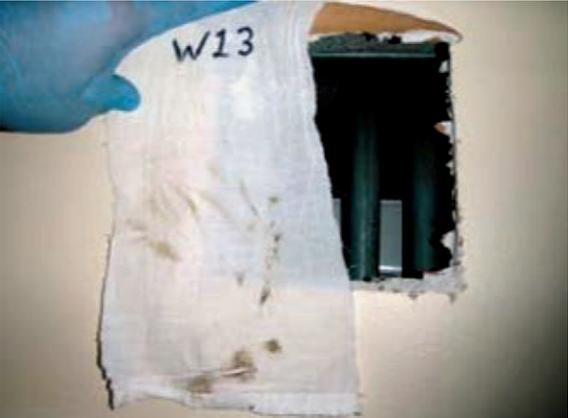
13	Apartment 207: Utility room–N. wall cavity–High	L	Brown dirt/ dust	Yes

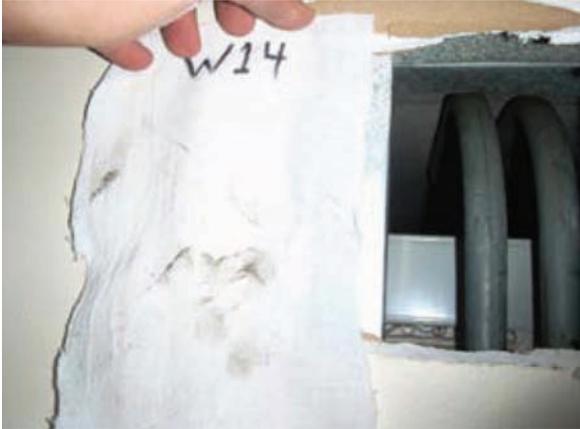
White Cloth (W) Sample ID	Description of Sample Location	White Cloth Sample Results			
		Deposit: None, Light, Medium, Heavy	Deposit Colors	Smoke Odor	Photograph
14	Apartment 207: Utility room–N. wall–Ceiling cavity to N	M	Brown/black dust; possible soot	Yes

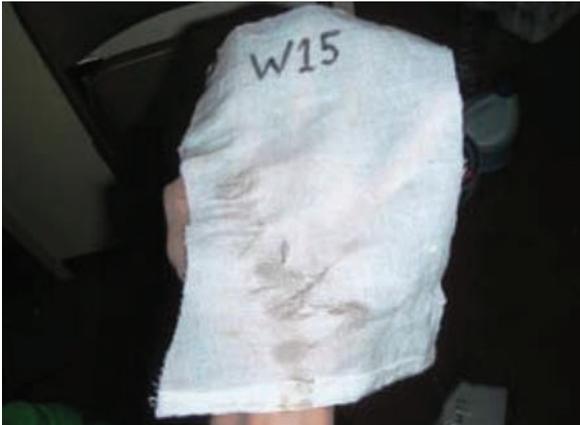
15	Apartment 207: Utility room–N. wall cavity–Low	M to H	Brown/black dust; possible soot	Yes

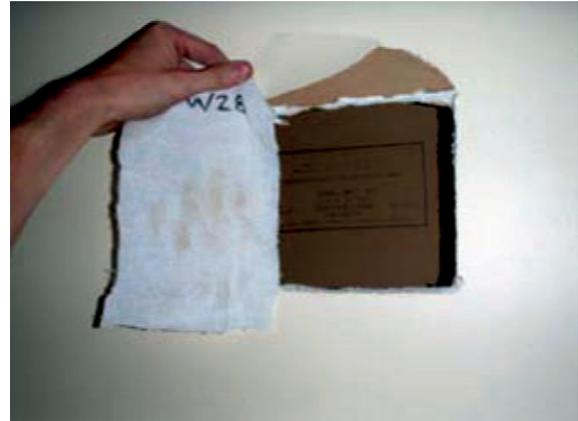
28 Apartment 206:
Bathroom–N. wall
cavity–Central L Brown/tan
dust No

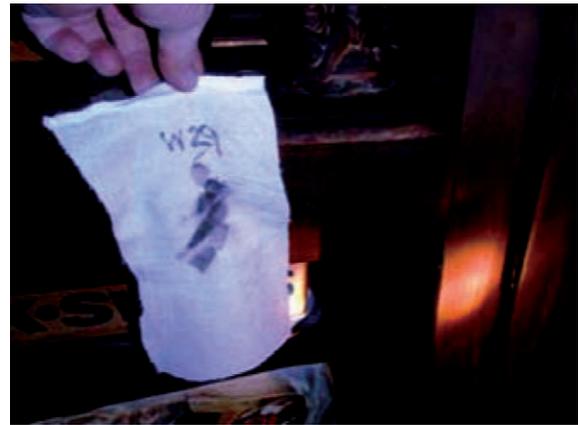
29 Apartment 201: Living
room–Contents near
east wall H Black soot Yes

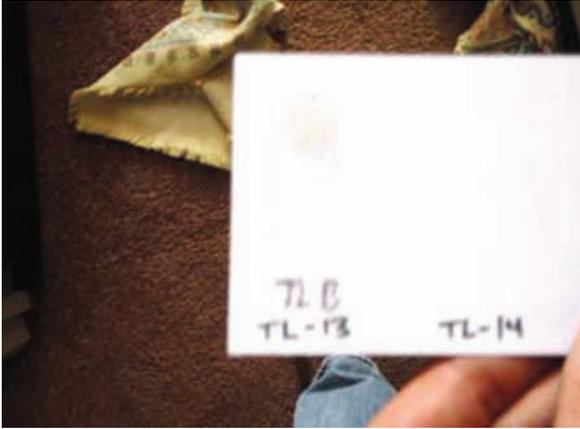
Tape Lift (TL) Sample ID	Description of Sample Location	Laboratory Results	Photograph
13	Apartment 207: Utility room–N. wall cavity–High	7% carbonaceous particles 32% cellulose fibers 11% epithelial (skin) cells 1% fungal spores 7% glass fiber 5% gypsum dust 1% hyphal fragments 25% mineral particles 5% miscellaneous 1% plant matter 1% pollen 1% starch particles 3% wood chips

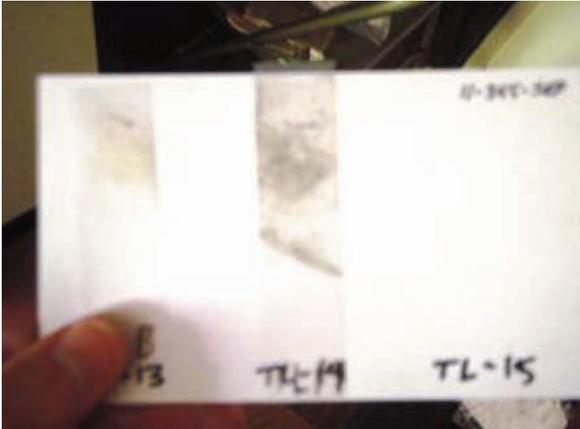
14	Apartment 207: Utility room–N. wall–ceiling cavity to N	8% carbonaceous particles. 28% cellulose fibers 12% epithelial (skin) cells 3% fungal spores 7% glass fiber 2% gypsum dust 20% mineral particles 5% Miscellaneous 2% plant matter 3% pollen 5% soot-like particles 2% starch particles 3% wood chips

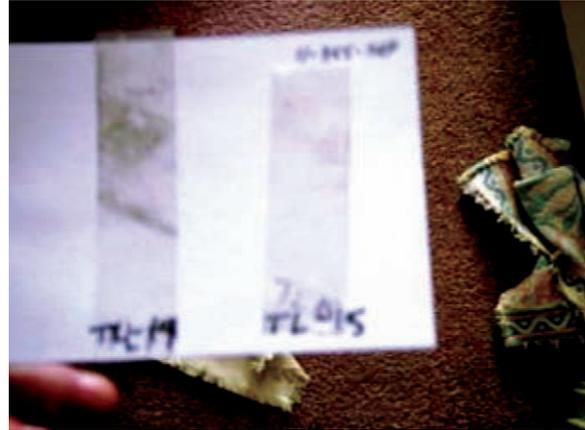
15 Apartment 207: Utility room–N.
wall cavity–Low

- 5% carbonaceous particles
- 40% cellulose fibers
- 20% epithelial (skin) cells
- 1% fungal spores
- 2% glass fiber
- 1% gypsum dust
- 1% hyphal fragments
- 16% mineral particles
- 5% miscellaneous
- 2% plant matter
- 2% pollen
- 3% soot-like particles**
- 1% spider web
- 1% wood chips

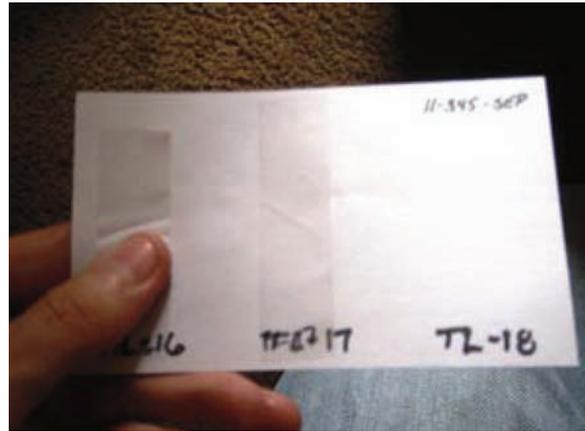
17 Apartment 206: Living room–S.
wall cavity–High

- 7% carbonaceous particles
- 33% cellulose fibers
- 17% epithelial (skin) cells
- 7% glass fiber
- 2% gypsum dust
- 2% insect parts
- 23% mineral particles
- 5% miscellaneous
- 1% plant matter
- 2% pollen
- 1% wood chips

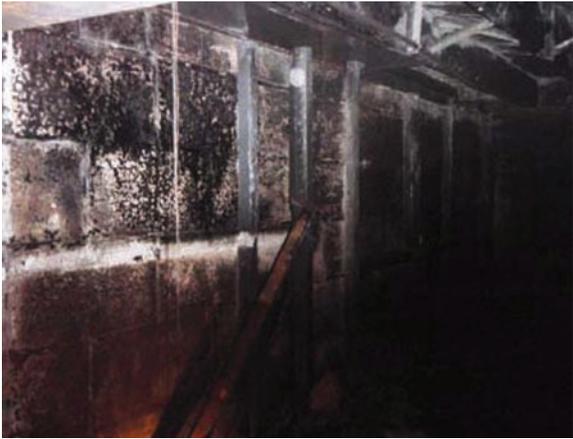
Component(s)	Photograph	Recommendation
Foundation wall surfaces—except central south wall

Remove residual stud walls, clean and seal
South central upper foundation wall

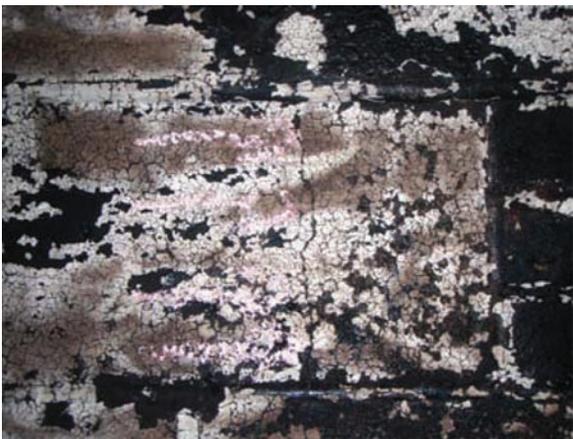
Remove and replace top three rows of CMU—3 blocks wide—just east of steel I-beam
Charred and burned-through wood ceiling joists, beams, and subflooring

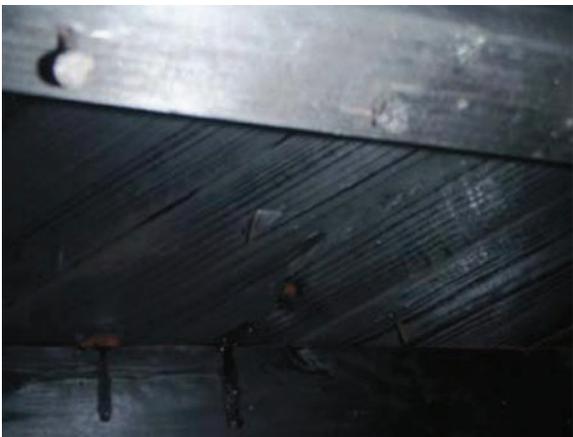
Remove and replace; shore to support areas above West half: Joists J1 to J12 East half: Joists J1 to J10 Ceiling decking: All

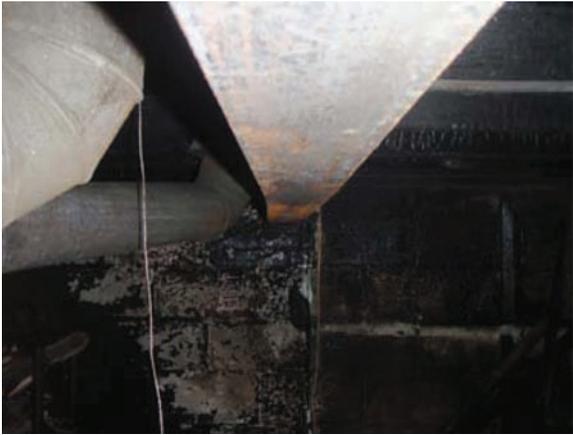
Component(s)	Photograph	Recommendation
South ~11' of steel I-beam

Cut, remove, replace—tie into remaining beam above south support metal post with plates—bolt or weld together to match the original beam integrity Shore as necessary
West window

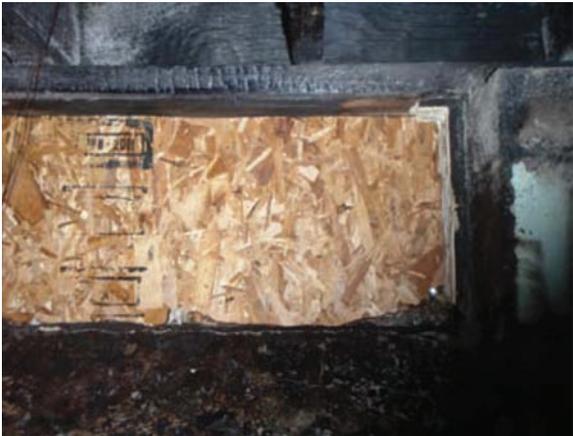
Remove and replace
South gas meter and piping

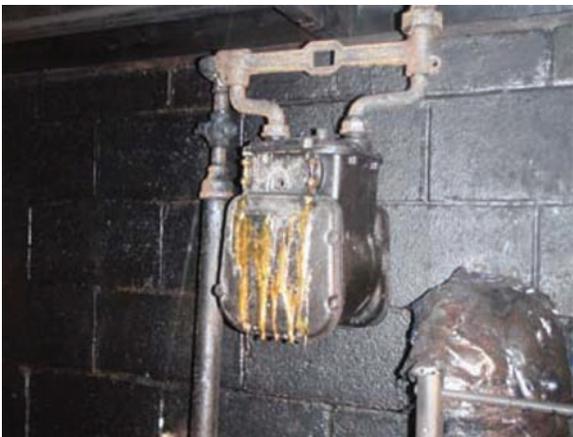
Remove and replace

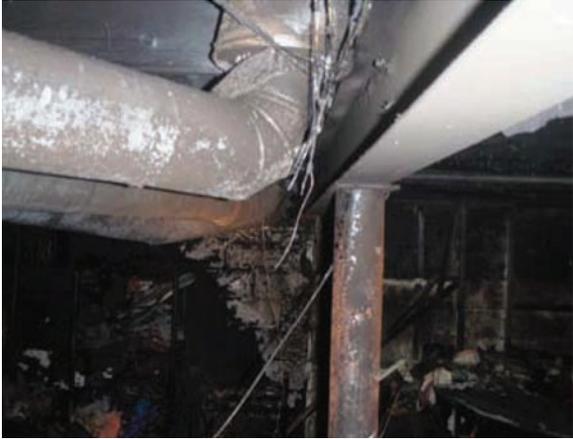
Component(s)	Photograph	Recommendation
Ductwork

A photograph showing a large, white, cylindrical ductwork pipe in a basement office room. The pipe is heavily damaged, with significant chipping and peeling of the surface material, revealing a dark, charred interior. The surrounding area is cluttered with debris and shows signs of fire damage.	Clean and seal or remove and replace—select most cost-effective option
Natural gas black piping/copper and PVC plumbing

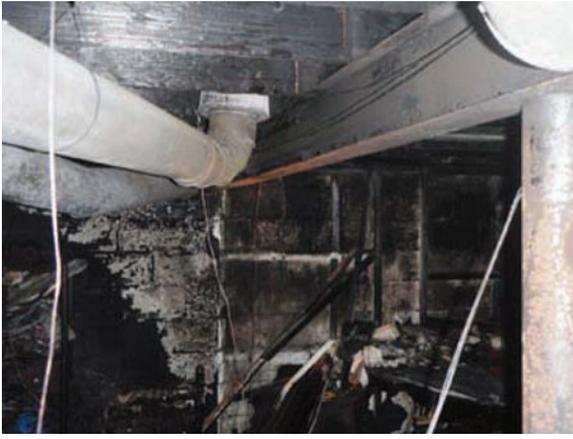
A photograph showing a close-up of plumbing pipes in a basement office room. The pipes are heavily damaged, with significant chipping and peeling of the surface material, revealing a dark, charred interior. The surrounding area is cluttered with debris and shows signs of fire damage.	Plumbing surfaces could be cleaned, but it may be more efficient to remove and replace, given the ceiling joists will be removed and replaced
Soot-covered floor surfaces

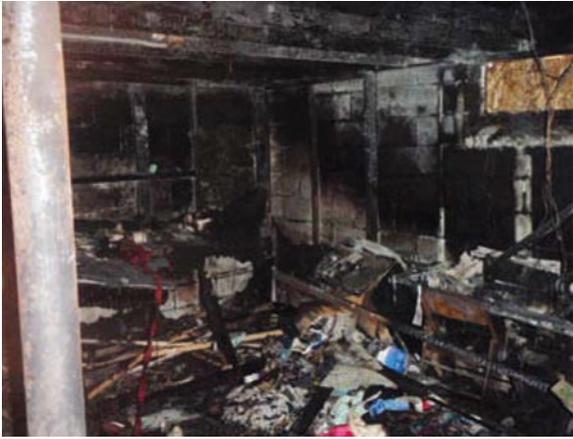
A photograph showing a wide view of a basement office room. The floor is heavily covered in a thick layer of black soot and debris. The walls and ceiling are also heavily damaged, with significant chipping and peeling of the surface material, revealing a dark, charred interior. The room is cluttered with debris and shows signs of fire damage.	Clean and seal

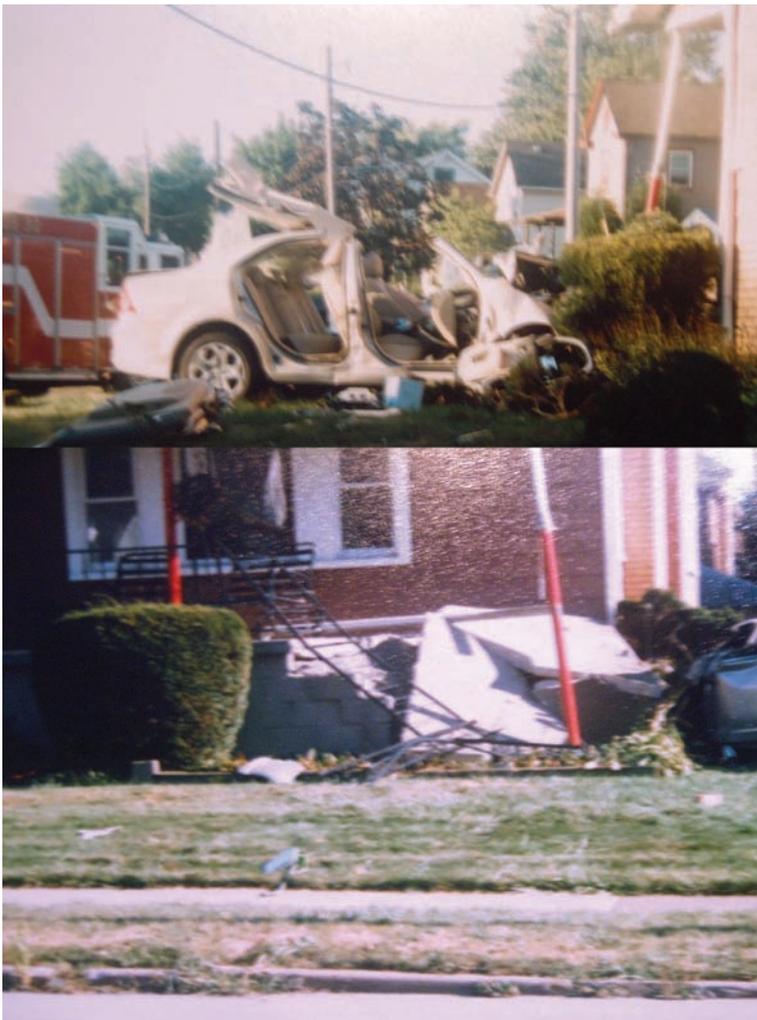
FIGURE 18.1
Vehicle—house impact and resulting damage.

damage to a building. An illustration of damage to a car and home from the car crashing into the concrete porch of the home is shown in Figure 18.1.

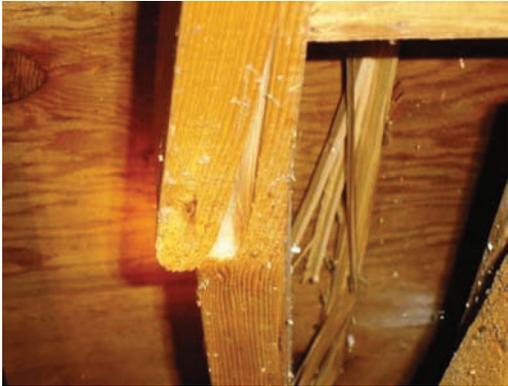
Item	Characteristics	Photograph
Split or crack in wood member	Brightness or lighter color on crack or cracked surfaces

As illustrated in Table 18.2, the best criteria for determination of whether the damage is recent or “fresh” are:

- A brighter or lighter color of the crack or split surfaces.
- Lack of debris within the crack. Debris can include dirt, paint, cobwebs, insects and insect debris, mold, algae, or lichen.

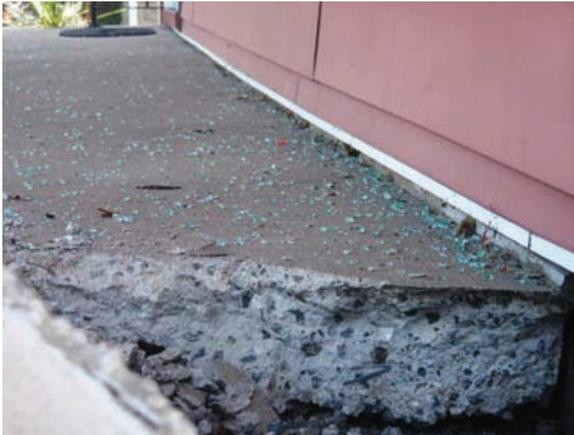
Cracks and displacement to concrete	Brightness or lighter color on crack or cracked surfaces

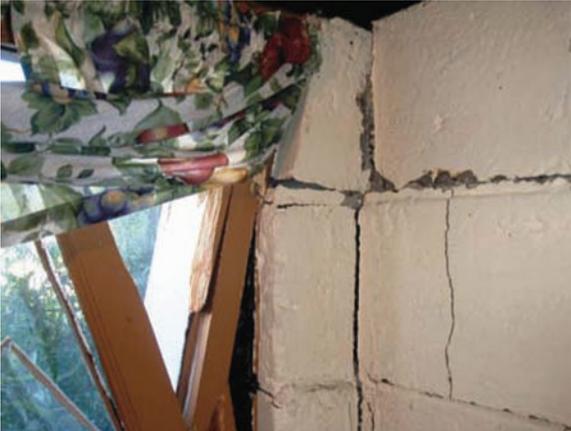
Item	Characteristics	Photograph
Cracks and displacement to concrete masonry unit (CMU)	Brightness or lighter color on crack surfaces or cracked CMU block surfaces (note also fresh cracks to wood window frame)

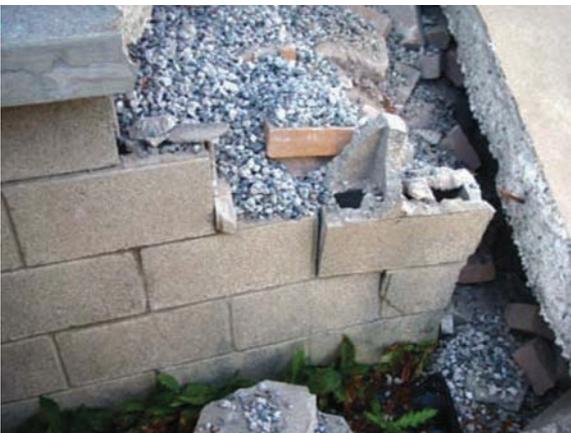
Displacement to CMU	Brightness or lighter color on crack surfaces or cracked CMU block surfaces No debris (dirt, spider webs, algae) in cracks

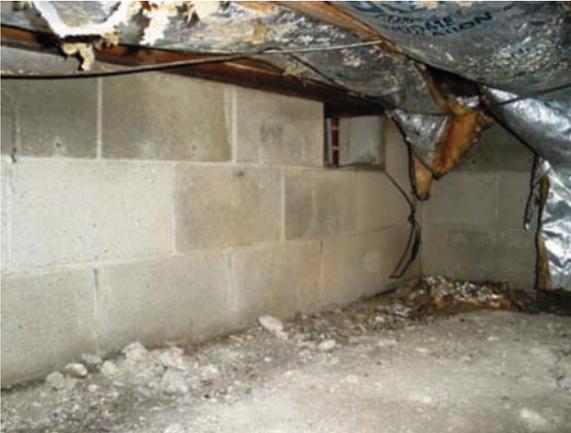
Displacement to CMU	Brightness or lighter color on crack surfaces or cracked CMU block surfaces No debris (dirt, spider webs, algae) in cracks

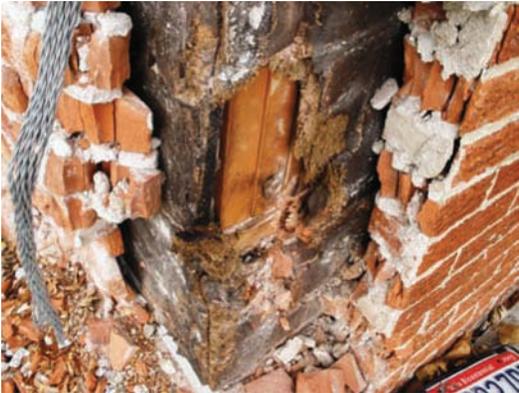
Item	Characteristics	Photograph
Displacement and missing brick masonry	Brightness or lighter color on gap/crack surfaces No debris (dirt, spider webs, algae) in cracks

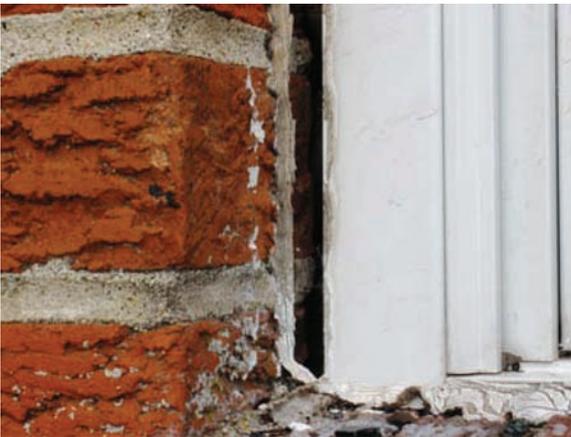
Cracks and displacement to brick masonry; veneer displaced from window frame	Gaps or cracks at brick/mortar interface with mortar; brightness or lighter color on crack surfaces No debris (dirt, spider webs, algae) in cracks

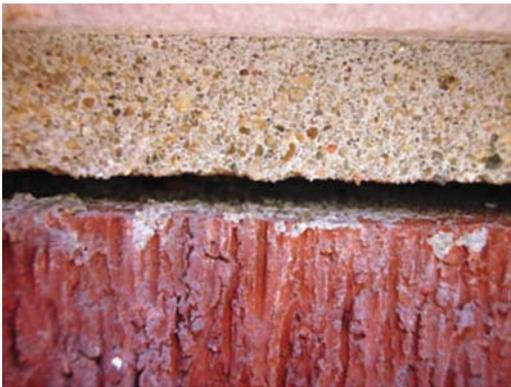
Cracks and displacement to brick masonry	Gaps or cracks at brick/mortar interface with mortar; brightness or lighter color on crack surfaces No debris (dirt, spider webs, algae) in cracks

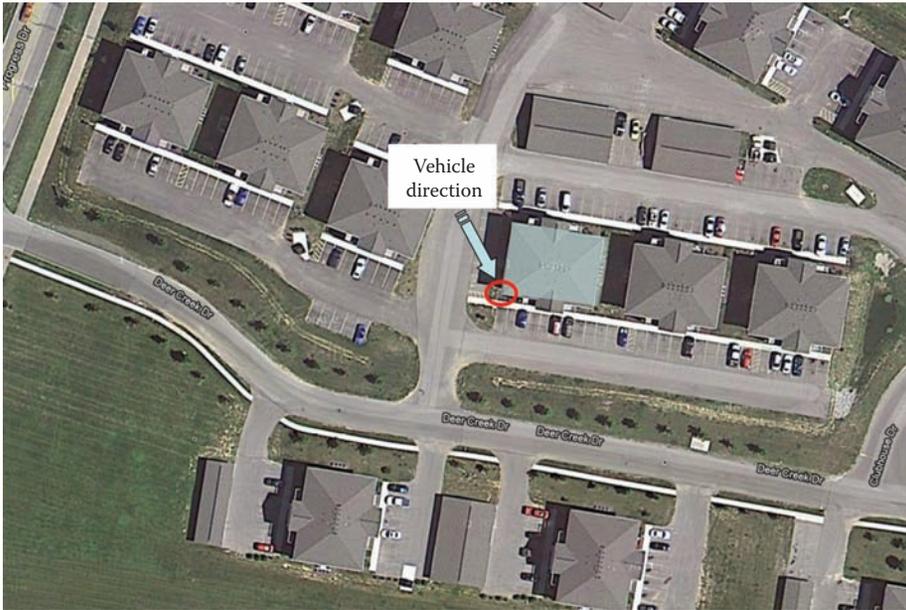
FIGURE 18.2
Example of vehicle impact location schematic.

- Any photographs and police reports associated with the incident.
- The location where the building was struck (e.g., Figure 18.2).
- Visible structural and cosmetic damage observations for all spaces. The inspection should be completed indoors for all spaces and outdoors for all elevations and the roof. The report should include a delineation of damaged areas, including extent of damage to wall, floor, and ceiling surfaces, as well as structural framing members or materials such as those formed from concrete, CMU, stone, steel, and wood. Results should be summarized by space as illustrated in Figure 18.3 and Table 18.3. Nonstructural cosmetic damage caused by the vehicle impact should also be summarized, including locations and areas of damage.

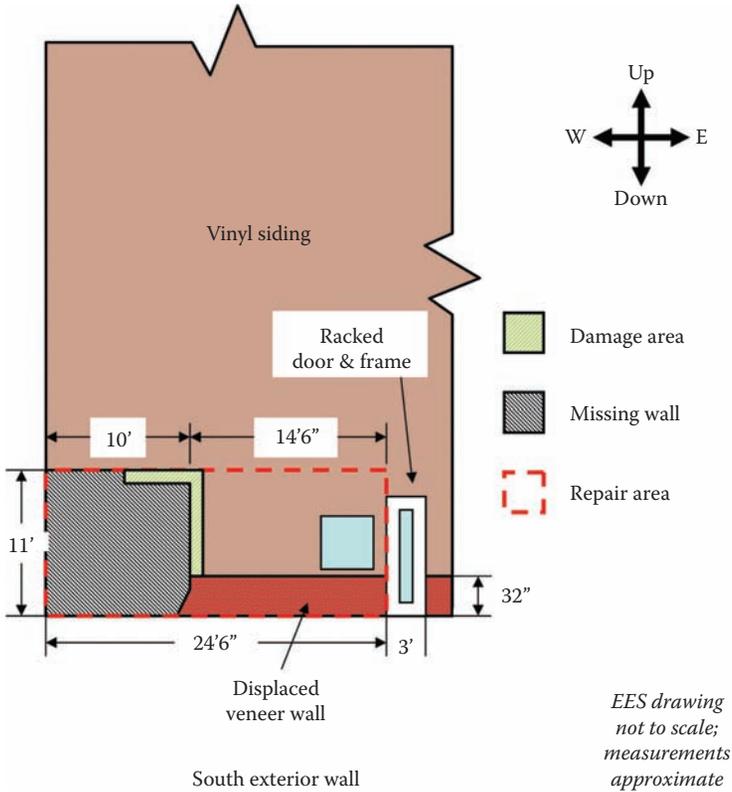
FIGURE 18.3
Example of elevation layout schematic.

Examples of Vehicle Damage Findings and Recommendations for a Given Elevation (See Figure 18.3)

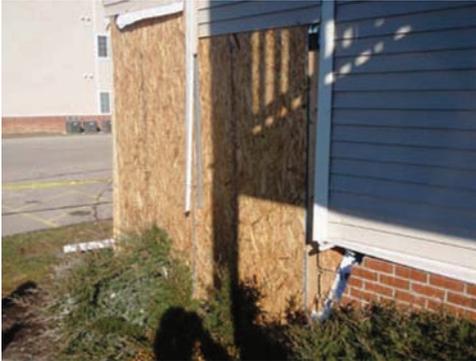
Component(s)	Photograph	Recommendation
<p>Red brick veneer (~32" high × ~24-1/2' long) from southwest corner east</p>

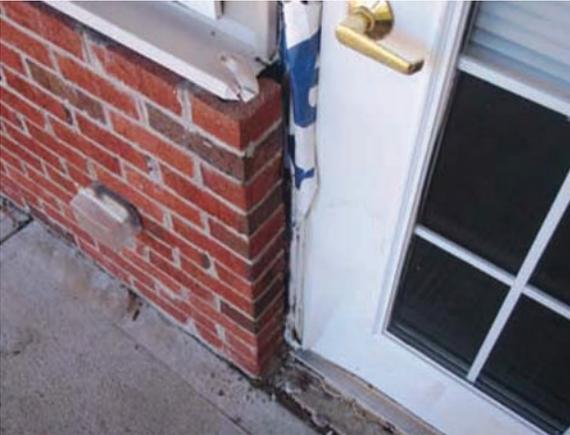
<p>Remove and/or replace</p>
<p>Metal cap/flushing (~8" wide × ~24-1/2' long)</p>

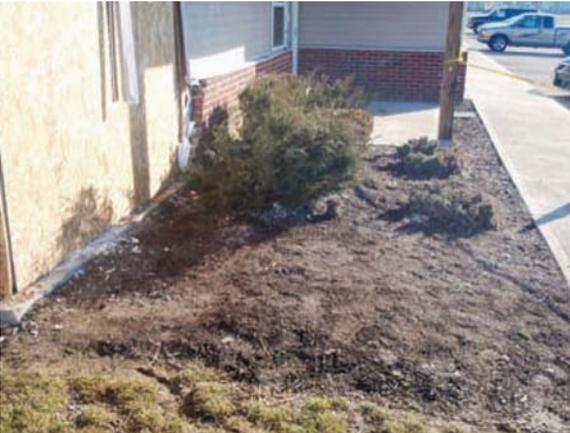
<p>Remove and/or replace</p>
<p>Vinyl siding (~24-1/2' wide × ~7' high) lower southwest corner— replace more than damaged since end of panels damaged</p>

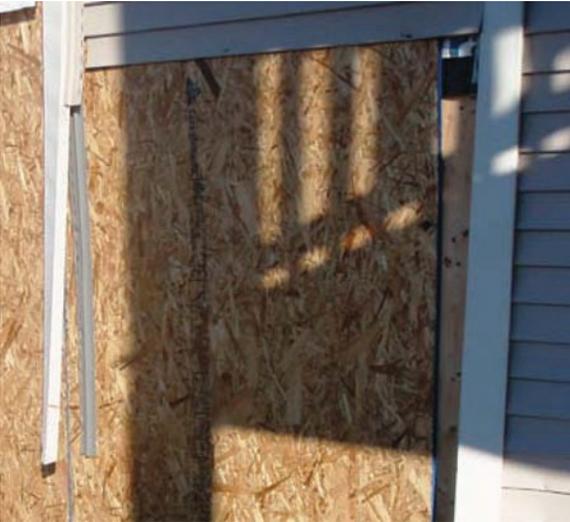
Component(s)	Photograph	Recommendation
South bedroom window and framing

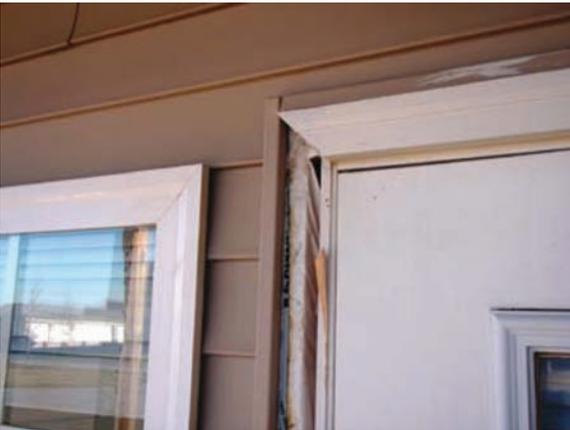
Replace
South entry door and framing

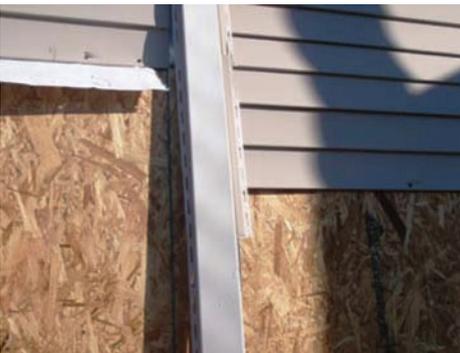
Replace
Vertical vinyl trim

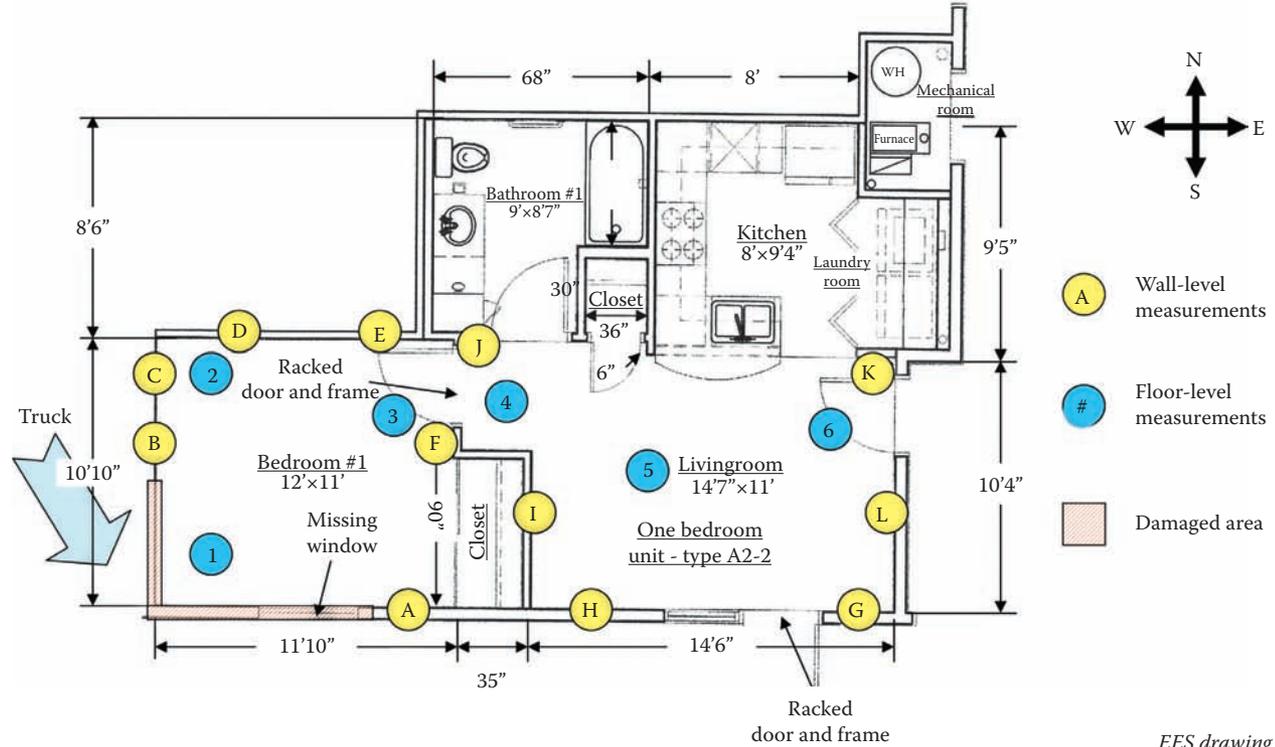
First floor – unit #1

EES drawing not to scale; measurements approximate

FIGURE 18.4
Example of elevation plumb or level measurement schematic.

- Cracks should be reported in terms of size, freshness, and location. Interpretation of crack results should follow guidelines outlined in Chapter 15, this volume.
- Plumb and level measurements on floors, walls, ceiling, or framing members should be reported in tabular format and any distorted surfaces noted. Results should be interpreted as outlined in Chapters 14 and 15, this volume. Examples of wall plumb and floor level measurements are shown in Figure 18.4 and Tables 18.4 and 18.5; note for example that the center of the bedroom west wall (Table 18.4) has an unacceptable slope of 0.6 degrees.

Examples of Wall Plumb Measurement Results (See Figure 18.4)

Examples of Floor Level Measurement Results (See Figure 18.4)

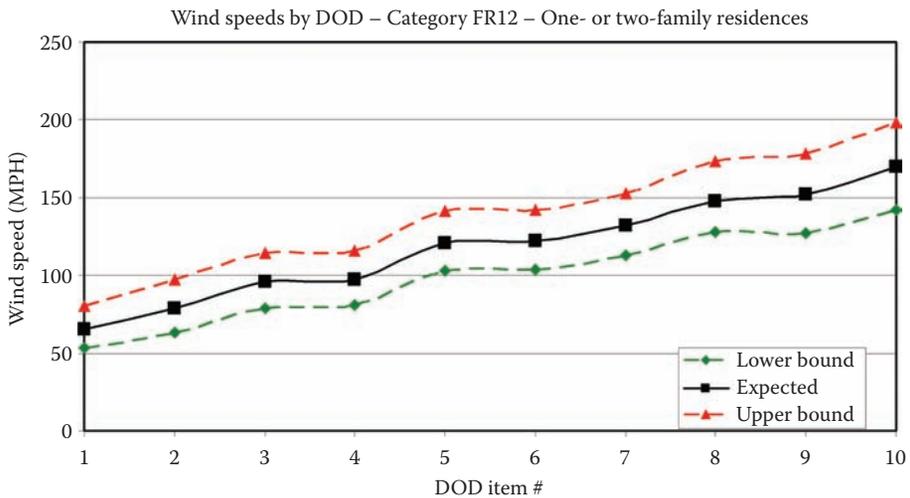
FIGURE 19.4 Plot of tornado degree of damage (DOD) estimates for damage indicator (DI) 2—“One- or Two-Family Residences (FR12).”

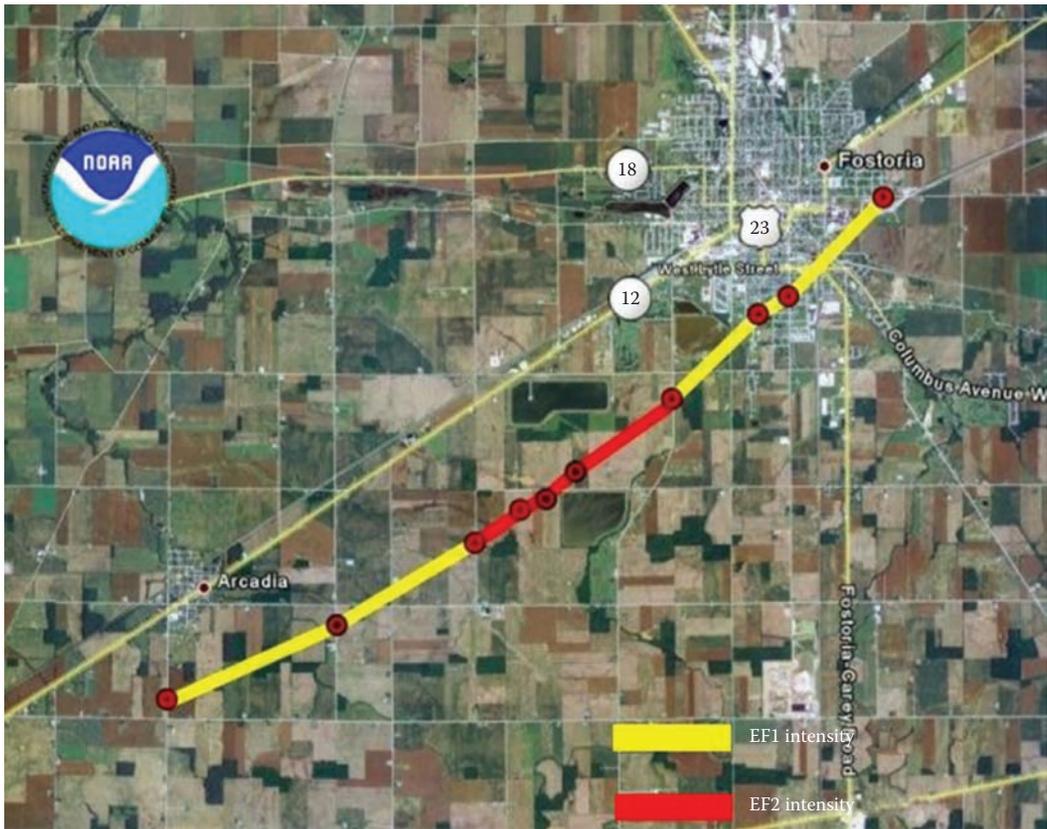
FIGURE 19.5

Path of tornado with multiple EF ratings. (Adapted from NOAA "Tornado Path in Fostoria, OH, <http://www.erh.noaa.gov/index.php>)

The WISE of TTU published their work on an enhanced Fujita scale in June 2004,⁷ and most weather experts, including NOAA, now use the operational EF scale as shown in Table 19.5 to describe the strength of a tornado that hit an area and caused specific damage to specific buildings, structures, trees, and other DIs. It should be noted that the overall EF rating is based on the highest estimated wind speed to have occurred corresponding to DOD observations for given DIs. Often multiple EFs are assigned to a tornado along its path.⁹ An example of a tornado with multiple EF ratings along its path is shown in Figure 19.5. In this example from NOAA (Figure 19.5), the initial and final rating of a tornado was EF1. However, during the middle portion of time the tornado was on the ground, it was rated as an EF2. Lower operational EFs would apply to destruction not immediately within the path of the tornado.

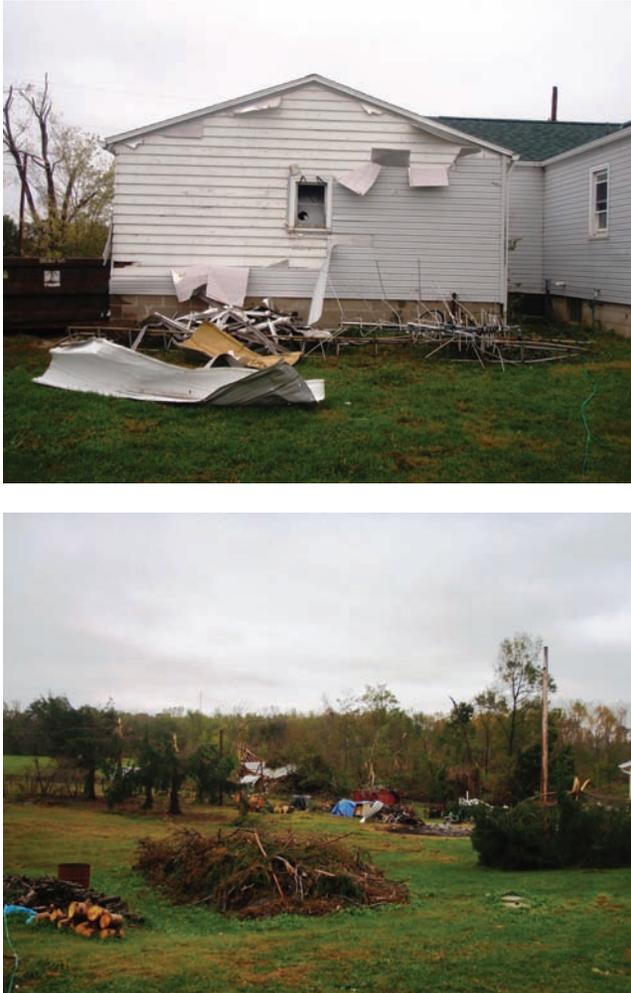
**FIGURE 19.6**

Example of tornado damage—garage severely damaged with limited damage to home; tree damage to left of side of garage.

cases, a portion of the structure or residence will be damaged more severely than the balance of the structure or residence. Examples of this situation are illustrated in Figure 19.6. In Figure 19.6, the vinyl siding had been ripped from the garage surfaces, whereas the home was relatively untouched. In this case, the tornado passed from the lower left of the photo to the left side of the garage.

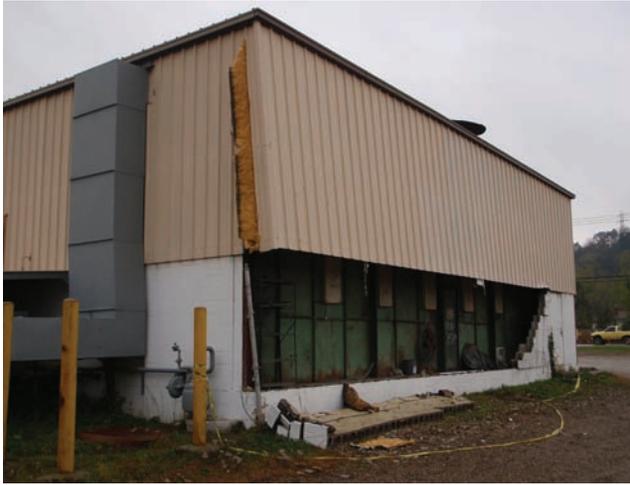
FIGURE 19.7

Example of tornado damage—failure of CMU wall on one side of commercial building.

The apparent pulling out of the wall system illustrated in Figure 19.7 is typical of damage from a tornado where the structure will appear to explode outward. This characteristic is due to the fact that the air pressure in a tornado is low relative to the air pressure in a building, causing the structure to be displaced outward.

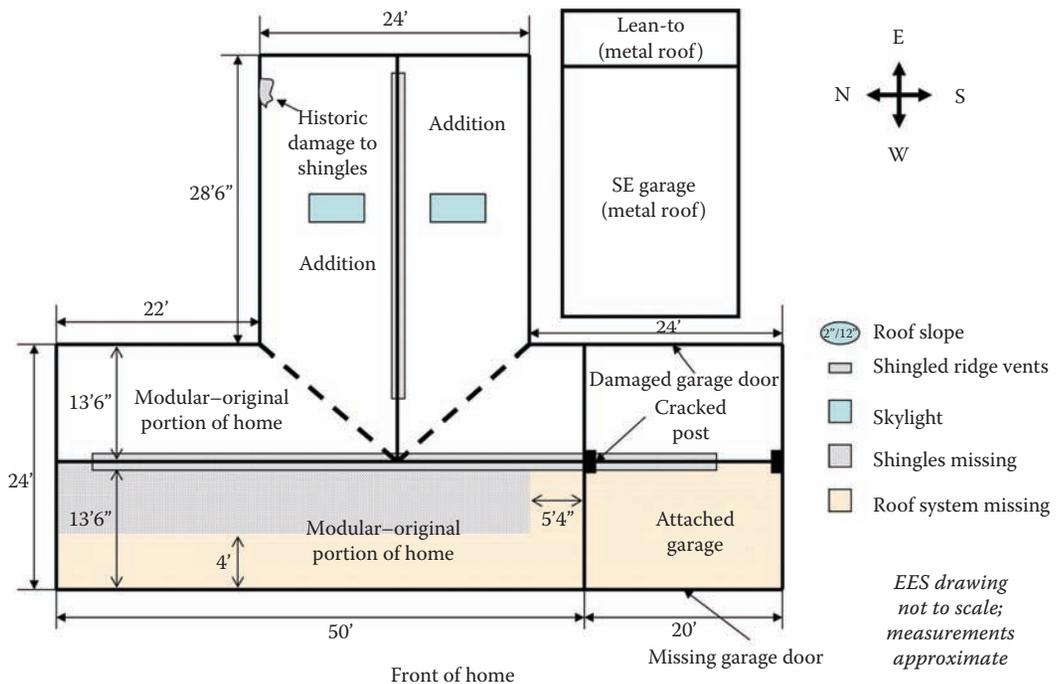
FIGURE 19.8 Tornado damage assessment roof layout schematic.

The types of documentation taken and reported during these types of inspections is illustrated in Figure 19.8 and Table 19.6. In this illustration, major structural damage occurred to the front half of the garage and home where the entire roof systems were torn away by the tornado.

Aside from an analysis of field information collected during the inspection, a detailed analysis of weather data should be completed. Information available from NOAA is often quite detailed regarding the strength, location, and path of a tornado along with damaged buildings and structures. Often, specific data for the structure in question are actually contained in this information and can support the extent of damage likely to be seen and reported. An illustration of the data available from NOAA's SPC for the tornado responsible for the damage to the home shown in Figure 19.8 is shown in Figure 19.9.¹⁰ The lowest left photograph shown in Figure 19.9 was of the home actually inspected in the example given in Figure 19.8 and is shown as the second item in the storm path.

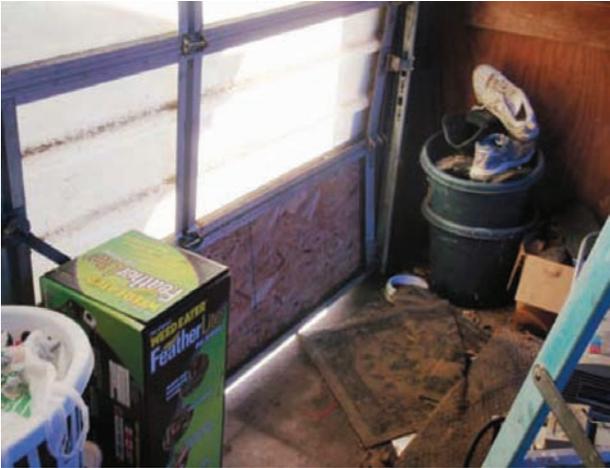
Component(s)	Photograph	Recommendation
Front and back attached garage doors Front attached garage door rails and door opener

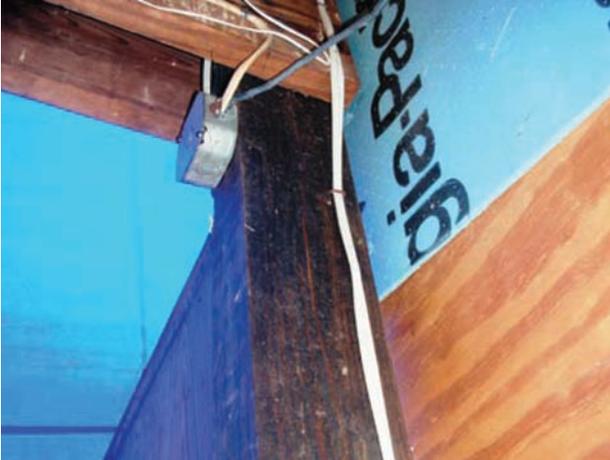
Remove and replace
Attached garage—north central post

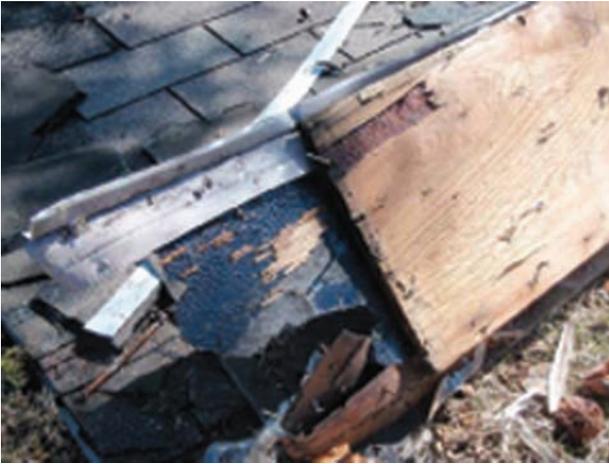
Component(s)	Photograph	Recommendation
West roof elevation including rafters West roof insulation West house ceilings ridge vent

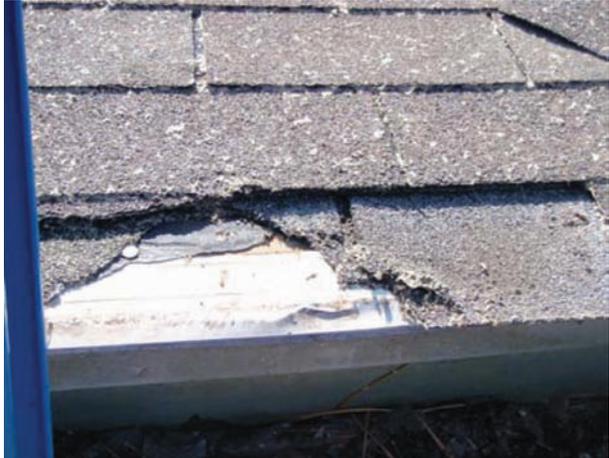
Remove and/or replace
North roof (addition)— Impact damage at eave to shingles, felt, drip edge, and gutter

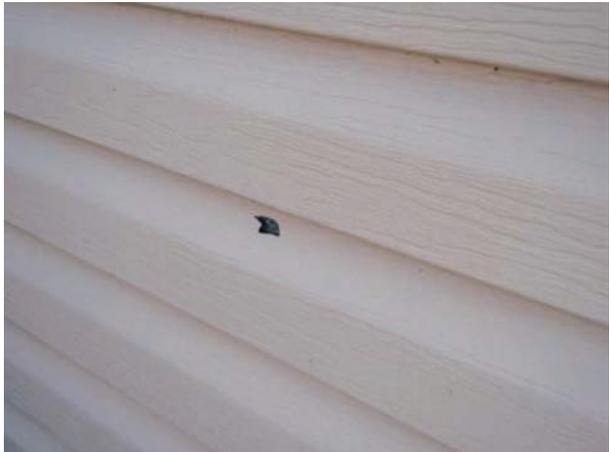
Remove and repair/replace
Missing siding— West side of garage and south side of home (two locations) Holes in west house and south garage vinyl siding (three locations)

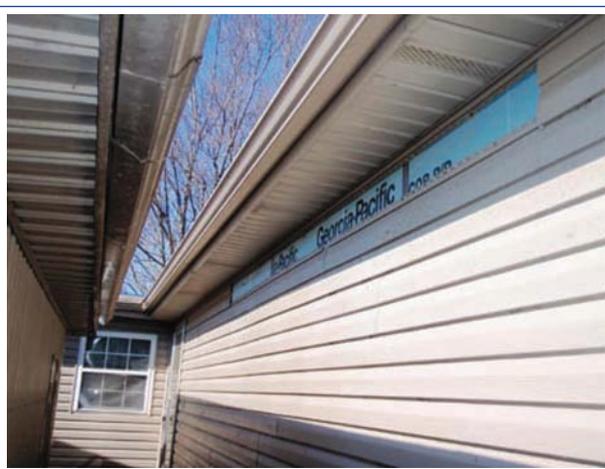
Component(s)	Photograph	Recommendation
<p>Damage to SE garage south roof—East rake trim and north gutter</p>

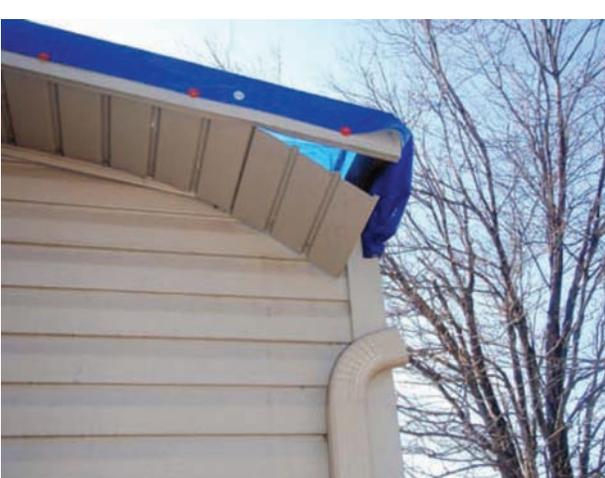
<p>Repair</p>
<p>Damaged/missing soffit, fascia, gutters and downspouts</p>

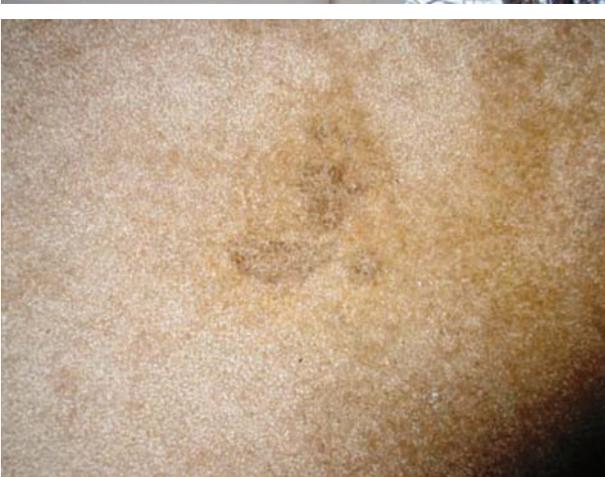
<p>Repair or remove/replace or replace as necessary</p>
<p>West central bedroom floor and living room carpeting and floor damaged by water</p>

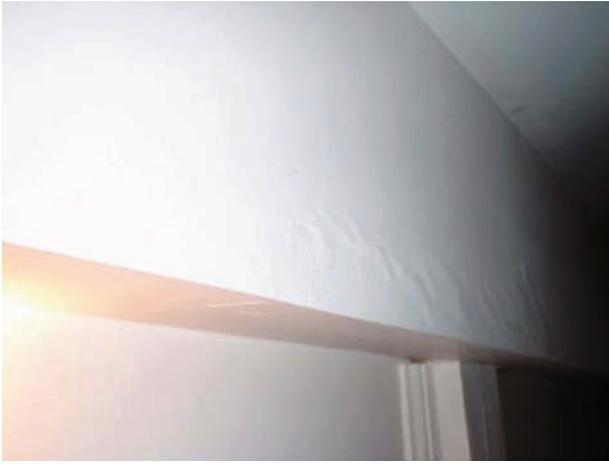
Component(s)	Photograph	Recommendation
Wall and ceiling cracks/damage to interior spaces
