FORENSIC ENGINEERING

**Damage Assessments for
Residential and Commercial
Structures**

**Edited by
Stephen E. Petty**

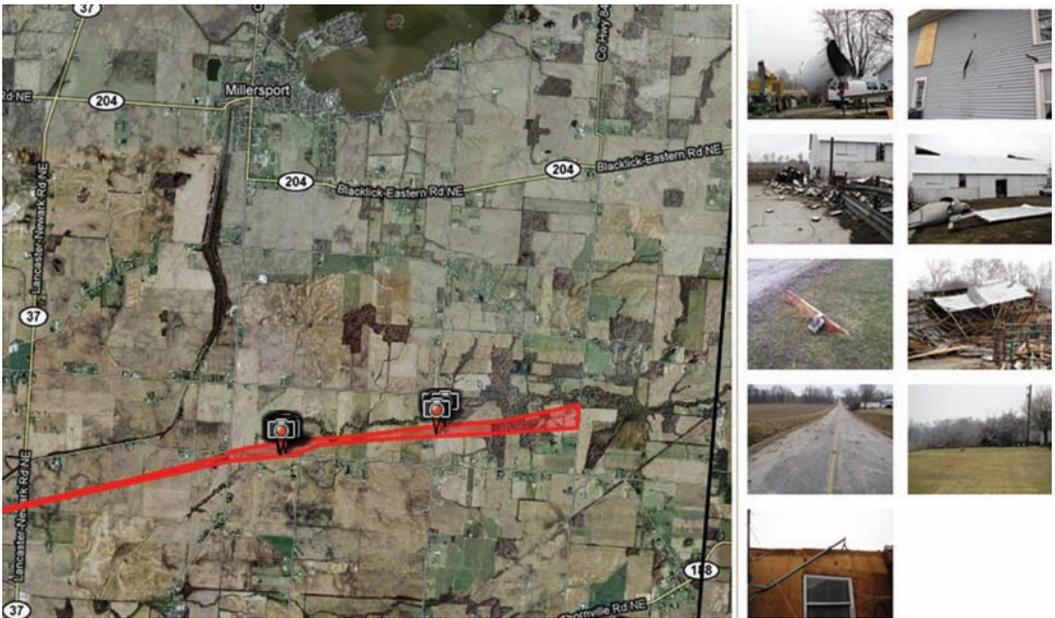
FIGURE 19.9

February 28, 2011, tornado path and damage photographs. (Adapted from NOAA, “National Weather Service Forecast Office—Wilmington, OH, February 28, 2011 Tornado Event,” <http://www.erh.noaa.gov/index.php>.)

Aside from an analysis of field information collected during the inspection, a detailed analysis of weather data should be completed. Information available from NOAA is often quite detailed regarding the strength, location, and path of a tornado along with damaged buildings and structures. Often, specific data for the structure in question are actually contained in this information and can support the extent of damage likely to be seen and reported. An illustration of the data available from NOAA's SPC for the tornado responsible for the damage to the home shown in Figure 19.8 is shown in Figure 19.9.¹⁰ The lowest left photograph shown in Figure 19.9 was of the home actually inspected in the example given in Figure 19.8 and is shown as the second item in the storm path.

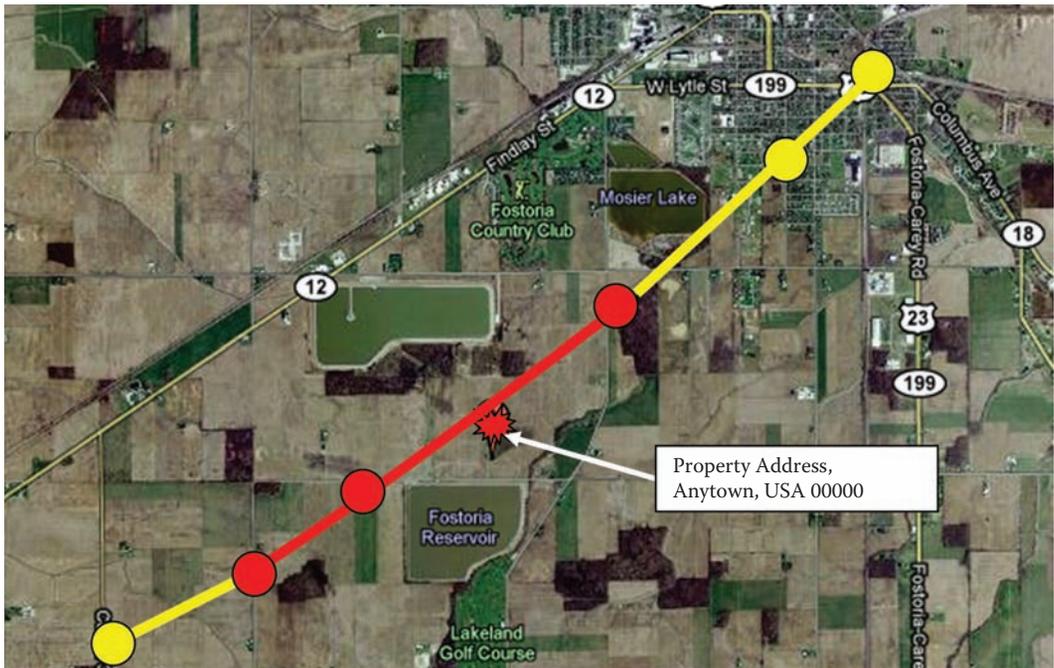
FIGURE 19.11

Example of proximity of structure to the tornado path. (Adapted from NOAA, “National Weather Service Forecast Office—Wilmington, OH, February 28, 2011 Tornado Event,” <http://www.erh.noaa.gov/index.php>.)

If possible, information on the proximity of the structure to the tornado should be determined. An example depicting the location of a structure relative to the path of a tornado is shown in Figure 19.11. In this example case, the structure, a barn, was located just south of the tornado path.

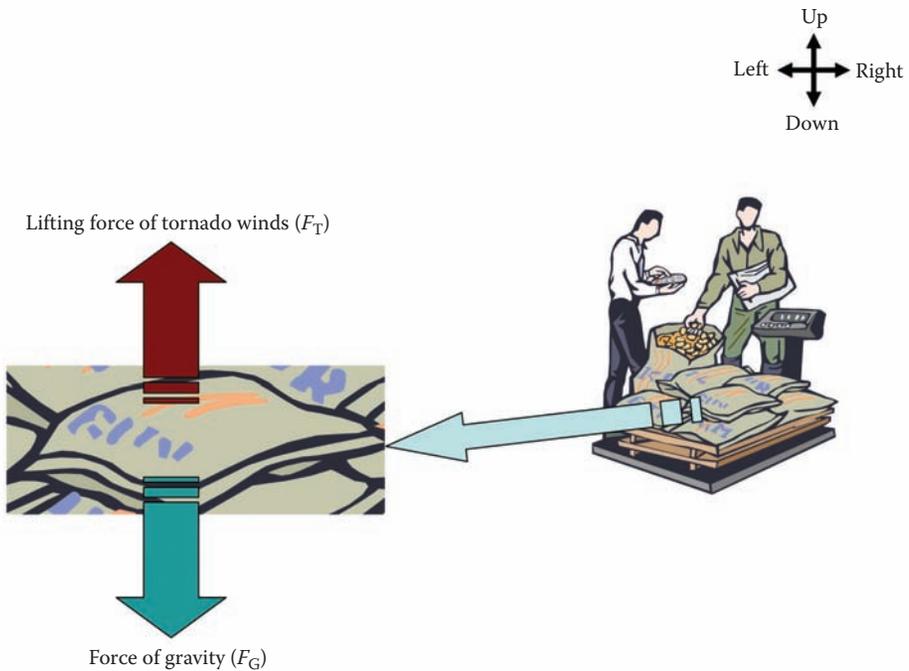
EES drawing

If $(F_T) > (F_G)$ or $(F_T) - (F_G) > 0$, the content will be lifted or moved.

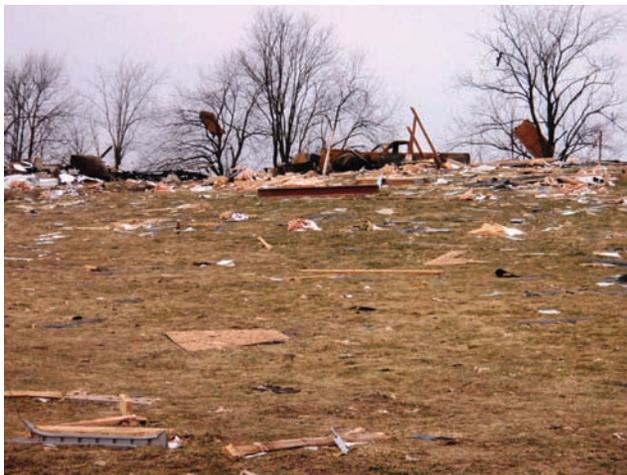
FIGURE 20.1
Propane explosion debris field.

Claims resulting from blast damage primarily occur for one of three events: (1) blasts from nearby quarrying (surface) operations, (2) blasts from nearby mining (surface and subsurface) operations, or (3) propane and natural gas explosions. Damage to nearby structures from blasts associated with these three events can range from minimal to catastrophic. Photographic examples of the debris field associated with the destroyed home and nearby damage to an adjacent home from a propane leak explosion are illustrated in Figures 20.1 and 20.2, respectively.

Upon arriving at the site, the inspection process should follow the overall approach outlined in Chapter 1, this volume. In many of these cases, like the one depicted in Figures 20.1 and 20.2, the damage assessment will be performed on adjacent properties since the site of the actual explosion may be a total loss. Specific questions for the interview should include the following:

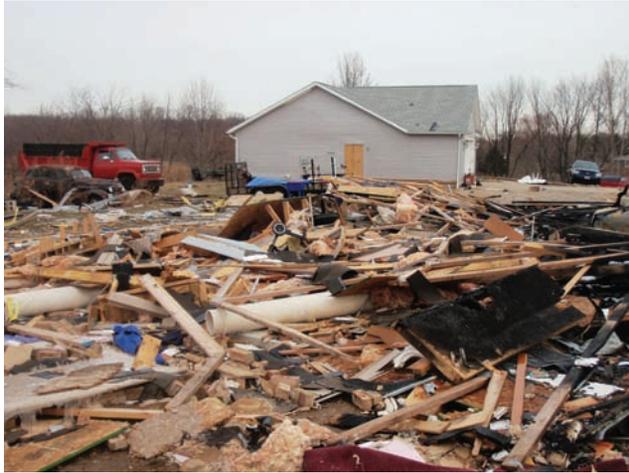
FIGURE 20.2

Propane explosion—damage to nearby home from explosion location.

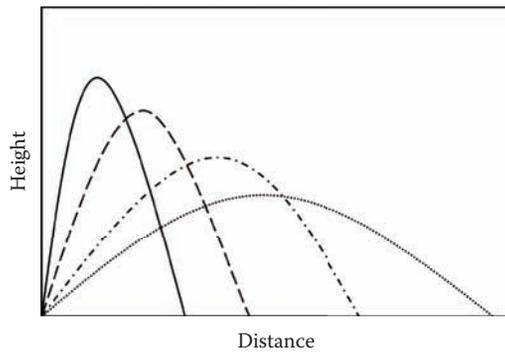
FIGURE 20.3

Debris trajectories for several initial flight directions.

Debris impacts are tied to projectiles propelled by the energy of the blast, impacting nearby structures. These objects typically move in a parabolic arc, where the distance traveled is associated with the amount and direction with which the energy is imparted on an object, the mass of the object, and gravitational forces driving the object back to the ground (Figure 20.3). In fact, the distance traveled and the mass of the objects in the debris field are often used to determine the magnitude of the blast (i.e., energy) in forensic investigations.¹⁻³

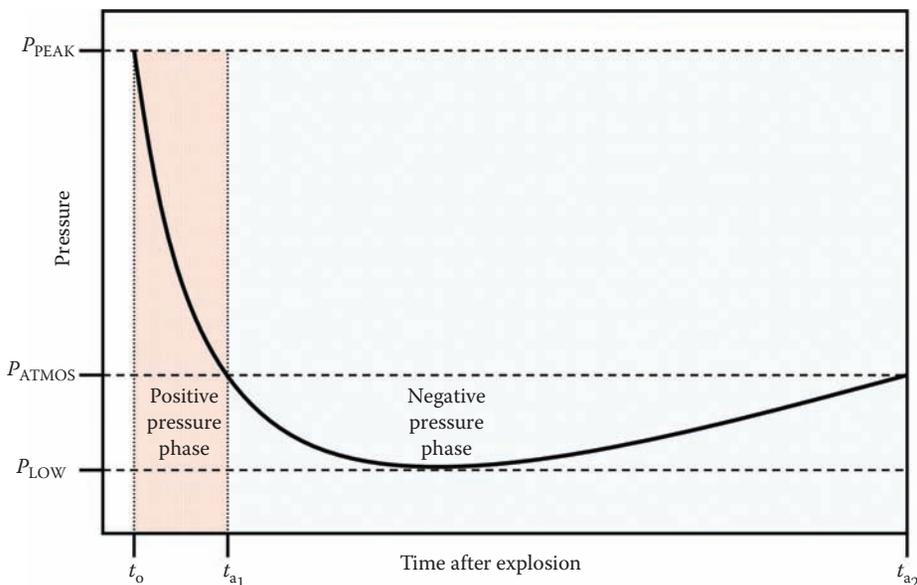
FIGURE 20.4

Time pressure history after explosion.

Air concussion damage is associated with the pressure wave caused by the energy released in a blast or explosion, wherein the air is compressed and then expands outward. Interestingly, the pressure wave encountered by a blast or explosion can be both positive and negative (Figure 20.4).

Initially, the blast wave will be of positive pressure, and then, after the initial pressure wave passes, a negative pressure wave will occur as air rushes into the vacuum created by the passing of the positive wave. Thus, one can observe damage where elements of the structure move away from the blast or explosion (i.e., damages from positive pressure wave from the blast) or move toward the blast or explosion (i.e., damages from negative pressure wave). The initial pressure from an explosion is dependent on the type and amount of material involved in the explosion. Property damage characteristics associated with degree of overpressure in pounds per square inch (psi) are summarized in Table 20.1.

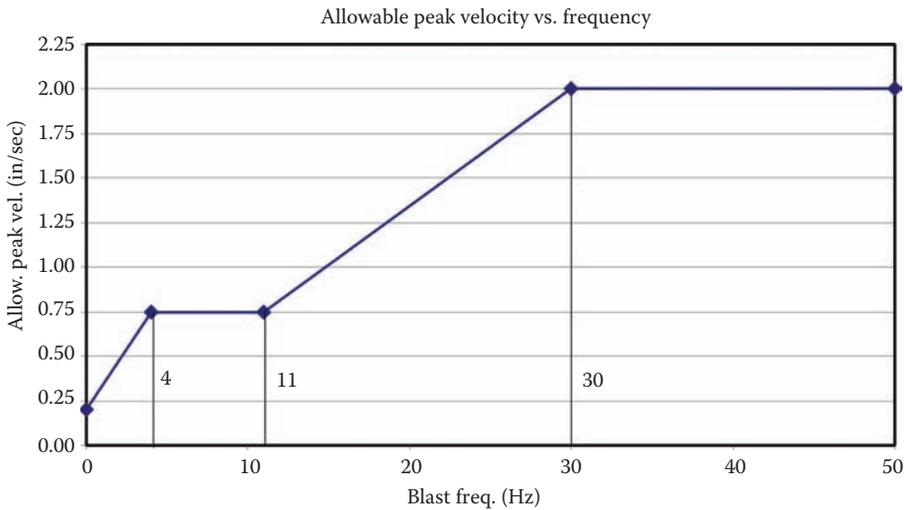
FIGURE 20.5
Allowable peak velocity versus blast vibration frequency.

As summarized by Noon³ and used in modern state codes, it has been recognized that as one moves closer to the blast site, the higher ground frequencies dominate ground movement, whereas farther out from the blast site, lower frequencies dominate since the higher frequencies are attenuated. For this reason, current recommended levels for “safe” peak velocities were expanded and adjusted from those in BOM Bulletin 656⁶ for blast vibration frequency. Allowable peak velocities versus frequency are summarized in Figure 20.5.

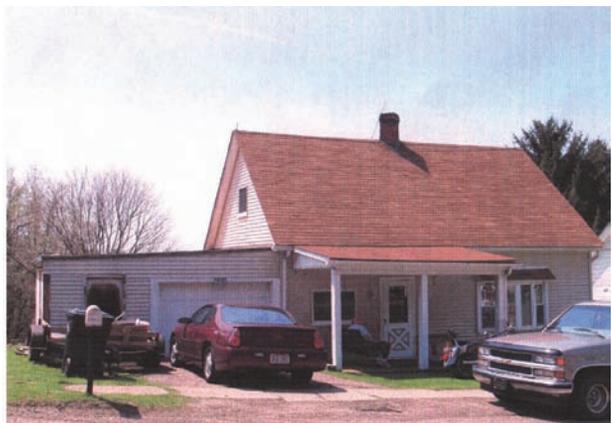
FIGURE 20.6

Example of pre-blast survey—title page.

- Was a pre-blast survey of the property completed? If so, collect a copy of the survey (see pages of an actual pre-blast survey in Figures 20.6 through 20.8). In some cases, this may be available from the company or its representatives who performed the blasting. Pre-blast surveys allow for the comparison of cracks observed during the inspection with pre-blast crack results to determine probable new cracks.

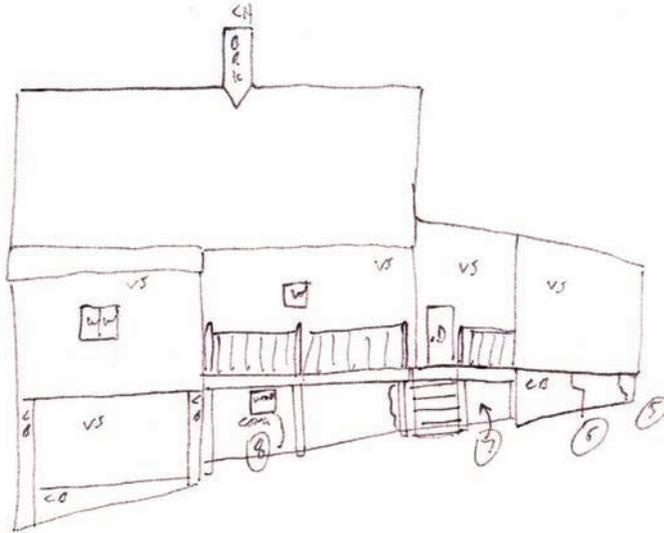
FIGURE 20.7
Example of pre-blast survey—south exterior.

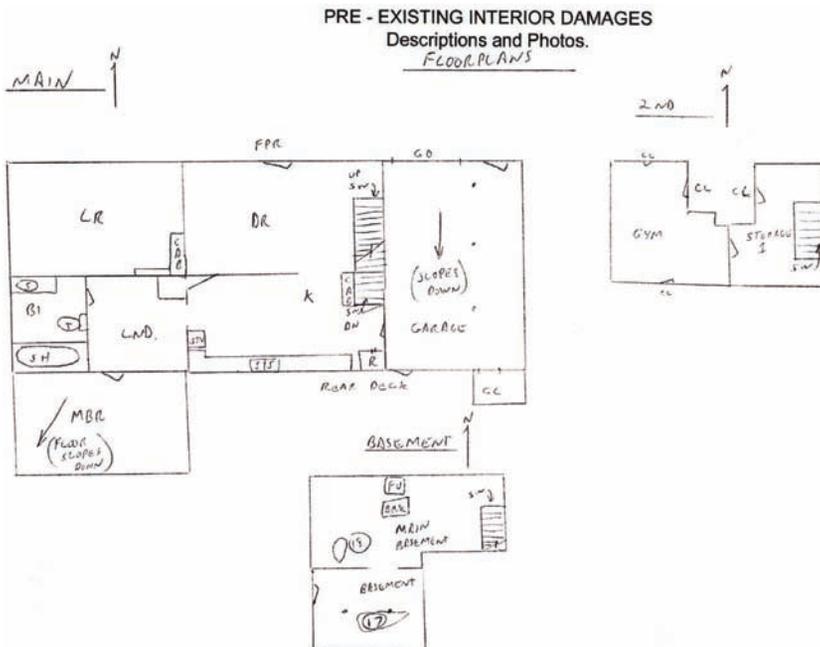
FIGURE 20.8
Example of pre-blast survey—inside—plan view.

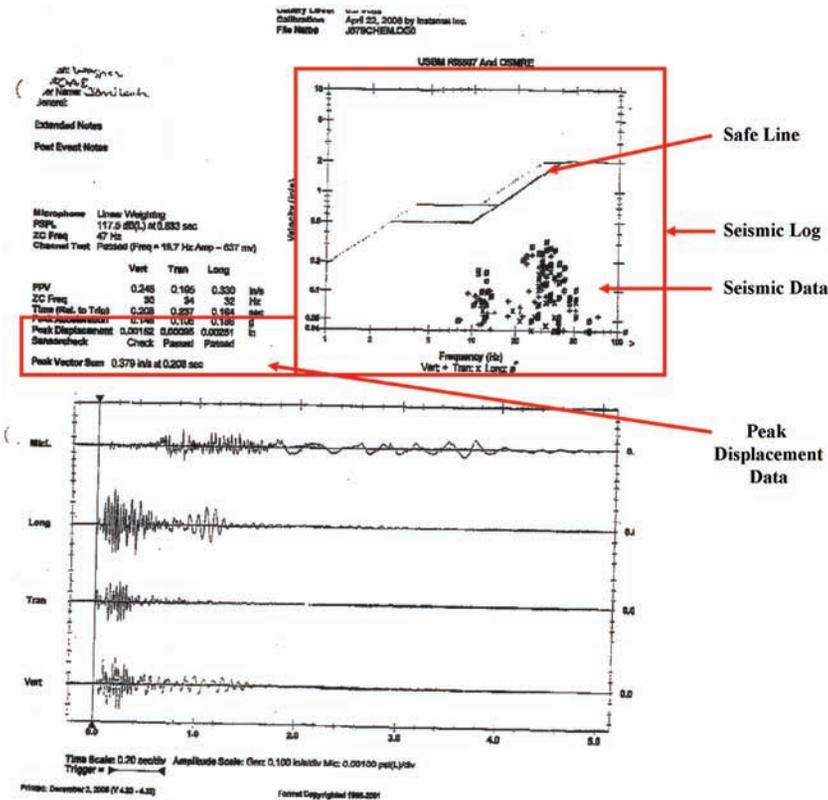
FIGURE 20.10 Example of blast seismic record—seismic page.

Figure 20.10 provides seismic data for a specific blast at a specific location and compares it with safe levels versus frequency. Note in this example that most of the blast data reported a frequency above 10 Hz.

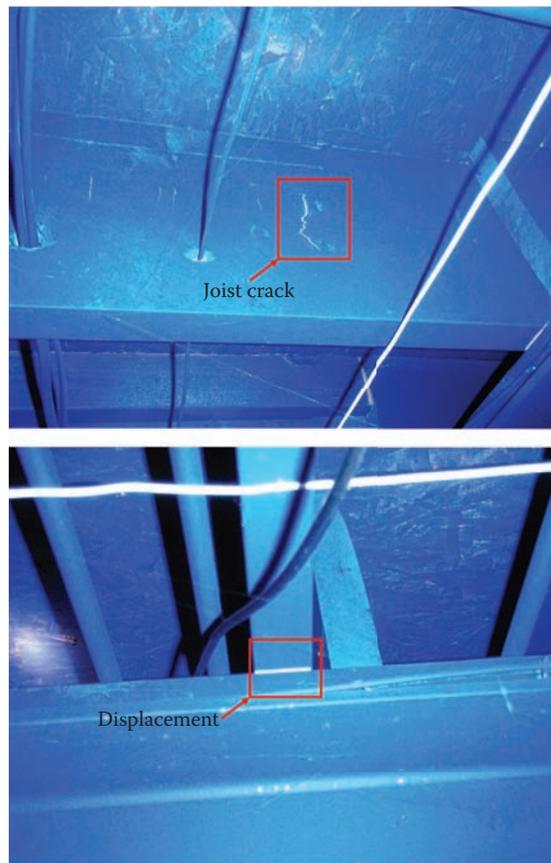
FIGURE 20.11
Explosion damage and movement to basement wood members.

- Fresh cracks in wood members such as joists (Figure 20.11), rafter members, or studs
- Gaps associated with movement between structural members (often change in color or where area not painted exposed (Figure 20.11)
- Dislocated truss members from gusset plate connections (Figure 20.12)
- Disconnected plastic plumbing or wiring (often seen in attics and crawlspaces; Figure 20.12)
- Gaps or racking of windows and doors
- Warping or bulging of floors
- Gaps or disconnections in heating, ventilation, and air conditioning (HVAC) ductwork

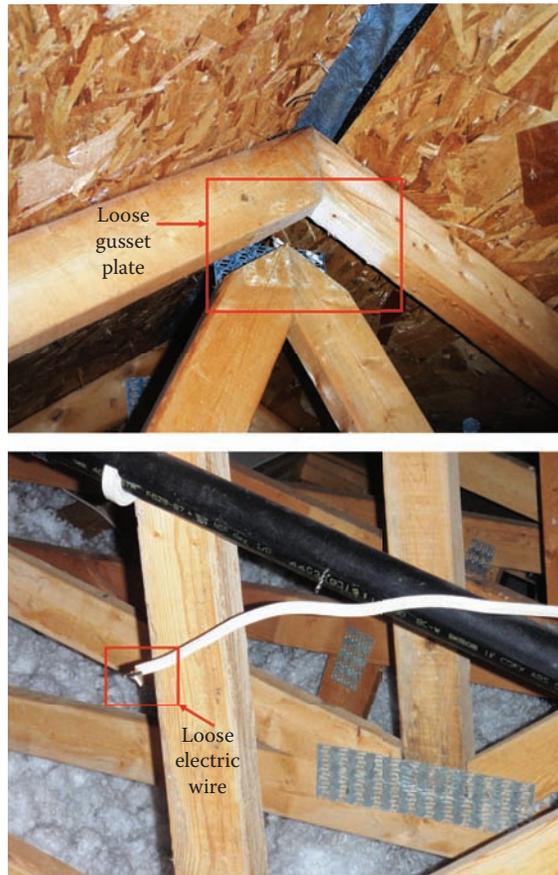
FIGURE 20.12
Explosion damage—dislocated truss members and wire in attics.

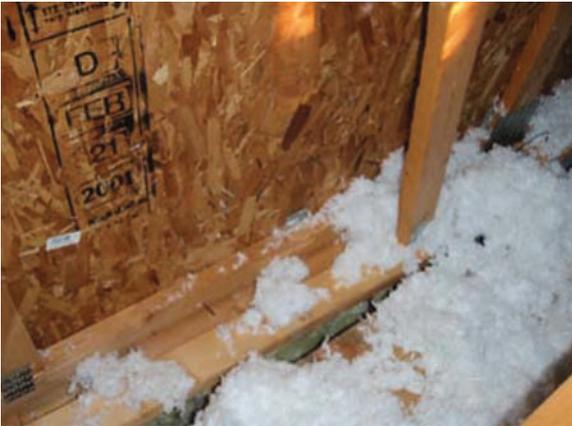
<p>A photograph showing a close-up of an attic space. The walls are covered in oriented strand board (OSB) with a date stamp that reads 'D FEB 21 2001'. The floor consists of wooden joists with a layer of white fiberglass insulation. A wooden stud is visible on the right side.</p>	Remove and replace
Main attic–SW Corner–Hole in decking

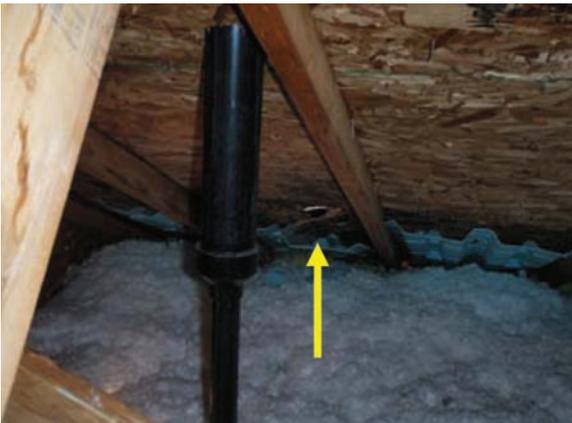
<p>A photograph showing a corner of an attic where wooden decking meets a vertical wooden post. A hole is visible in the decking. A yellow arrow points to this hole. Blue insulation is visible at the base of the post.</p>	Repair decking and roof shingles

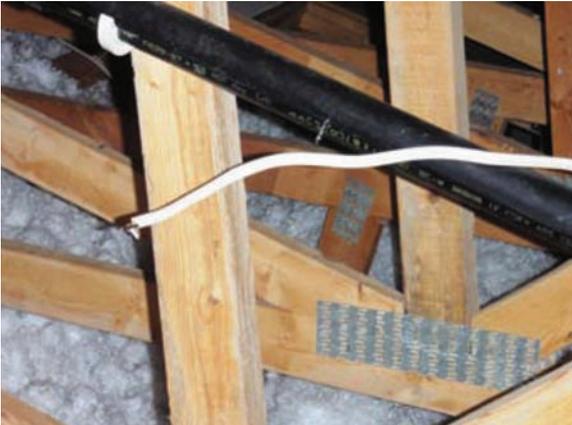
Component(s)	Photograph	Recommendation
Main attic—Loose electrical wire

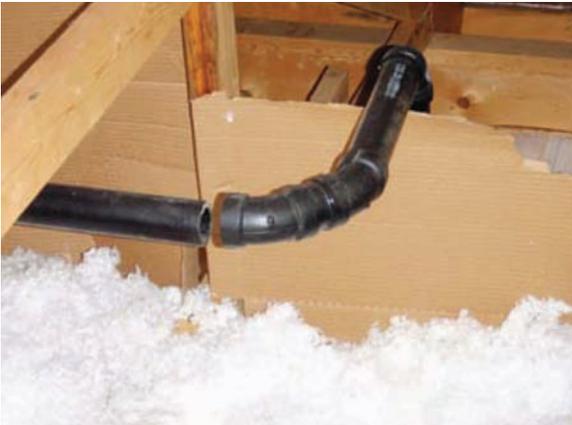
Inspect and repair
Main attic—loose soil stack line

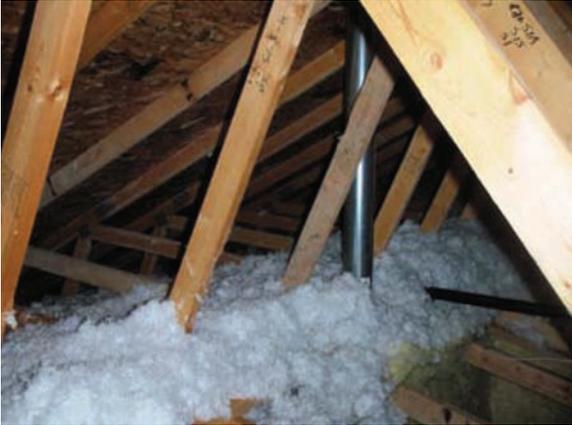
Inspect and repair
Loose boards on floor of attic Missing insulation

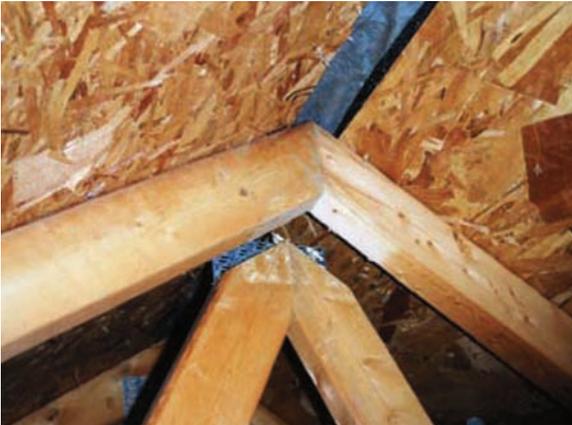
Component(s)	Photograph	Recommendation
Garage attic—Loose gusset plate

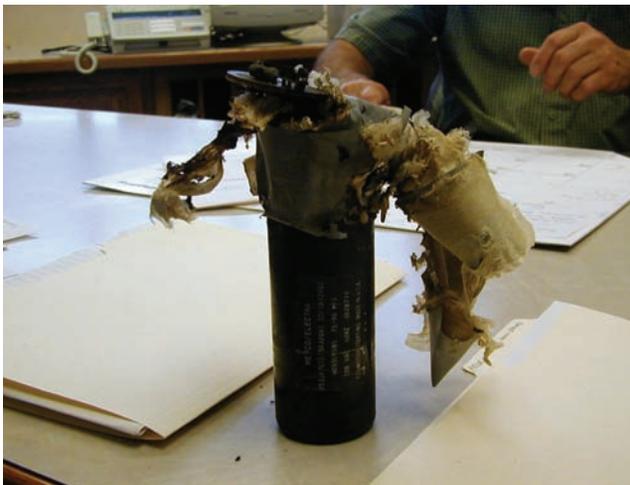
FIGURE 21.4
Explosive lightning damage to HVAC outdoor unit run capacitor.

Experience has shown lightning to damage the top edges of brick masonry chimneys since they are a structural high point. The damage is caused when moisture in the brick masonry is very rapidly vaporized, causing the brick to be damaged as if it exploded. Lightning damage to air conditioning outdoor units is typically manifested as high-voltage damage (blackened or melted) to items such as the contactor and/or run capacitor on the unit (Figure 21.4).

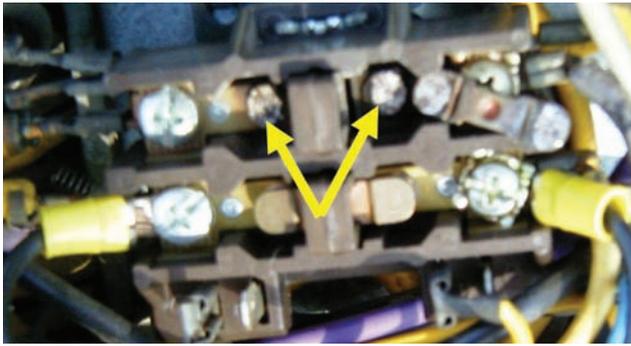
FIGURE 21.6

Melted points on an HVAC contactor.

- Circuit breakers supplying power to the unit were not blown closed.
- The points on the contactor were melted (Figure 21.6) and the packing of the run capacitor was blown out the end of the capacitor (Figure 21.7).

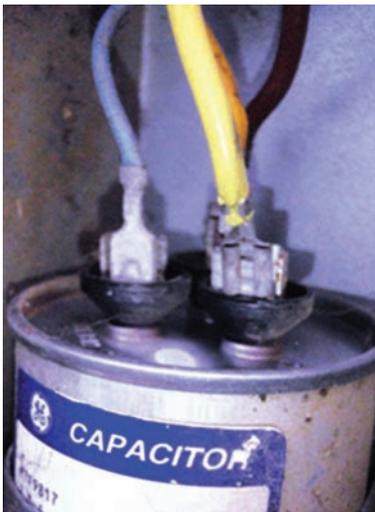
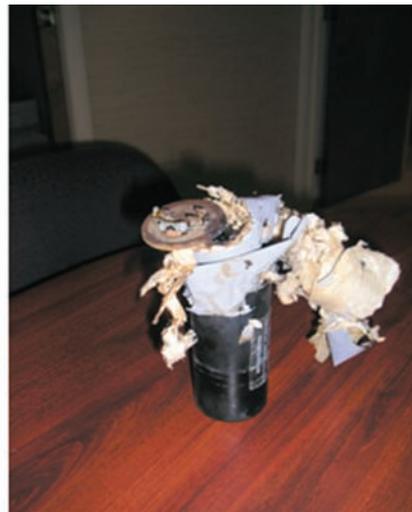
FIGURE 21.7

Normal and lightning damaged HVAC outdoor unit run capacitors.

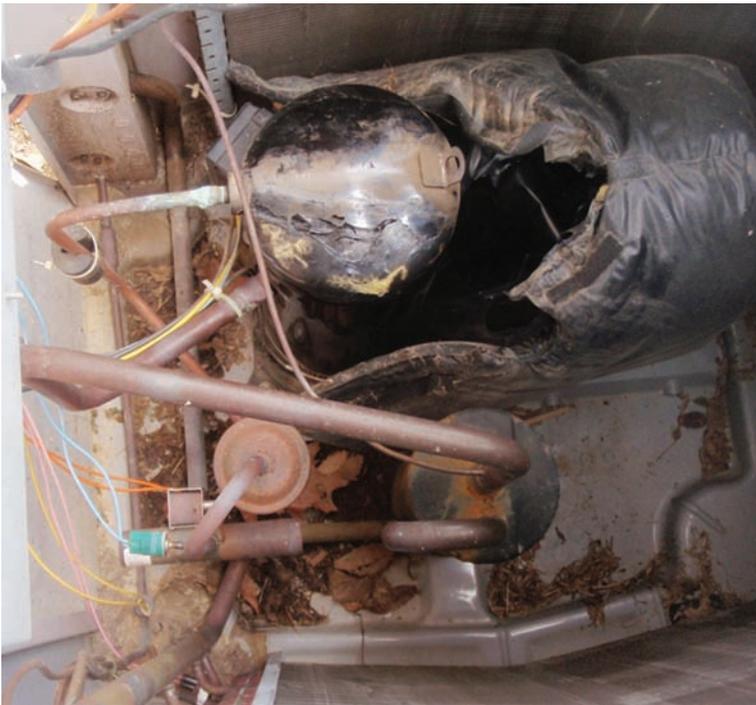
**FIGURE 21.8**

Heat pump outdoor unit—view from above.

Compressor Observations: Light heat effects were present on the paint on top of the unit. On removing the fan, the inside of the unit and the compressor could be observed. Light amounts of leaf debris were present near the base of the compressor; no compressor oil was observed near the base of the unit (Figure 21.8). The compressor was a Copeland Scroll compressor. The model number on the label was ZR49K3-PFY-230 and the serial number was 98J873539. The ends of all three wires to the compressor were not blackened, nor were the leads into the compressor. The electrical leads, by color, were black, blue, and yellow (Figure 21.9). Once the fan and fan housing were pulled up, the cover for the compressor leads was exposed to complete continuity and impedance checks (electrical checks) on the compressor. Results of the electrical checks on the compressor motor are summarized in Table 21.4.

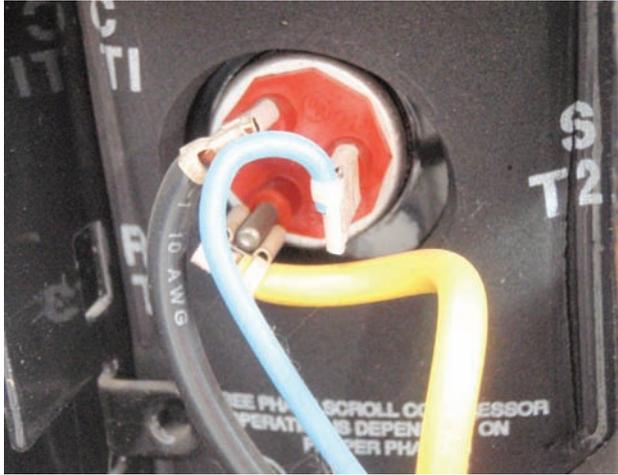
FIGURE 21.9
Heat pump outdoor unit—compressor power lead lugs.

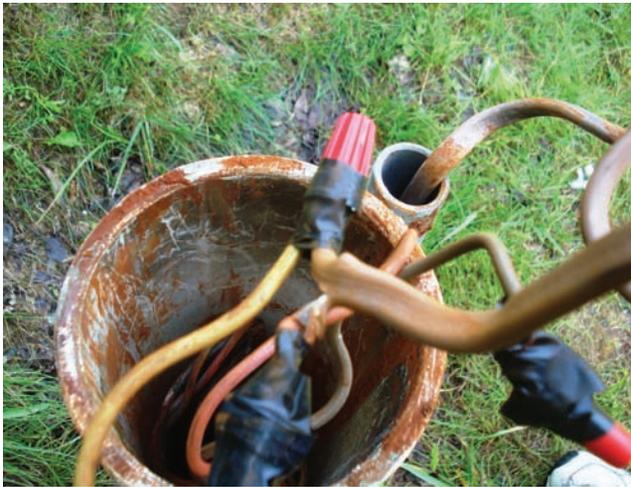
FIGURE 21.10
Well head casing and pump/motor wiring.

be inspected for evidence of high-voltage damage. An example of a well-head casing and well-head wiring is shown in Figure 21.10. As seen, no high-voltage damage was present to the well casing or well pump or motor wiring.

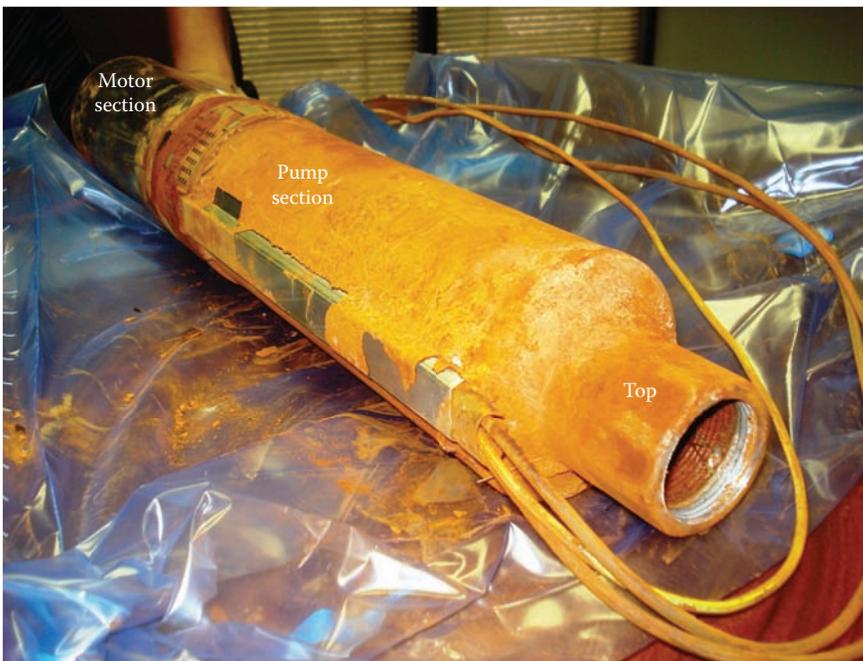
FIGURE 21.11
Removed well pump/motor.

In this example, no high-voltage damage was present, but heavy iron and soil deposits covered the unit, including the intake area of the pump. The motor section is typically located at the bottom of the unit and the pump section is above the motor section.

Similarly, once the well pump or motor is removed (Figure 21.11), general observations of the casing and wiring entering the casing should be made with a focus on evidence of high-voltage damage (e.g., burn marks, melted or burned wires).

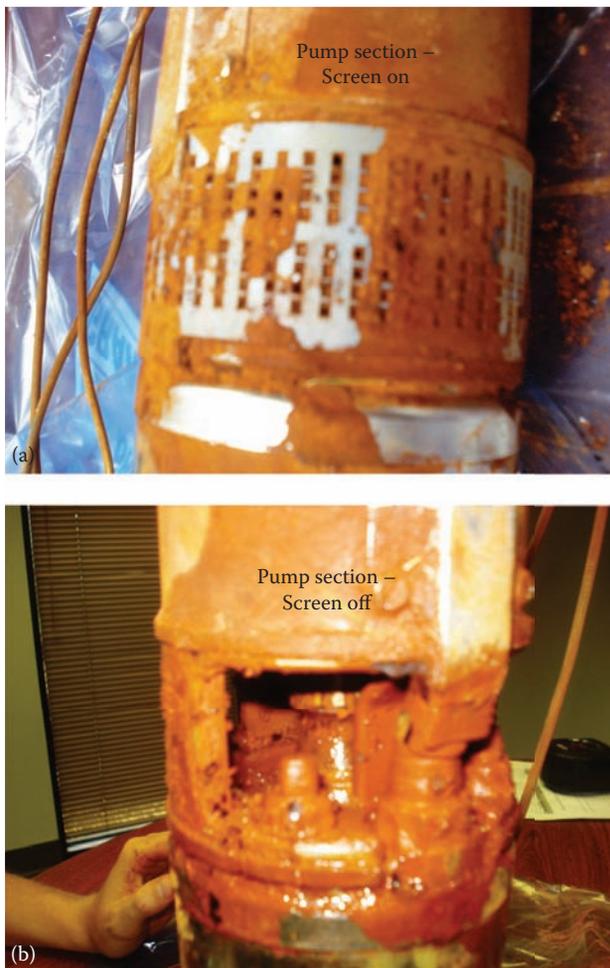
FIGURE 21.12
Well pump screen (a) and assembly behind screen (b).

The screen at midlevel was removed and exposed the nuts holding the lower motor assembly to the upper pump assembly. The screen was over half clogged with wet, rust-colored deposits. Once the screen was removed, the area behind the screen (pump inlet) was also heavily coated in wet, rust-colored deposits (Figure 21.12).

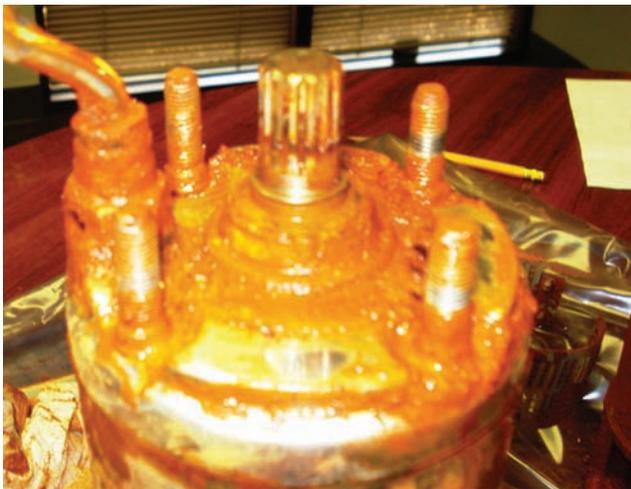
FIGURE 21.13
Well pump—motor assembly and drive to pump assembly.

The motor shaft, when manually manipulated by hand, would not rotate (Figure 21.13). When vice-grips were placed on the shaft, the shaft would not turn clockwise under full hand force, but would barely rotate counterclockwise with full hand force. The motor was clearly seized.

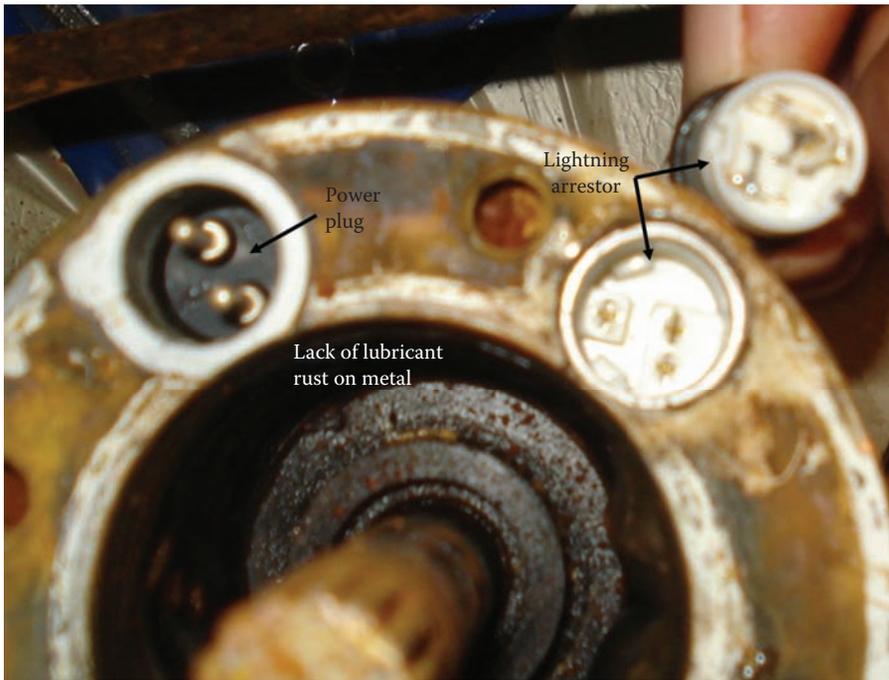
FIGURE 21.14

Lack of lubricant near motor windings and lack of high-voltage damage to wire connector or voltage arrester.

The top of the motor case was removed and exposed the motor windings and casing. The windings were rusted and very little oil was present in the case. What little material was drained from the motor case had a water/sediment appearance. Neither the electrical wiring connector, nor the arrestor plug, appeared to contain burn marks or melted leads consistent with high-voltage damage (Figure 21.14).
