Architectural Institute of Japan *Editor*

Preliminary  
Reconnaissance Report  
of the 2011 Tohoku-  
Chiho Taiheiyo-Oki  
Earthquake

This report is on the disaster caused by the magnitude-9.0 gigantic subduction-zone earthquake that occurred off the coast of Miyagi Prefecture on March 11, 2011. It was the largest earthquake that has struck Japan in its recorded history.

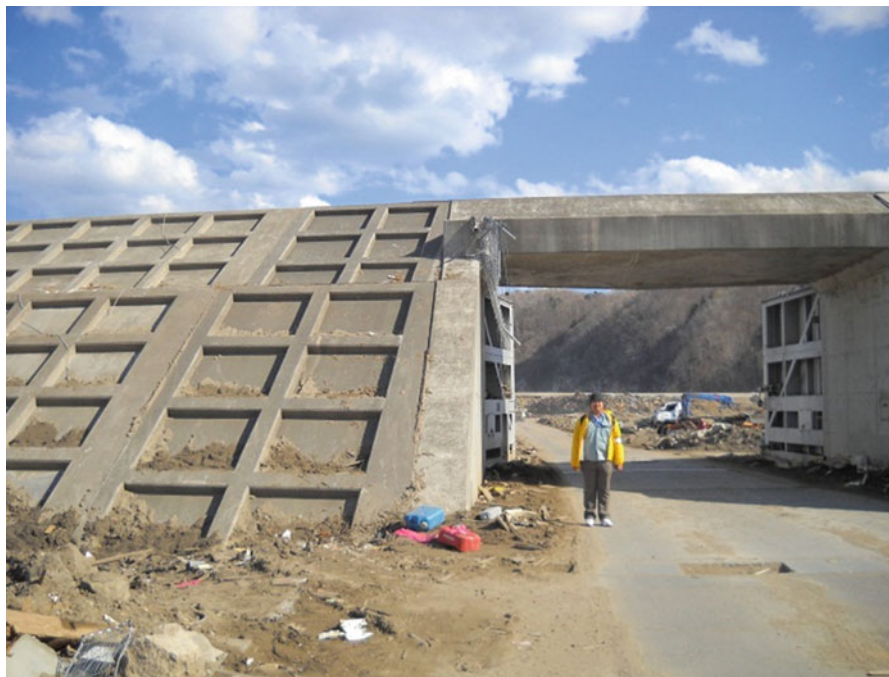
Figure 2.75 shows seawall with height of 10 m from the sea level. All the buildings have some damages except those buildings on the hillside. Figure 2.76 shows several remaining reinforced concrete and steel buildings after tsunami. Figure 2.77 shows a 5-storied building of steel construction in which the inundation depth reached 7 m. Figure 2.78 shows a 2-storied building of steel construction in the central area of Taro-Cho. The exterior cladding of the first story was totally destroyed. This building survival may be attributable to the destruction of the cladding, which resulted in reduction of tsunami pressure.

**Fig. 2.75** A huge seawall in Taro-Cho, 10 m high from the sea level

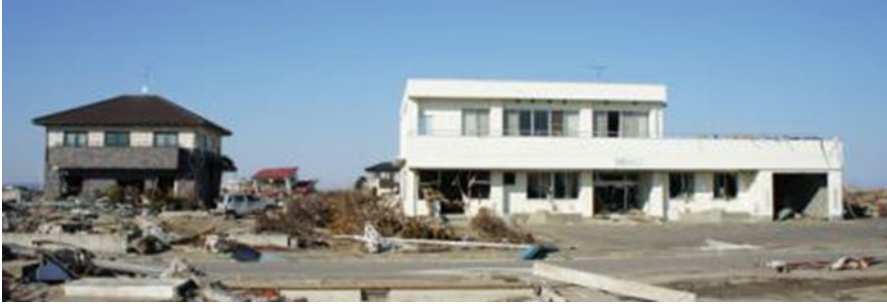
With a few exceptions, most wood houses were completely washed away by the tsunami. Figure 3.22 demonstrates one of the few wood houses left standing, due to a location downstream of a reinforced concrete building. Inundation depth estimated from remaining reinforced concrete buildings reached 6–8 m.

**Fig. 3.22** Wood house remained downstream of RC building

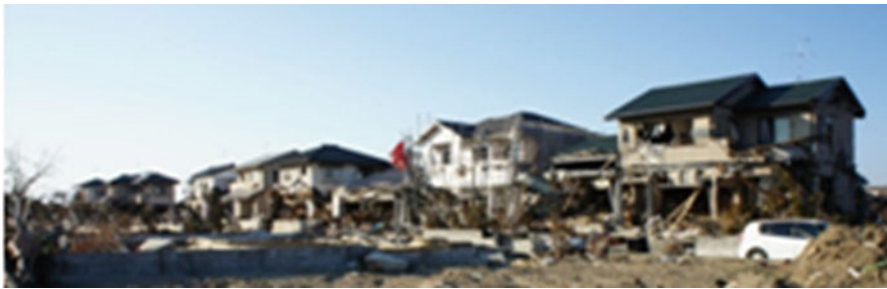
**Fig. 3.23** Wood houses remained in a line

In an area approximately 1.5 km away from the shoreline in Arahama district, many low-rise buildings were washed away. In this area, some houses situated in a line the direction of the water flow withstood damage, as evident in Fig. 3.23. Inundation depth in this area was estimated to be about 4–5 m, from the remaining houses being low-rise and non-wooden. On the other hand, there were several cases identified that no buildings were left standing in the direction of the tsunami waves.

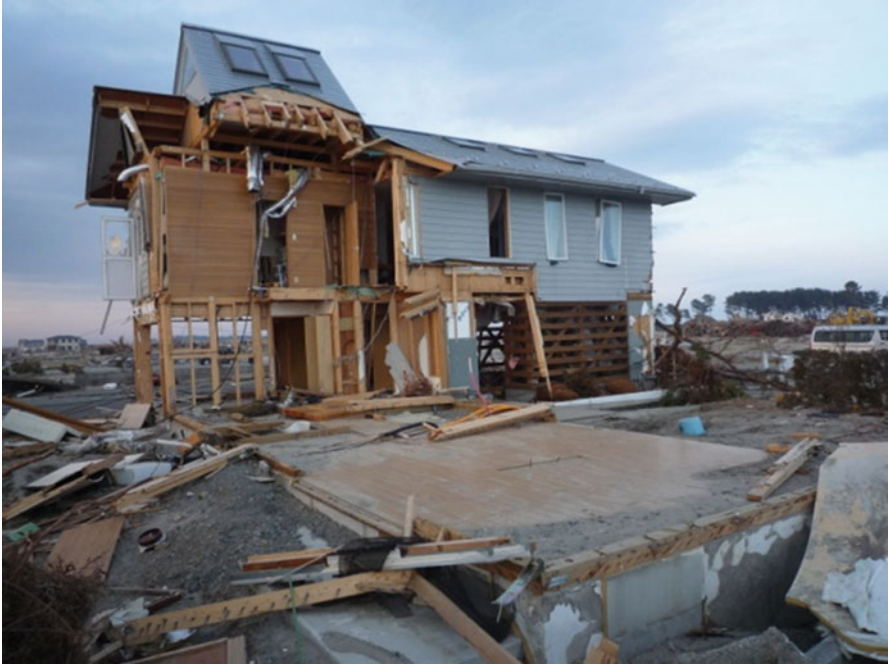
The extent of the severe damage was mostly on the eastern peninsular region. One timber building, as pictured in Fig. 3.34, was previously “L” shaped in plan. The part of the house that had the largest amount of area exposed to the tsunami

wave washed away while the shorter side remained. Judging from the joint fastener in Fig. 3.35, the completion of construction is estimated after 2000.

**Fig. 3.34** A portion of a wood house washed away

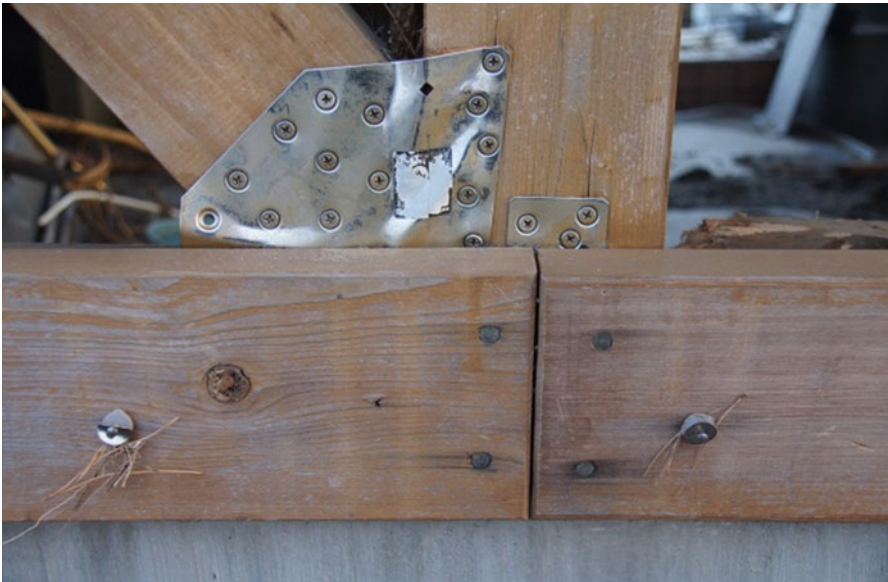
**Fig. 3.35** Fastener of joint in the house of Fig. 3.34

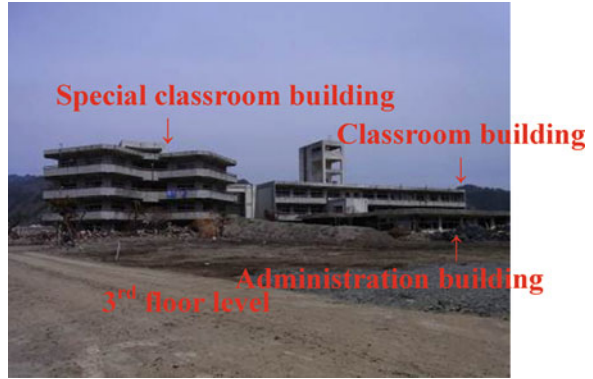
The gymnasium suffered most serious damage by tsunami that flowed over the riverbank in the northeast. In the building, steel frames supporting a roof completely collapsed southwestward by tsunami as shown in Fig. 4.3. Although the buildings had no structural damage by tsunami and/or ground shaking except the gymnasium, the interior was remarkably damaged due to sand deposit and debris flow. The damage in the third floor of classroom building is shown in Fig. 4.4. Tsunami trace was observed at the height of 10 cm from the third floor level in the stair hall of the classroom building (7.9 m from the ground level).

**Fig. 4.3** Damage to gymnasium

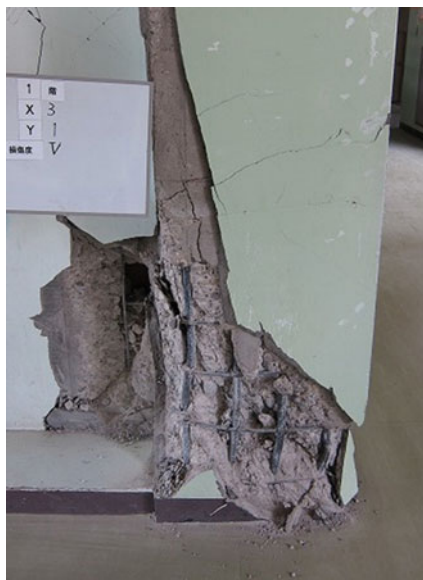
Structural members in the first story suffered most severe damage in NS direction. Shear failure of columns was observed accompanied with spall-off and crushing

**Fig. 4.11** Shear failure of a column at the first story

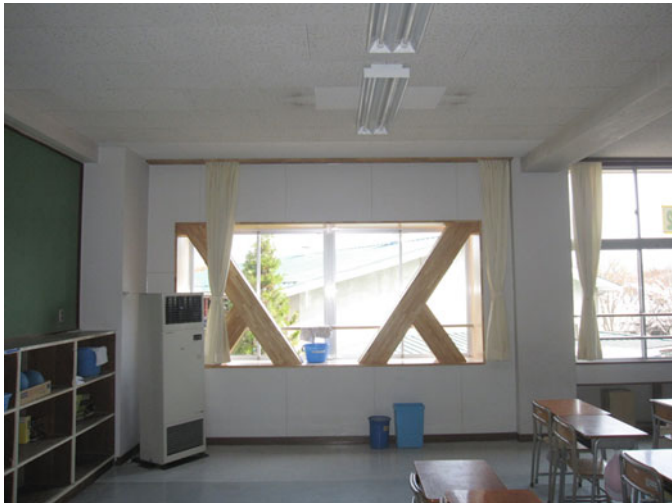
**Fig. 4.13** Seismic retrofit with framed steel brace in east building

The first and the second stories of the east building had been seismically retrofitted by the addition of framed steel braces (see Fig. 4.13), and RC shear walls in the longitudinal direction. On the other hand, the seismic retrofit had not been applied to the west building, as the seismic capacity index  $I_s$  of the building was larger than 0.7, which is the criterion set by the municipality of Sendai City.

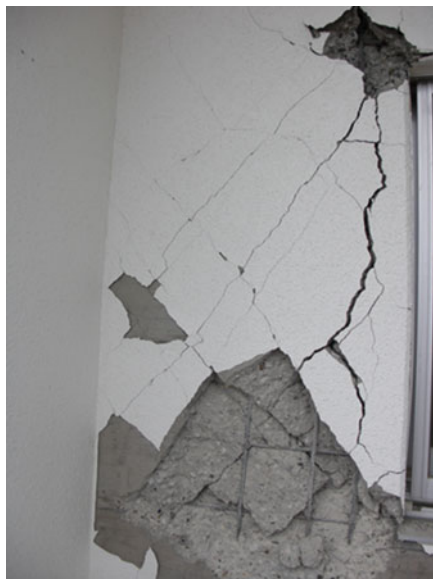
A shear wall with an opening at the second floor in the longitudinal direction failed in shear as shown in Fig. 4.17, the thickness of the wall was 150 mm. Many flexural cracks of damage rate II were observed for RC beams of all floor levels. Cover concrete spalled off at the end of the beams. Shear cracks of damage rate II

**Fig. 4.17** Shear failure of R/C wall with opening at second floor

occurred at a plastic hinge region of the beams. RC walls located at an out-of-frame failed remarkably in shear, accompanied with spall-off of concrete and buckling of steel bars. The residual seismic capacity rate  $R$  was estimated to be 69% for the second story in the longitudinal direction and the building damage was graded as “moderate.”

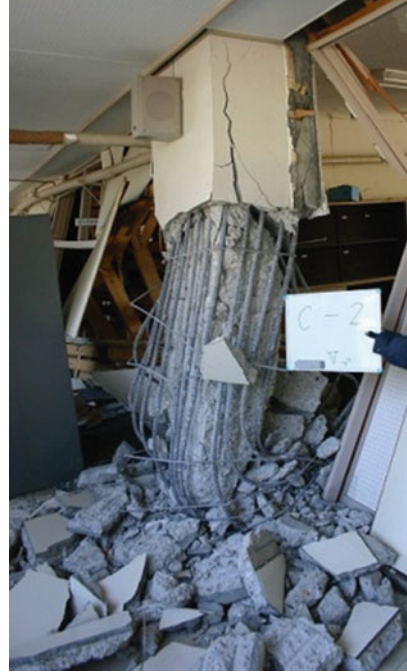
**Fig. 4.28** Shear failure of isolated column of first floor supporting walls of upper floors

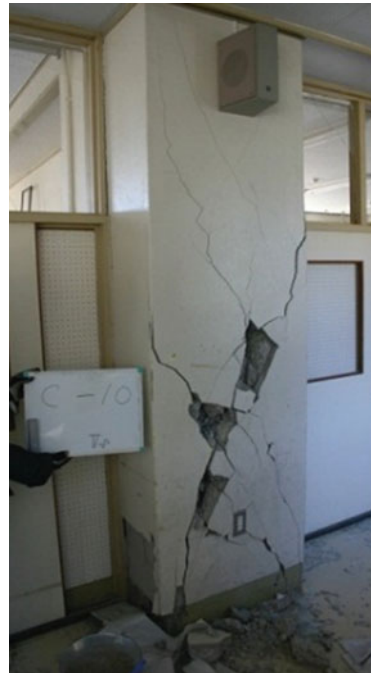
**Fig. 4.29** Shear failure of side column of barbell type shear wall of first floor

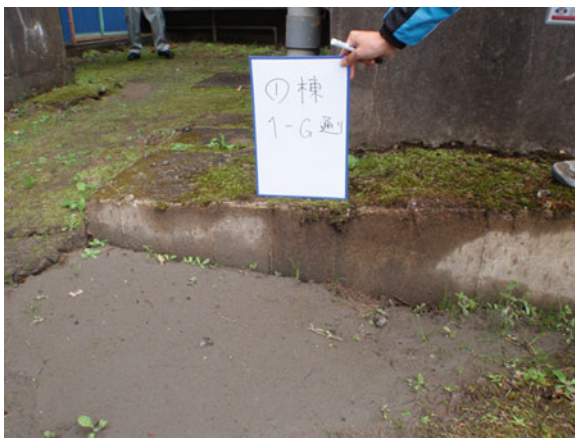
S junior high school is located in Katori city in the area of the Tone River basin where the JMA seismic intensity scale was 5-upper. Damage to foundation was observed in two three-story reinforced concrete school buildings as shown in Fig. 4.45, which were built in 1970–1971 and supported by PC piles with the depth of 16 m. The soil liquefaction was observed around the buildings and the peripheral soils settled down by 30–50 cm as shown in Fig. 4.46. The inclination of the building due to the settlement of the base foundations was observed as shown in Fig. 4.47. The maximum inclination of the building was around  $1/70$  rad, by which the damage was classified into the severe damage to the foundation. Compression failure was identified at the top of the PC piles reportedly from the excavation survey conducted later on.

**Fig. 4.46** Liquefaction of ground around the building

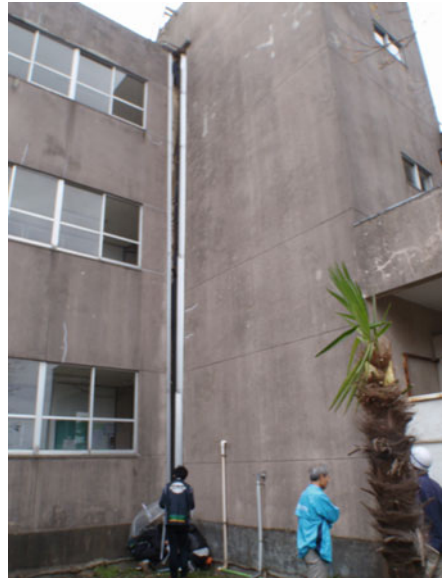
**Fig. 4.47** Inclination of buildings

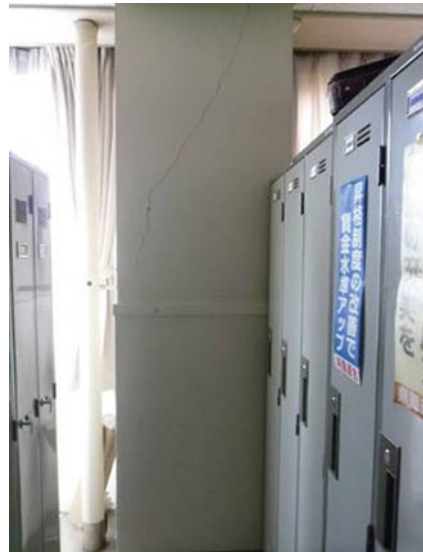
**Fig. 4.53** Column in the third story

The third story suffered more damage than the other stories, where minor flexural cracks were observed in the columns and two RC short columns suffered wide shear cracks in the third story as shown in Fig. 4.53. It is estimated that the strength of RC columns in the third story was much smaller than that of SRC columns in the second

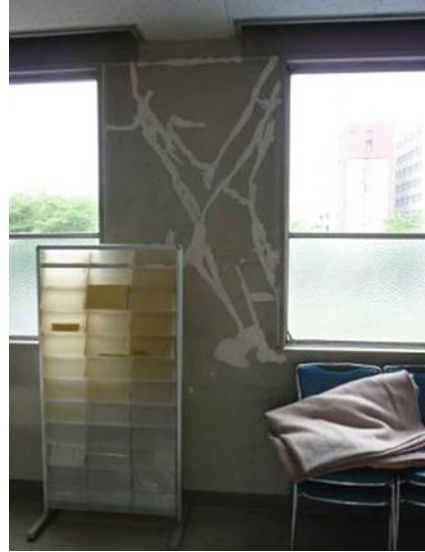
**Fig. 4.54** Non-structural wall in the third story

story, which might cause heavy damage to the third story. Many non-structural walls located between the exterior columns suffered severe damage in shear failure as shown in Fig. 4.54. The residual seismic capacity ratio  $R$  was estimated to 81% in the longitudinal direction of the third story and the damage was graded as “minor.”

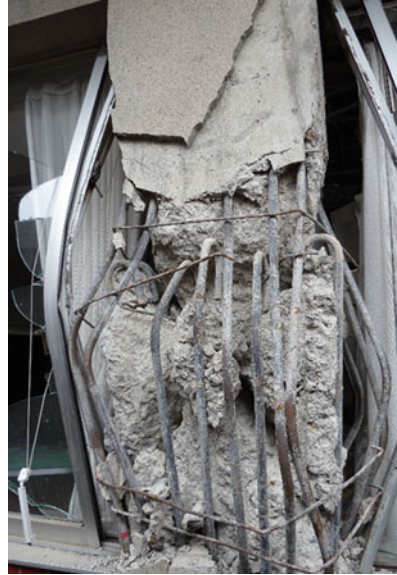
Axial shear failure of short columns due to spandrel walls was observed in the first story (damage rate of V, Fig. 4.55). The neighboring column in the next span is missing irregularly, which might have caused relatively higher axial load on the damaged column compared with the others. Twenty-five millimeter round bars were used as longitudinal bars in the column, some of which were interrupted and anchored by 180° hook in the middle of the column. The shear crack spreads from the middle level, and the shear failure might have affected by the reinforcing detail and also by insufficient amount of hoops. Several other short columns in the peripheral frames showed shear cracks especially in the east and south corners. Buckling of the longitudinal bars was observed at the bottom of the boundary corner columns

**Fig. 4.55** Shear failure of short column

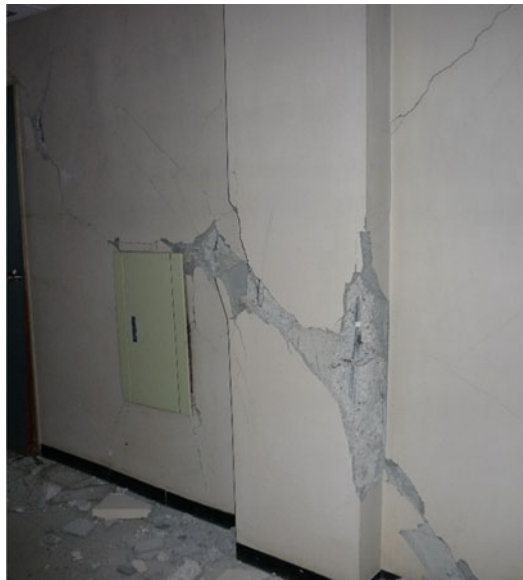
**Fig. 4.56** Shear failure of wing walls

The shear failure and cracks were observed in the columns with wing walls in the north and east section on the second story (damage level III, Fig. 4.56).

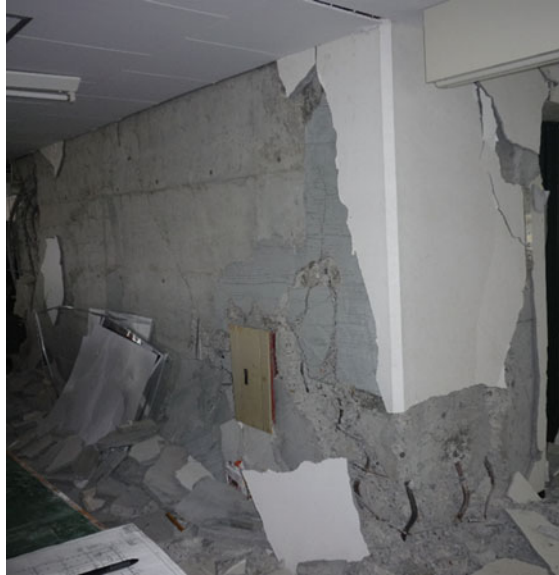
**Fig. 4.57** Shear failure of structural walls

The structural walls including center core walls on the second floor showed shear failure in both directions (damage level V, Fig. 4.57). Non-structural walls were also heavily damaged in a passage and east section.

The building suffered heavy damages in the first and second stories where the residual seismic performance ratios  $R$  were evaluated as 50% and 38% for the first story and the second story, respectively, thus the damage level is graded as “severe” for the both of them.

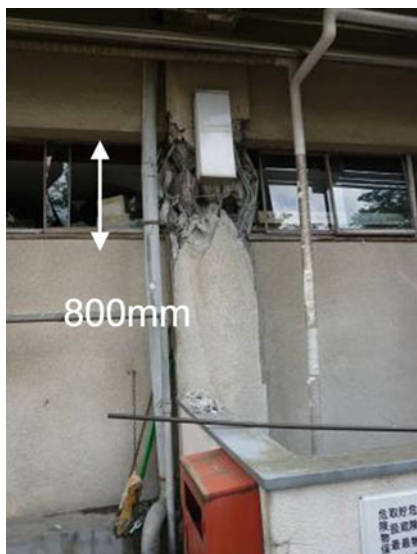
Fig. 4.59 Shear failure of short column in first floor

spandrel walls as shown in Figs. 4.59 and 4.60, a column with wing wall in Fig. 4.61 and a wall with opening in Fig. 4.62. Horizontal dislocation at the top of the walls on the third story was observed as shown in Fig. 4.63.

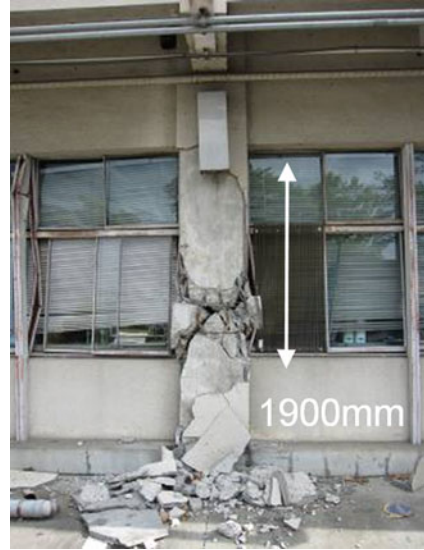
**Fig. 4.60** Shear failure of short column in first floor

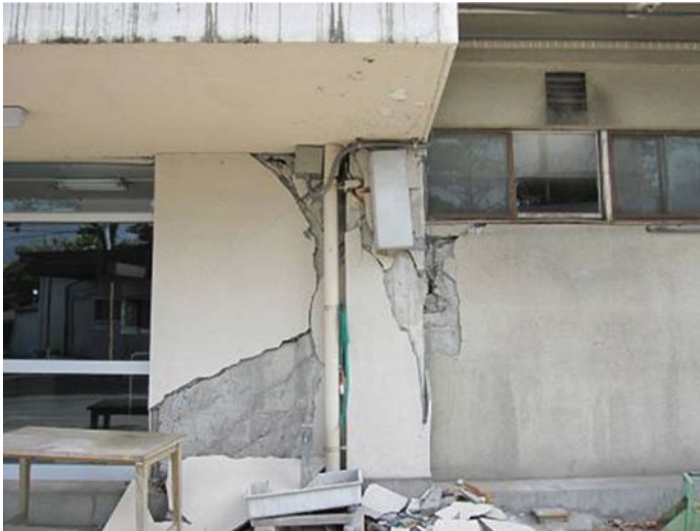
**Fig. 4.61** Column with wing wall

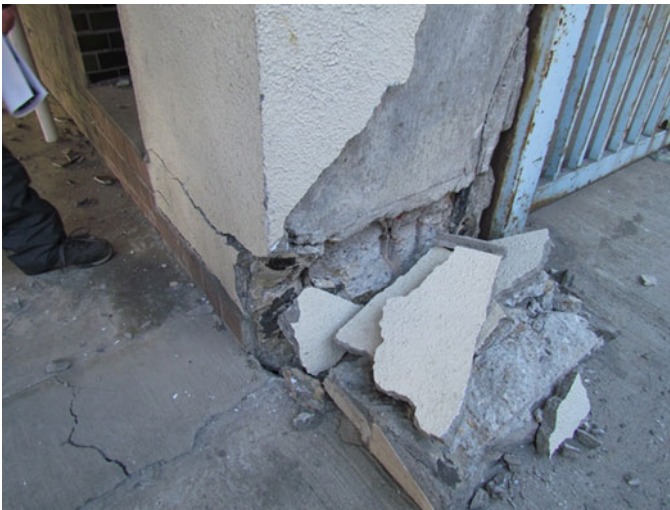
Fig. 4.65 Bottom of column

dwelling houses of an inside passage type with 84 units. An overview is shown in Fig. 4.64. Observed damages are flexural failure at the bottoms of four columns in the first story as shown in Fig. 4.65, and shear failures of structural shear walls in the first and second story as shown in Fig. 4.66, non-structural walls around the doors from the third through ninth story as shown in Fig. 4.67, and also external walls between the

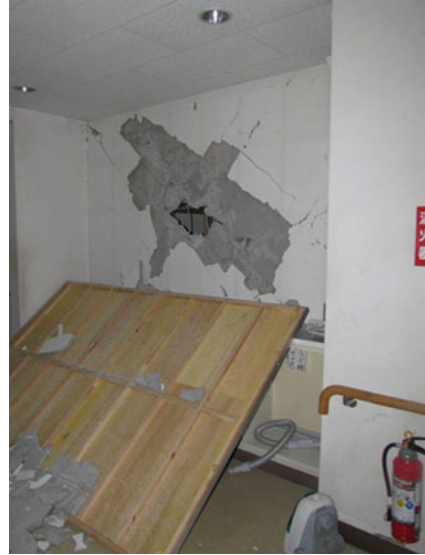
**Fig. 4.66** Shear wall

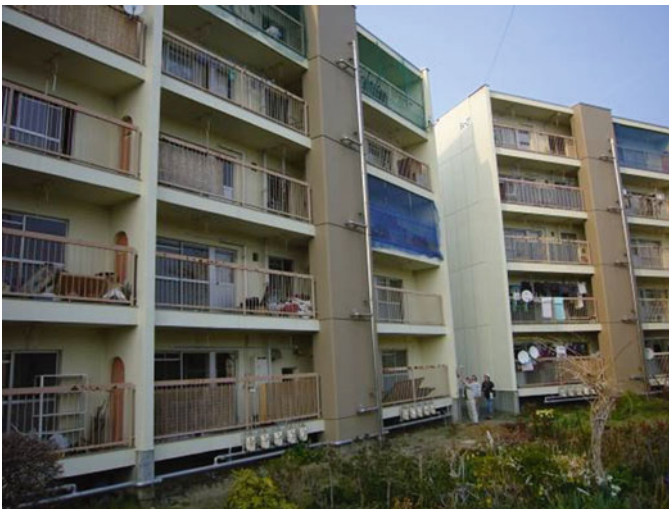
Because of the ground subsidence in the vicinity of Apartment Building Complex B a five-story building rotated which caused serious damage to the retaining wall, foundations, and building infrastructure. Damaged retaining wall is shown in Fig. 6.10, while Fig. 6.11 shows the building in a rotated state. Also, Figs. 6.12 and 6.13 show the condition of the soil surrounding the building. The angle of building rotation in the short side direction is  $22/1000$  rad, while the rotation angle in the long side direction is  $9/1000$  rad. The inclination was measured at all four corners of the building using 1-m-long inclinometer. This buildings complex experienced the seismic intensity of 6-upper.

**Fig. 6.11** View of rotated building

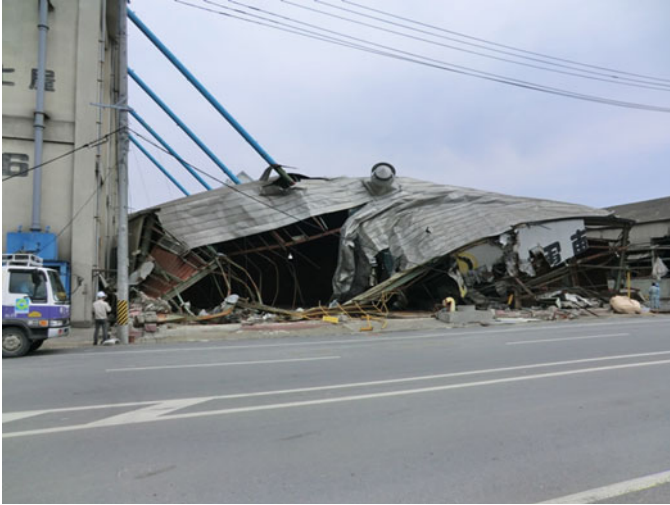
Fig. 8.53 Port facility C: external view

Observations: two spans closest to the shore collapsed. Fracture of anchor bolts

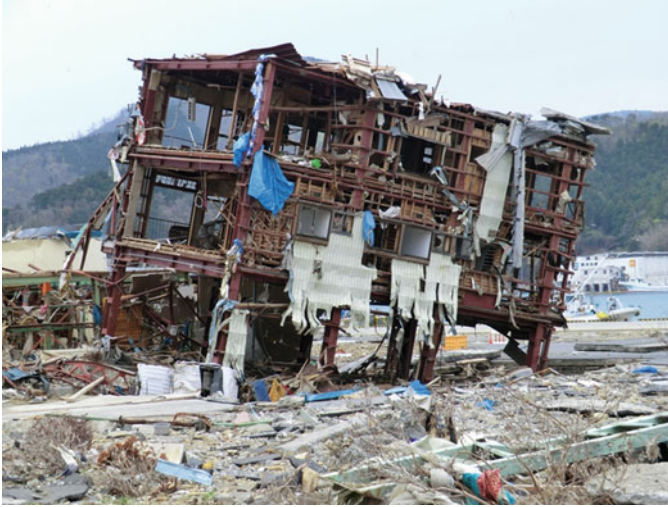
**Fig. 8.55** Building A: external view showing large tilt

Observations: building tilted after foundation scouring

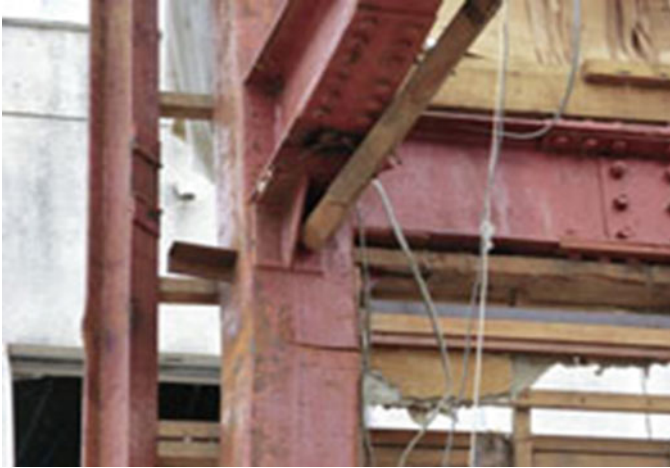
**Fig. 8.65** Building E: beam-to-column connections at corner column

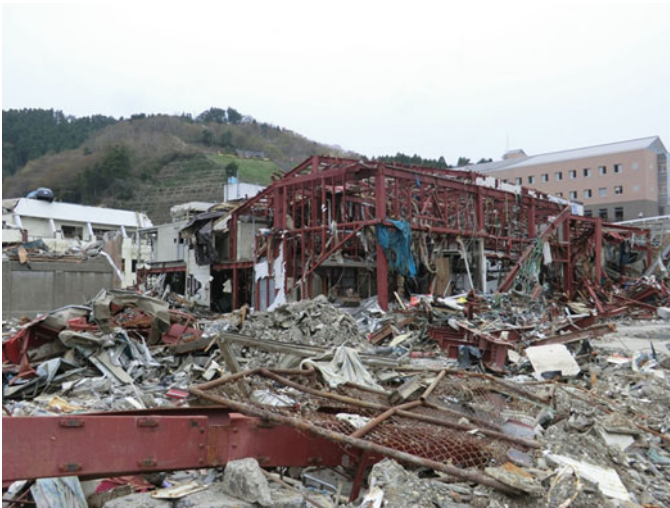
### **8.3.2.6 Building F (Figs. 8.66, 8.67, and 8.68)**

**Fig. 8.66** Building F: external view

Observations: collapsed. Fracture of beam-to-column connections, anchor bolts, and horizontal braces

**Fig. 8.67** Building F: beam-to-column connection

**Fig. 8.68** Building F: column base

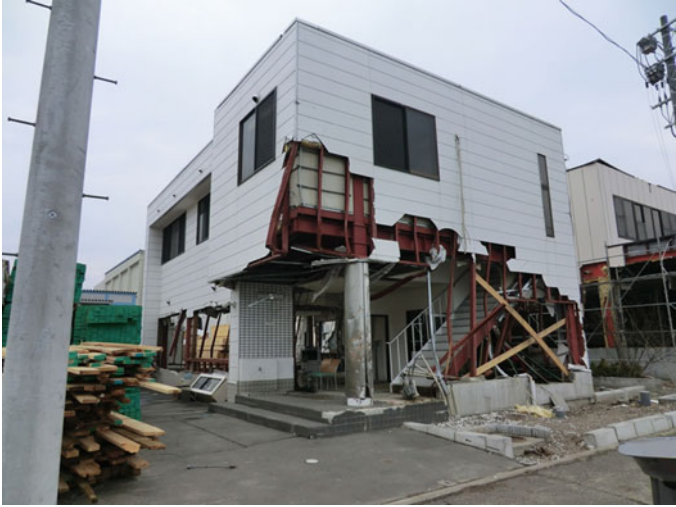
**Fig. 8.77** Office building C: external view

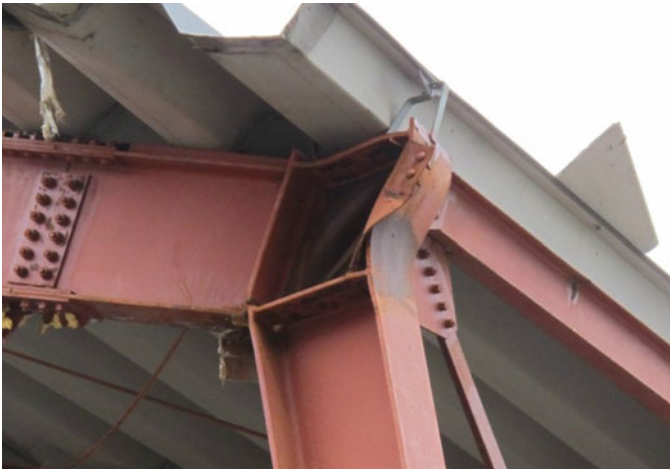
**Fig. 8.129** Factory G: large deformation of column panel zone

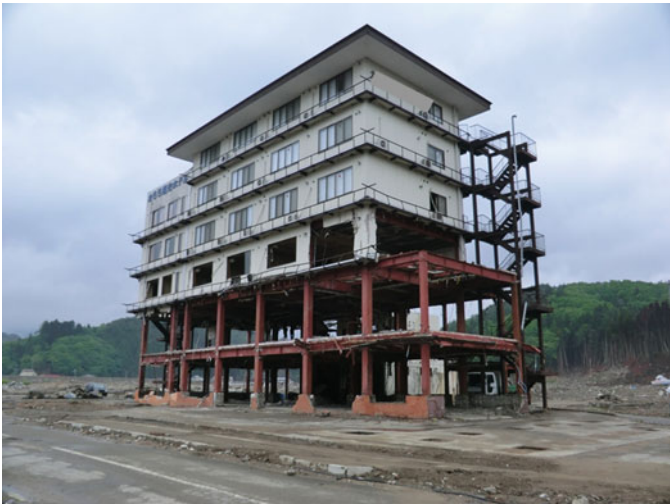
**Fig. 8.149** Hotel B: external view

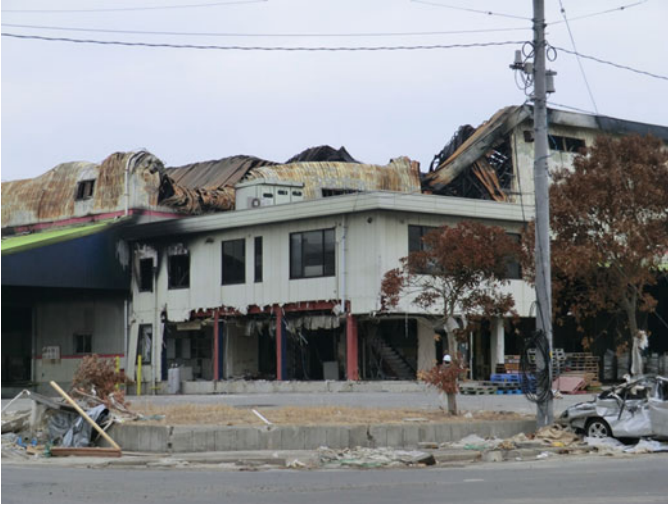
Damage in some buildings was exacerbated by fire that initiated after the earthquake and tsunami. The cause of fire is unknown (Figs. 8.160, 8.161, 8.162, and 8.163).

**Fig. 8.160** Warehouse (Miyagino, Sendai)

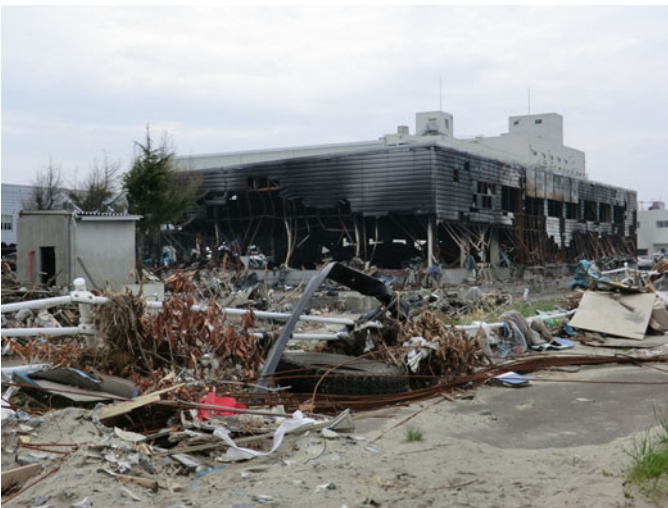
**Fig. 8.161** Building (Miyagino, Sendai)

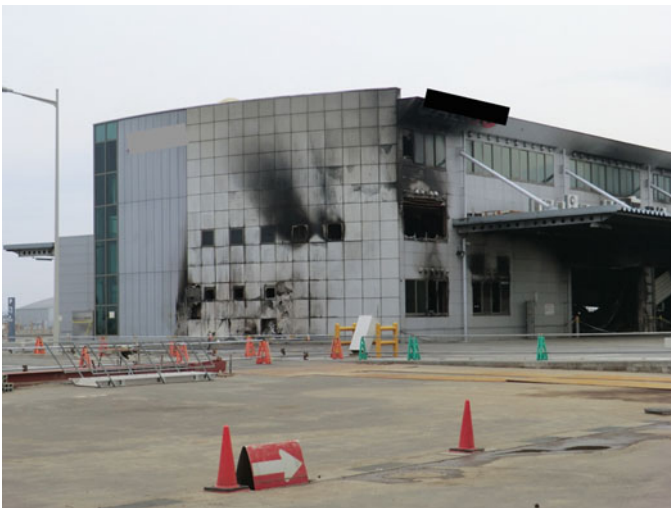
**Fig. 8.163** Delivery station (Natori)

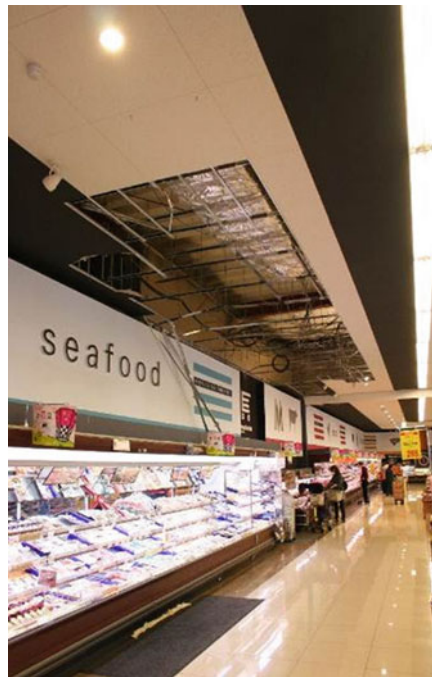
Low-rise commercial steel structures have been frequently constructed all over Japan. Most ceilings in this type of structure were severely damaged. The main damage was in the falling and breaking of ceiling panels connected to light-gauge steel, especially near the connection with a wall (Figs. 9.11 and 9.12). The exterior wall made of ALC panels, as shown in Fig. 9.13, exhibited peculiar damage. This is possibly due to interference between exterior wall and light-gauge steel of the ceiling.

**Fig. 9.11** Damage to ceiling panels

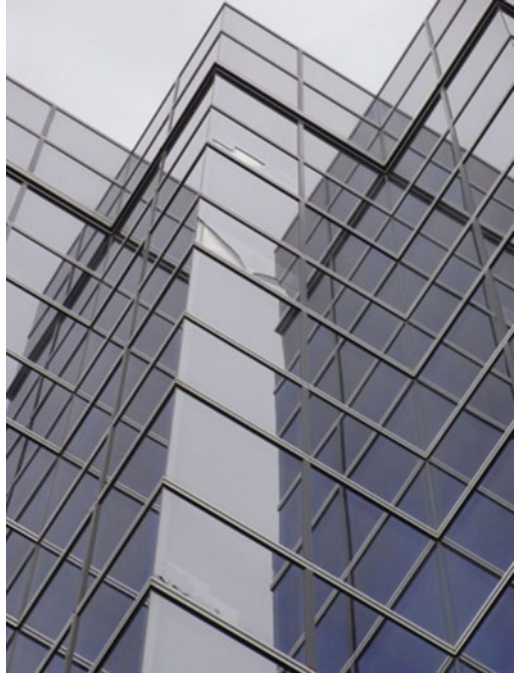
Horizontal composite windows was damaged due to large inter-storey displacement (Fig. 9.29). Furthermore, partial damage on glass curtain walls were also reported (Fig. 9.30). However, glass curtain walls of skyscrapers appeared to be intact (Fig. 9.31).

**Fig. 9.30** Damaged glass curtain walls

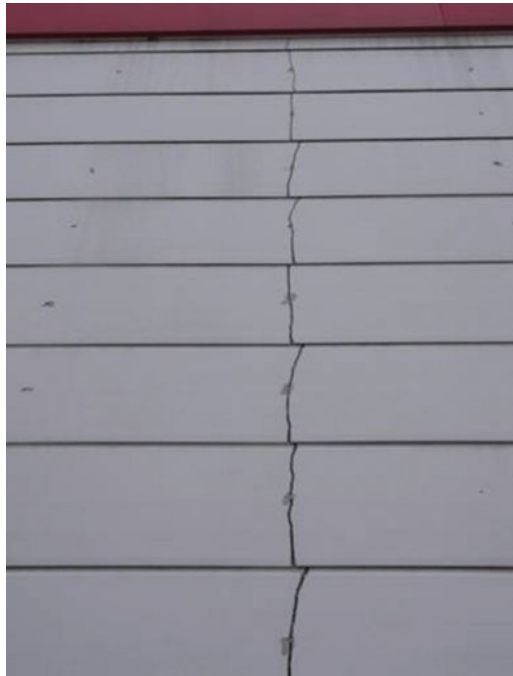
In addition to damage observed above, there were falling-off of non-curtain wall type precast concrete panels in Sendai (Fig. 9.32). There was also damage in the form of falling-off of glass blocks in Fujinomiya (Fig. 9.33). Cracks on exterior walls, such as steel structure siding boards, were also observed (Fig. 9.34).

**Fig. 9.34** Cracks on siding boards of exterior wall

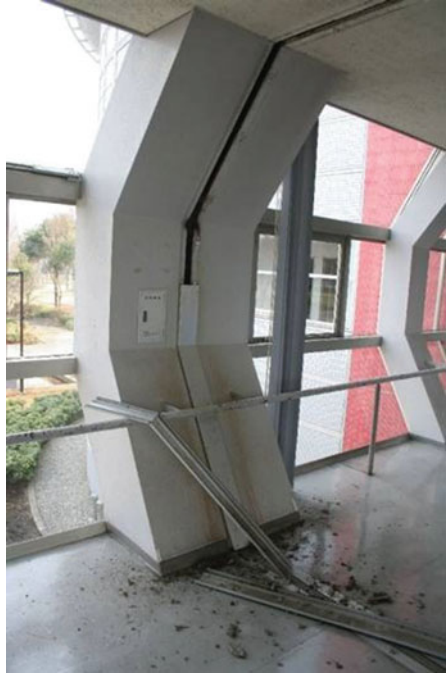
In lots of cases, damage to expansion joints was seen in school buildings, commercial buildings between parking areas, and factories (Figs. 9.41 and 9.42).

**Fig. 9.41** Damaged expansion joint

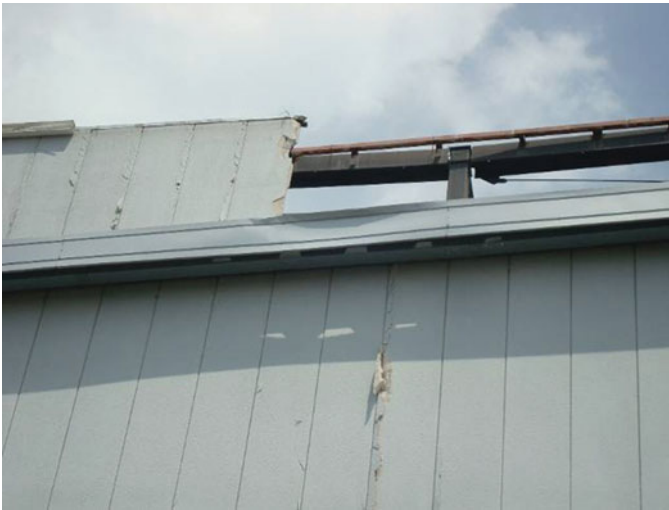
**Fig. 9.44** Damaged parapet

Workpieces such as signboards saw extensive damage in many cases (Figs. 9.43 and 9.44).

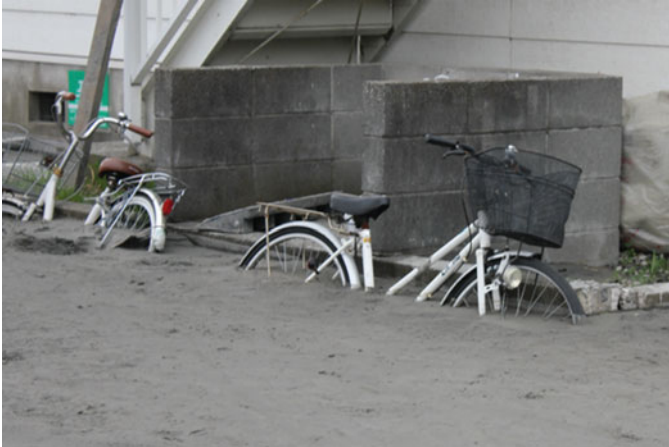
- In the area where liquefaction occurred, sand boils (Fig. 10.6), ground subsidence, inclination and settlement of buildings with spread foundation (Figs. 10.7 and 10.8), damage of piping due to the difference in level between buildings with pile foundation and surrounding buildings (Fig. 10.9), uplift of underground structure (manhole, emergent water tank and underground parking) (Fig. 10.10), damage to water and sewage, cave-in of roads, and falling of the poles, were observed to varying degrees. But little structural damage due to vibration was observed.

Fig. 10.6 Sand boils and buried cycle

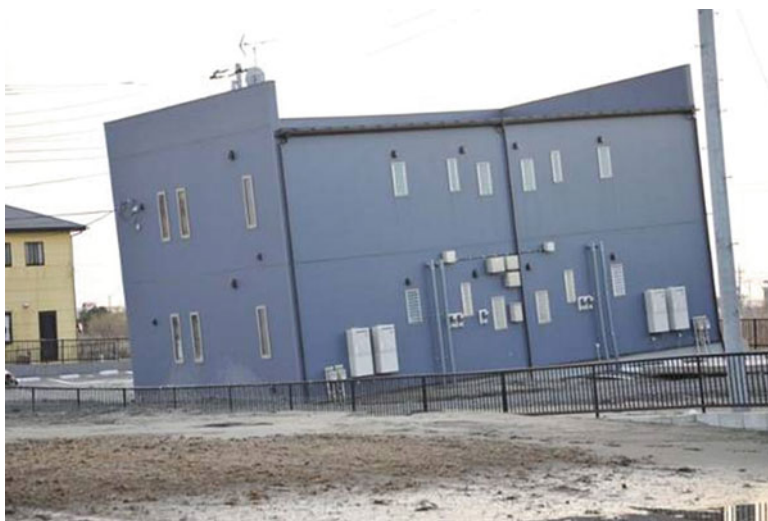
In the Fukashiba and Horiwari districts, many sand volcanoes occurred causing housing with spread foundations to tilt and subside (Fig. 10.18), the ground around pile foundation buildings to subside, underground structures to rise up, and roads and pedestrian walkways to experience subsidence and become uneven. In Fukashiba

**Fig. 10.18** A leaning building

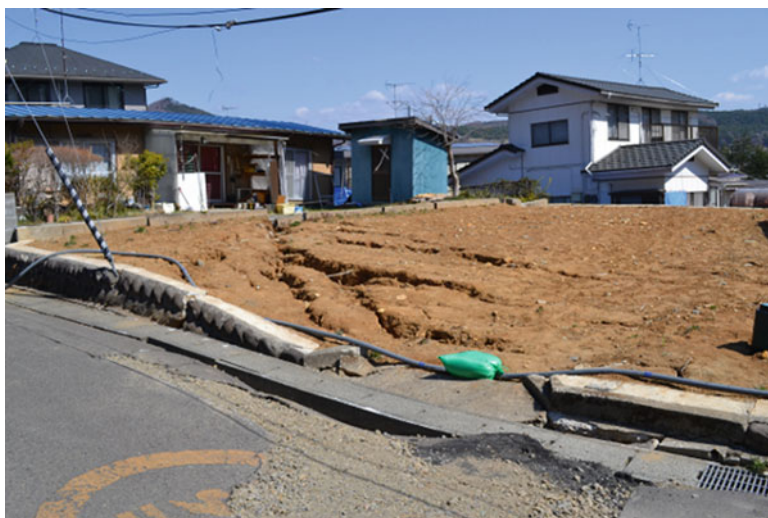
Fig. 10.23 Large cracks

backfill. Some of the upper retaining walls were newer than the lower ones, and some may have undergone repair. However near the upper part of the slope (P3), there were large cracks in the site as shown Fig. 10.23. At the top of the slope, there were also places with tensile cracks in the retaining wall. This means that at these points, tensile force was produced in the ground. The locations of compression and
